**Inspection Photo (s)**  
**GMR 21-10B**  
**API # 05-045-08195**  
**Inspection # 689303120**

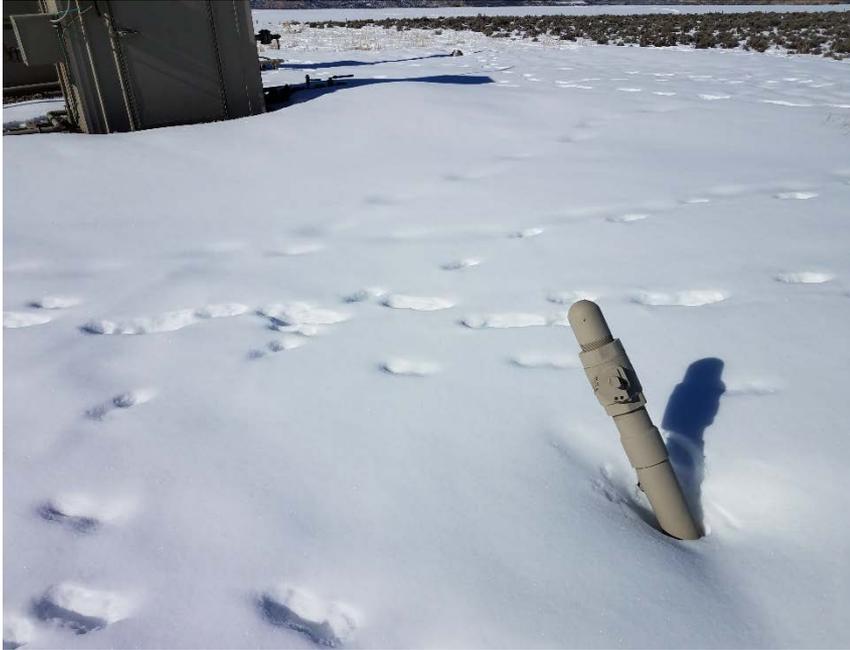
**Location Photo #3, unmarked, unused flowline riser.**

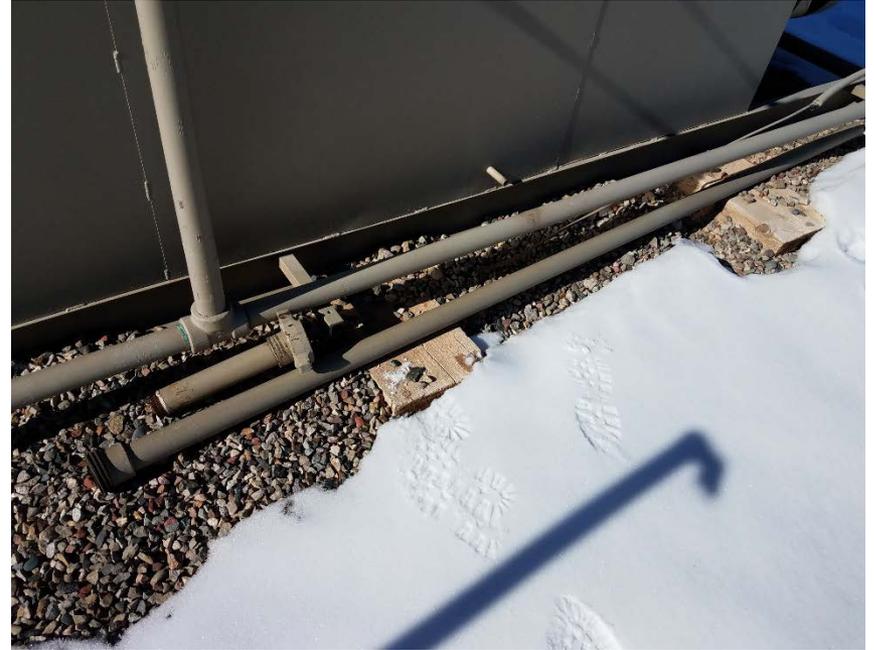
**Location Photo #4, unused equipment next to separator.**
