**Inspection Photo (s)**  
**GMR 28-2A**  
**API # 05-045-09838**  
**Inspection # 689303124**

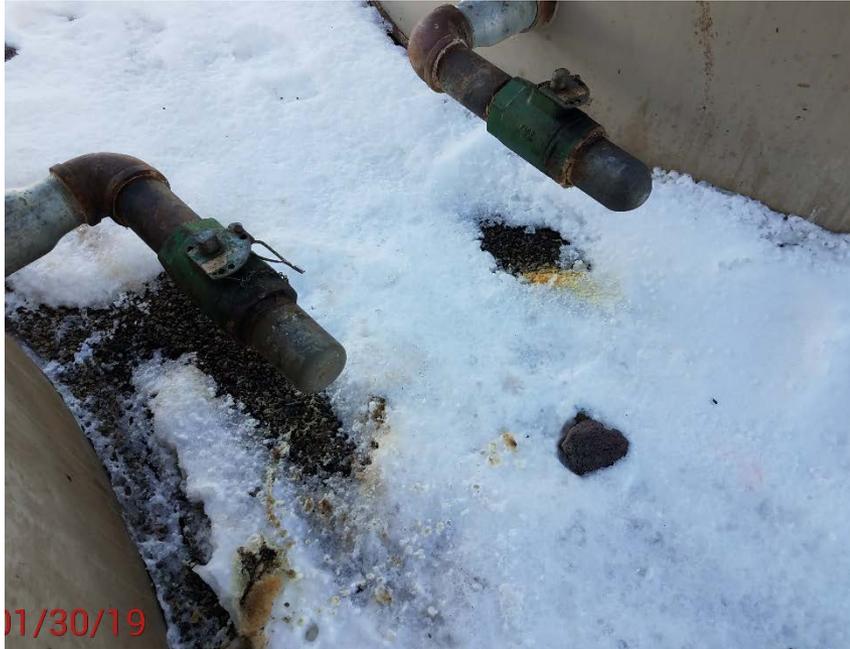
**Location Photo #3, Stained soil. Mechanical integrity of valves.**

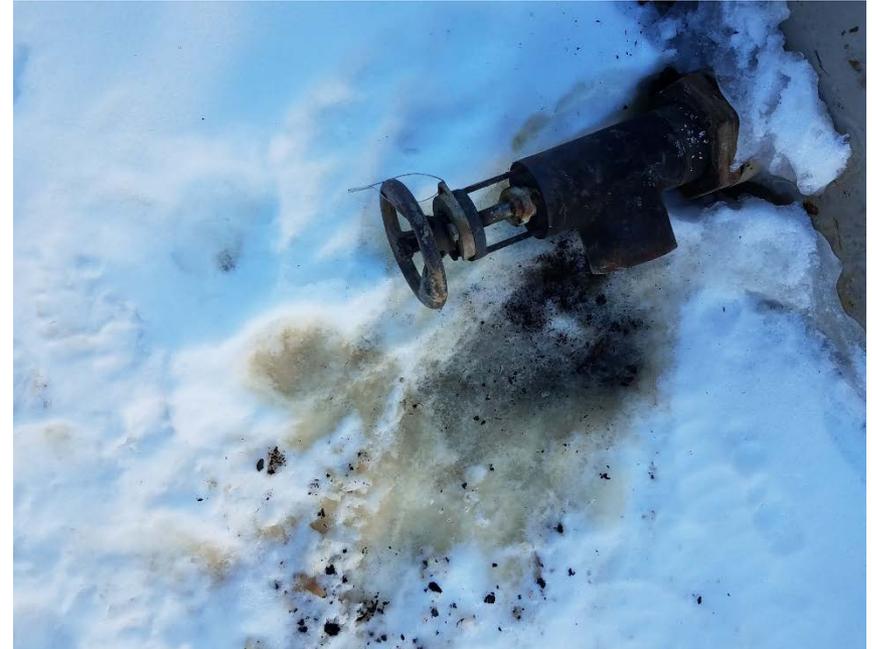
**Location Photo #4, stained material.**
