**Inspection Photo (s)**  
**GMU 33-6**  
**API # 05-045-10829**  
**Inspection # 689303126**

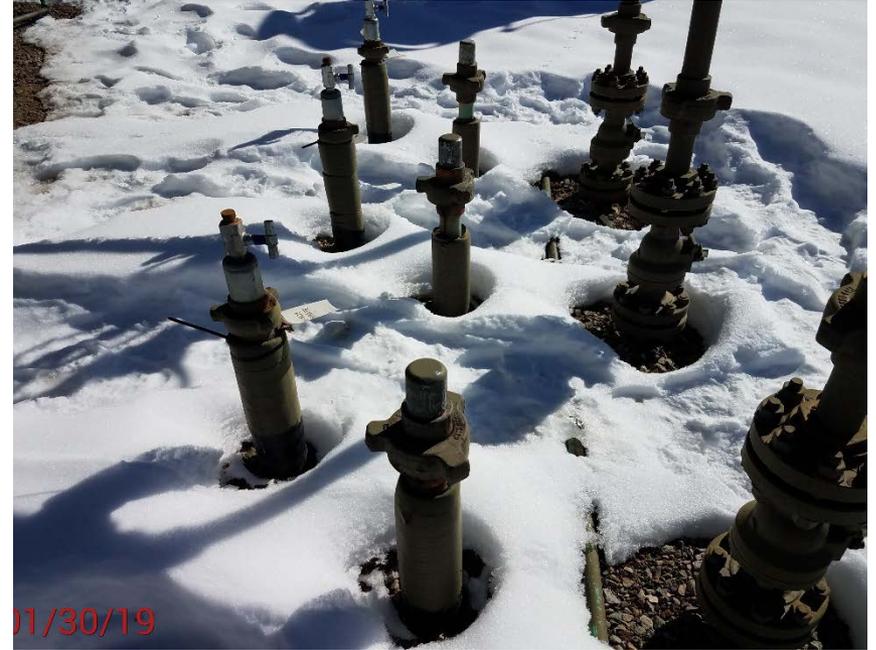
**Location Photo #4, Unmarked flowline risers.**

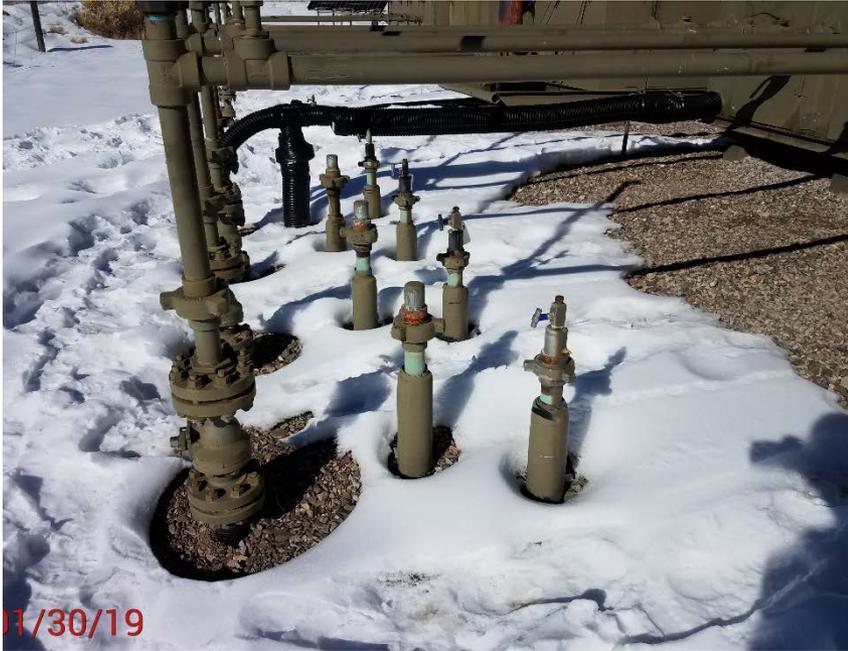
**Location Photo #5, unmarked flowline risers.**

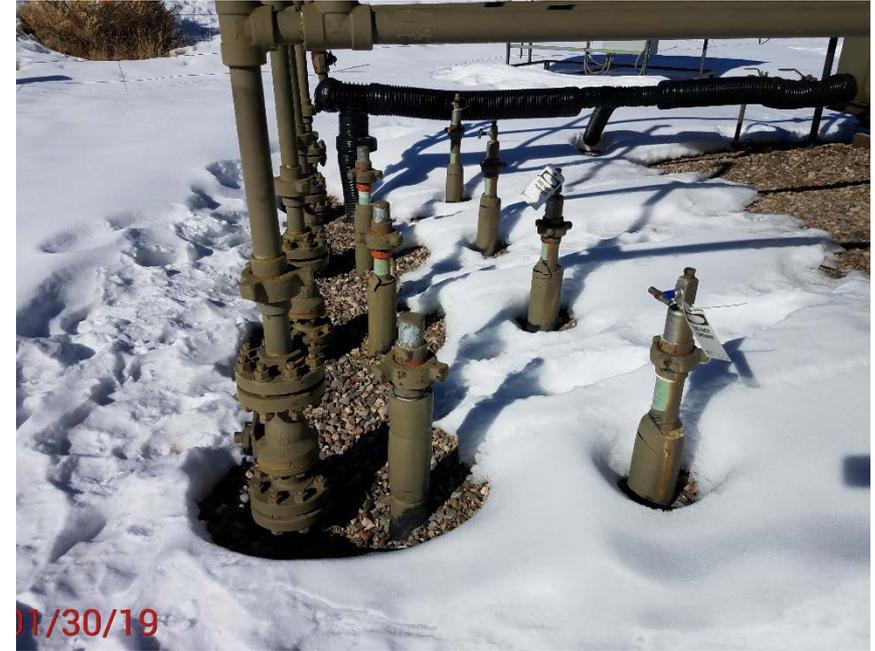
**Location Photo #6, unmarked flowline risers.**
