Inspection Photo (s)
GMR 34-10A
API # 05-045-17578
Inspection # 689303128

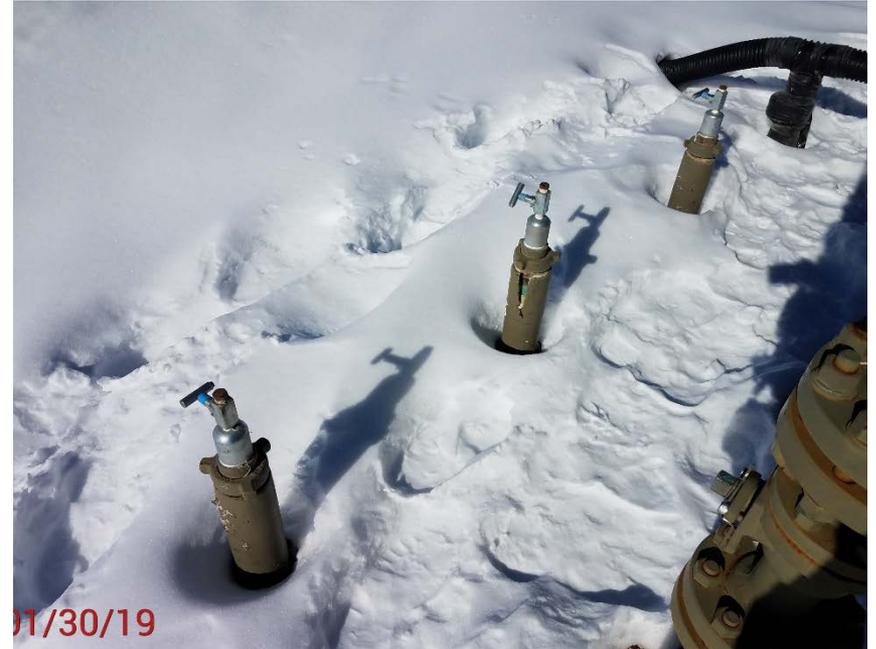
Location Photo #4, 3 Unmarked flowline risers.

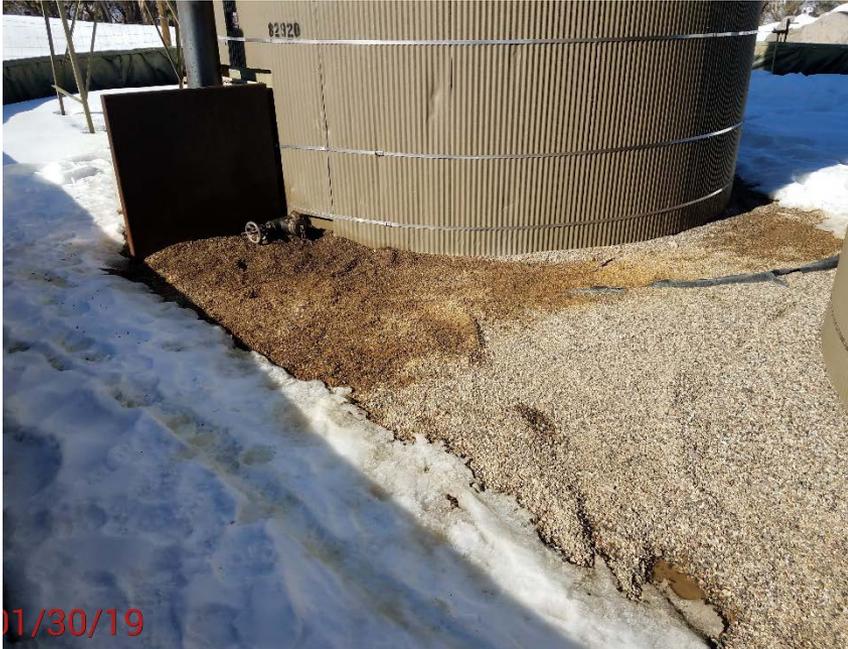
Location Photo #5, Stained material in battery containment.

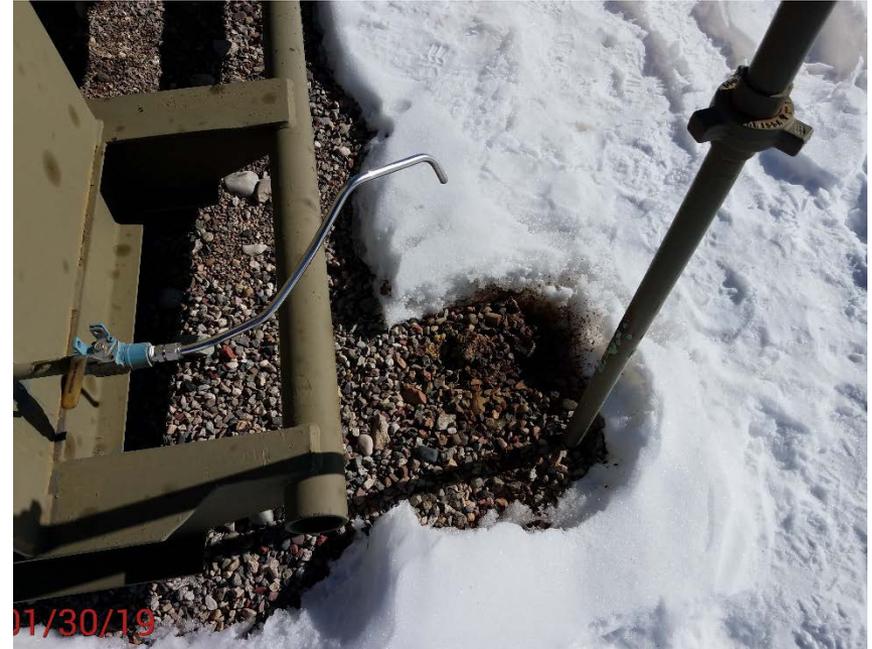
Location Photo #6, Stained rock at blowdown line from separator.

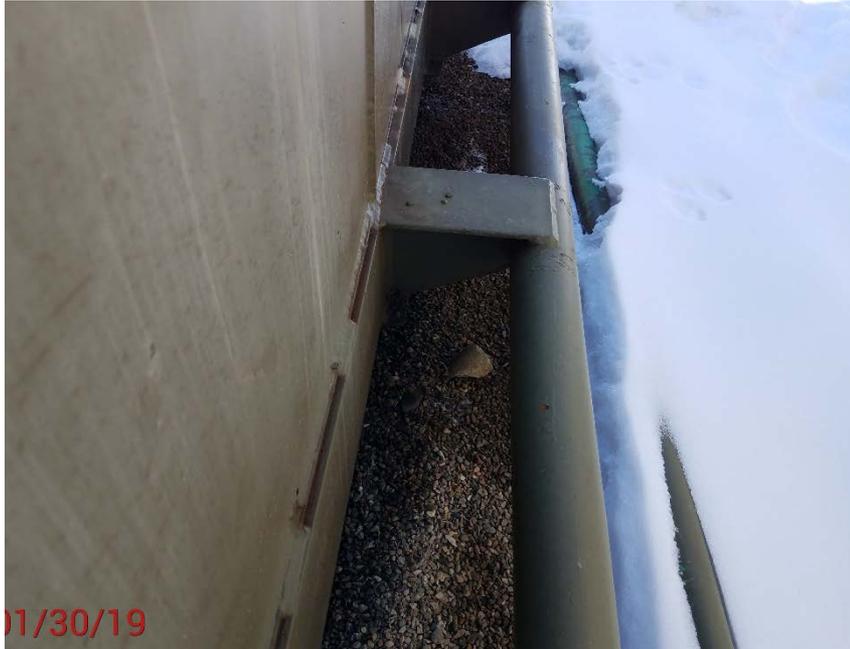
Location Photo #7, Stained rock on North end of Vertical Separators.

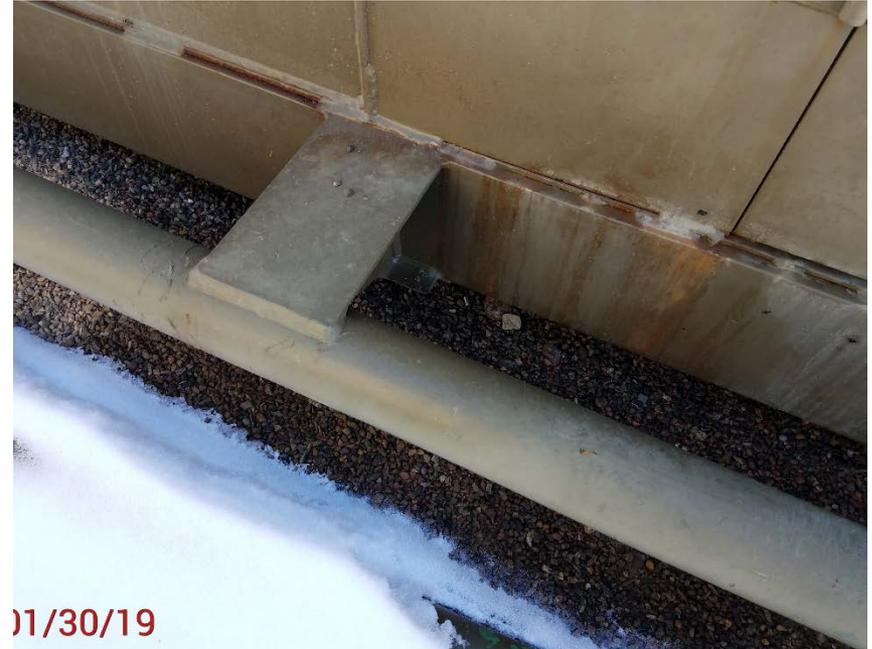
Location Photo #8, Stained rock on North end of Vertical Separators.

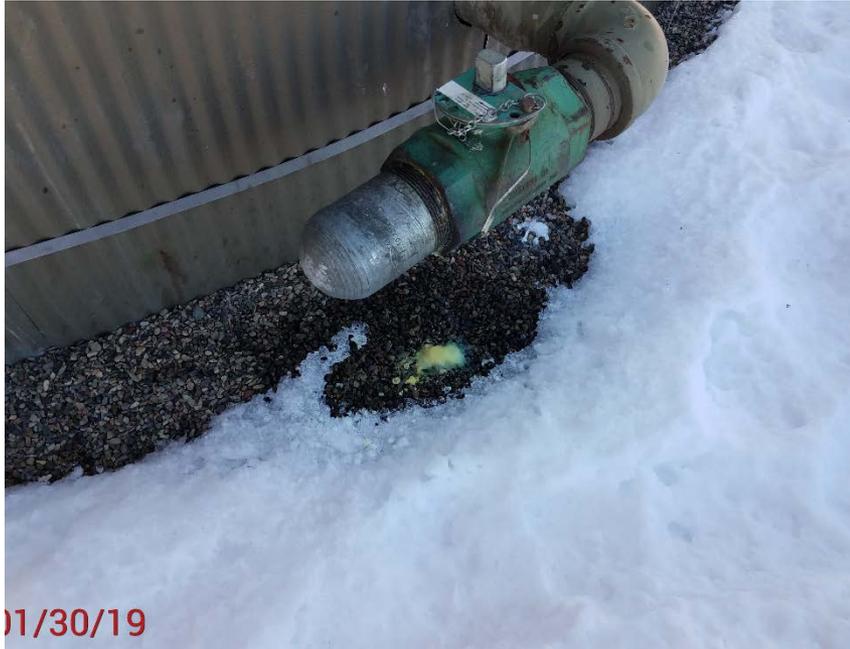
Location Photo #9, Mechanical condition of tank valve. Stained rock below valve.

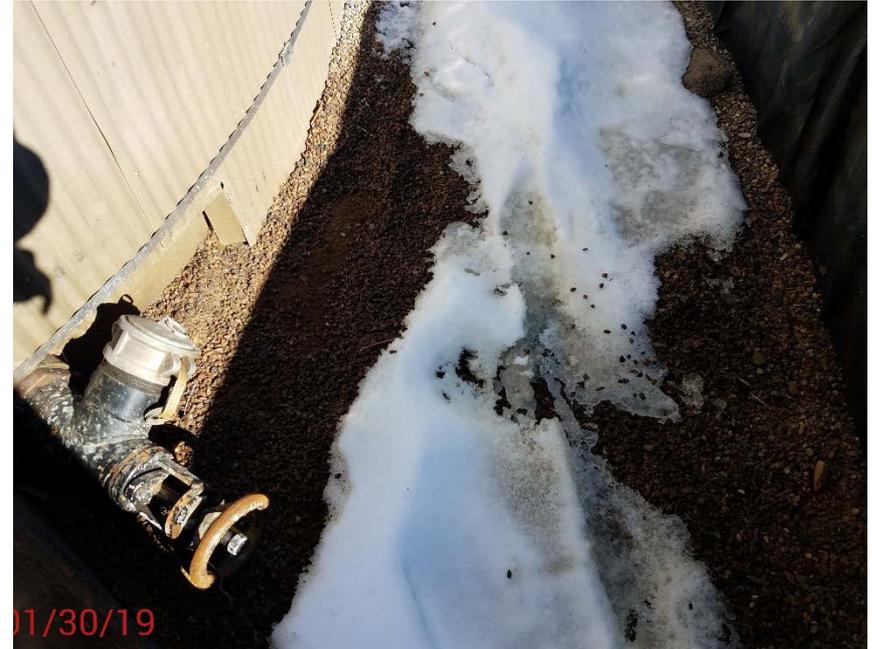
Location Photo #10, Stained material in battery containment.
