Inspection Photos 1/30/19
Location: Norbert Samford #1
API # 001-07140

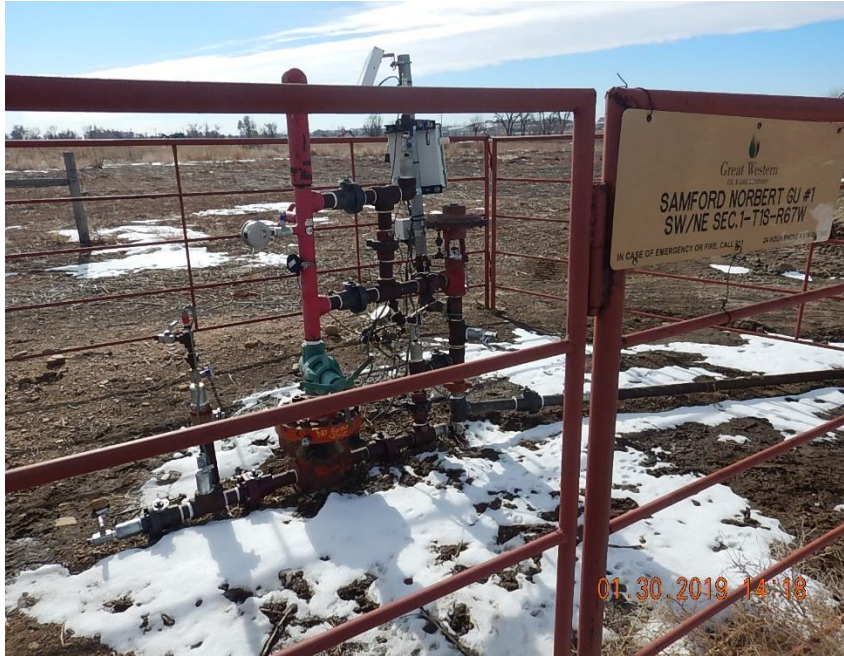
Great Western signage and wellhead.

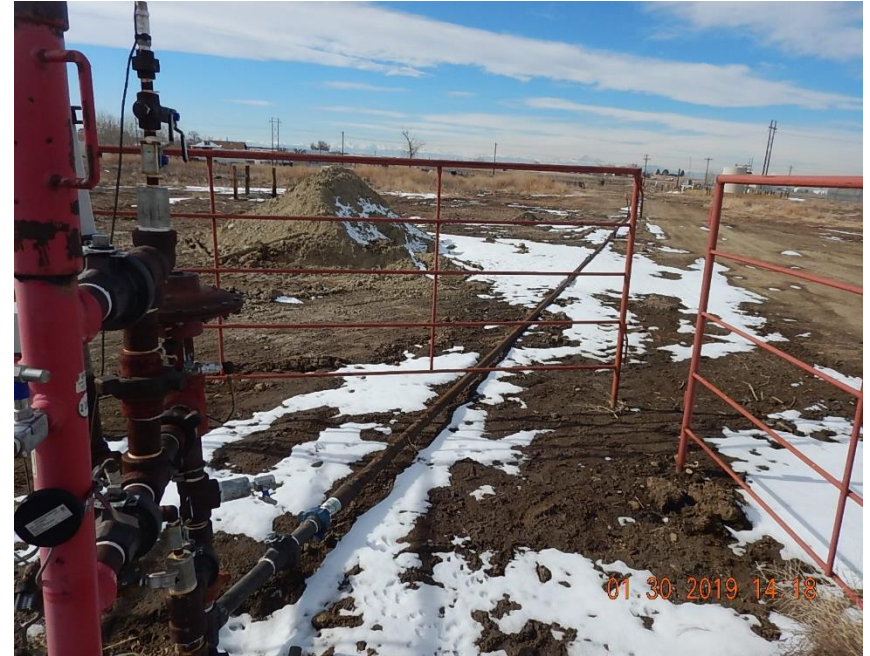
Flowline on ground surface running NW to battery

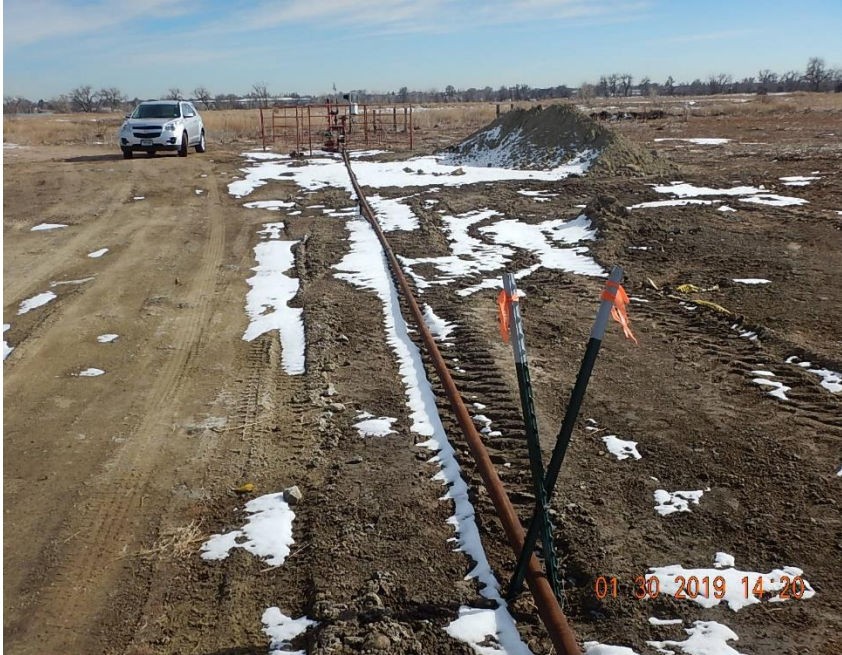
View of flowline adjacent to lease road (looking SE toward wellhead).

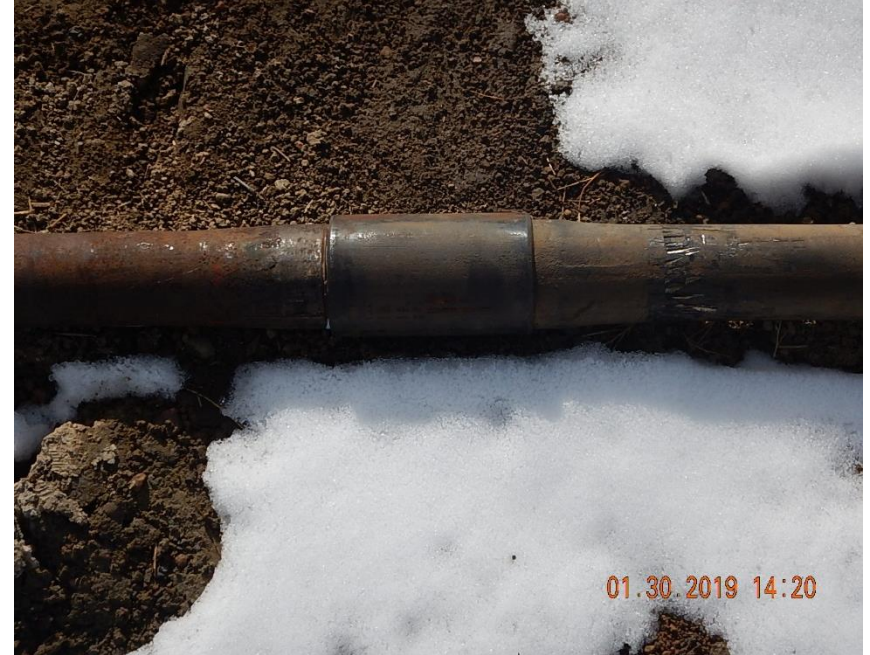
Flowline tubing/ threaded connection; material is un coated. Note the impact on the steel from the pipe wrench.

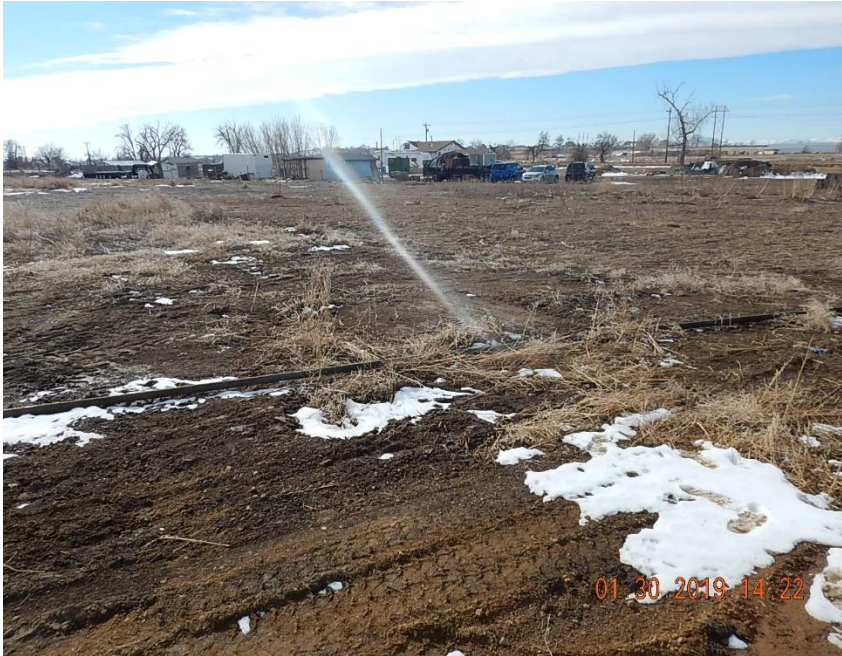
View of flowline on ground surface and adjacent residence to the south.

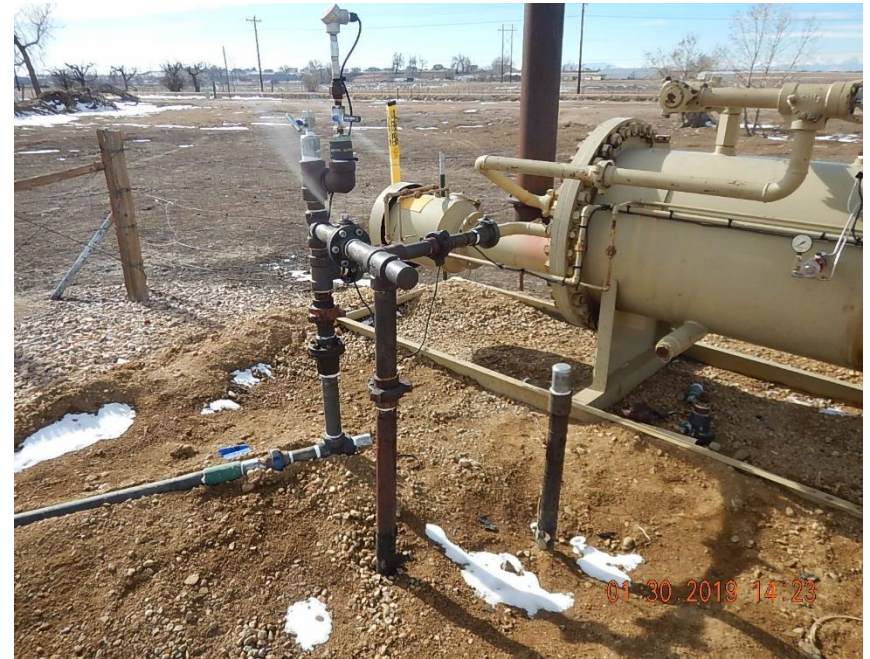
Flowline tie in at horizontal separator; also unused and unmarked flowline riser (incomplete abandonment); Riser is absent of lockout/ tagout.
