Location Name: Crow Creek State Production Facility Location ID: 432762 Inspection Date: 1/30/2019

COLORADO
Oil & Gas Conservation
Commission
Department of Natural Resources

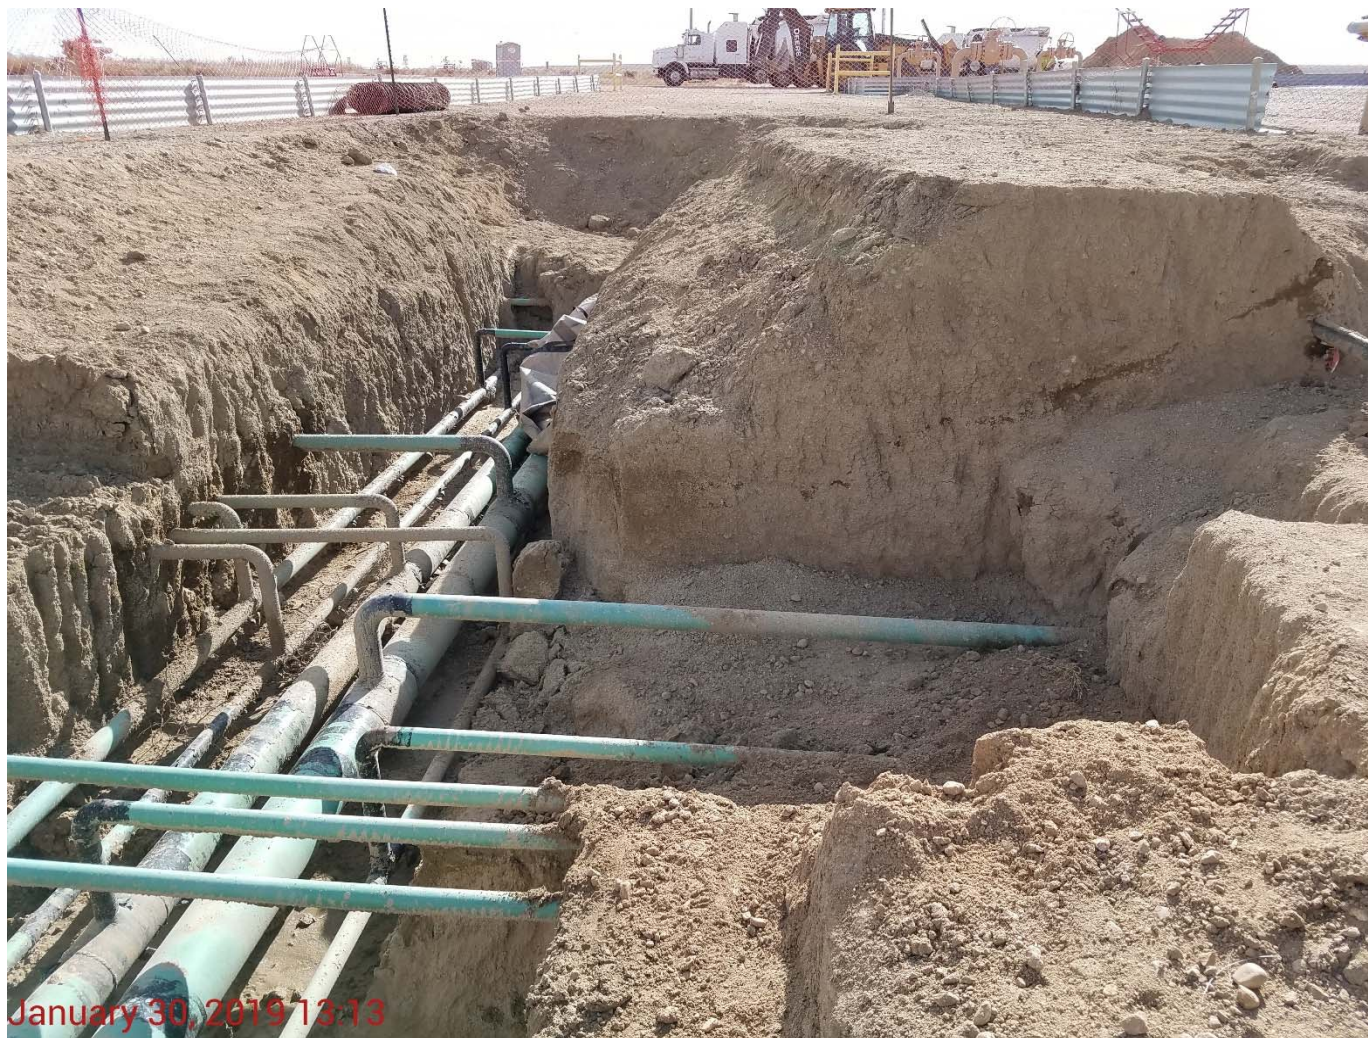
Photo 1 – View trench in area of release, looking south. Stained soil can be seen in eastern sidewall, and in preferential flow toward west and surface where release was discovered. Lateral piping entering trench is unused piping installed for future production. Main line piping are from east to west (left to right in photo): abandoned water line, 2"-diameter active water line, 6" active produced fluids line (suspected release source), 8" active gas line, 2" water line.

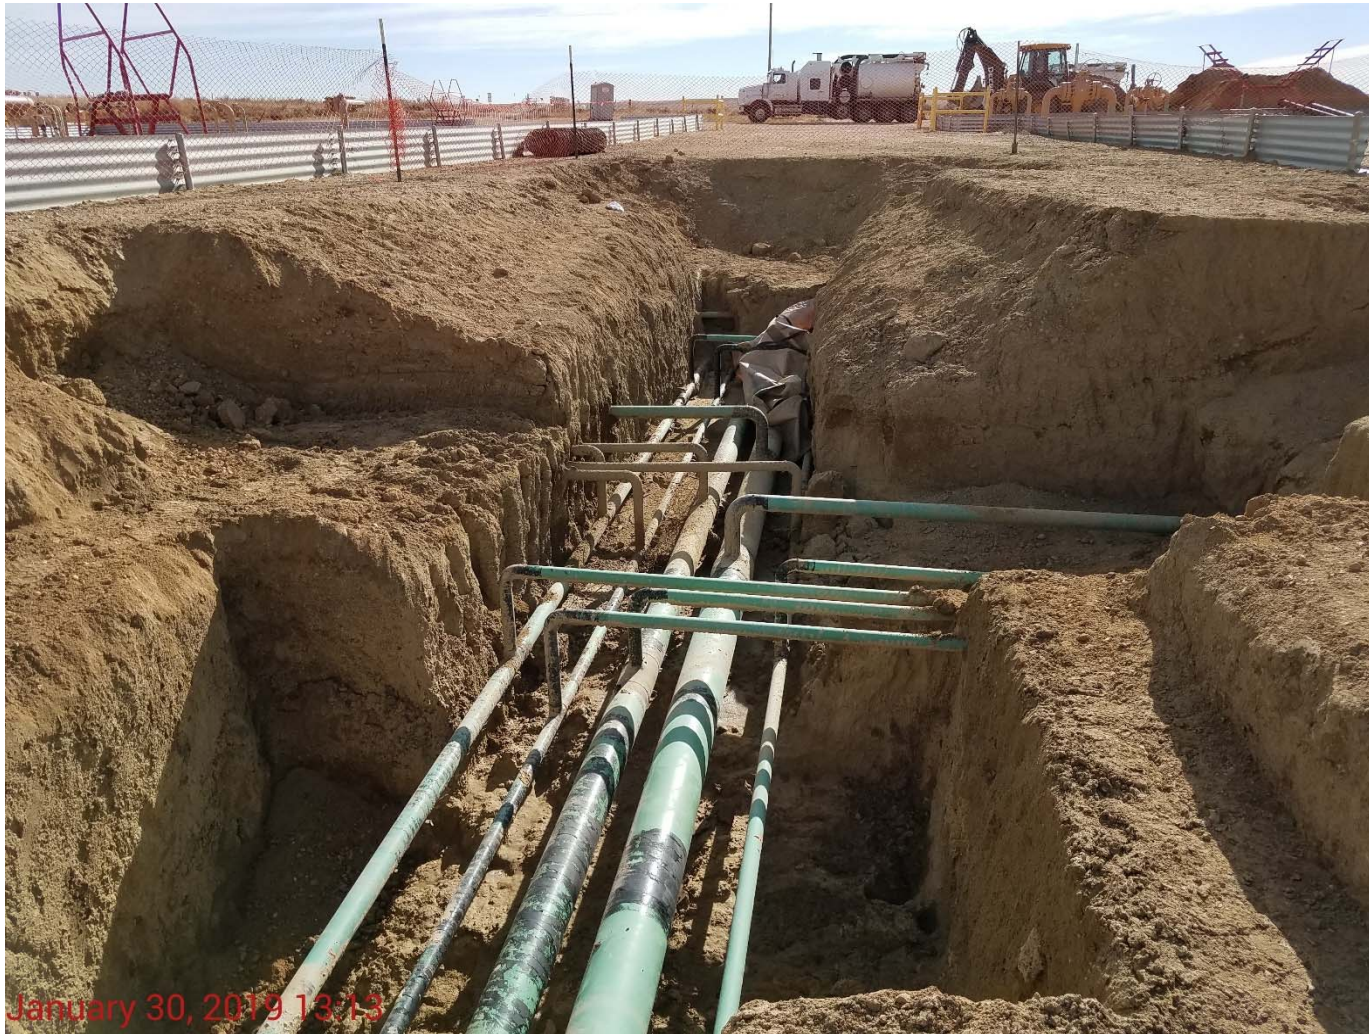
Photo 2 – View trench in area of release, looking south. Stained soil can be seen in eastern sidewall, and in preferential flow toward west and surface where release was discovered. Lateral piping entering trench is unused piping installed for future production. Main line piping are from east to west (left to right in photo): abandoned water line, 2"-diameter active water line, 6" active produced fluids line (suspected release source), 8" active gas line, 2" water line.
