Inspection Photos

Operator: VERDAD RESOURCES LLC - 10651

Location ID: 425541

Inspection Doc. Number: 682504467

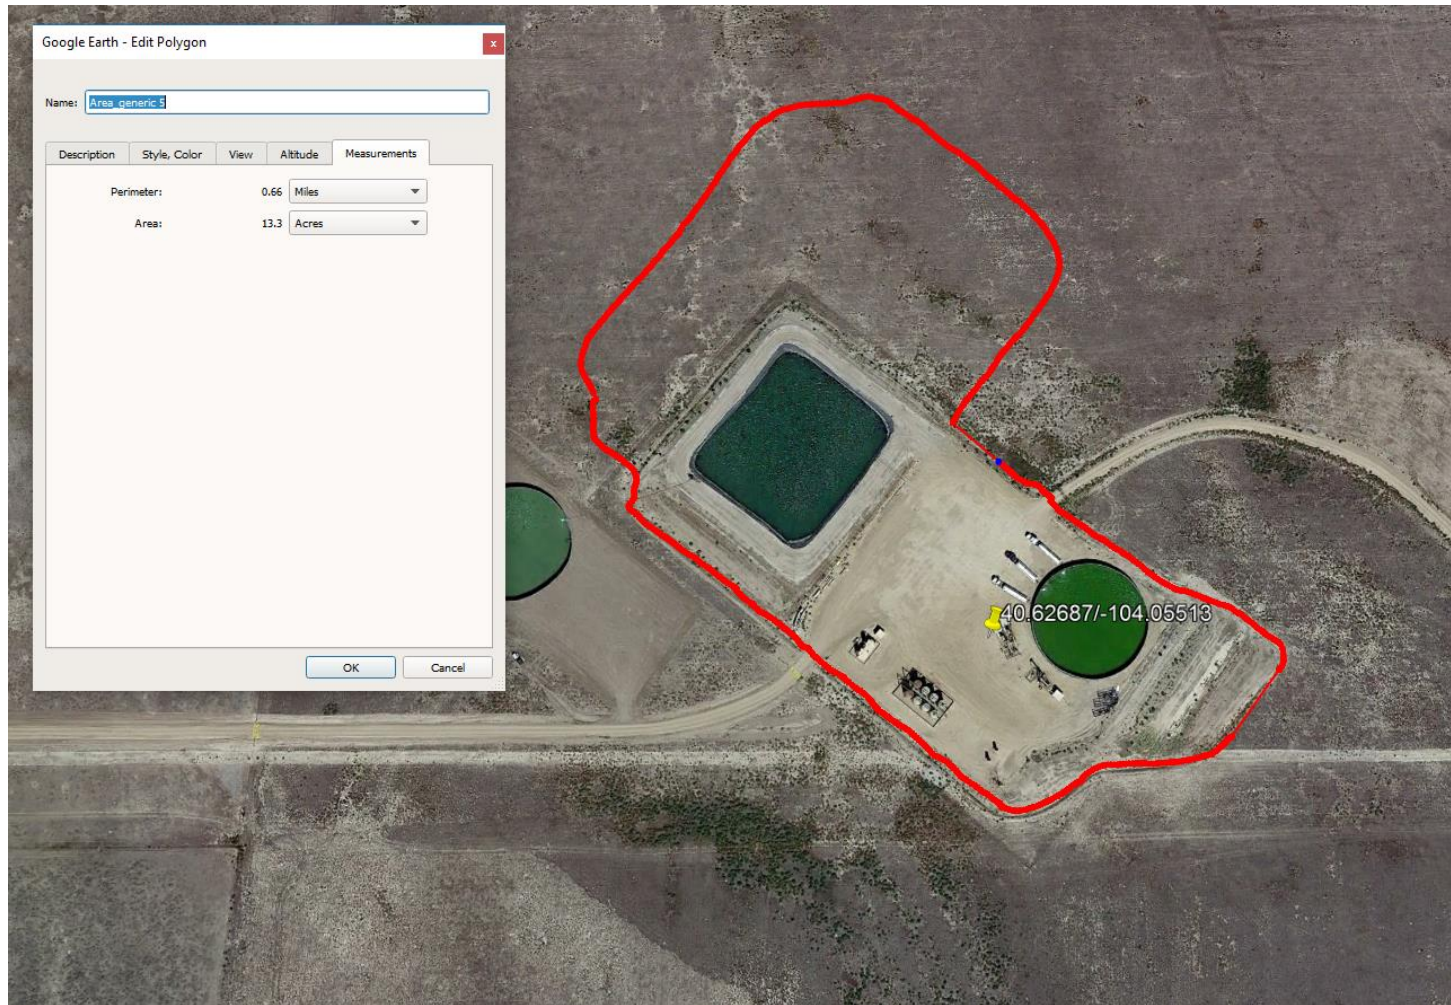
Photo 1: 2013 Google earth aerial imagery. Photo shows disturbance area for the location. A disturbance area of 13.3 acres was measured using a Trimble Juno 3B handheld device. This exceeds the permitted disturbance area of 4.5 acres. Note: pit has been expanded to the northeast since aerial photo. See photo 6 and doc. #400581604 for additional details.

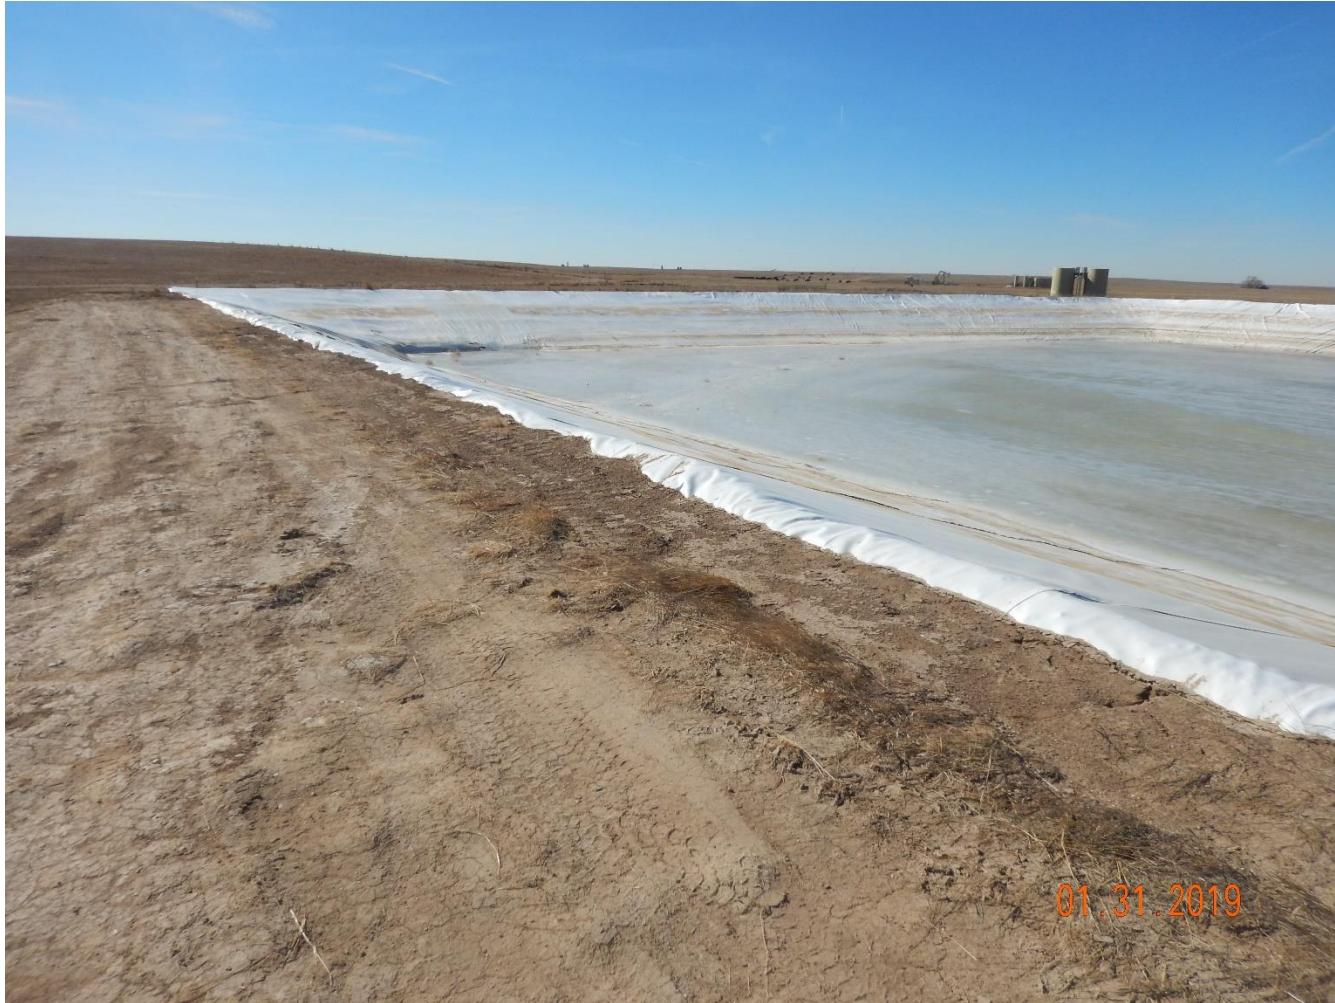
Photo 2: Photo taken from the southeast end of pit #431409, facing west. Location received an approved 502.b variance to delay interim reclamation of the location for three (3) years until 12/31/2018. Photos 2- 4 shows pit has not been closed/reclaimed.

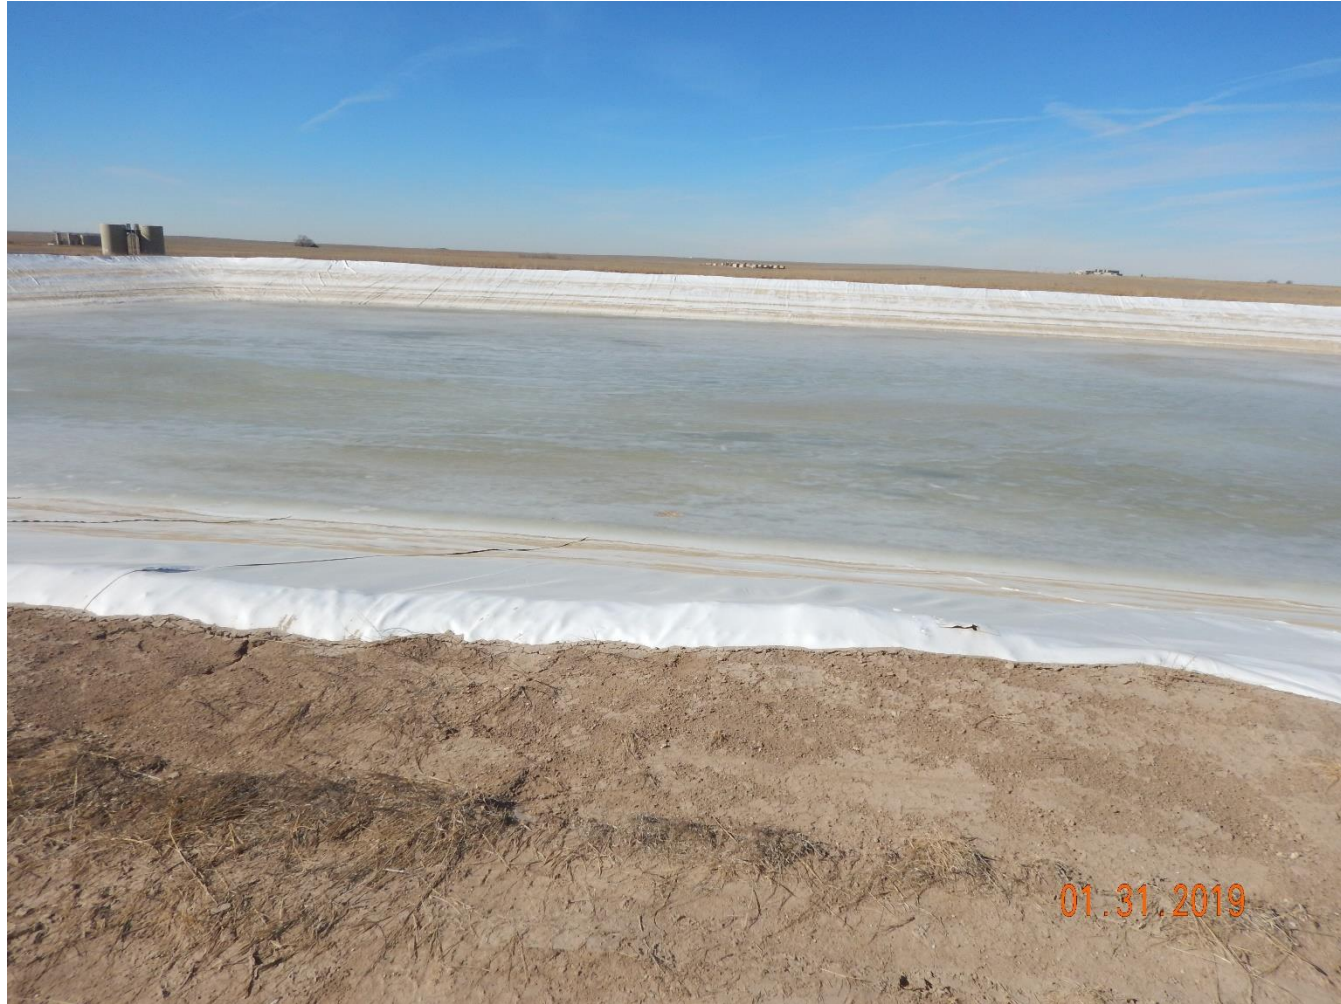
Photo 3: See comments under photo 2.

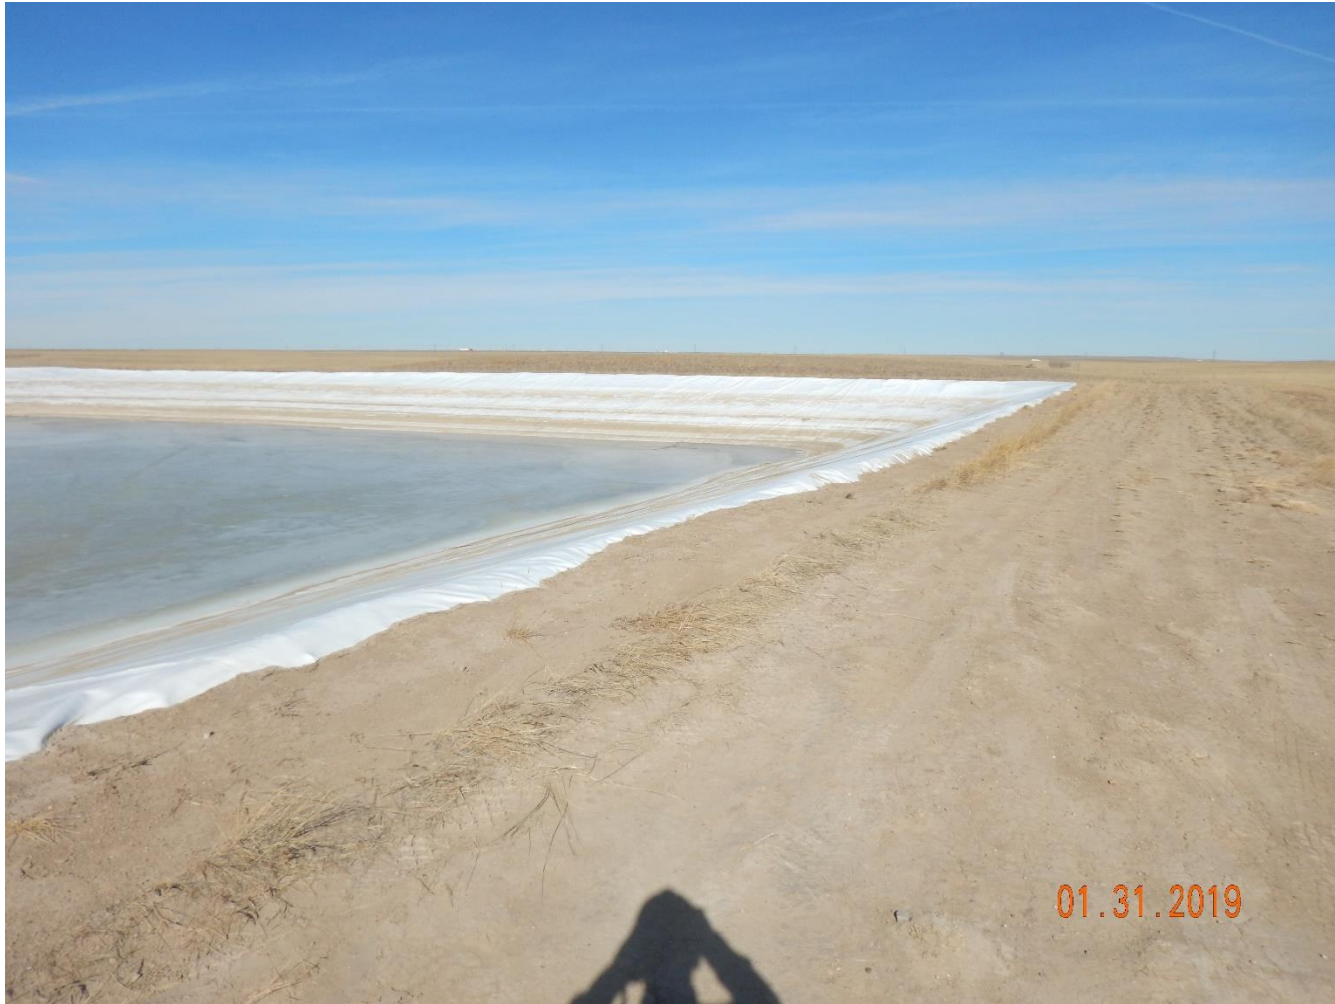
Photo 4: See comments under photo 2.

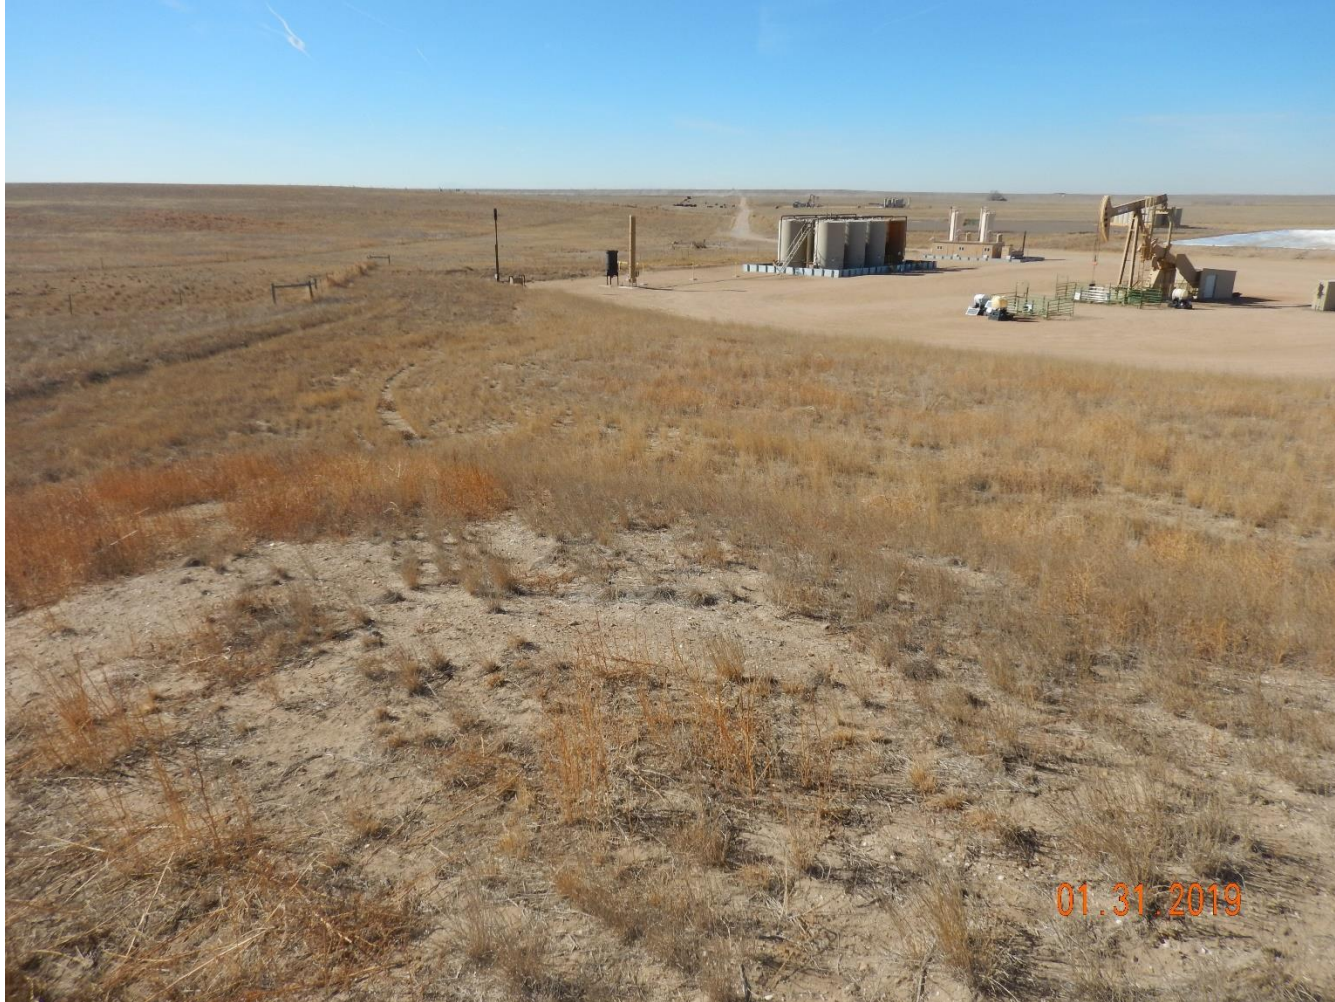
Photo 5: Photo taken from the south end of the location, facing west. Photo provides and overview of the location. Photo also shows interim reclamation has not been conducted in accordance with COGCC rule 1003.

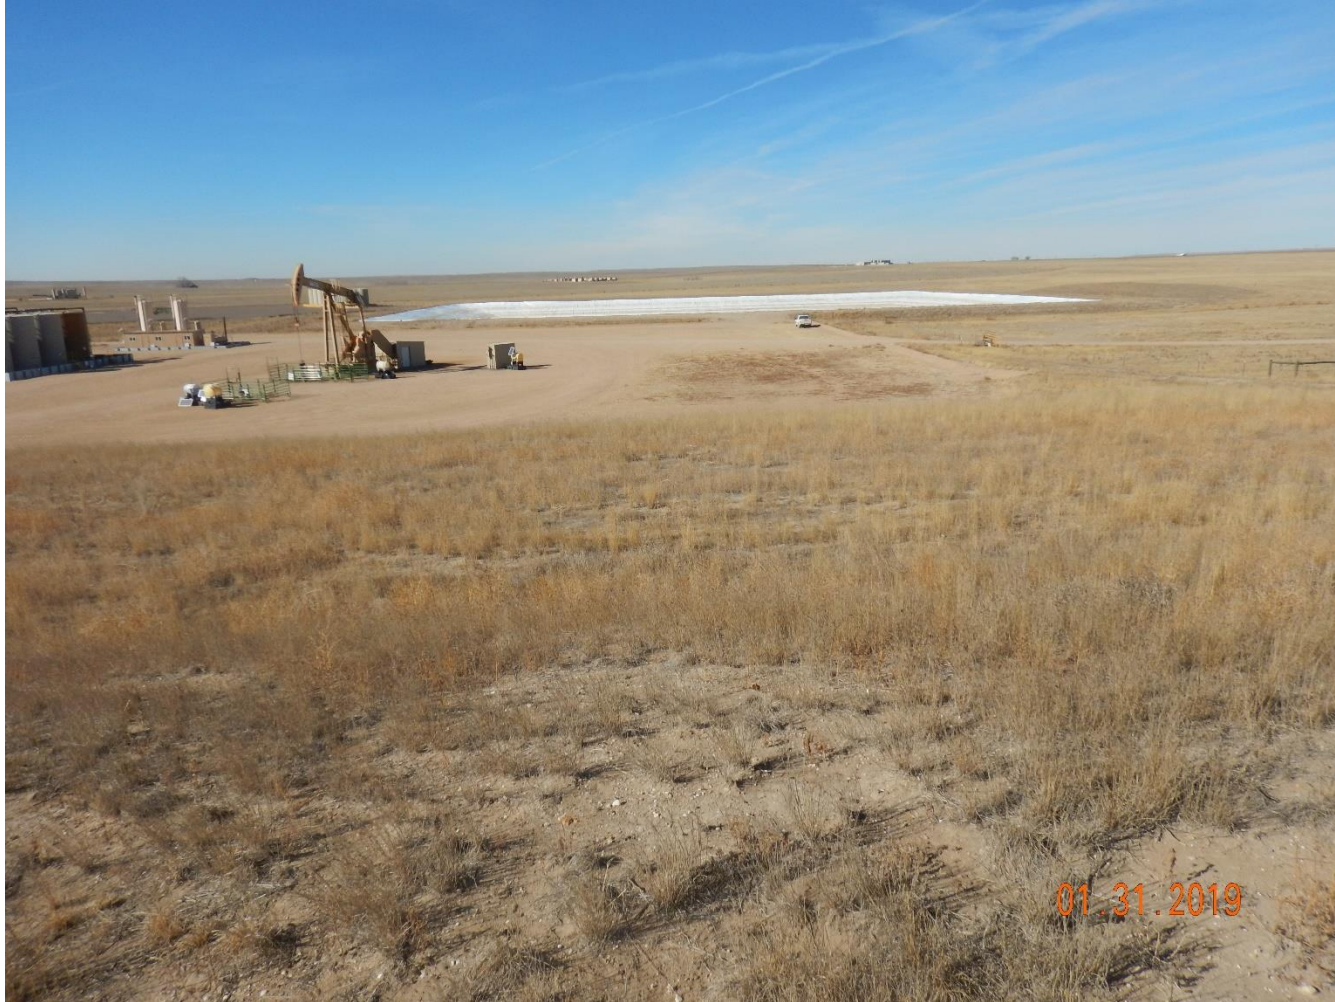
Photo 6: Photo taken from the south end of the location, facing northwest. Photo provides an overview of the location. Photo also shows interim reclamation has not been conducted in accordance with COGCC rule 1003.

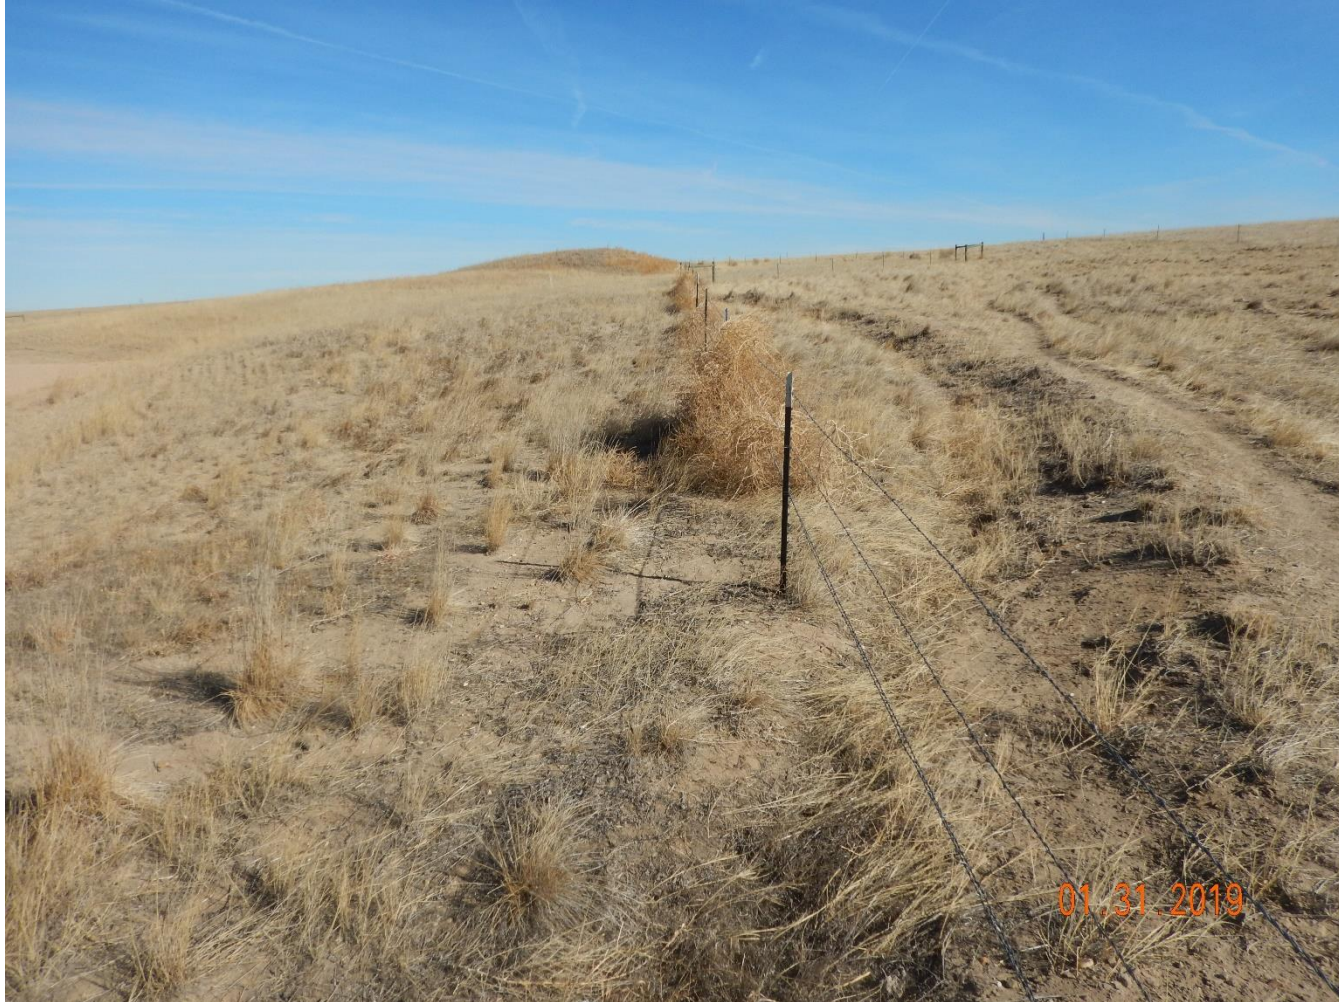
Photo 7: Photo taken from the southeast corner of the location, facing north. Photo shows interim reclamation has not been conducted in accordance with COGCC rule 1003

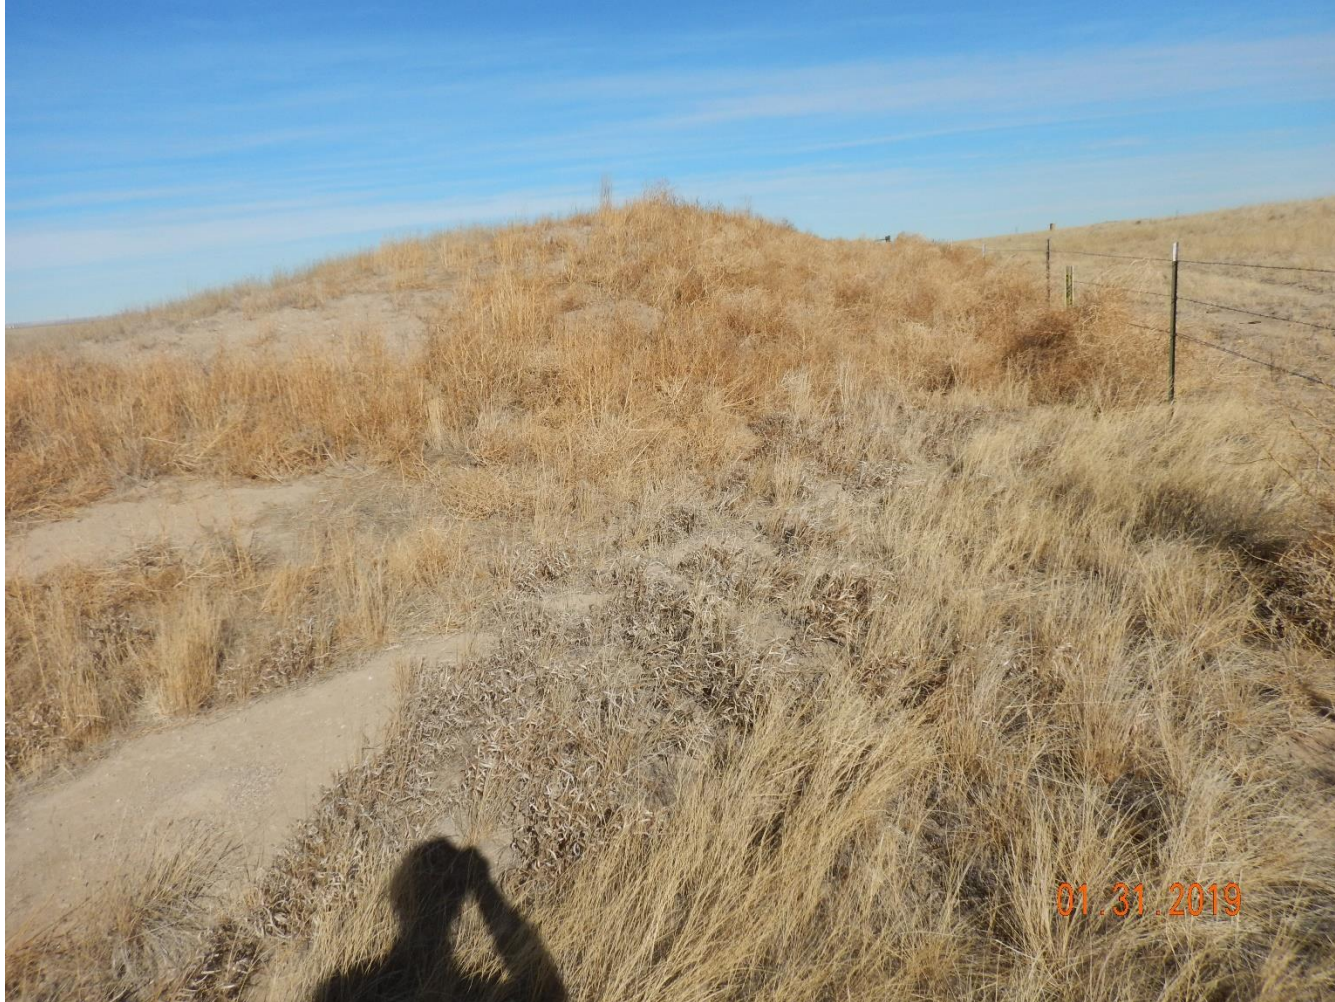
Photo 8: Photo taken from the south end of the location. Russian thistle (*Salsola tragus*) weed establishment along portions of the well pad perimeter and weed debris along the perimeter of the location. Russian thistle is a troublesome annual nonnative weed that easily breaks off at the stem and becomes a tumbleweed.

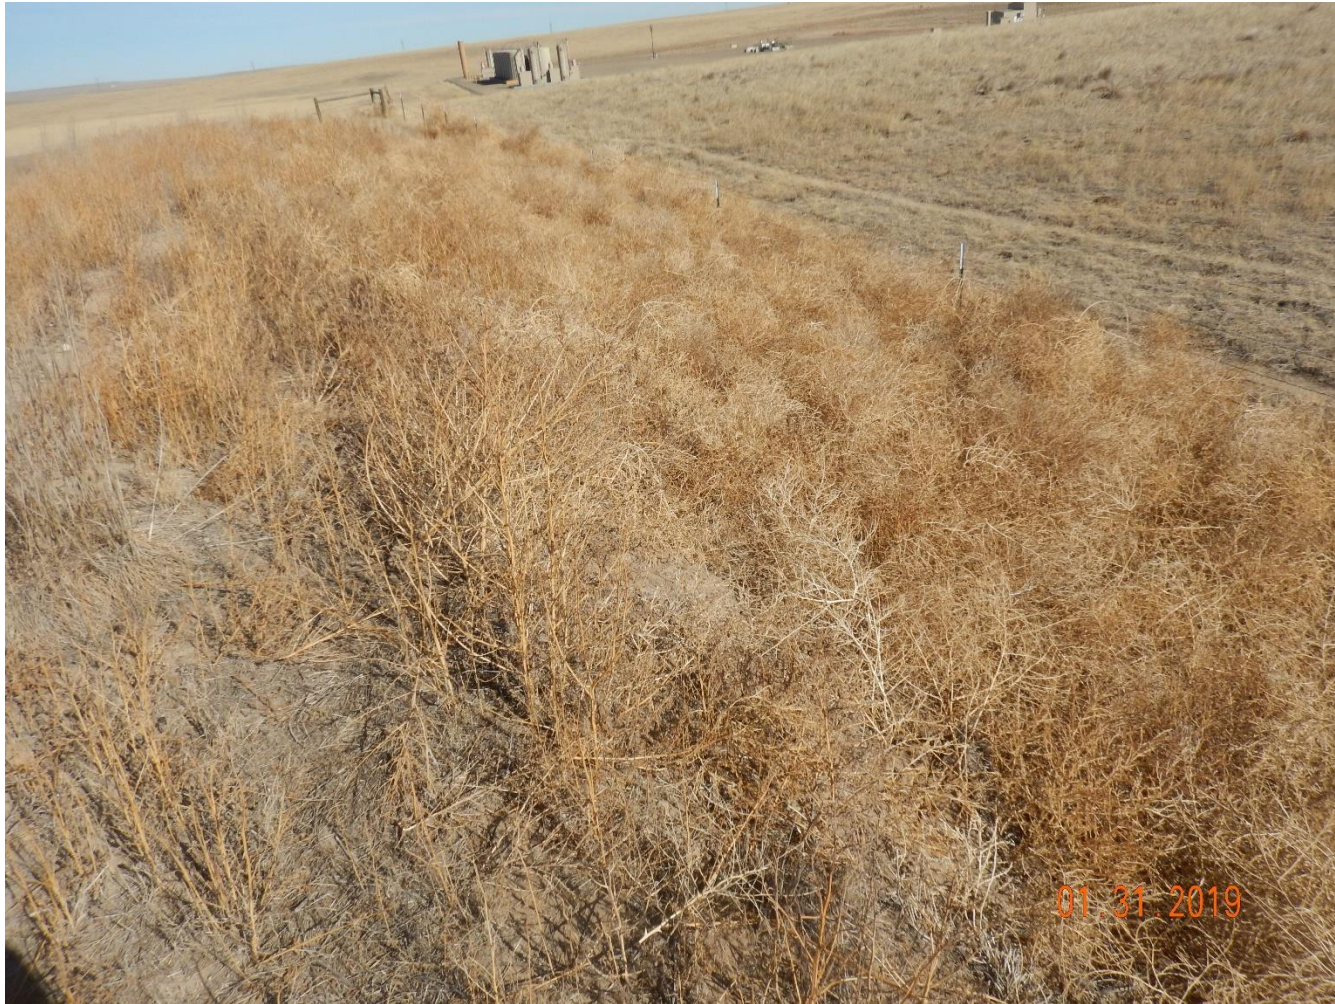
Photo 9: See comments under photo 8

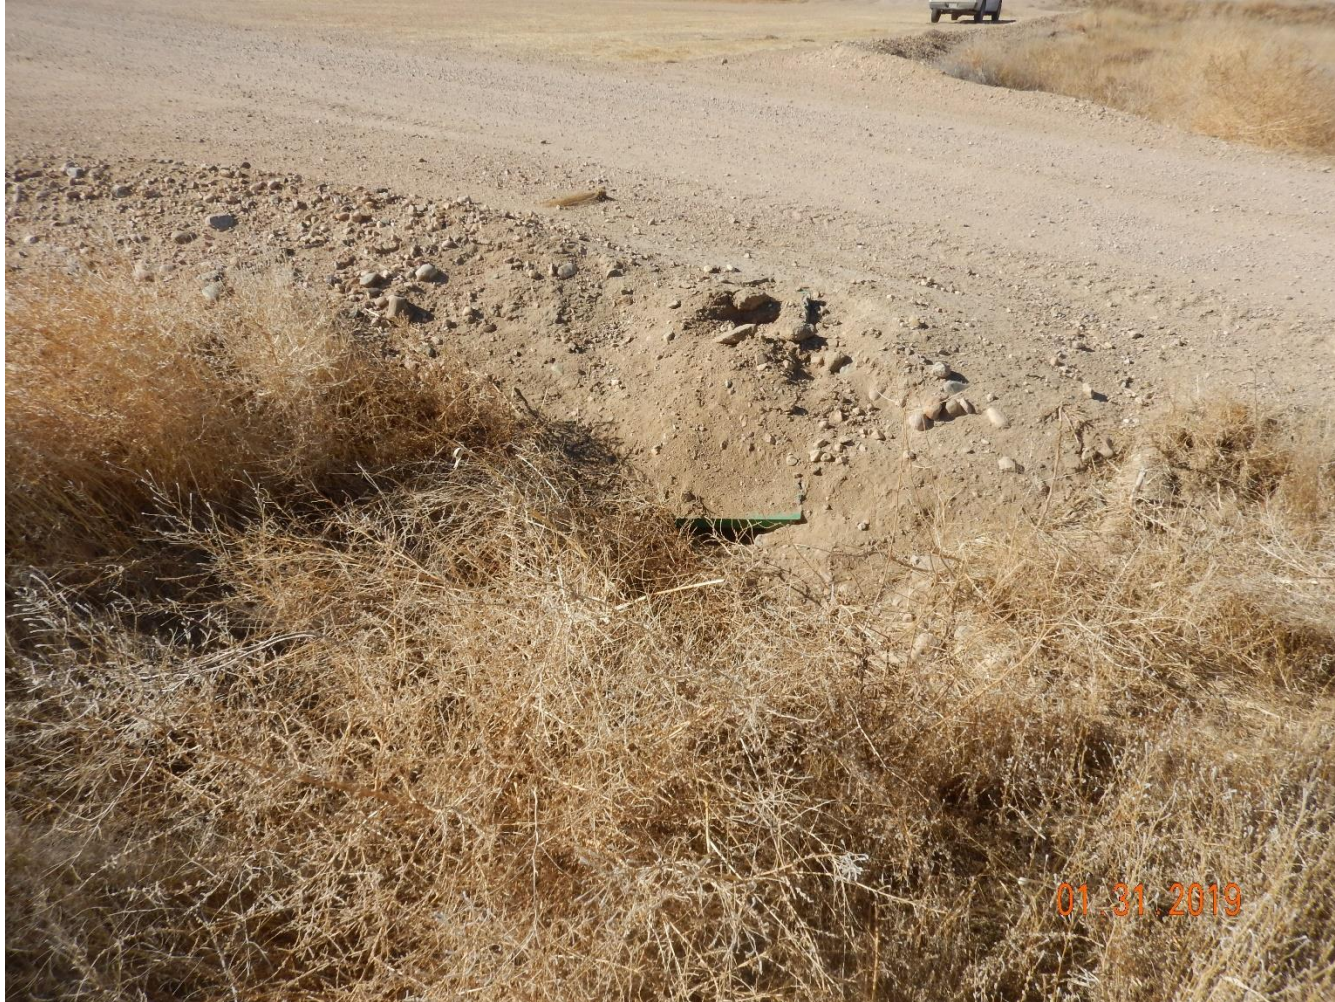
Photo 10: Photo taken from the access road on the east end of the location. Photo shows culvert has filled with sediment and no longer in proper functioning condition.
