## Inspection Photos

Location Name: DOLAN RANCHES-611N59W /27SWSW

Location #: 317614

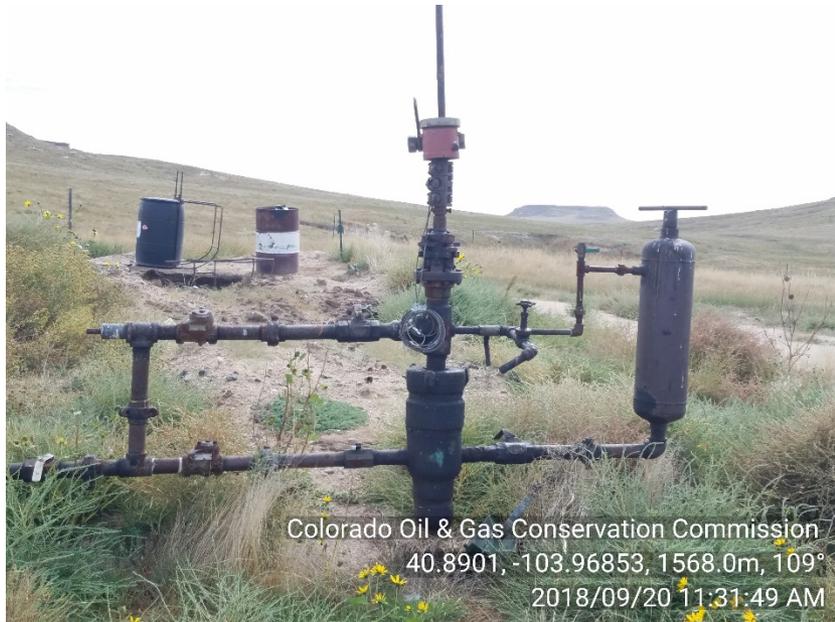
**Photo #1**

**Dolan Ranches 13-27 (API # 05-123-07364) Wellhead**

**Bradenhead does NOT appear plumbed to surface**

**Weeds**

*from prev. FIR*

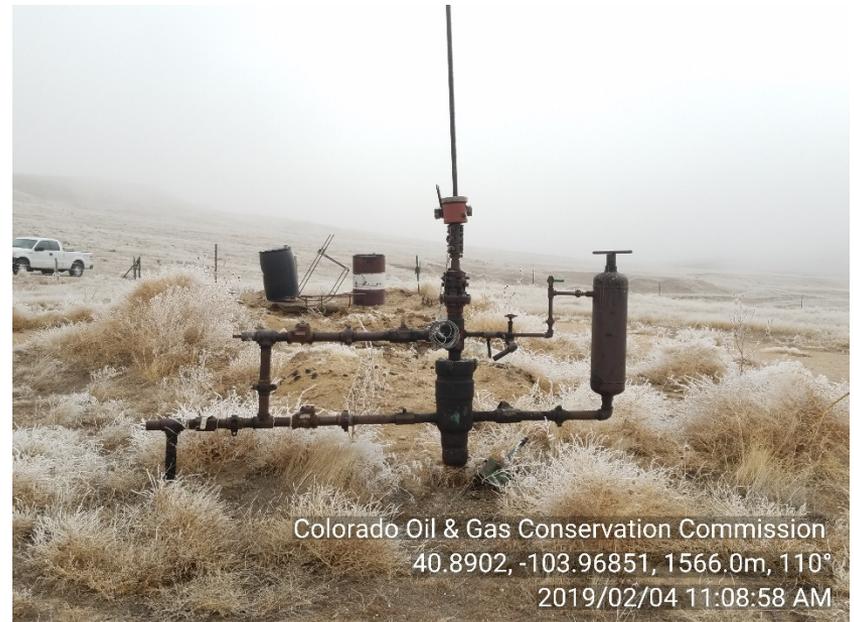
**Photo #2**

**Dolan Ranches 13-27 Wellhead**

**Bradenhead does NOT appear plumbed to surface**

**Weeds**

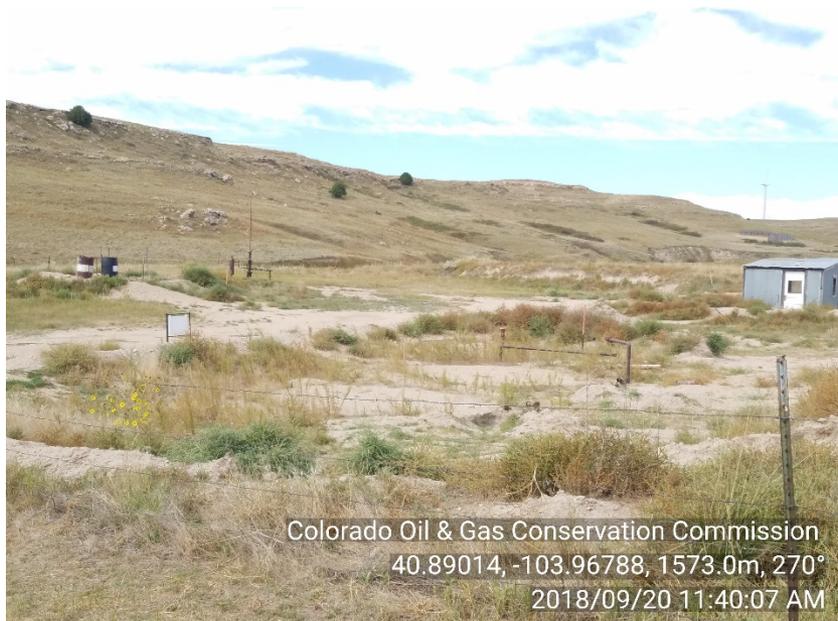
**Photo #3**

**Dolan Ranches 13-27** Battery

**Weeds**

*from prev. FIR*

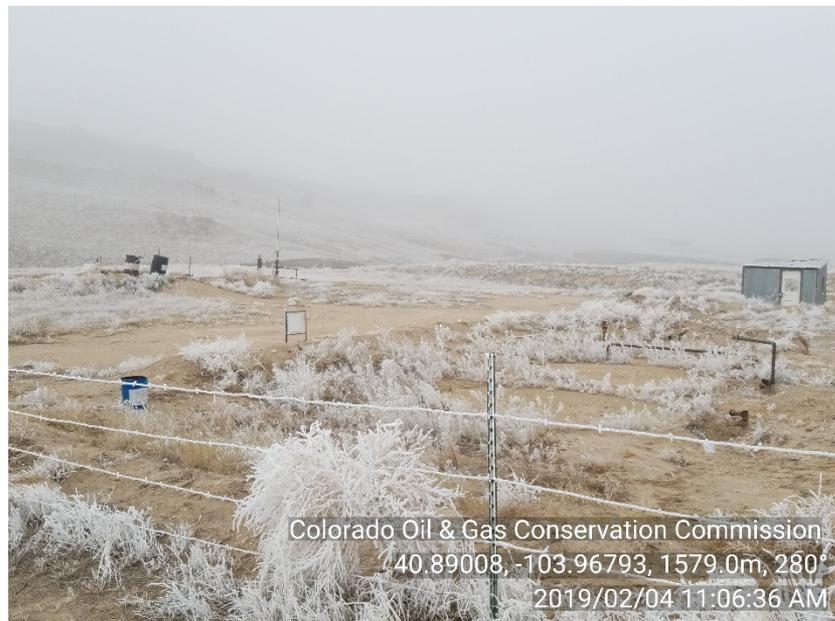
**Photo #4**

**Dolan Ranches 13-27** Battery

**Weeds**

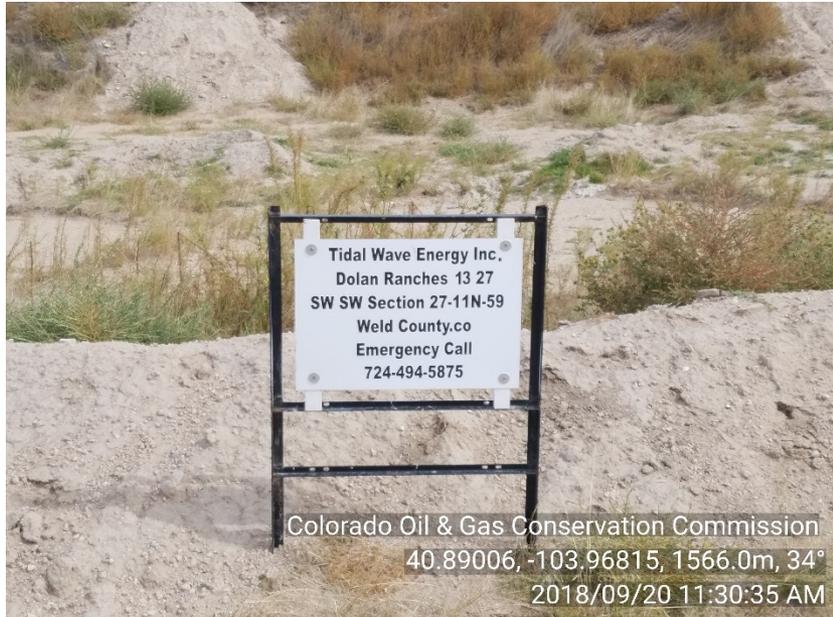
**Photo #5**

**Dolan Ranches 13-27** Crude oil tanks area

**Battery sign**

**Weeds**

*from prev. FIR*

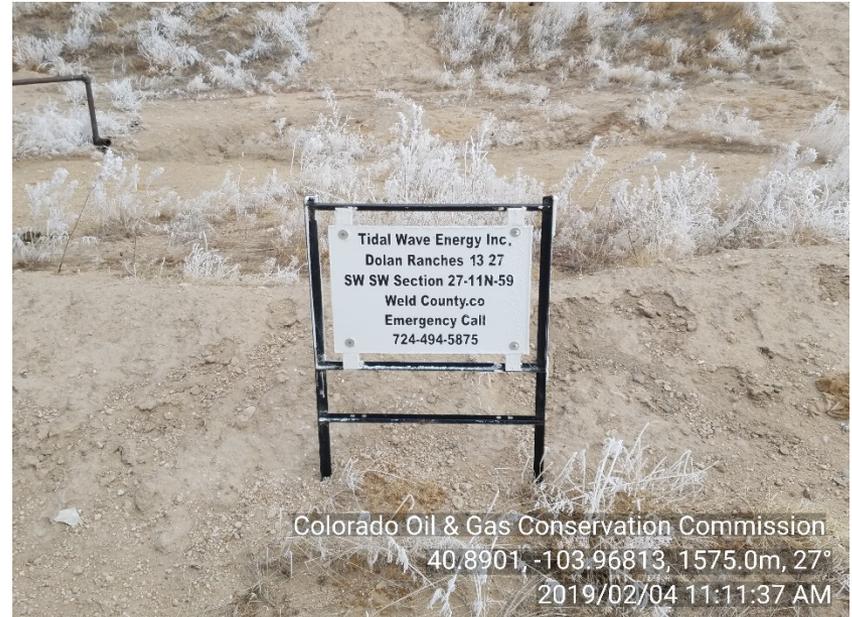
**Photo #6**

**Dolan Ranches 13-27** Crude oil tanks area

**Battery sign**

**Weeds**

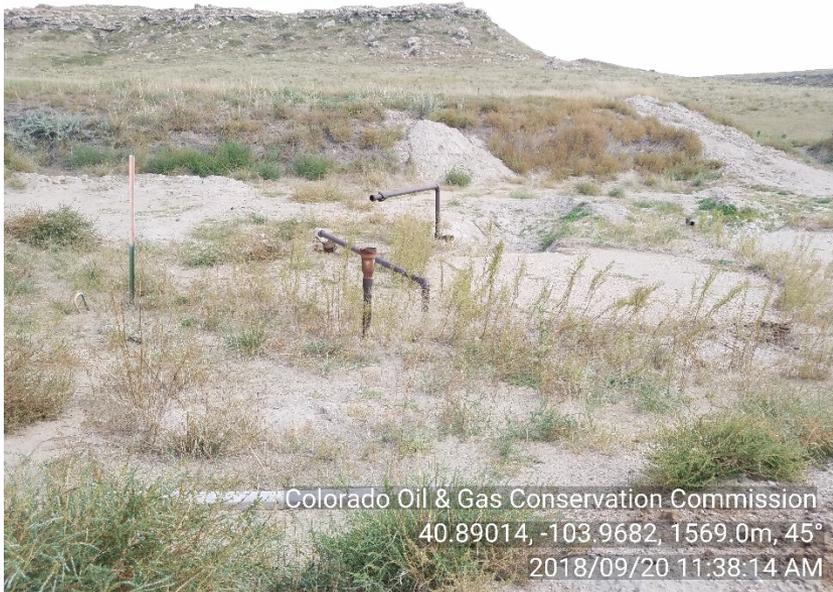
**Photo #7**

**Dolan Ranches 13-27** Crude oil tanks area  
Tanks have been removed. Piping remains  
**Unused Equipment | Uncapped piping**  
*from prev. FIR*

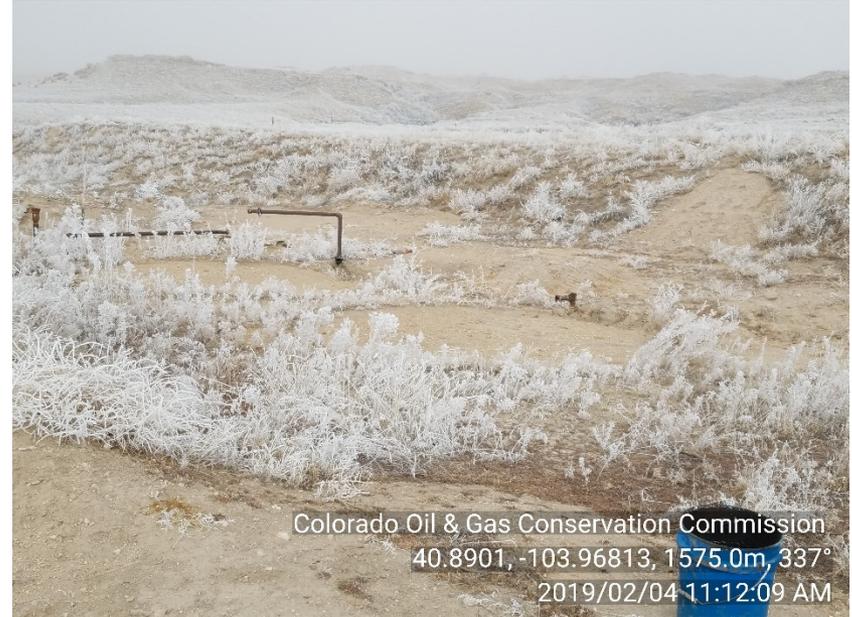
**Photo #8**

**Dolan Ranches 13-27** Crude oil tanks area  
Tanks have been removed. Piping remains  
**Unused Equipment | Uncapped piping**

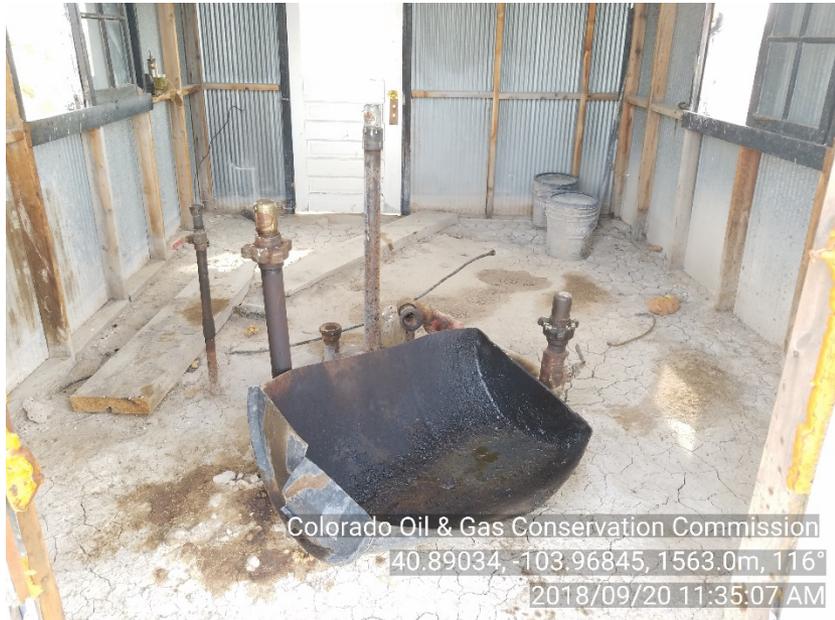
**Photo #9**

**Dolan Ranches 13-27** Treater area  
Treater removed. Piping remains  
Unused Equipment | Stained soil  
*from prev. FIR*

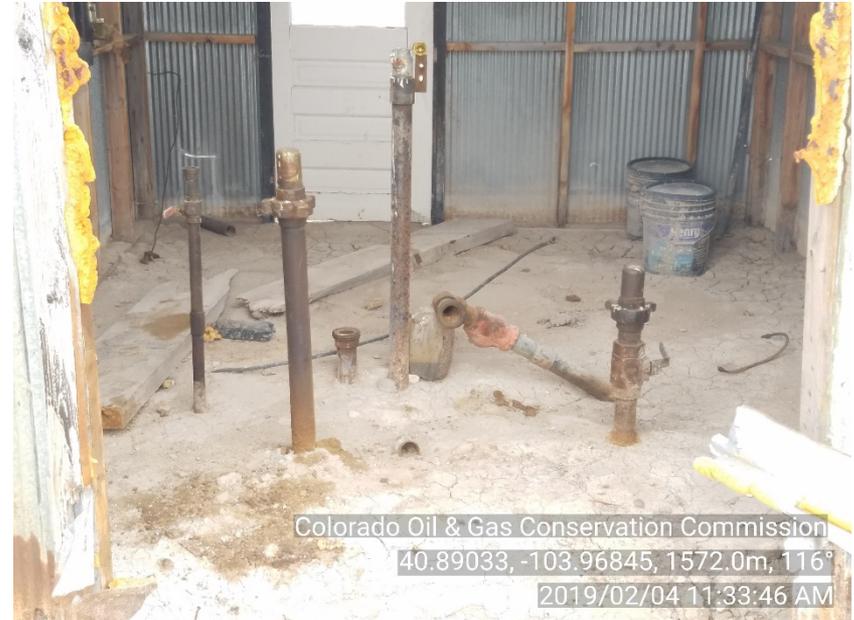
**Photo #10**

**Dolan Ranches 13-27** Treater area  
Treater removed. Piping remains  
**Unused Equipment | Stained soil**

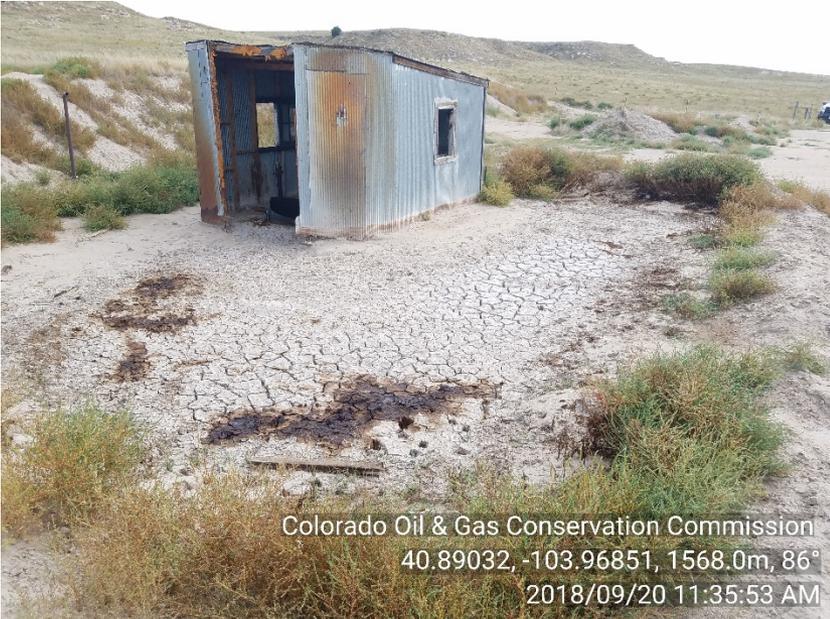
**Photo #11**

**Dolan Ranches 13-27** Treater area

**Stained Soil**

*from prev. FIR*

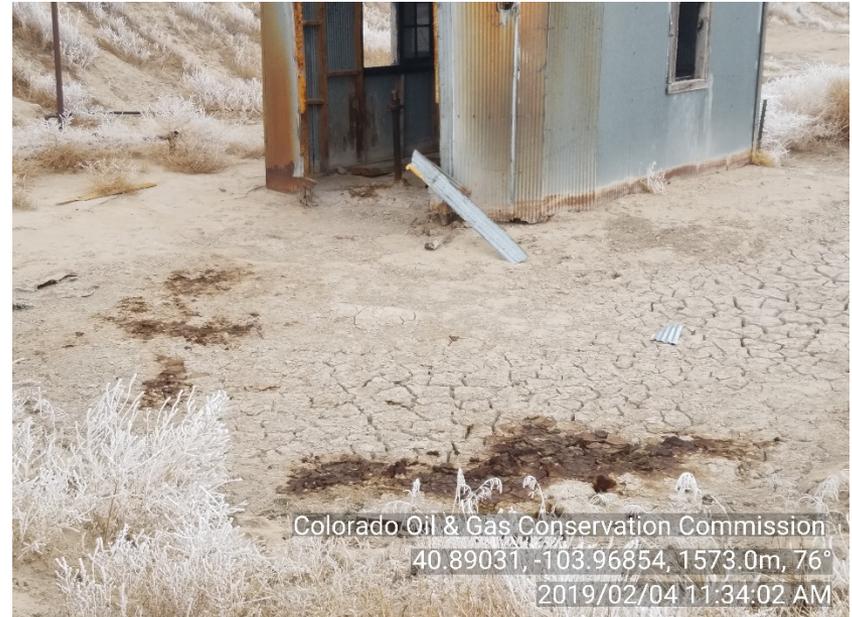
**Photo #12**

**Dolan Ranches 13-27** Treater area

**Stained Soil**

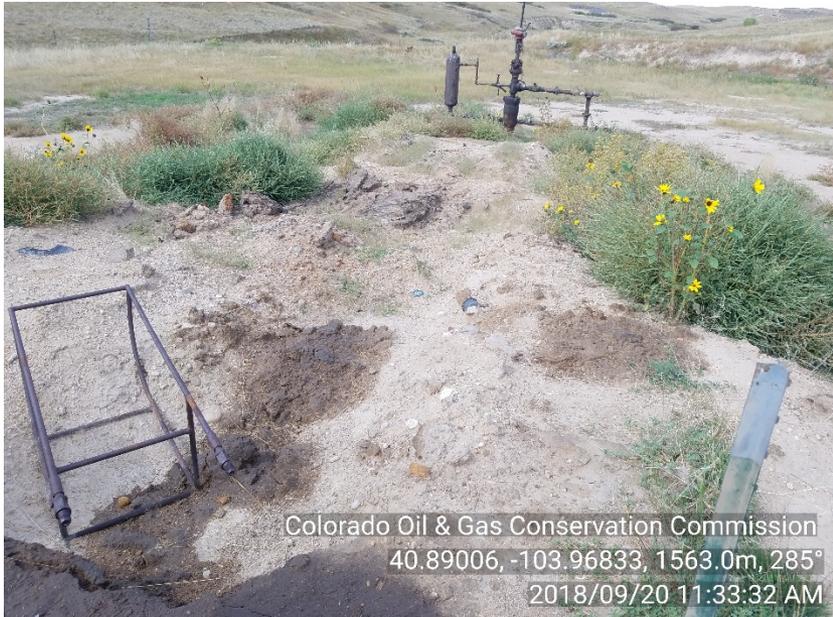
**Photo #13**

**Dolan Ranches 13-27** Wellsite

Pumpjack area

**Weeds | Stained soil**

*from prev. FIR*

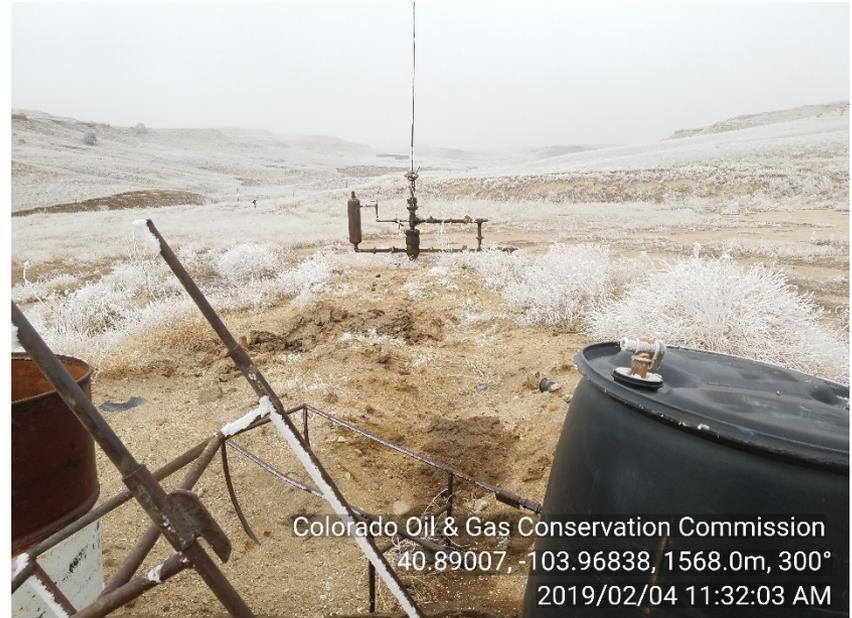
**Photo #14**

**Dolan Ranches 13-27** Wellsite

Pumpjack area

**Weeds | Stained soil | Unused Equipment**

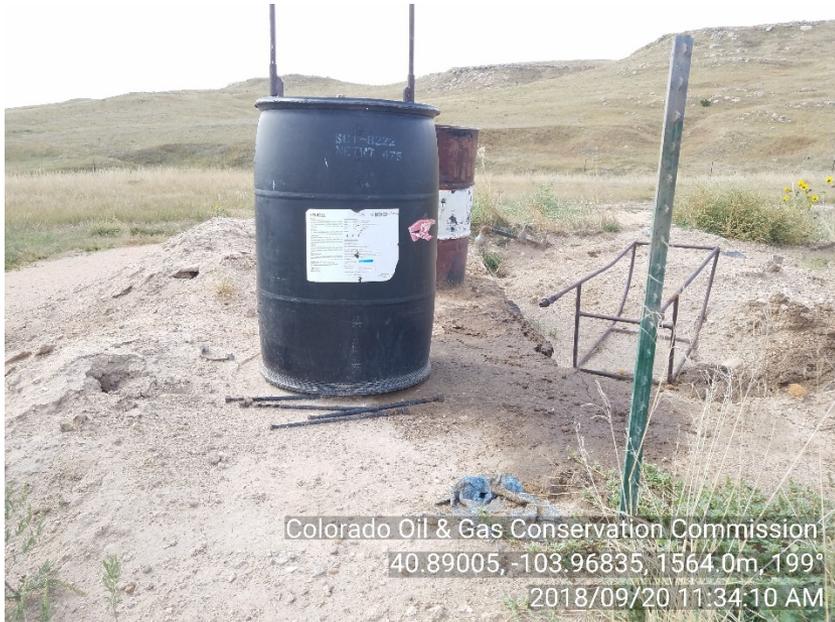
**Photo #15**

**Dolan Ranches 13-27 Wellsite**  
**Unused chemical drum & rack**  
**Trash & Debris**  
*from prev. FIR*

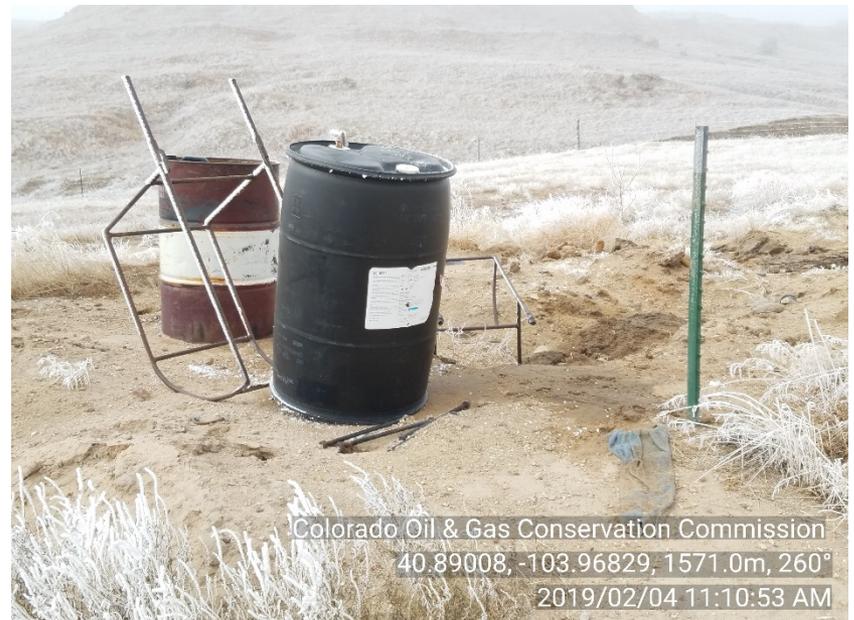
**Photo #16**

**Dolan Ranches 13-27 wellsite**  
**Unused chemical drum & rack**  
**Trash & Debris**

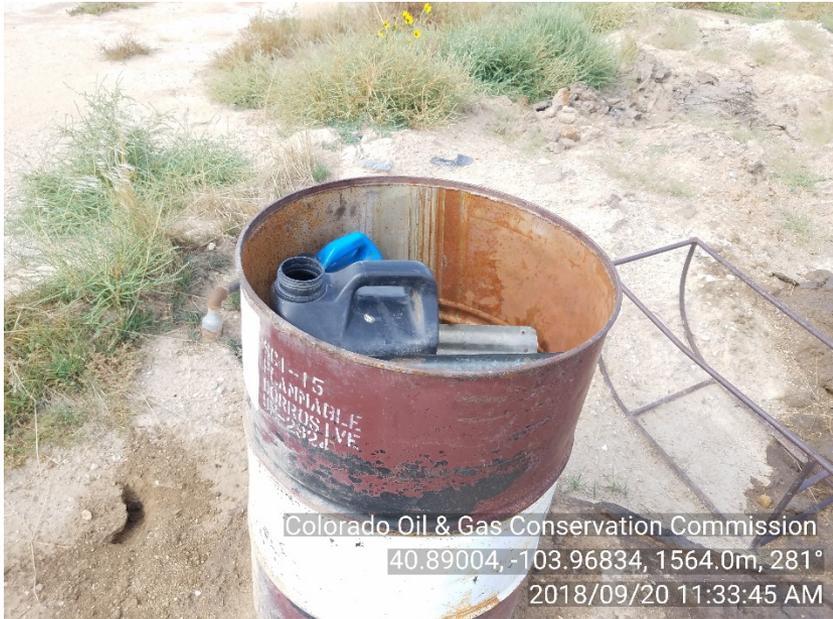
**Photo #17**

**Dolan Ranches 13-27** Wellsite

**Trash**

*from prev. FIR*

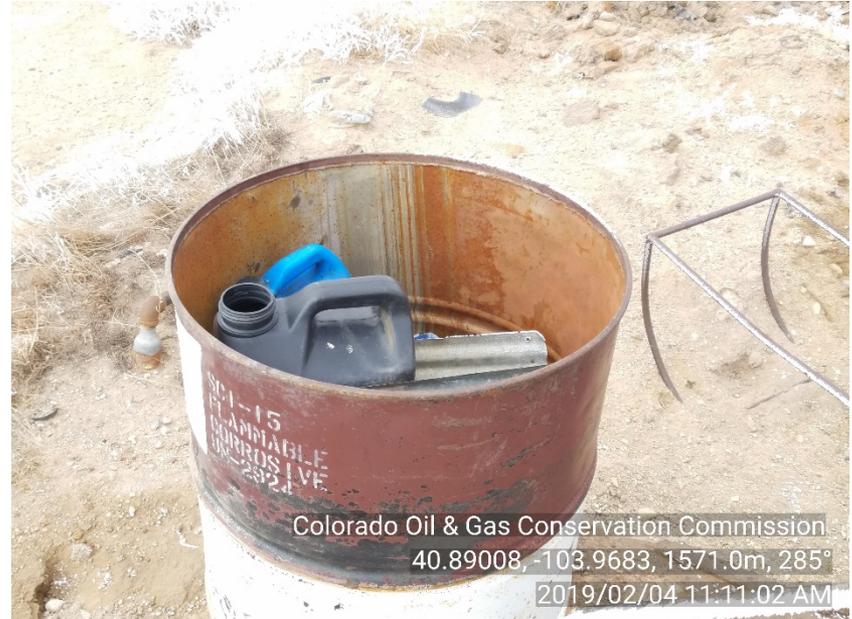
**Photo #18**

**Dolan Ranches 13-27** Wellsite

**Trash**

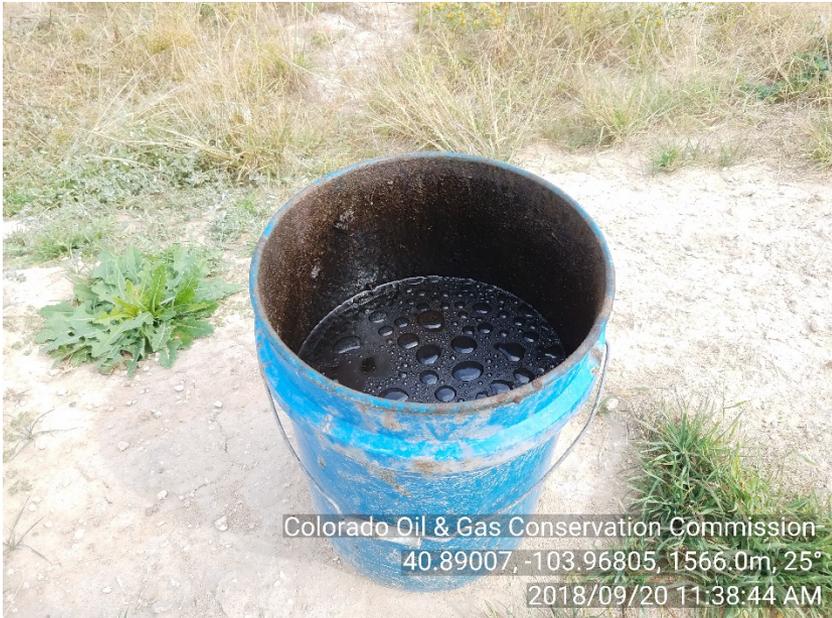
**Photo #19**

**Dolan Ranches 13-27** Crude oil tanks area

**Open bucket of oily waste**

*from prev. FIR*

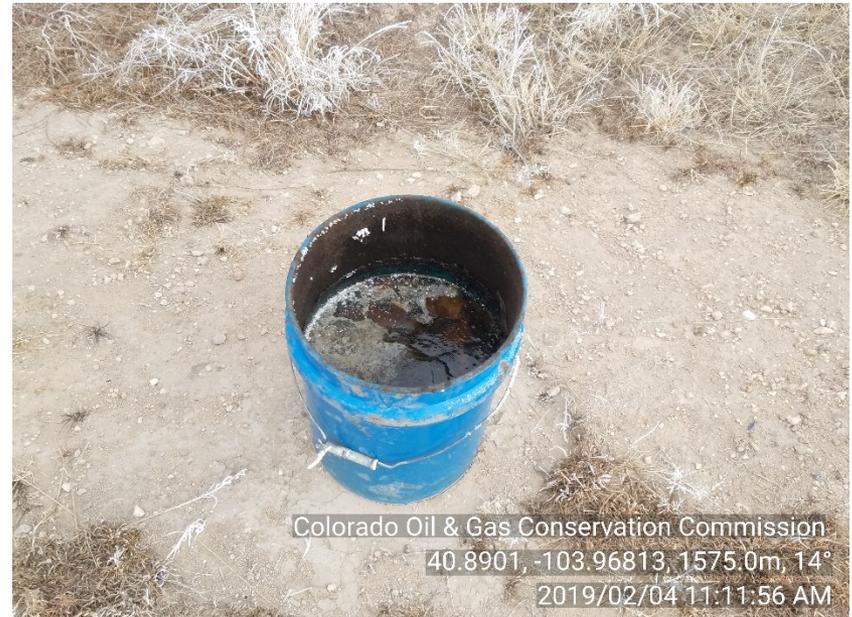
**Photo #20**

**Dolan Ranches 13-27** Crude oil tanks area

**Open bucket of oily waste**

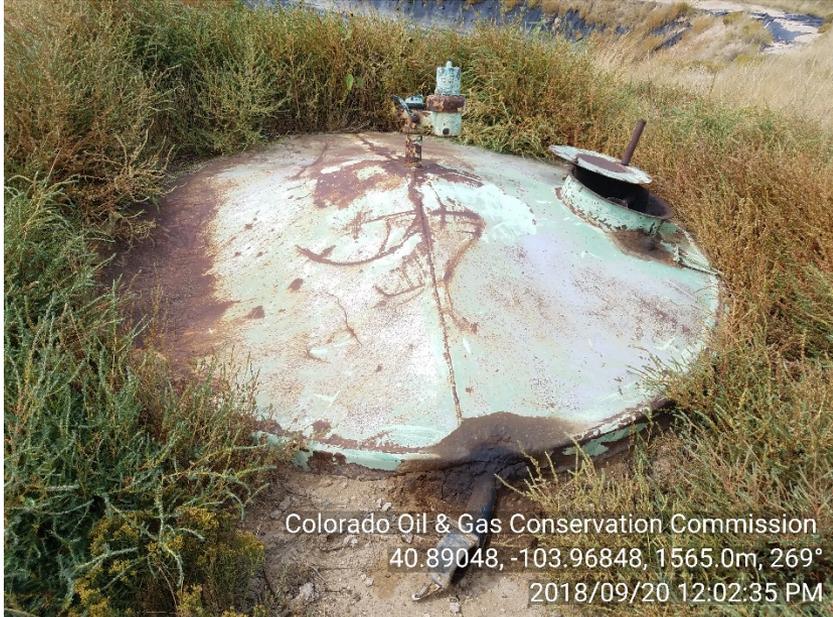
**Photo #21**

**Dolan Ranches 13-27 Pit skim tank**

**No capacity or contents label**

**Stained soil | Weeds**

*from prev. FIR*

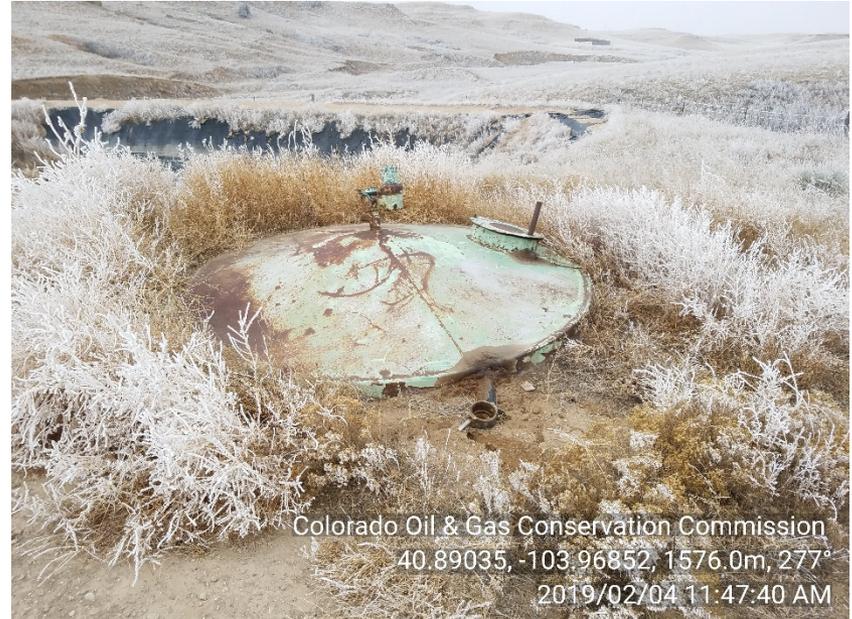
**Photo #22**

**Dolan Ranches 13-27 Pit skim tank**

**No capacity or contents label**

**Stained soil | Weeds**

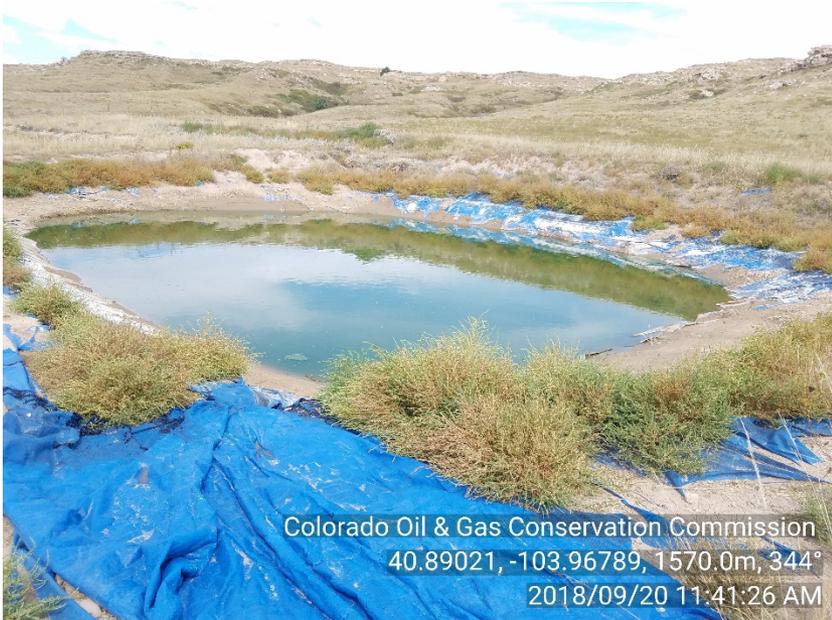
**Photo #23**

**Dolan Ranches 13-27** Northeast pit

**Weeds | Damaged liner | Algae**

*from prev. FIR*

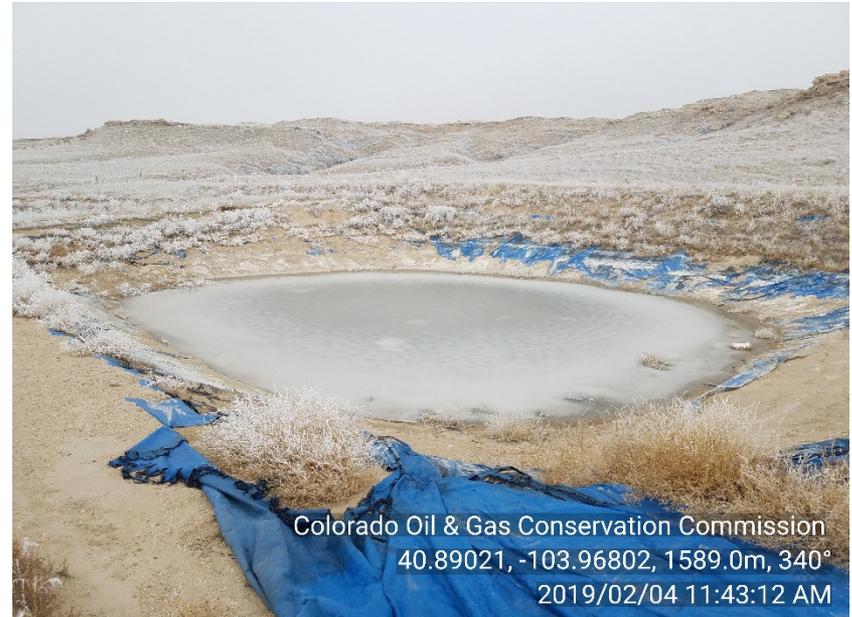
**Photo #24**

**Dolan Ranches 13-27** Northeast pit

**Weeds | Damaged liner**

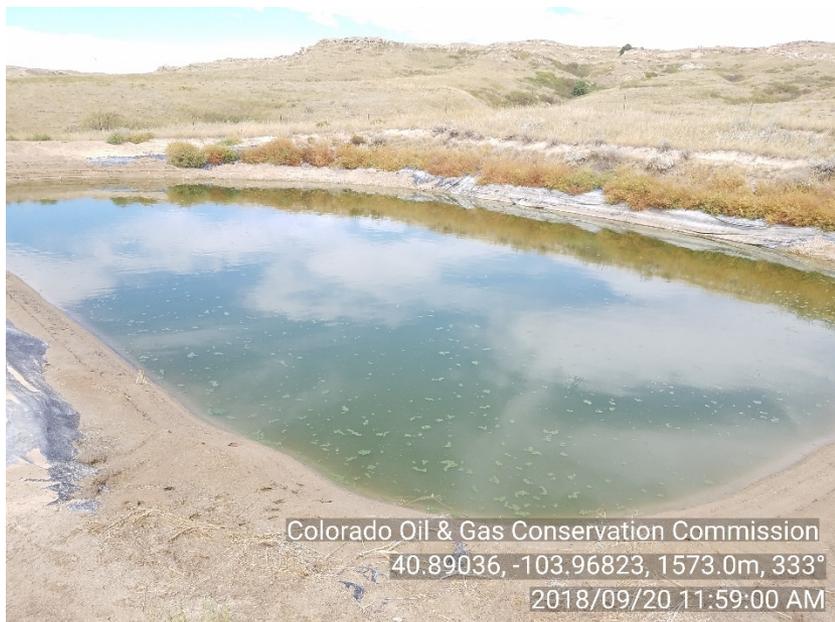
**Photo #25**

**Dolan Ranches 13-27 Northwest pit**

**Weeds | Damaged liner | Algae**

*from prev. FIR*

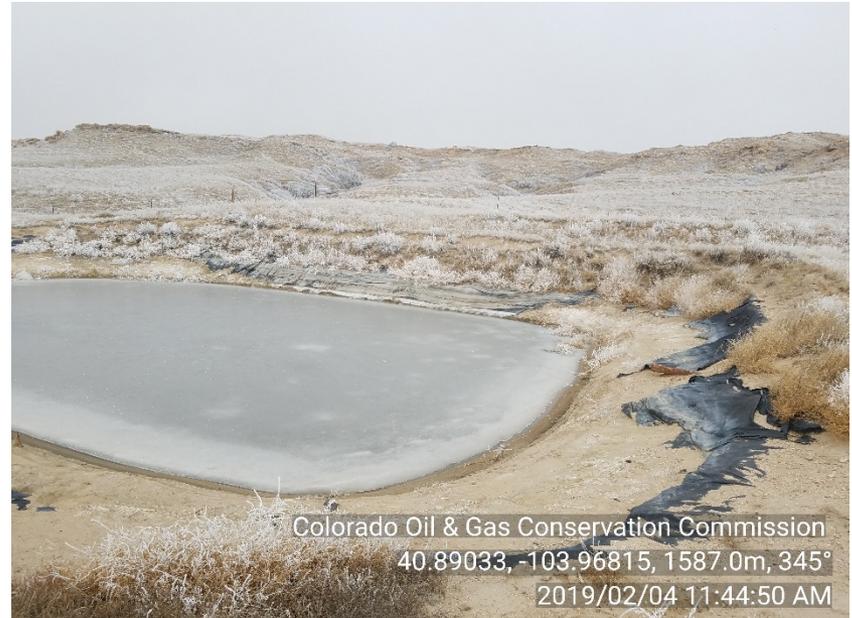
**Photo #26**

**Dolan Ranches 13-27 Northwest pit**

**Weeds | Damaged liner**

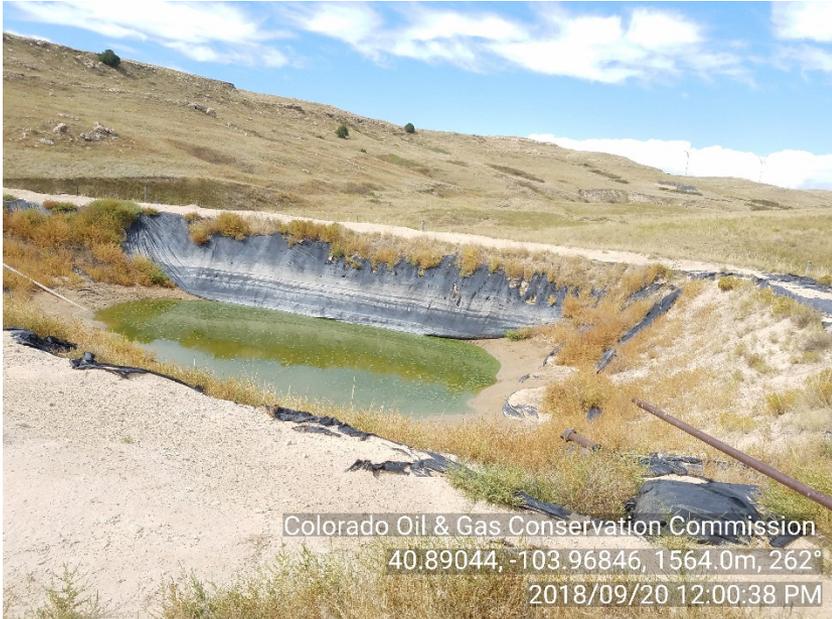
**Photo #27**

**Dolan Ranches 13-27 Southwest pit**

**Weeds | Damaged liner | Algae**

*from prev. FIR*

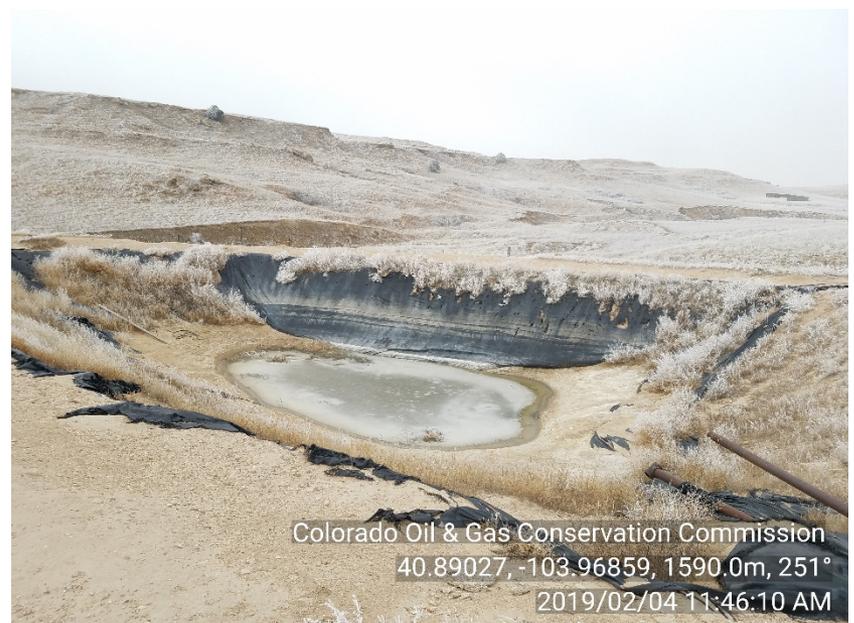
**Photo #28**

**Dolan Ranches 13-27 Southwest pit**

**Weeds | Damaged liner**

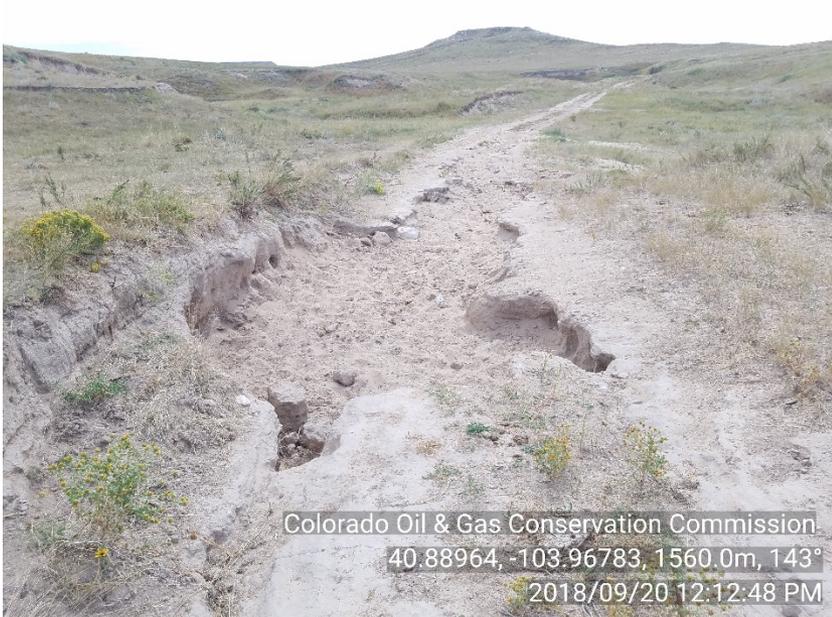
**Photo #29**

**Dolan Ranches 13-27** Access road

**Severe erosion | No BMP**

*from prev. FIR*

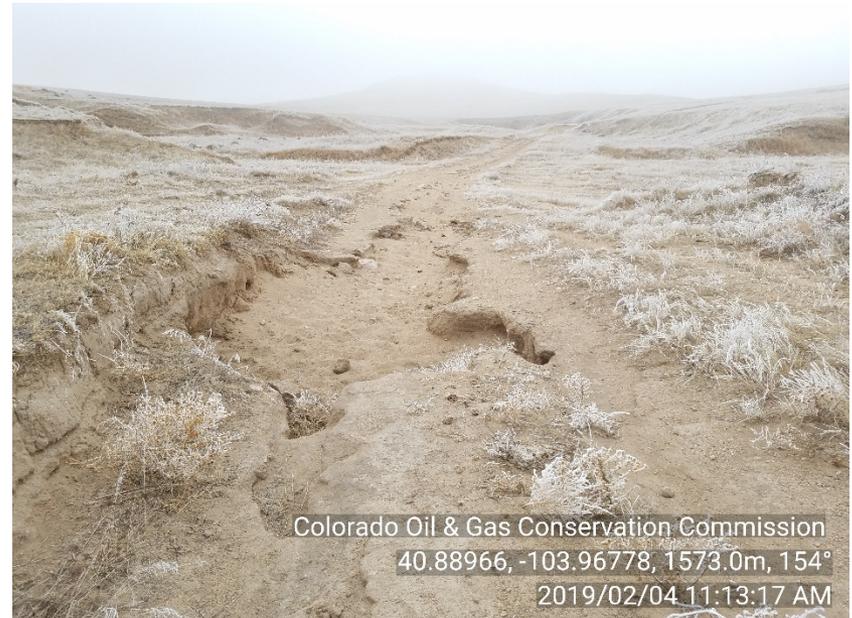
**Photo #30**

**Dolan Ranches 13-27** Access road

**Severe erosion | No BMP**

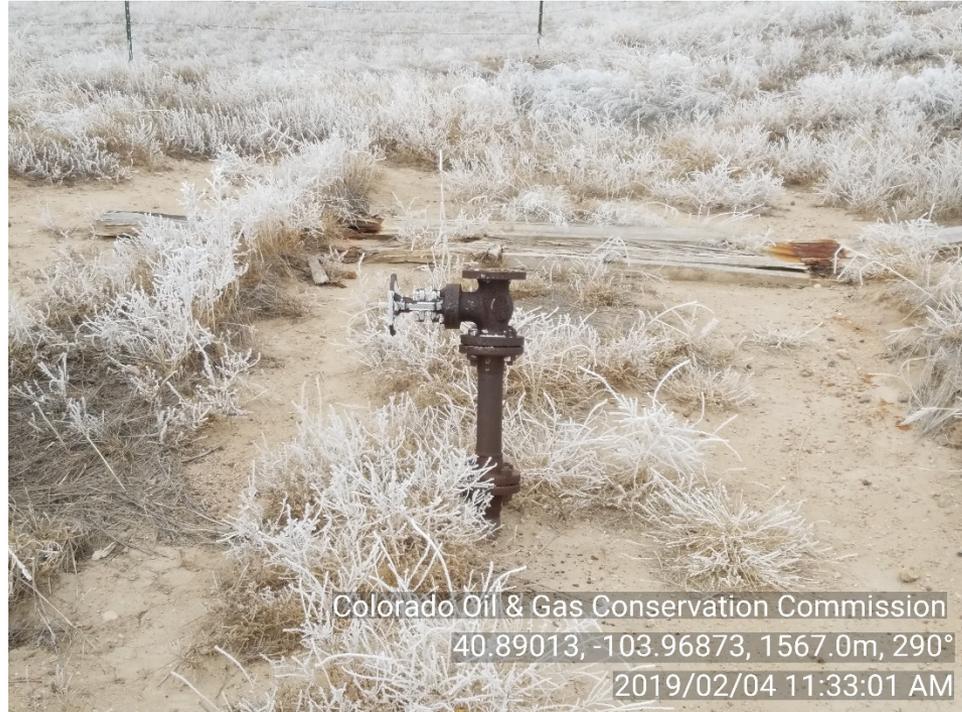
**Photo #31**

**Dolan Ranches 13-27**

**Unmarked riser w/ closed valve**

**NOT LOTO**

*SW of wellsite*
