Inspection Photos

2/04/2019

Operator: MALLARD EXPLORATION LLC # 10670

Location ID: 453517

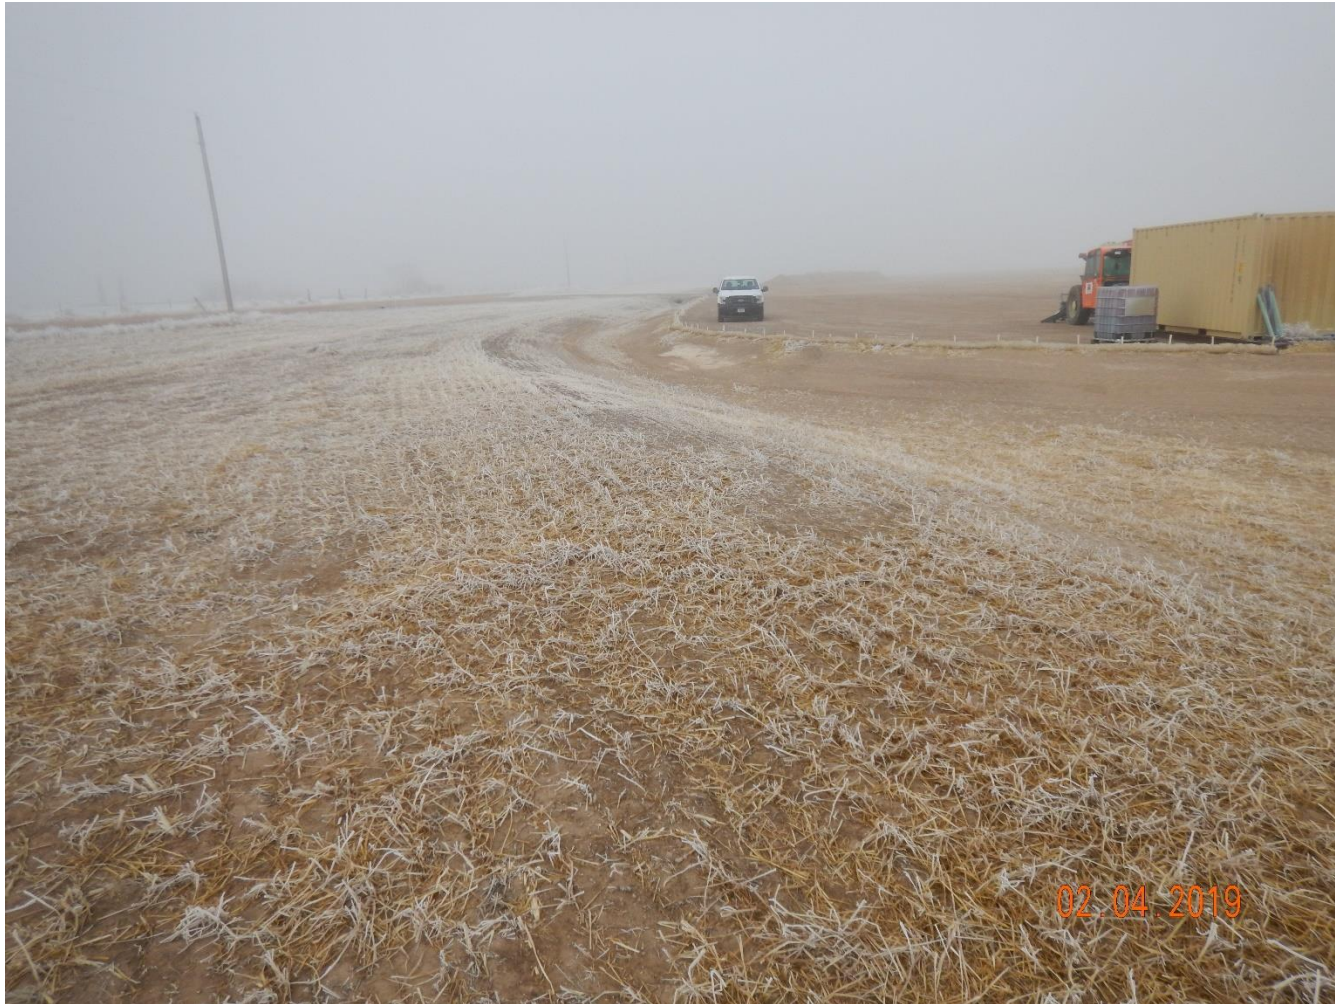
Photo 1: Photo taken from the southeast corner of the location, facing west. Photo shows perimeter stormwater ditch. Photo also show disturbed areas along perimeter of location appears to have been seeded and mulched.

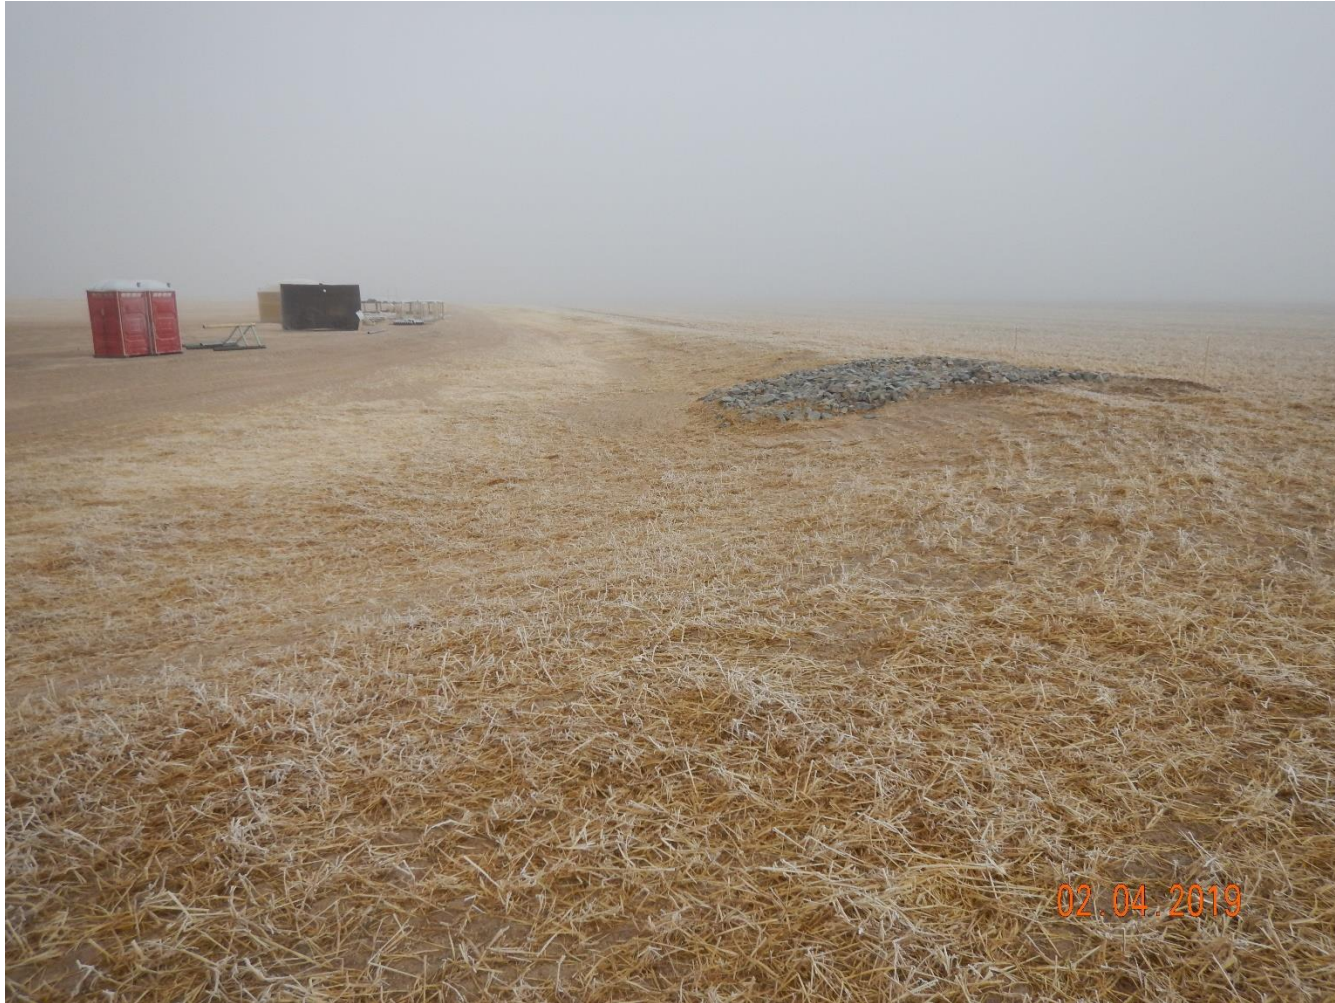
Photo 2: Photo taken from the southeast corner of the location, facing west. Photo shows perimeter stormwater ditch, and sediment pond/trap. Photo also show disturbed areas along perimeter of location appear to have been seeded and mulched.

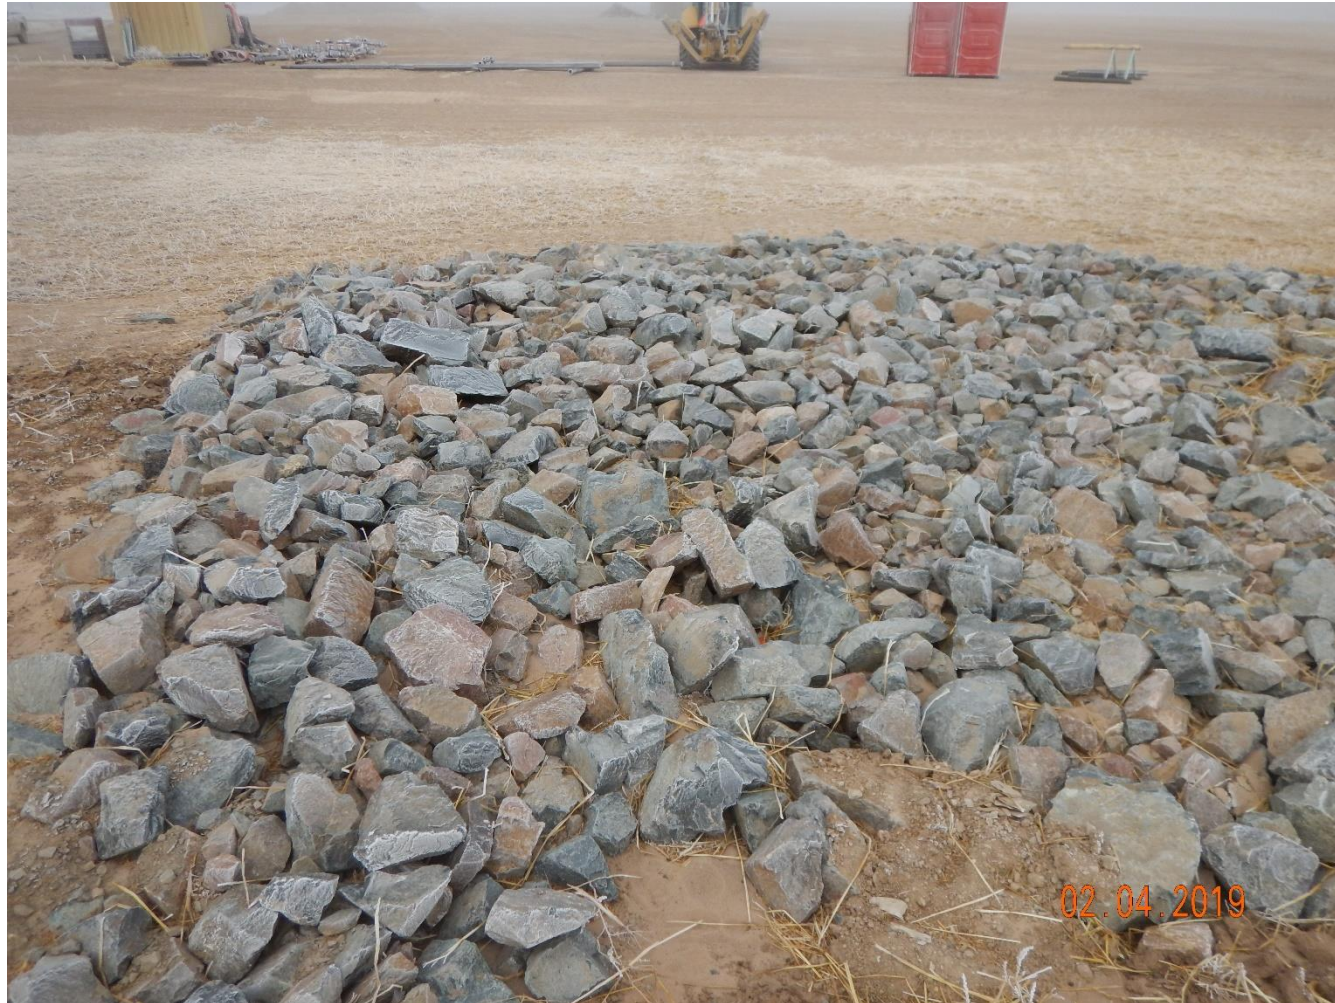
Photo 3: Photo taken from the southeast end of the location. Photo shows the outlet of the sediment pond/trap has been armored. Outlet protection appears to be sufficient and in proper functioning condition.

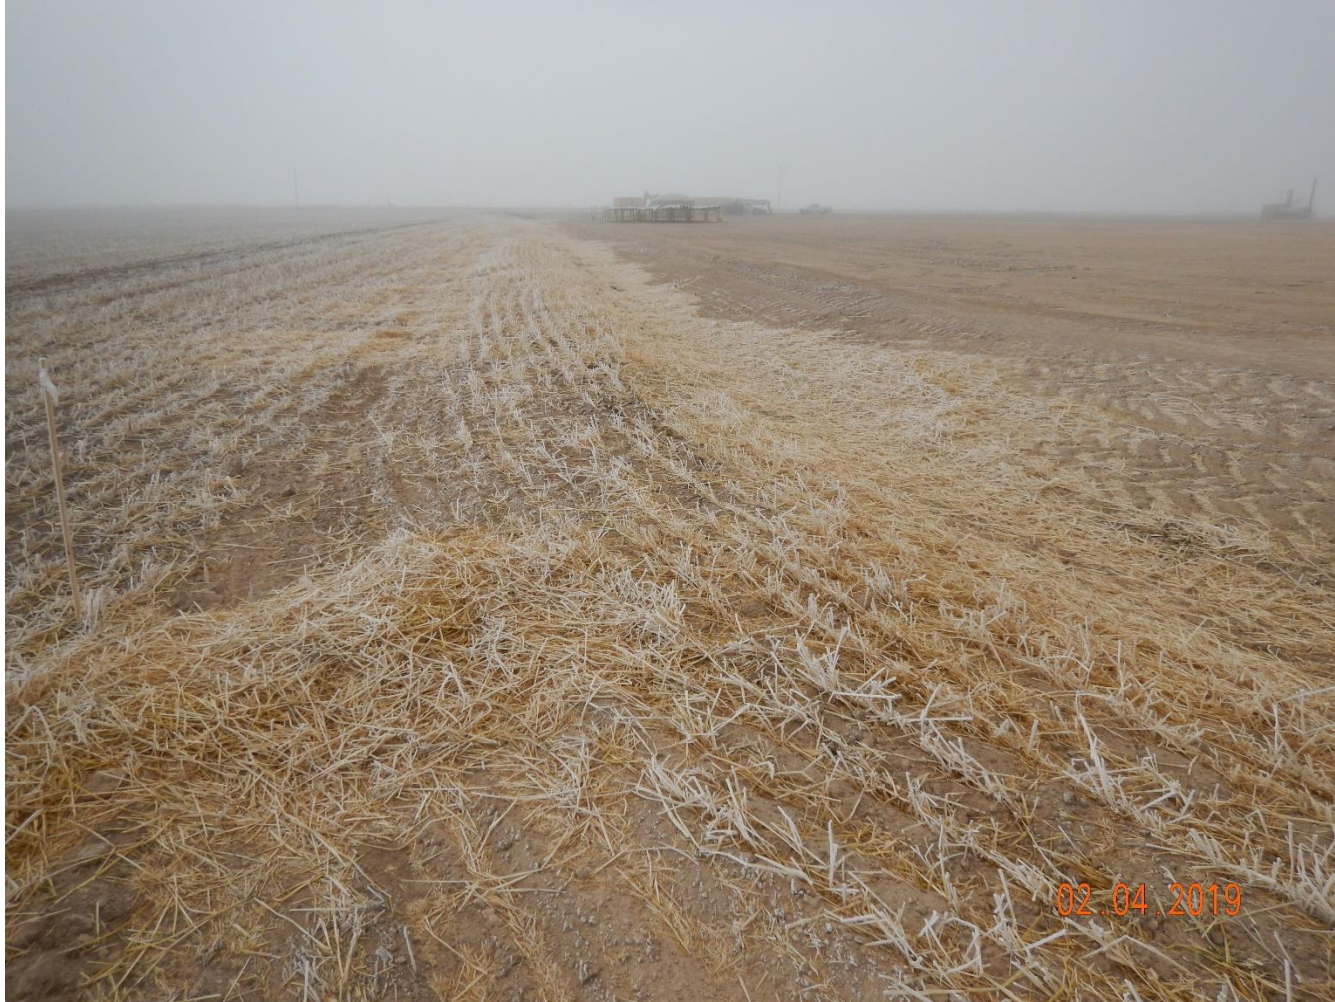
Photo 4: Photo taken from the northeast corner of the location. Photo shows the perimeter stormwater ditch has been installed. Ditch appears to have been installed in accordance with good engineering practices and in proper functioning condition. Photo also shows disturbed areas along perimeter of location appears to have been seeded and mulched.

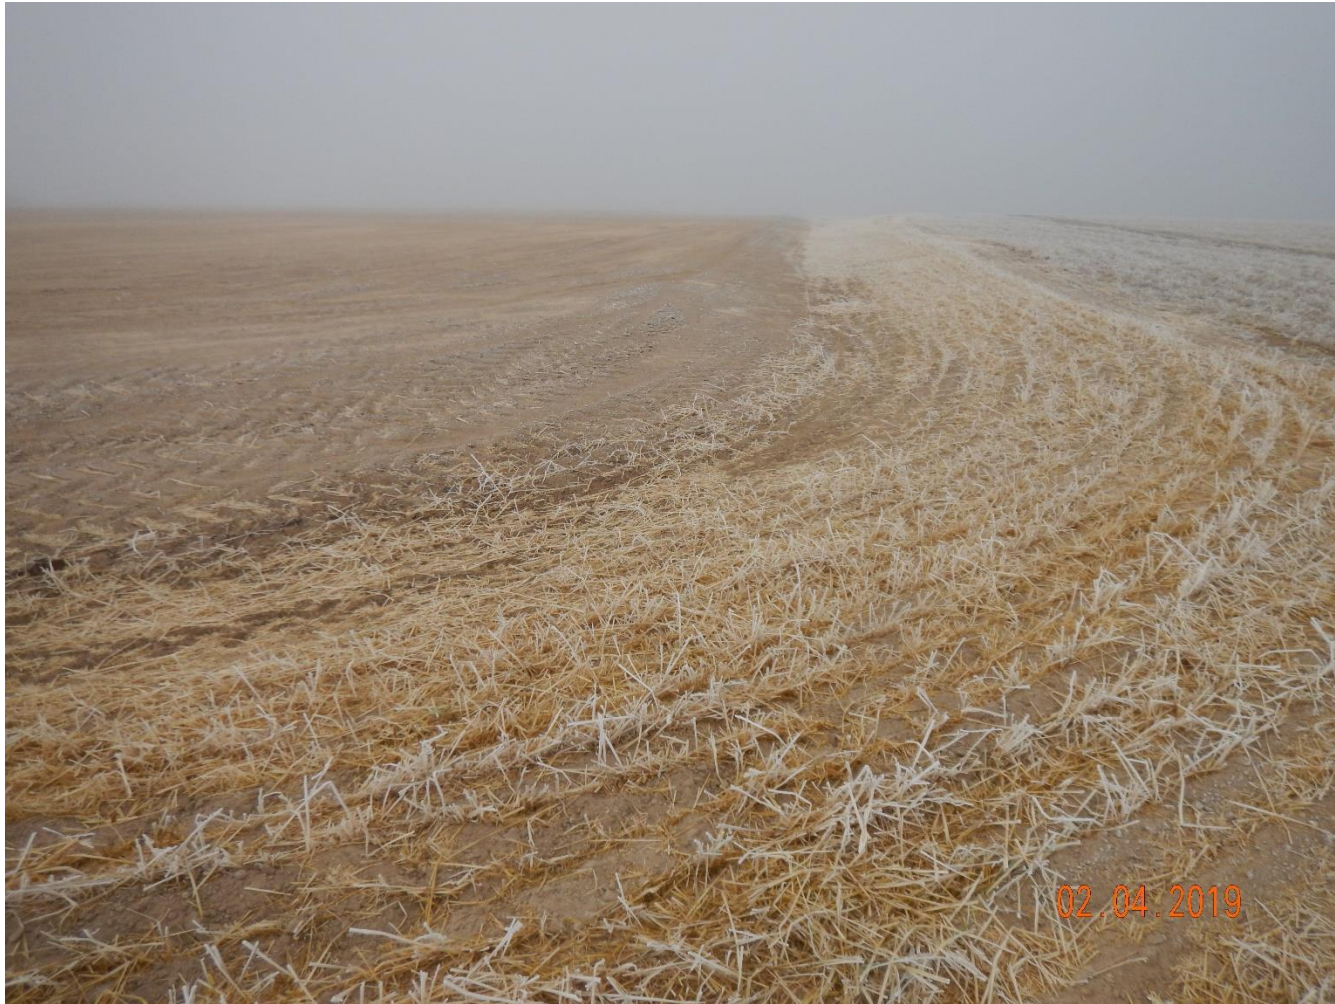
Photo 5: Photo taken from the northeast corner of the location. See comments under photo 4.

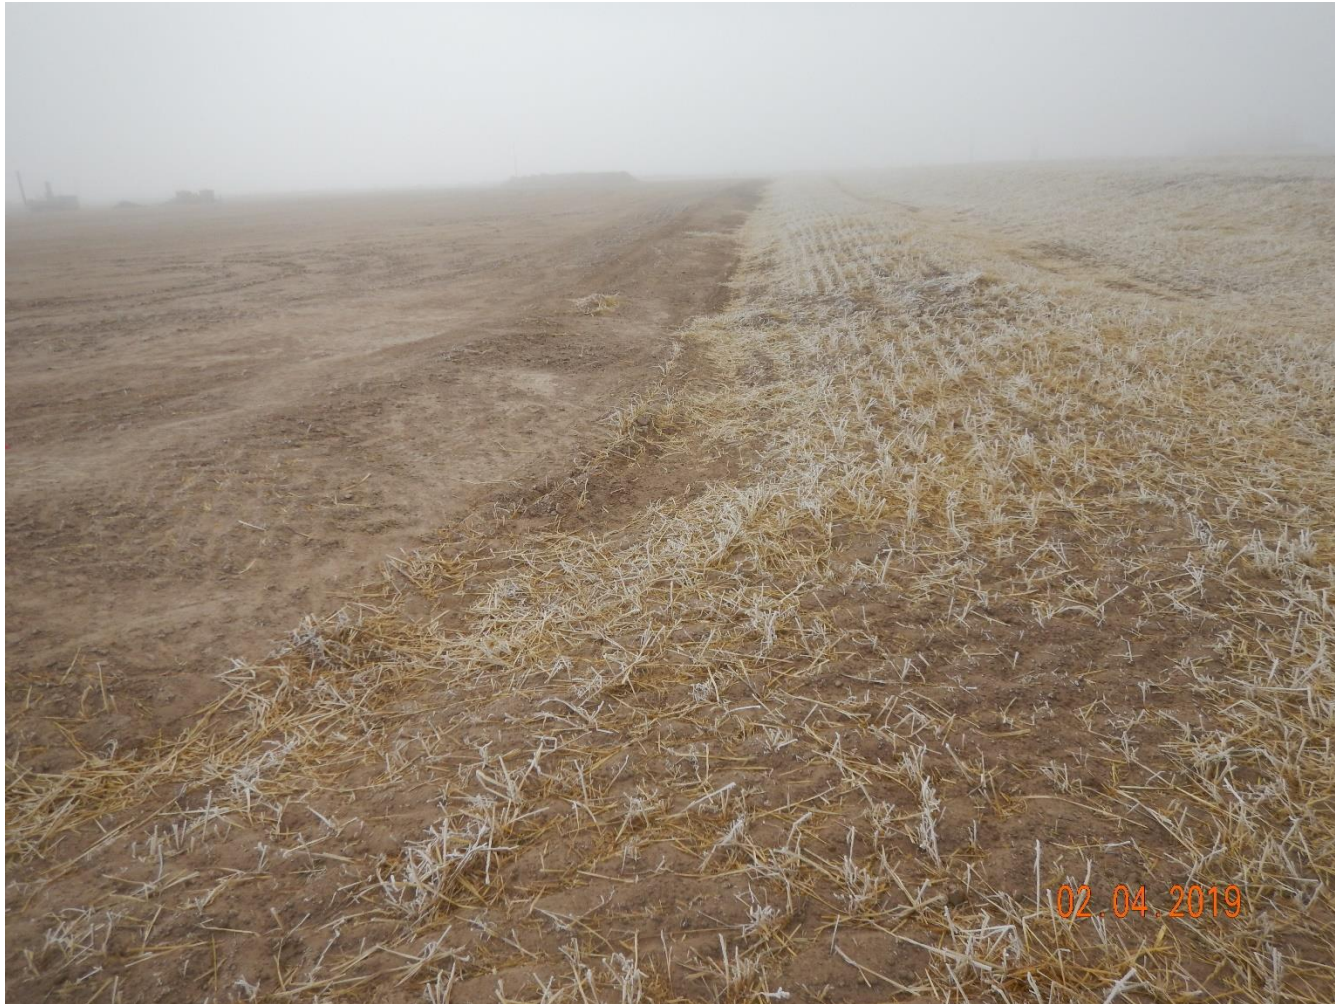
Photo 6: Photo taken from the northwest corner of the pad, facing south. See comments under photo 4.

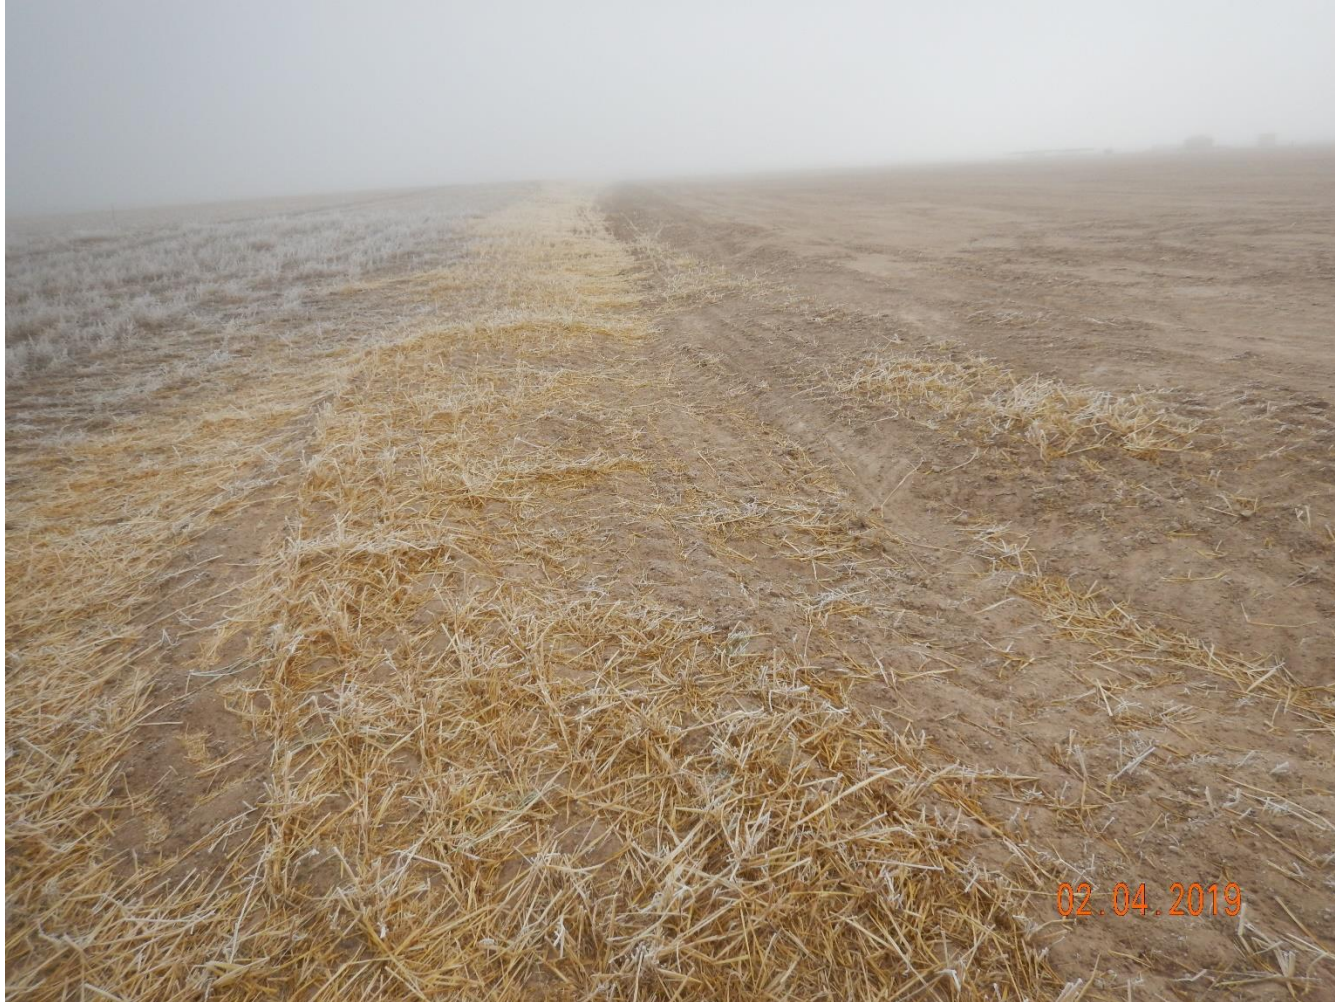
Photo 7: Photo taken from the northwest corner of the pad, facing east. See comments under photo 4.

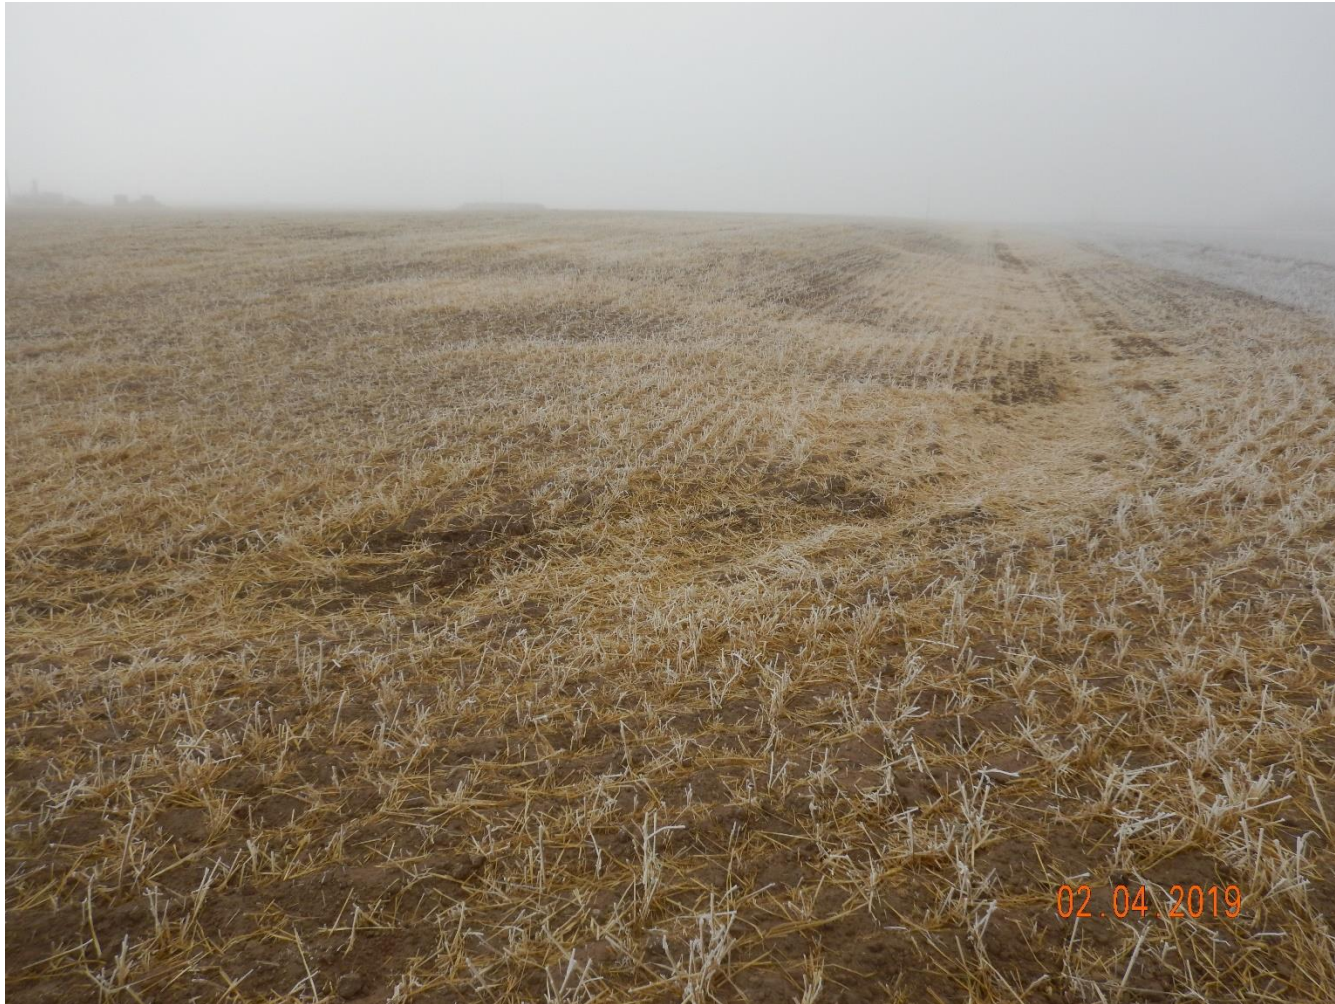
Photo 8: Photo taken from the northwest corner of the location, facing south. See comments under photo 4. Photo also shows topsoil stockpile appears to have been stabilized and seeded.

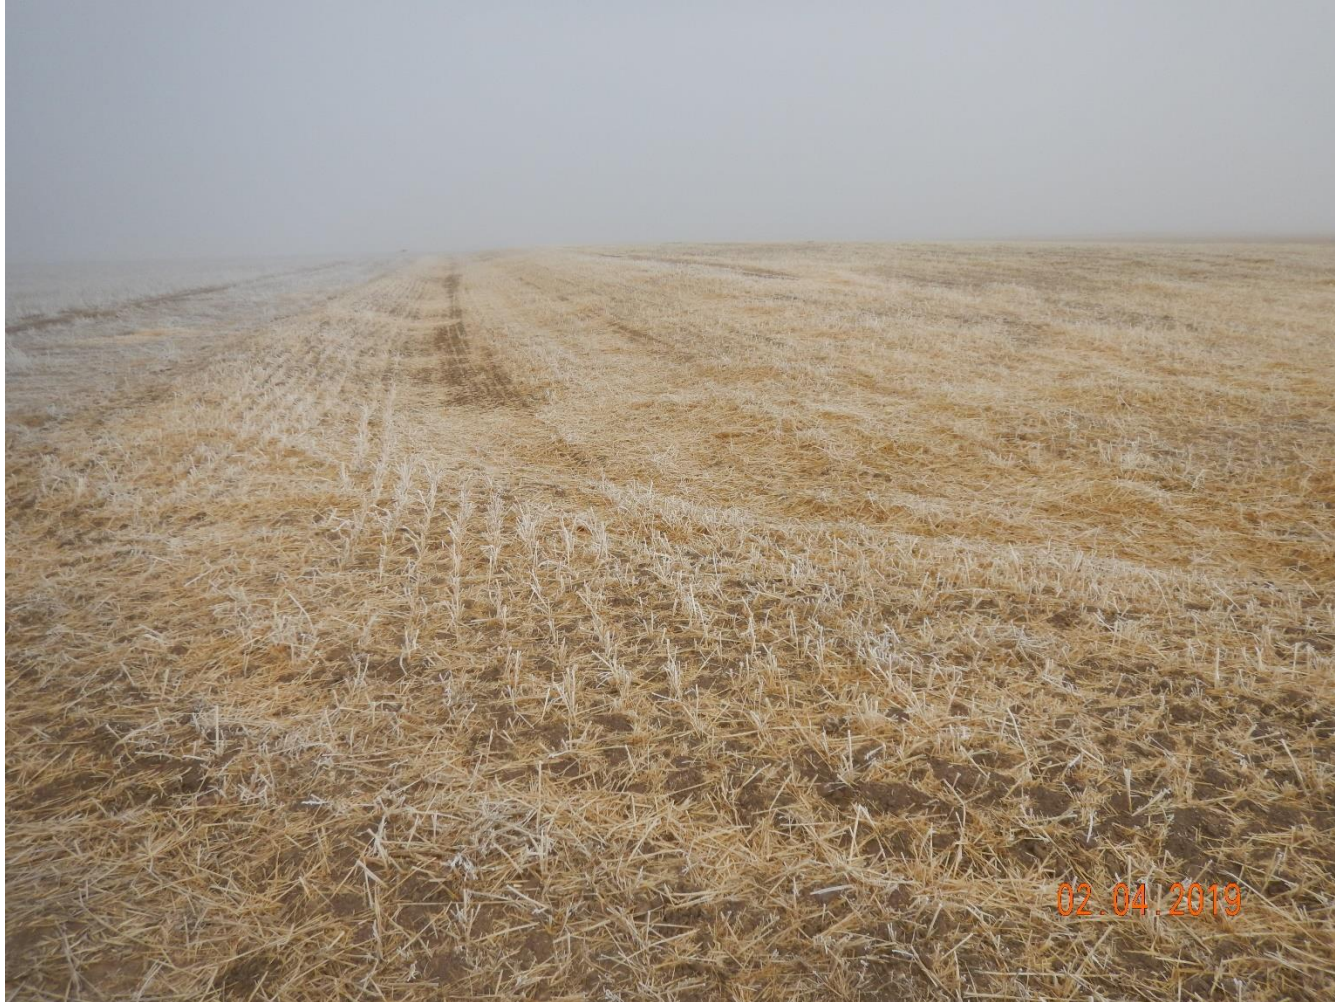
Photo 9: Photo taken from the southwest corner of the pad, facing north. See comments under photo 4. Photo also shows topsoil stockpile appears to have been stabilized and seeded.

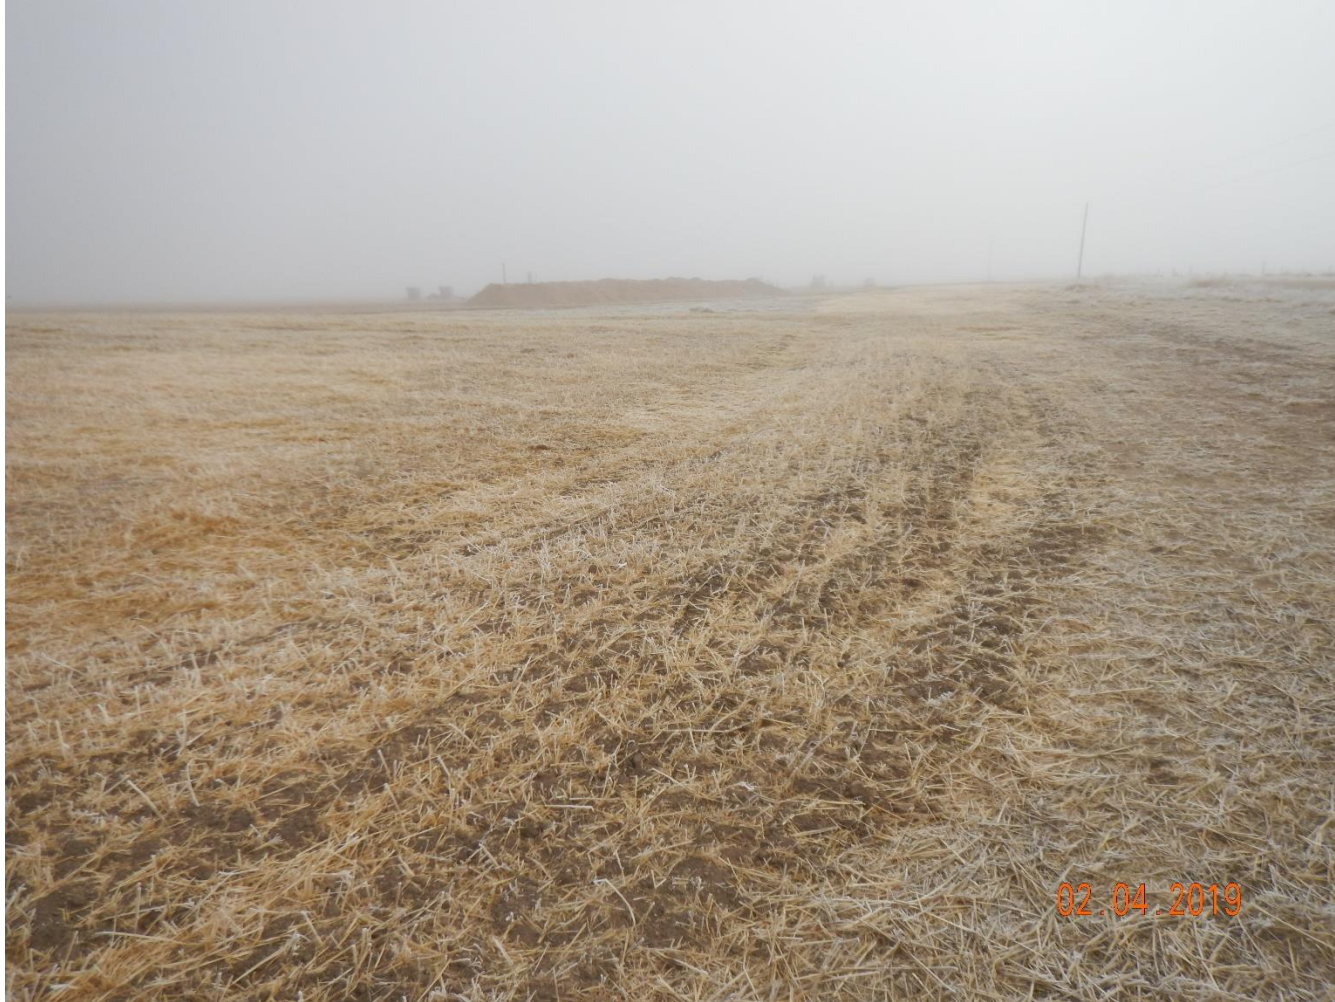
Photo 10: Photo taken from the southwest corner of the pad, facing east. See comments under photo 4.

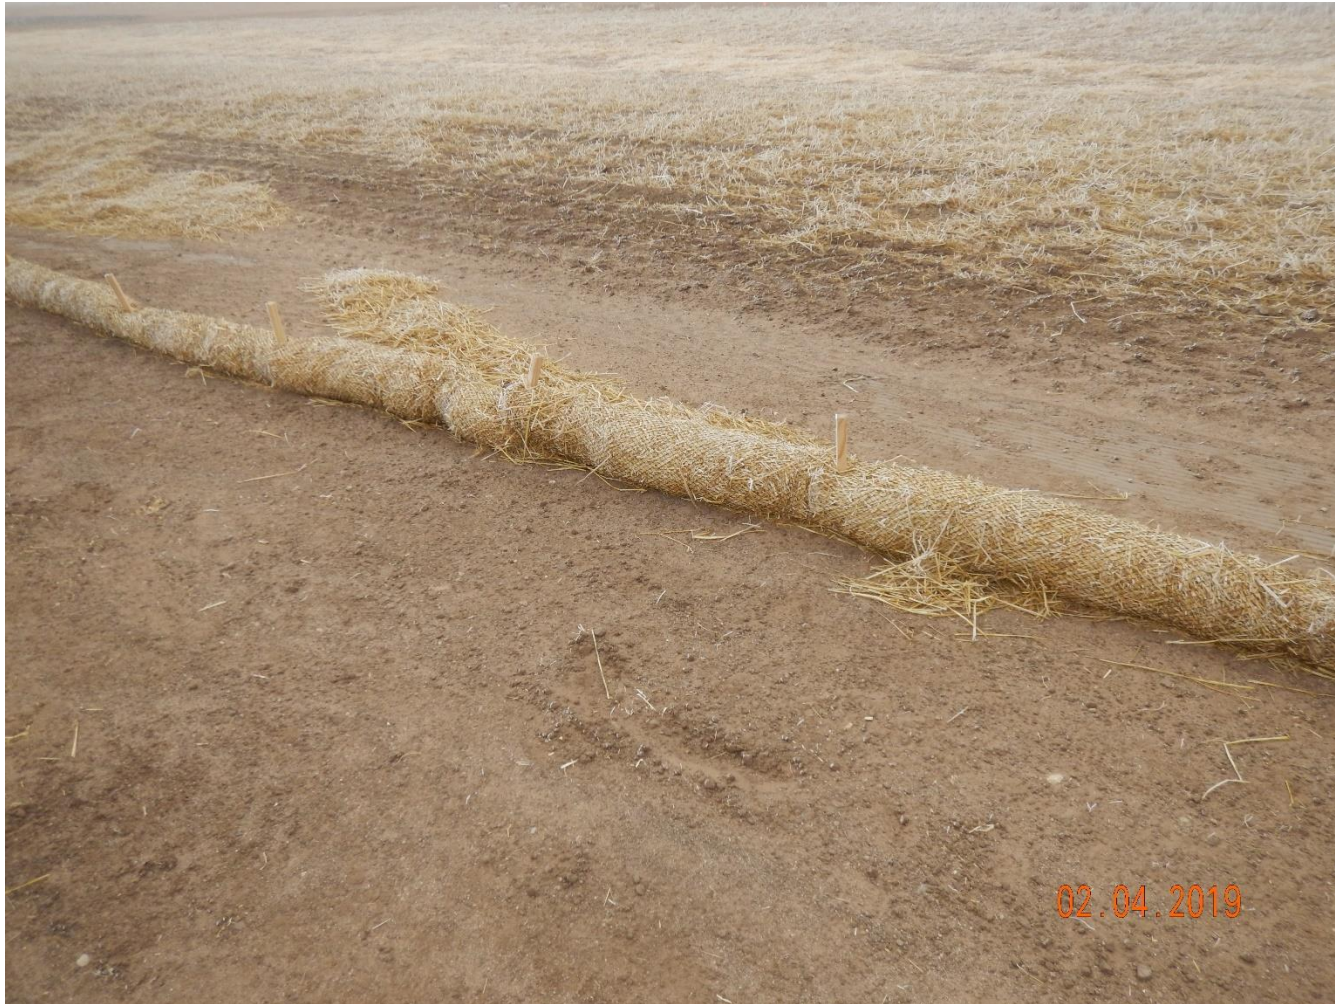
Photo 11: Photo taken from the south end of the pad. Photo shows wattles do not appear to have been installed in accordance with good engineering practice. Wattles are required to be trenched in order to be in proper functioning condition.

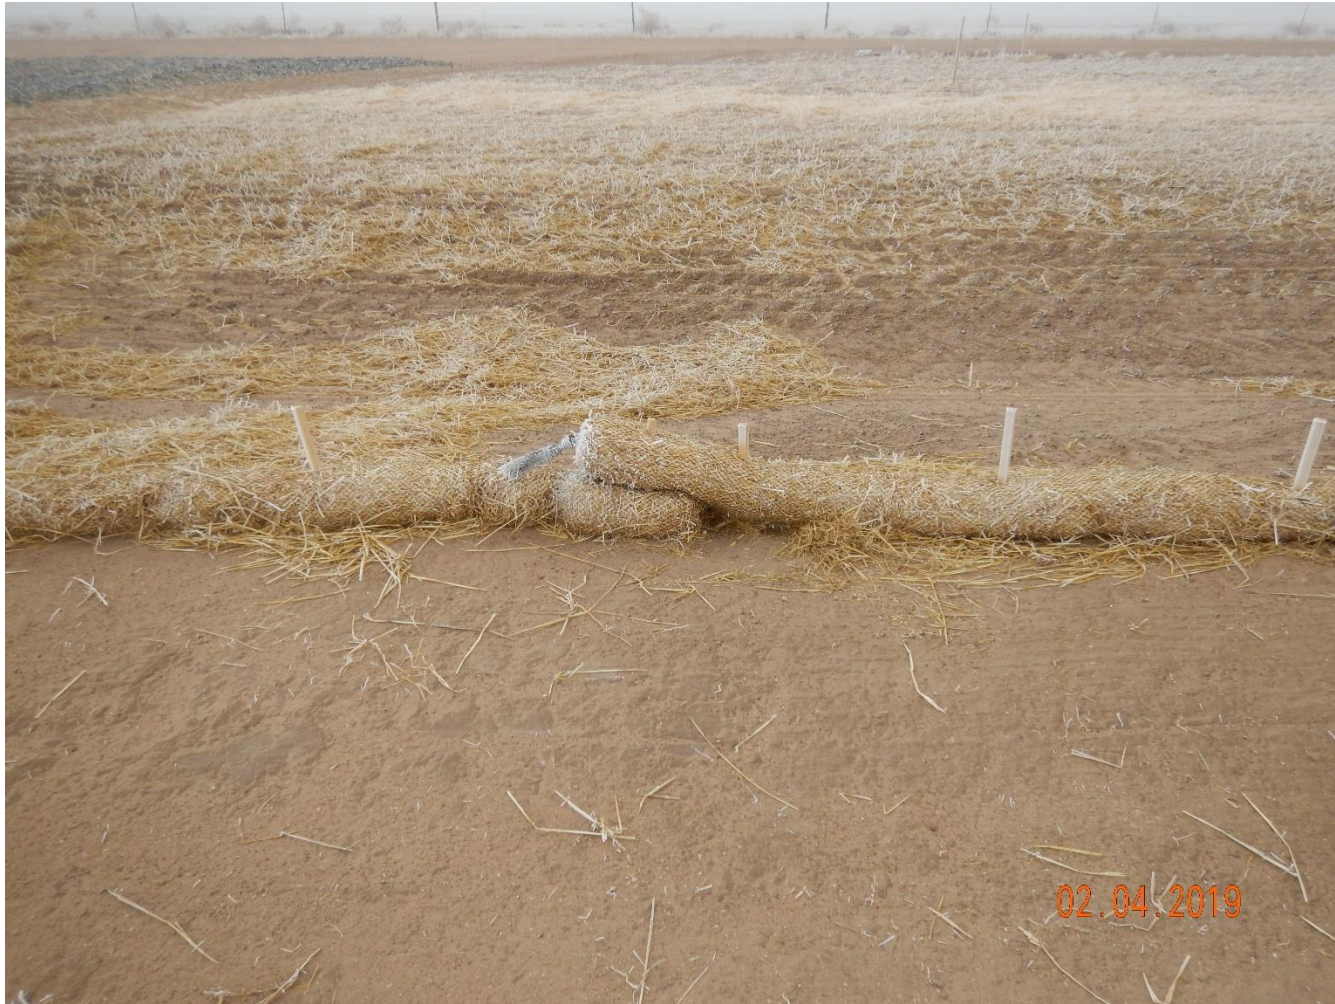
Photo 12: Photo taken from the south end of the pad. Photo shows wattles do not appear to have been installed in accordance with good engineering practice. Wattles are required to be tightly “butted” at the ends.

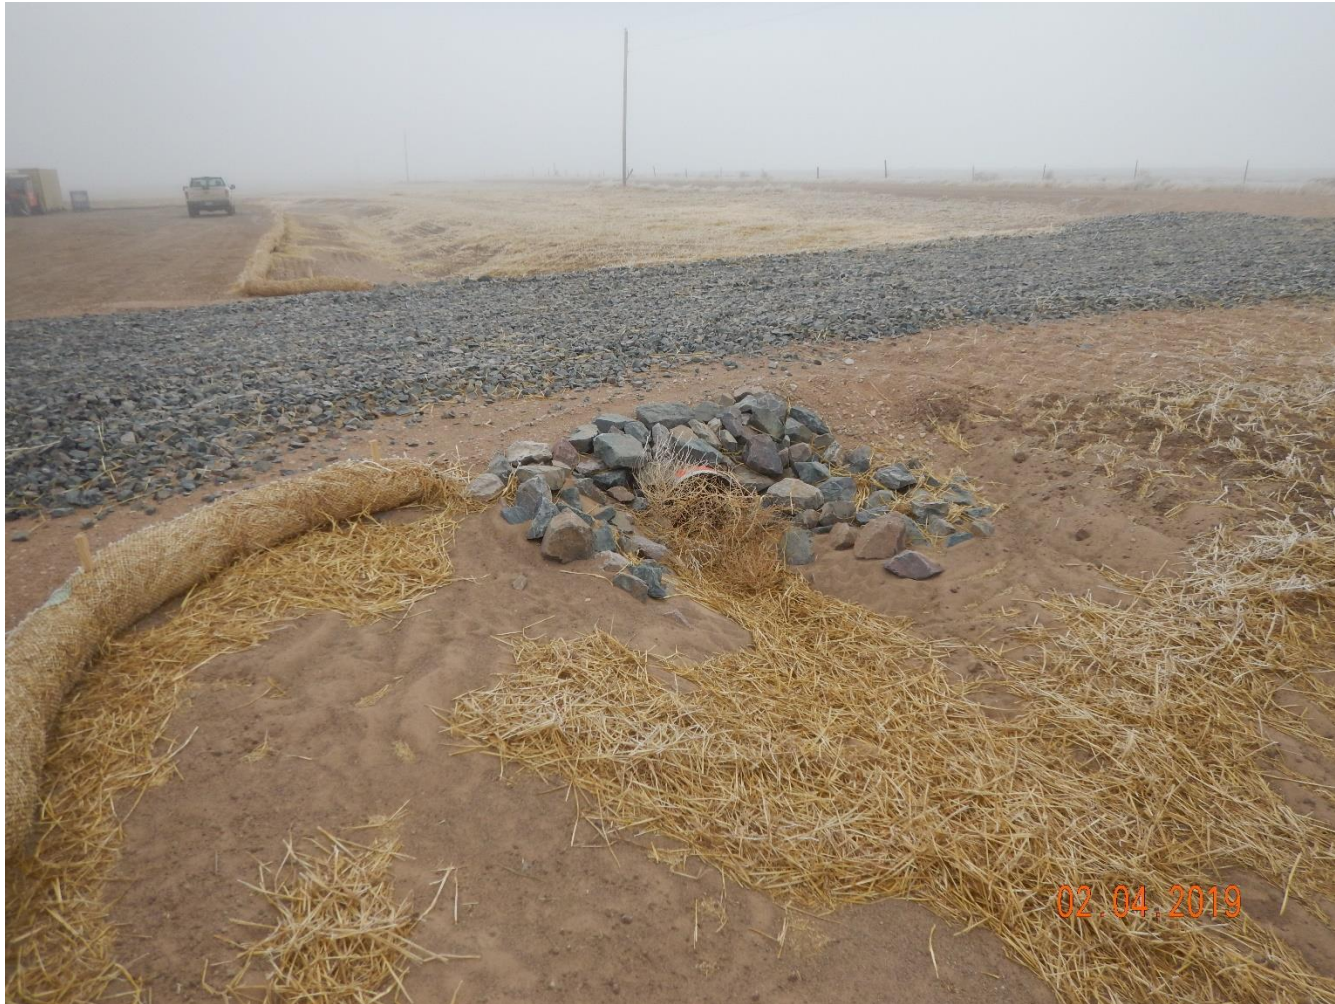
Photo 13: Photo taken from the south end of the location. Photo shows culvert and rock armoring. Photo also shows tracking pad.
