Inspection Photos
Location Name: PEOC-NVG 41-23H
API: 05-107-06173

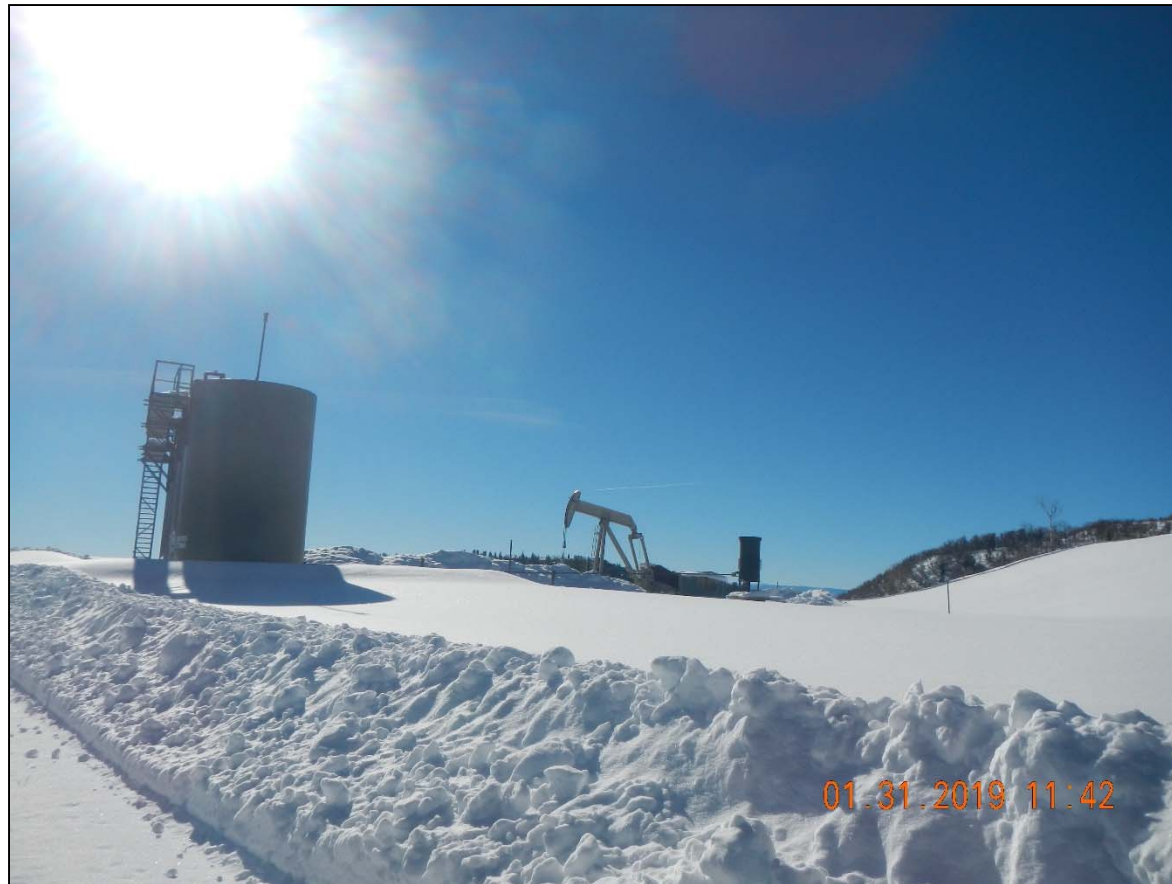
Photo 1. Overview of location taken at entrance facing southeast.

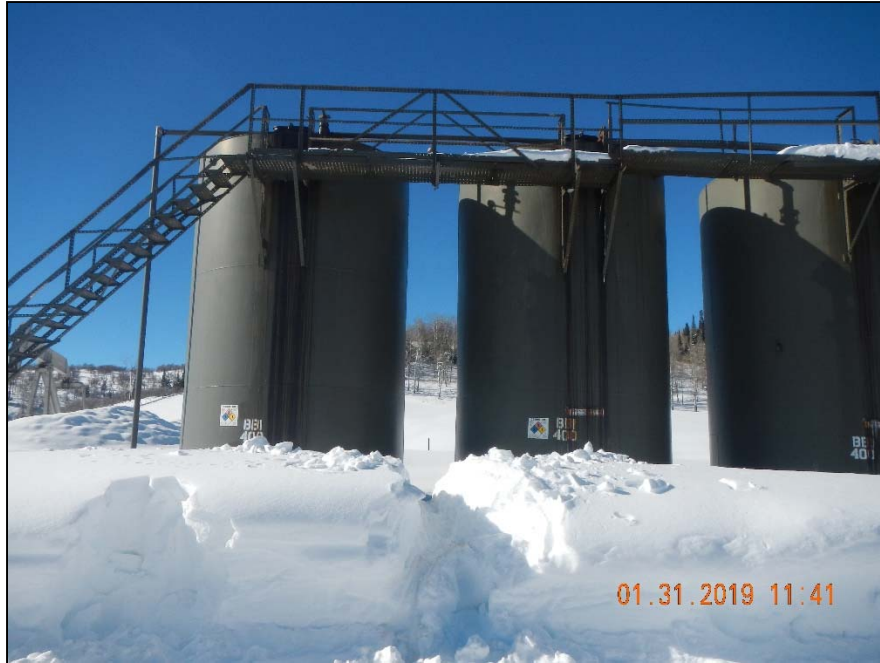
Photo 2. Staining on tank sides.

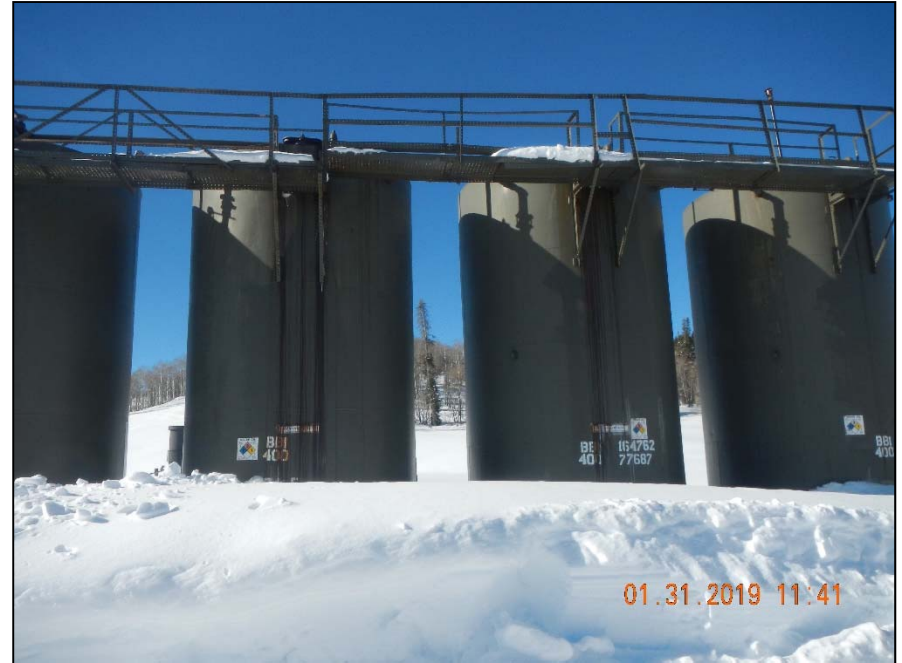
Photo 3. Staining on tank sides.
