Inspection Photos
Location Name: GENGHIS 44-16
API #: 05-071-06753
Insp. Doc. # 695100131

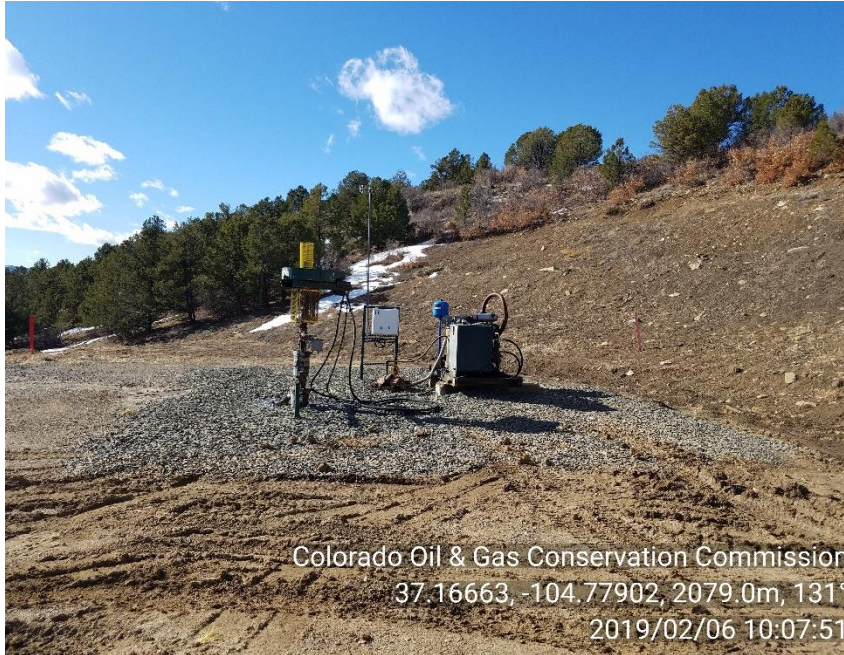
PHOTO 1: WELLHEAD

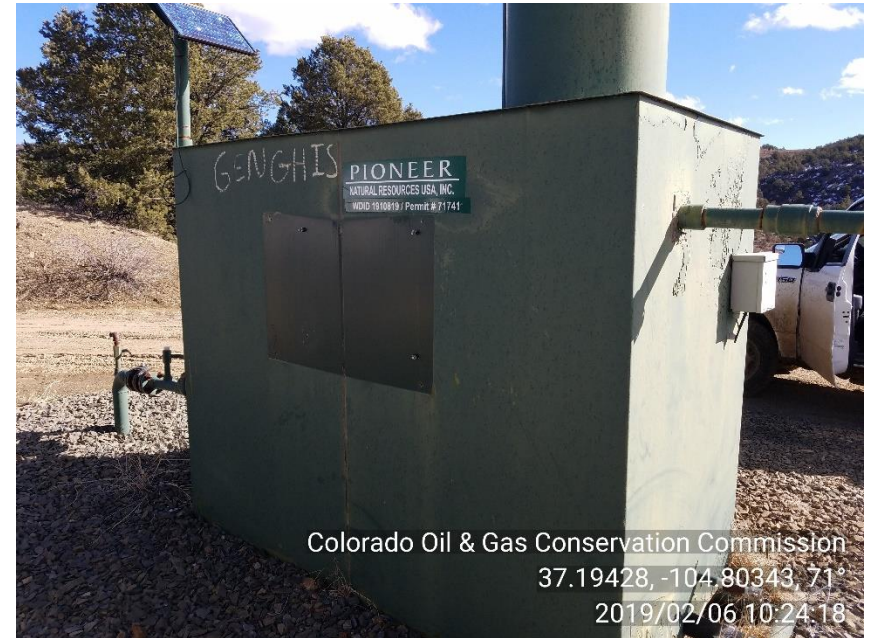
**PHOTO 2: WELL SIGN/METER HOUSE/SIGN NOT POSTED OR
INACCURATE INFORMATION/NO EMERGENCY CONTACT NUMBER**

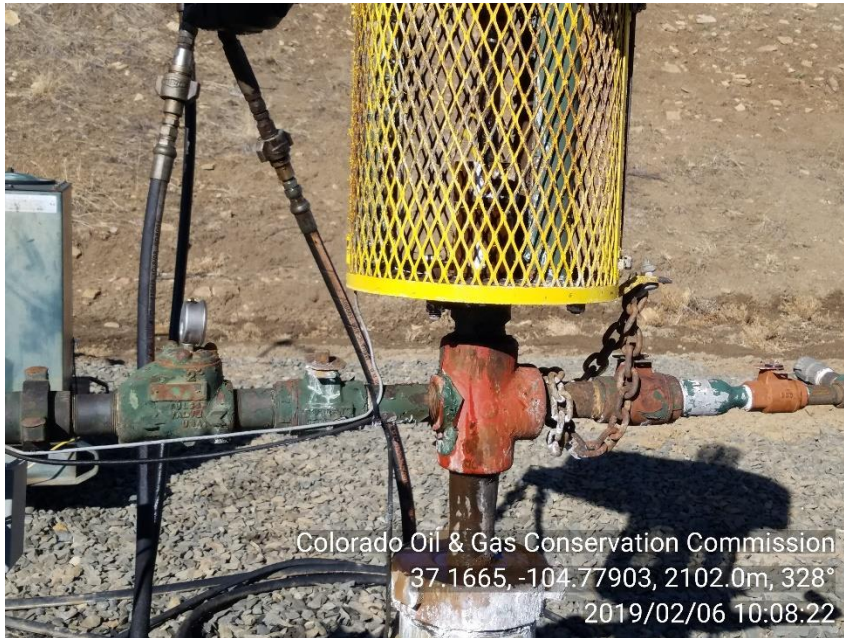
PHOTO 3: STANDING WATER ON TBG HEAD APPEARS TO HAVE LEAKING PACKING ON POLISH ROD

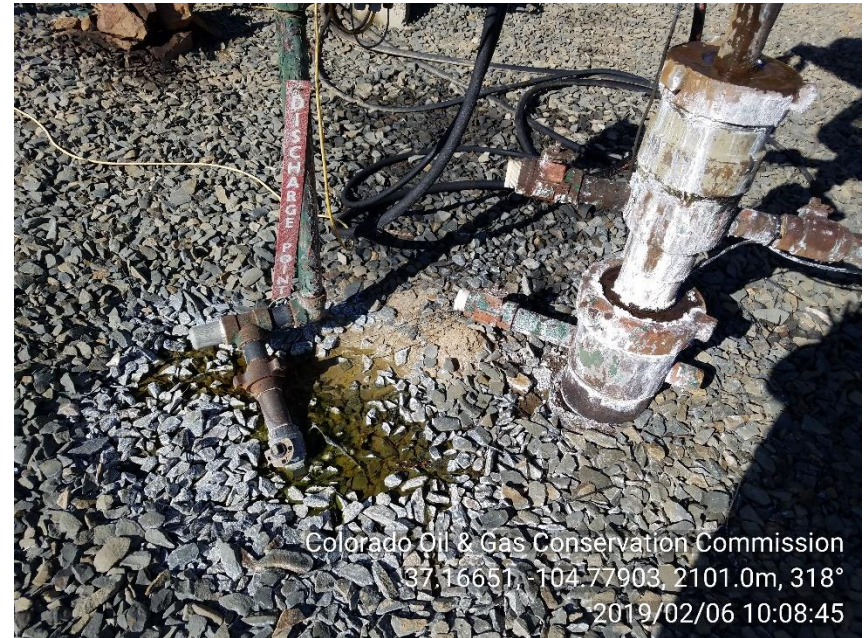
PHOTO 4: STANDING WATER NEXT TO WELLHEAD/ STAINED SOIL AROUND WELLHEAD APPEARS TO BE FROM LEAKING WATER AT POLISH ROD.

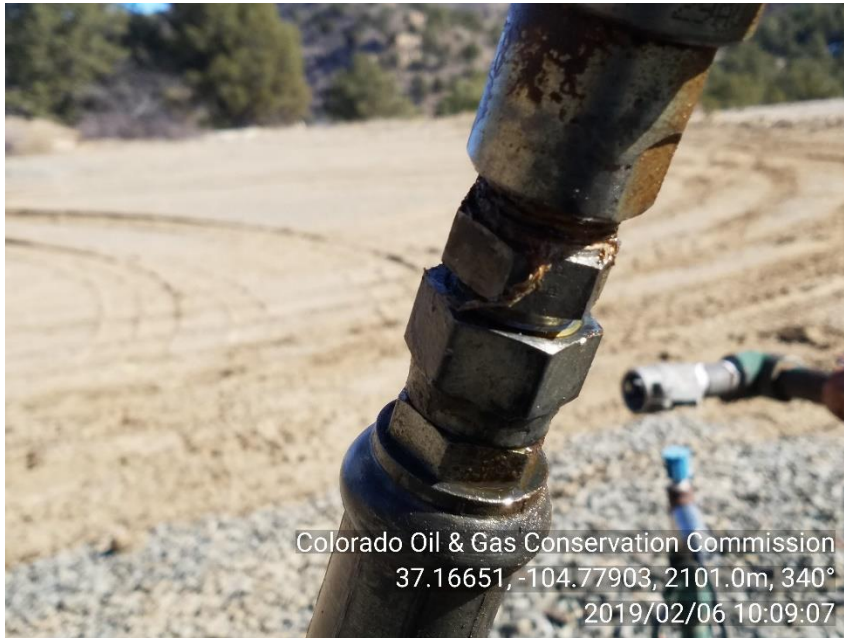
PHOTO 5: APPEARS HYDRAULIC HOSE CONNECTION IS SEEPING

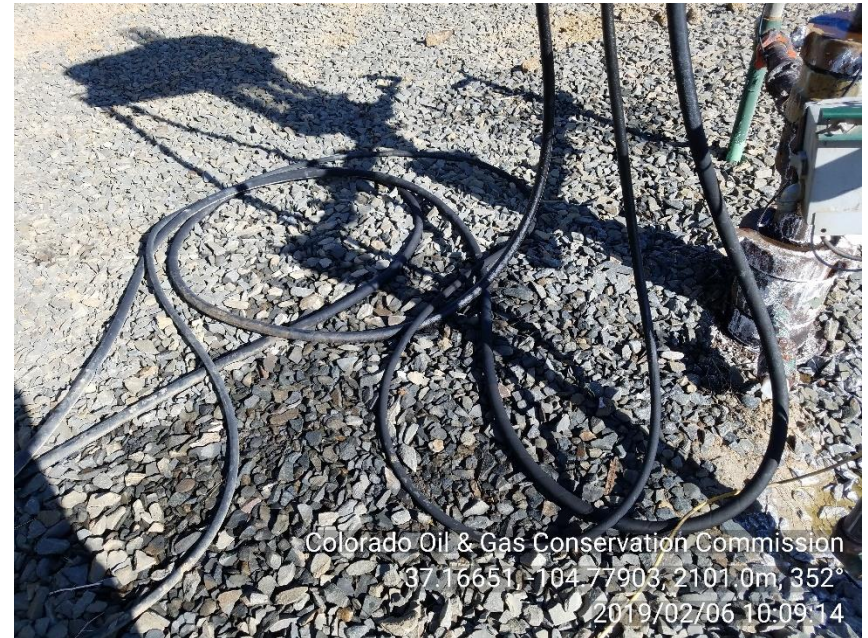
PHOTO 6: STAINED SOIL UNDER DRIVEHEAD NEXT TO WELLHEAD.

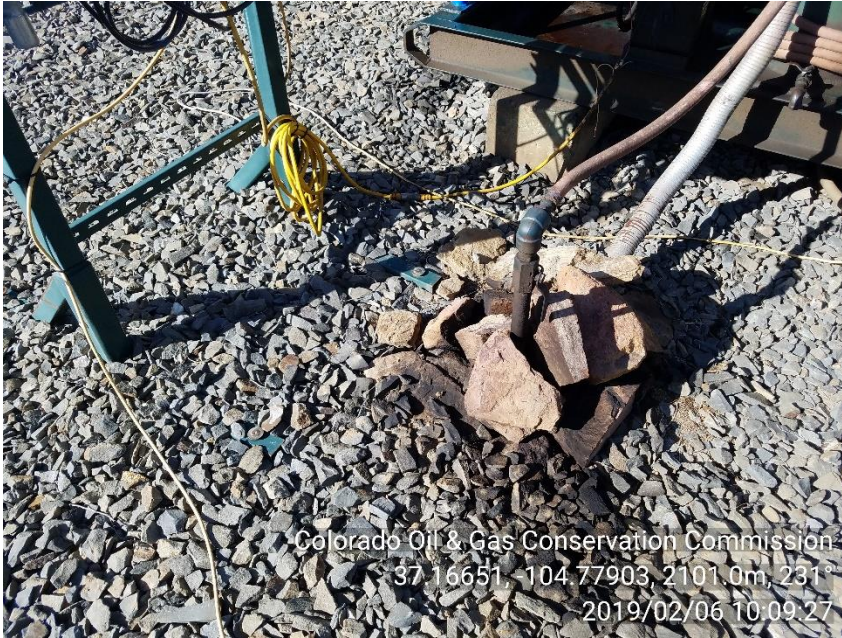
PHOTO 7: STAINED SOIL NEXT TO ENGINE SKID AT EXHAUST PIT OUTLET.

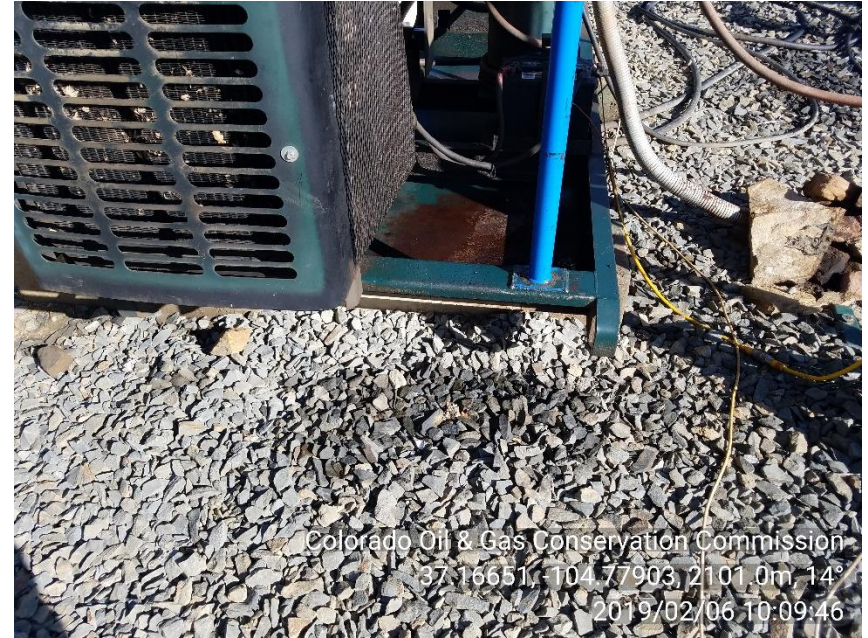
PHOTO 8: STAINED SOIL IN FRONT OF ENGINE SKID.

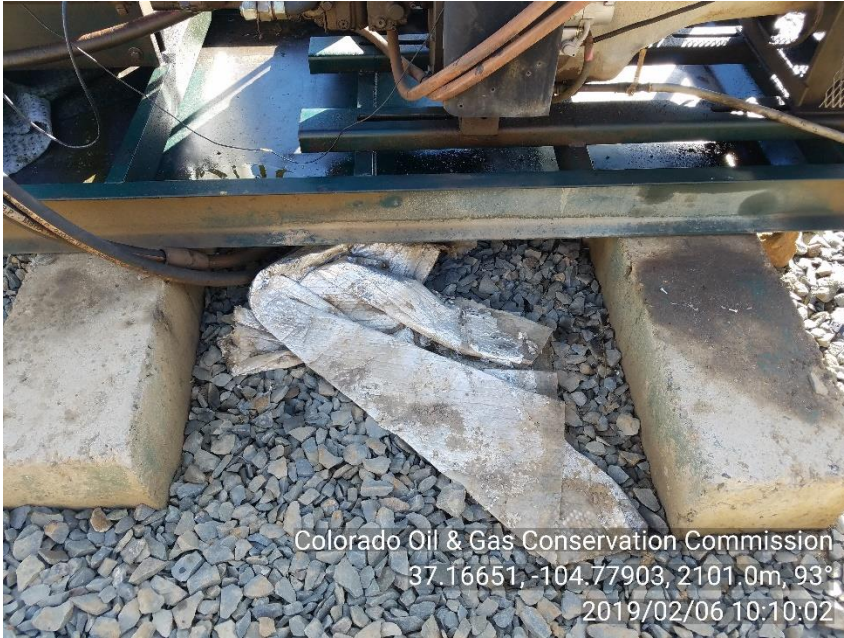
PHOTO 9: TRASH UNDER ENGINE SKID.

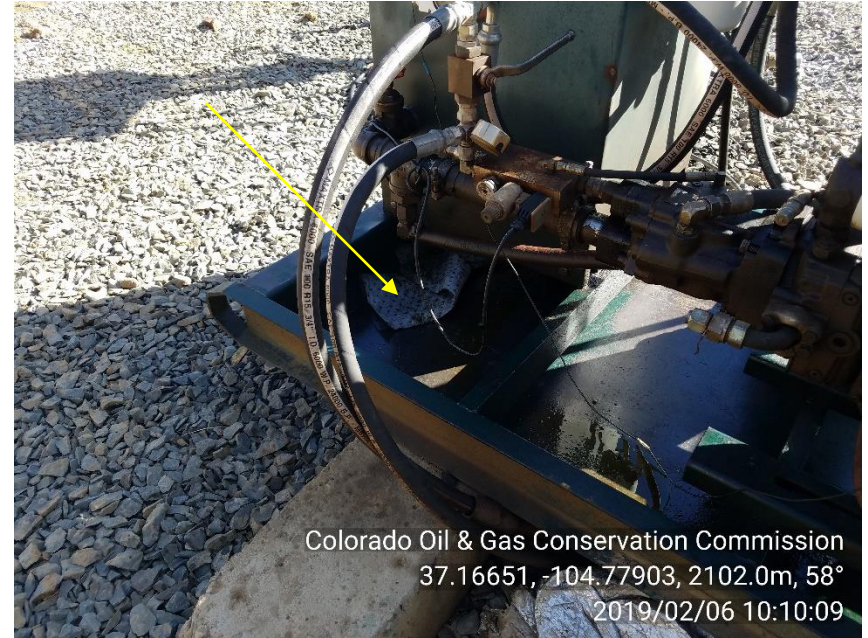
PHOTO 10: TRASH INSIDE ENGINE SKID.

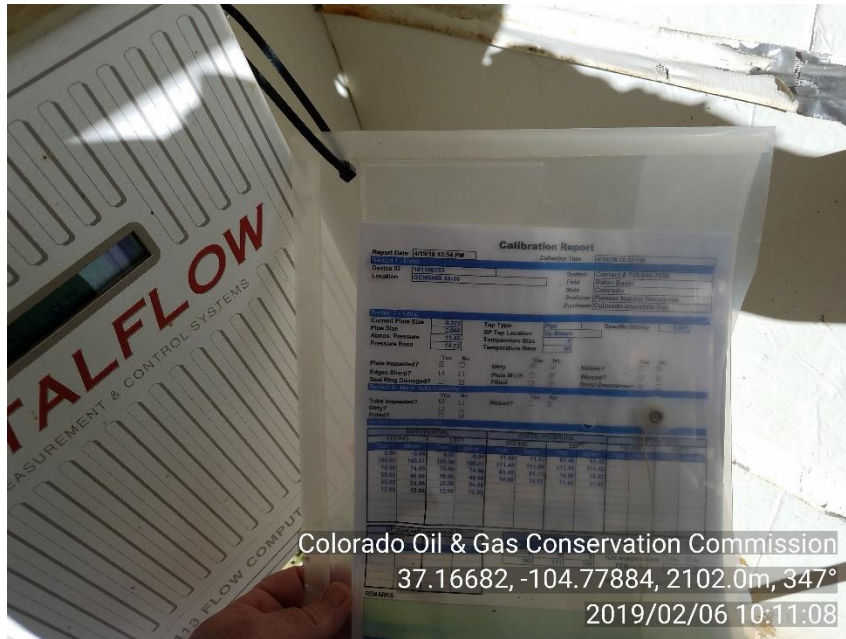
PHOTO 11: METER HOUSE CALIBRATION LOG.
