# Construction and Stormwater Inspection

Operator: ENERPLUS RESOURCES (USA) CORPORATION - #10177

Location ID: 455319

Inspection Photos  
Location Name: Alberta Cities East Pad  
Location ID: 455319

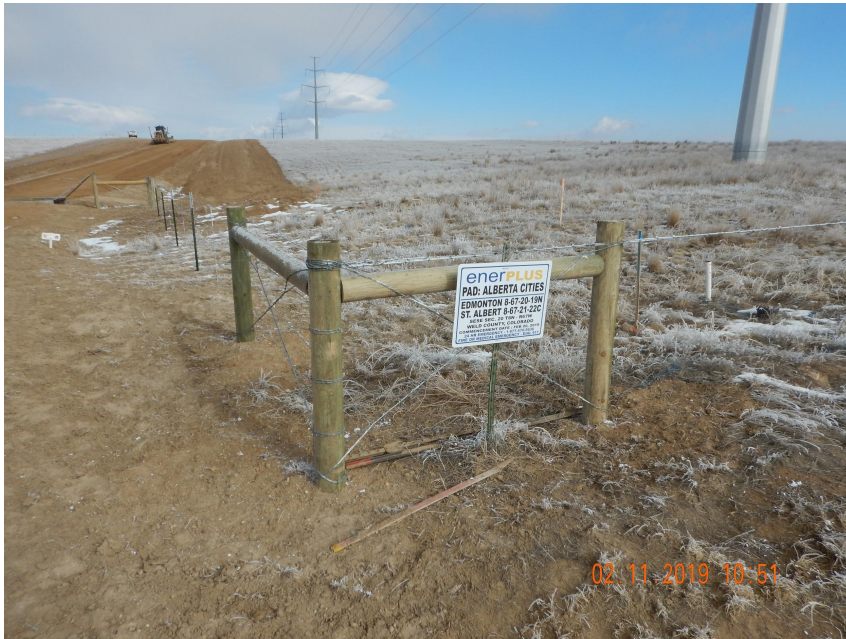
**Photo 1.** Photo taken from the entrance of location, facing North. Photo illustrates Operator sign.

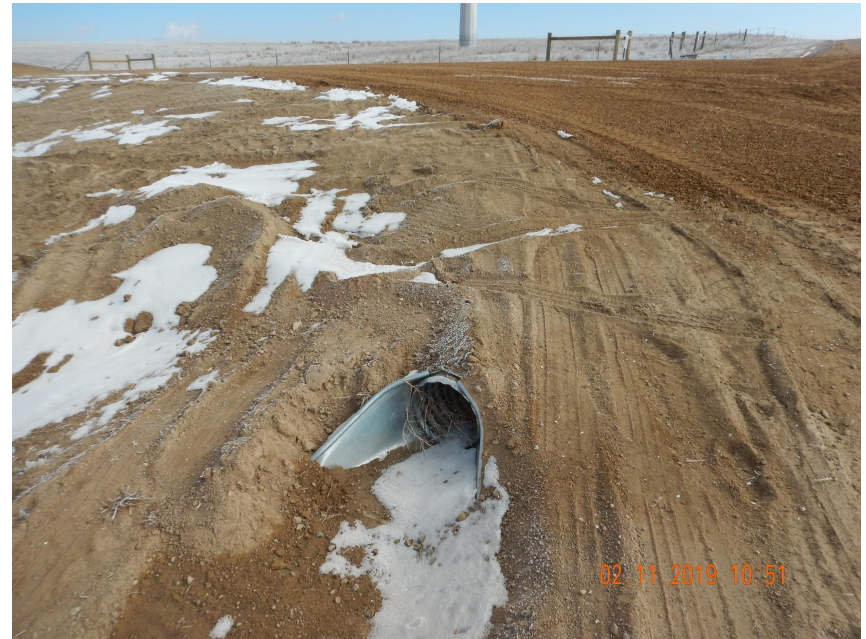
**Photo 2.** Photo taken from the entrance of location, facing East. Photo illustrates a culvert that has been installed in conjunction with the road side ditch.

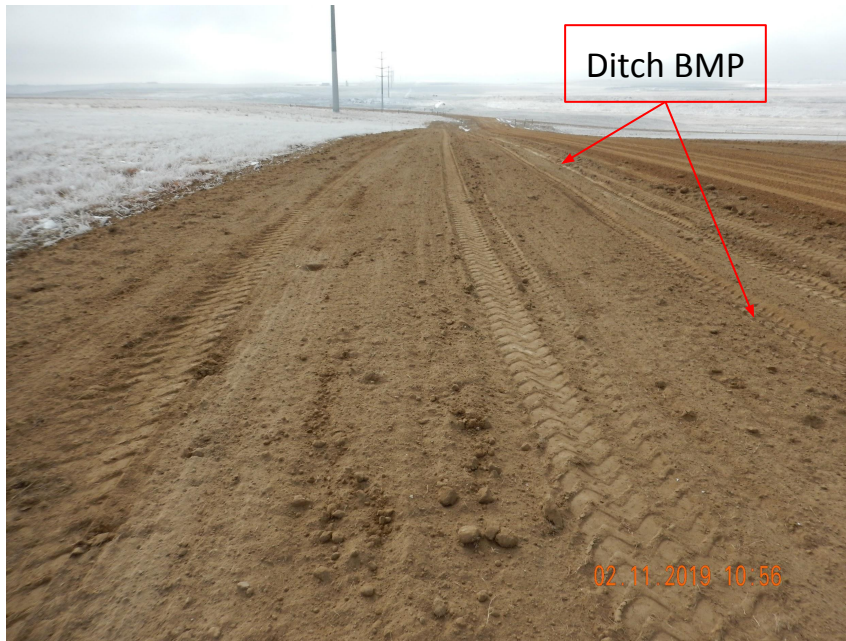
**Photo 3.** Photo taken from the northern access road, facing South. Photo illustrates a ditch BMP installed along the access road. Operator shall install additional BMPs to stabilize the ditch BMP upon completion of construction operations. Also, it is unclear why so much area outside of the ditch BMP has been disturbed. Nonetheless, Operator is responsible for reclaiming all disturbances and shall comply with Rule 1004 vegetative standards.

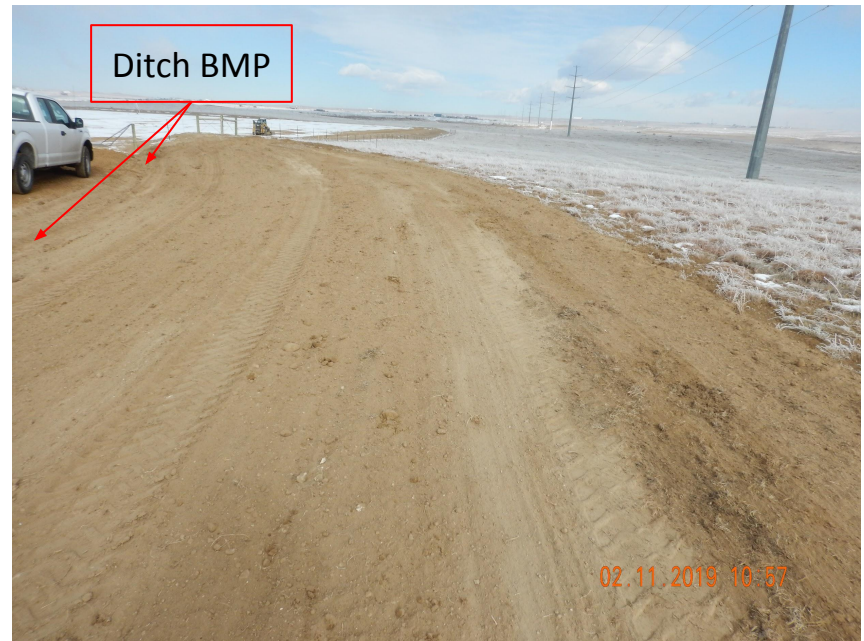
**Photo 4.** Photo taken from the northern access road, facing North. See comments under Photo 3.

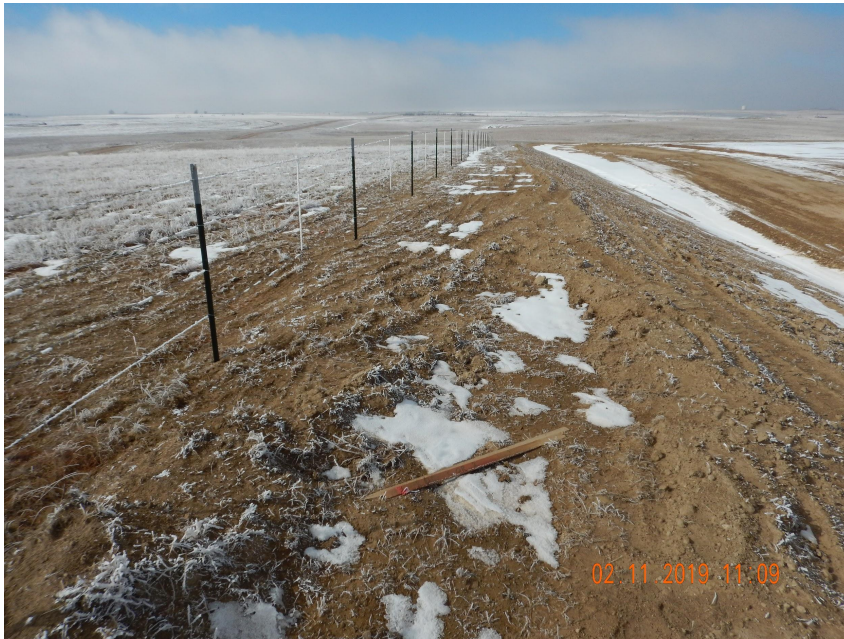
**Photo 5.** Photo taken from the southeastern perimeter of the location, facing West. Photo illustrates fencing around the perimeter of the location.

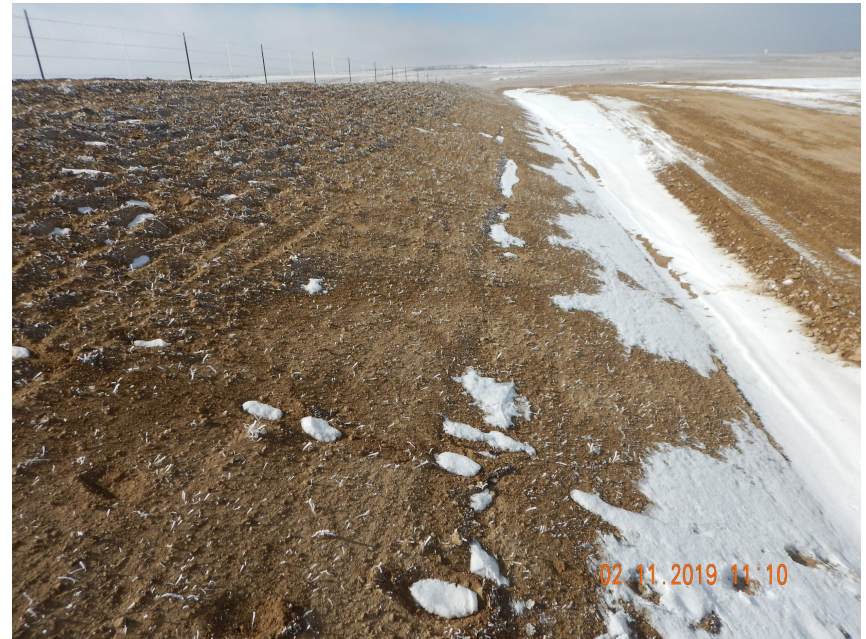
**Photo 6.** Photo taken from the southern cut slope, facing West. Operator shall properly stabilize all cut and fill slopes for long-term stabilization. Cut and fill slopes have been temporarily stabilized with equipment tracking.

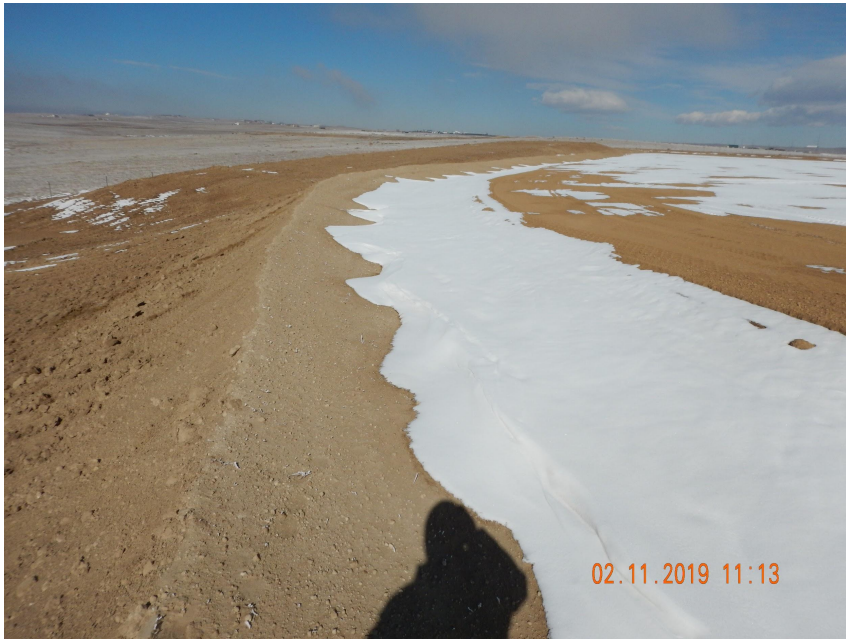
**Photo 7.** Photo taken from the southwestern well pad, facing North. Photo illustrates an unconsolidated berm that has been installed around the western, northern and eastern well perimeter. Operator shall properly stabilize berm BMP.

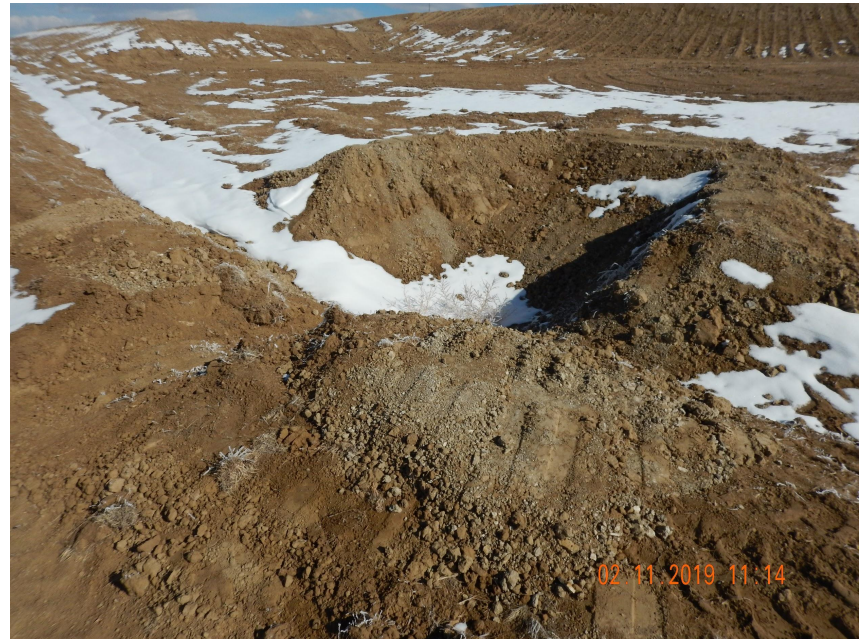
**Photo 8.** Photo taken from the southwestern perimeter of location, facing Northeast. Sediment trap is in-process of being constructed. If this is the only planned stabilized outlet for the location, this is not constructed to a sufficient size for an approximate 10 acre well pad.

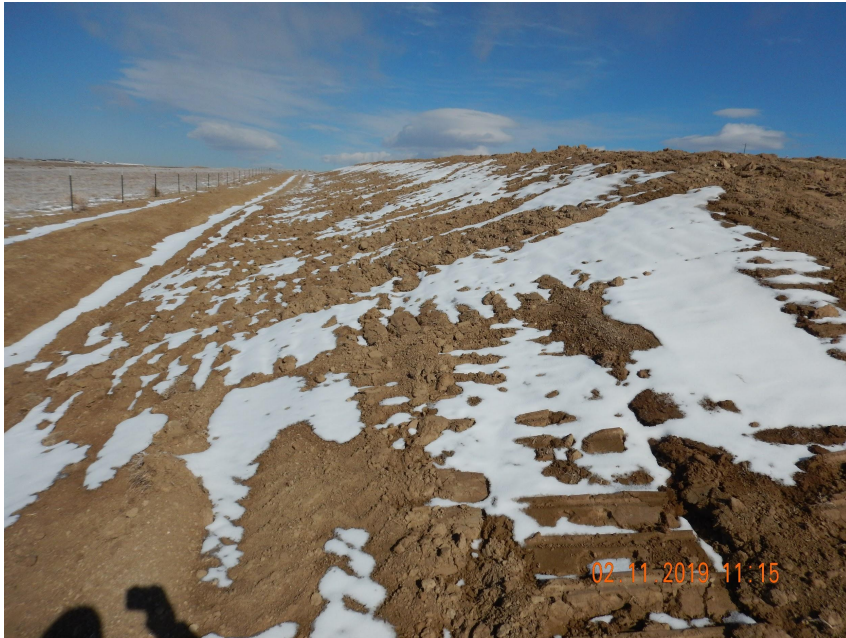
**Photo 9.** Photo taken from the southern topsoil stockpile, facing North. Photo illustrates the topsoil has been temporarily stabilized with equipment tracking. Operator shall stabilize the topsoil stockpile for long-term stabilization and to protect the topsoil from weed establishment.

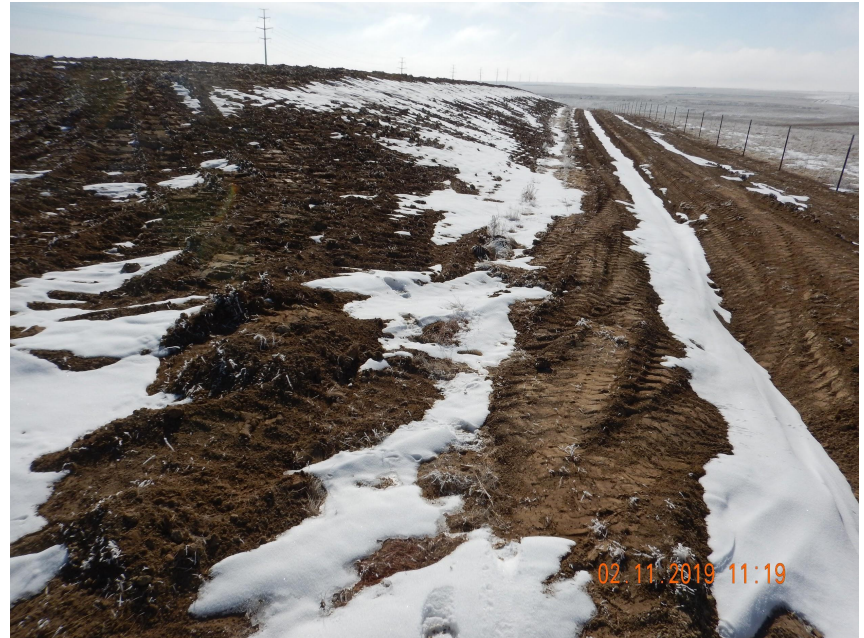
**Photo 10.** Photo taken from the northern topsoil stockpile, facing South. See comments under Photo 9.

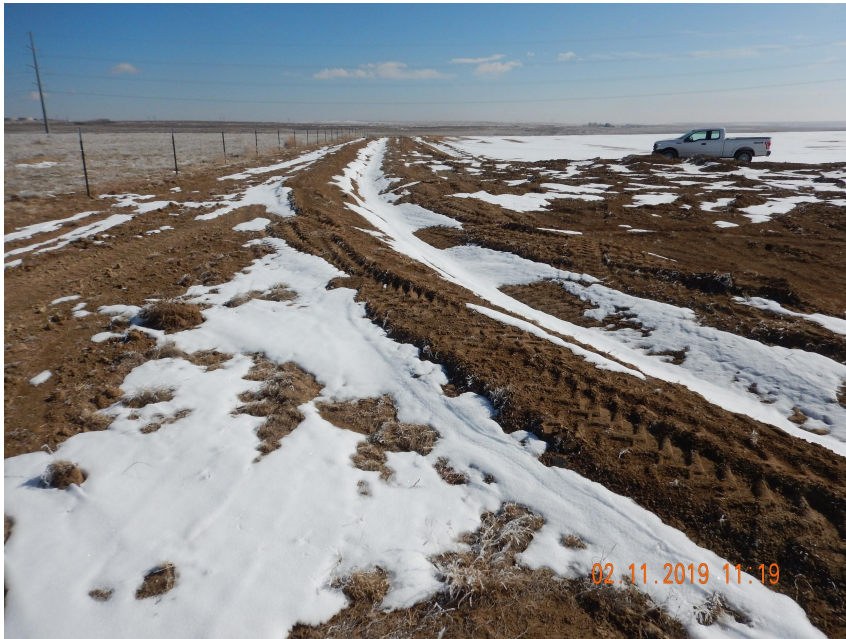
**Photo 11.** Photo taken from the northwestern perimeter of location, facing East. Photo illustrates a ditch and berm BMP that has been installed which is currently only directed to one stabilized outlet.

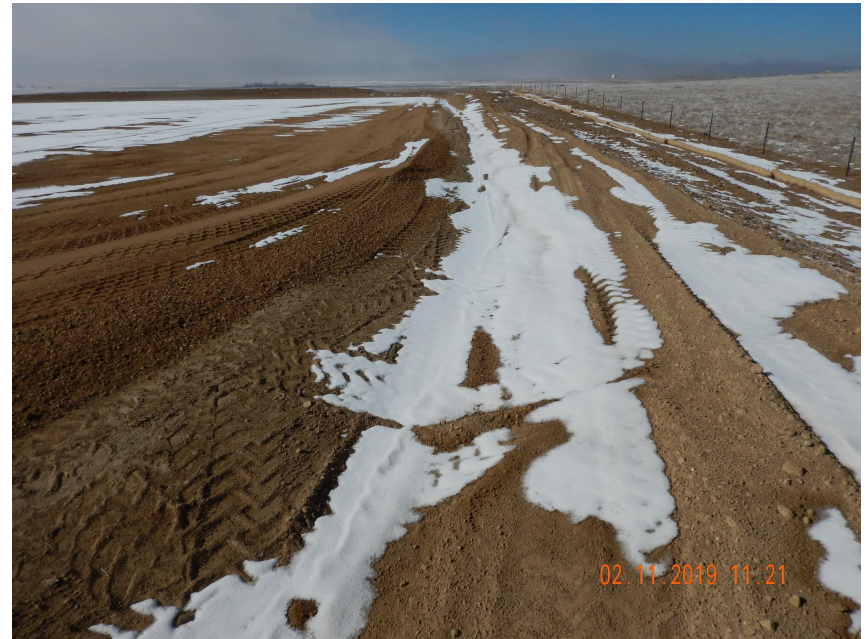
**Photo 12.** Photo taken from the northeastern perimeter of location, facing West. Straw wattles have been installed around the portions of the northern and eastern perimeter which have not been properly installed.

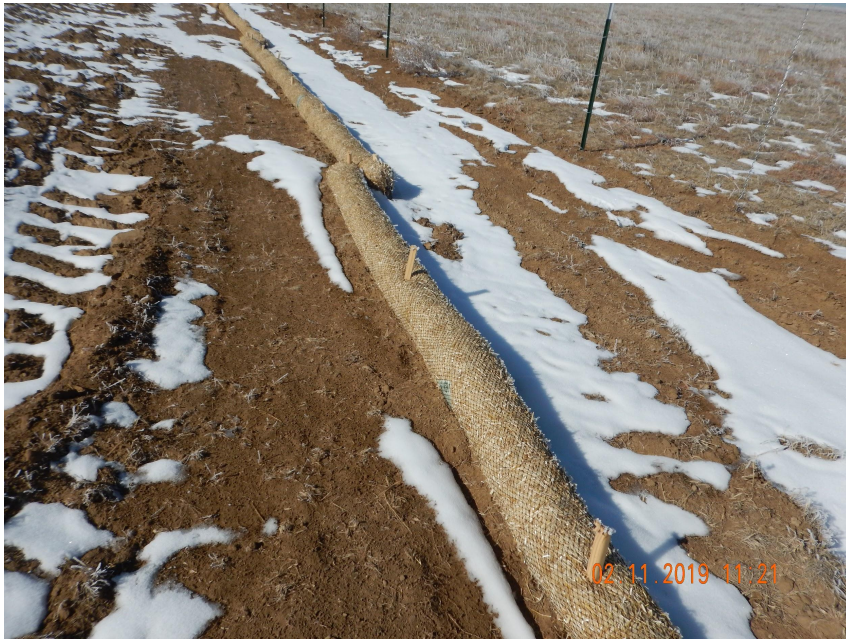
**Photo 13.** Close up photo taken from the northeastern perimeter of location, facing West. Straw wattles have not been properly installed (i.e., trenched).

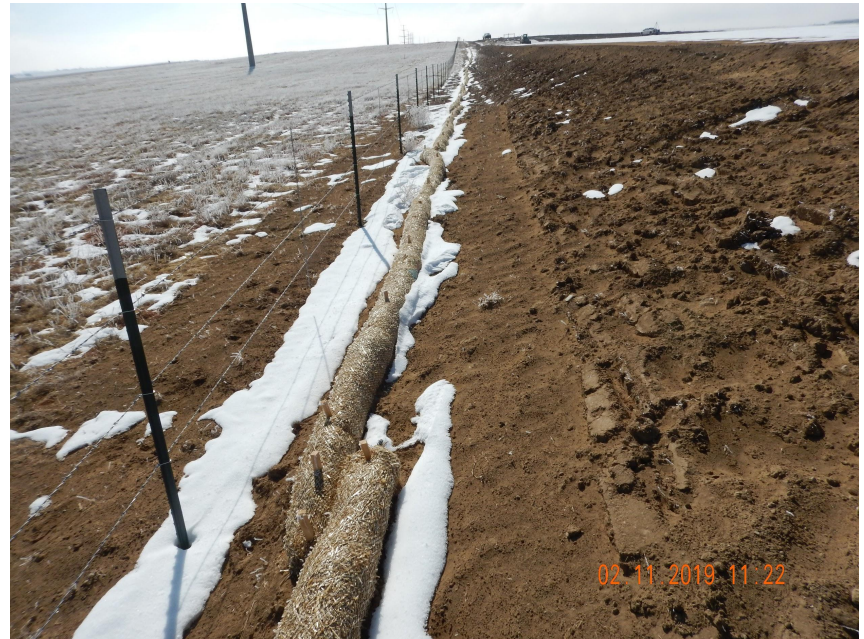
**Photo 14.** Photo taken from the northeastern perimeter of location, facing South. See comments under Photo 13.
