Inspection Photos
Location Name: John A Kunzman #1
Location ID: 317729

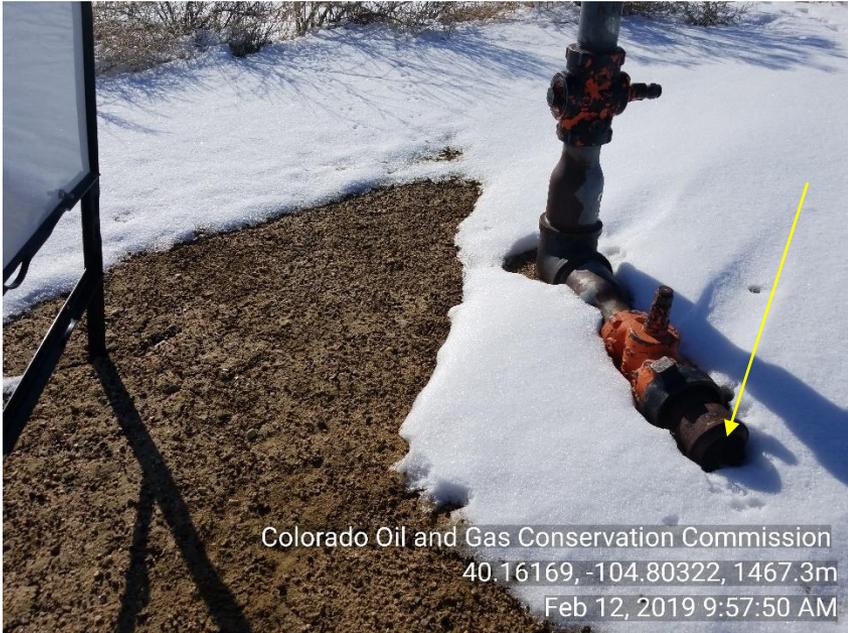
Photo 3 Unmarked riser not plugged or LOTO

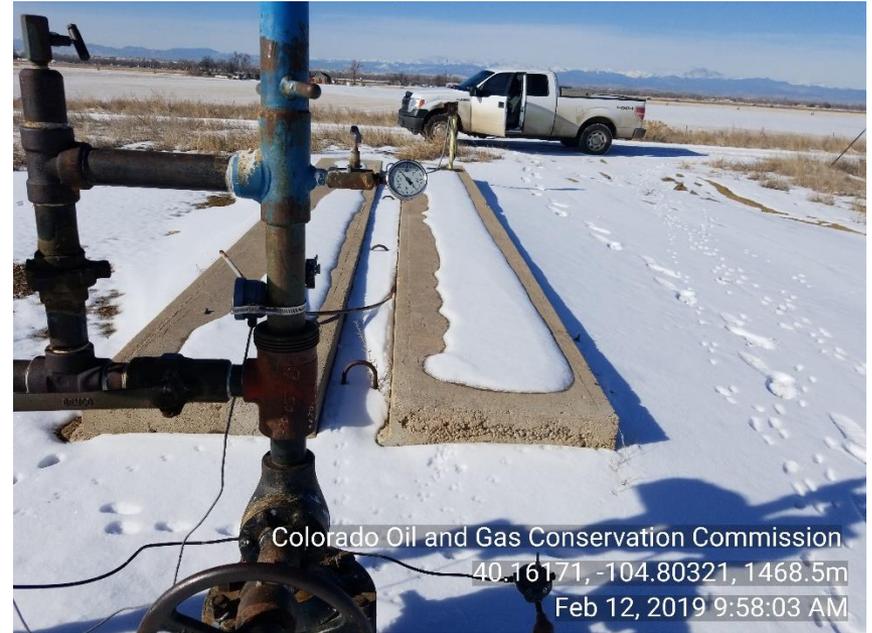
Photo 4 Unused equipment cement PU pad

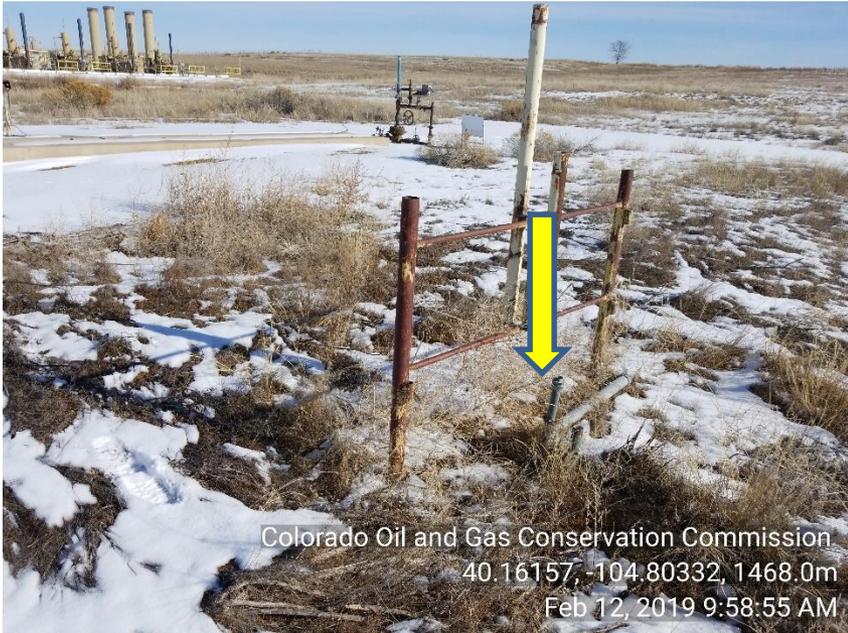
Photo 5 Unmarked riser not plugged or LOTO

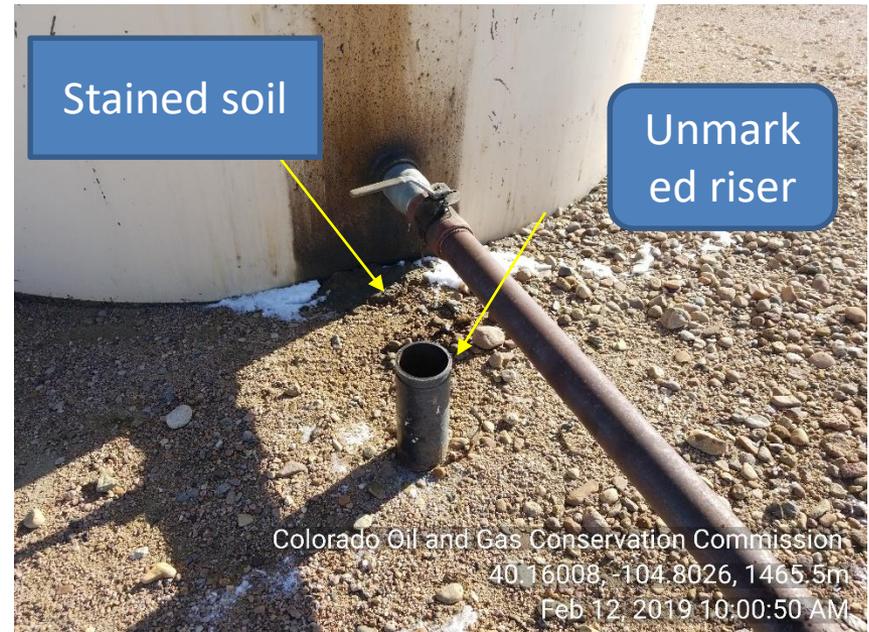
Photo 6 Stained soil. Unmarked riser not plugged or LOTO

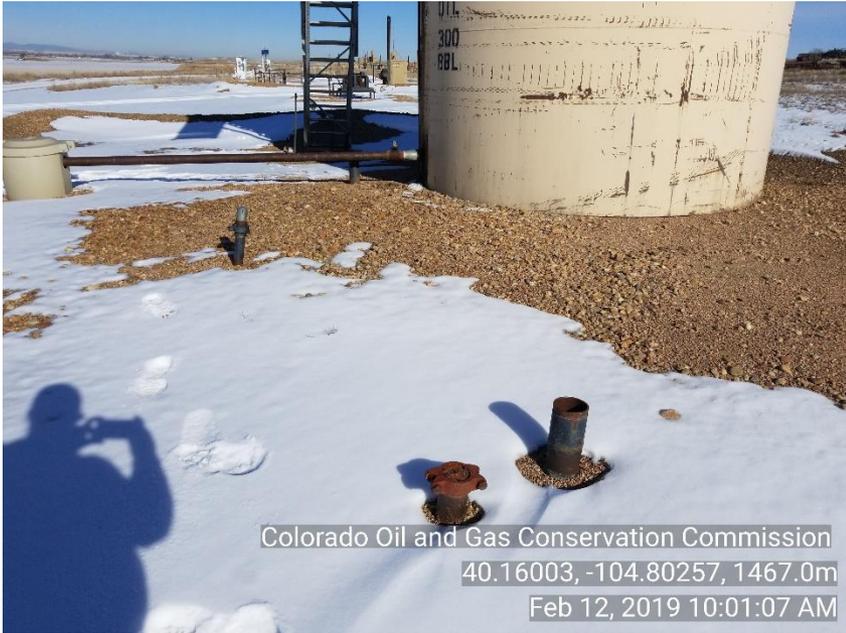
Photo 7 Unmarked riser's not plugged or LOTO

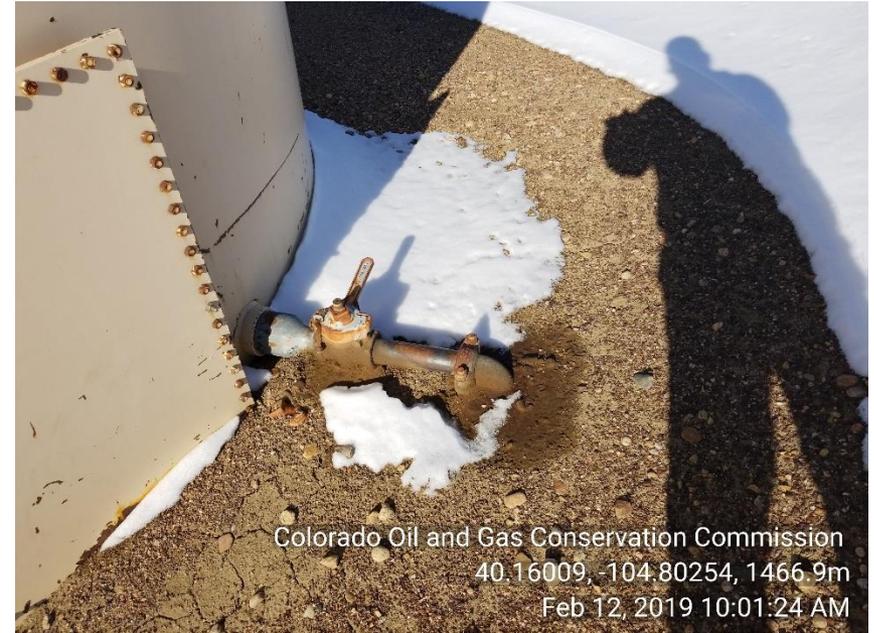
Photo 8 Stained soil in back of crude oil tank

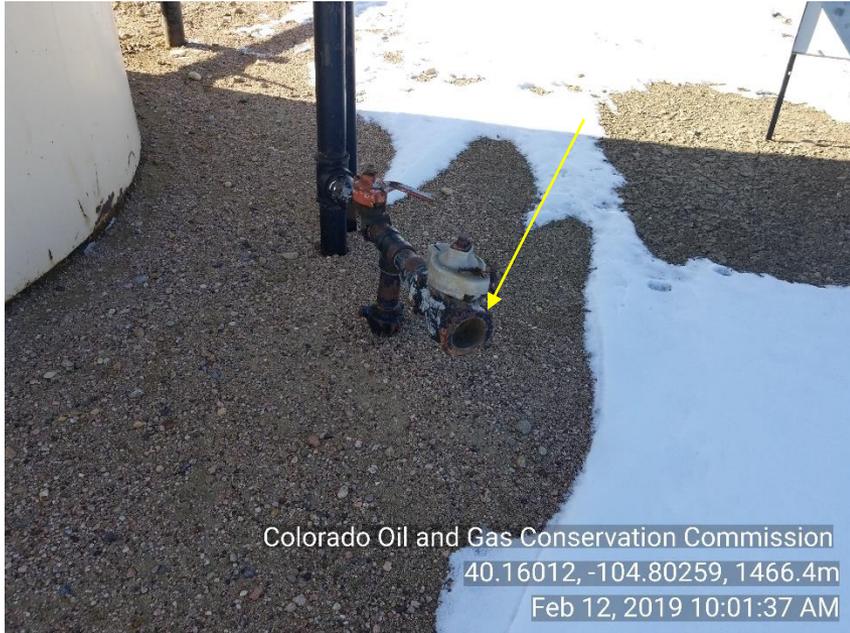
Photo 9 Load line to crude oil tank not bull plugged

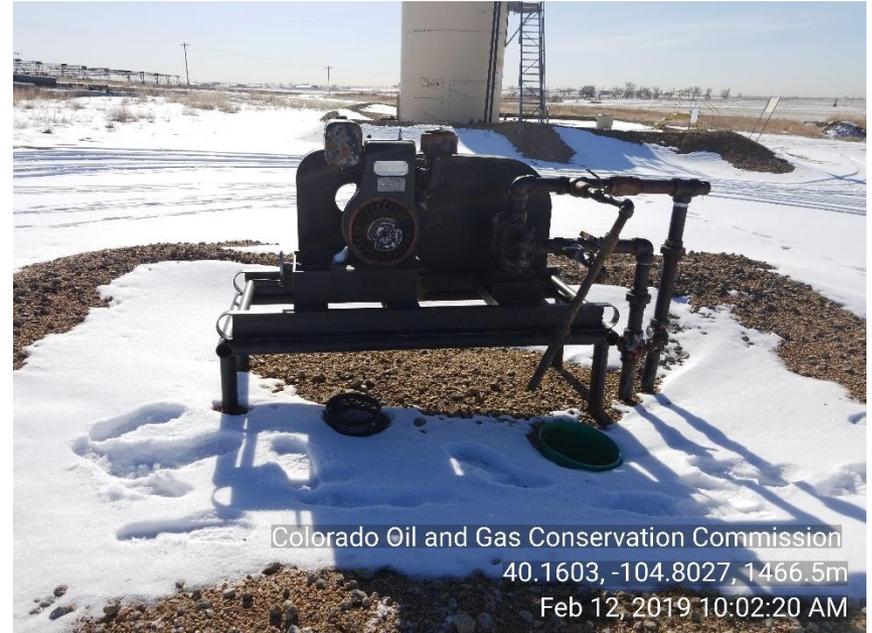
Photo 10 unused equipment

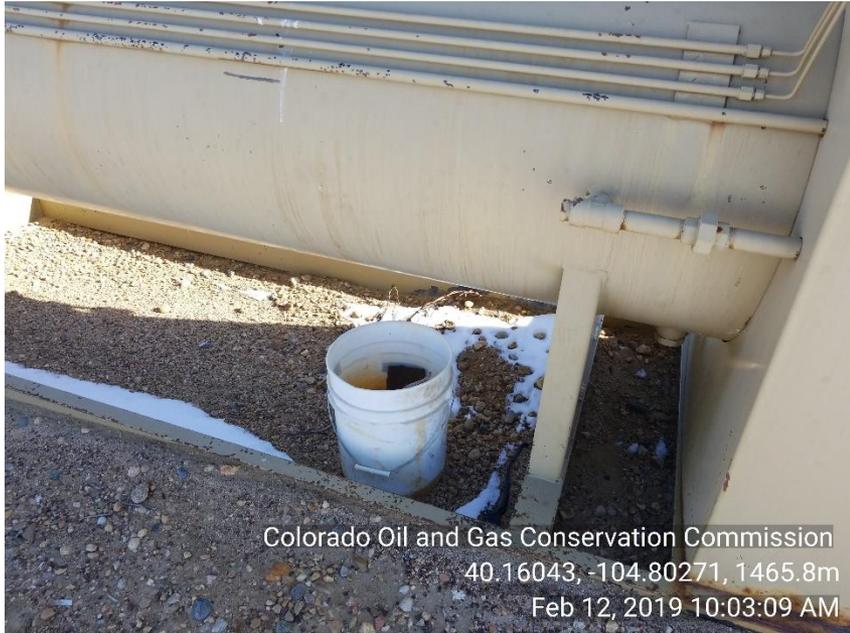
Photo 11 TRASH bucket with trash under sep

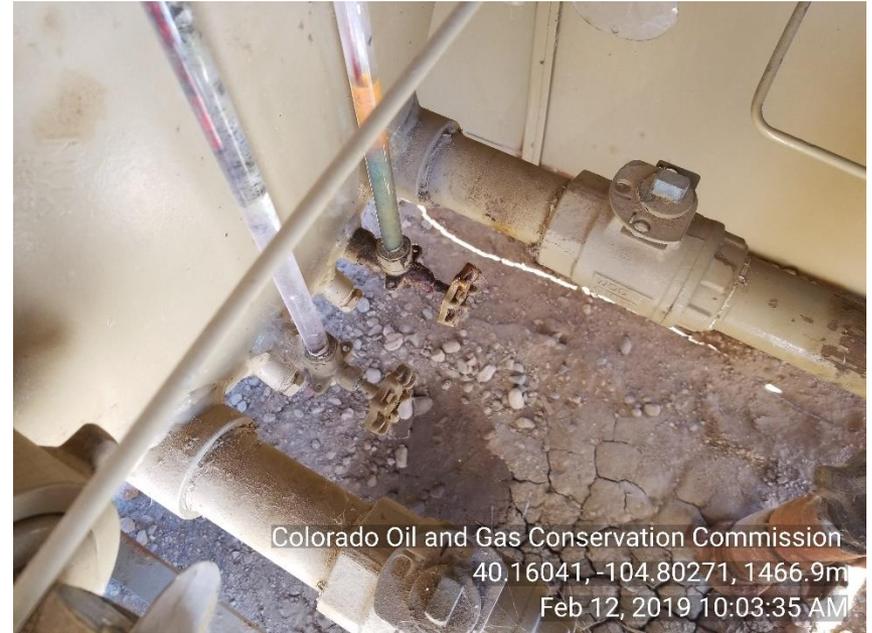
Photo 12 Leaking VLV on sight glass and stained soil inside SEP

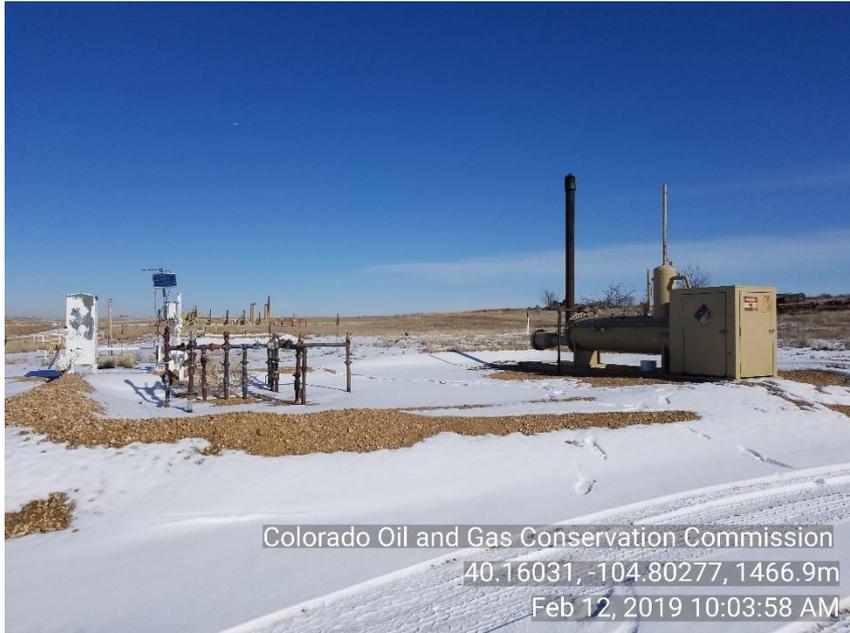
Photo 13 Sep and meter run pic

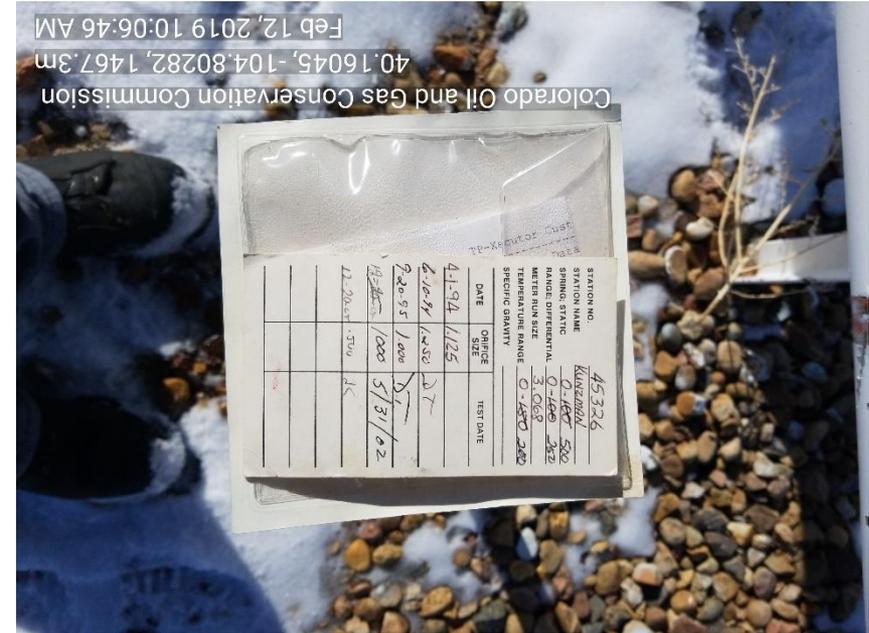
Photo 14 meter not calibrated since 2005

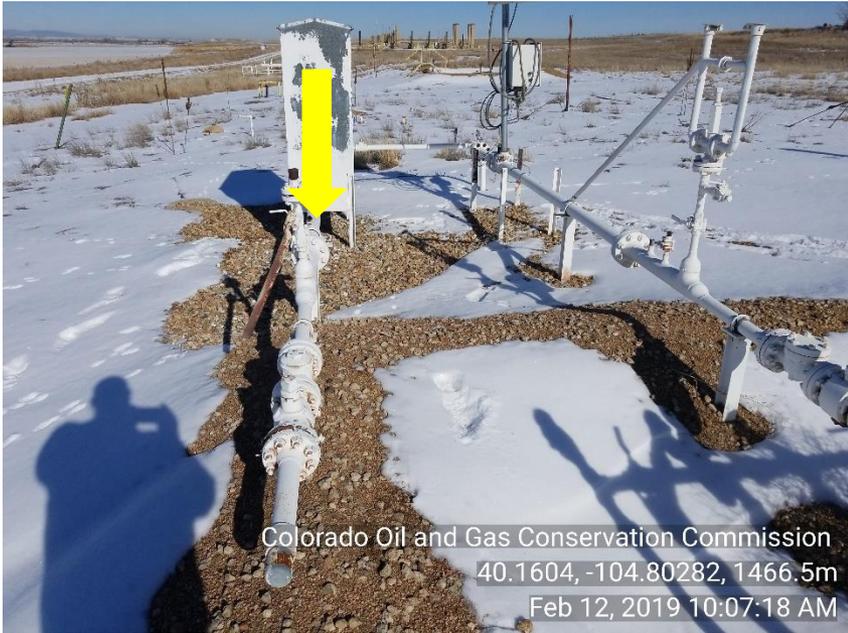
Photo 15 Unused equipment unused meter run

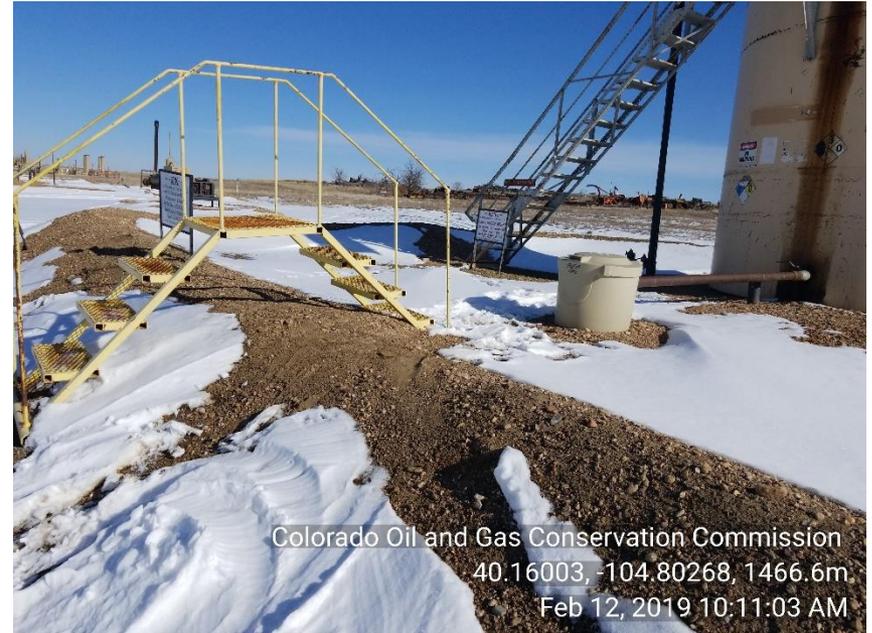
Photo 16 berms inadequate

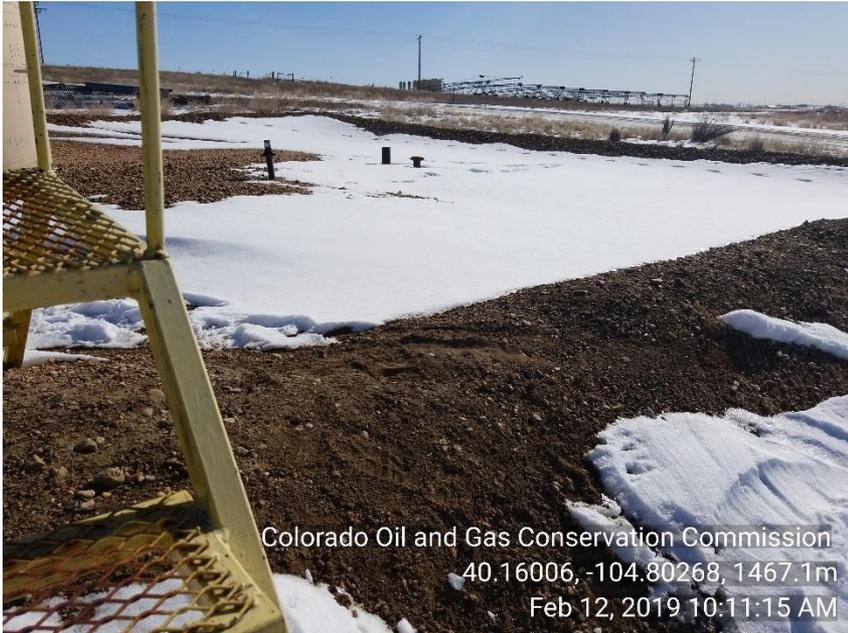
Photo 17 Berms inadequate
