Inspection Photos
Location Name: Sawyer #32-2
Location ID: 327177

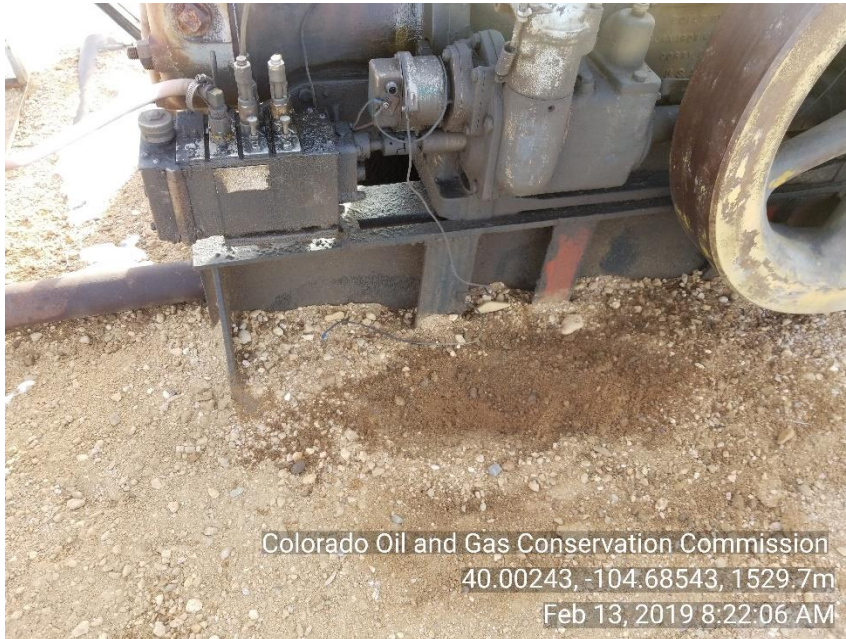
Photo 3 stained soil around PU motor

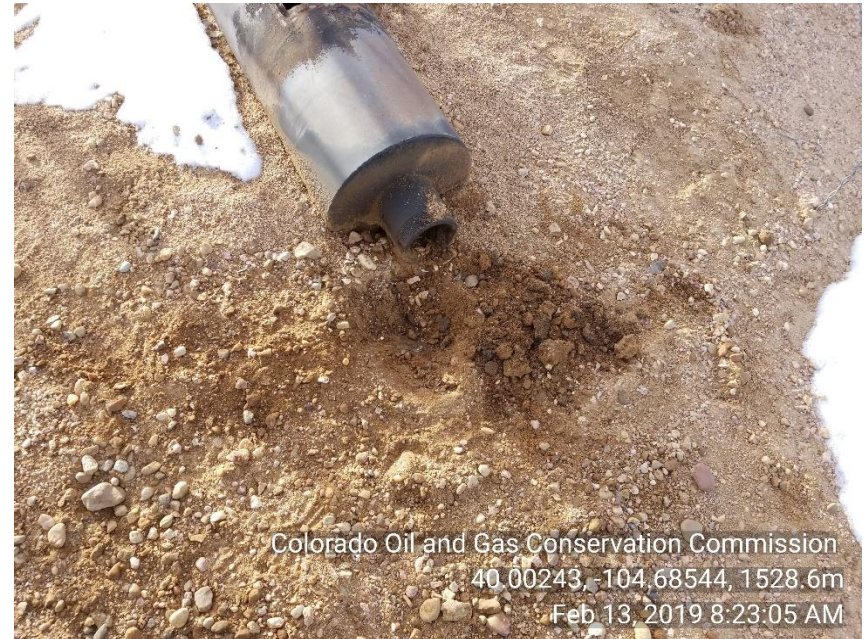
Photo 4 Stained soil around PU exhaust

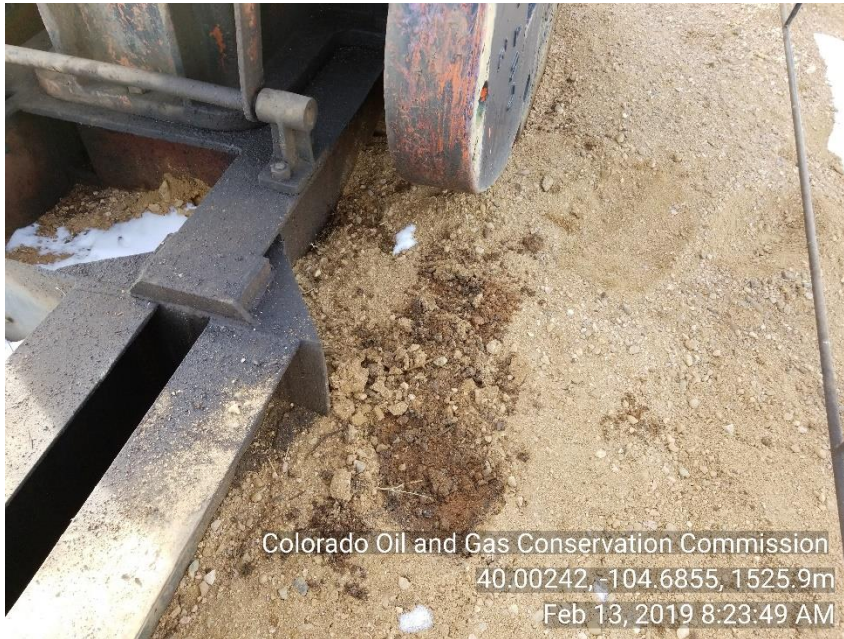
Photo 5 Stained soil around PU base

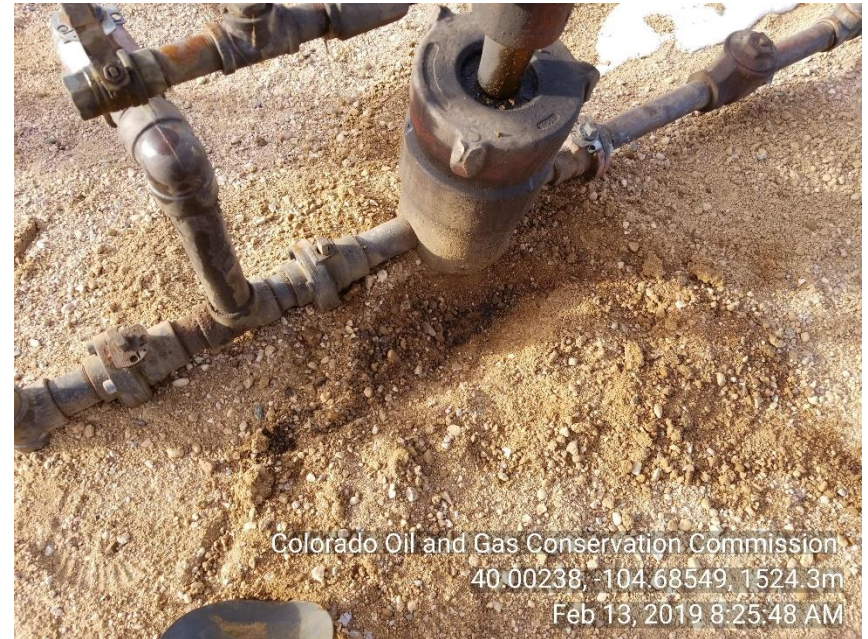
Photo 6 Stained soil Around WH

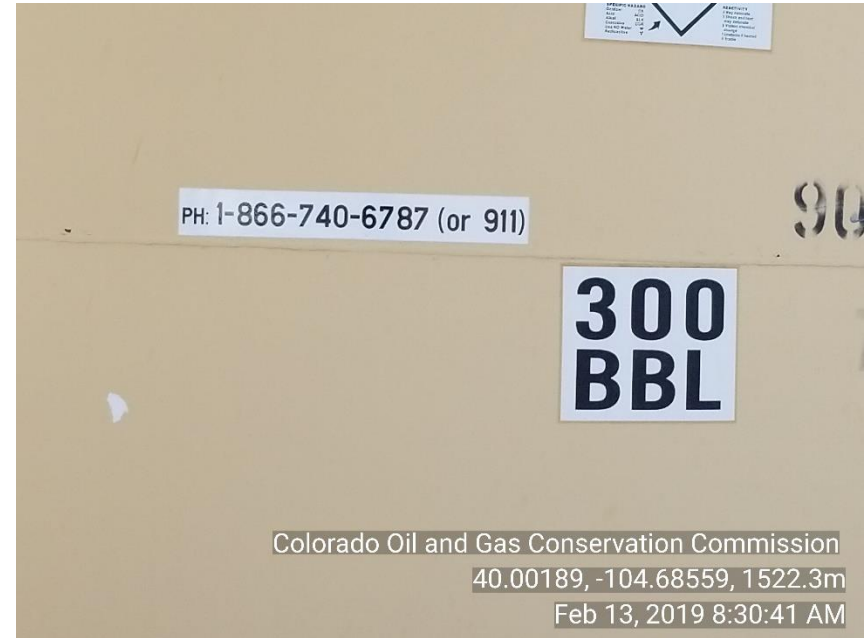
Photo 10 Emergency number not a working number

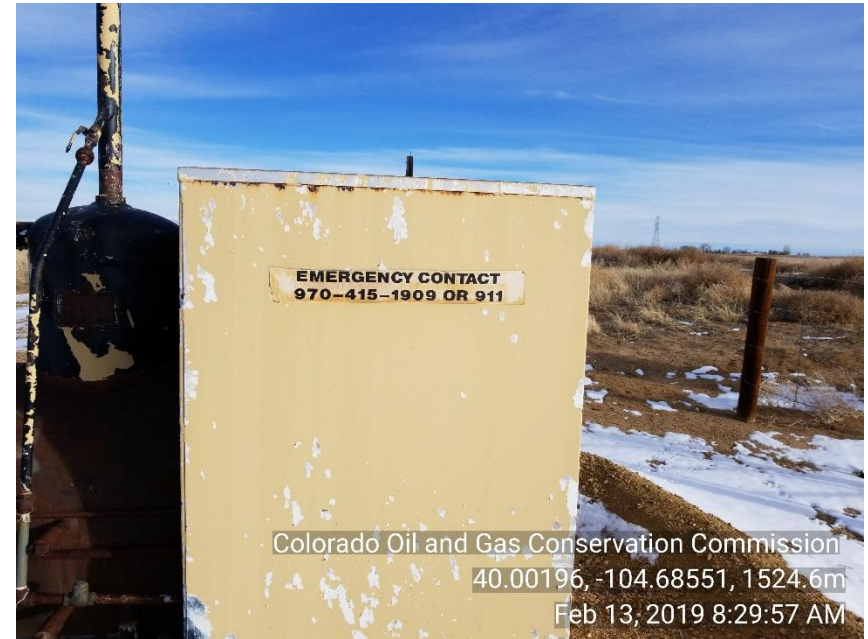
Photo 12 Emergency number goes to voicemail of George Gugger

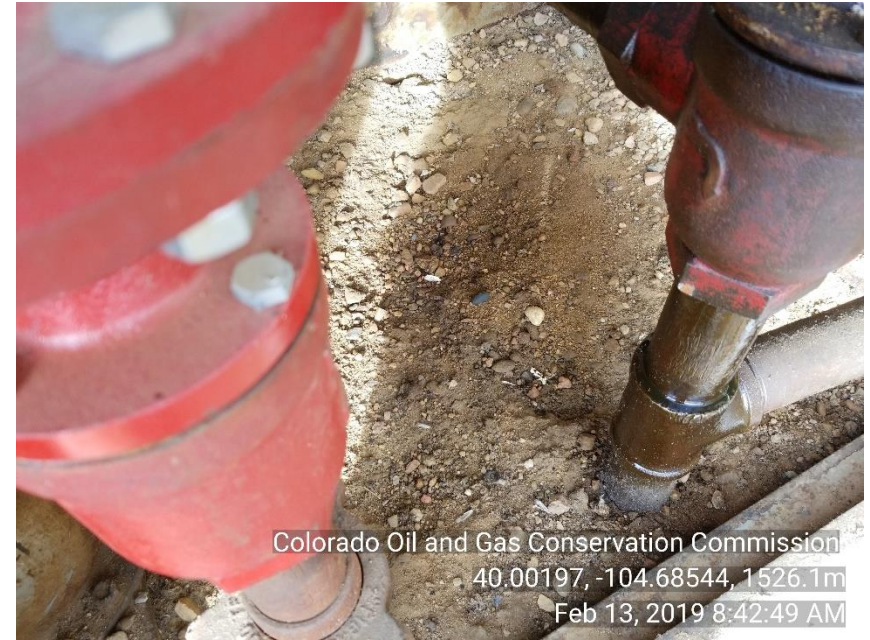
Photo 16 leaking fitting and stained soil inside separator
