Inspection Photo (s)
Specialty 43C-21
API # 05-045-14823
Inspection # 689303235

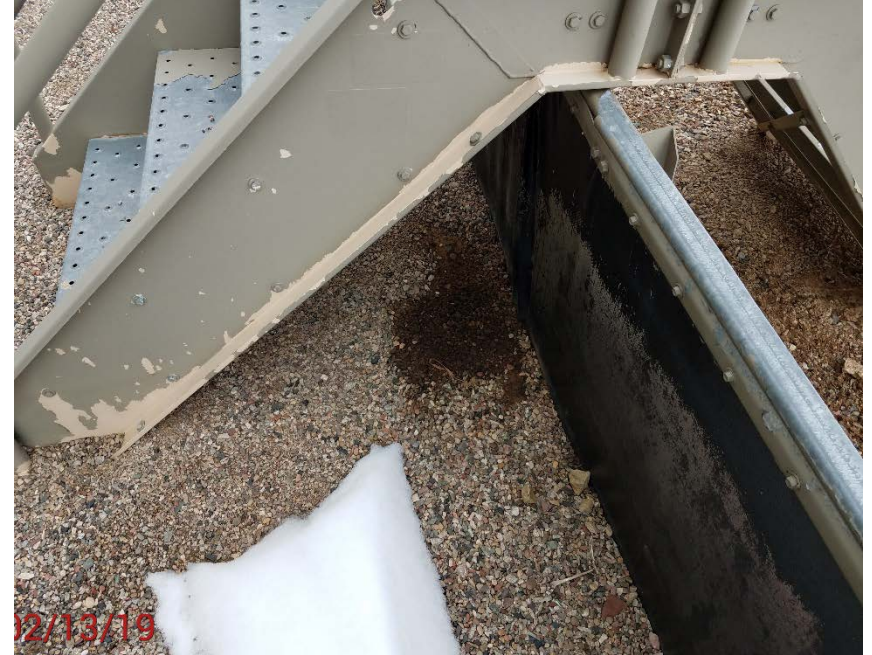
Location Photo #4, Stained ground under access stairs into battery containment.

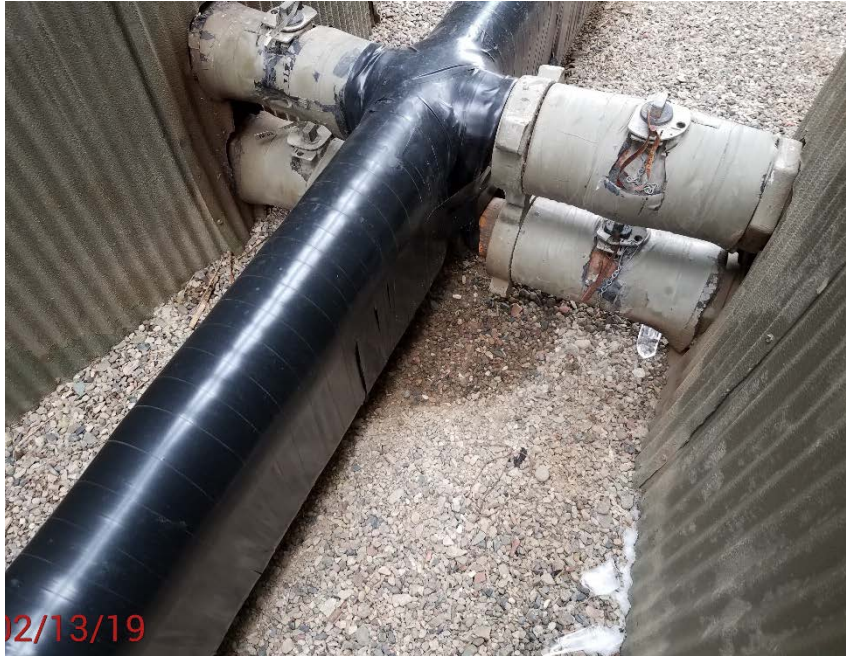
Location Photo #5, Stained ground under tank valves, mechanical condition of pipe fittings.

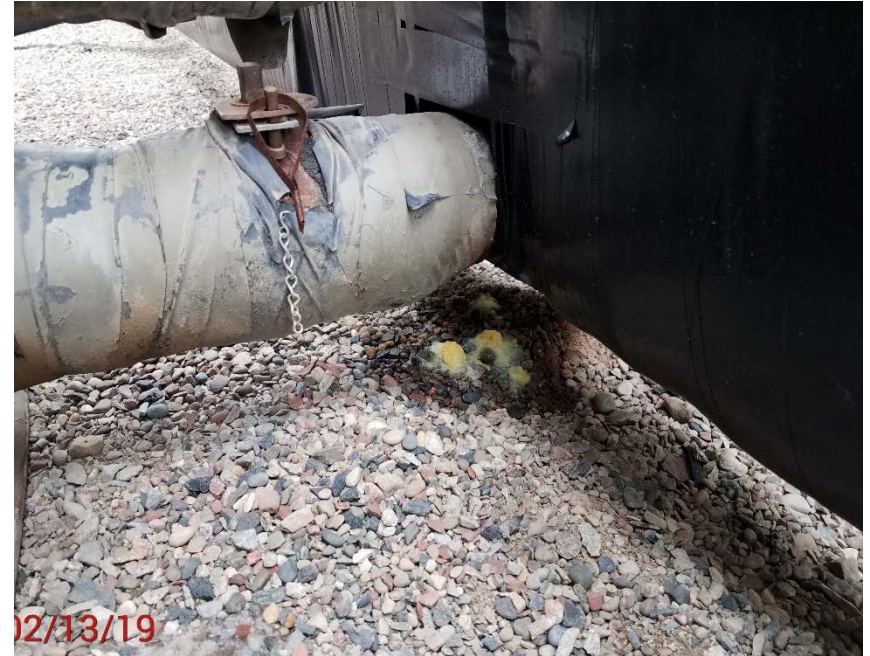
Location Photo #6, Stained ground under tank valves, mechanical condition of pipe fittings. Condensate on ground.

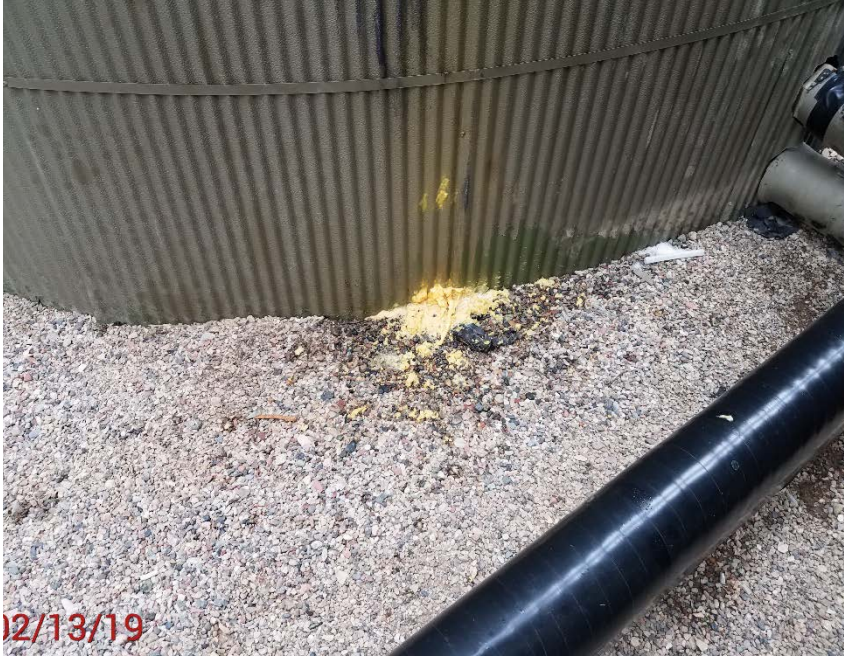
**Location Photo #7, Condensate on ground,
stained material.**

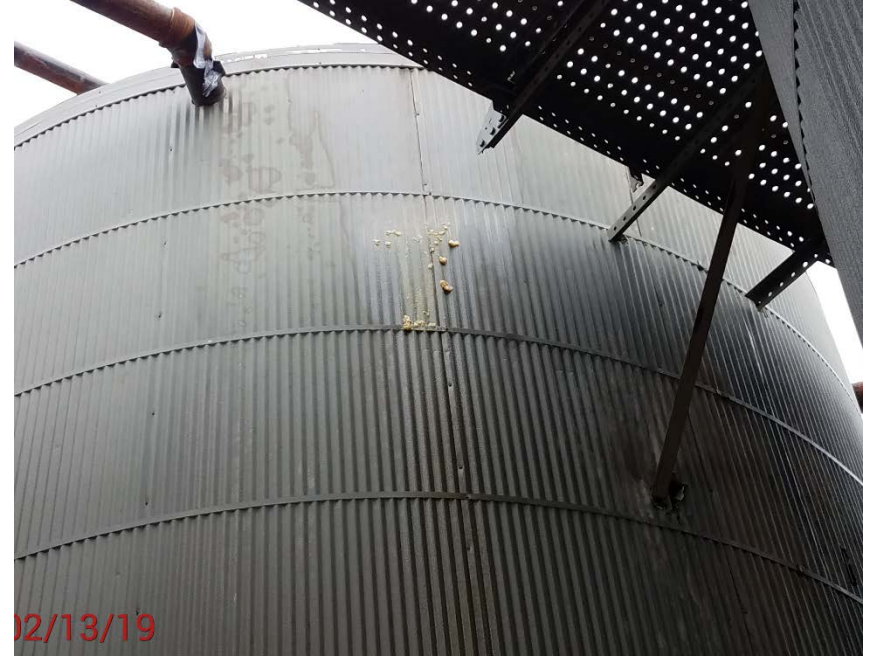
**Location Photo #8, Mechanical condition of
tank.**
