Inspection Photos

API: 05-071-08810

Operator: PIONEER NATURAL RESOURCES

Inspection Date: 2/8/2019

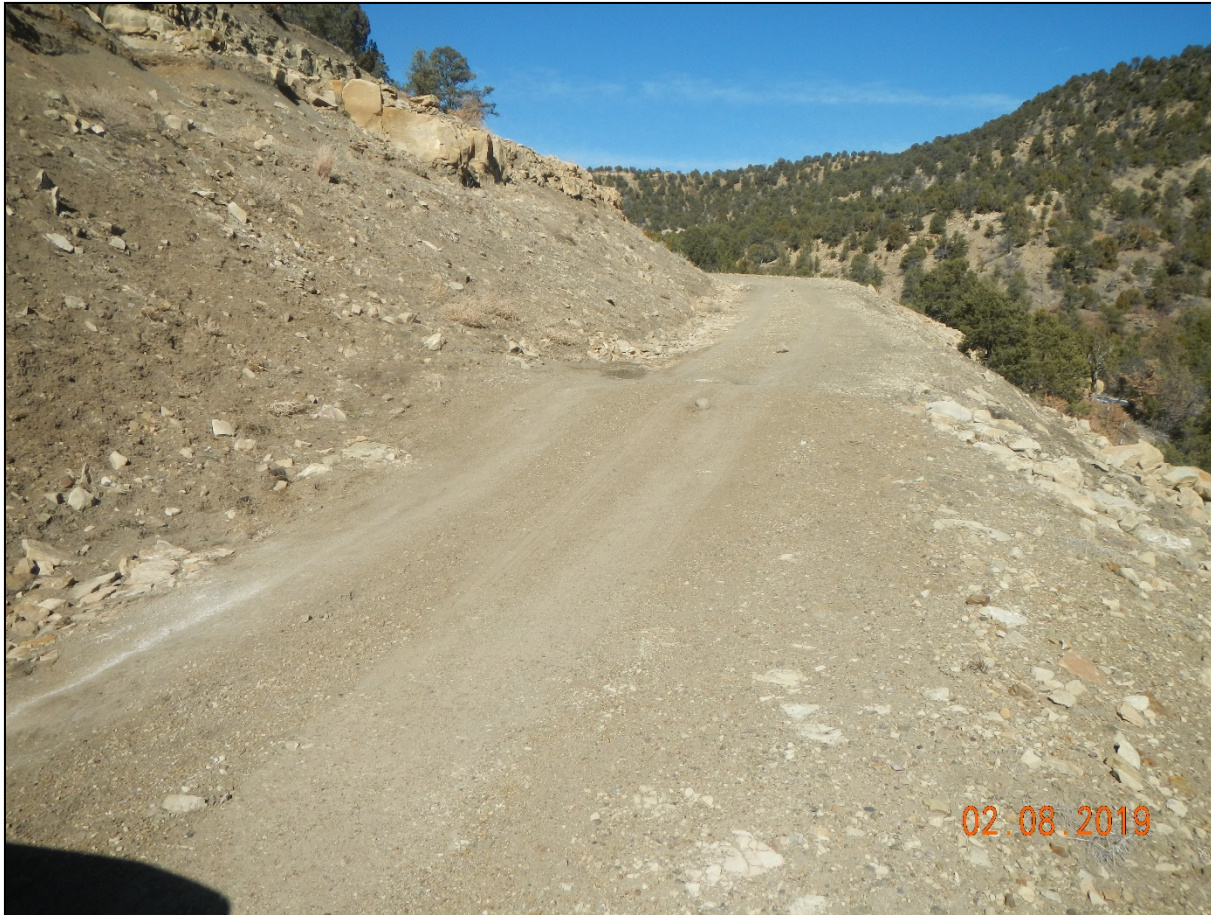
Photo 1. Facing north along the access road. The access road has not been reclaimed.

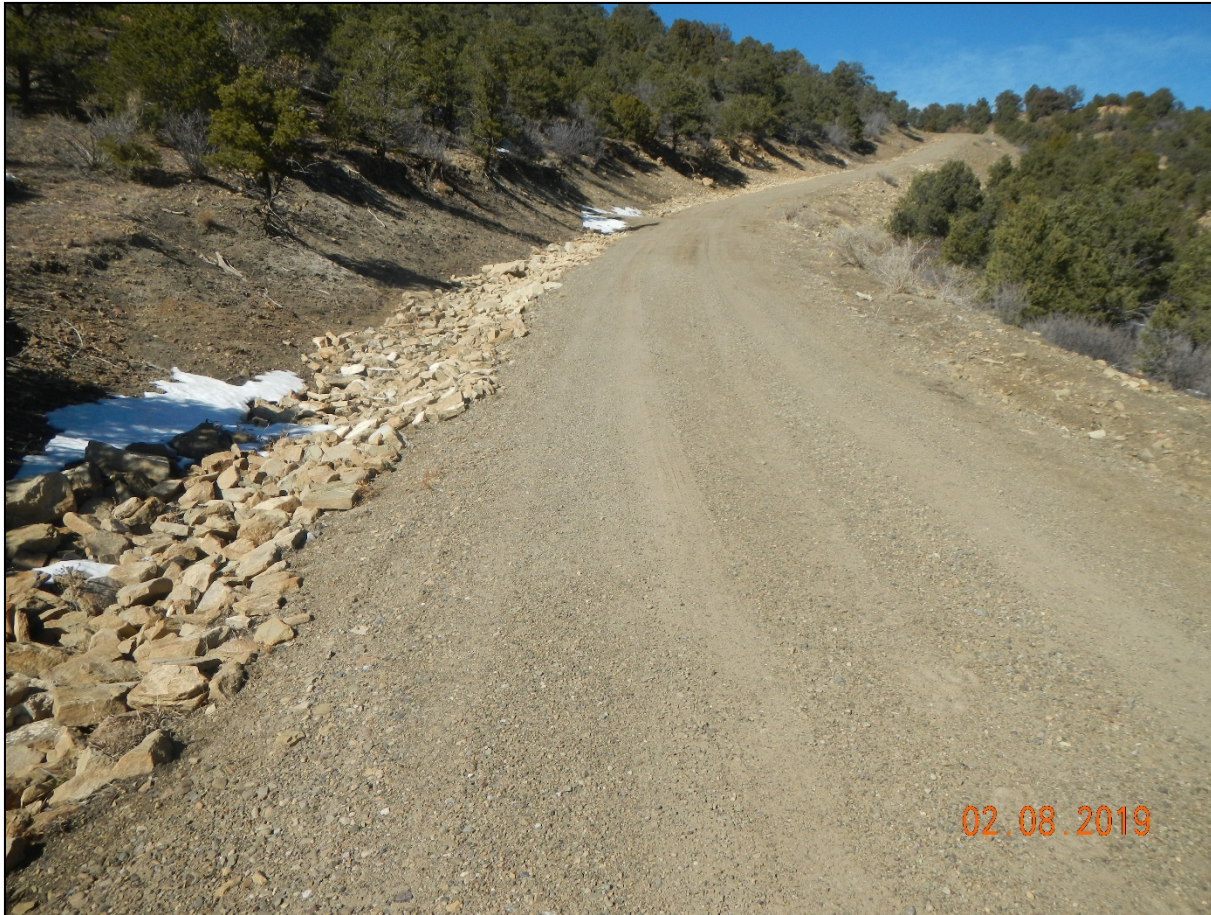
Photo 2. Facing northwest along the access road.

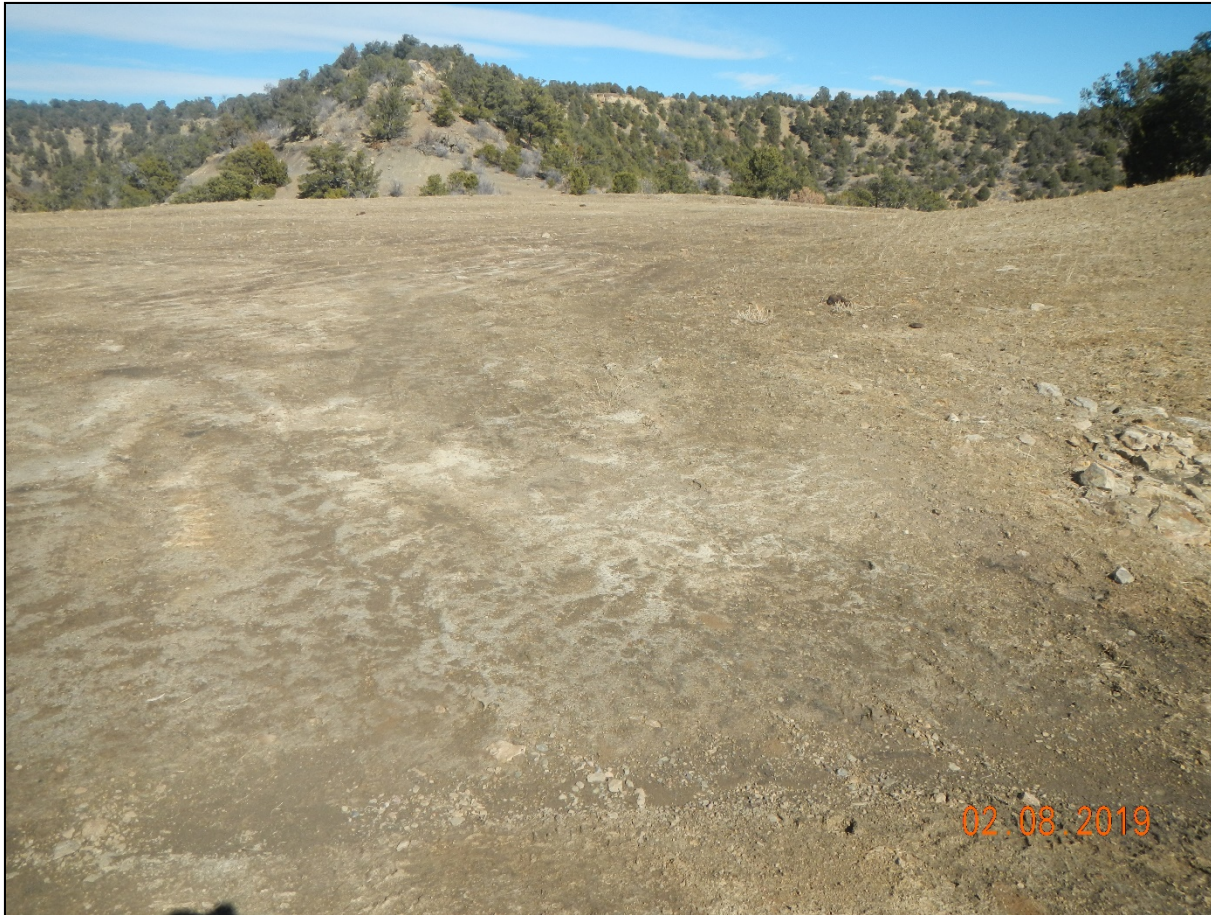
Photo 3. Facing north at the location.

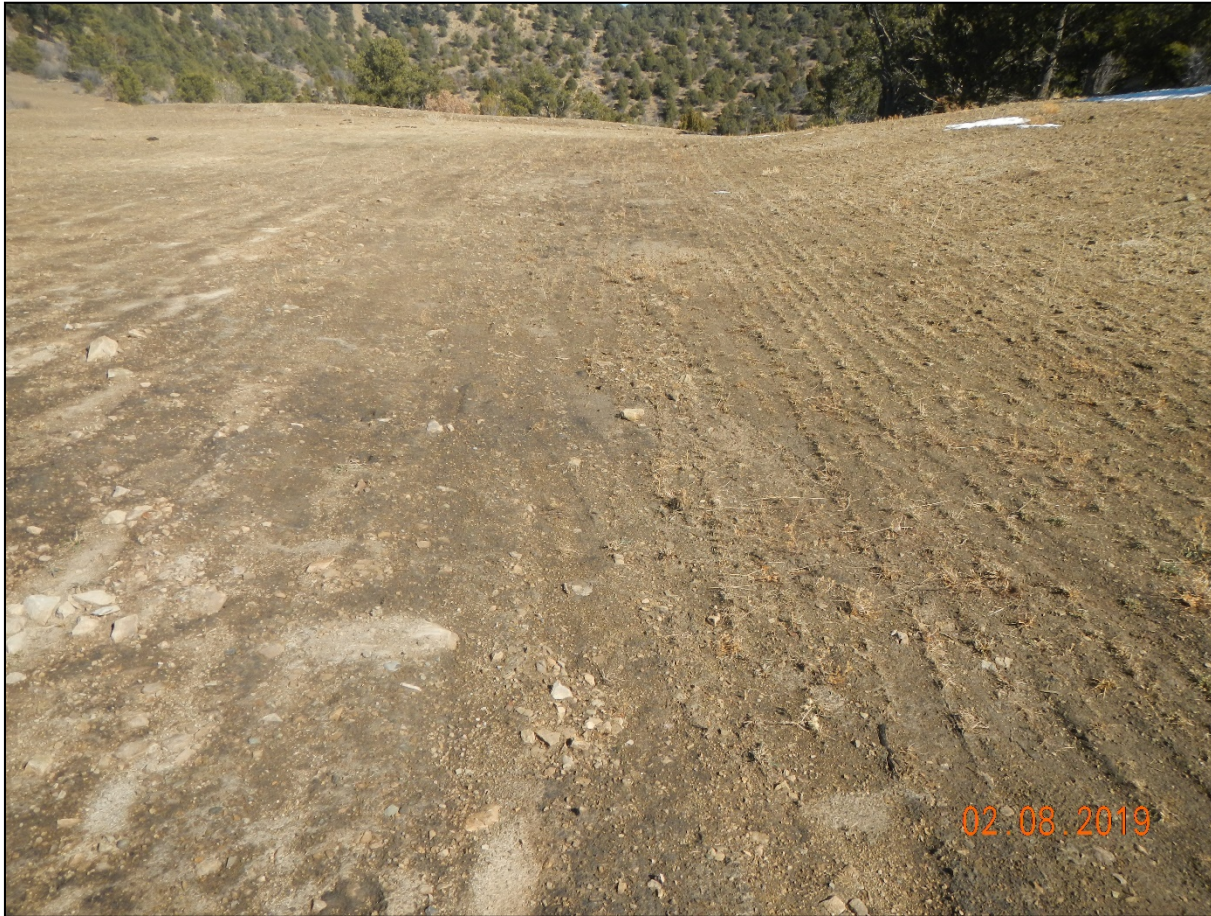
Photo 4. It appears the location was recontoured and seeded. Vegetation has not yet established.

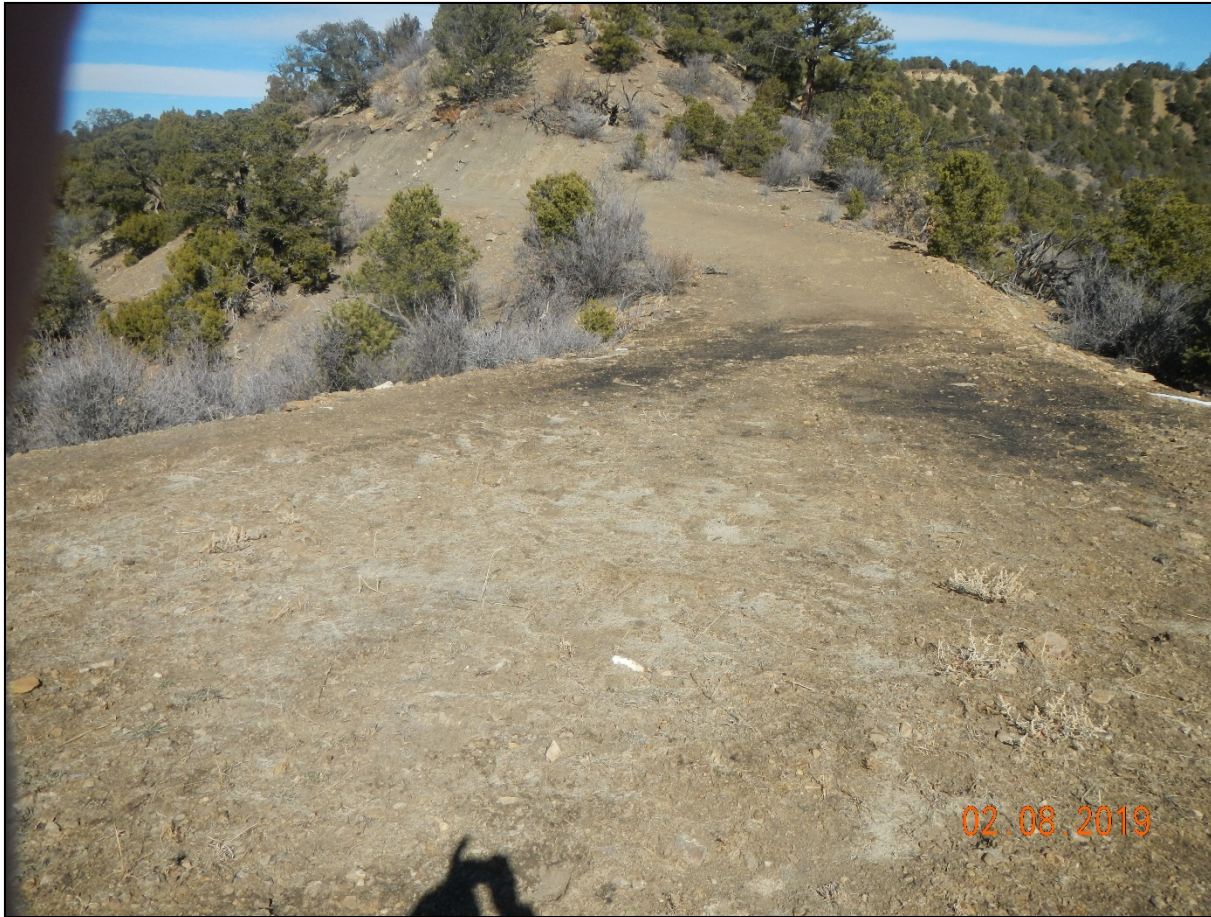
Photo 5. The road appears to continue past the location.

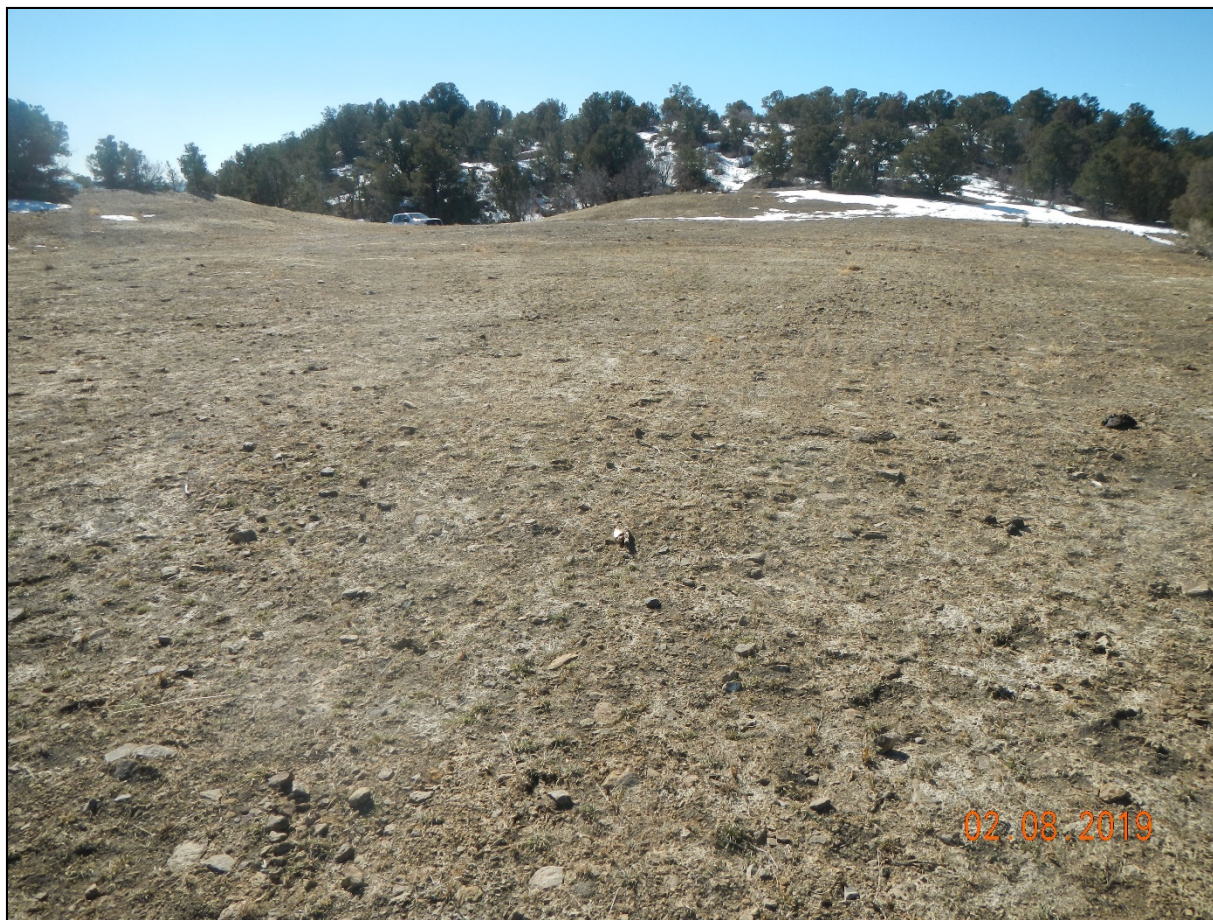
Photo 6. North side of the location facing south.
