Caerus

Corrosion Review

28-7 E280U Flowline Failure Analysis

February 12, 2019

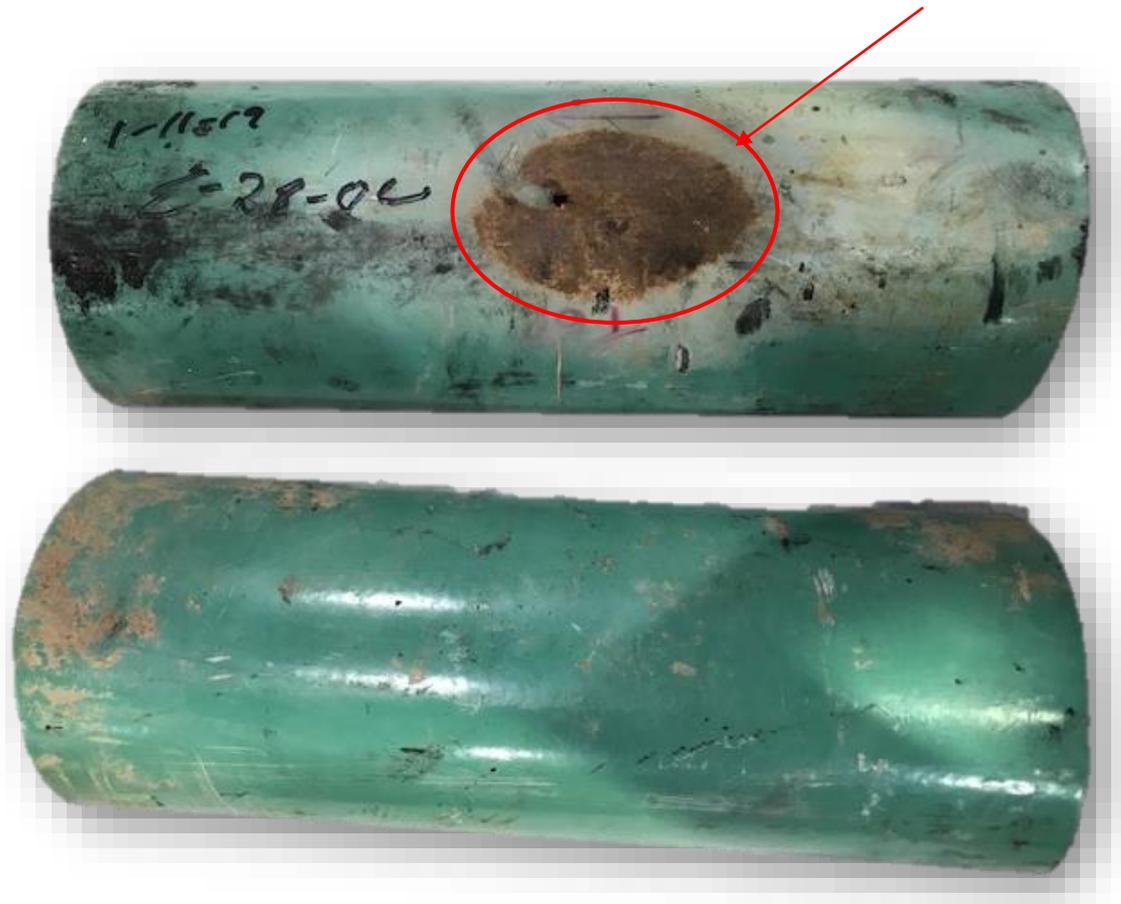
Sample Exterior, Before Cleaning

- Samples arrived wrapped in electric tape. Picture is as received.
- A hole is visible with an oily ring around it.
- Corrosion is internal to external

Hole in flowline

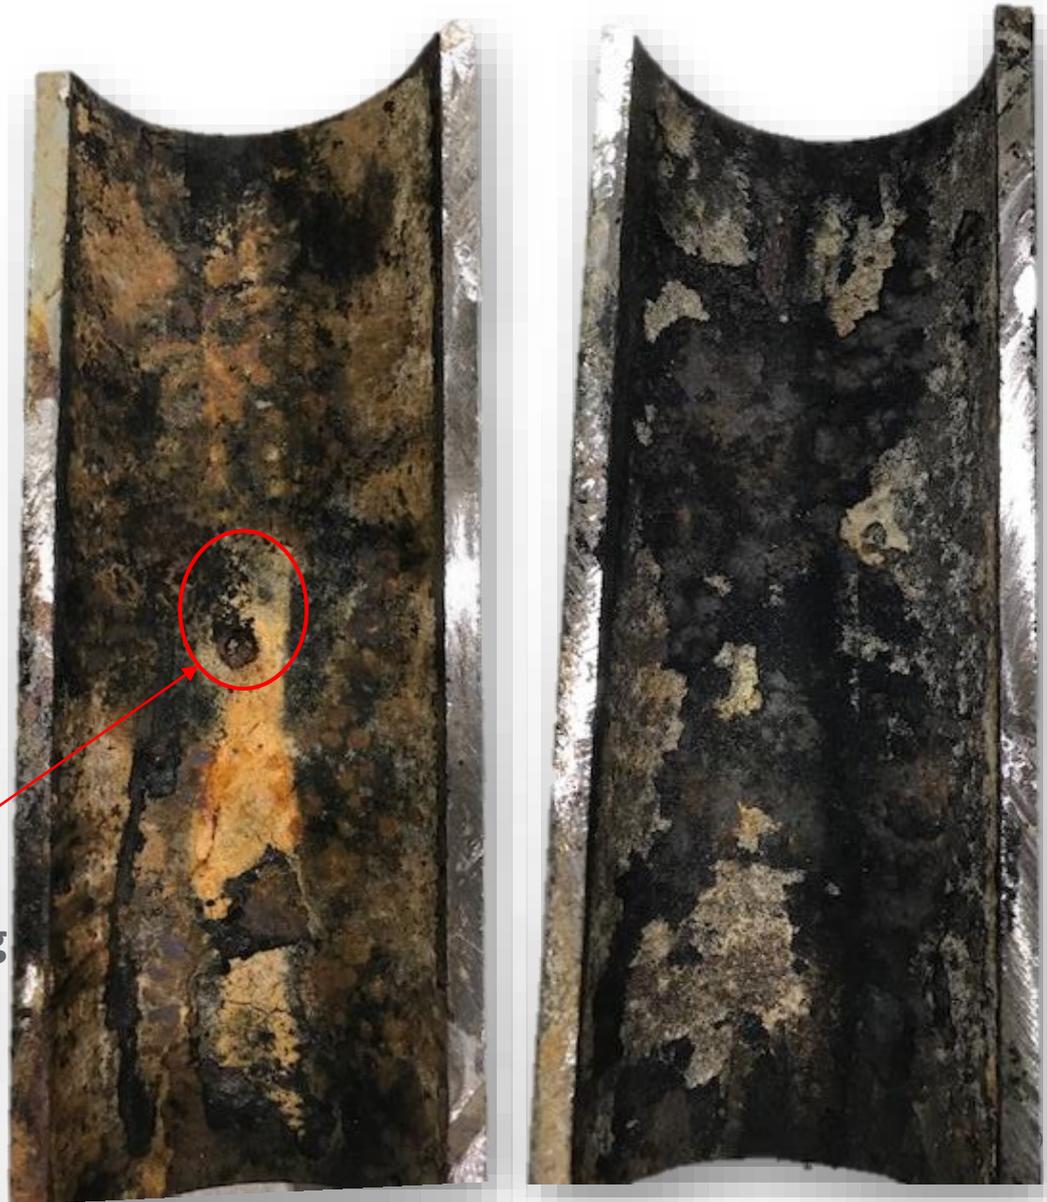
Sample Interior, Before Cleaning

- Oxidation and oil deposits visible.
- Solids tested positive for calcium carbonate and iron sulfide
- Iron sulfide is a common byproduct of SRB/H₂S corrosion

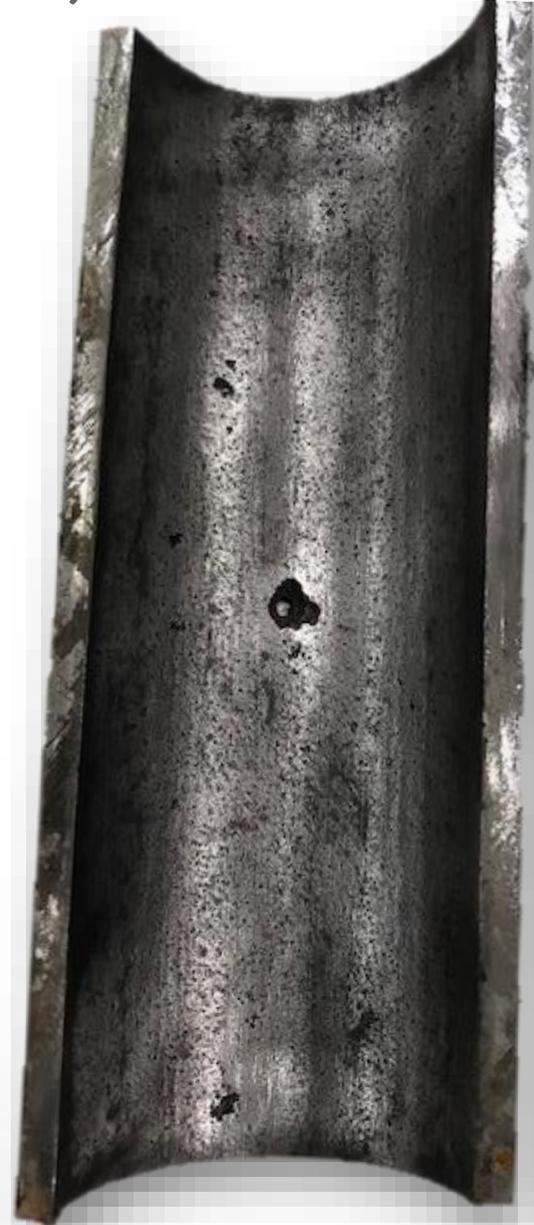
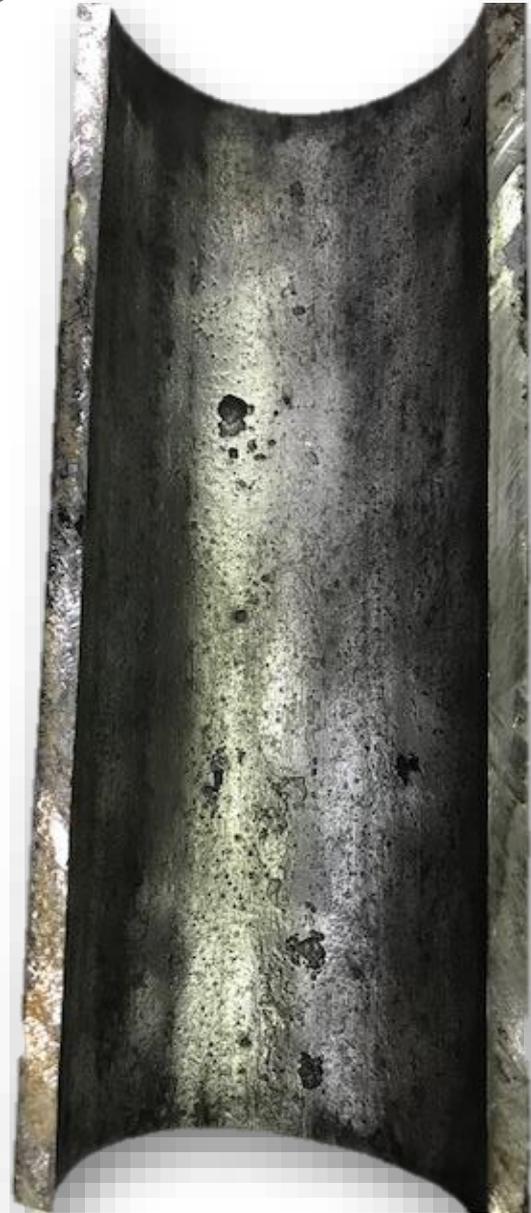
Sample Interior, After Cleaning

- Light pitting found throughout the sample
- Isolated pits found on both sides of pipe
- Orientation of pitting suggests that the line is always wet

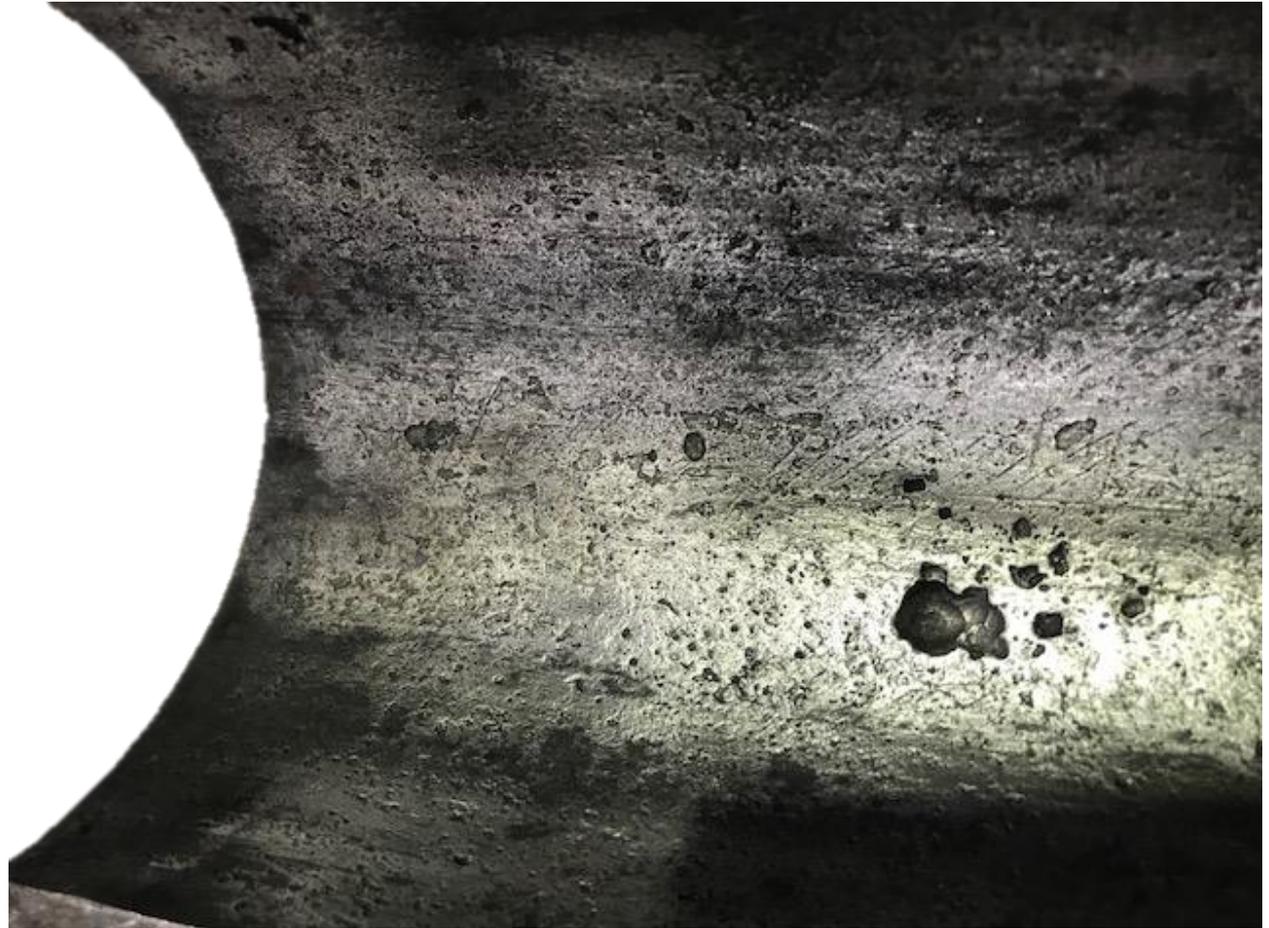
Pit Morphology

- Mild corrosion pitting found throughout the sample
- Iron sulfide in base of light pits suggests H_2S corrosion
- Corrosion pitting visible on either side of the welds

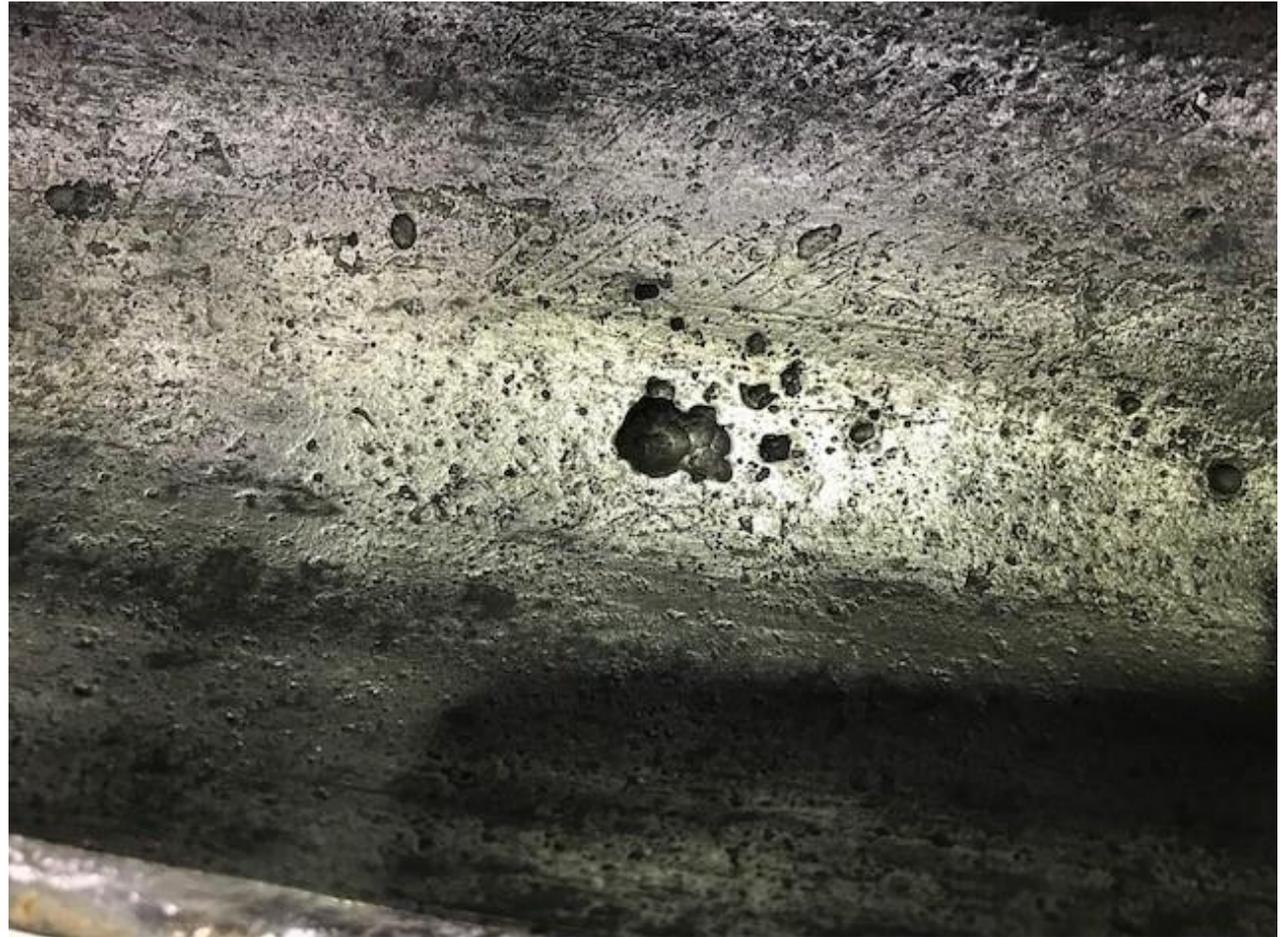
Pit Morphology - Bottom of Line

- Deep, isolated pits found among lighter pitting
- Pits have stair stepped pattern and pits within pits
- Characteristic of sulfate-reducing bacteria

- **Corrosion in flowline is exclusively internal corrosion**
- **Hole in tubing found in the top of the line.**
- **Less severe pitting found throughout the line.**
- **Severe, isolated pits found were on both sides of line.**
- **Pit morphology is stair stepped with pits within pits and iron sulfide at the base of the pits.**
- **Light pitting is highly characteristic of H₂S pitting.**
- **Severe pitting is highly characteristic of sulfate-reducing bacteria.**
- **Sulfate reducing bacteria secrete H₂S, which reacts with iron to form iron sulfide.**
- **Pitting failure likely due to Microbially Influenced Corrosion (MIC). H₂S pitting is likely a byproduct of SRB metabolism.**

- **Perform bug bottle testing to confirm the presence of bacteria.**
- **Perform H₂S testing to confirm the presence of H₂S gas.**
- **Initiate treatment with biocide at the saltwater disposal. Treat with XC102w an initial treatment concentration of at least 100 ppm. Treatments can be applied continuously or batch as practical and economic considerations dictate.**
- **Monitor biocide performance with bug bottle testing. A typical KPI for bacteria testing is less than or equal to 2 bug bottle turns (representing 100 bacteria/mL or less)**

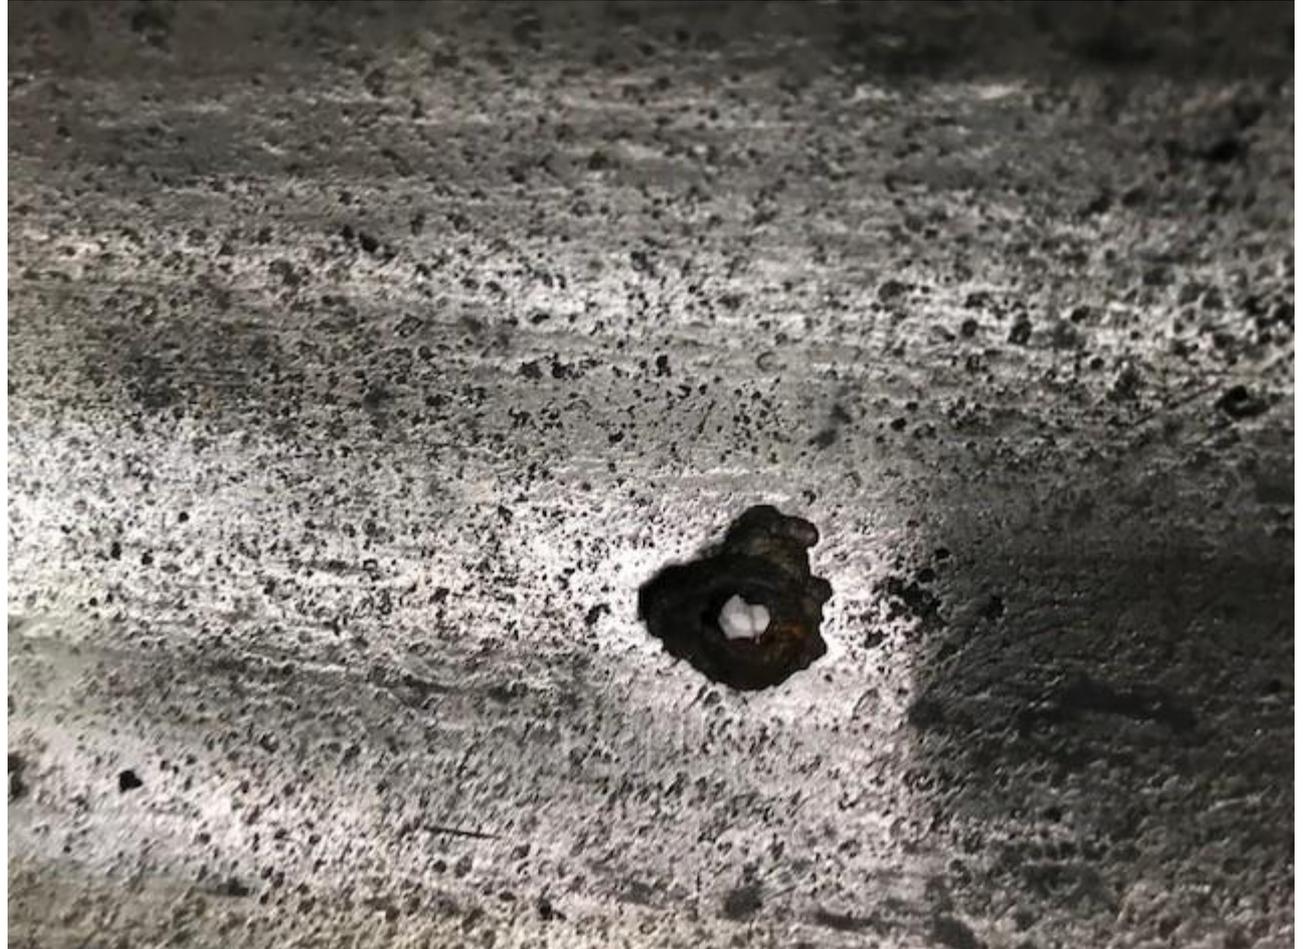
Pit Morphology - Top of Line

- Deep, isolated pits found among lighter pitting with through hole wall
- Pit similar to bottom of line with stair stepped pattern
- Black material tested positive for iron sulfide
