Inspection Photos
Location Name: William D Lansdown #1
Location ID: 317613

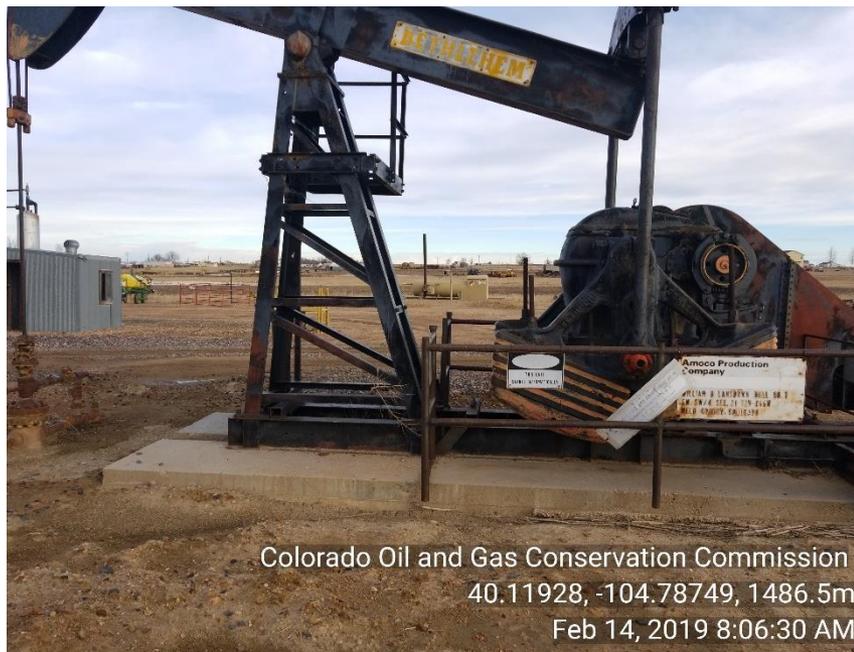
Photo 1 WH/PU Sign faded and in disrepair

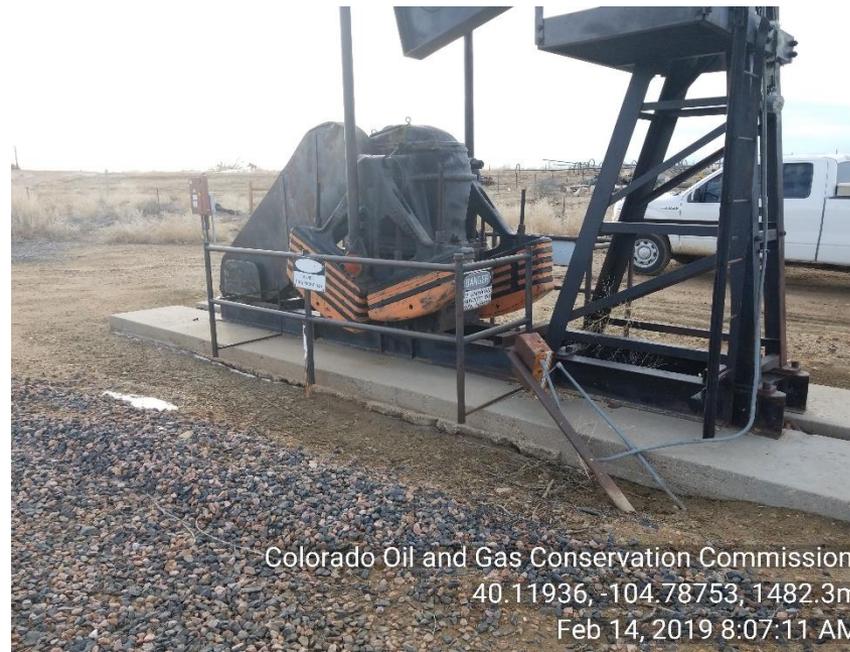
Photo 2 electric panel knocked over

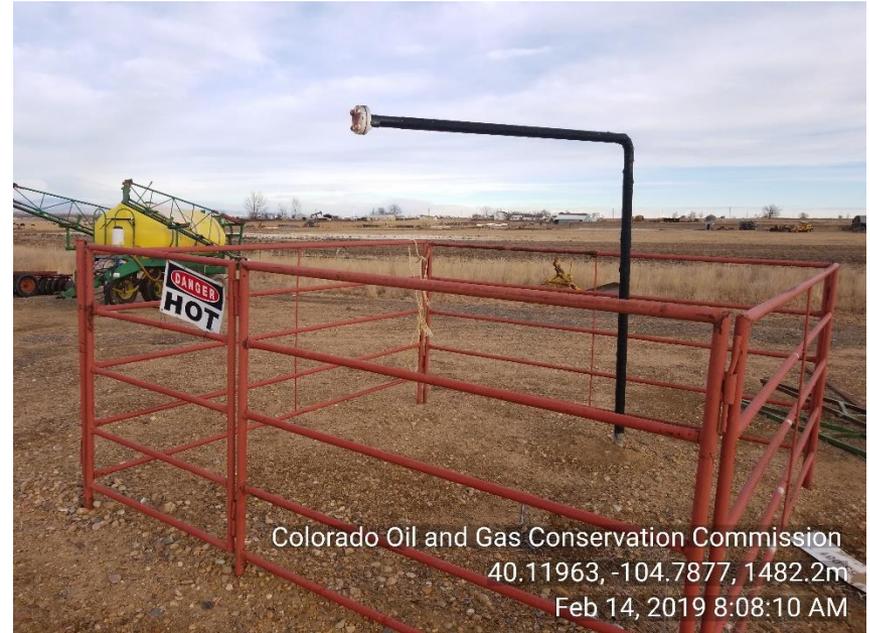
Photo 4 Unused unmarked and not LOTO riser

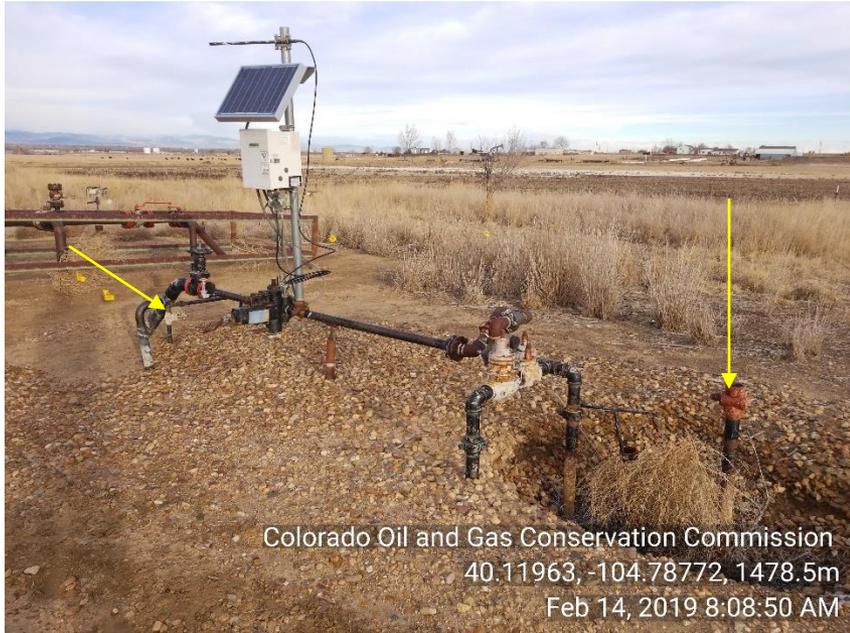
Photo 5 Meter run Unused, unmarked and not LOTO risers

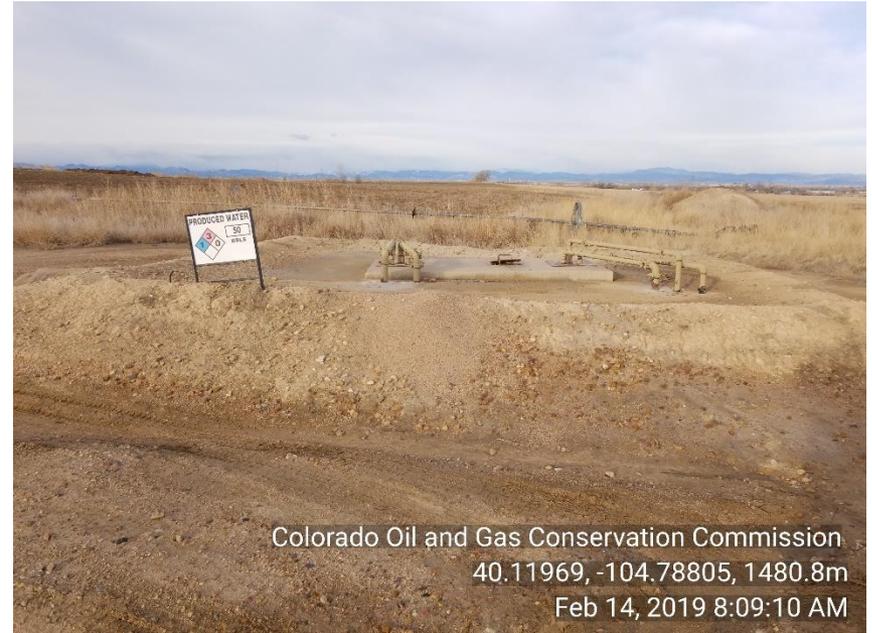
Photo 6 Produced water tank. Berms not adequate and in disrepair.

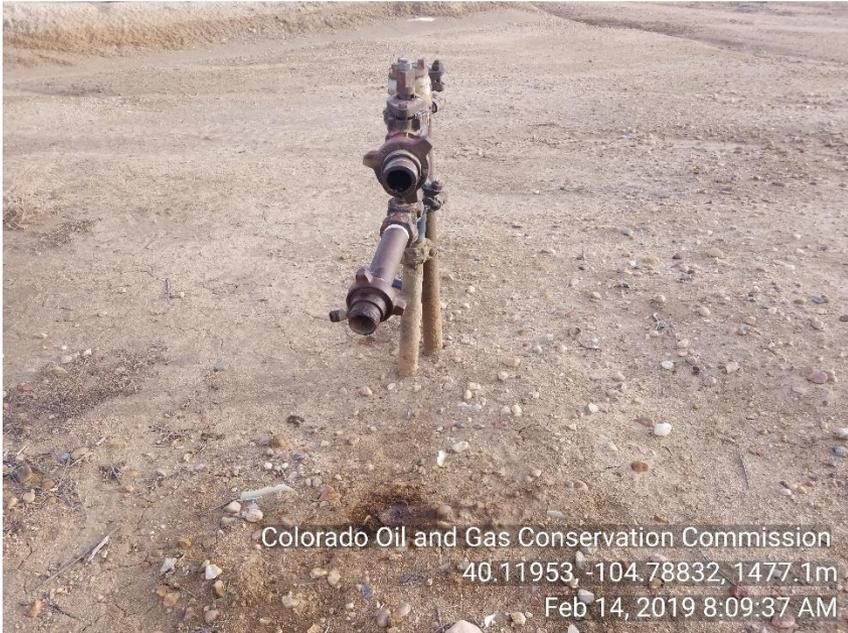
Photo 7 Unused, unmarked and not LOTO risers and stained soil

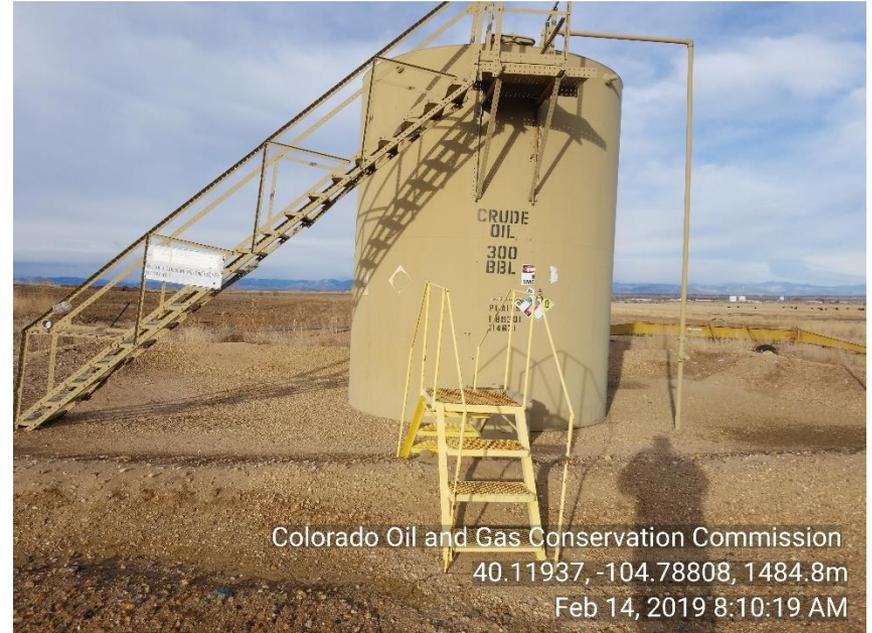
Photo 8 TNK BTRY Loc sign faded, NFPA placards torn off

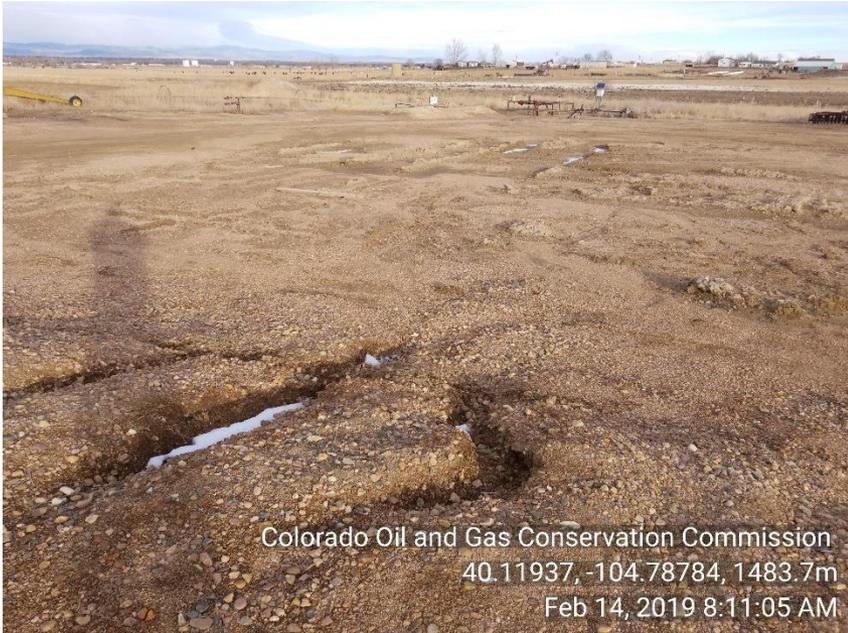
**Photo 9 location does not have proper drainage reeling
across location**

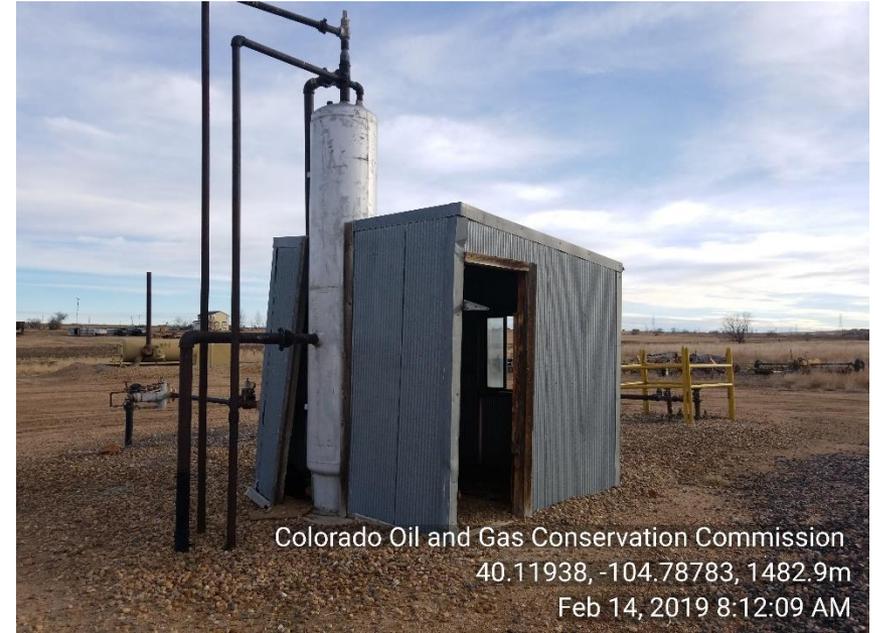
Photo 10 Vert Sep building in disrepair
