**Inspection Photos**  
**Location Name: Millard #1**  
**Location ID: 333131**

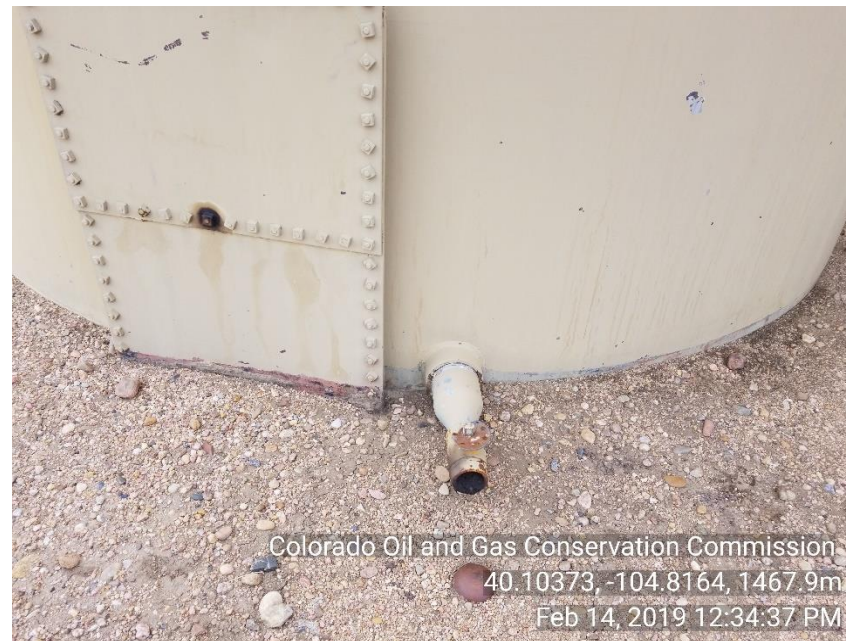
**Photo 4 no bull plug on crude oil load line**

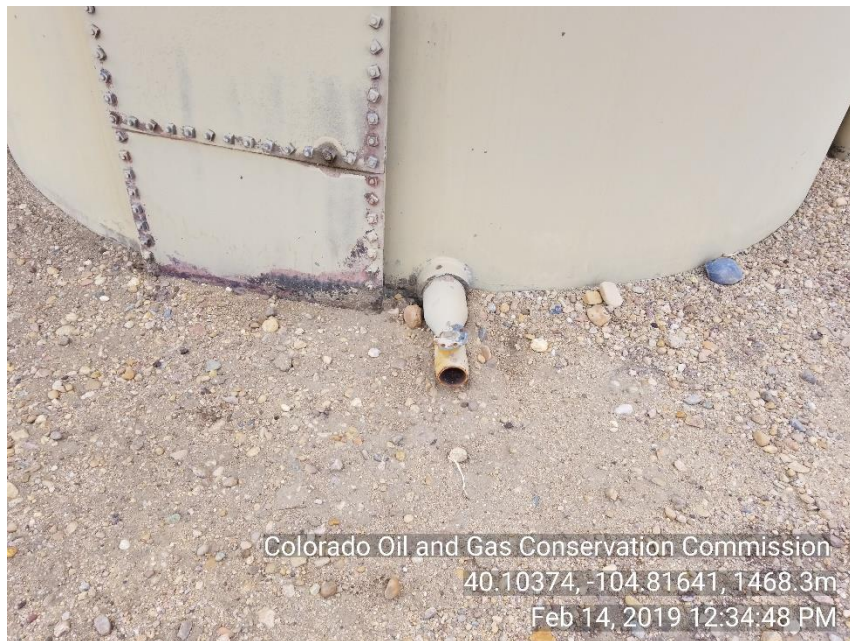
**Photo 5 no bull plug crude oil tank load line**

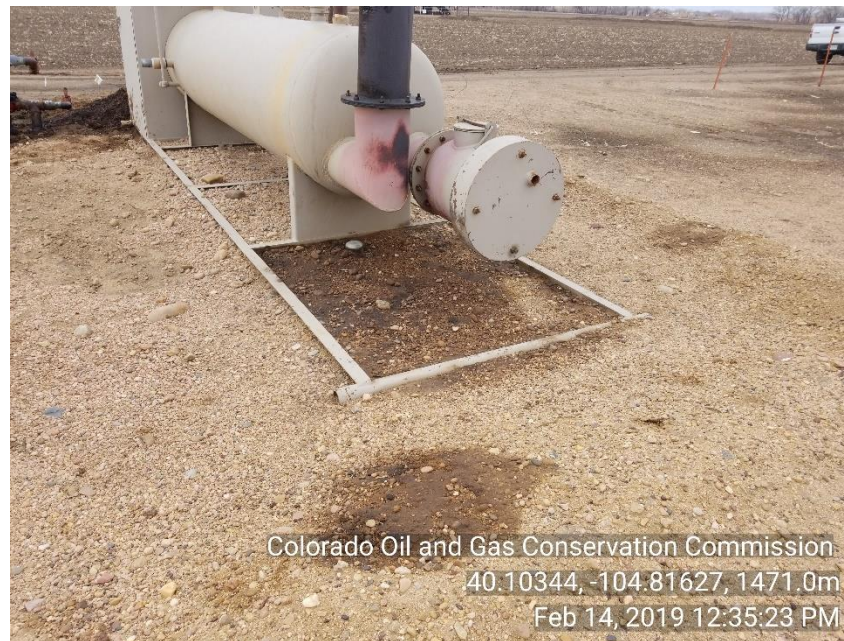
**Photo 6 Stained soil horizontal separator**

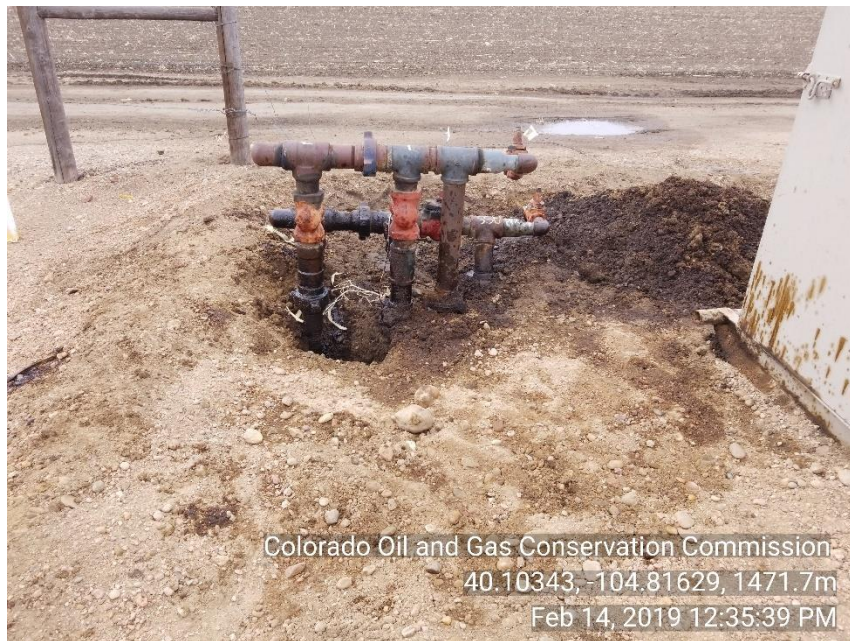
**Photo 7 stained soil appeared to have leak in front of sep**

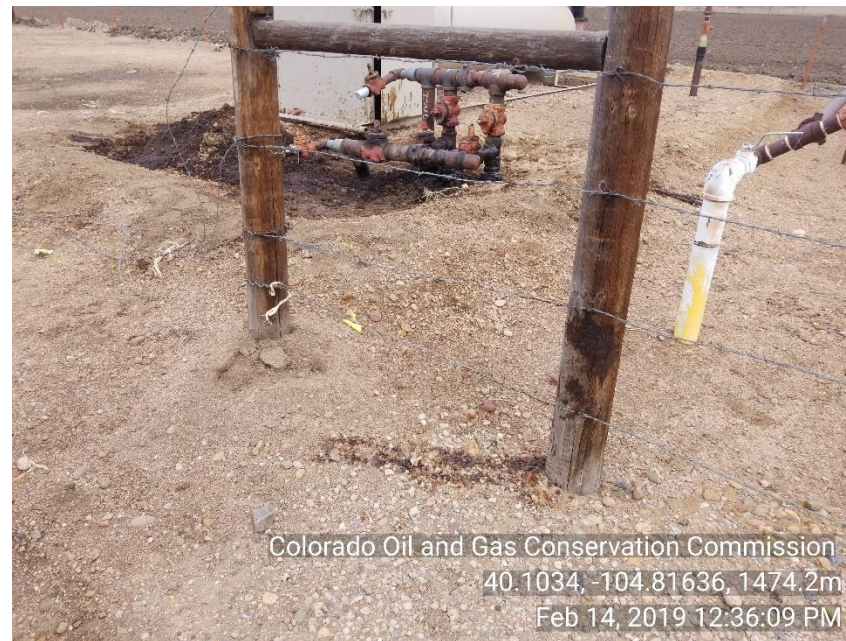
**Photo 8 Stained soil in front of separator**

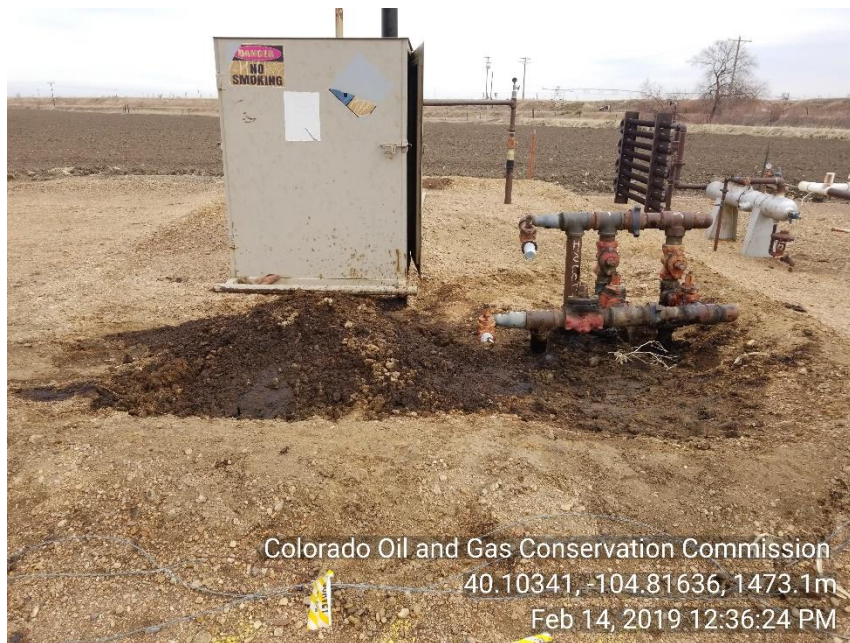
**Photo 9 stained soil appeared to have leak in front of sep**

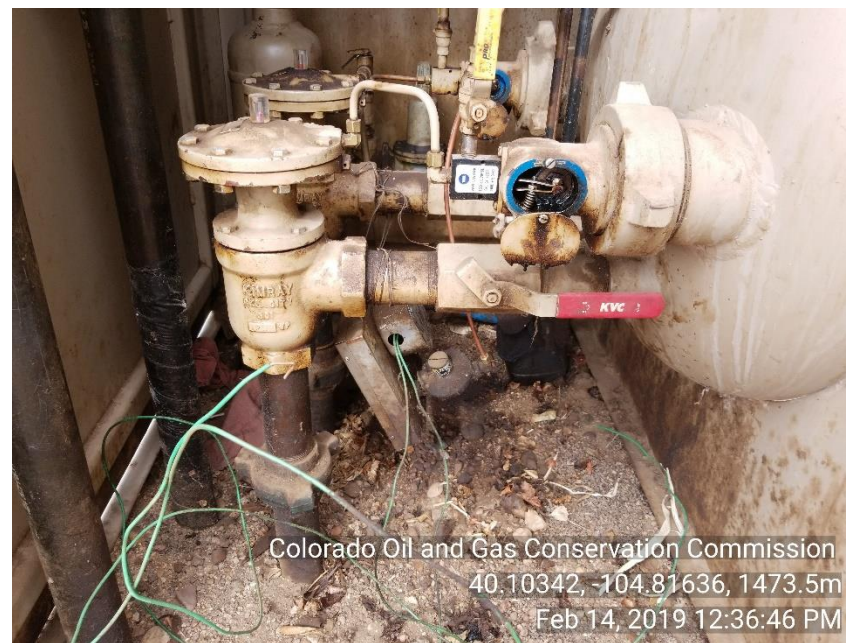
**Photo 10 Stained soil inside sep house**

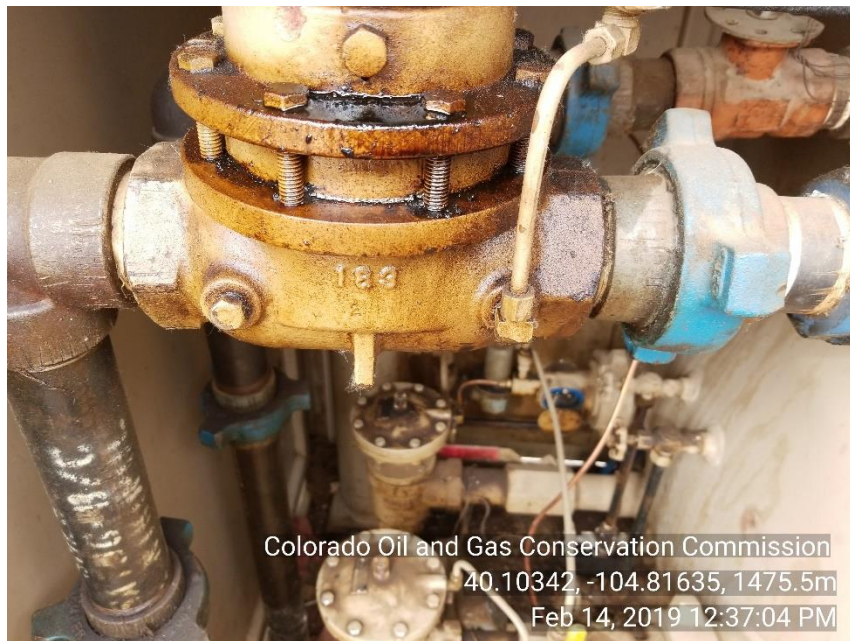
**Photo 11 fluid on 2" piping inside sep house**

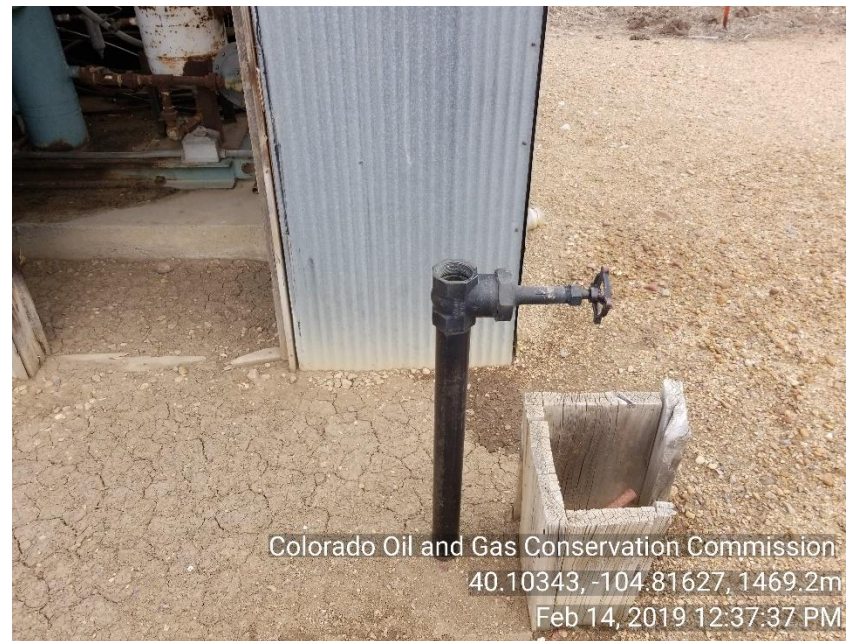
**Photo 12 unused unmarked and not LOTO riser**

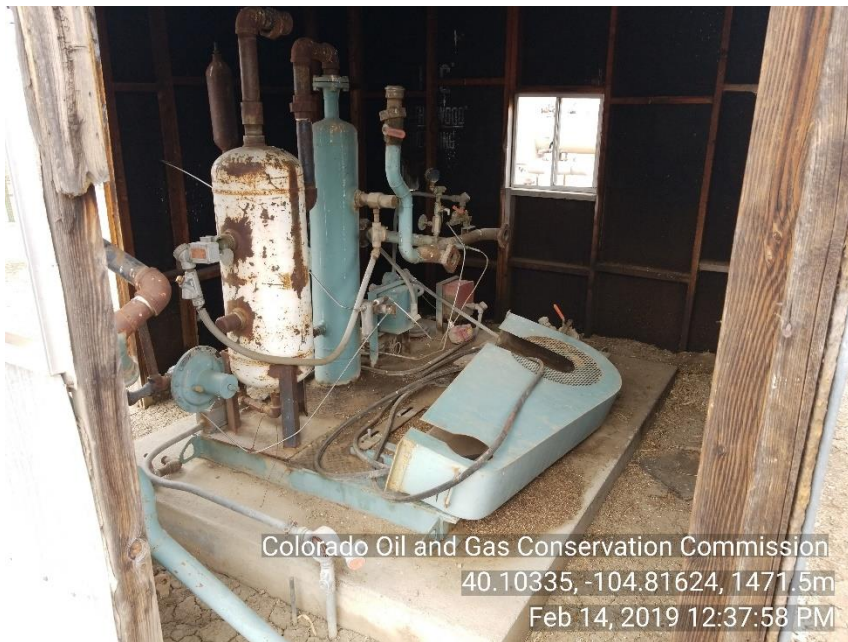
**Photo 13 Unused equipment**
