Inspection Photos

API: 05-071-08360

Operator: PIONEER NATURAL RESOURCES

Inspection Date: 2/14/2019

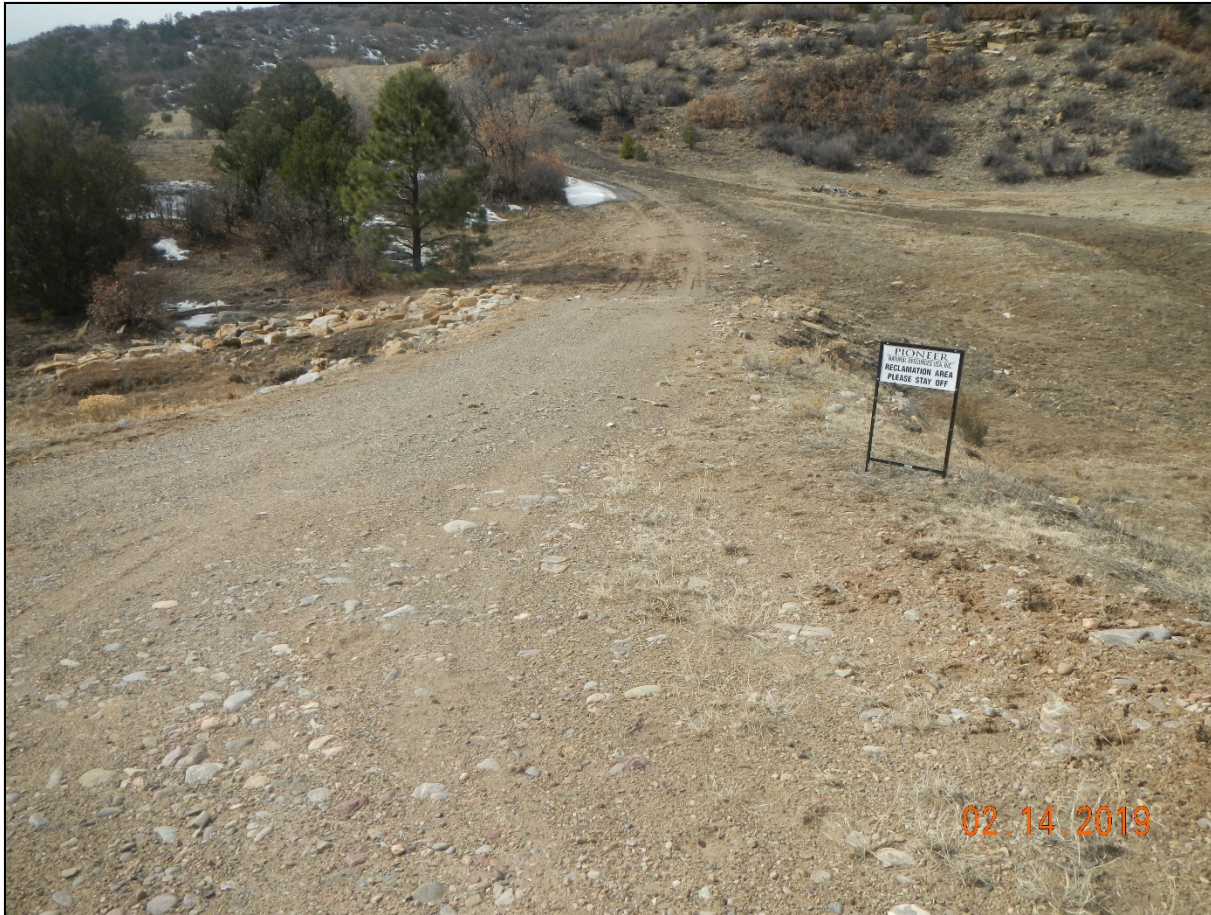
Photo 1. Facing west at the beginning of the access road.

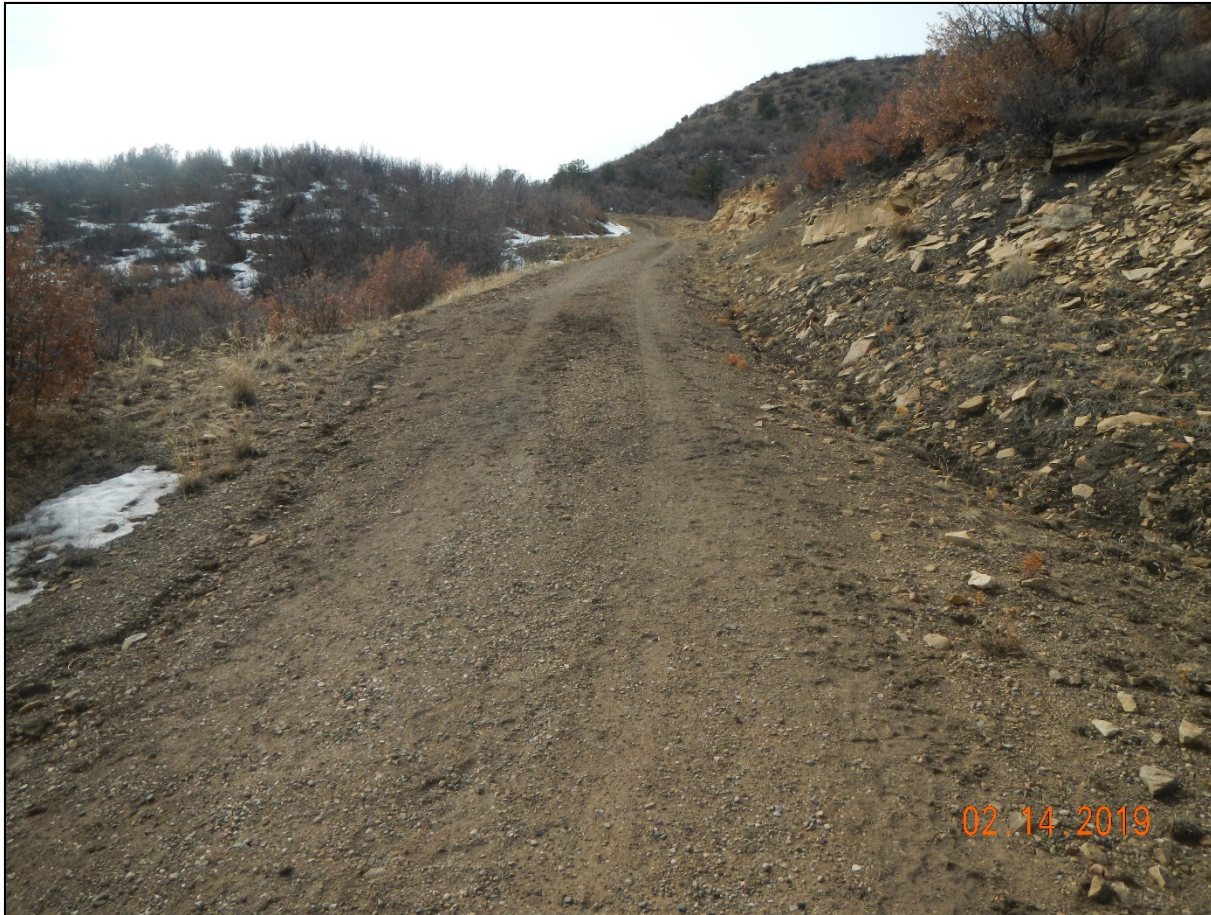
Photo 2. Facing west along the access road.

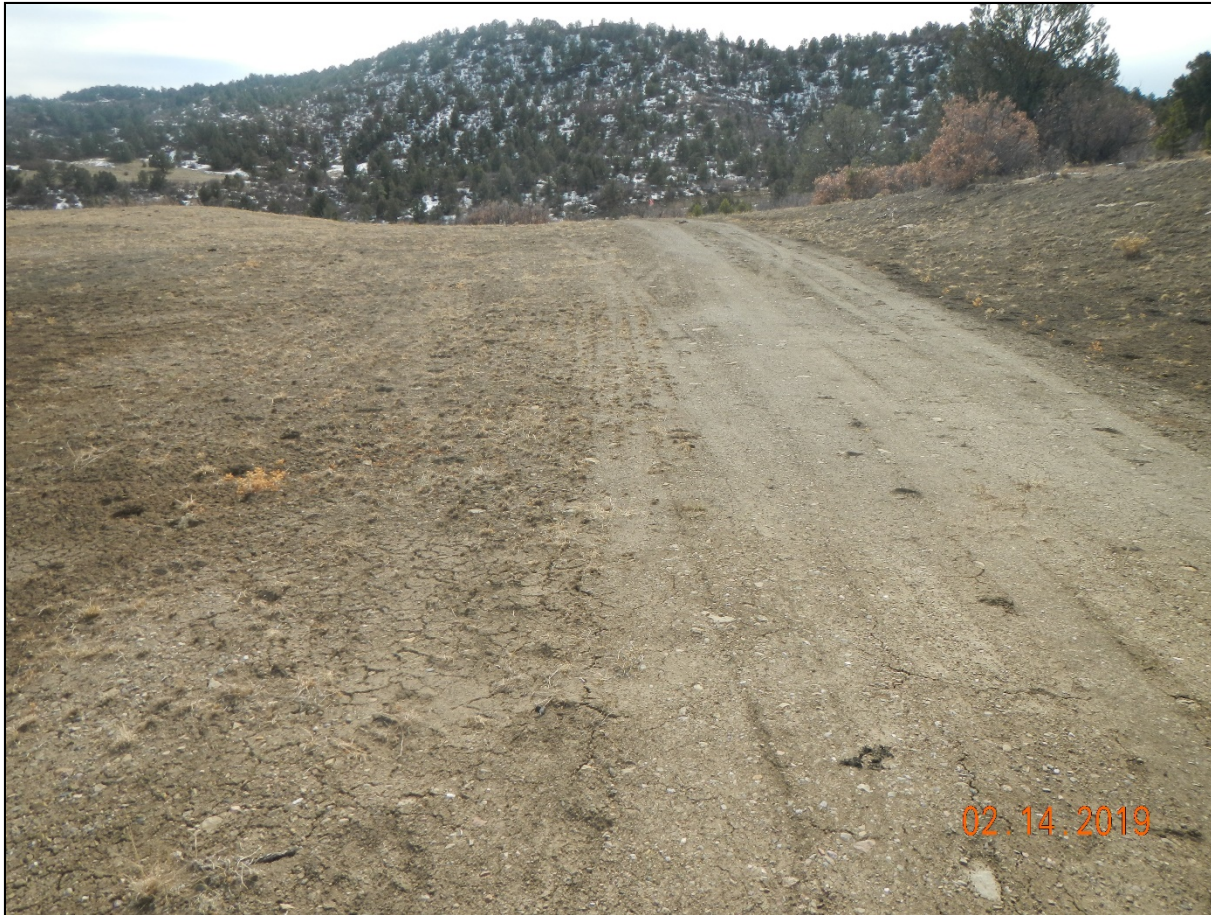
Photo 3. Facing south toward the location. The access road continues past the location.

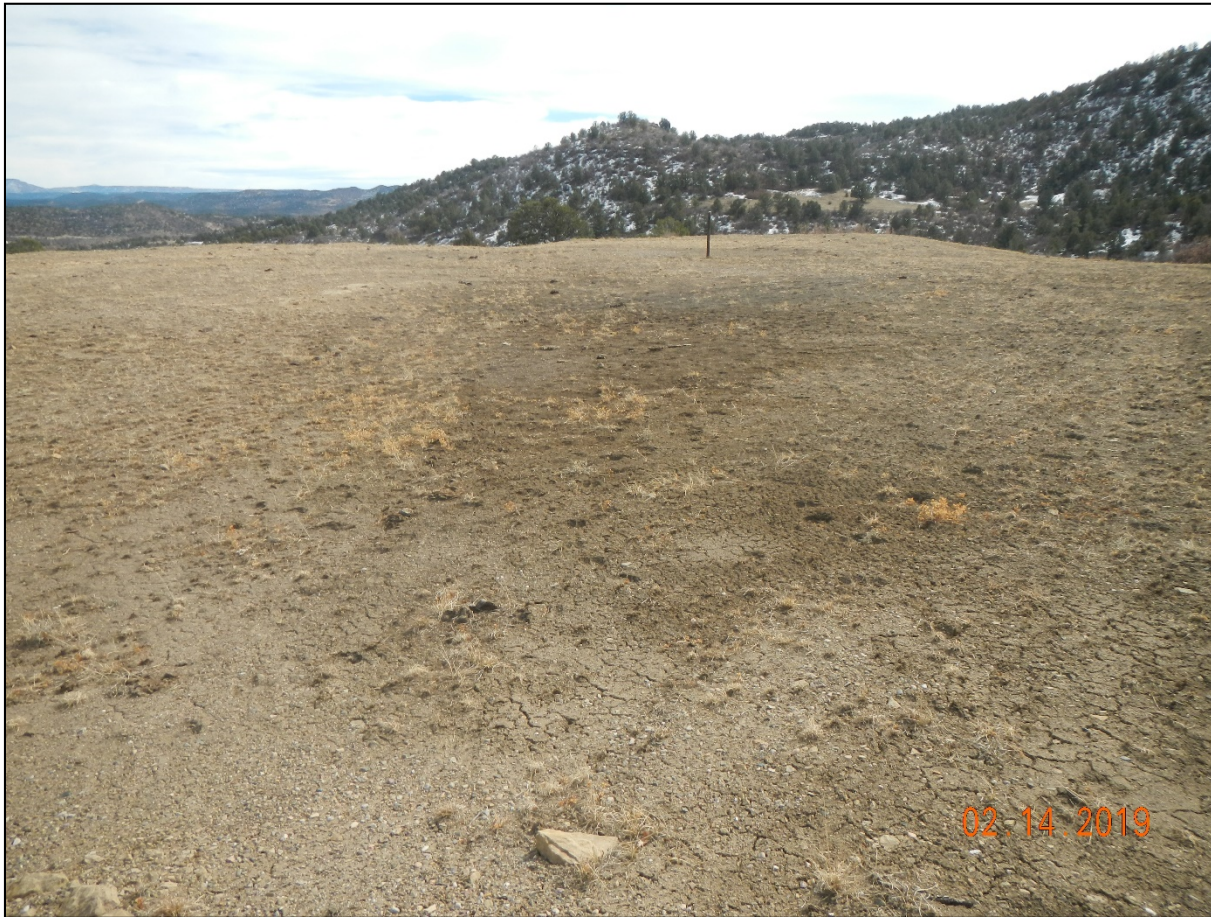
Photo 4. Facing southeast toward the location.

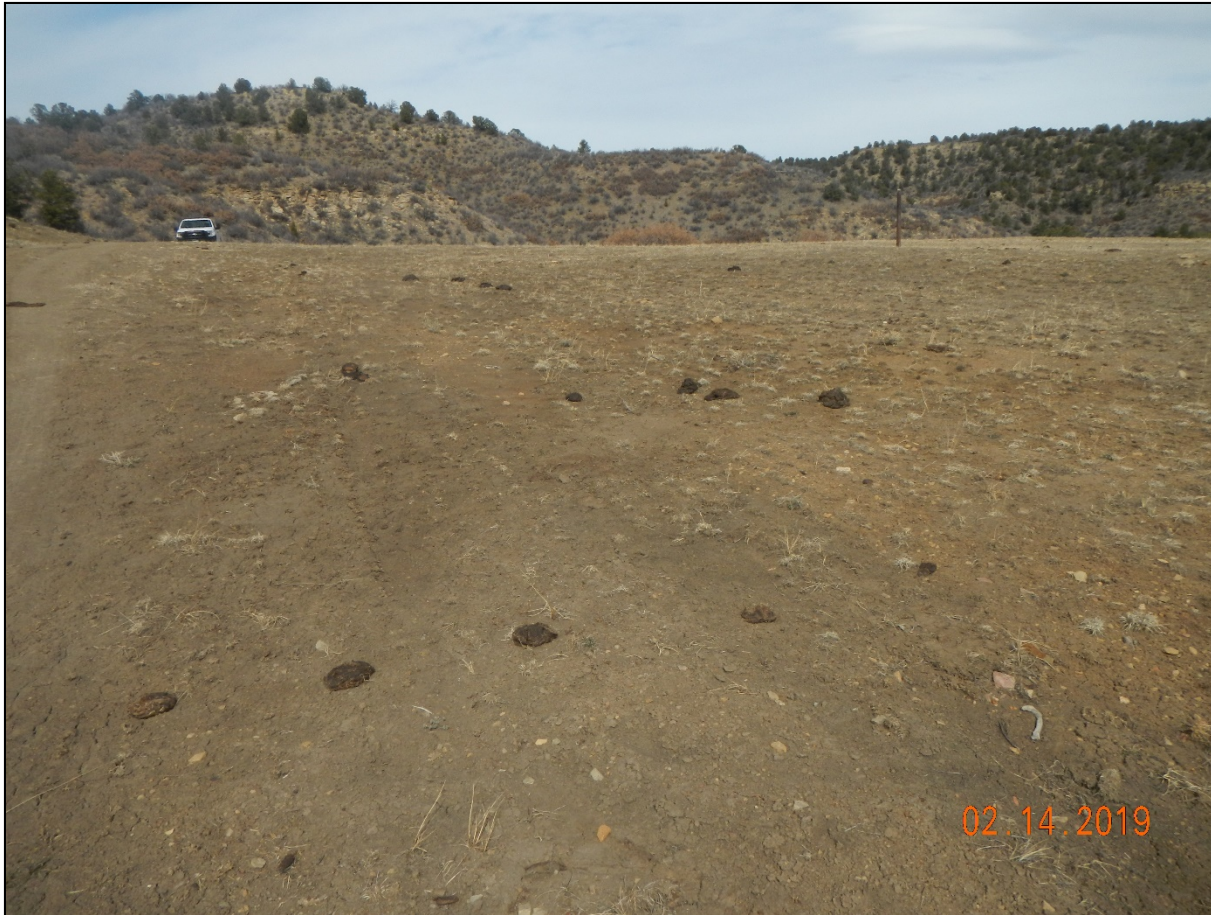
Photo 5. Facing north toward the location.

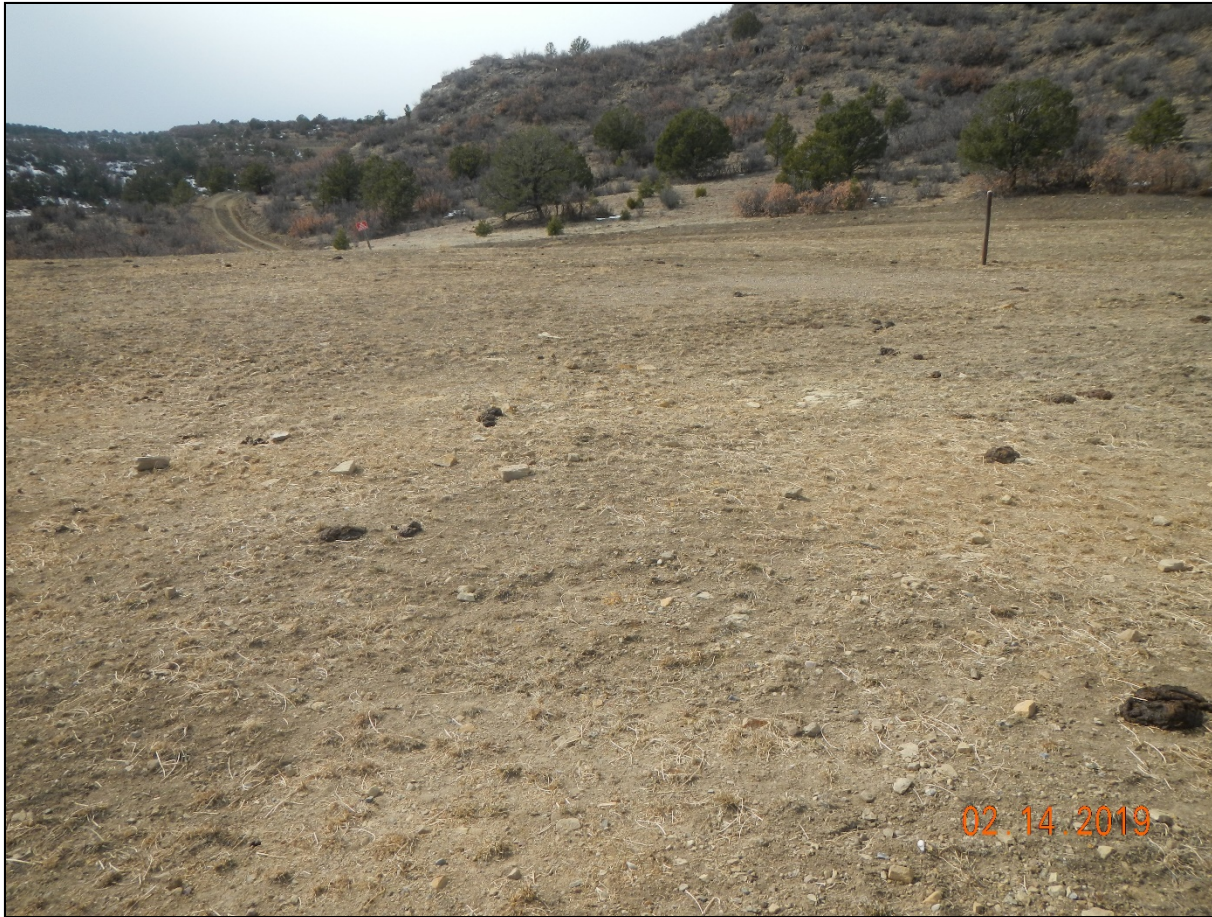
Photo 6. East side of the location facing southwest. It appears cattle having been grazing the site.

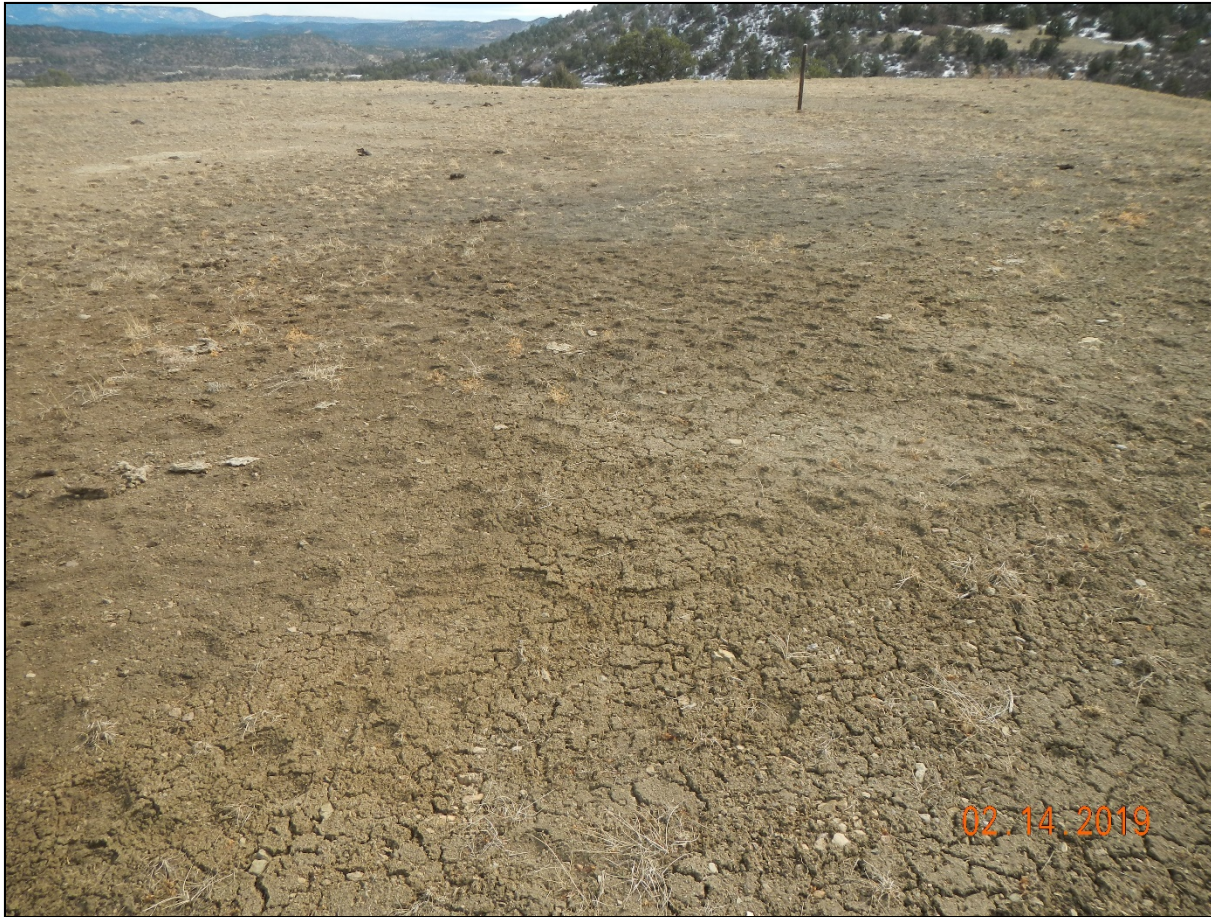
Photo 7. The vegetation at the location has not established. Additional reseeding needs to be performed.

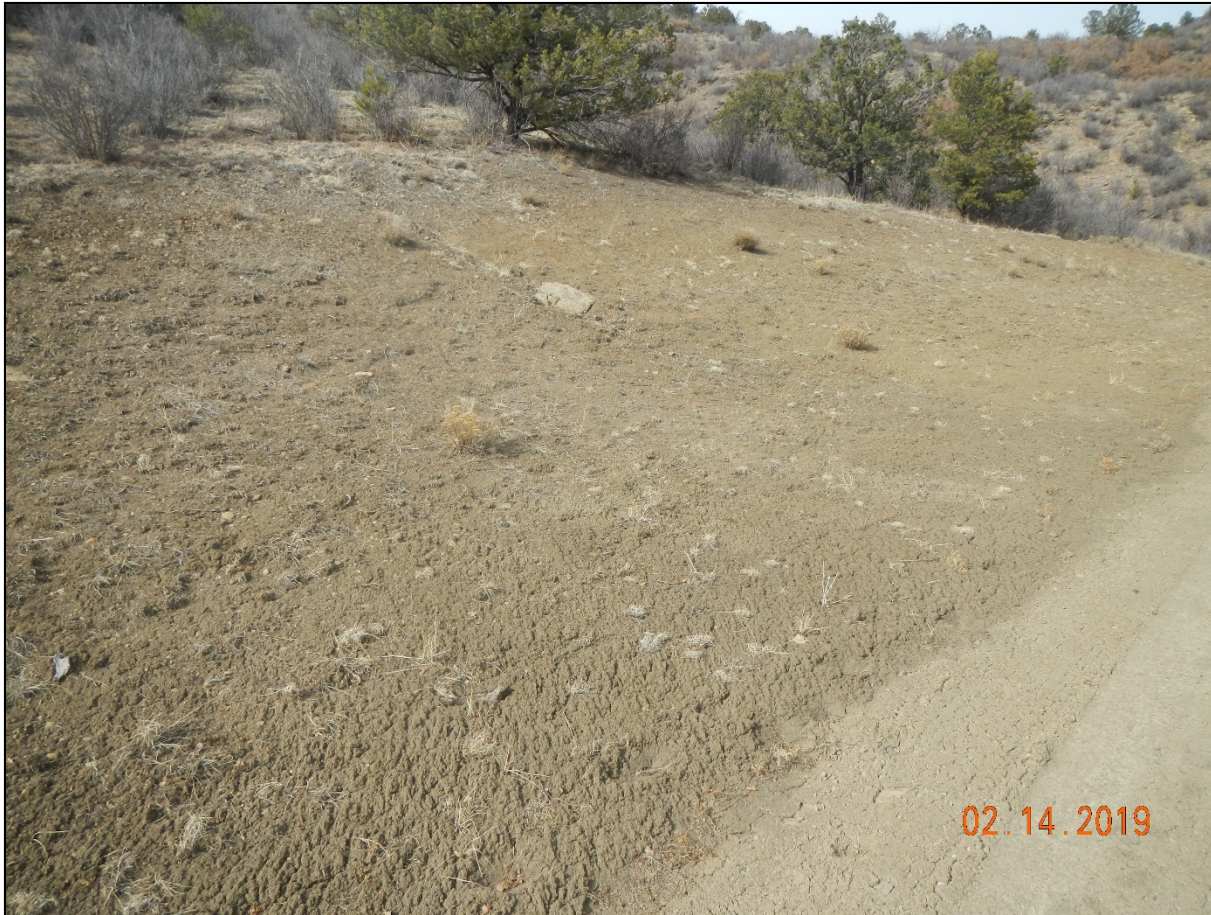
Photo 8. There is very little vegetation along the cut slope.
