Inspection Photos

API: 05-071-07045

Operator: PIONEER NATURAL RESOURCES

Inspection Date: 2/14/2019

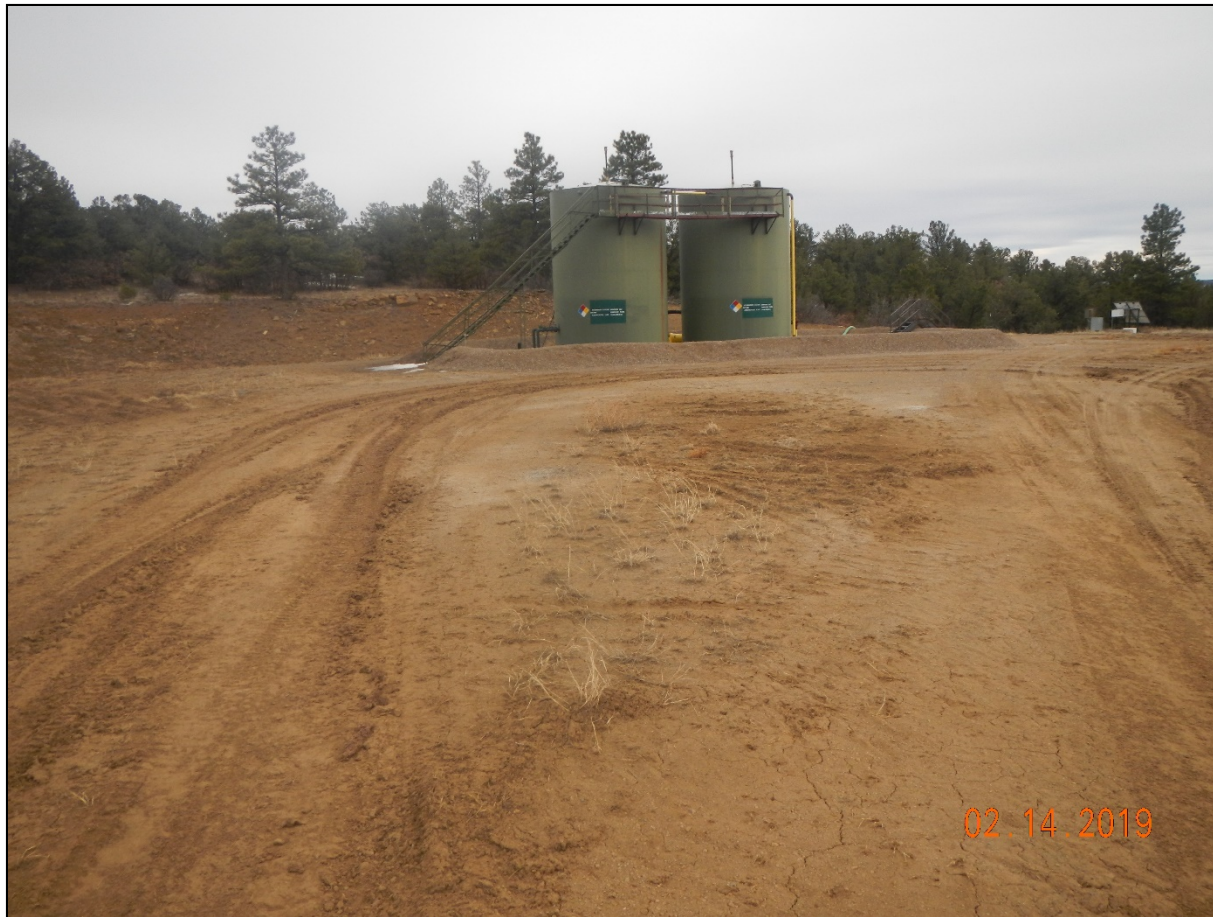
Photo 1. Facing southeast toward the location.

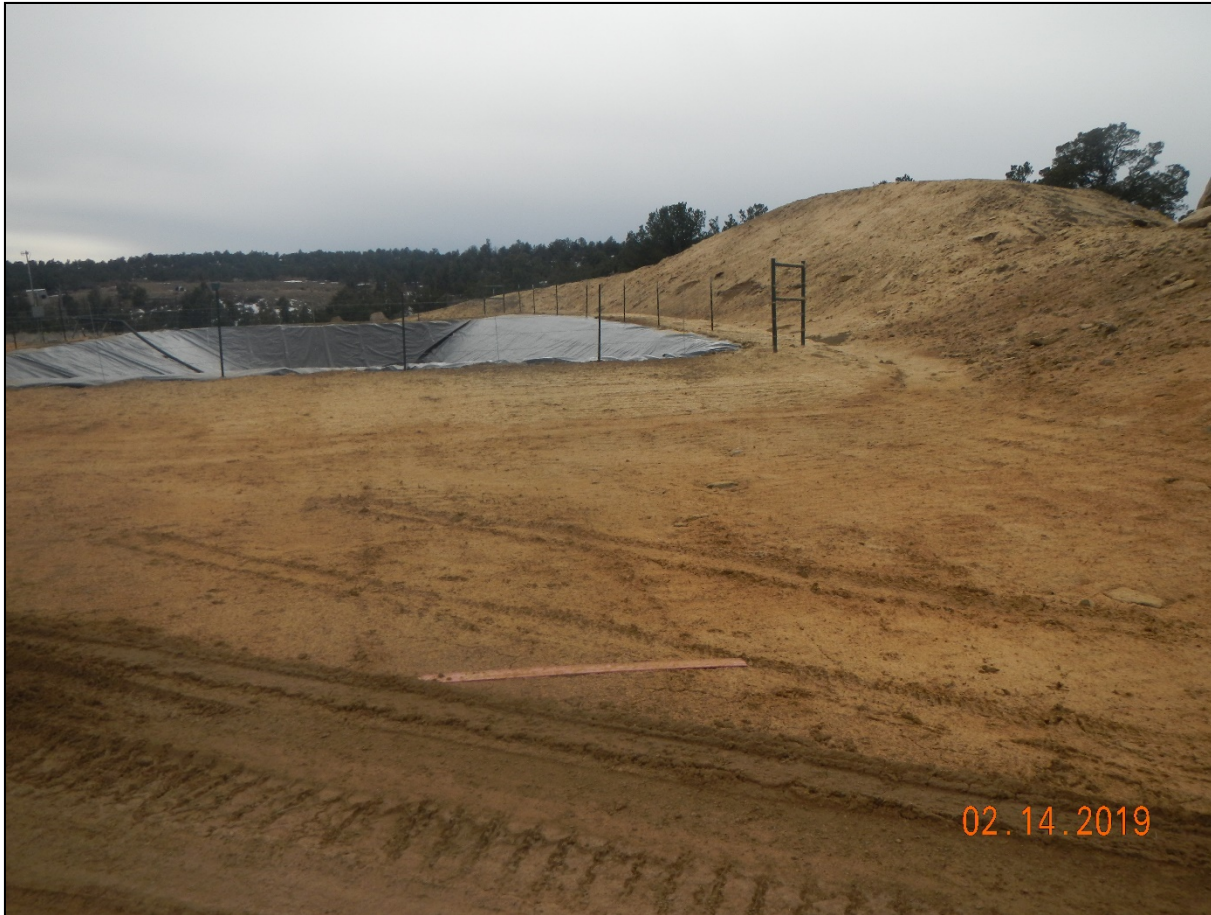
Photo 2. Facing south toward the pit. This area has recently been hydromulched.

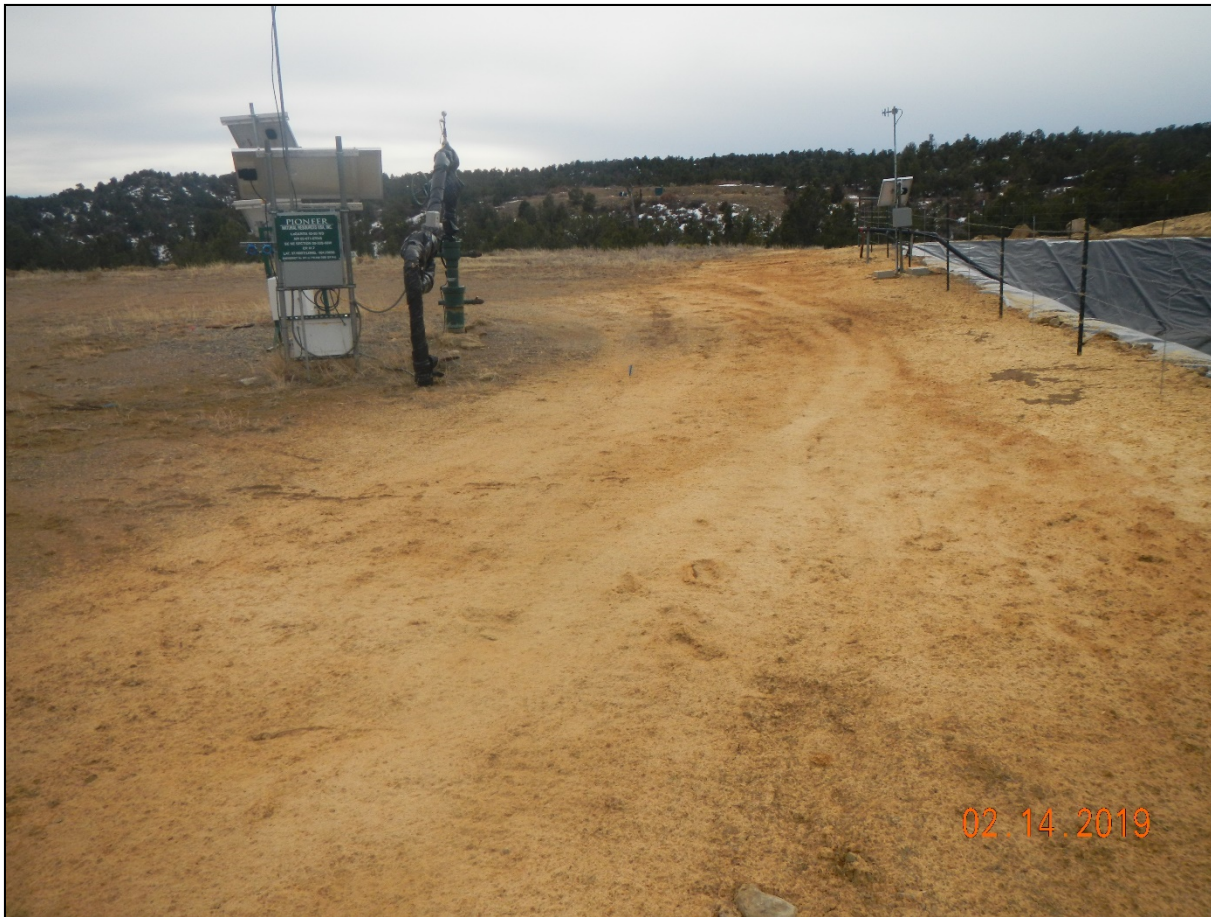
Photo 3. Facing toward the wellhead. Well sign is present.

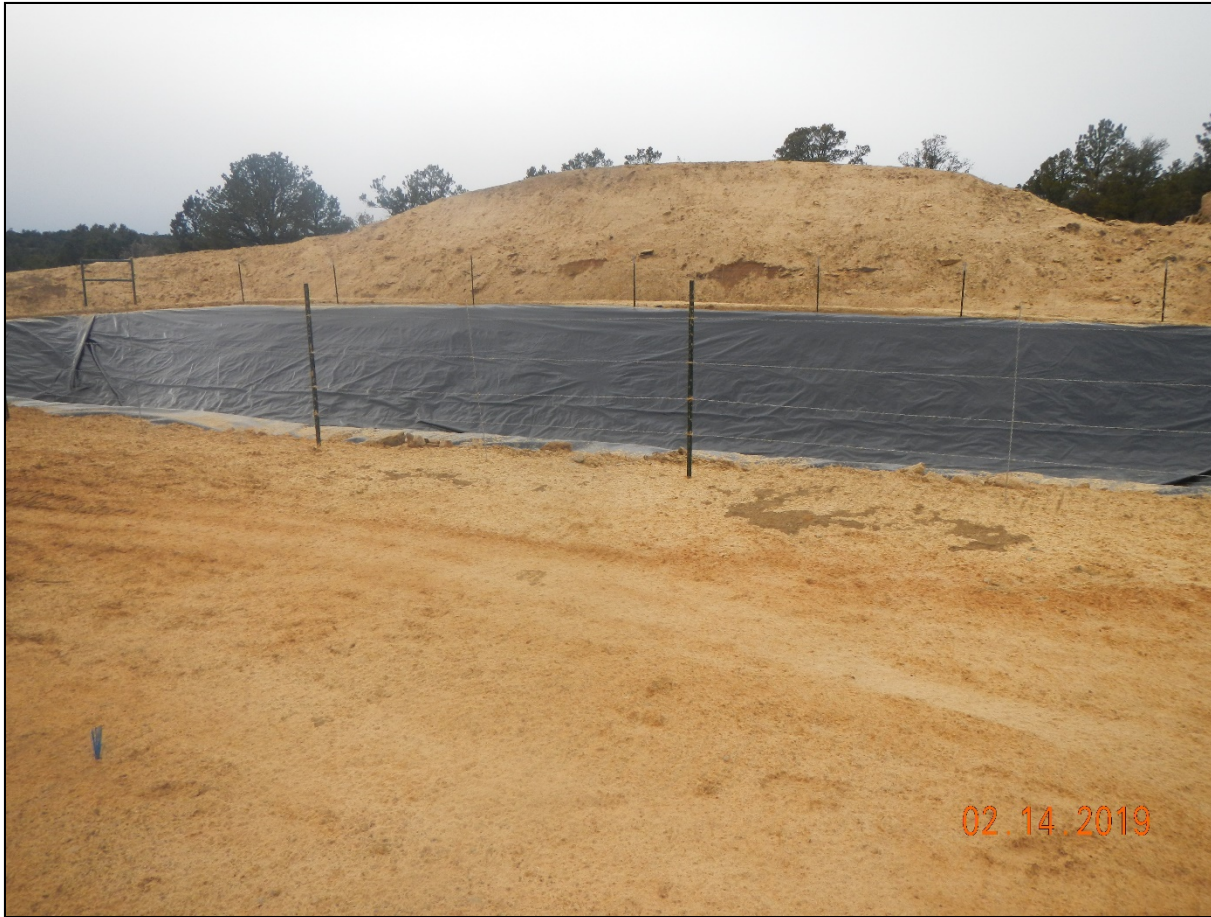
Photo 4. A new lined pit appears to have been installed.

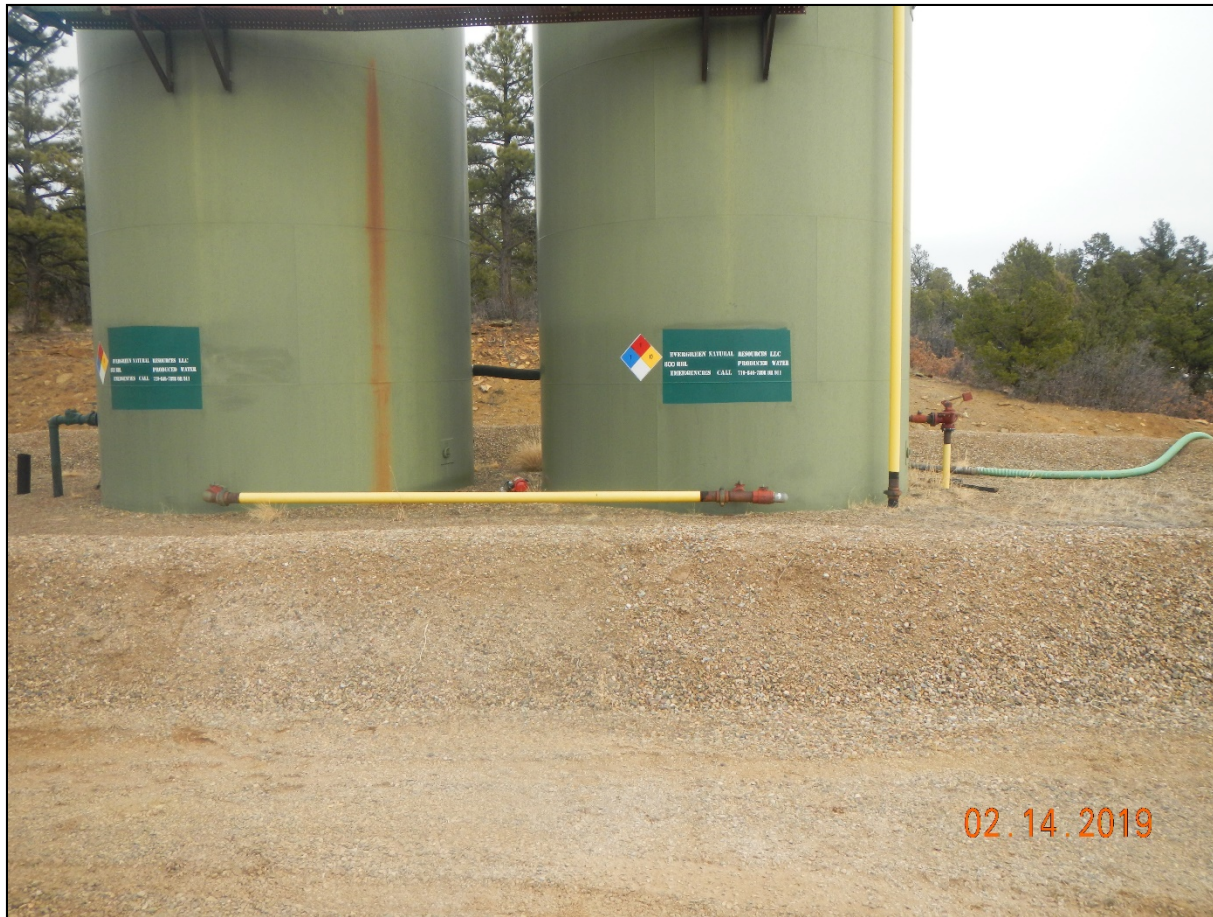
Photo 5. Tanks are properly labeled.
