Construction and Stormwater Inspection

February 20-22, 2019

Operator: ELEVATION MIDSTREAM LLC – 10687

Location ID: 460416

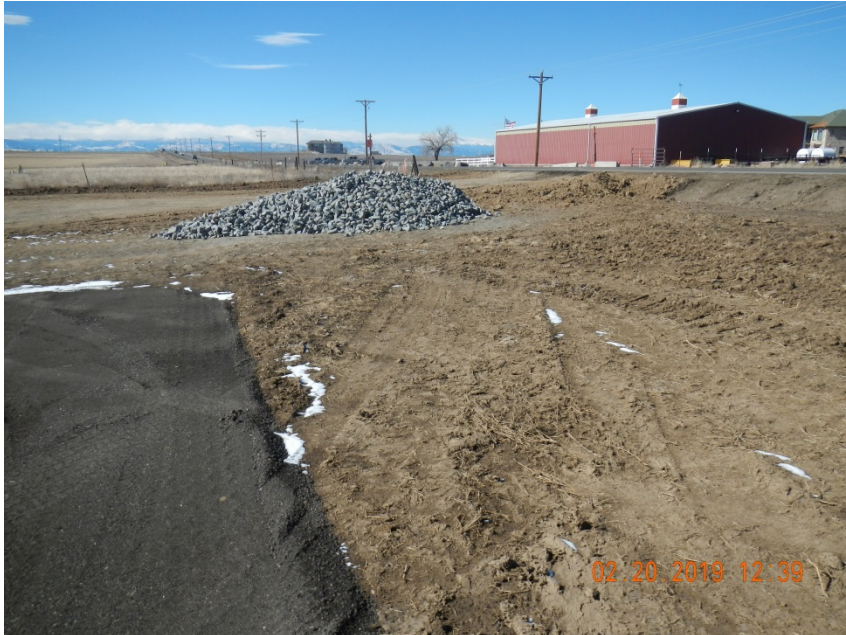
Photo 1. Photo taken from the northern perimeter of the location looking at the access road off CR 6, facing West. Operator is in the process of installing gravel to potentially to limit tracking onto the county road.

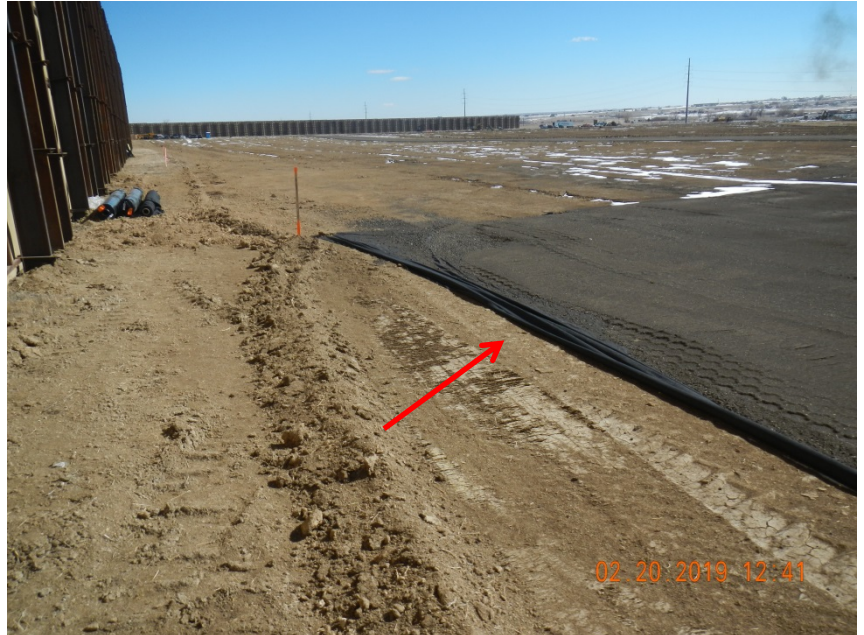
Photo 2. Photo taken from the northern perimeter of the location, facing East. Appears the operator has placed gravel over a geo textile fabric on top of the existing top soil.

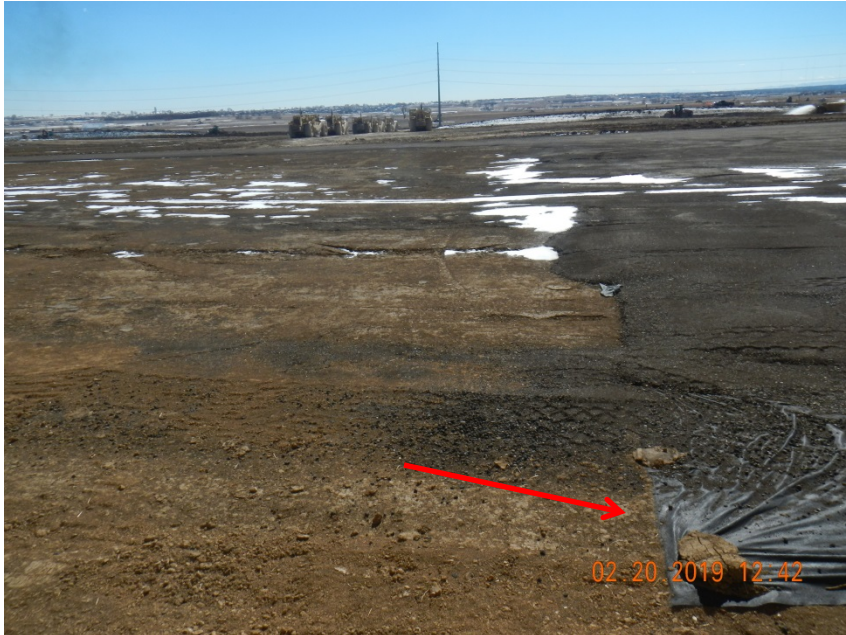
Photo 3. Photo taken from the northern perimeter of the location, facing South. See comments from Photo 2.

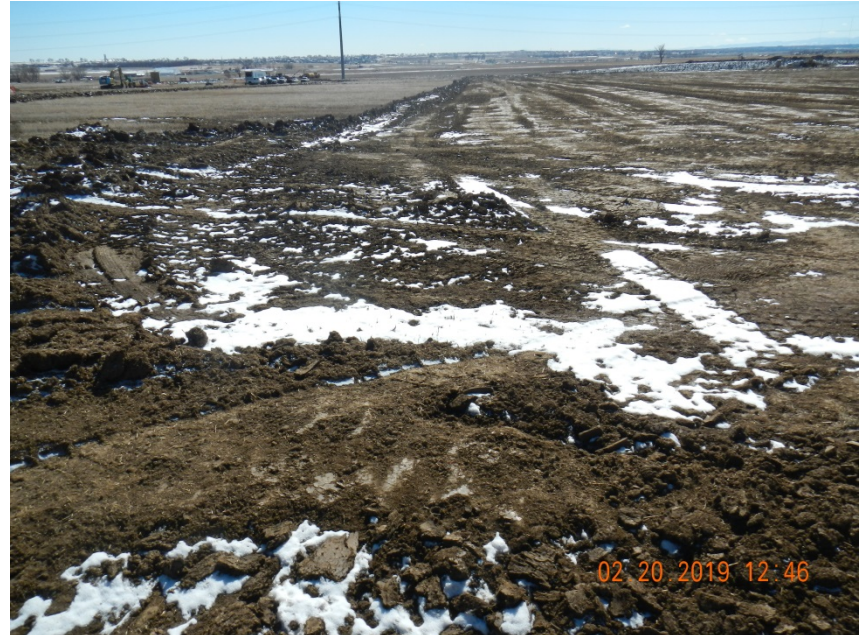
Photo 4. Photo taken from the northern perimeter of the location, facing South. Photo depicts potentially top soil not salvaged and that BMP's have not been installed around the entire perimeter of the location.

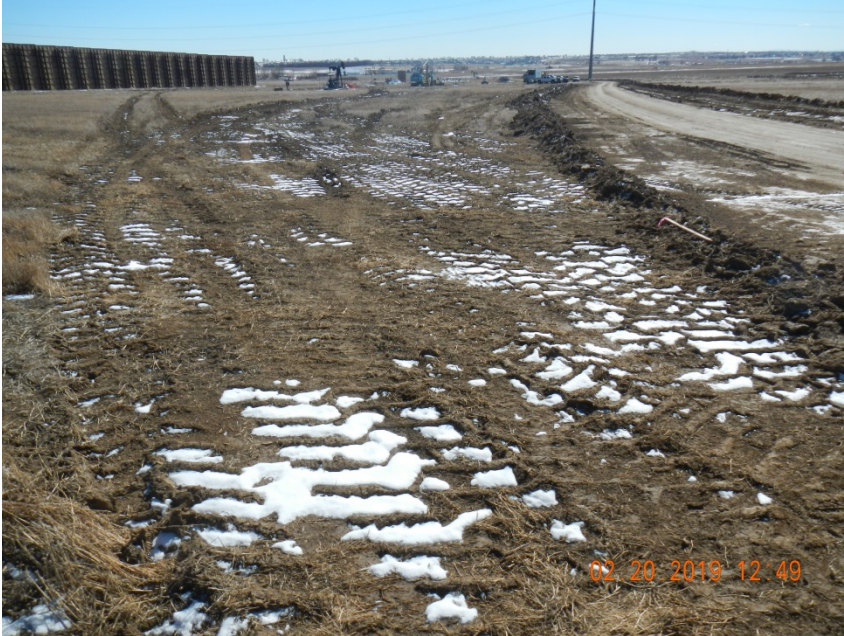
Photo 5. Photo taken from the northern perimeter of the location, facing South. See comments from Photo 4.

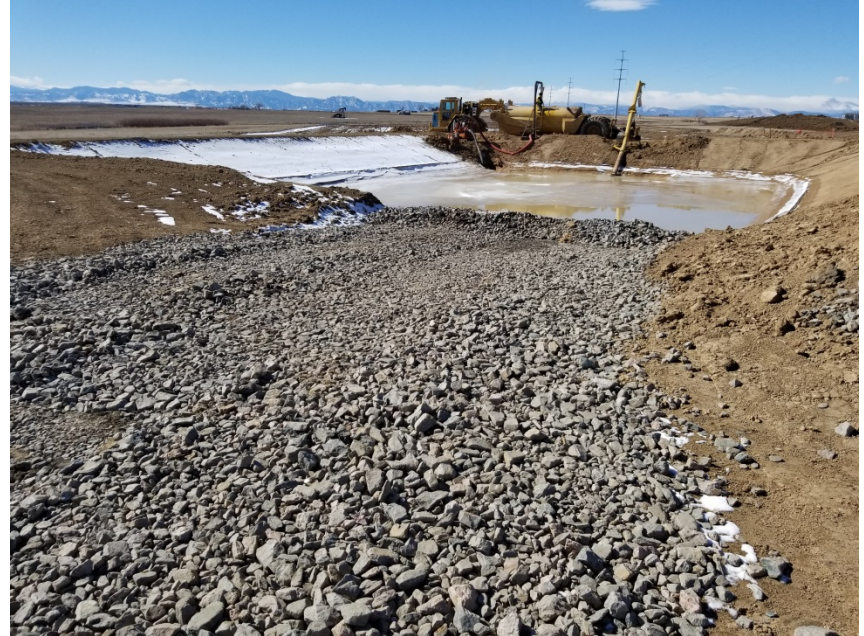
Photo 6. Photo taken from the Southern perimeter of the location, facing West. Photo depicts a temporary pond installed to fill water trucks.

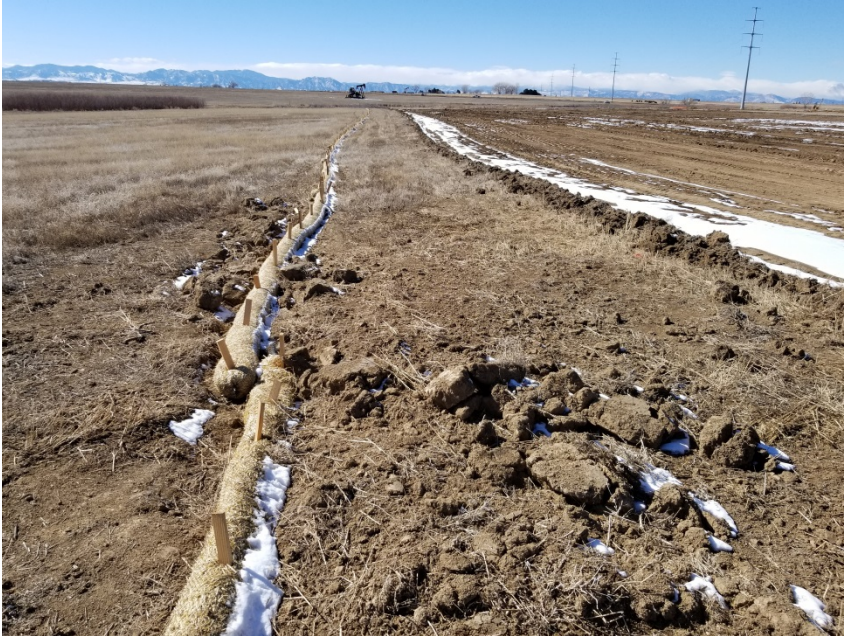
Photo 7. Photo taken from the southern perimeter of the location, facing West. Photo depicts BMP's installed around the parts of the southern perimeter of the location.

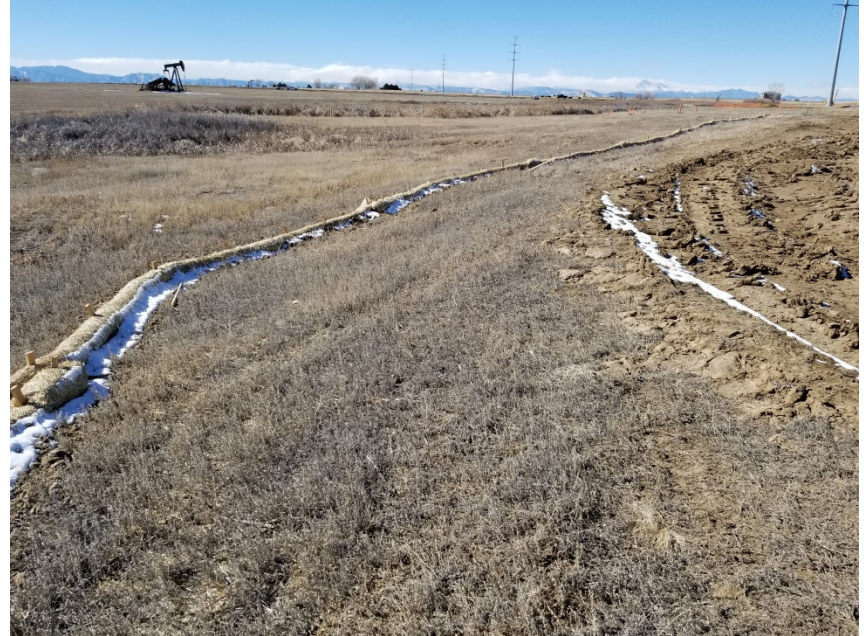
Photo 8. Photo taken from the Southern perimeter of the location, facing West. See comments from Photo 7.

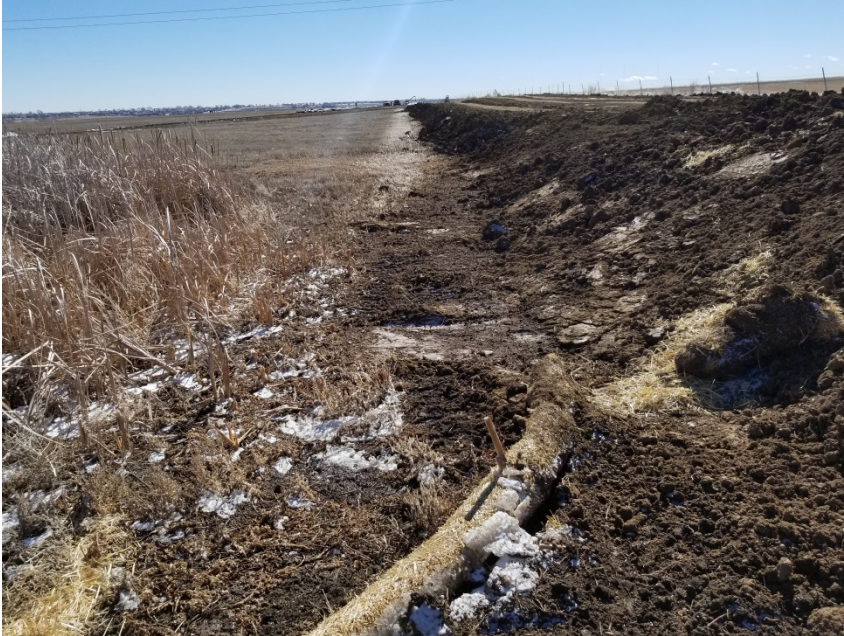
Photo 9. Photo taken from the western perimeter of the location, facing Southwest. Photo depicts BMP's have not been installed around the entire perimeter of the location and note the wetland on the left in the Photo.

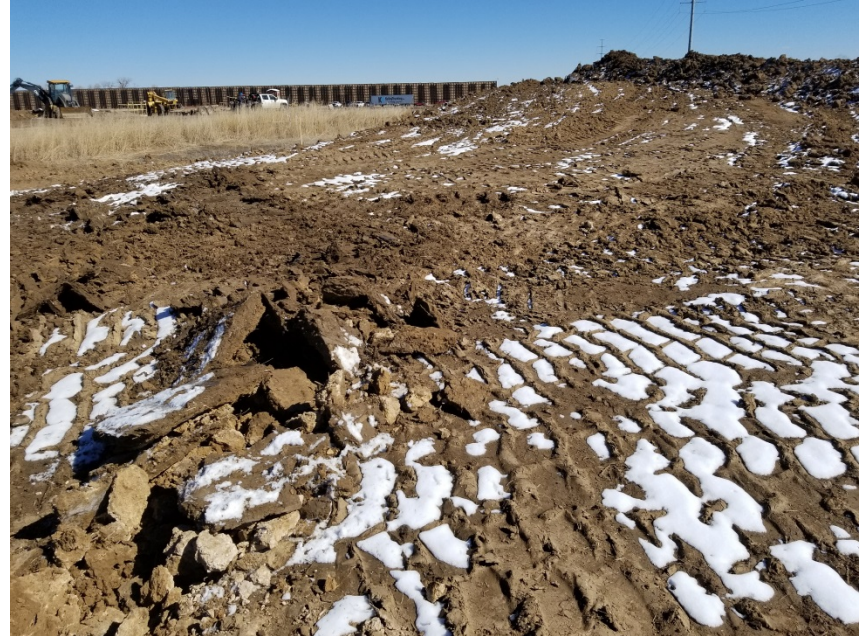
Photo 10. Photo taken from the Southern perimeter of the location, facing North. Photo illustrates a topsoil stockpile being stored along the southern area and is being temporarily stabilized with equipment tracking.

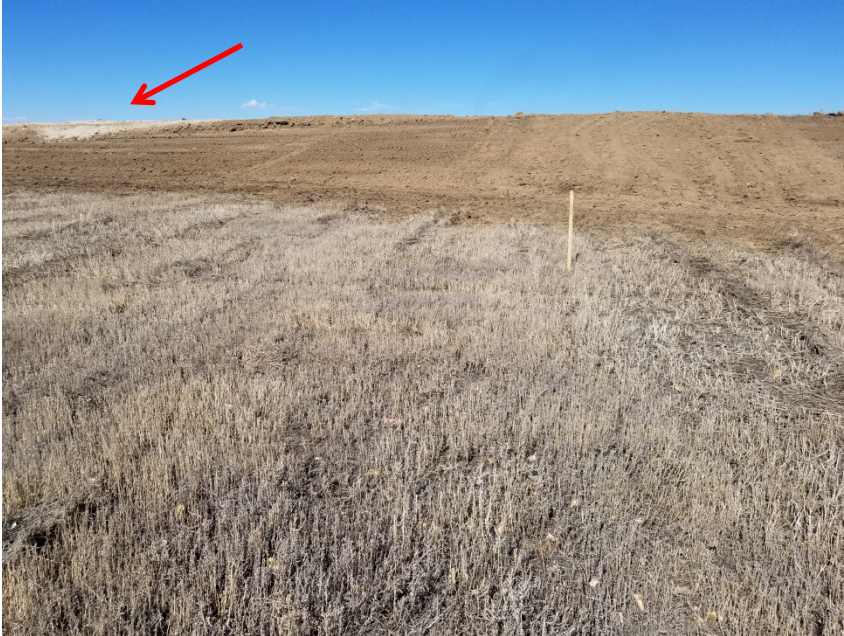
Photo 11. Photo taken from the southern perimeter of the location, facing North. Photo illustrates the second topsoil stockpile being stored along the southern area. Note the soil color change in the left of the photo. Appears the Operator was placing subsoil on top of the topsoil stockpile.

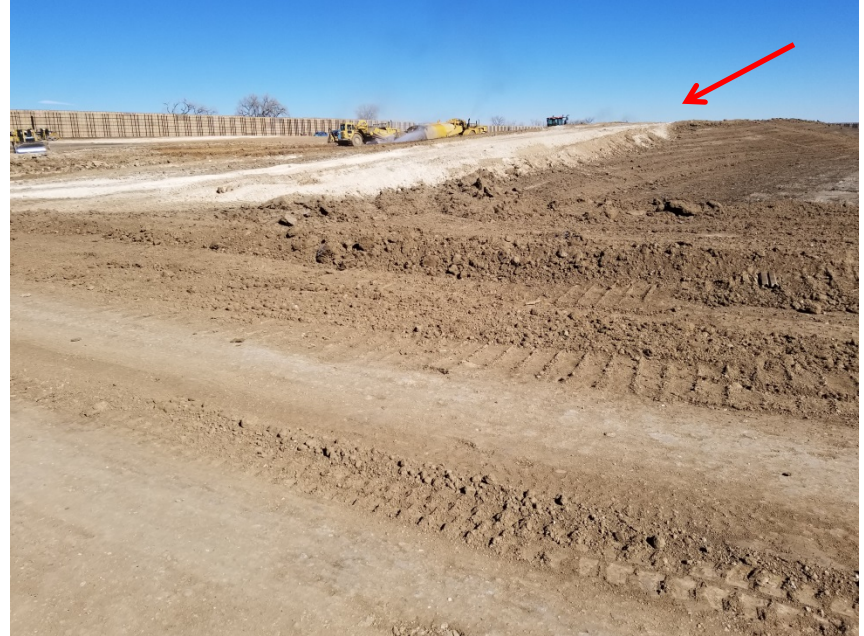
Photo 12. Photo taken from the western perimeter of the location, facing Northeast. See comments from Photo 11.

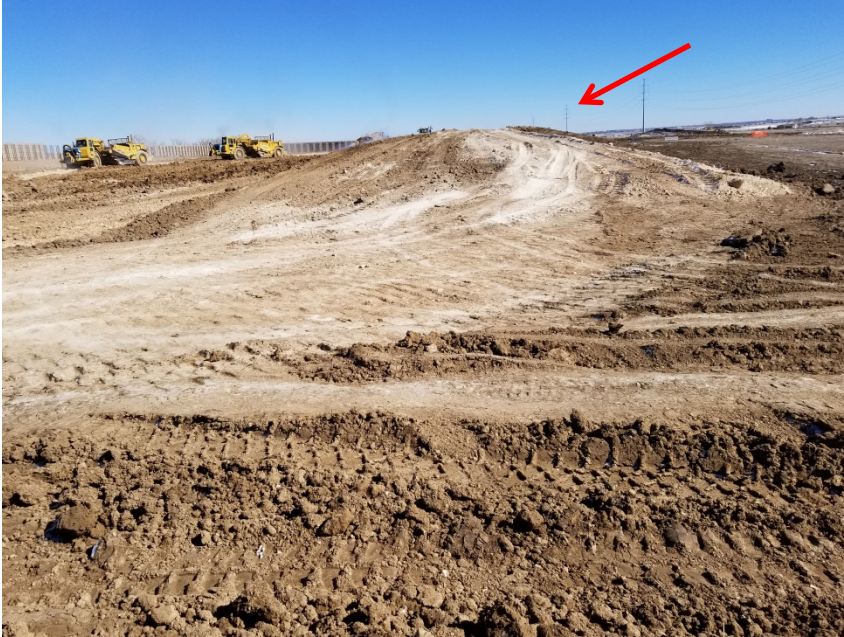
Photo 13. Photo taken from the western perimeter of the location, facing East. See comments from Photo 11.

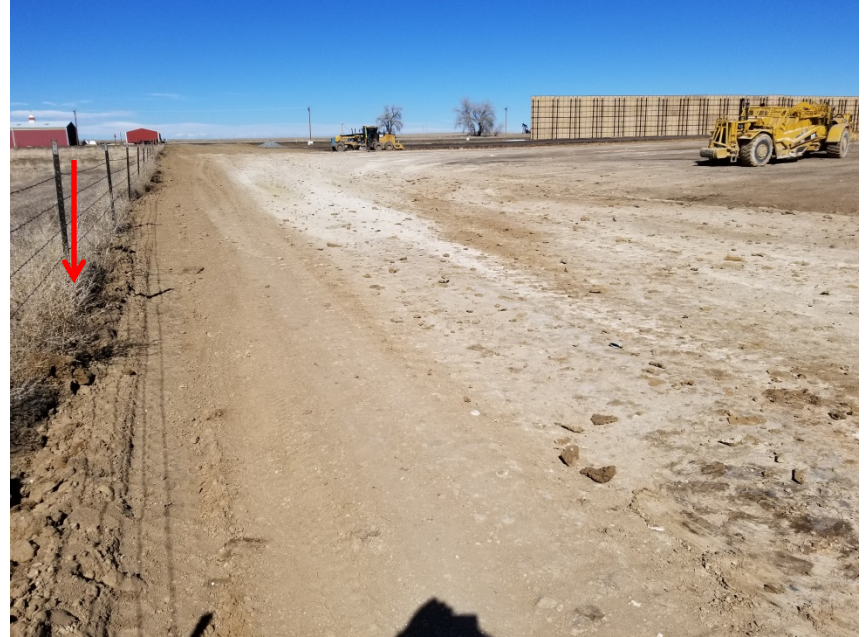
Photo 14. Photo taken from the western perimeter of the location, facing North. Photo depicts BMP's have not been installed around the entire perimeter of the location and note the wetland on the left in the Photo.

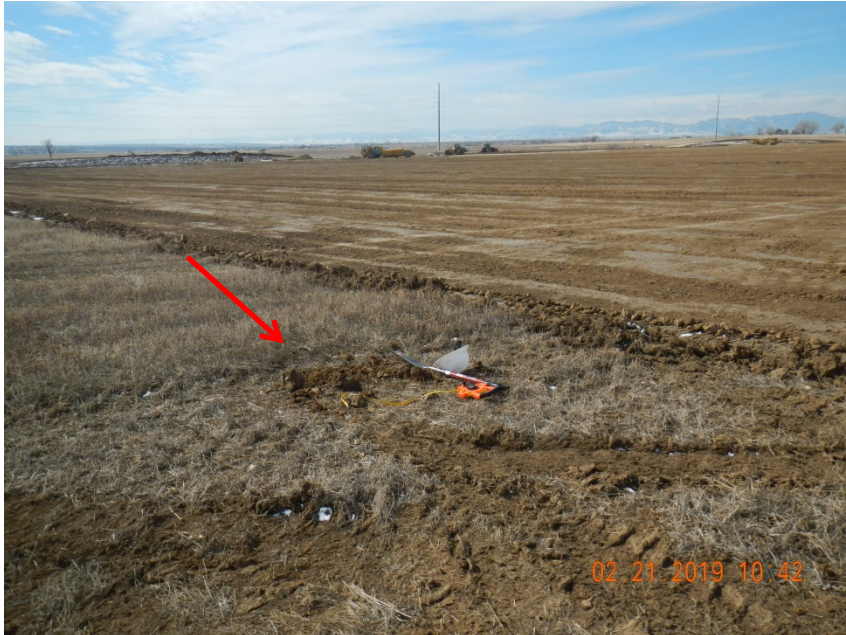
Photo 15. Photo taken from the eastern perimeter of the location, facing Southwest. Photo depicts 1 of 2 topsoil test pits excavated on location in the undisturbed area. Topsoil averaged approximately 9 inches observed across all test pits.

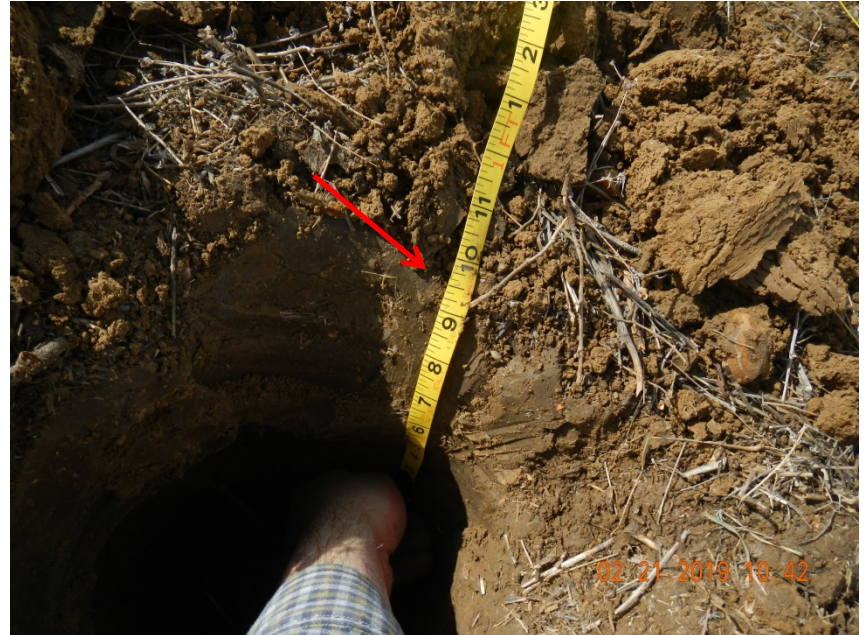
Photo 16. Photo taken from the eastern perimeter of the location. See comments from Photo 15.

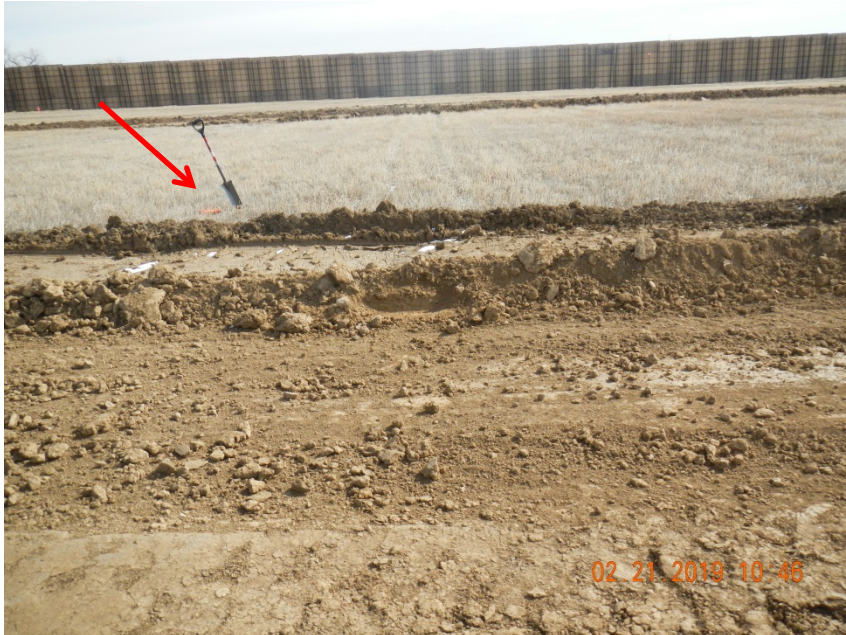
Photo 17. Photo taken from the eastern perimeter of the location, facing East. Photo depicts 2 of 2 topsoil test pits excavated on location in the undisturbed area. Topsoil averaged approximately 9 inches observed across all test pits.

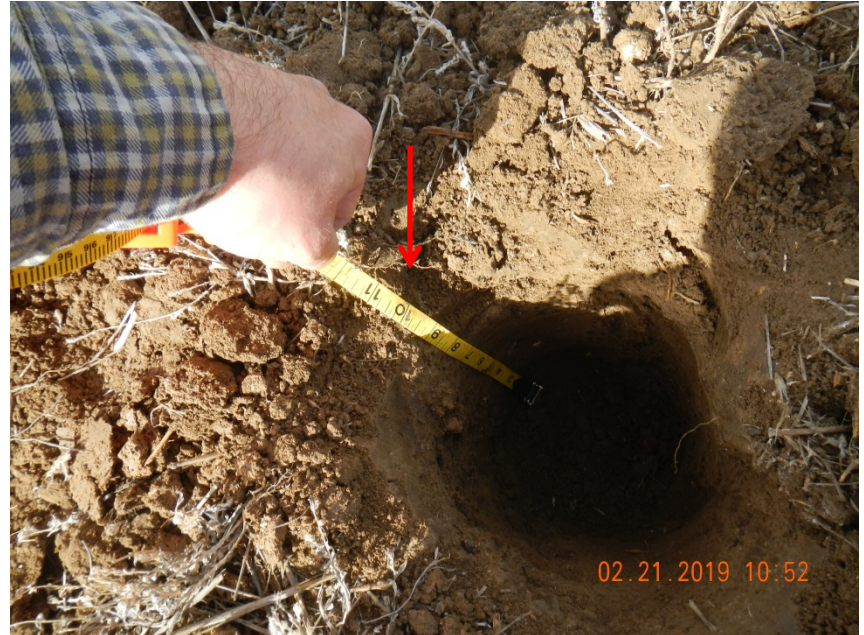
Photo 18. Photo taken from the eastern perimeter of the location. See comments from Photo 17.

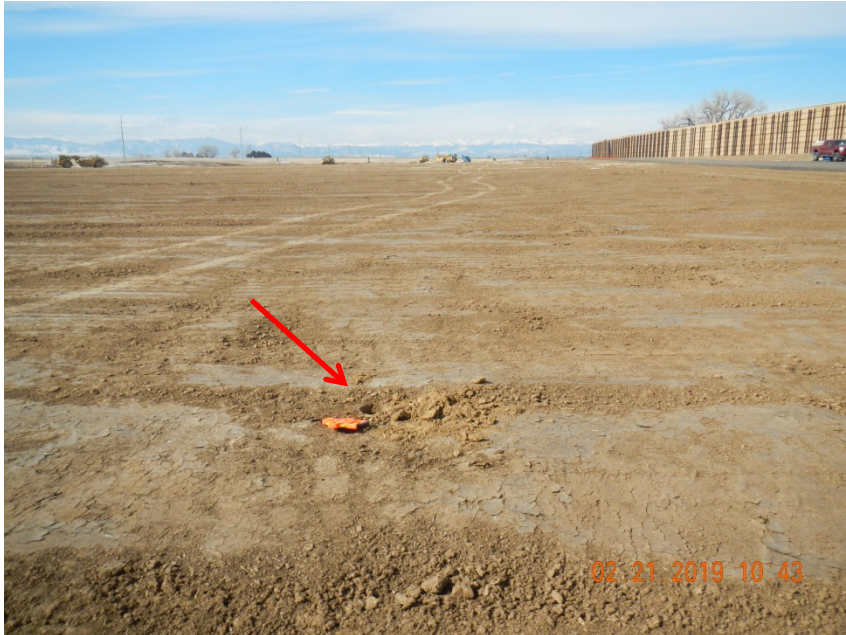
Photo 19. Photo taken from the eastern perimeter of the location, facing Southwest. Photo depicts 1 of 3 topsoil test pits taken on location in the disturbed area that topsoil salvage operations were said to be complete by the Operator.

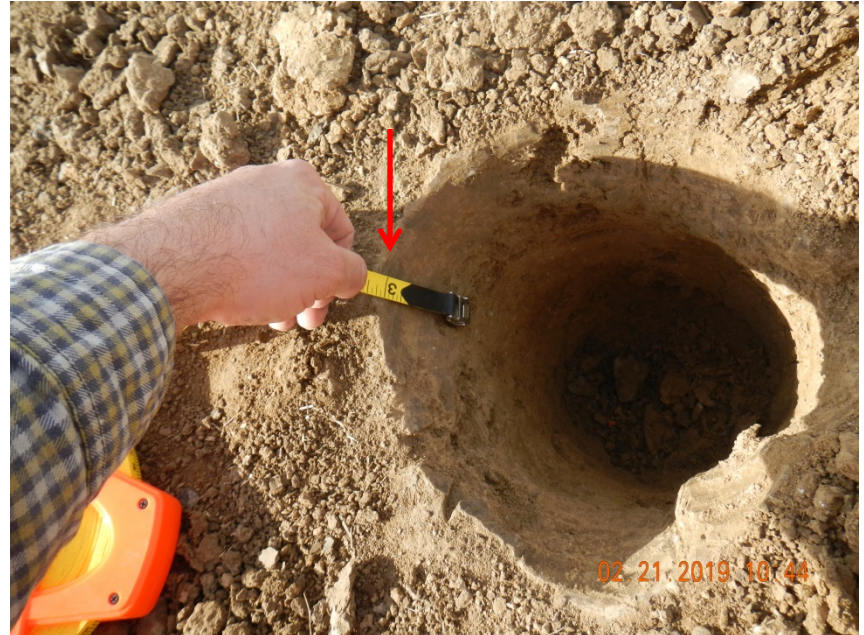
Photo 20. Photo taken from the eastern perimeter of the location. Photo depicts approximately 3 inches of top soil remaining in pit 1 of 3 within the disturbed area that topsoil salvage operations were said to be complete by the Operator.

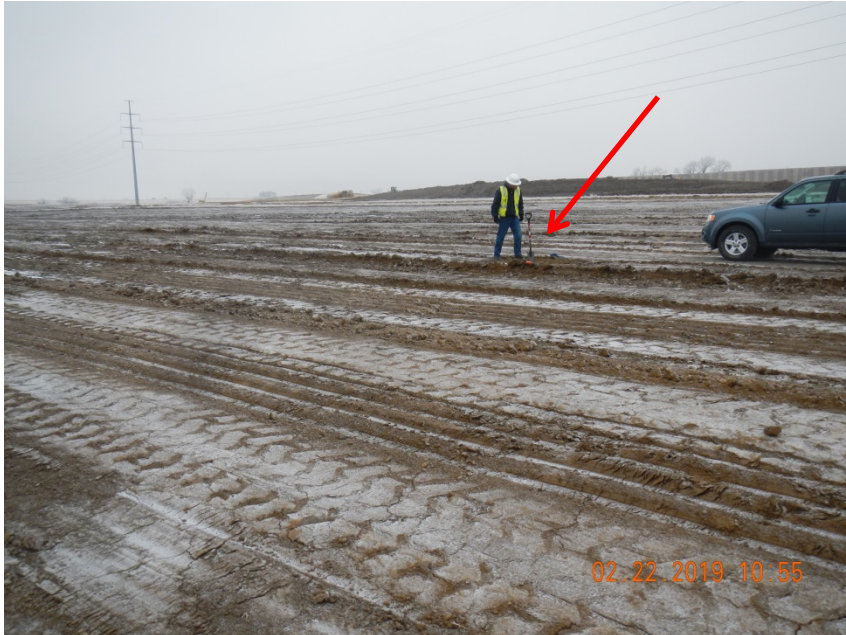
Photo 21. Photo taken from the southern perimeter of the location, facing Southwest. Photo depicts 3 of 3 topsoil test pits taken on location in the disturbed area that topsoil salvage operations were said to be complete by the Operator.

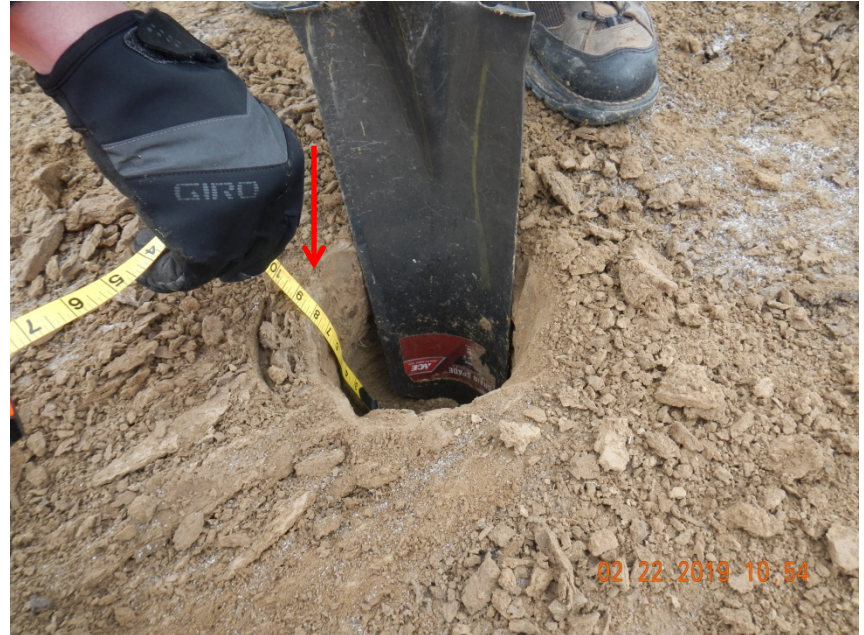
Photo 22. Photo taken from the eastern perimeter of the location. Photo depicts approximately 8 inches of top soil remaining in pit 3 of 3 within the disturbed area that topsoil salvage operations were said to be complete by the Operator.

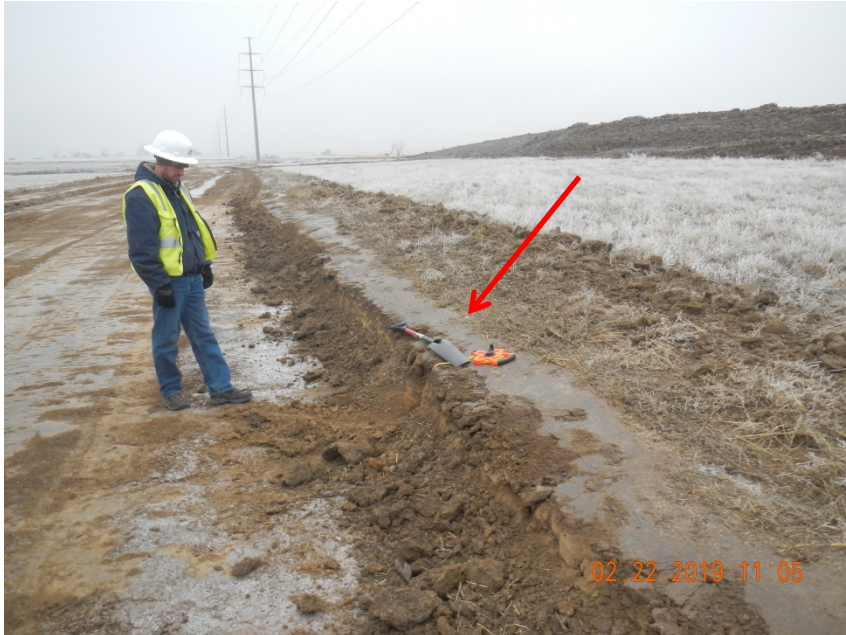
Photo 23. Photo taken from the southern perimeter of the location, facing West. Photo depicts a cut area where topsoil salvage operations were had been done by the Operator.

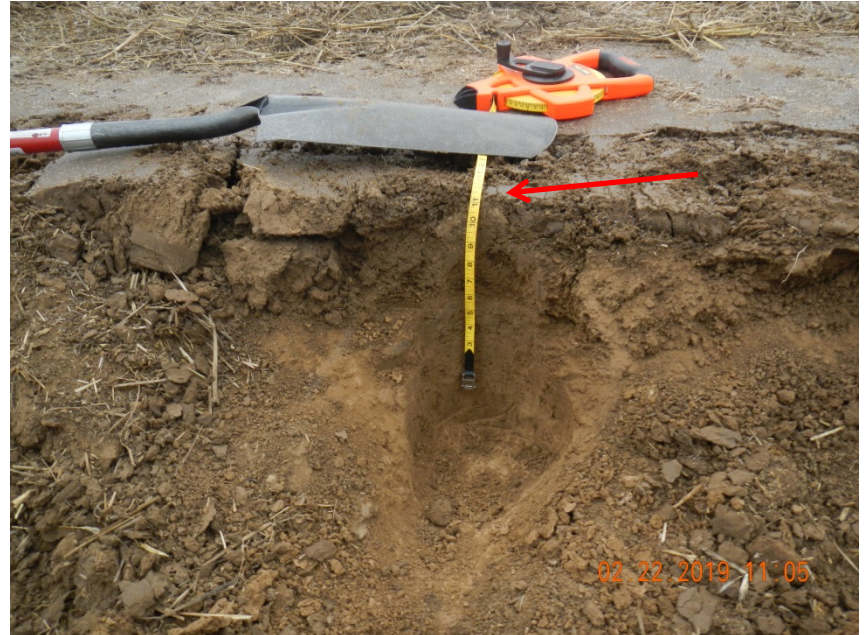
Photo 24. Photo taken from the eastern perimeter of the location. Photo depicts a topsoil depth of approximately 11 inches observed.

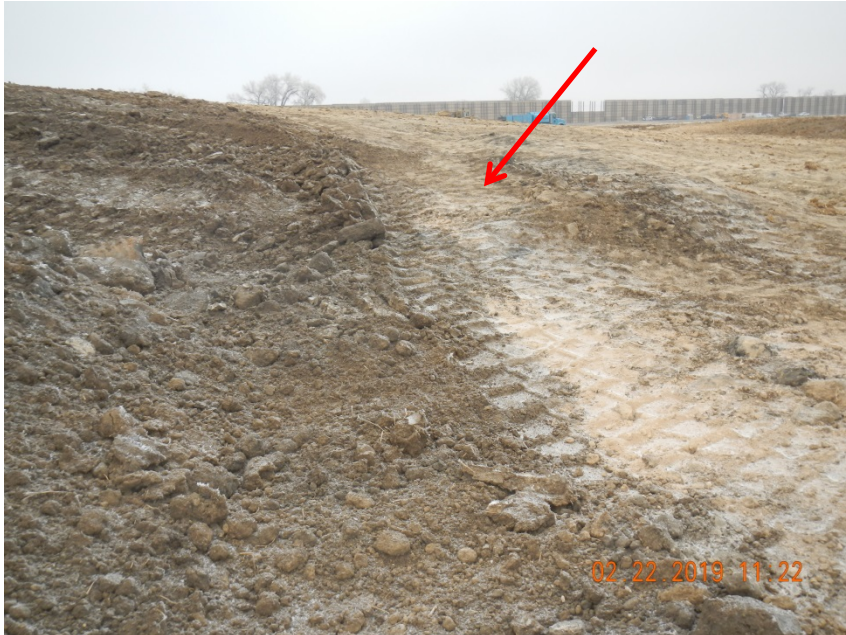
Photo 25. Photo taken from the southern perimeter of the location, facing North. Photo illustrates the second topsoil stockpile being stored along the southern area. Appears the Operator was still placing subsoil on top of the topsoil stockpile as of 2/22/2019.

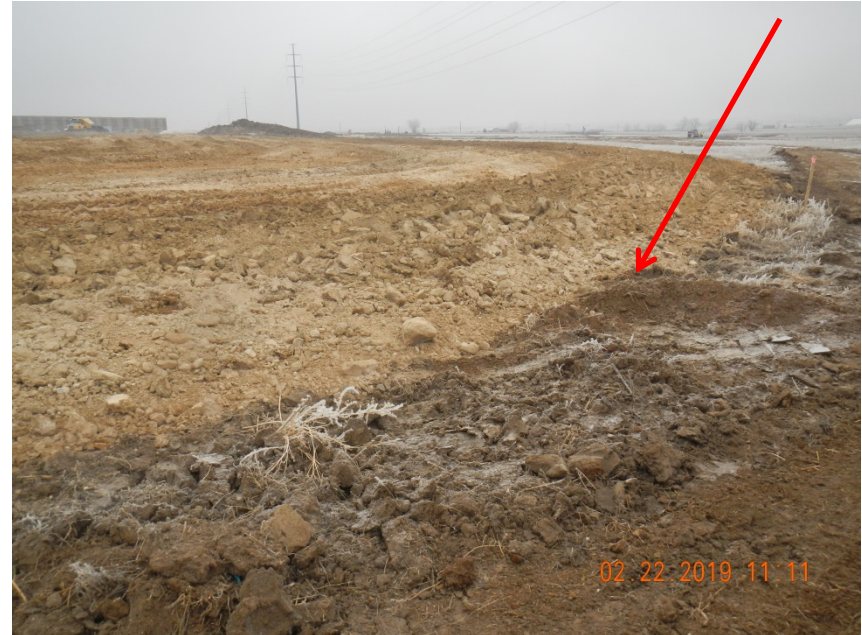
Photo 26. Photo taken from the southern perimeter of the location, facing North. Photo illustrates the area adjacent to the second topsoil stockpile being stored along the southern area. Note the soil color changes from the subsoil in the background to the topsoil in the foreground.

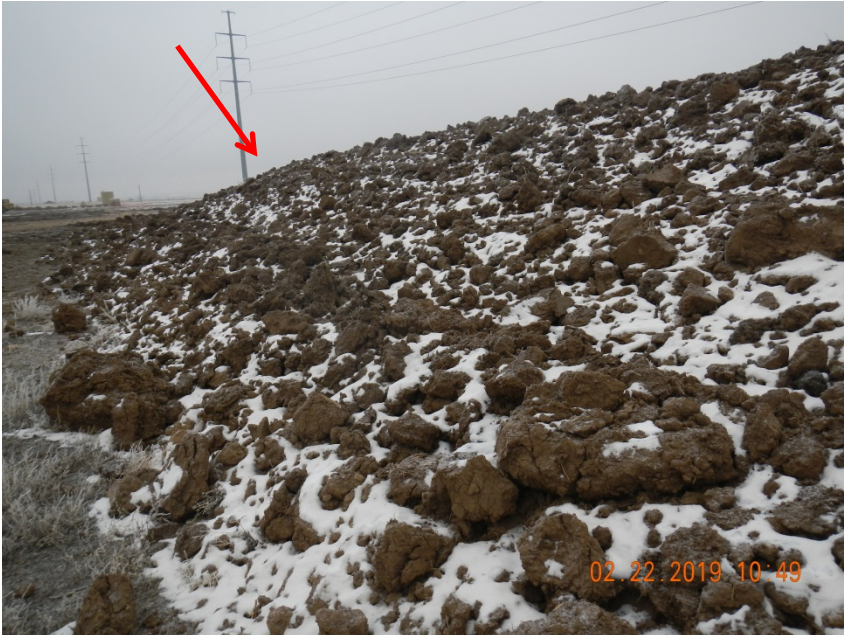
Photo 27. Photo taken from the southern perimeter of the location, facing East. Photo illustrates the first topsoil stockpile being stored along the southern area. Appears the Operator has not stabilized parts of the stockpile.

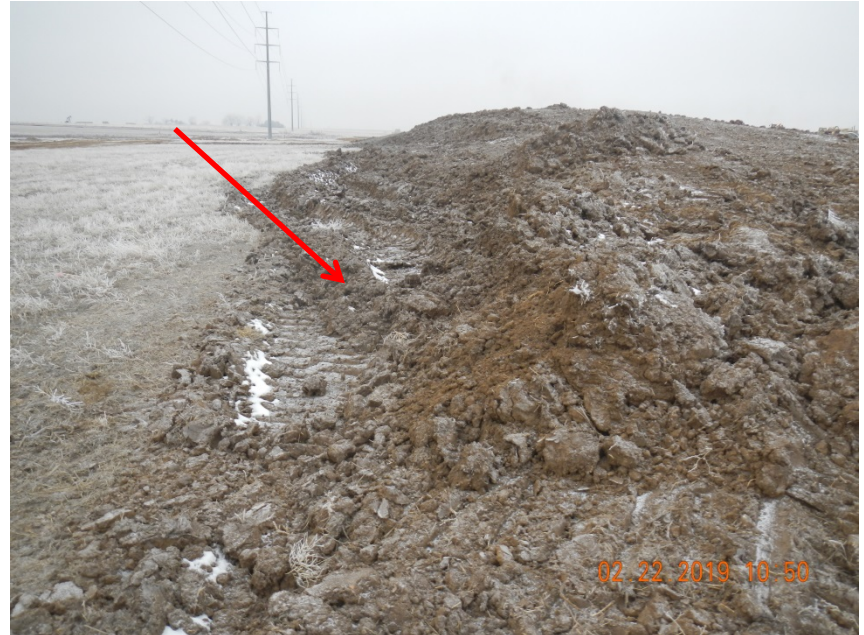
Photo 28. Photo taken from the southern perimeter of the location, facing West. Photo illustrates the first topsoil stockpile being stored along the southern area. Appears the Operator has not stabilized parts of the stockpile.
