Inspection Photos

Operator: NOBLE ENERGY INC - 100322

Location ID: 432189

Inspection Doc. Number: 682504529

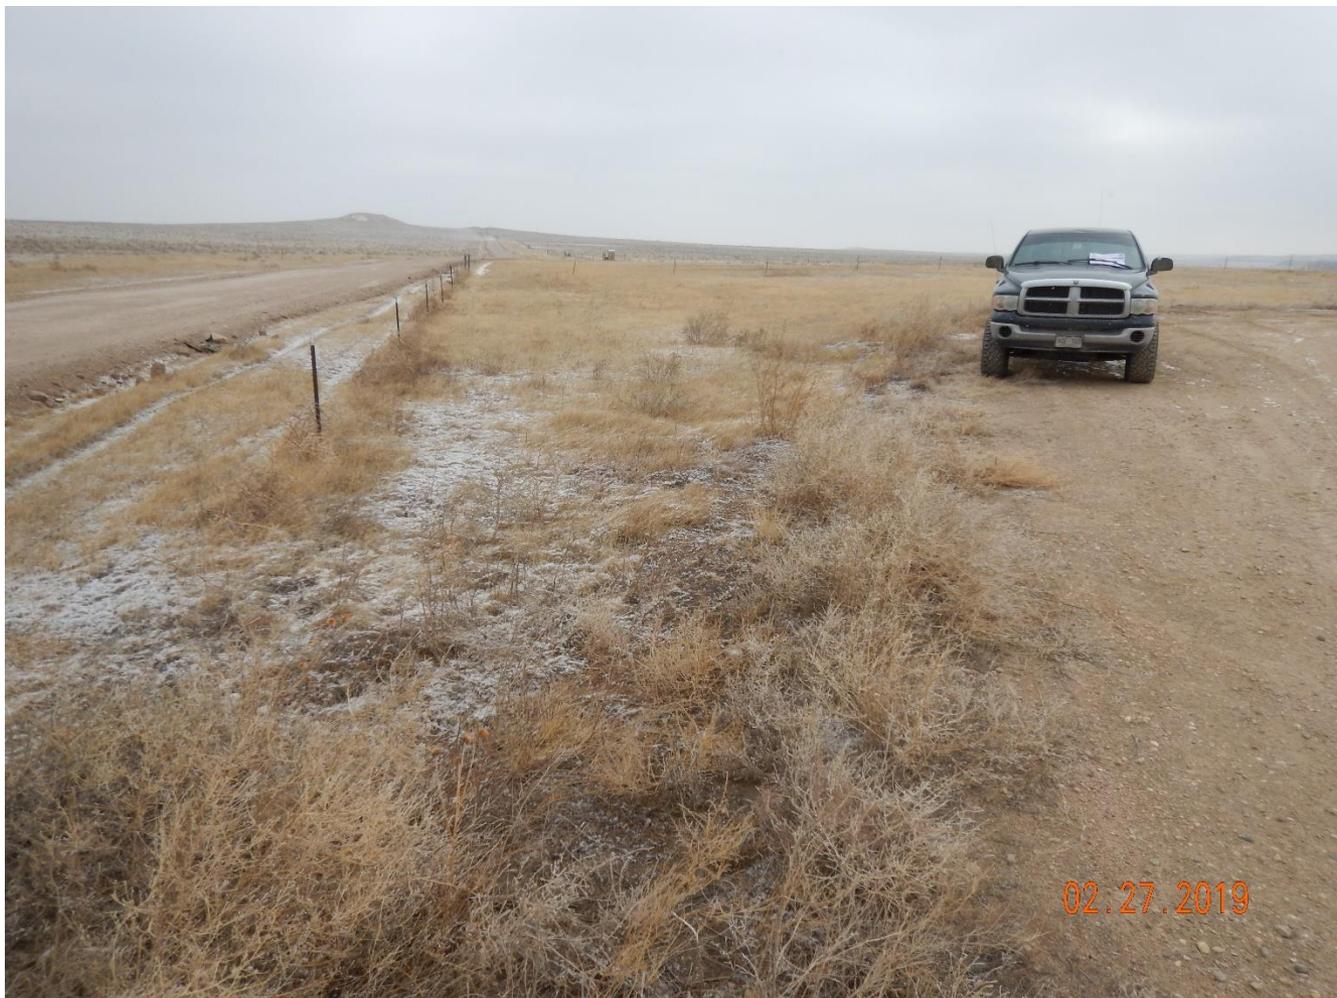
Photo 1: Photo taken from the north end of the location, facing east. Photo 1-4 provide an overview of the location (interim and production areas) from east, southeast, southwest to west.

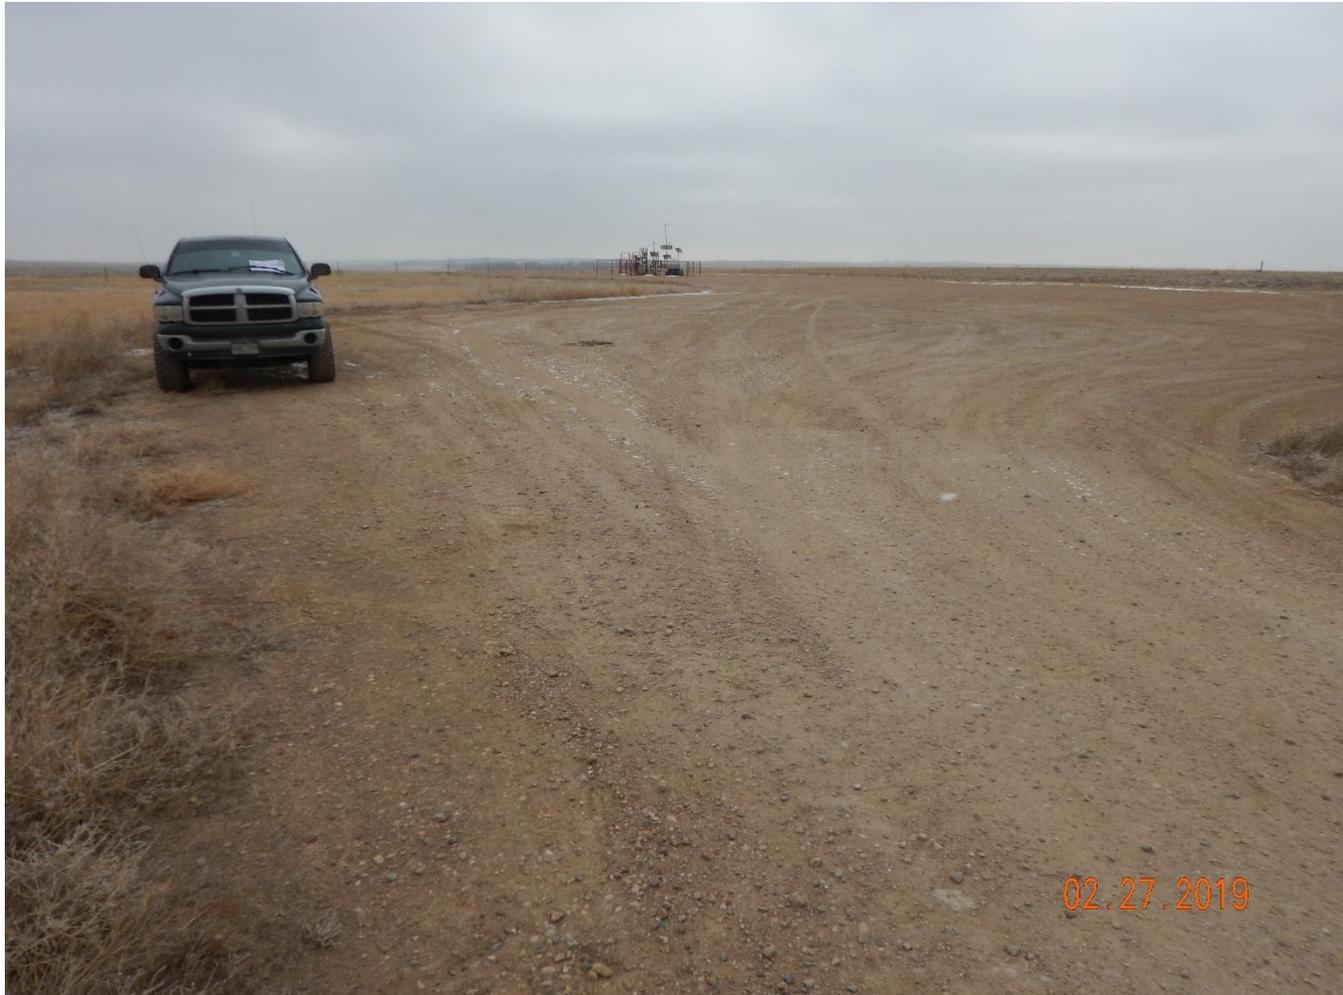
Photo 2: See comments under photo 1.

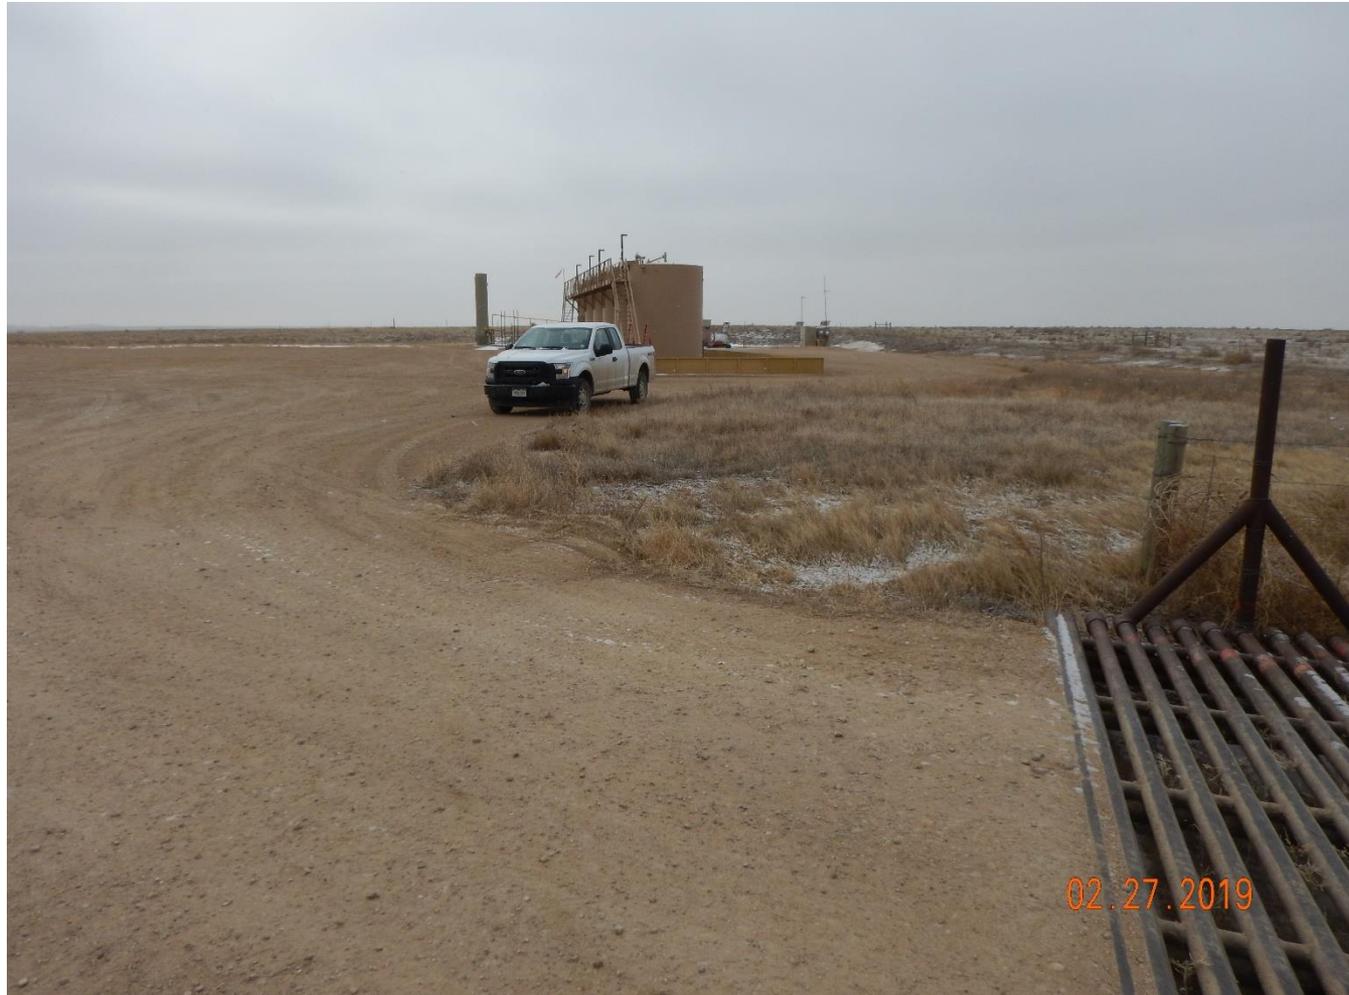
Photo 3: See comments under photo 1.

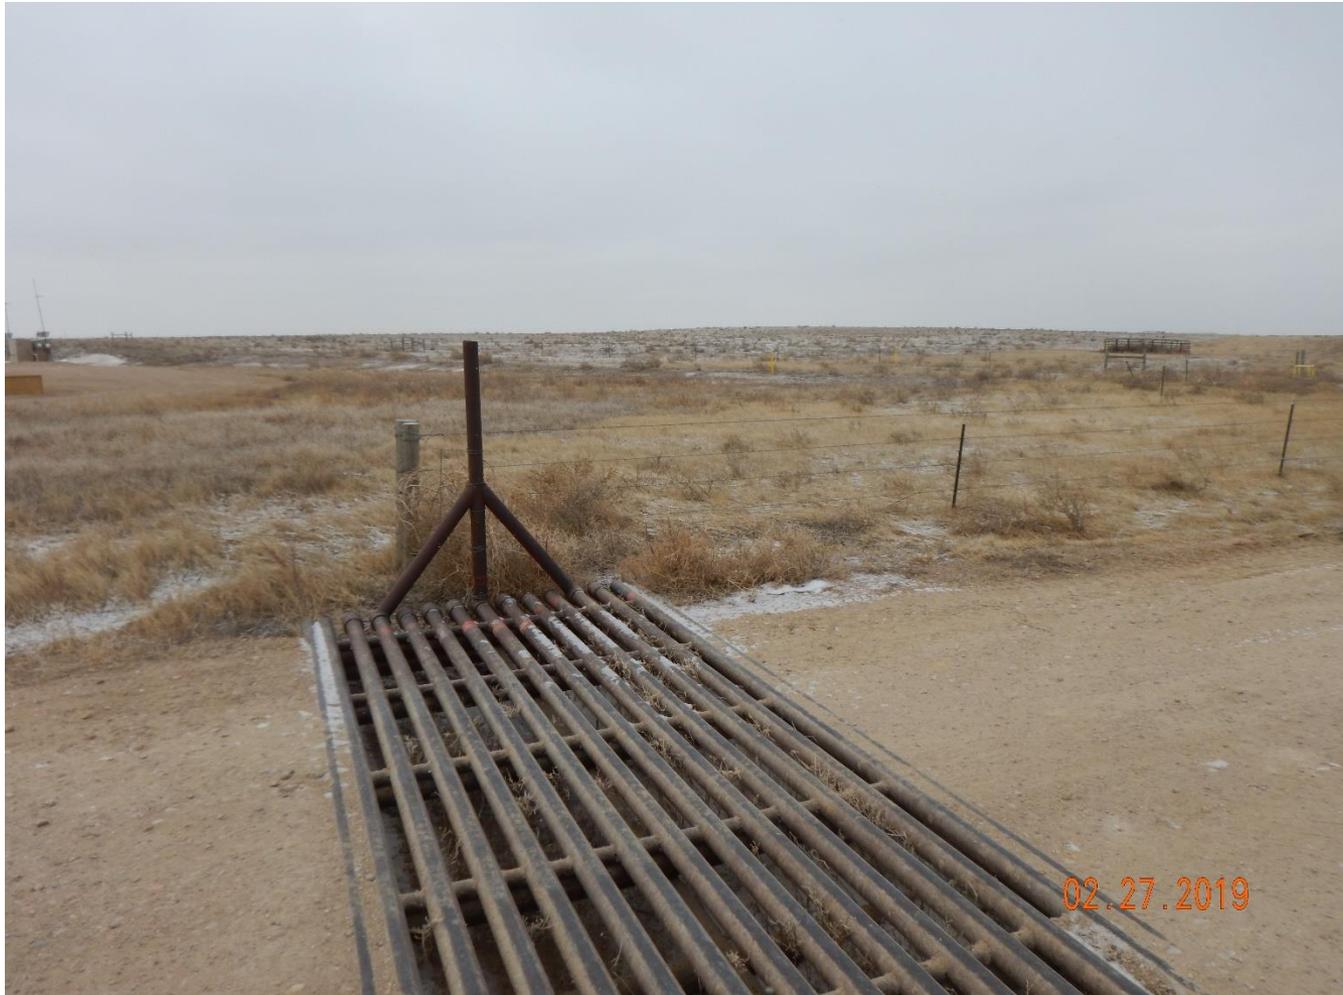
Photo 4: See comments under photo 1.

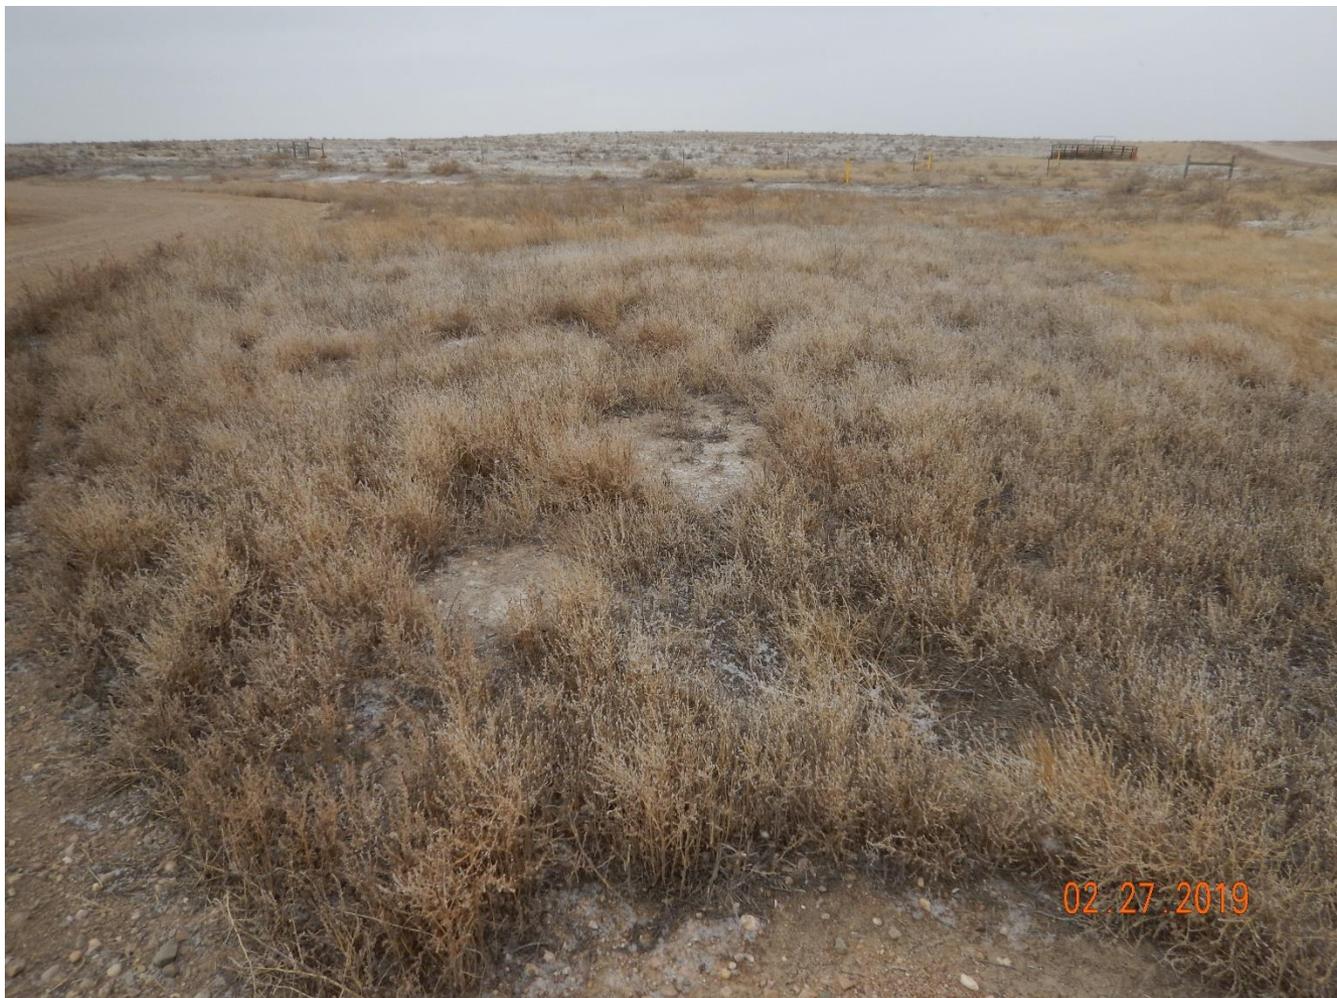
Photo 5: Photo taken from the northwest end of the location, facing west. Photo shows interim areas of the location are predominantly bare and exposed soil, or undesirable weedy plant species such as Kochia and Salsola sp. Areas are not progressing towards reclamation requirements.

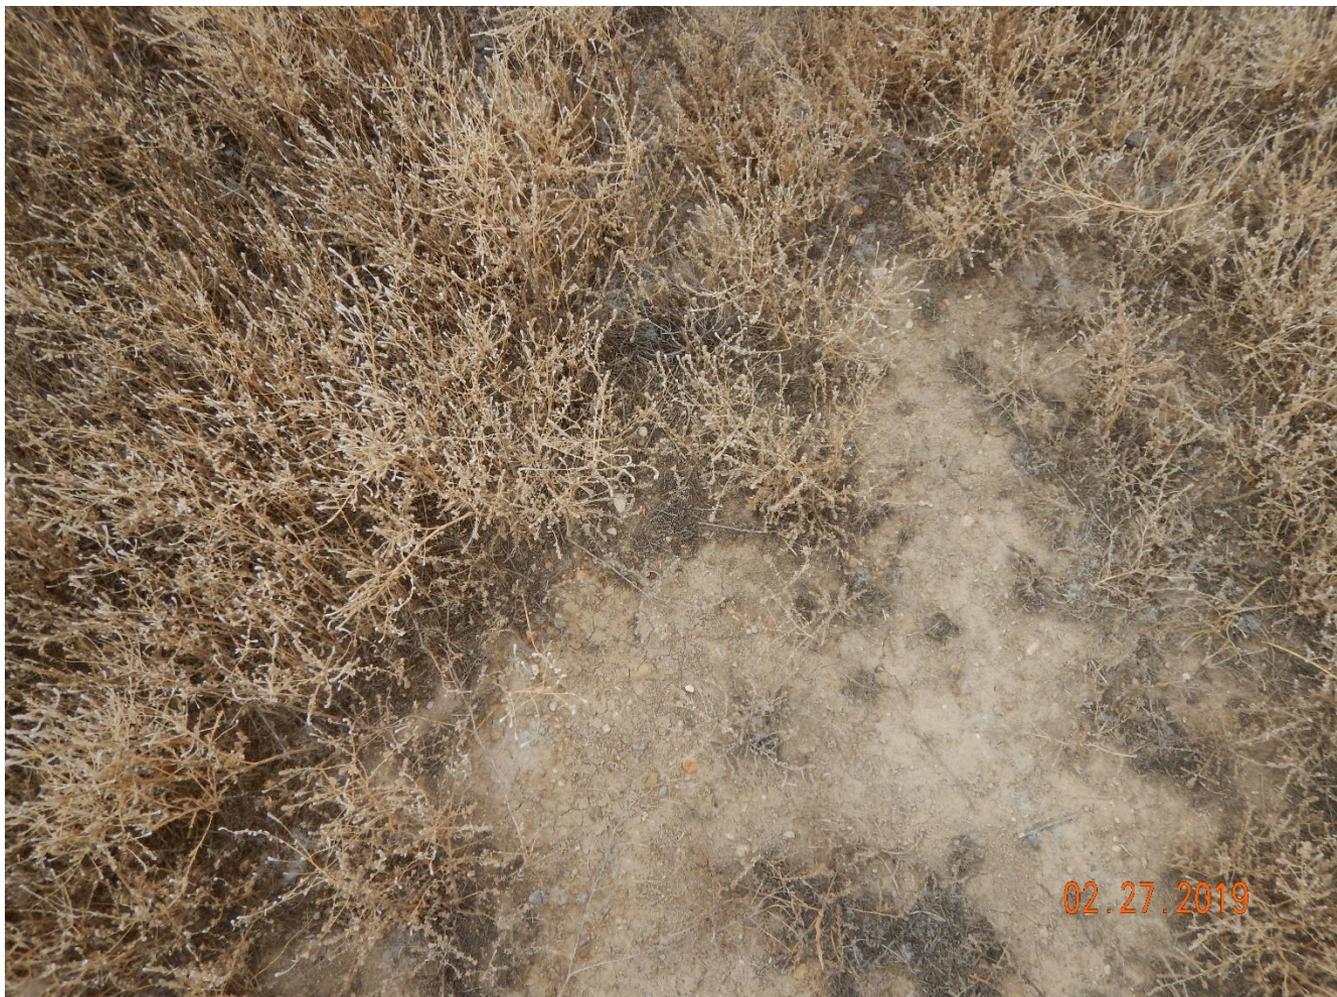
Photo 6: Photo taken from the northwest end of the location. Photo shows interim areas of the location are predominantly bare and exposed soil, or undesirable weedy plant species such as Kochia and Salsola sp. Areas are not progressing towards reclamation requirements.

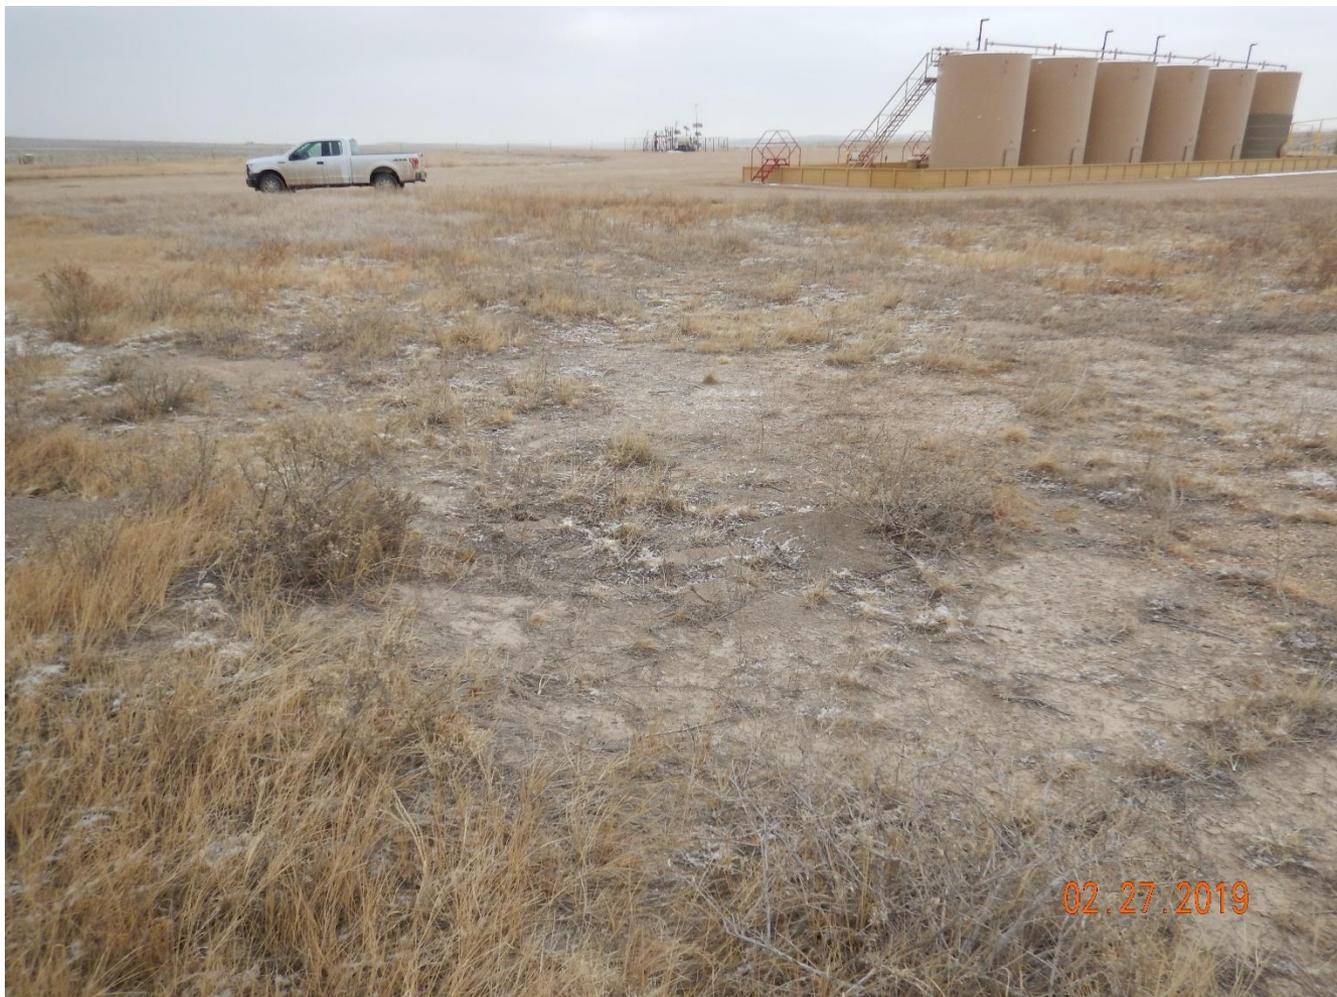
Photo 7: Photo taken from the northwest end of the location, facing southeast. Photo shows interim areas of the location are predominantly bare and exposed soil, or undesirable weedy plant species such as Kochia and Salsola sp. Areas are not progressing towards reclamation requirements.

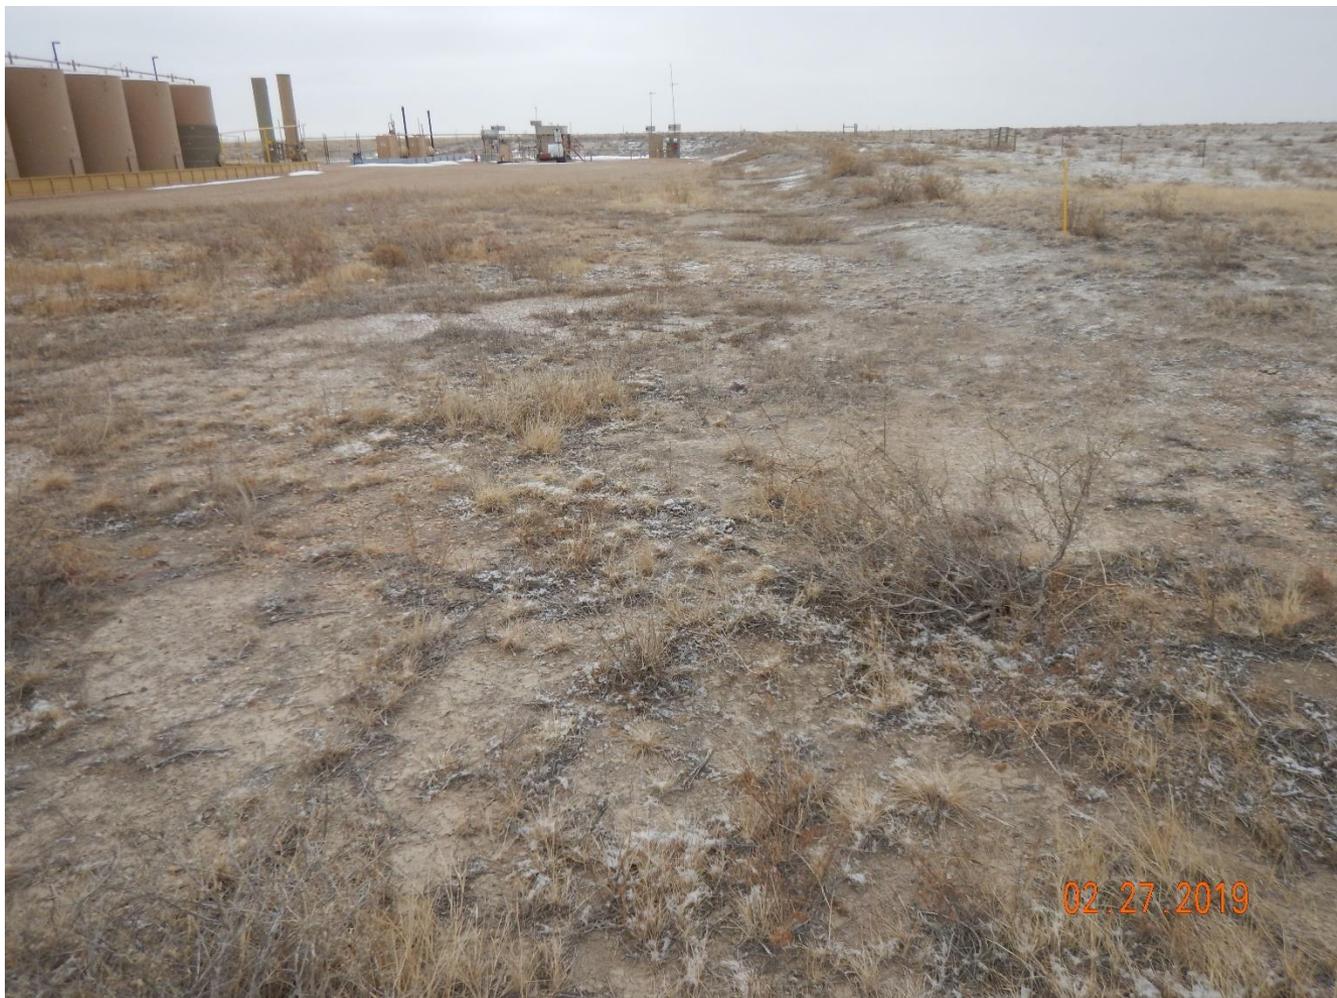
Photo 8: Photo taken from the northwest end of the location, facing south. Photo shows interim areas of the location are predominantly bare and exposed soil, or undesirable weedy plant species such as Kochia and Salsola sp. Areas are not progressing towards reclamation requirements.

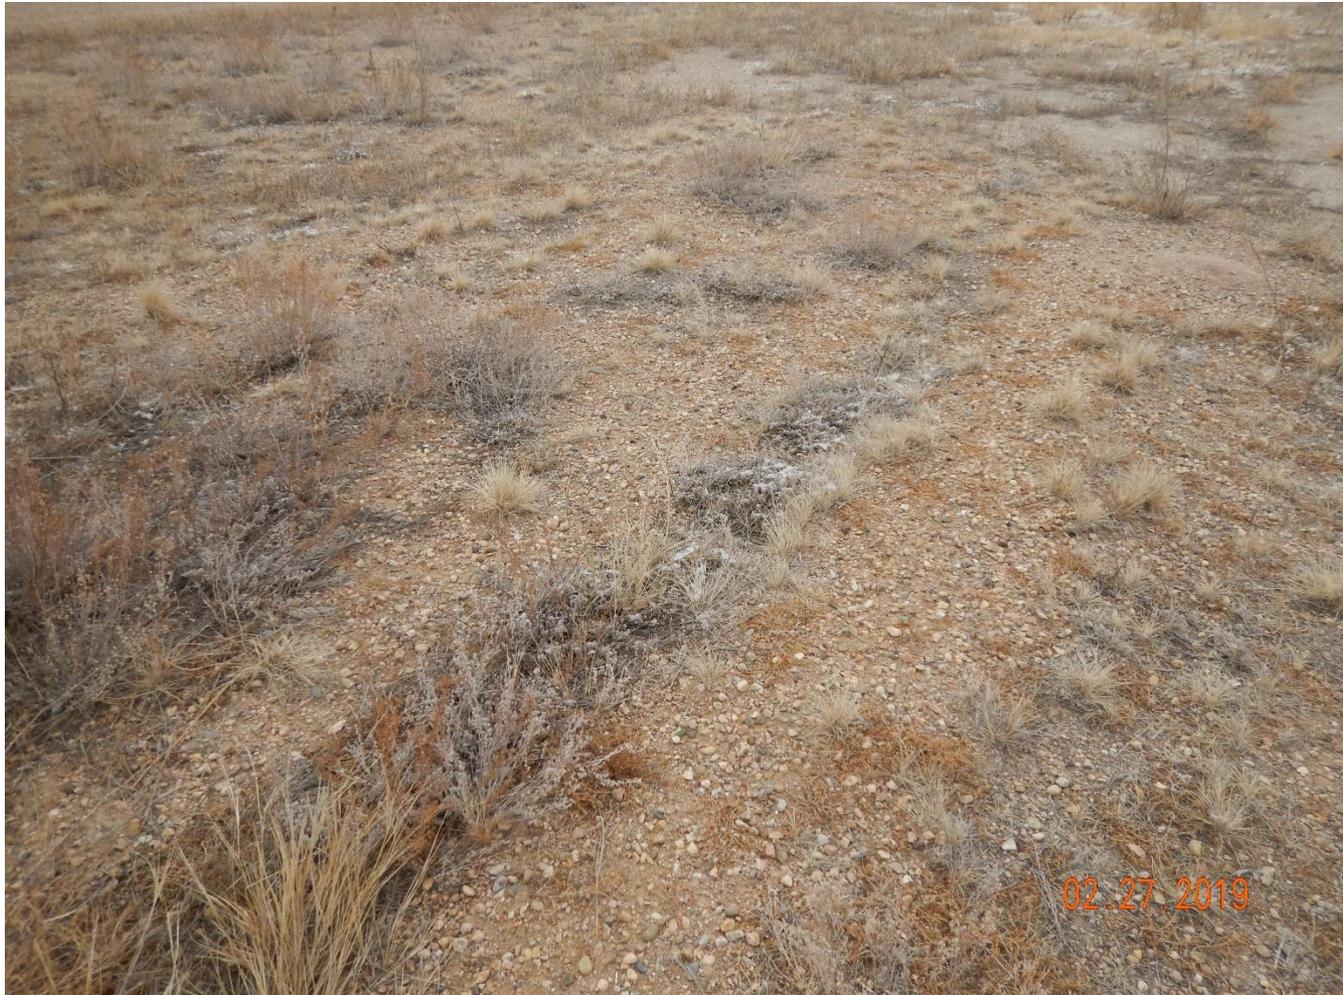
Photo 9: Photo taken from the west end of the location. Photo shows gravel/road base remains on portions of the interim areas. Gravel appears to be hindering reclamation.

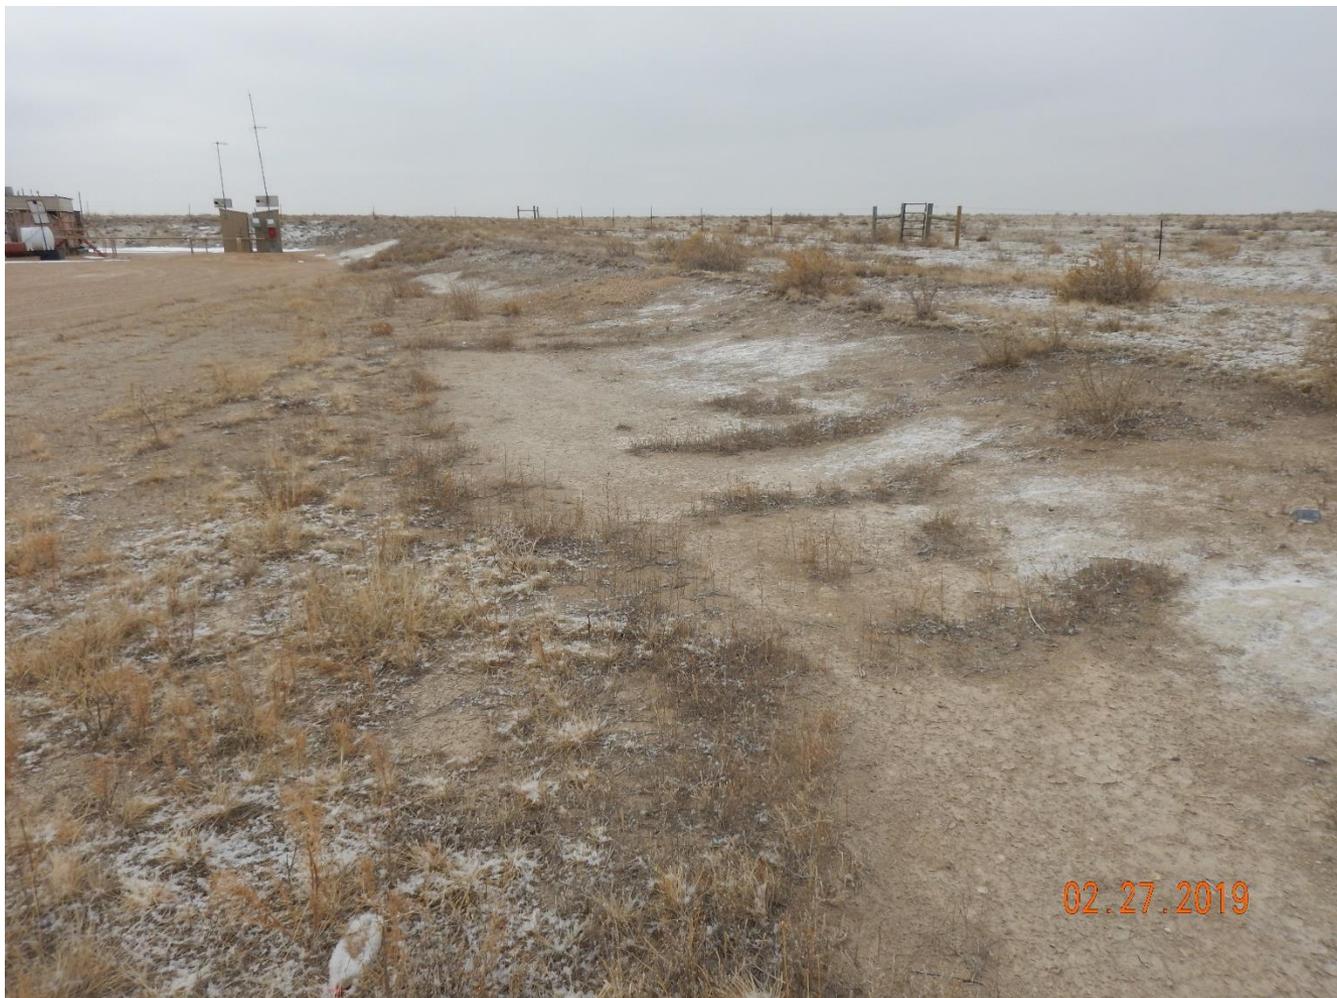
Photo 10: Photo taken from the west end of the location, facing south. Photo shows interim areas of the location are predominantly bare and exposed soil, or undesirable weedy plant species such as Kochia and Salsola sp. Areas are not progressing towards reclamation requirements.

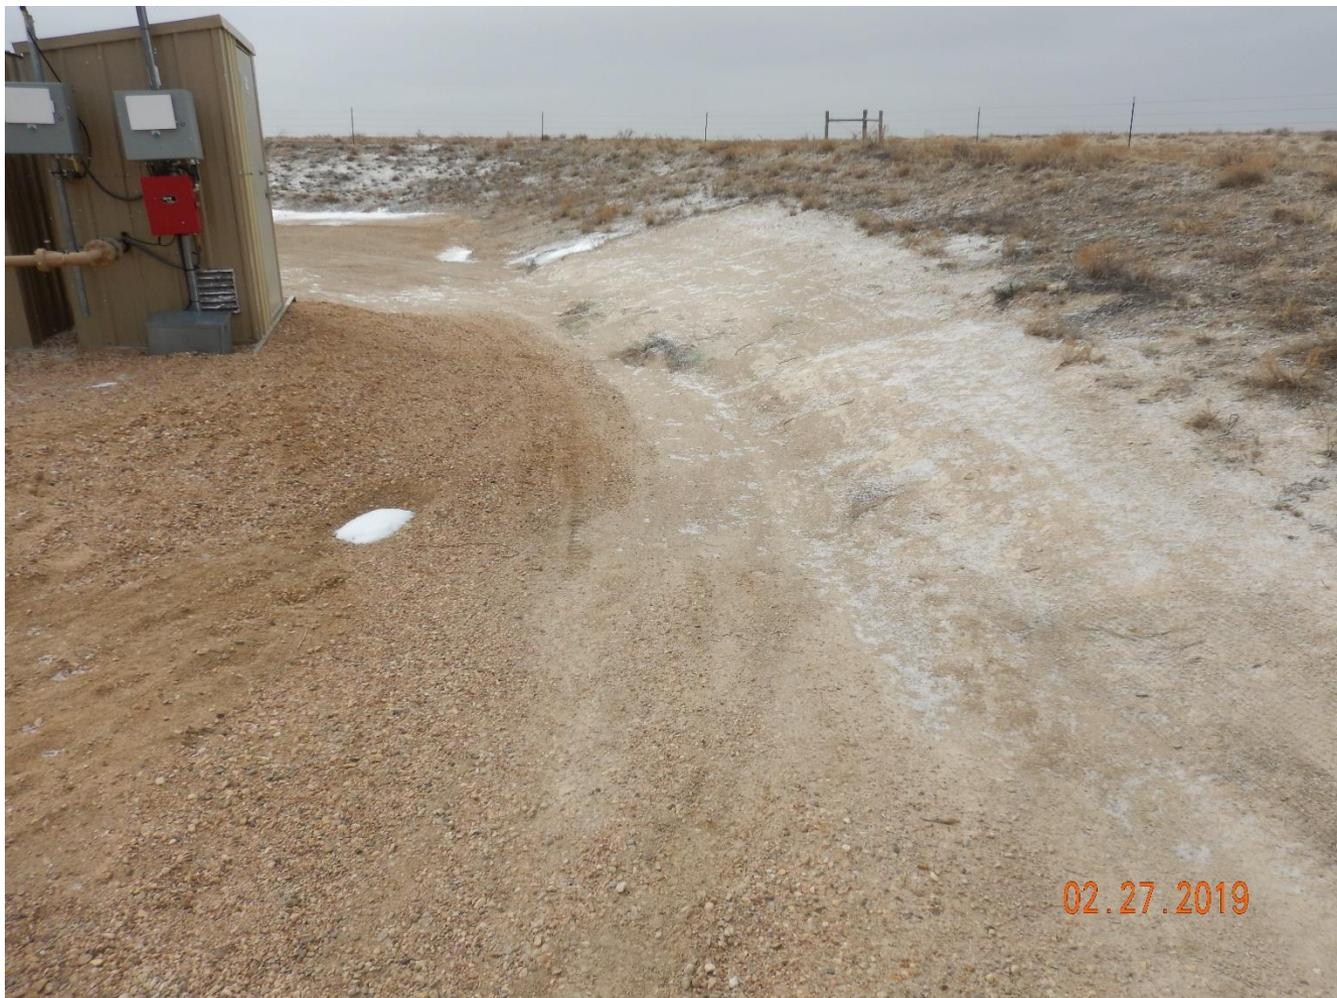
Photo 11: Photo taken from the west end of the location. Photo shows areas where operator appears to have traveled from the location onto slopes of the interim areas.

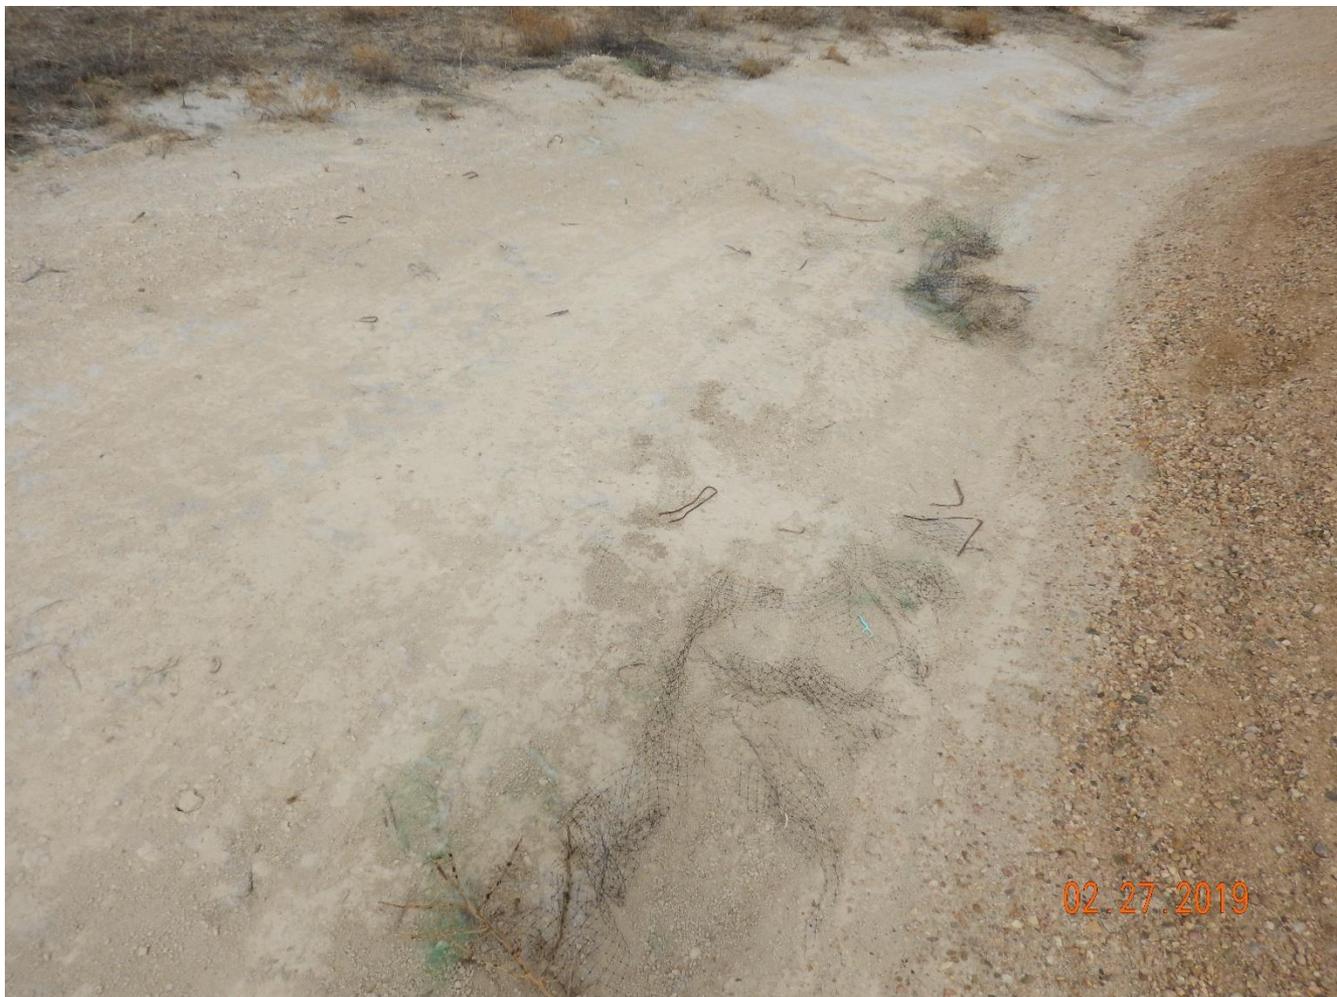
Photo 12: Photo taken from the slopes of the interim areas on the southwest end of the location. Photo shows slopes remains predominantly bare and exposed soil with little desirable perennial vegetative establishment. Photo also shows the erosion blankets/netting along slopes are in disrepair and no longer in proper functioning condition.

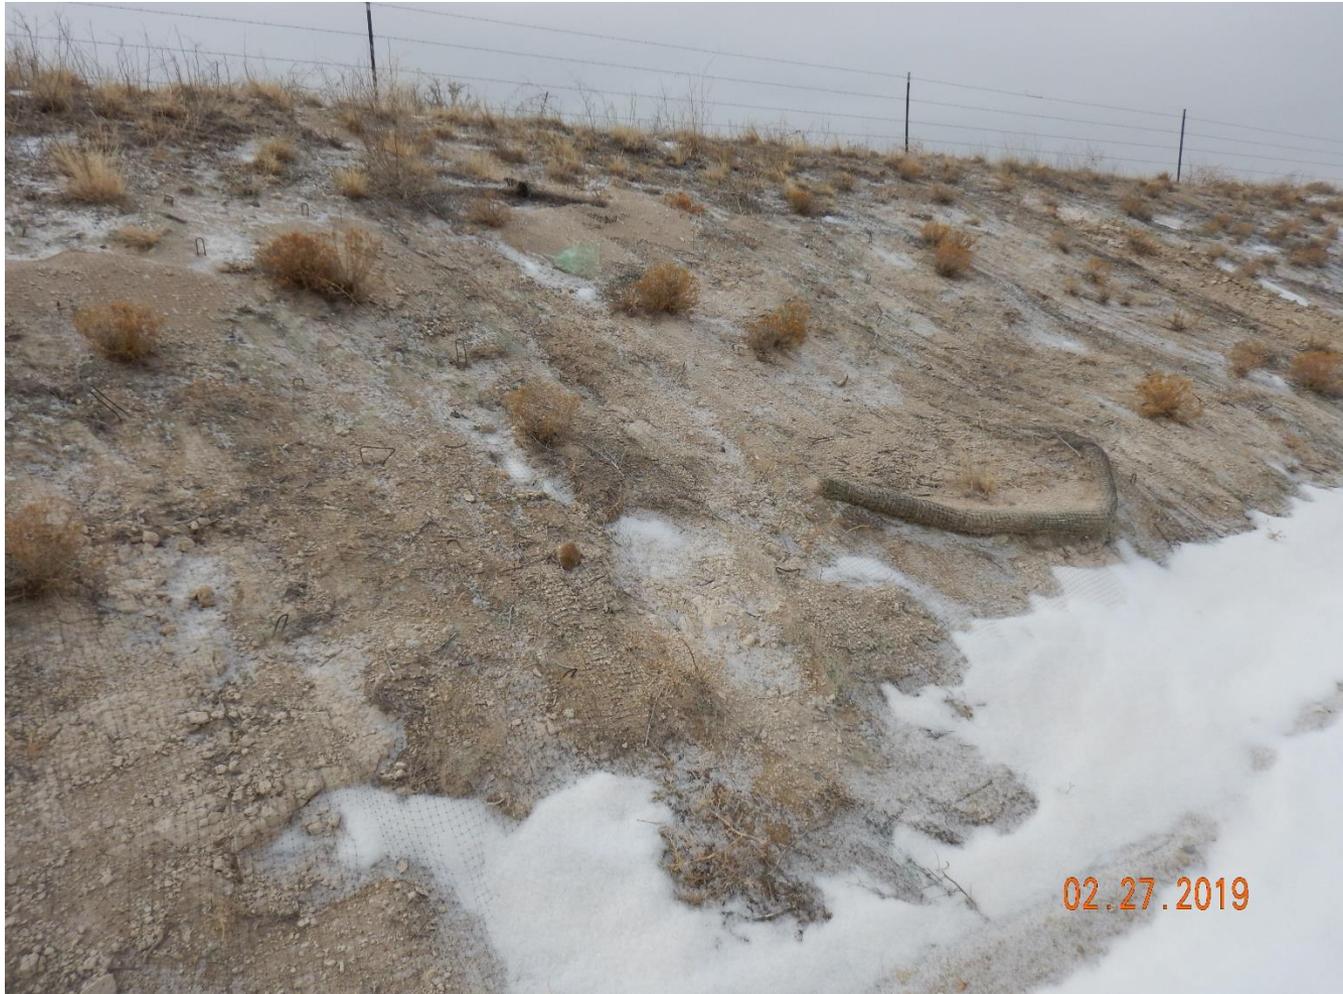
Photo 13: Photo taken from the slopes of the interim areas on the south end of the location, facing southwest. Photo shows slopes remains predominantly bare and exposed soil with little desirable perennial vegetative establishment. Photo also shows the erosion blankets/netting along slopes are in disrepair and no longer in proper functioning condition.

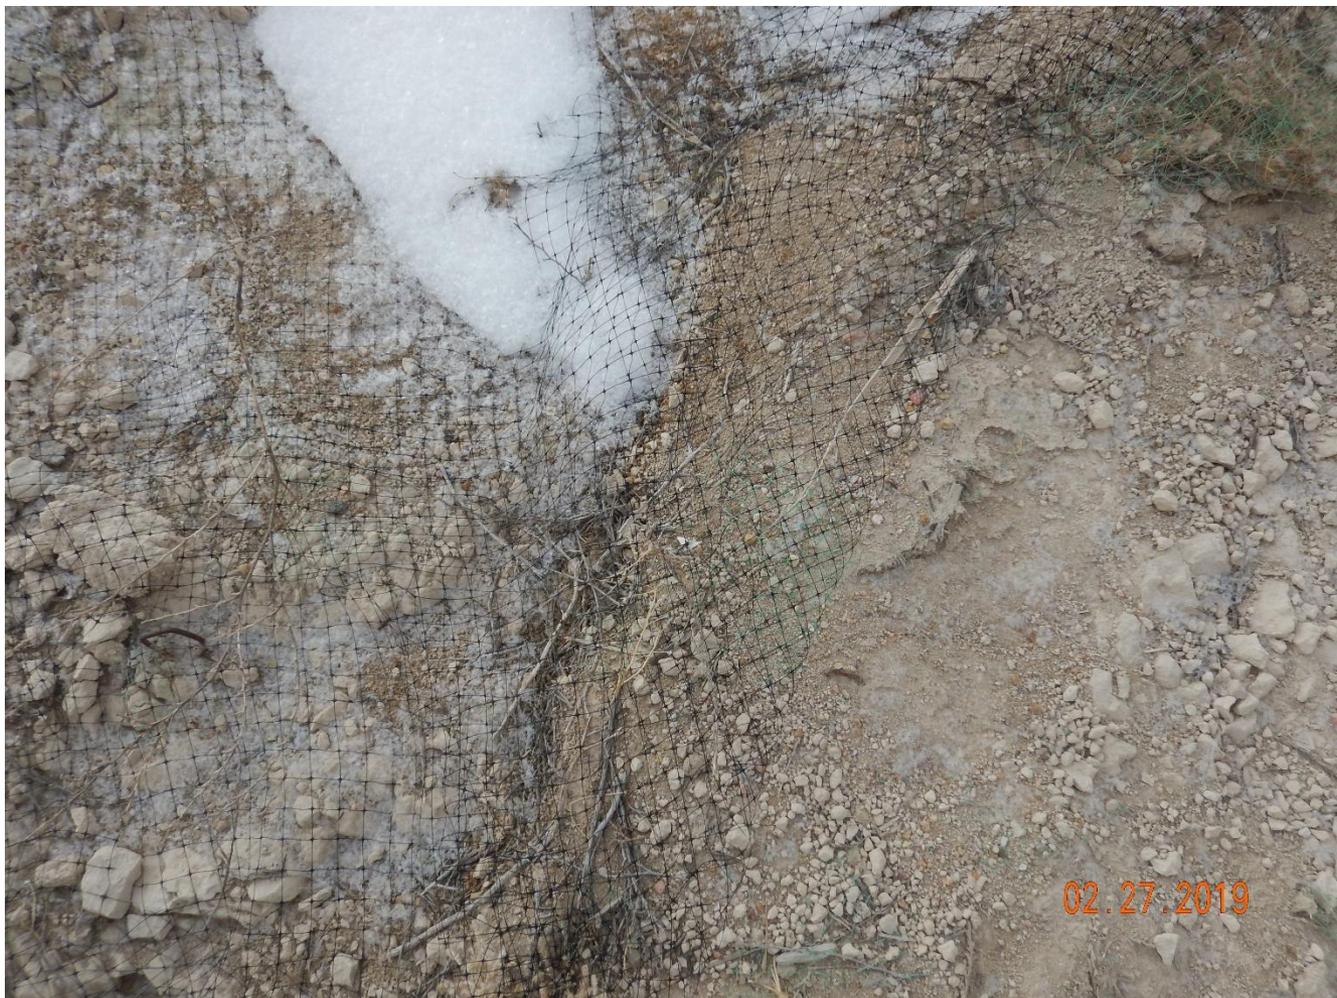
Photo 14: Photo taken from the slopes of the interim areas on the southwest end of the location. Photo shows the erosion blankets/netting along slopes are in disrepair and no longer in proper functioning condition.

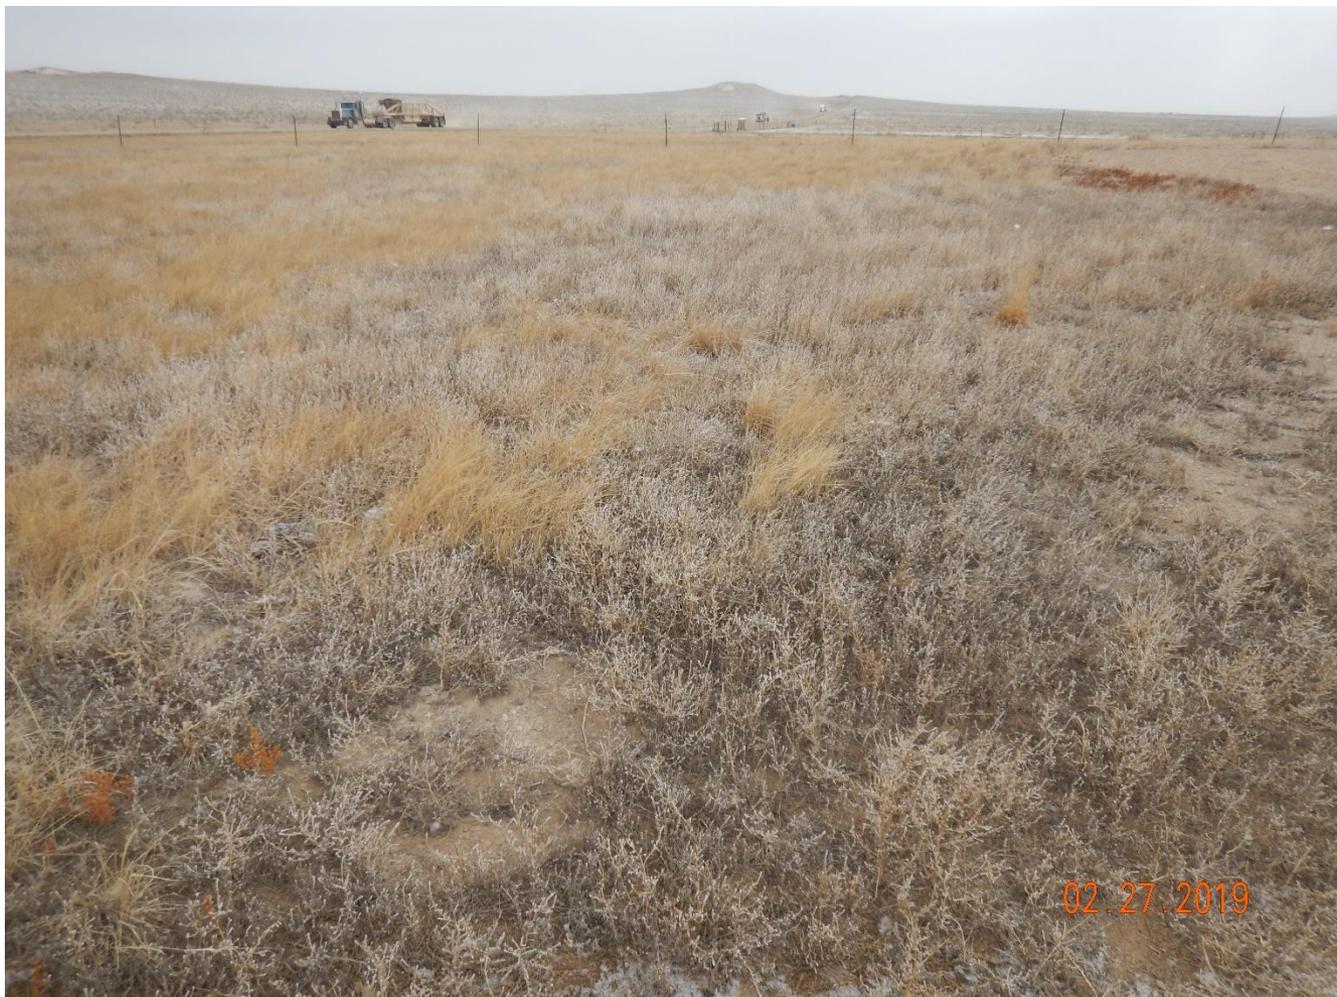
Photo 15: Photo taken from the interim areas on the northeast end of the location. Photo shows areas of the interim that are predominantly undesirable weedy plant species such as Kochia and Salsola sp.
