Inspection Photos

Operator: NOBLE ENERGY INC - 100322

Location ID: 433177

Inspection Doc. Number: 682504533

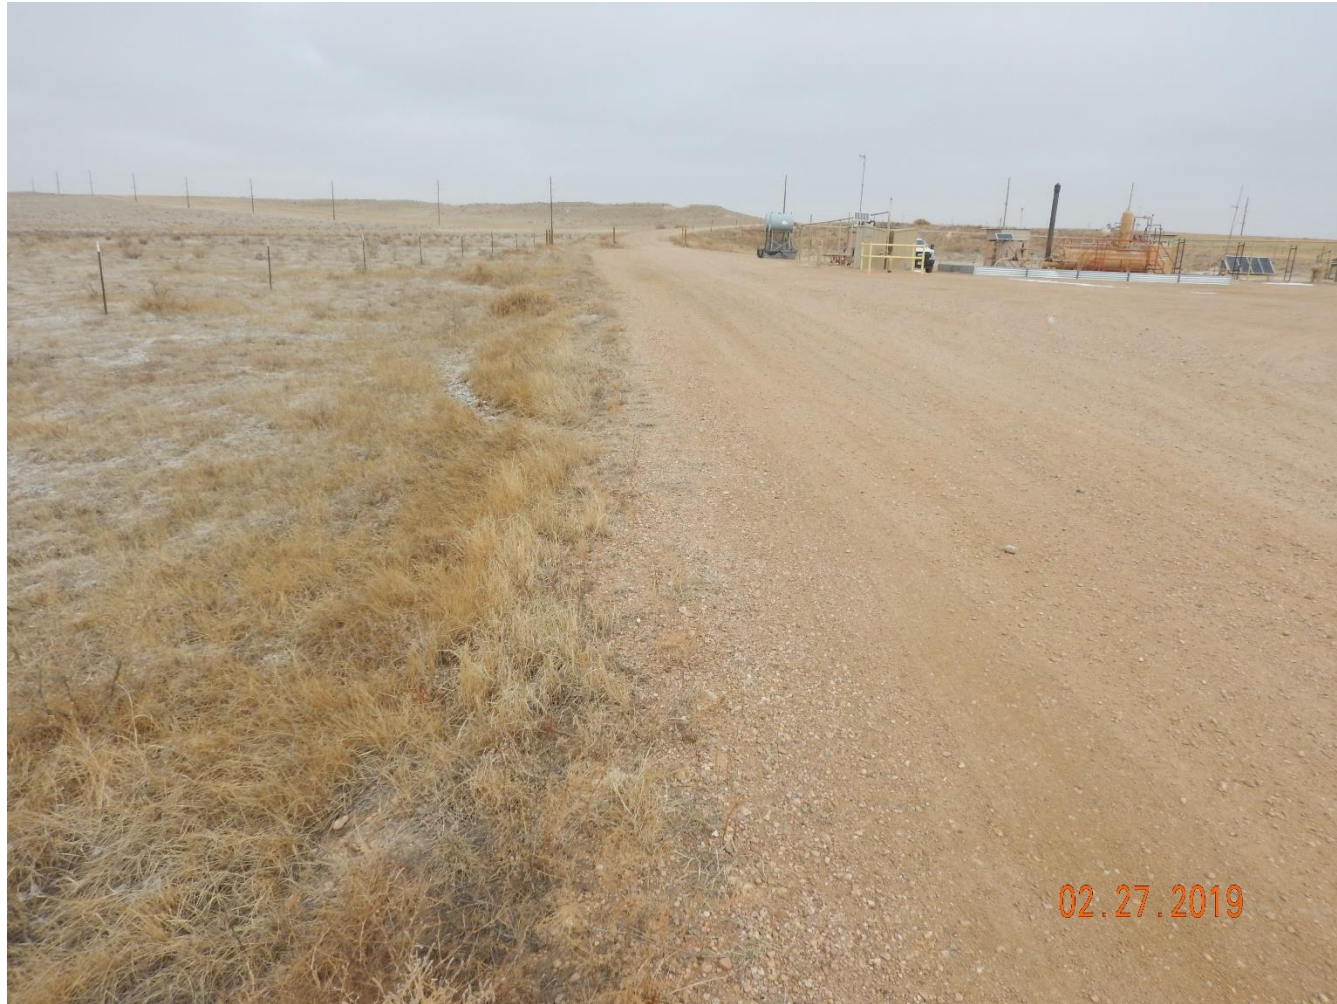
Photo 1: Photo taken from the southwest end of the location, facing north. Photos 1-3 provide an overview of the location from north, northeast to east.

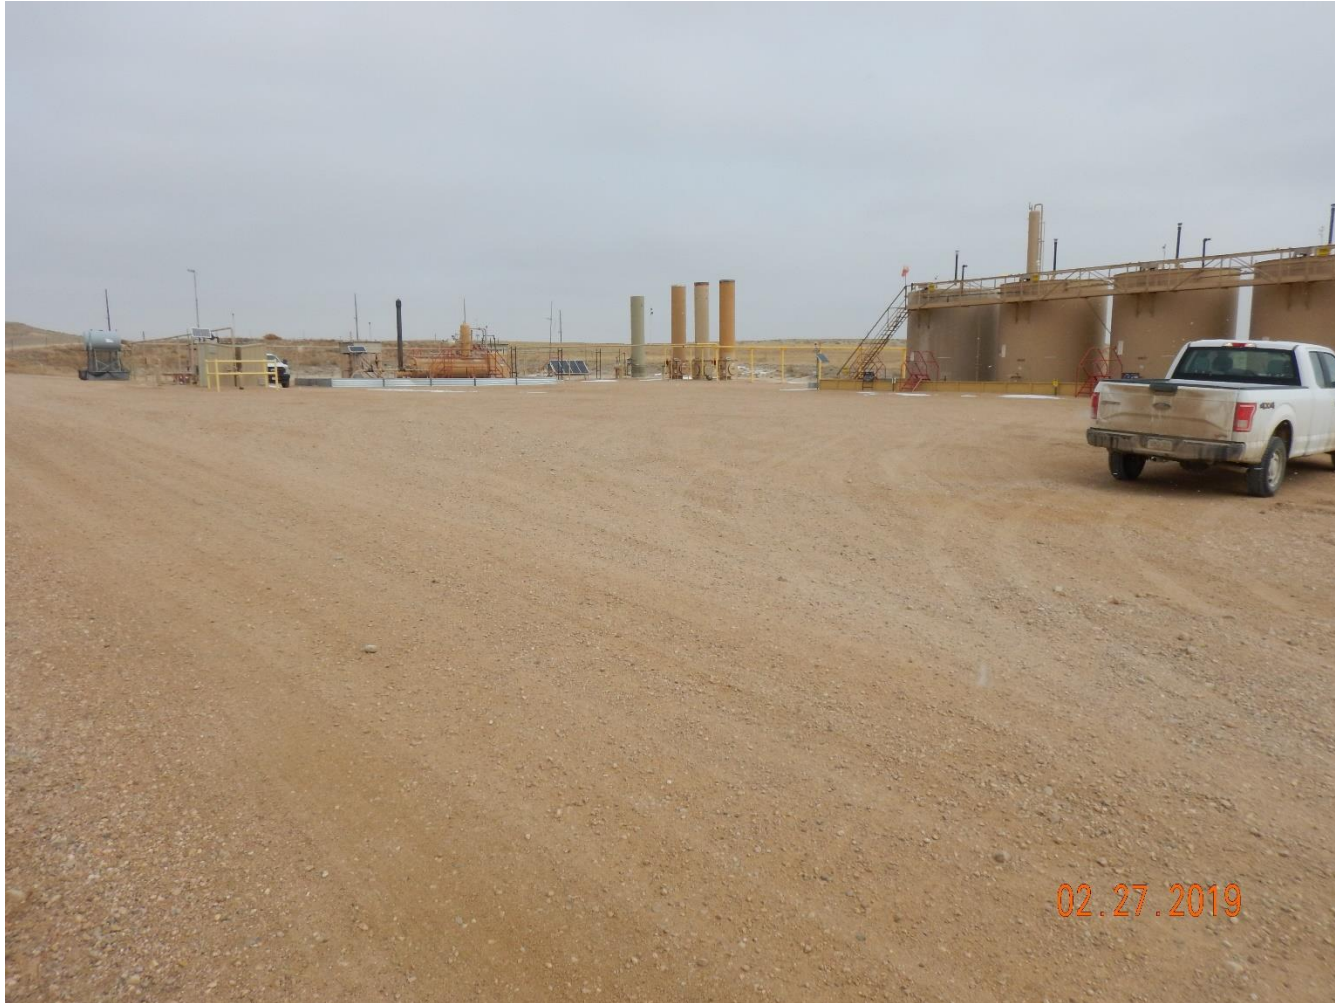
Photo 2: See comments under photo 1.

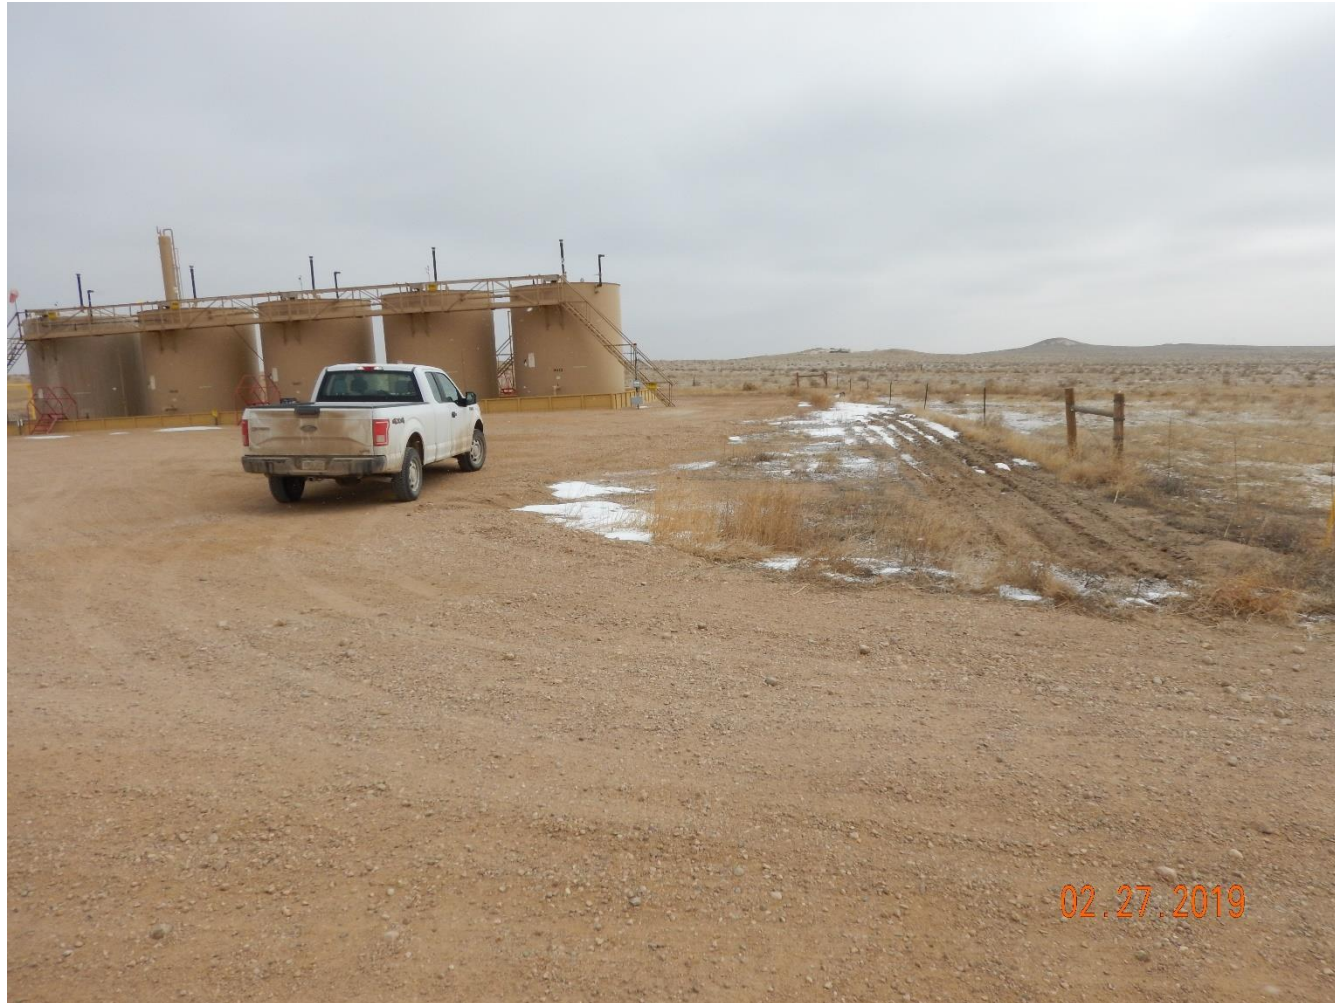
Photo 3: See comments under photo 1.

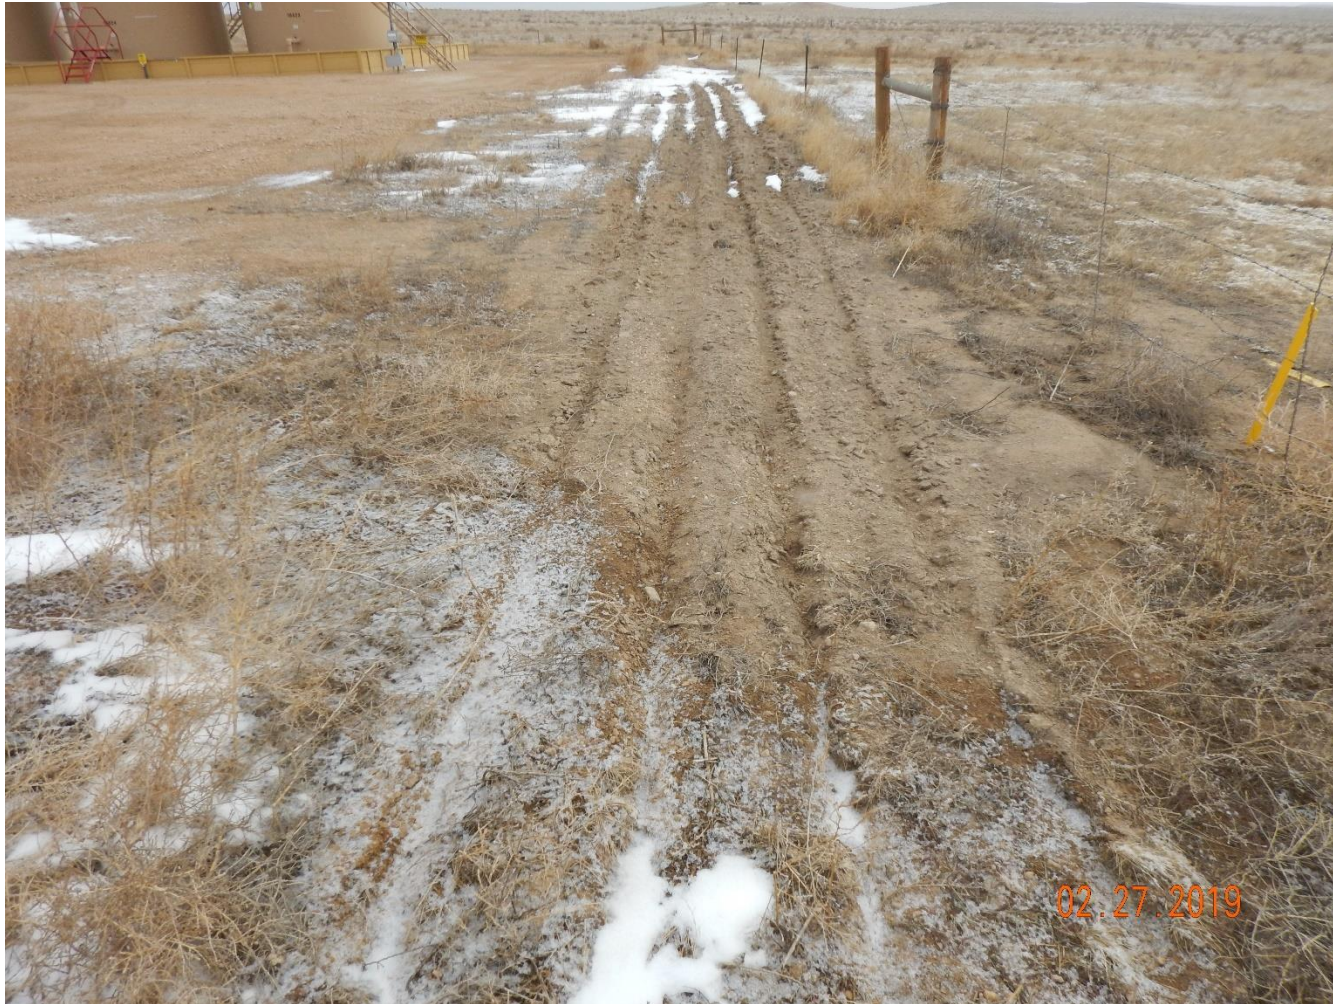
Photo 4: Photo taken from the south end of the location, facing east. Photo shows operator appears to have installed surface roughening along the southern perimeter.

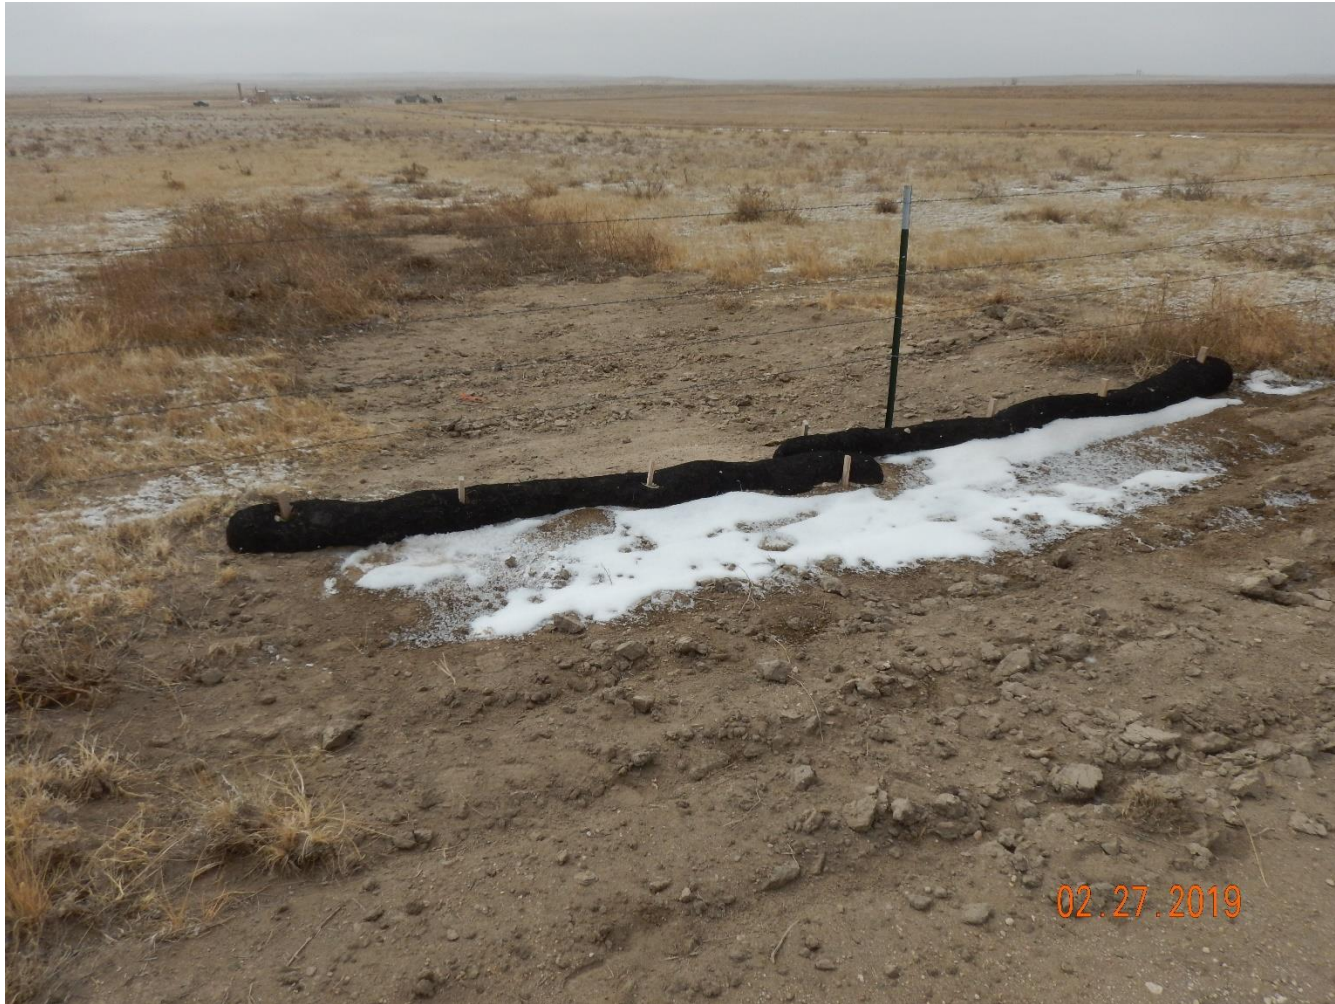
Photo 5: Photo taken from the southeast end of the location, facing southwest. Photo shows erosion log.

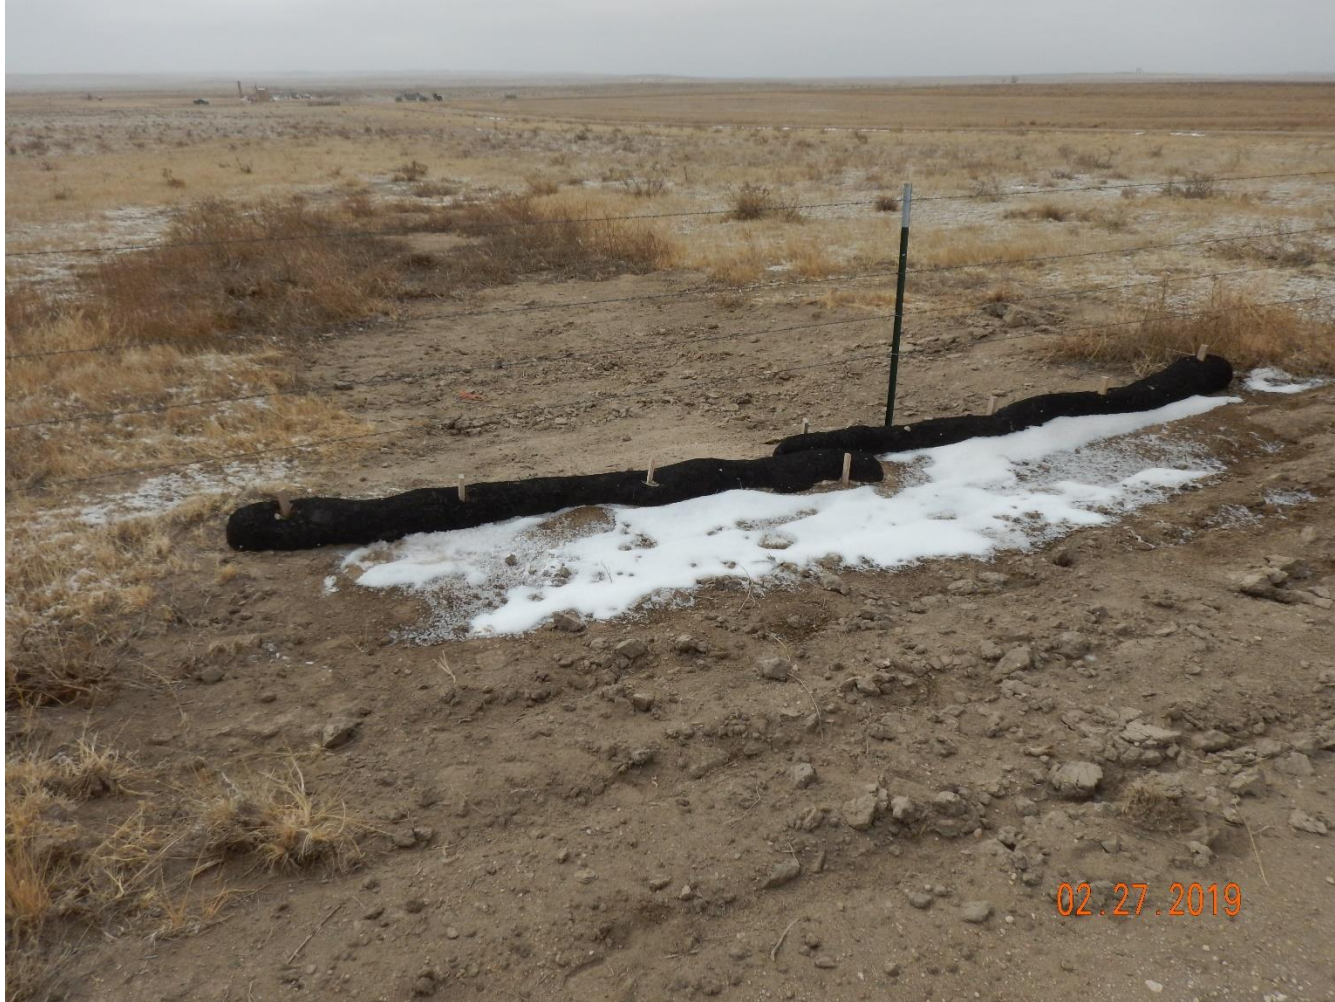
Photo 6: Photo taken from the southeast end of the location, facing southwest. Photo shows erosion log.

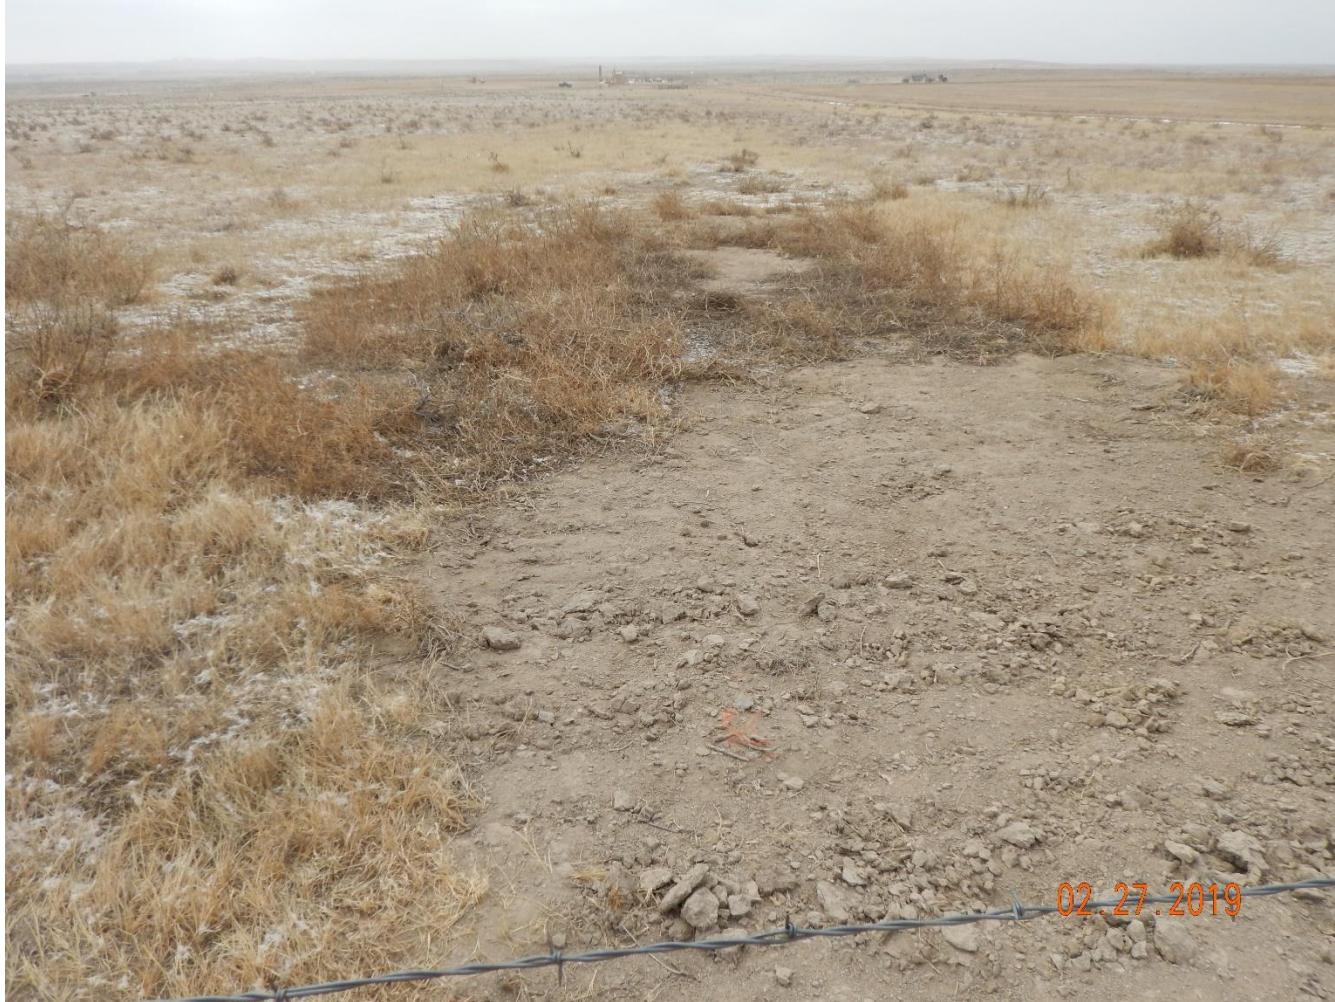
Photo 7: Photo taken from the south end of the location, facing south. Photo shows stormwater runoff from the pad appears to have caused degradation on the adjacent areas beyond the location.

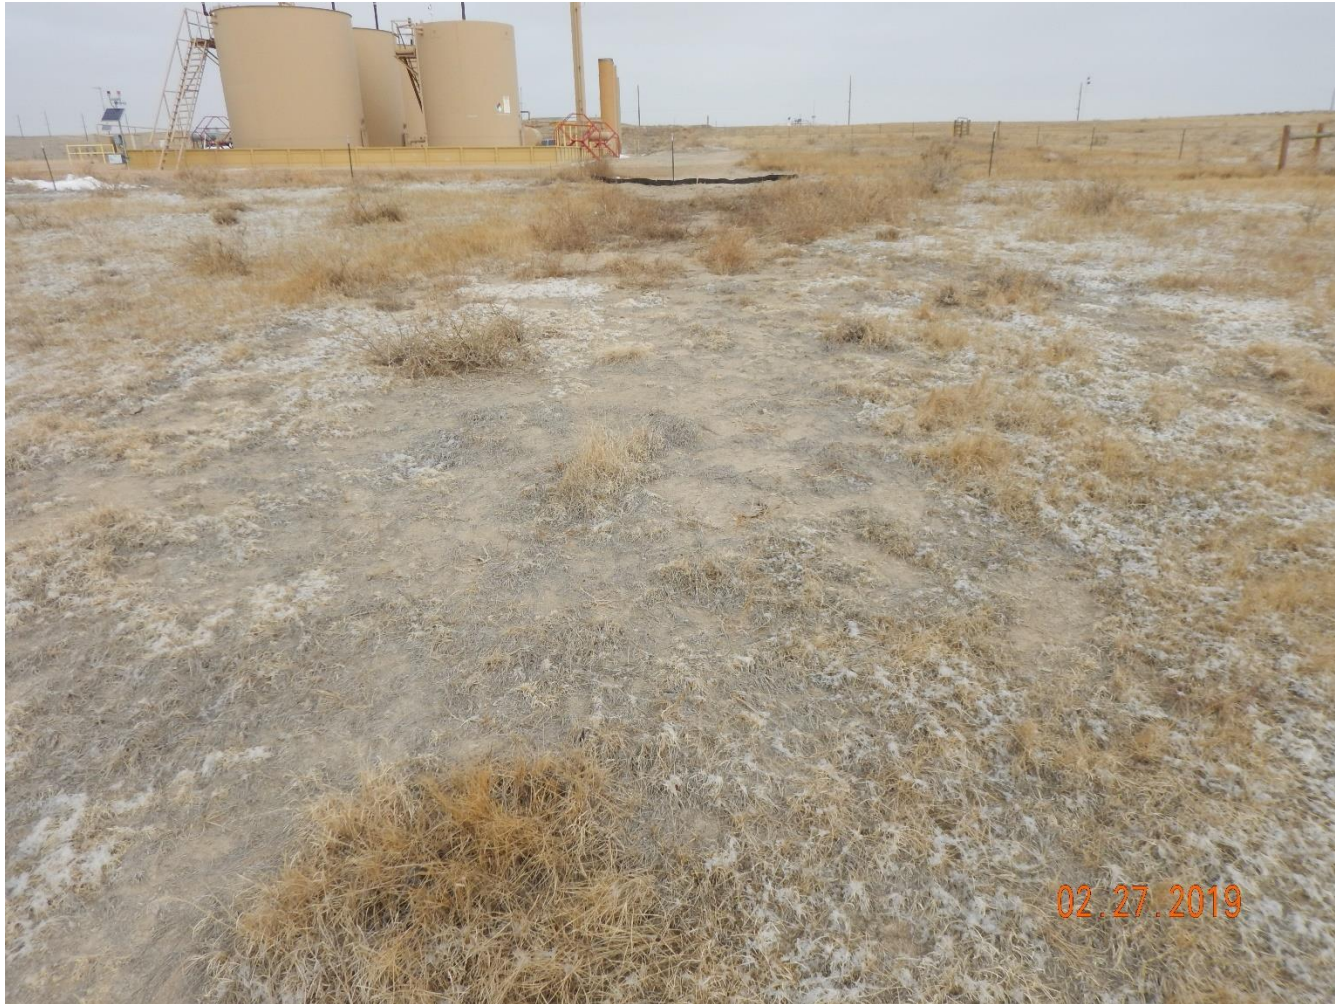
Photo 8: Photo taken from the south of the location, facing north. Photo shows stormwater runoff from the pad appears to have caused degradation on the adjacent areas beyond the location.

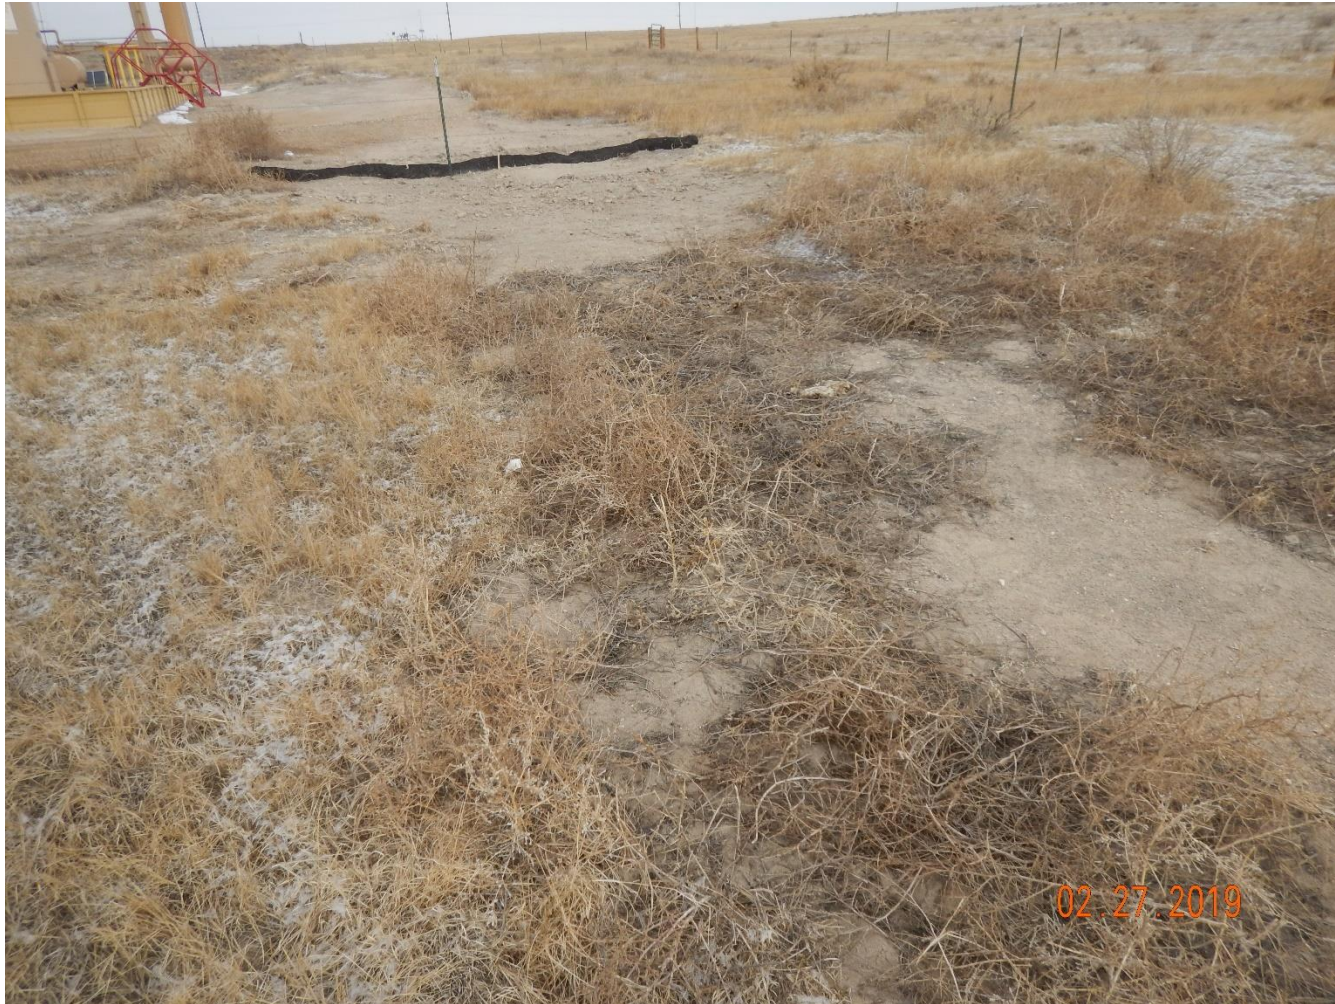
Photo 9: Photo taken from the south of the location, facing north. Photo shows stormwater runoff from the pad appears to have caused degradation on the adjacent areas beyond the location.

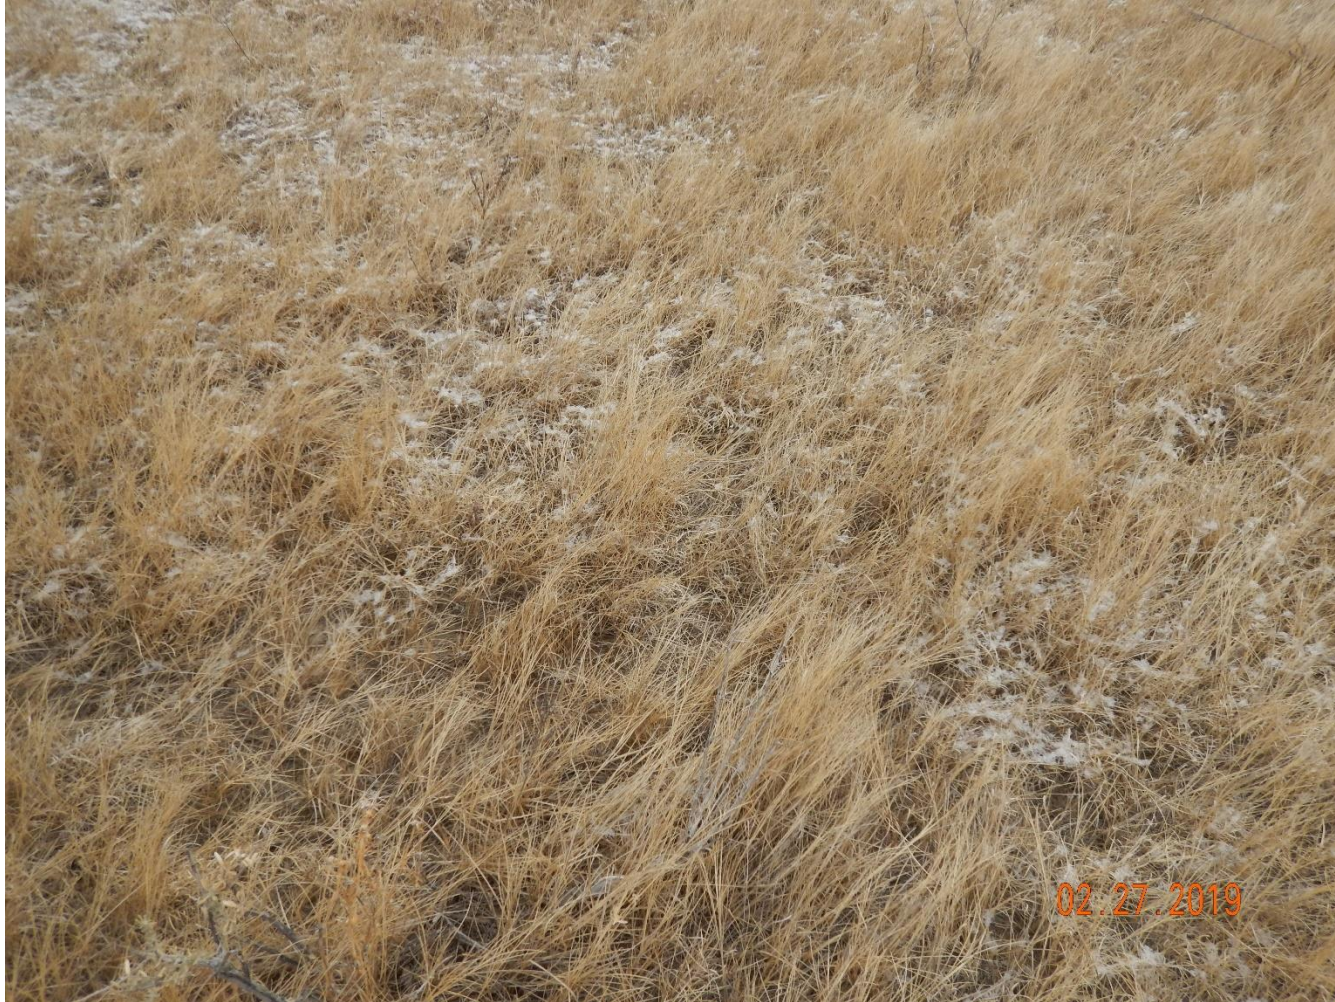
Photo 10: Photo taken from the adjacent reference area. Photo shows vegetation over the reference area.

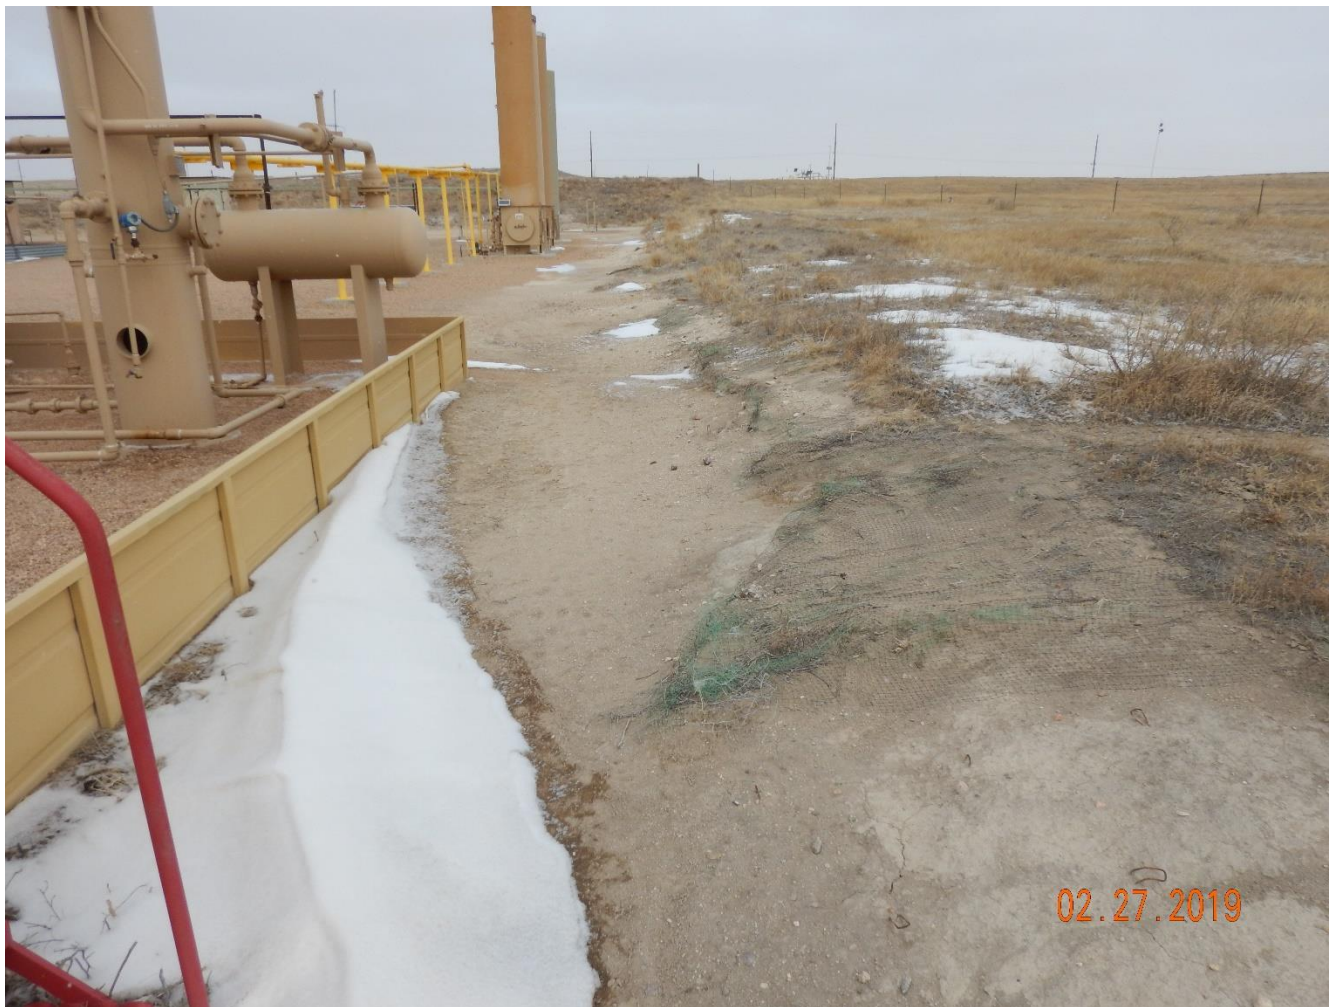
Photo 11: Photo taken from the slopes of the interim areas on the east end of the location, facing north. Photo shows slopes remains predominantly bare and exposed soil with little desirable perennial vegetative establishment. Photo also shows the erosion blankets/netting along slopes are in disrepair and no longer in proper functioning condition.

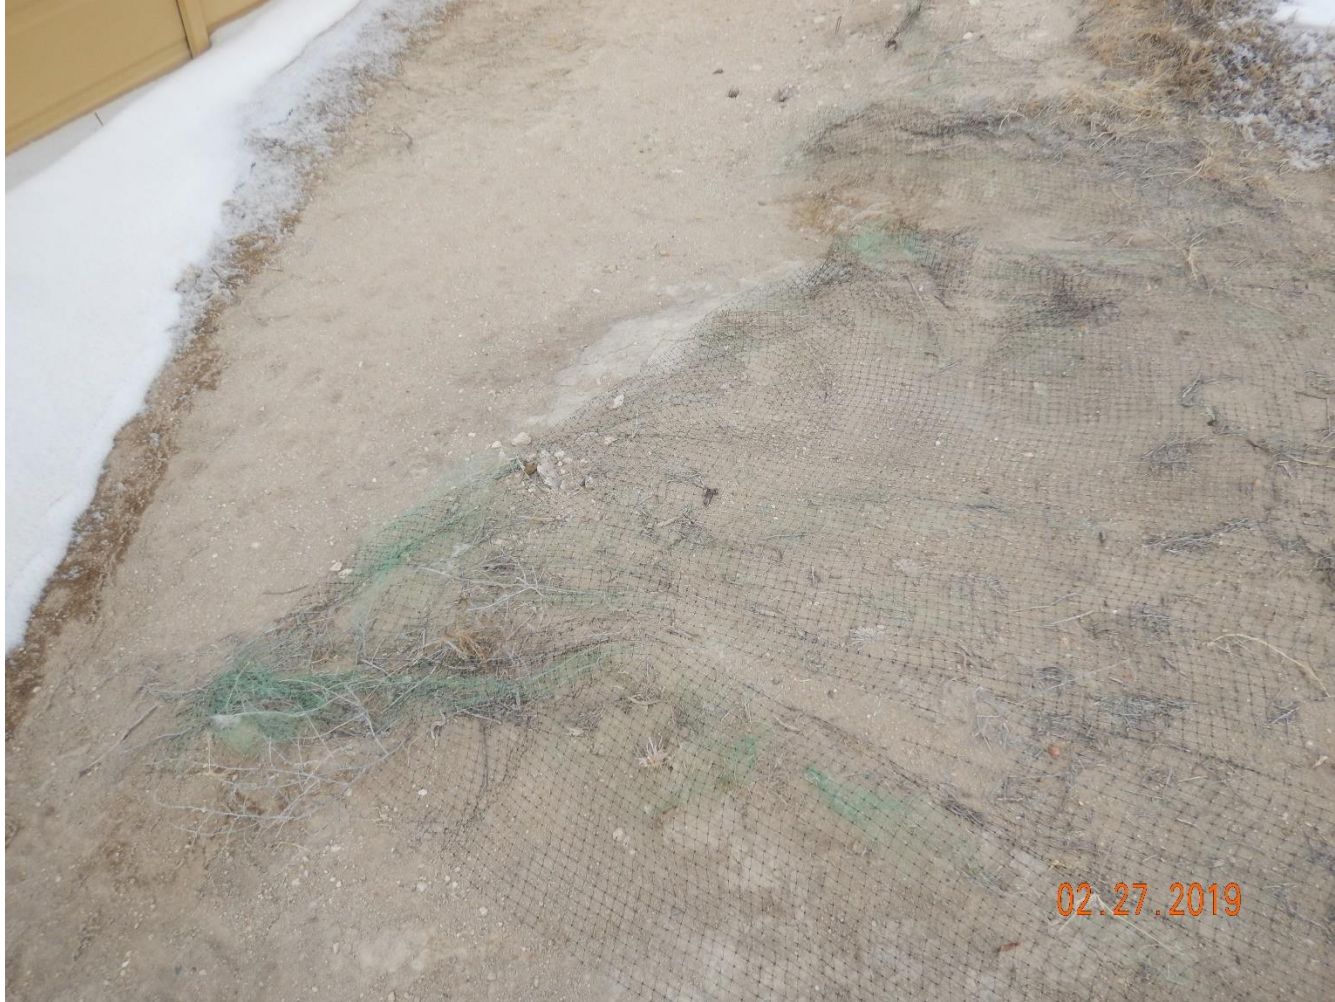
Photo 12: Photo taken from the slopes of the interim areas on the east end of the location. Photo shows slopes remains predominantly bare and exposed soil with little desirable perennial vegetative establishment. Photo also shows the erosion blankets/netting along slopes are in disrepair and no longer in proper functioning condition.

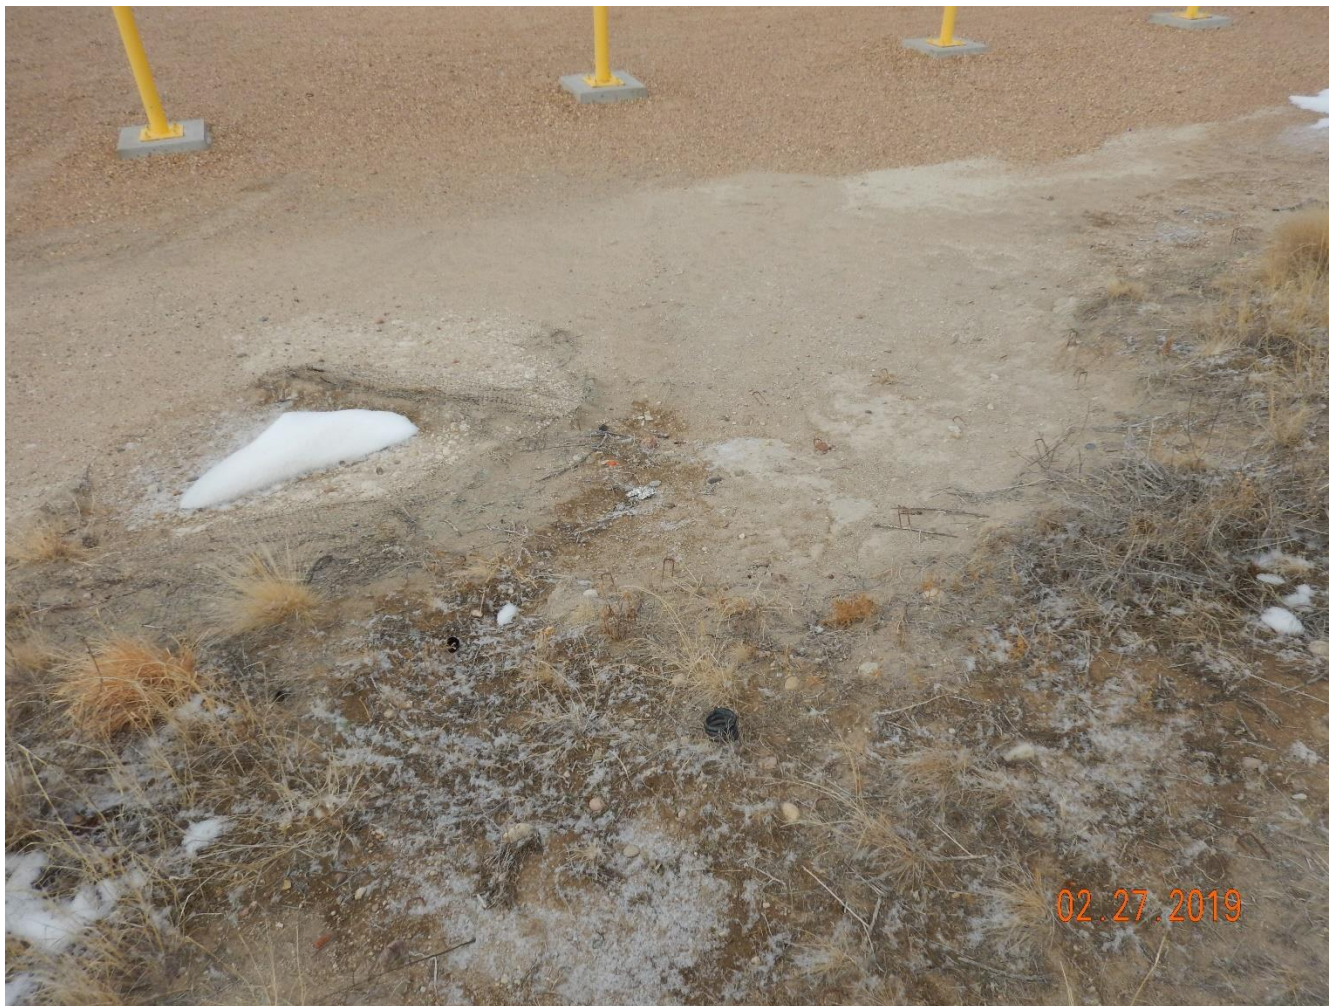
Photo 13: Photo taken from the slopes of the interim areas on the east end of the location, facing southwest. Photo shows slopes remains predominantly bare and exposed soil with little desirable perennial vegetative establishment. Photo also shows the erosion blankets/netting along slopes are in disrepair and no longer in proper functioning condition.

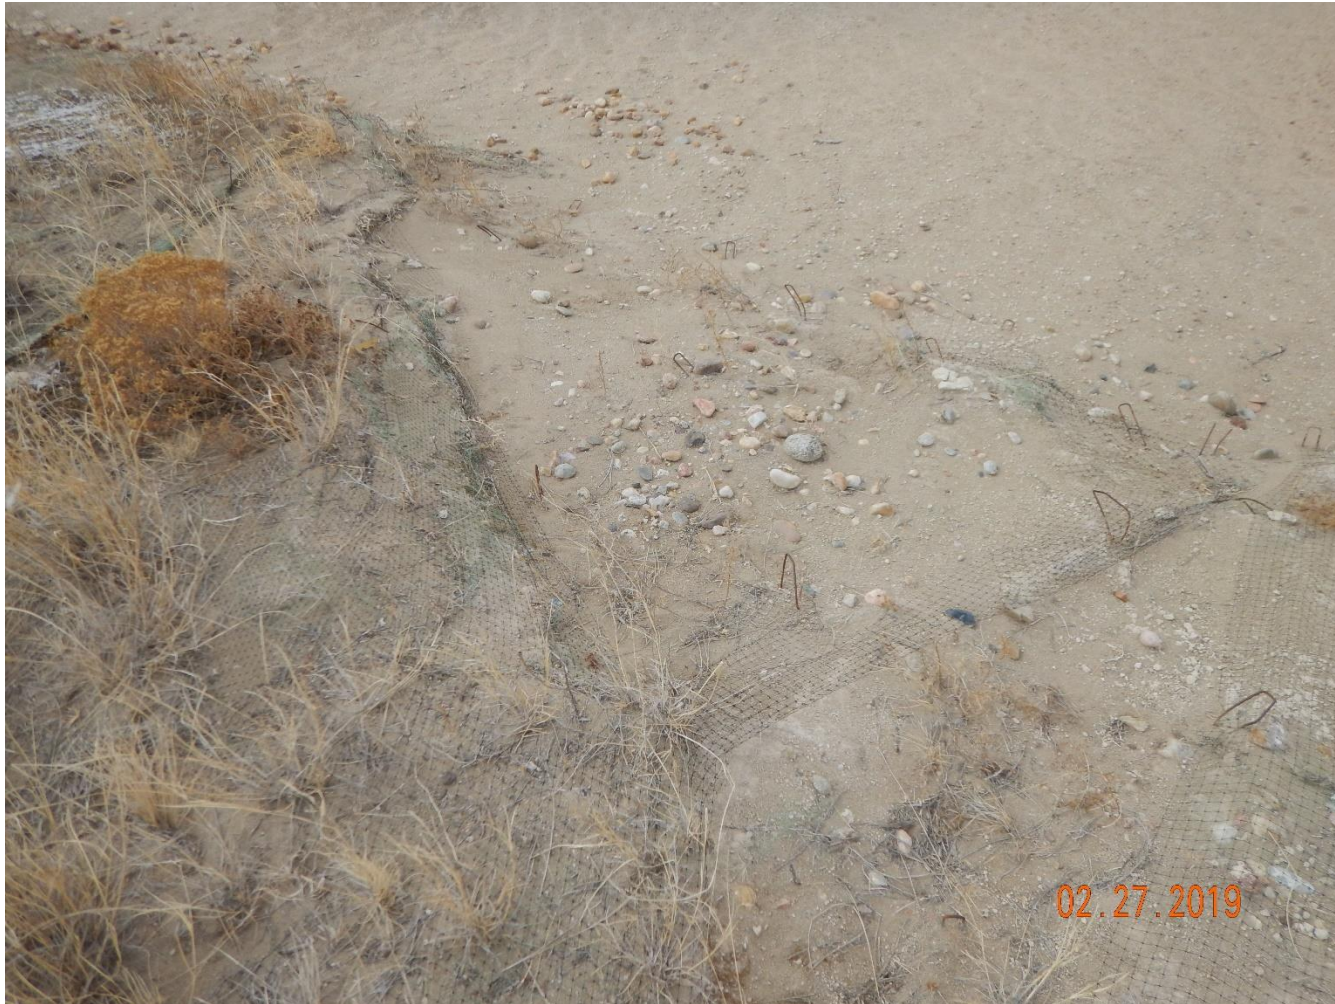
Photo 14: Photo taken from the slopes of the interim areas on the east end of the location. Photo shows the erosion blankets/netting along slopes are in disrepair and no longer in proper functioning condition.

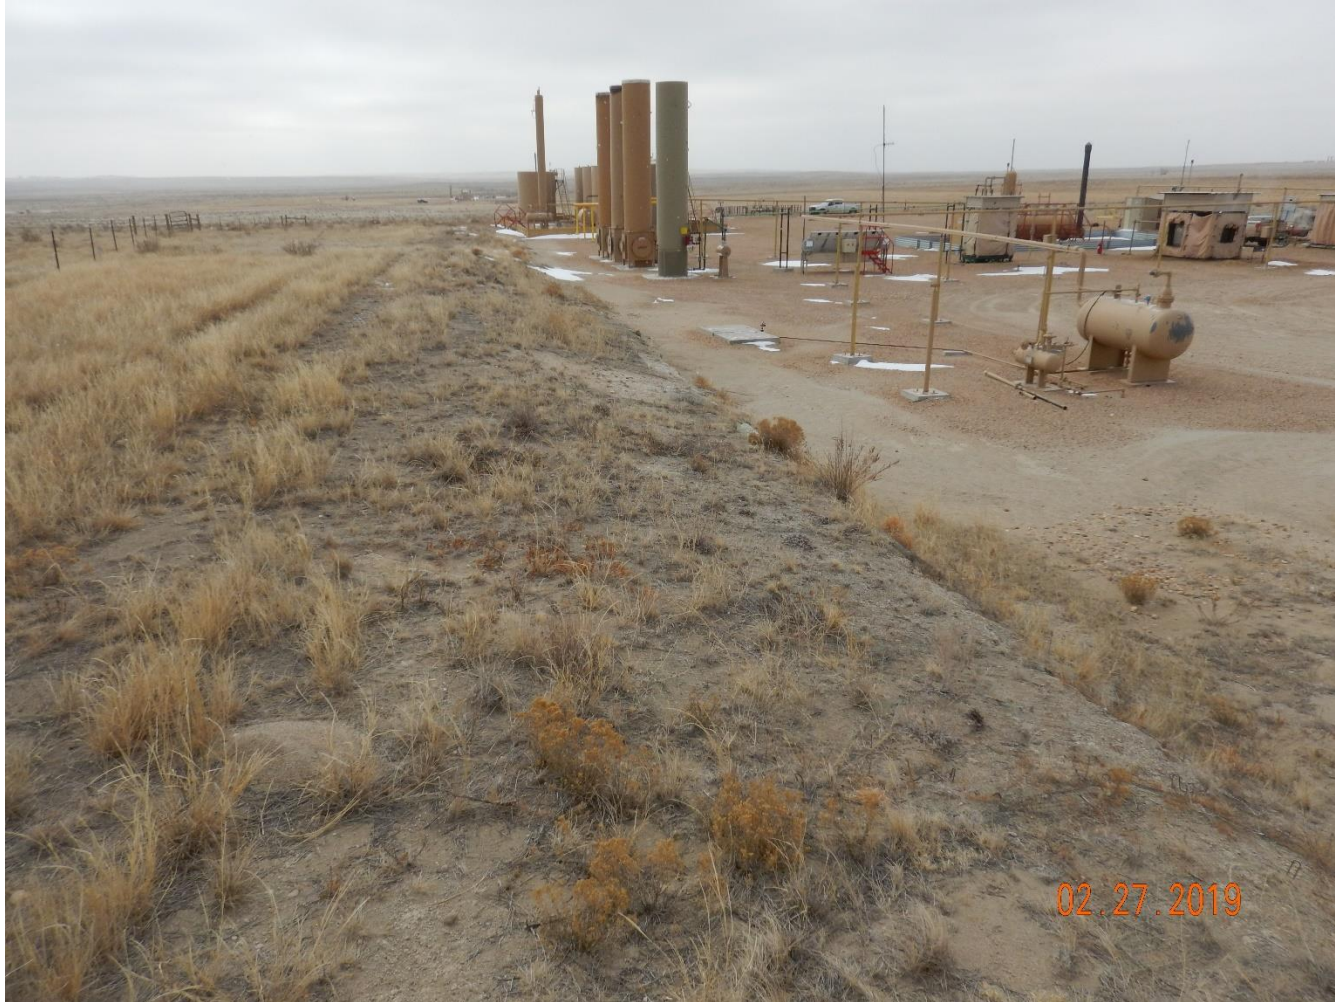
Photo 15: Photo taken from the northeast end of the location, facing south. See comments under photo 14.

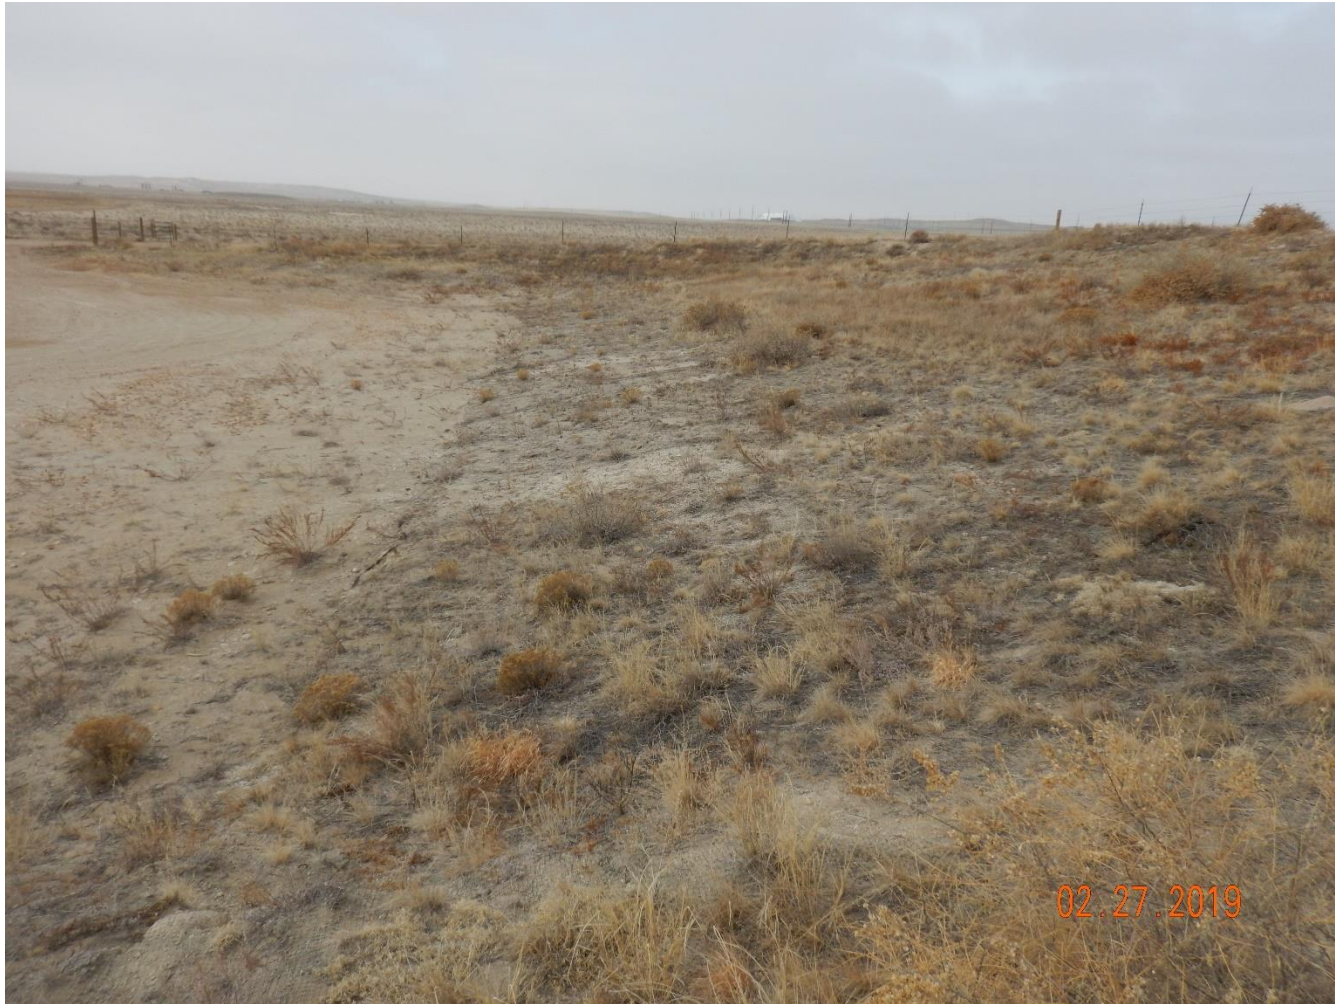
Photo 16: Photo taken from the northeast end of the location, facing west. See comments under photo 14.
