**Inspection Photos**  
**Location Name: Ute C #3**  
**API: 05-067-07644**

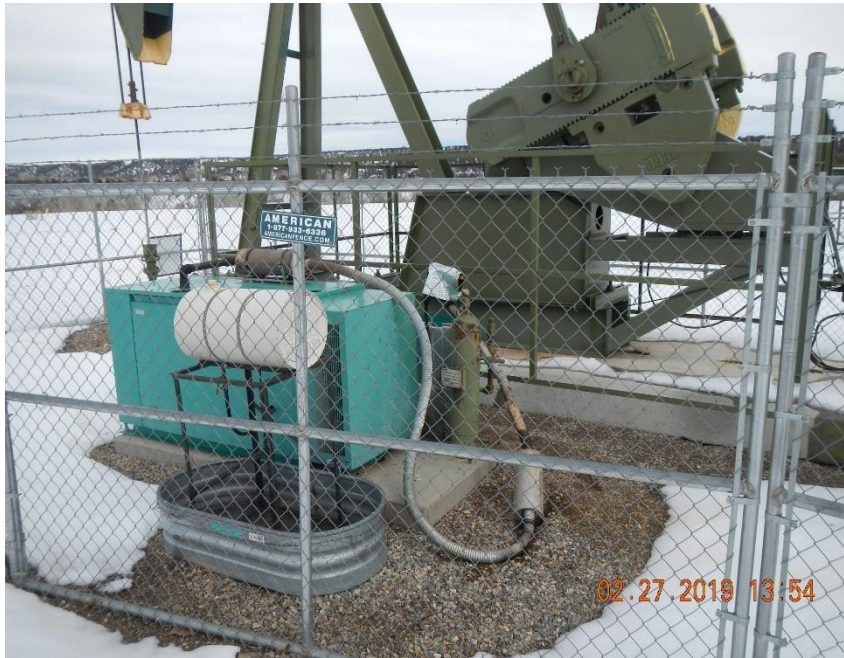
**Lube oil container on secondary containment. Label on container is illegible.**

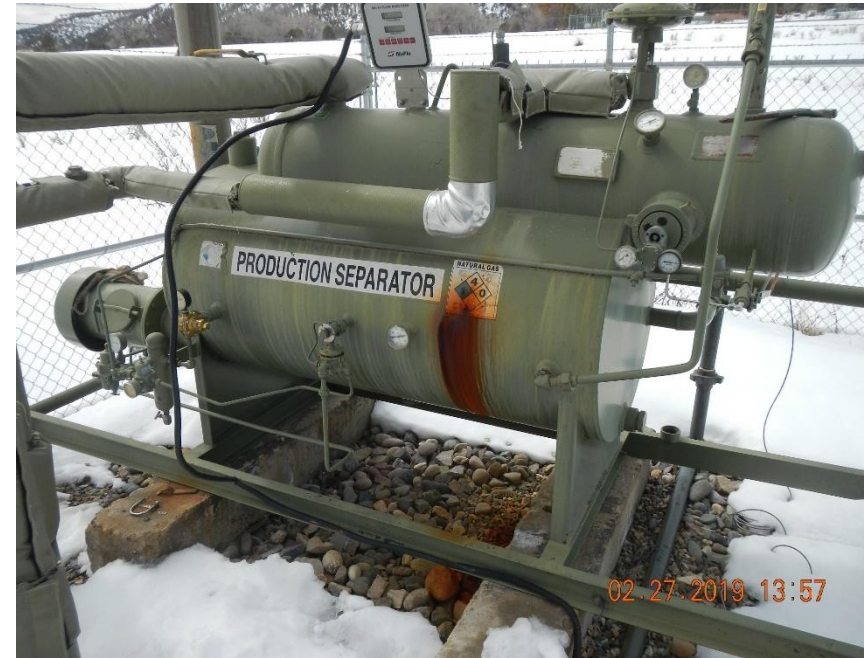
**Horizontal heated separator has rust colored staining below aluminum elbow.**

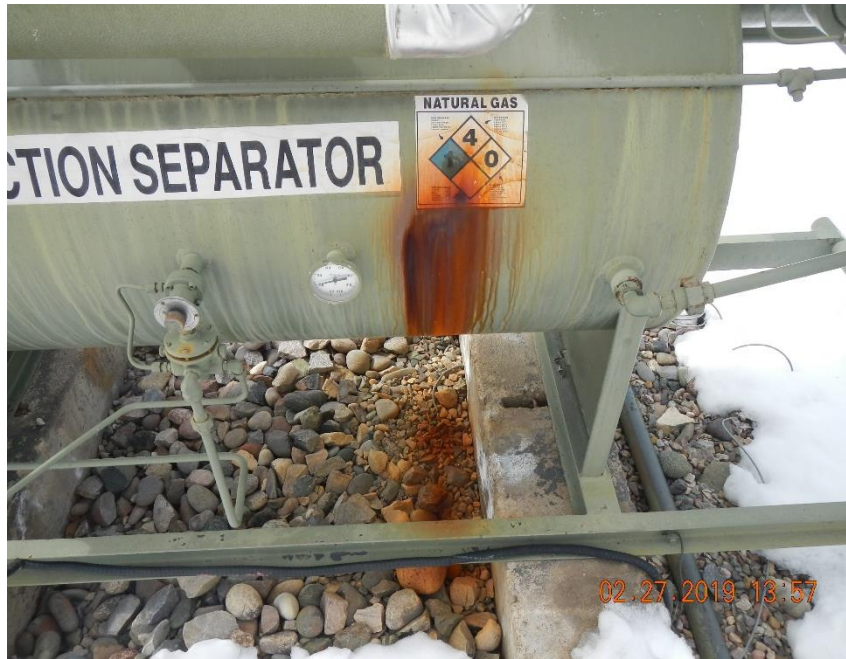
Rust colored staining present on vessel and gravel beneath aluminum elbow.

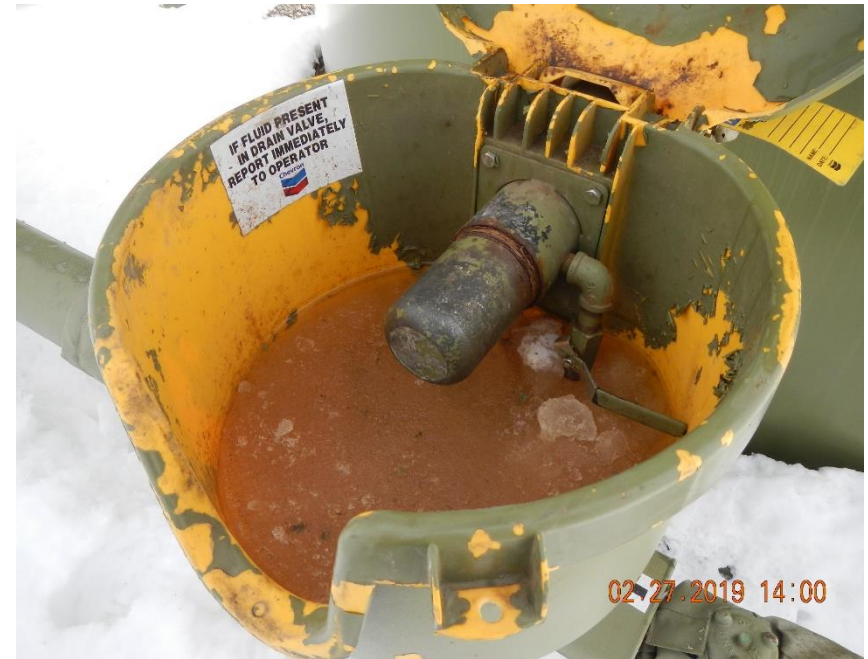
Drip pot on AST load out line with ice and fluids present.
