Inspection Photo (s)
Legg 2-26
API #05-045-07049
FIR Inspection # 689303388

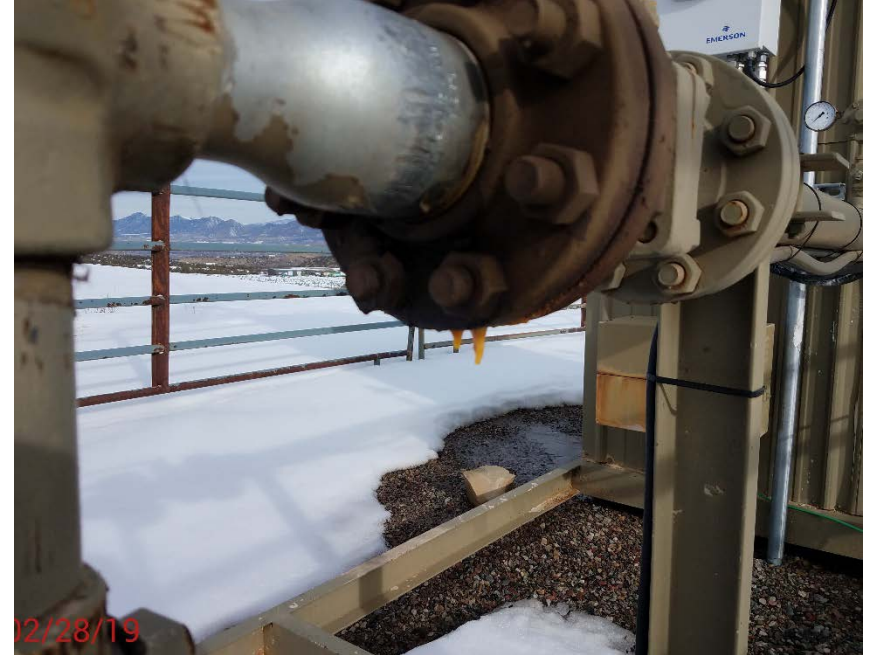
Location Photo #4, Leaking flange on inlet line to meter run
