Inspection Photo (s)
Werner 31B
API #05-045-19237
FIR Inspection # 689303394

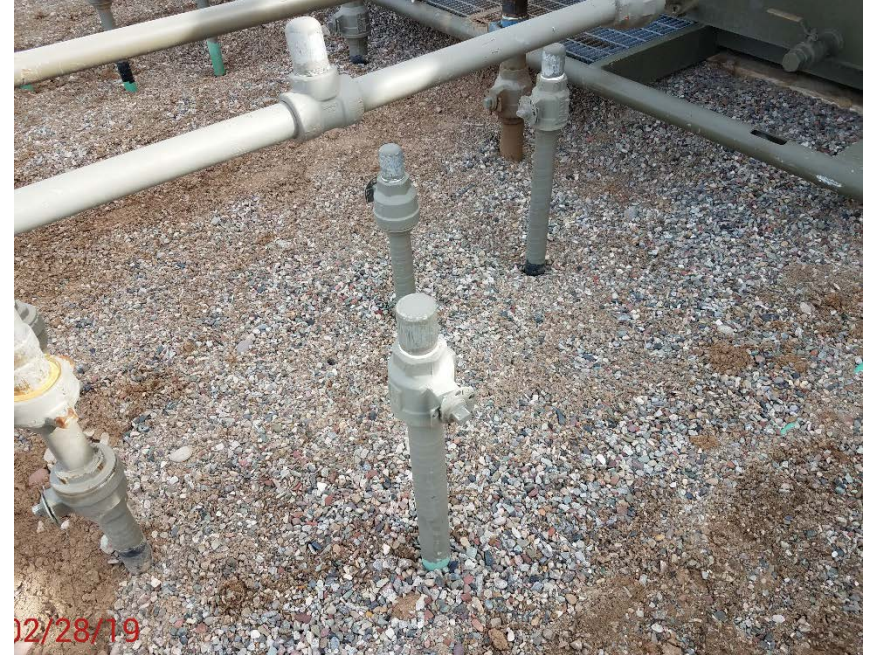
Location Photo #4, 3 unmarked/unused flow line risers.

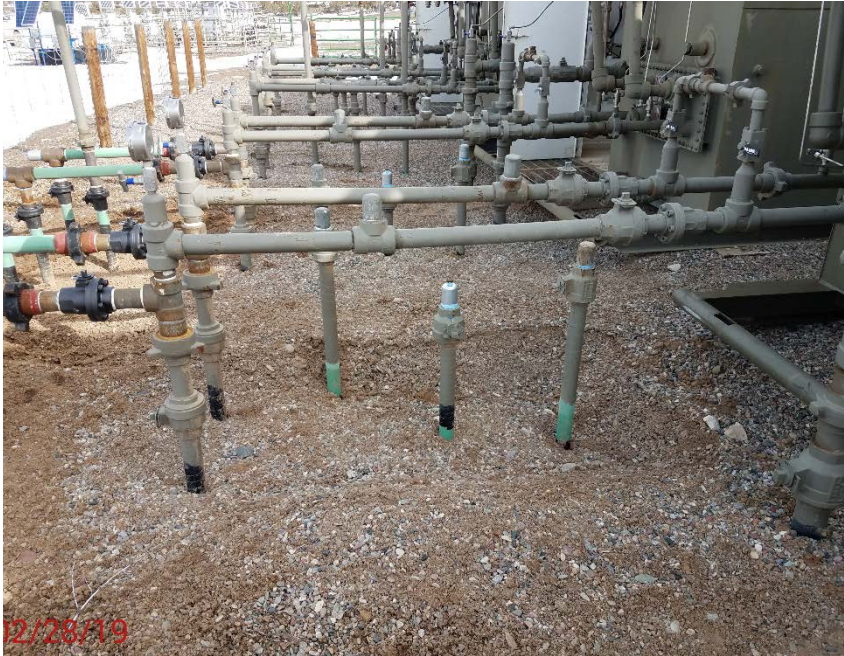
Location Photo #5, 6 unmarked/unused flow line risers.

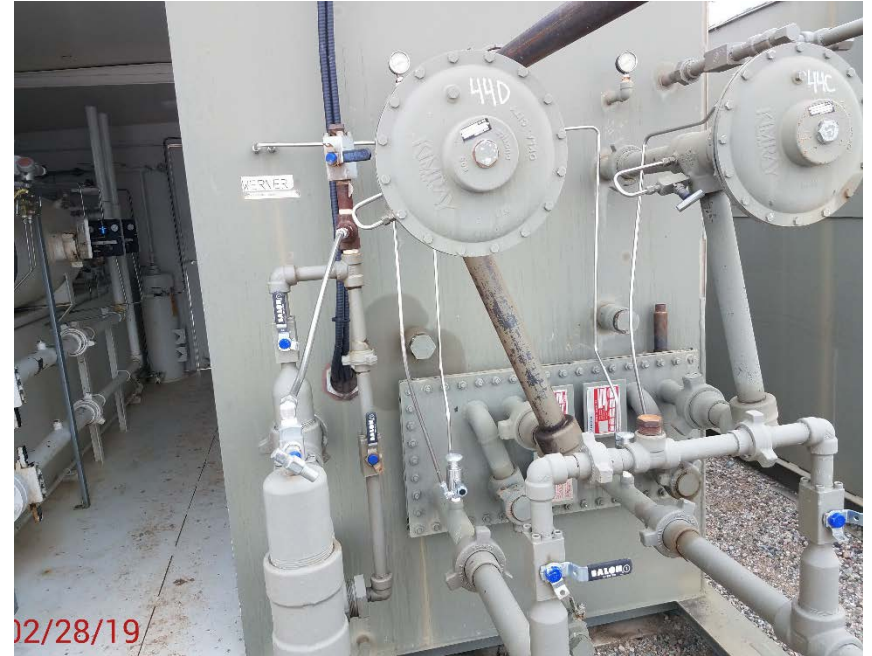
Location Photo #6 unit 44D has leaking fittings.

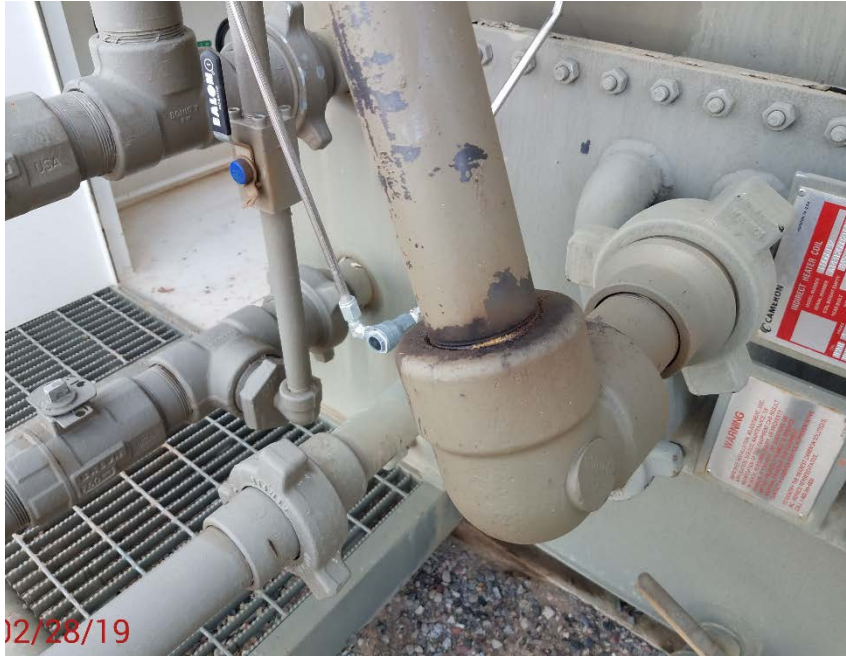
Location Photo #7, leaking fittings below the kimray on unit 44D

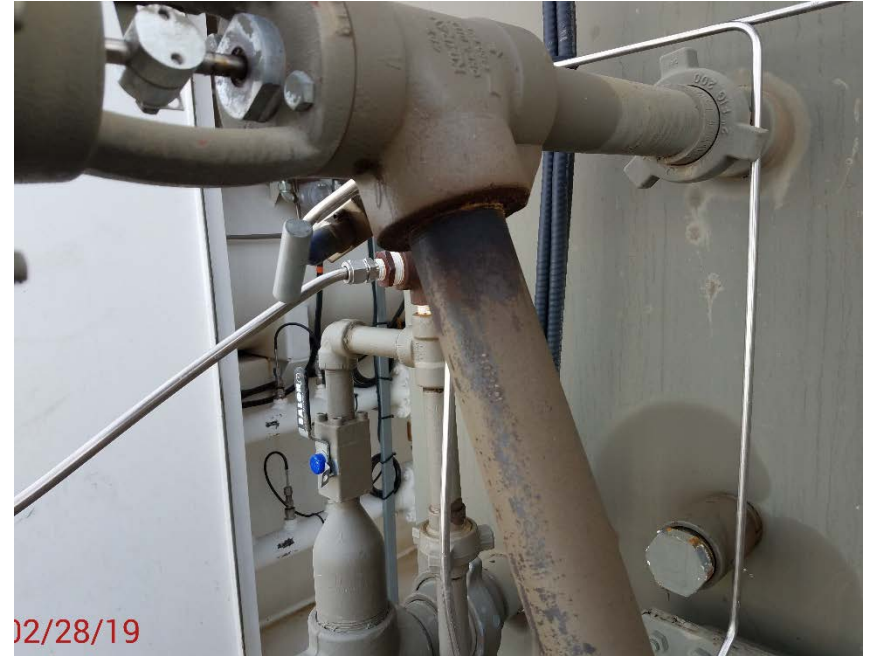
Location Photo #8, leaking fittings below the kimray on unit 44D

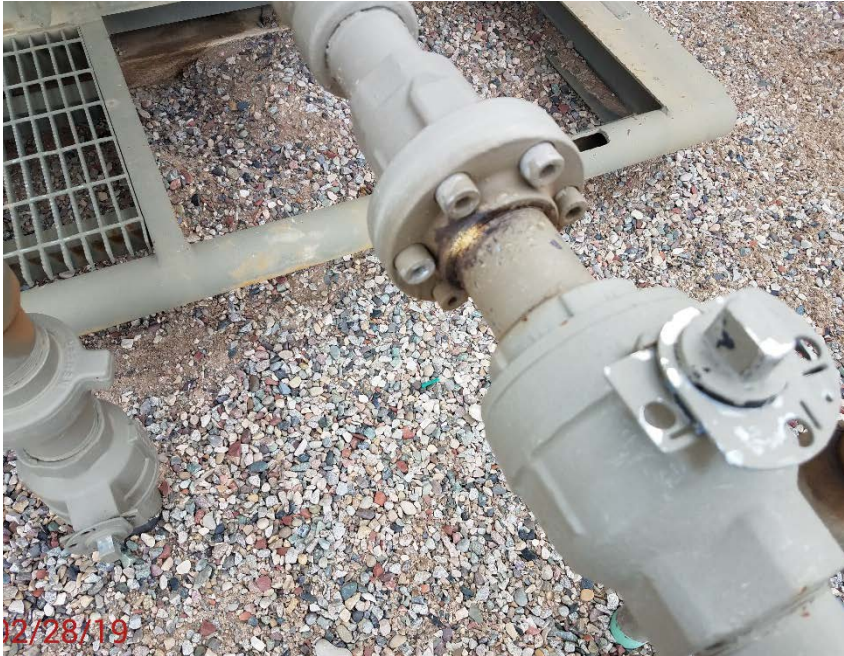
Location Photo #9, leaking fitting at the check valve unit 44D

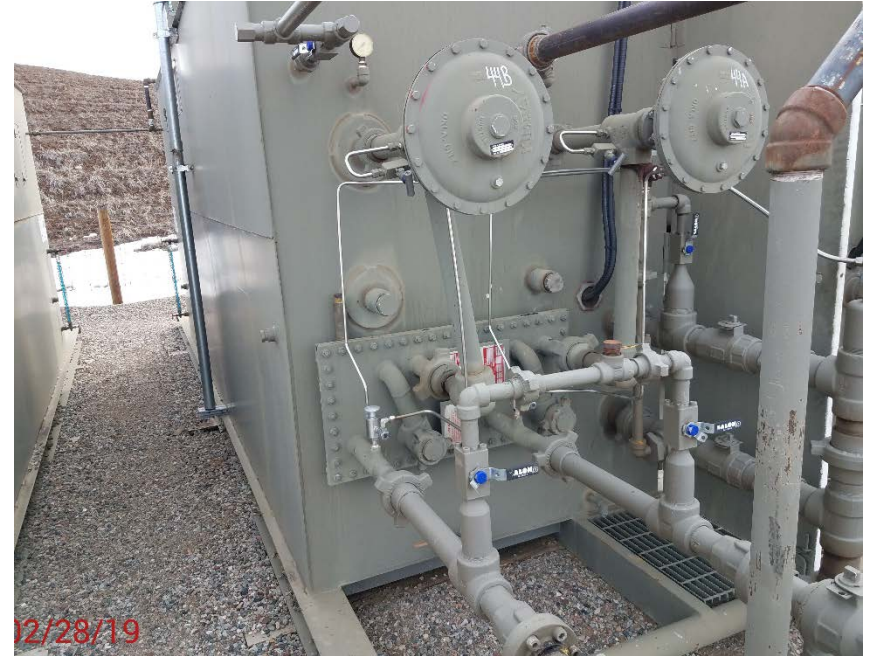
Location Photo #10, Leaking fitting on unit 44B.

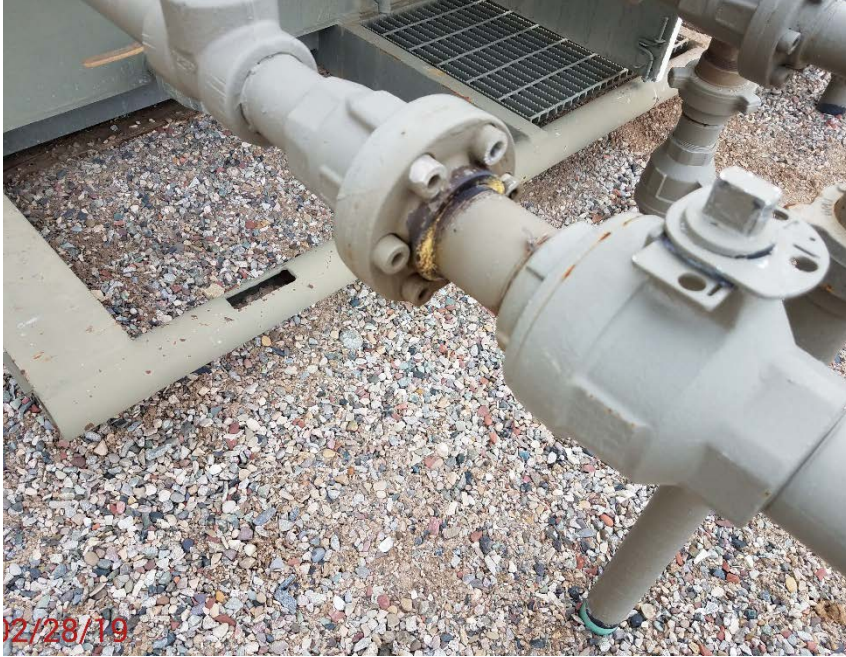
Location Photo #11, leaking fitting at check valve on unit 44B
