Inspection Photo (s)
Epperly 24B
API #05-045-20952
FIR Inspection # 689303396

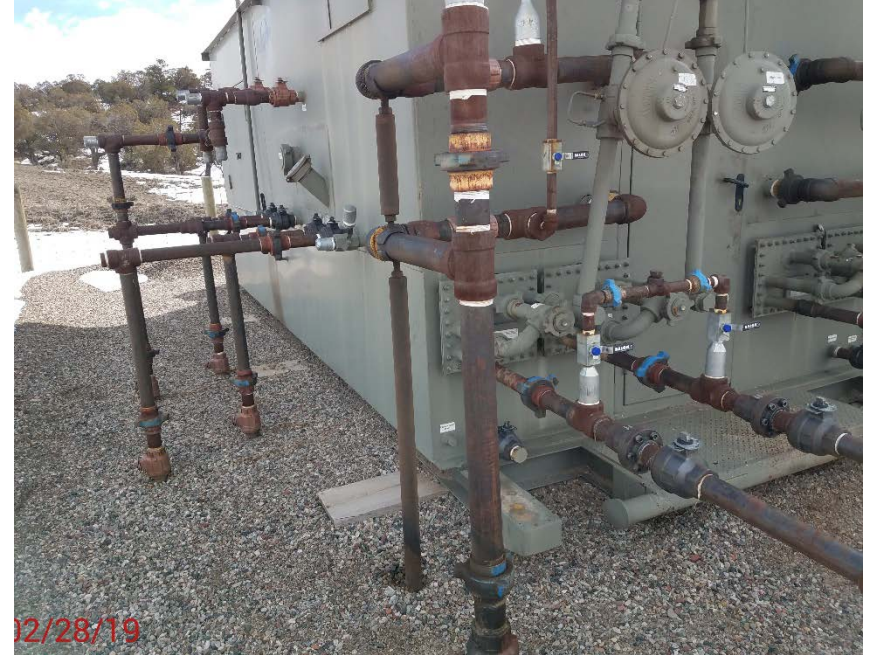
Location Photo #4, Leaking fittings on unit 23D

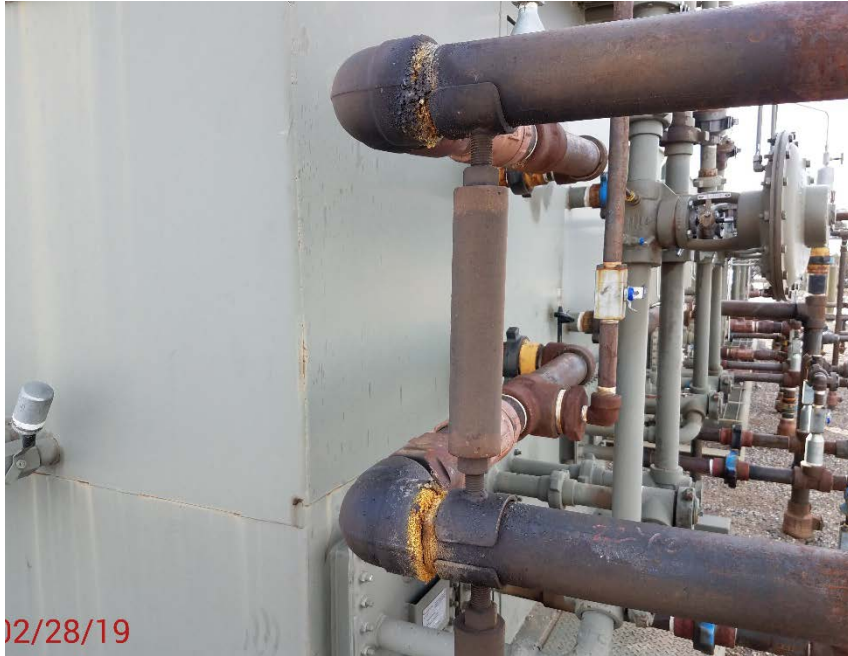
Location Photo #5, 2 leaking fittings on unit 23D

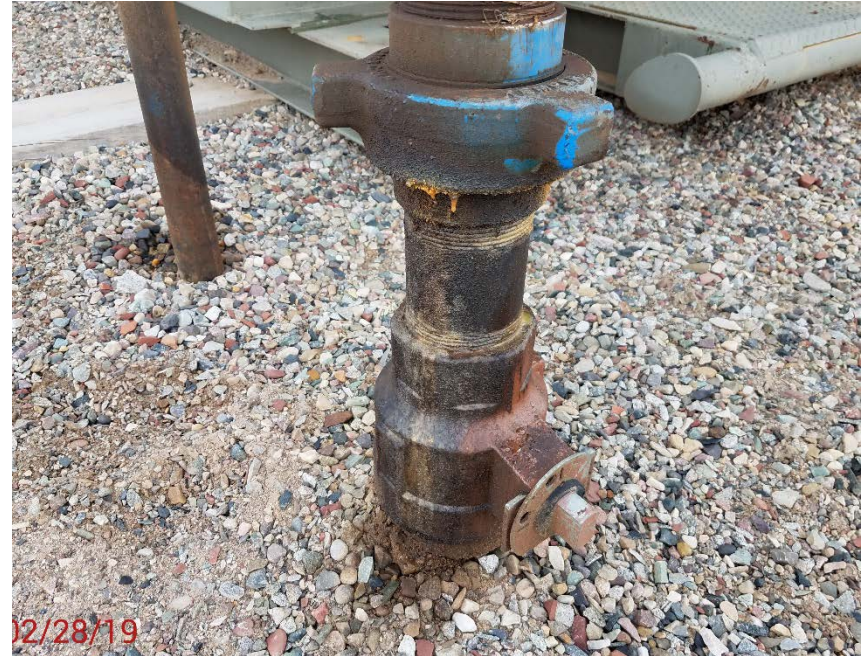
Location Photo #6, leaking fitting on unit 23D

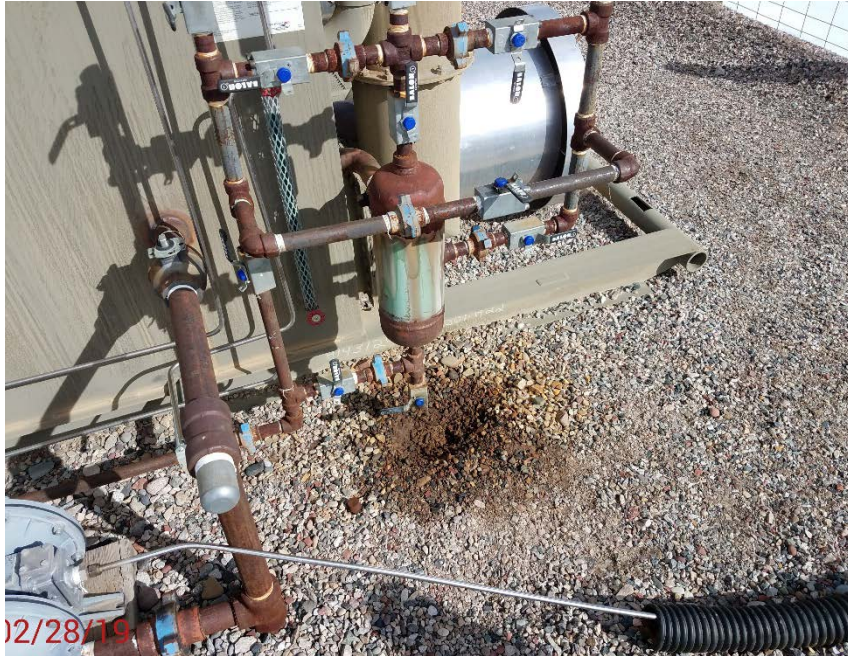
Location Photo #7, Stained material under scrubber pot.

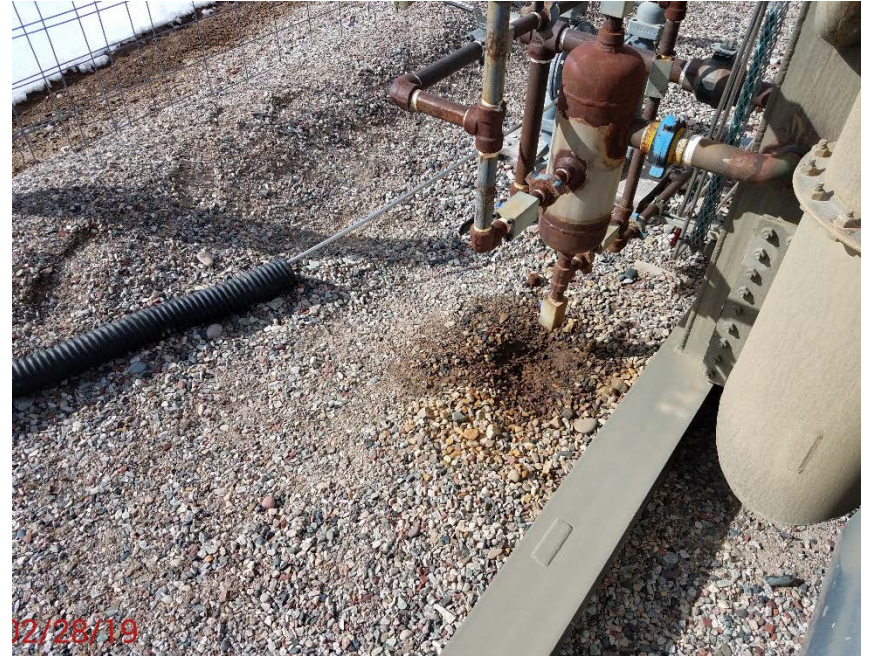
Location Photo #8, Stained material under scrubber pot.
