Inspection Photo (s)
Tharp 14D
API #05-045-18607
FIR Inspection # 689303404

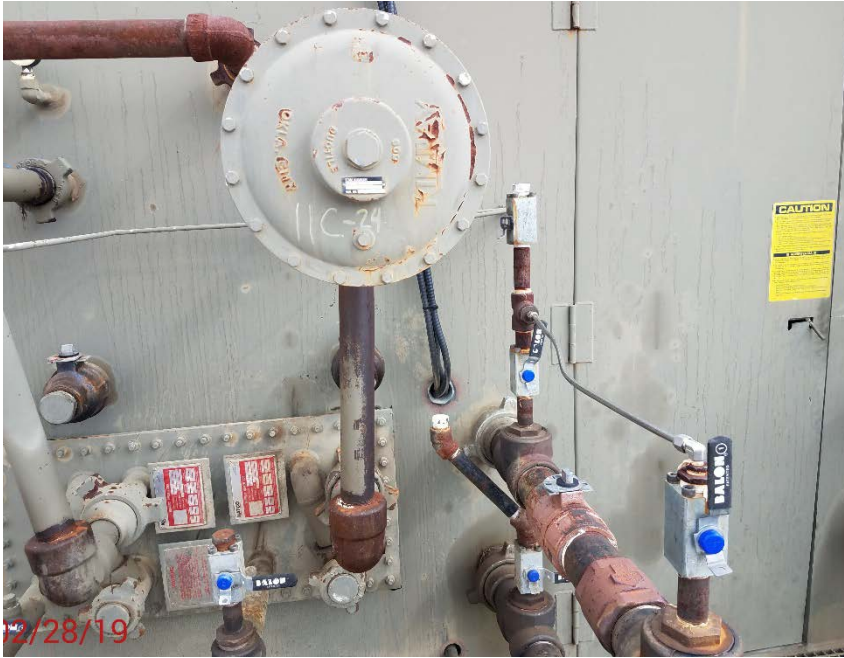
Location Photo #4, Separator 11C-24, has leaking fitting.

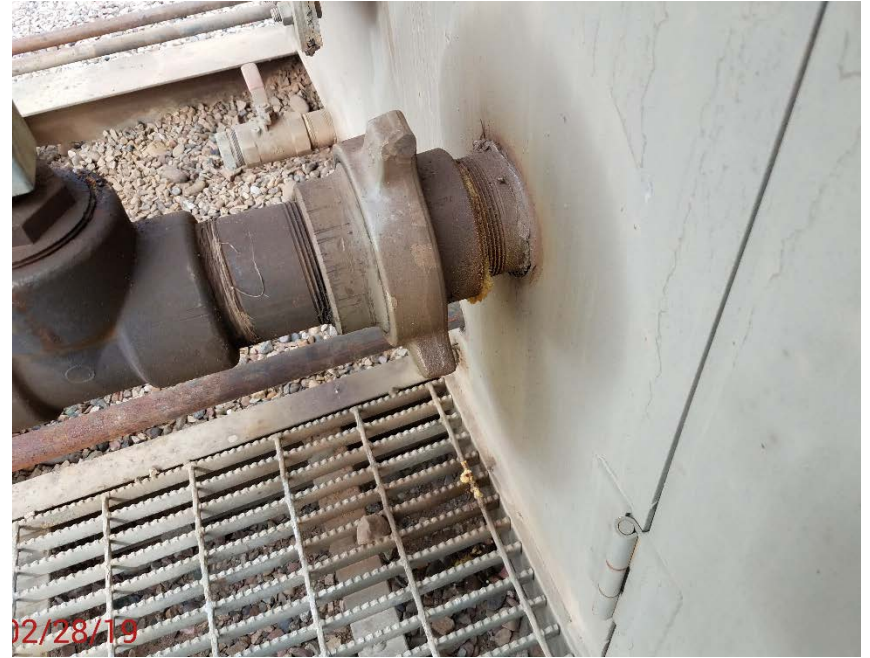
Location Photo #5, 11C-24 leaking fitting.

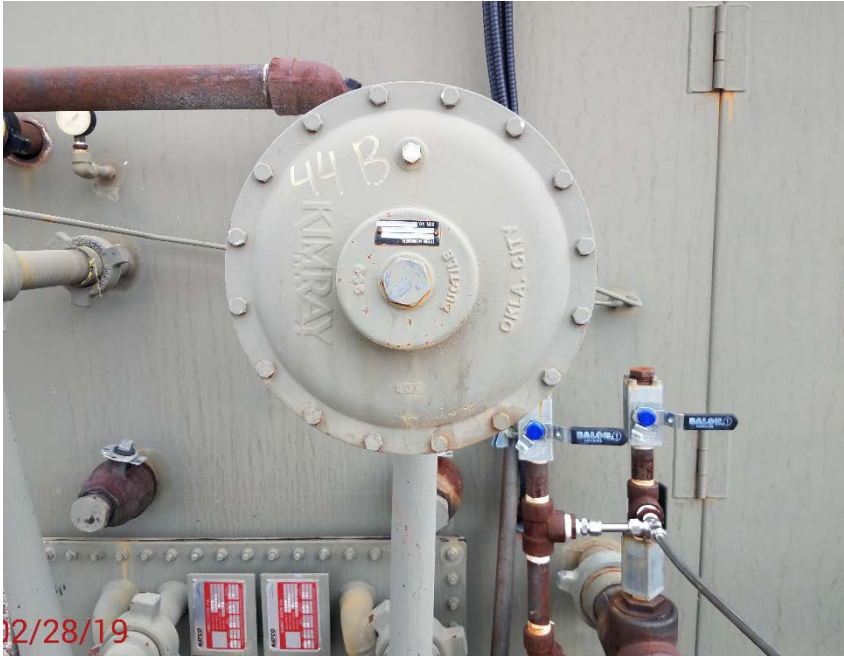
Location Photo #6, Separator 44B has a leaking fitting.

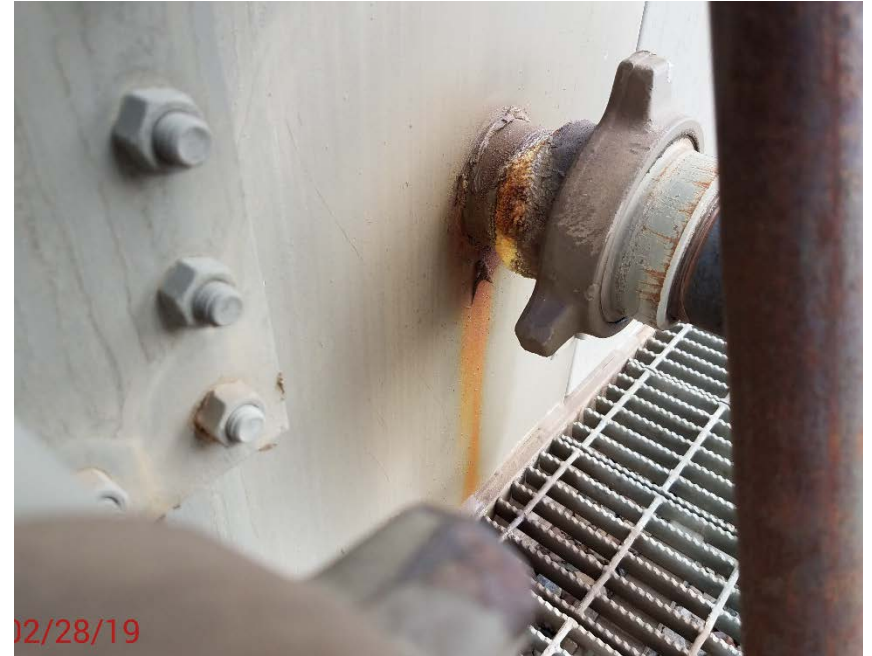
Location Photo #7, 44B leaking fitting.

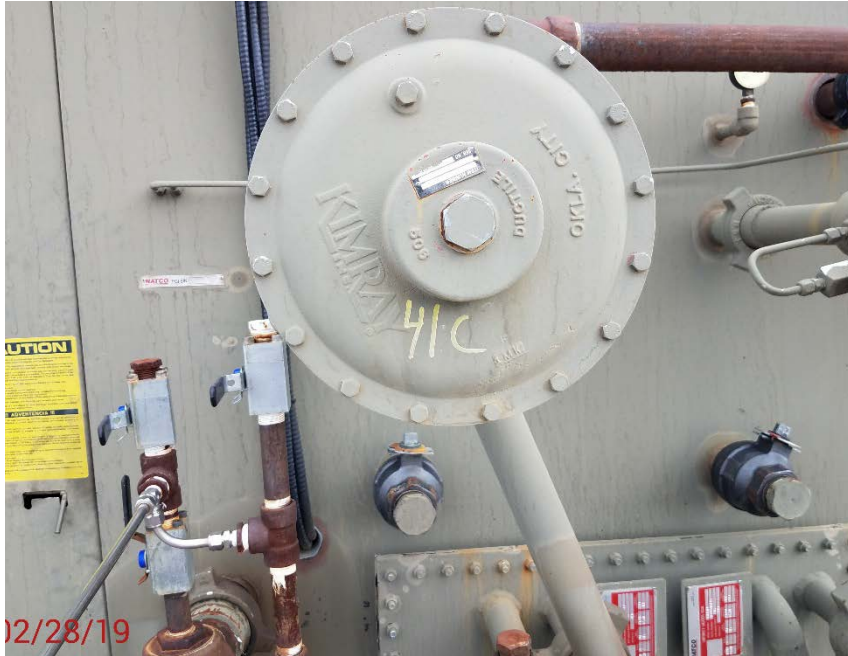
Location Photo #8, Separator 41C has a leaking fitting.

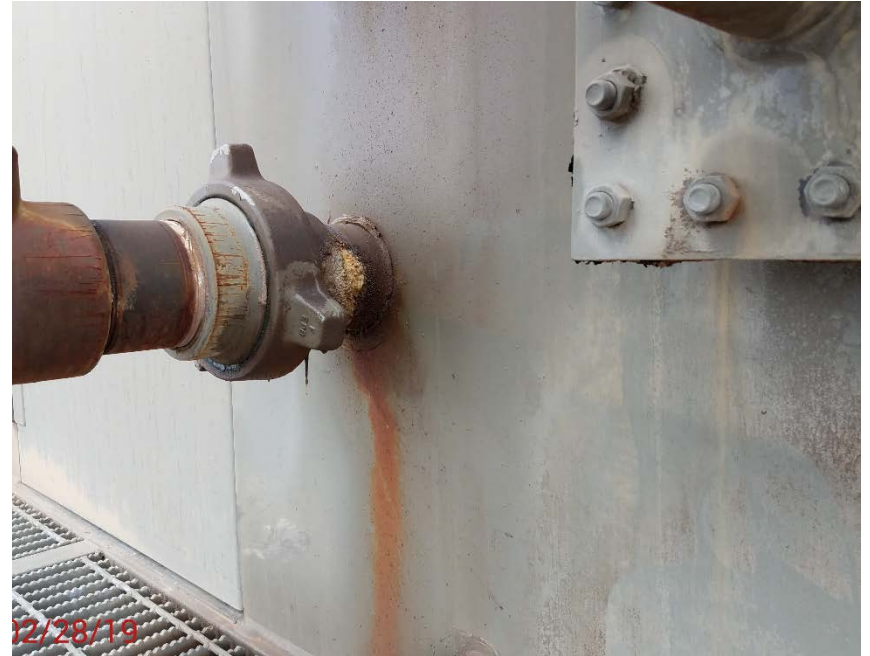
Location Photo #9, 41C leaking fitting.

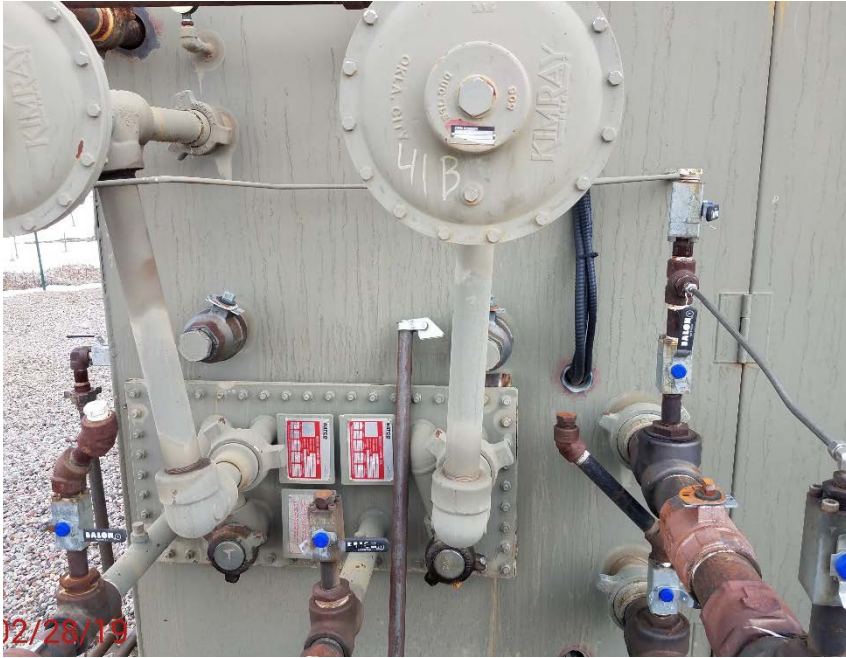
Location Photo #10, 41B has 2 leaking fittings.

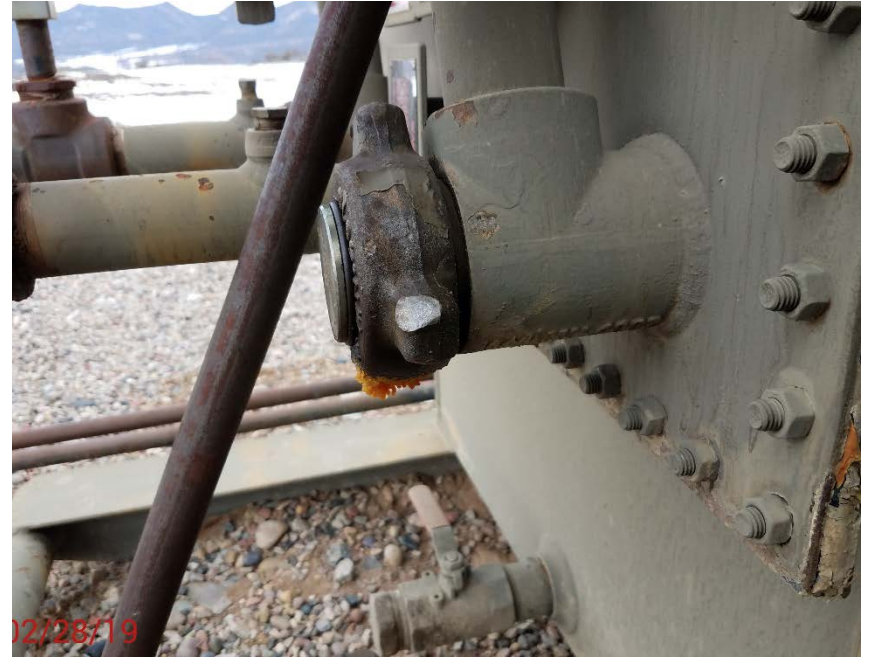
Location Photo #11, 41B 1 of 2 leaking fitting.

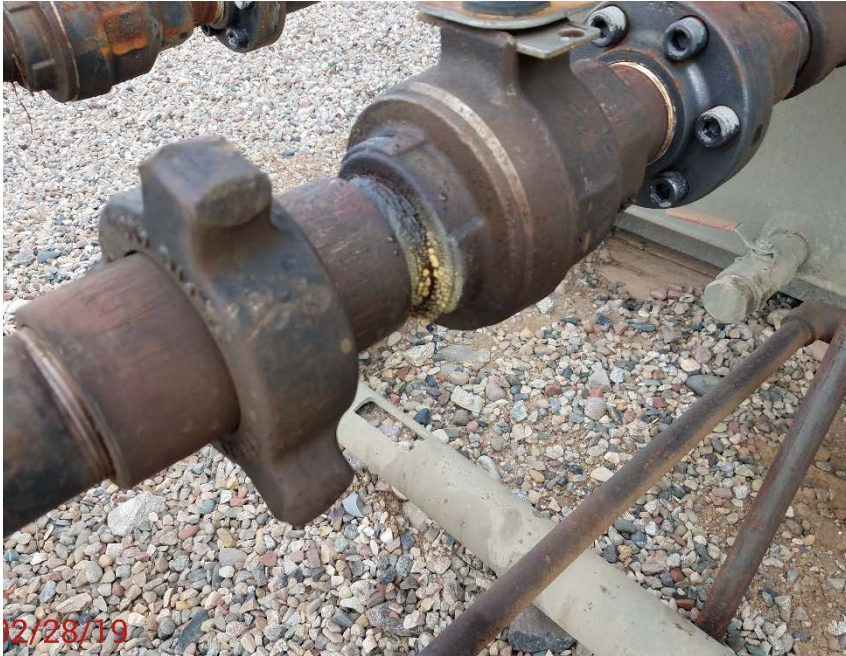
Location Photo #12, 41B 2 of 2 leaking fitting.
