Construction and Stormwater Inspection

February 21, 2019

Operator: NICKEL ROAD OPERATING LLC #10669

Inspection Photos
Location Name: DRAKE PAD
Location ID: 454899

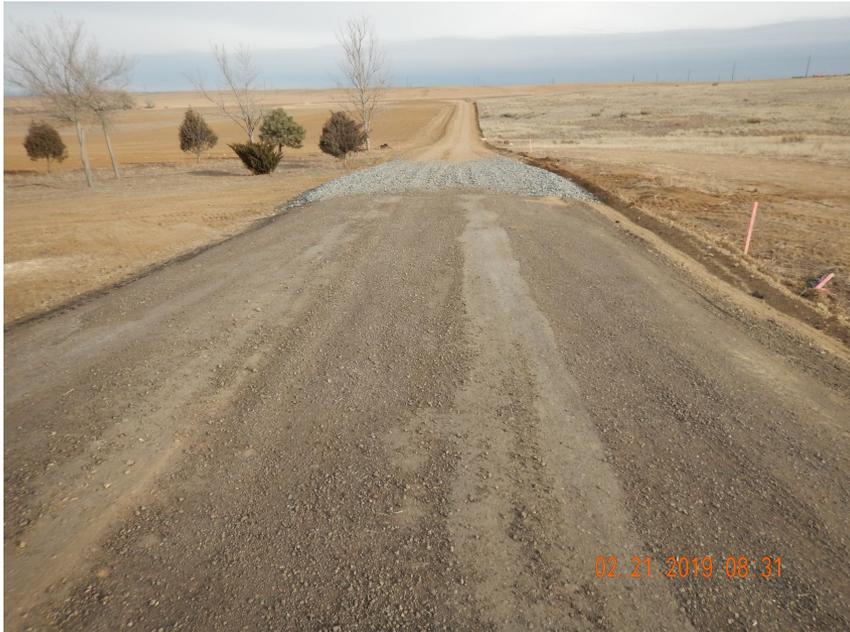
Photo 1. Photo taken from the entrance of the location off HWY 14, facing North. Photo illustrates vehicle track device BMPs have been installed and appear to be in proper functioning condition.

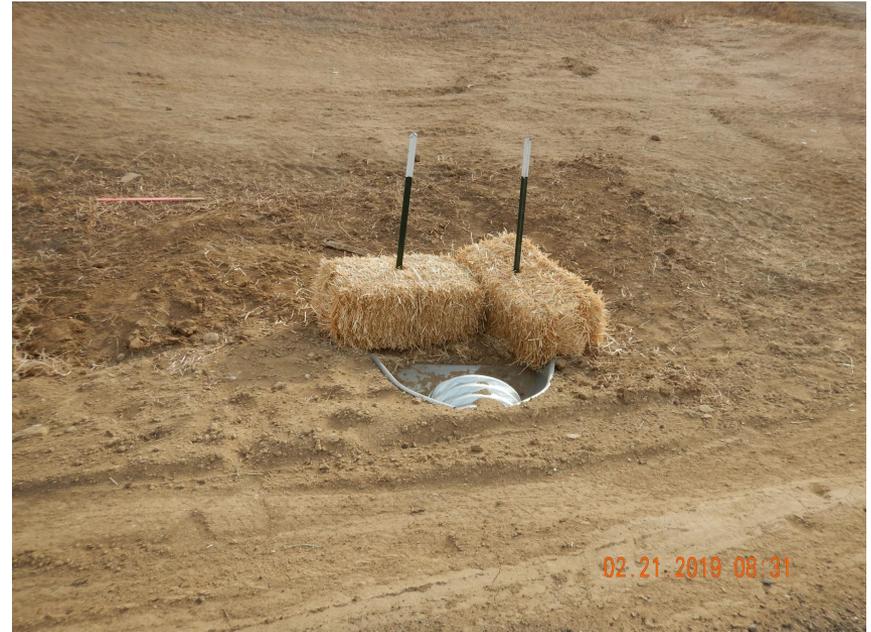
Photo 2. Photo taken along the access road, facing West. Photo illustrates straw bales used as stabilized outlets along the culverts.

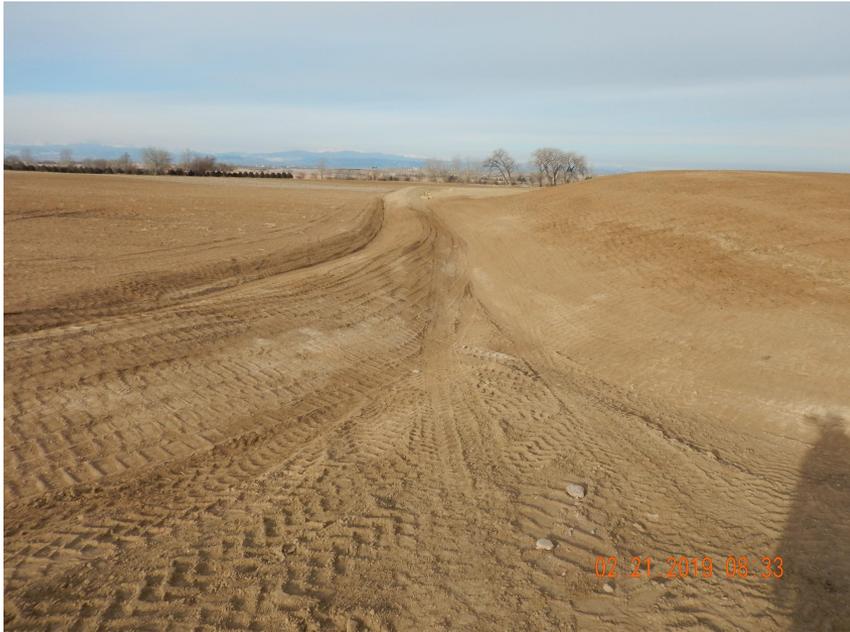
Photo 3. Photo taken from the southeastern perimeter of the location, facing West. Photo illustrates two sets of ditch and berms.

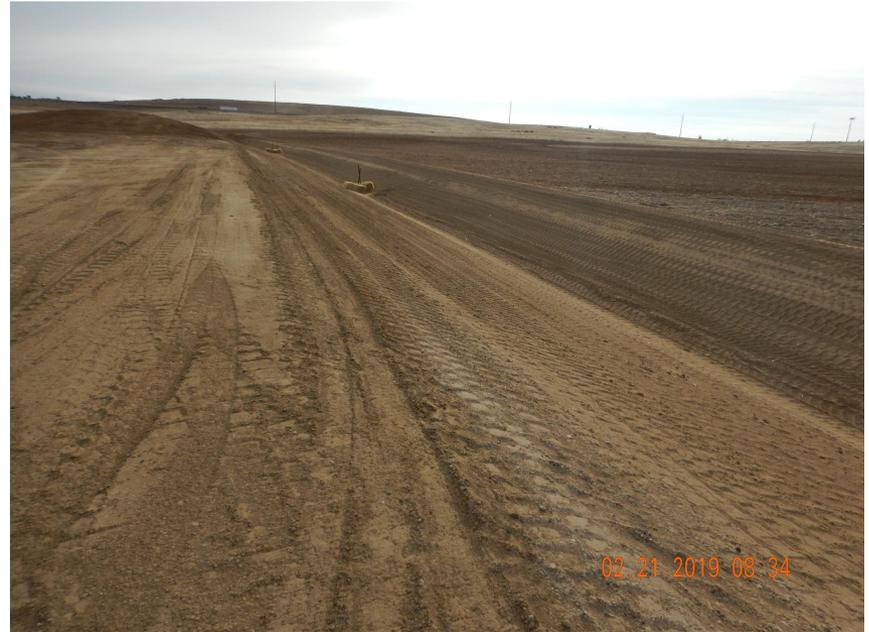
Photo 4. Photo taken from the southwestern perimeter of the location, facing East. See comments under Photo 3. Also, photo illustrates straw bales installed as check dams within the ditch BMP and rock is also used as check dams within the ditch BMP.

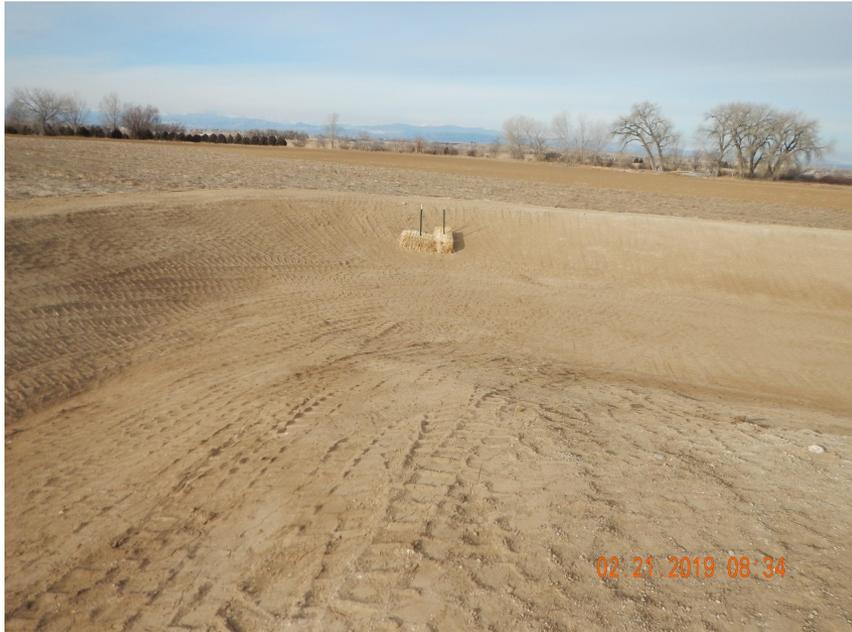
Photo 5. Photo taken from the southwestern perimeter of the well pad, facing West. Photo illustrates the retention area.

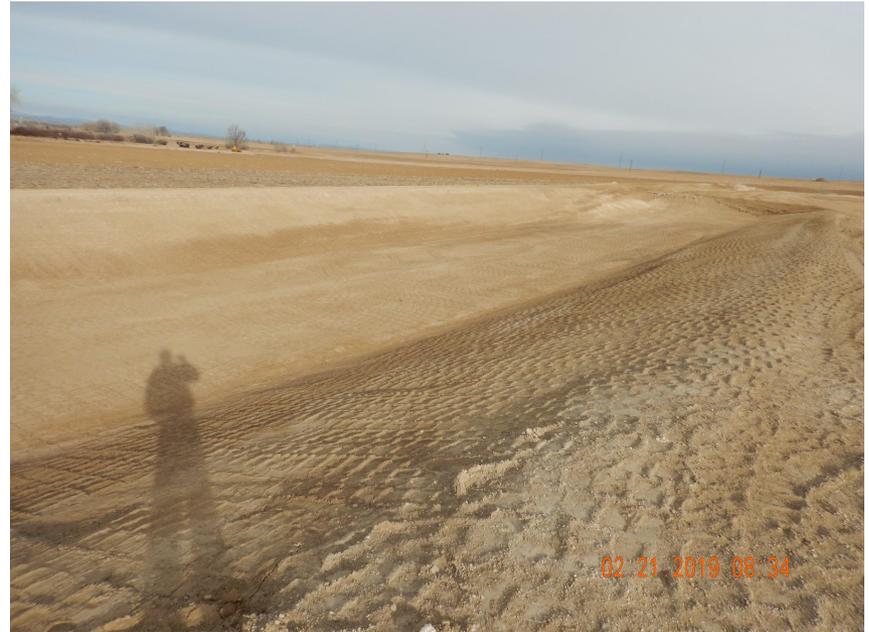
Photo 6. Photo taken from the southwestern perimeter of the well pad, facing Northwest. See comments under Photo 5.

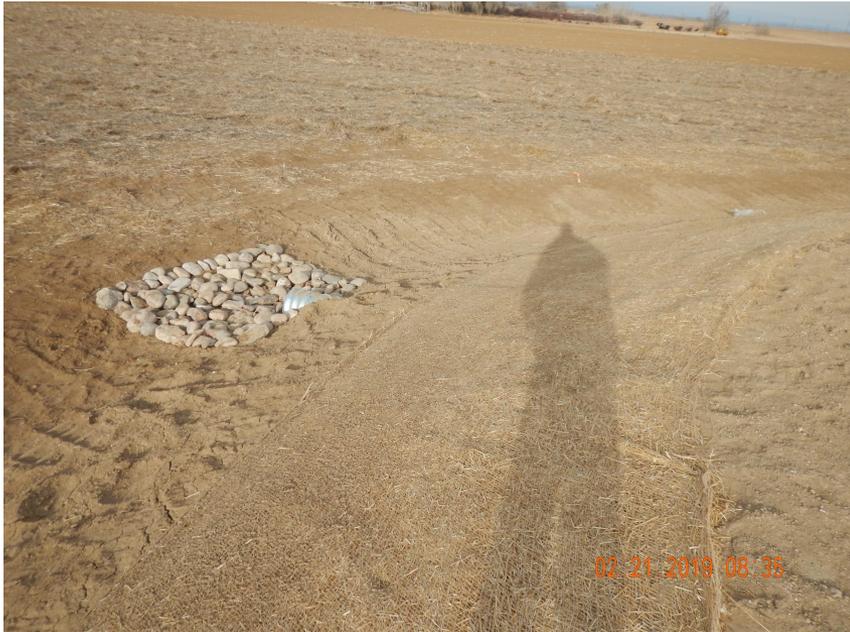
Photo 7. Photo taken from the southwestern perimeter of the location, facing West. Photo illustrates the stabilized outlet from the retention area. Erosion control blankets have been installed along portions of fill slopes.

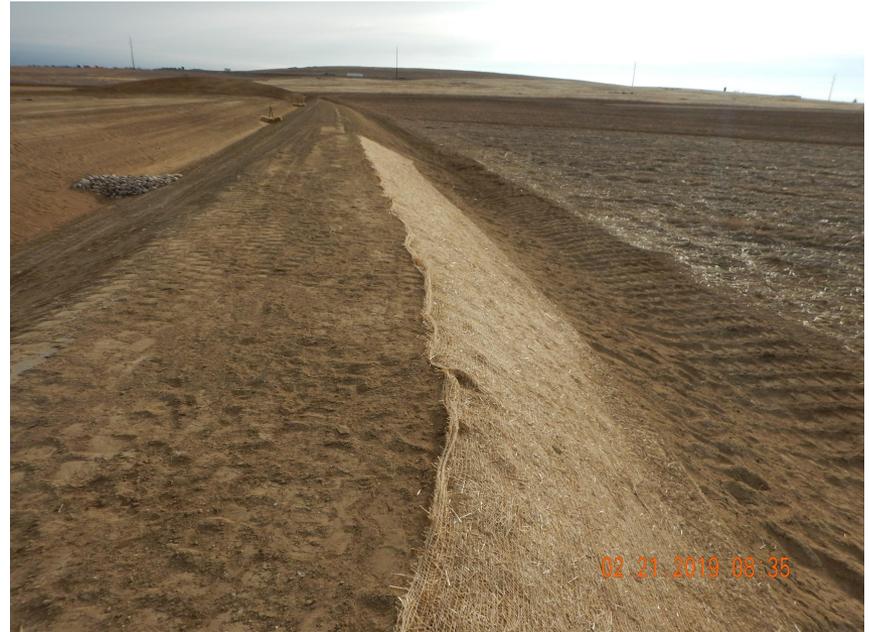
Photo 8. Photo taken from the southwestern perimeter of the location, facing East. See comments under Photo 7.

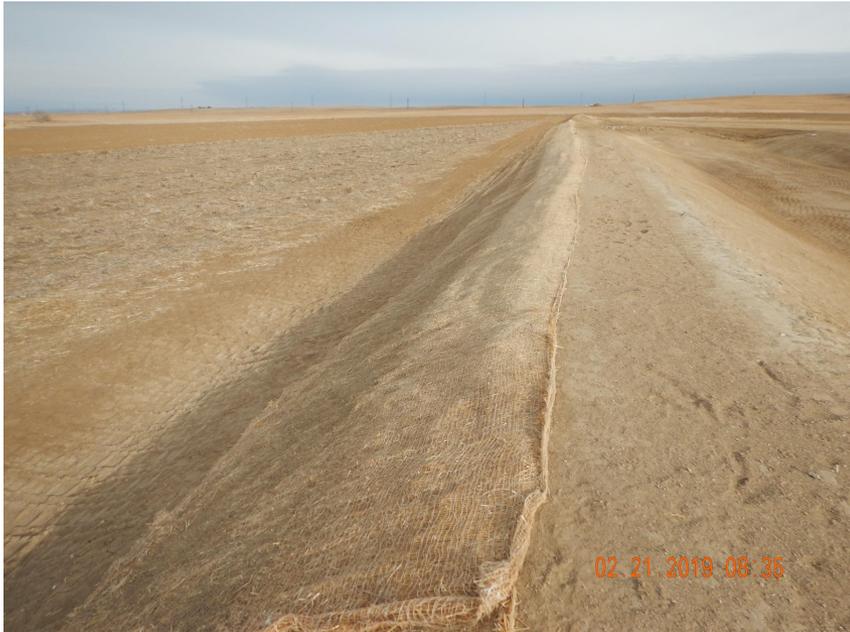
Photo 9. Photo taken from the southwestern perimeter of the location, facing North. See comments under Photo 7.

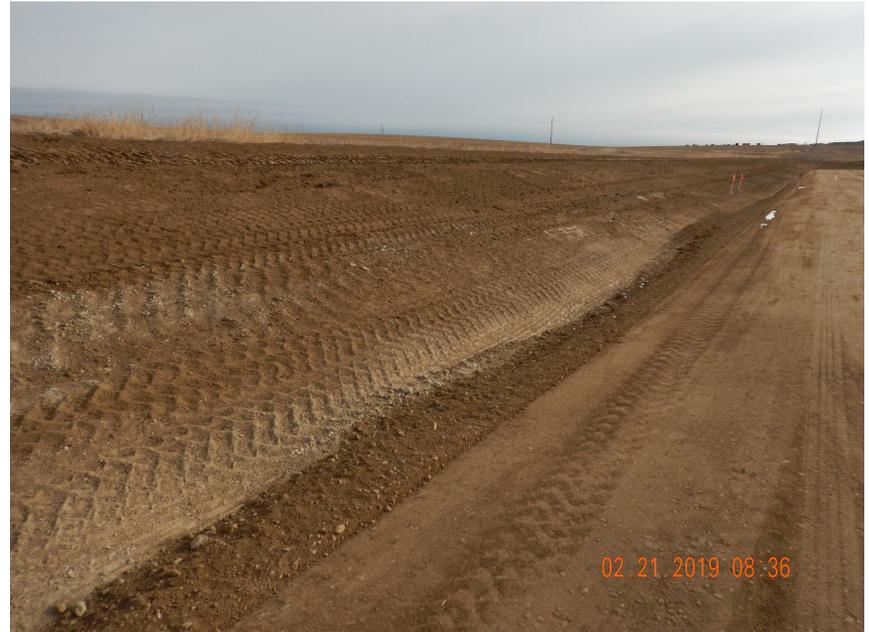
Photo 10. Photo taken from the northern perimeter of the well pad, facing East. Operator shall stabilize cut slopes.

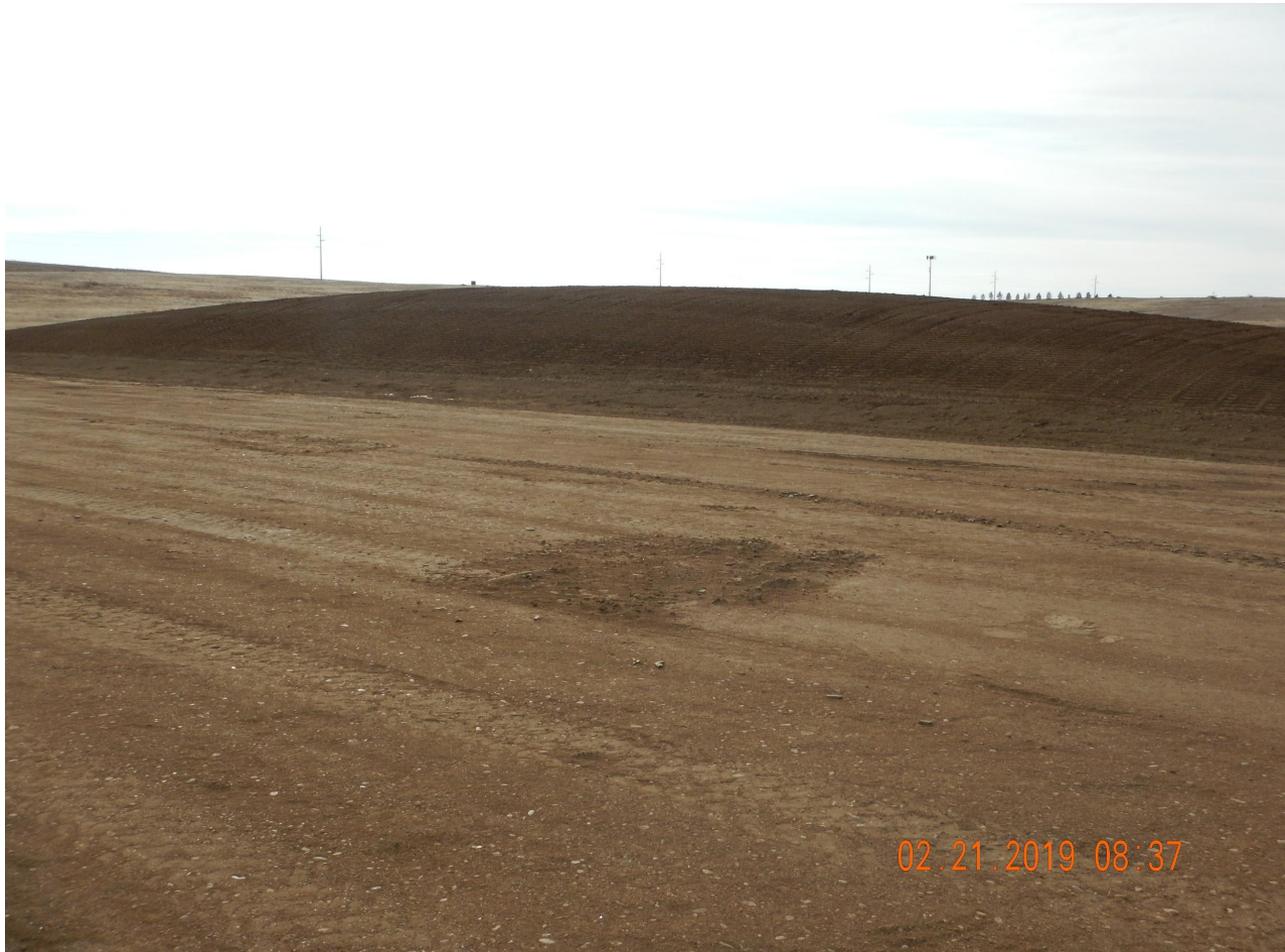
Photo 11. Photo taken from the southern well pad, facing South. Photo illustrates the topsoil stockpile which has been temporarily stabilized with equipment tracking.
