Final Reclamation and Stormwater Inspection

March 1, 2019

Operator: NOBLE ENERGY INC # 100322

Location ID: 327252

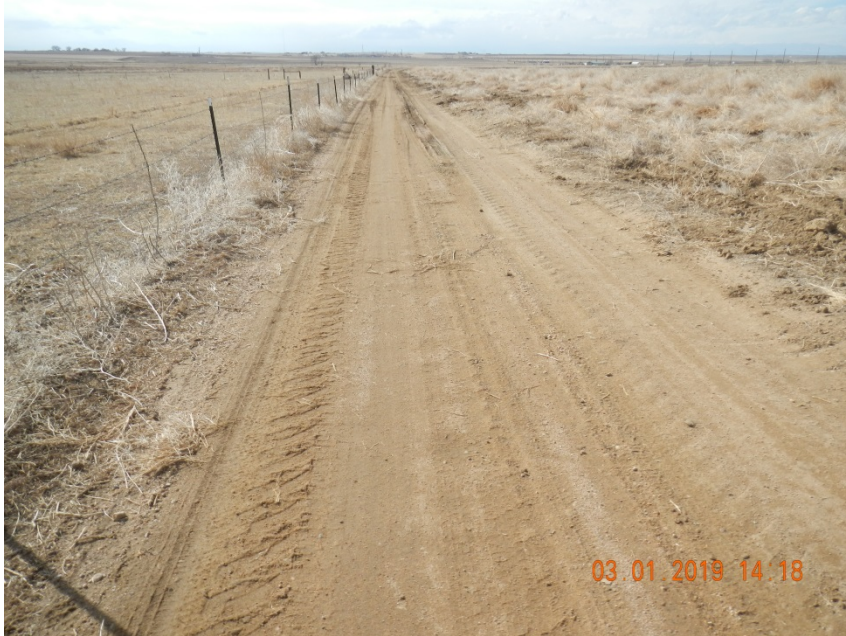
Photo 1. Photo taken from the access road off CR 55, facing West. Photo depicts current access road condition.

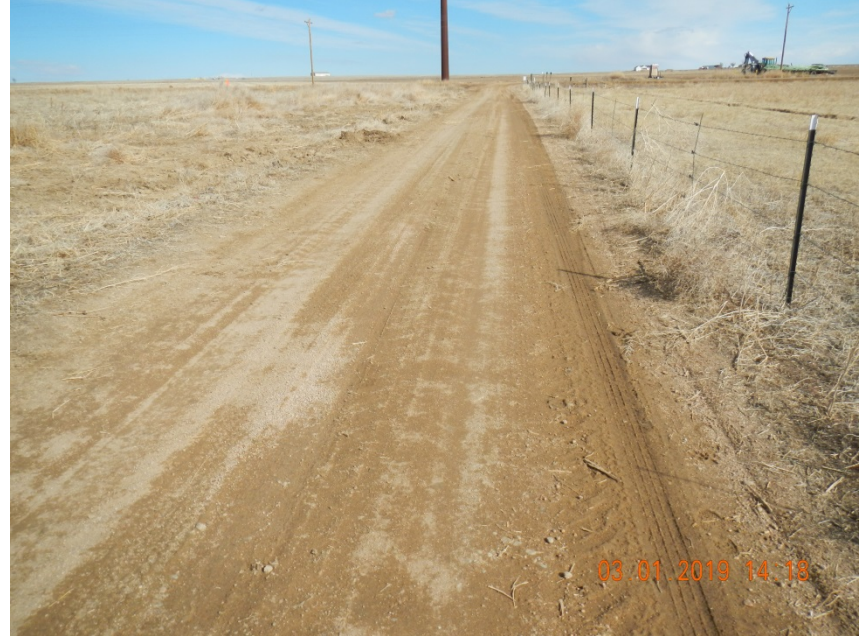
Photo 2. Photo taken from the access road off CR 55, facing East. Photo depicts current access road condition.

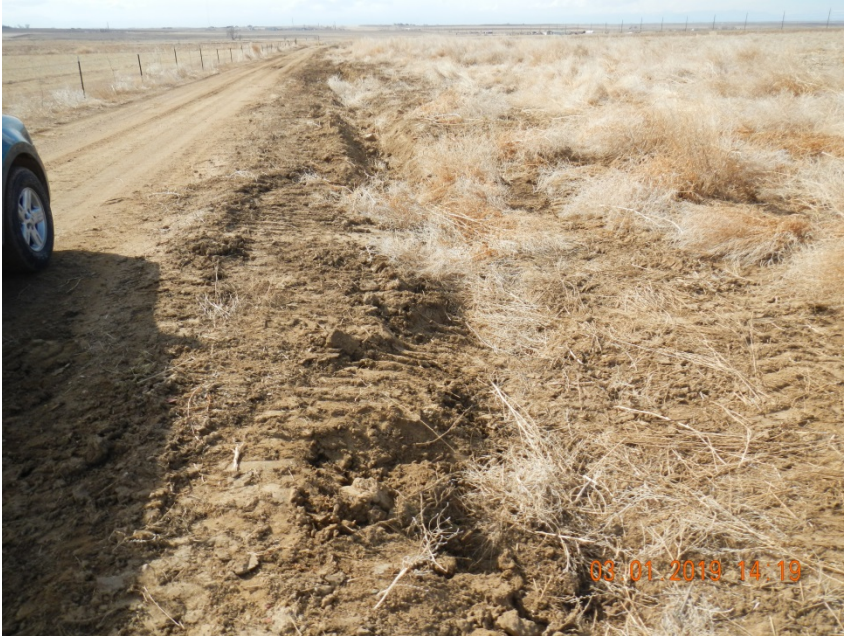
Photo 3. Photo taken from the access road, facing West. Photo depicts recent pipeline removal work on the north side of the road.

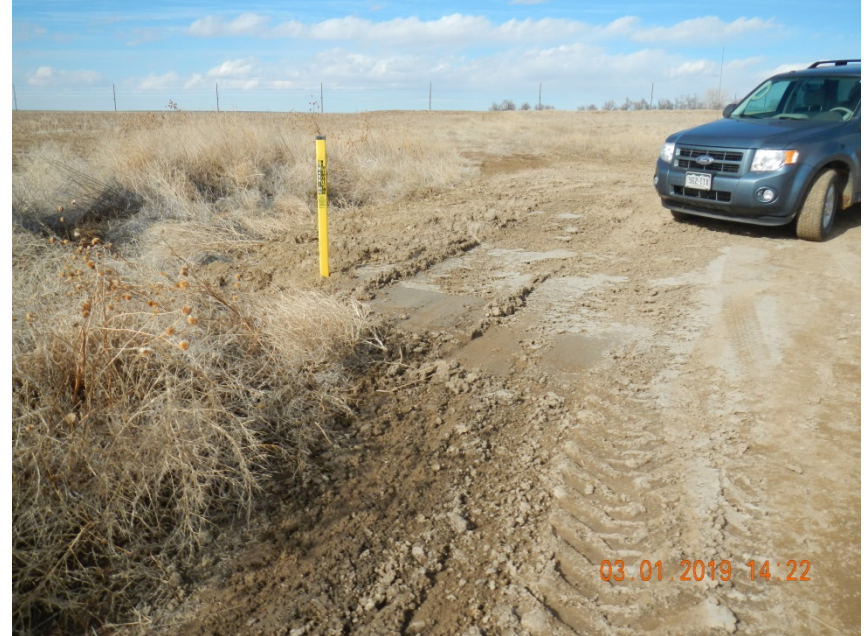
Photo 4. Photo taken from the location, facing North. Photo depicts recent pipeline removal work and a new line marker installed according to the complainant.

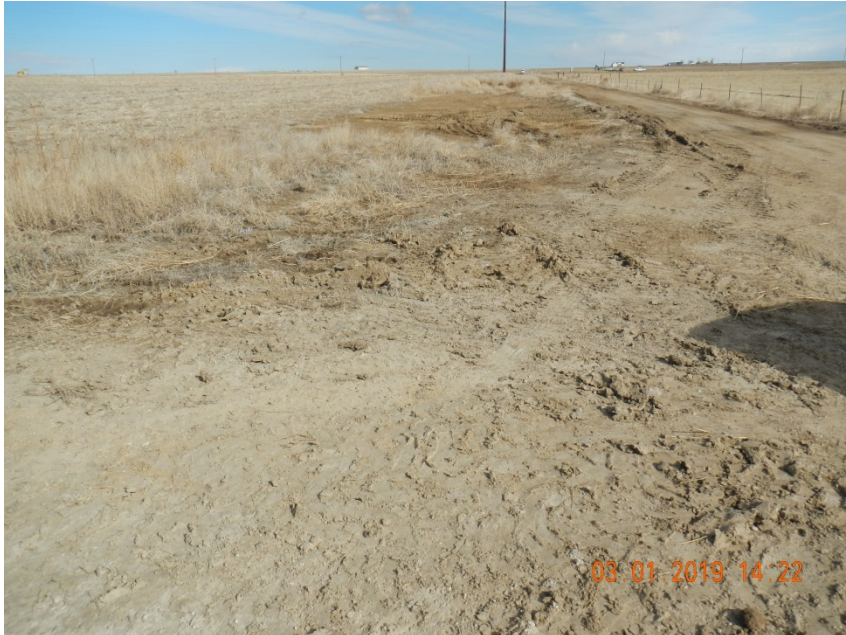
Photo 5. Photo taken from the location, facing East. Photo depicts recent pipeline and tank battery removal work according to the complainant.

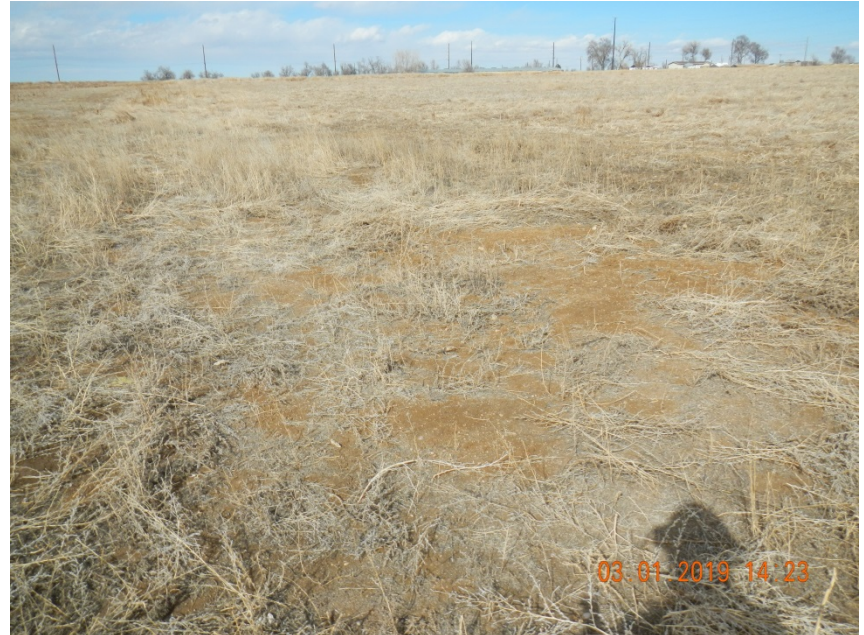
Photo 6. Photo taken from the location, facing North. Appears the operator has not performed reclamation activities with gravel remaining on location.

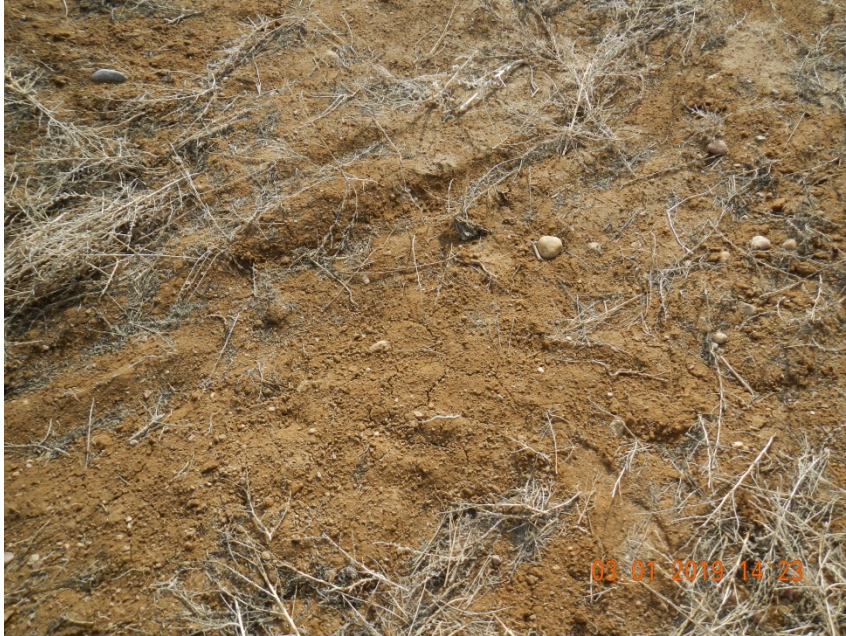
Photo 7. Photo taken from the location. See comments from Photo 6.

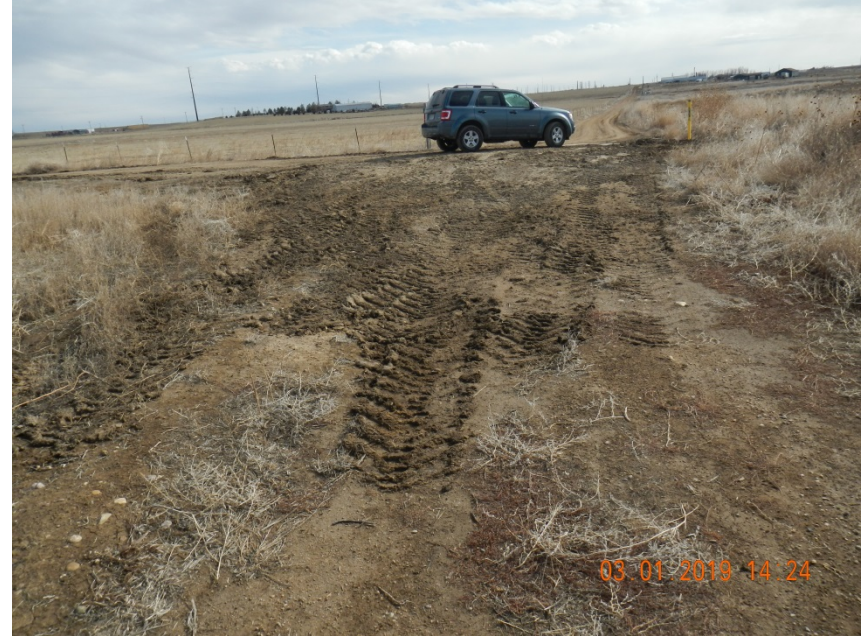
Photo 8. Photo taken from the location, facing South. Photo depicts the recent pipeline removal work in the background and the remaining access road and gravel in the foreground.

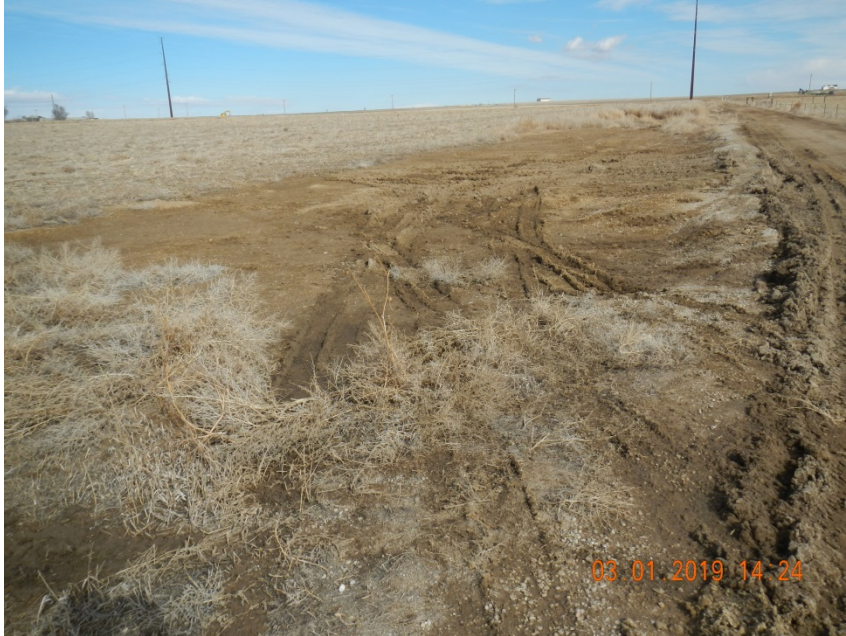
Photo 9. Photo taken from the location, facing East. Photo depicts recent pipeline and tank battery removal work according to the complainant.

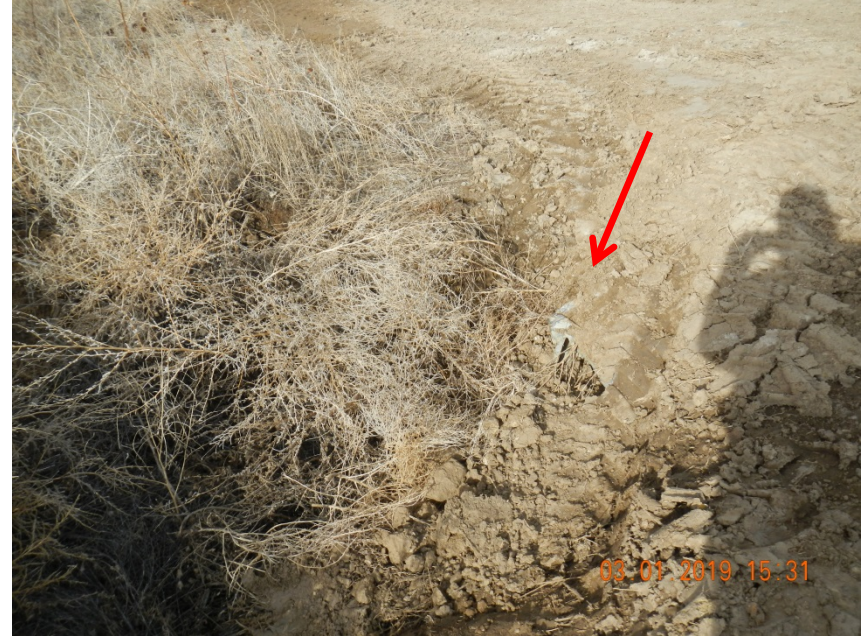
Photo 10. Photo taken from the western perimeter of the location. Photo depicts the culvert that was damaged/crushed during the pipeline removal work.

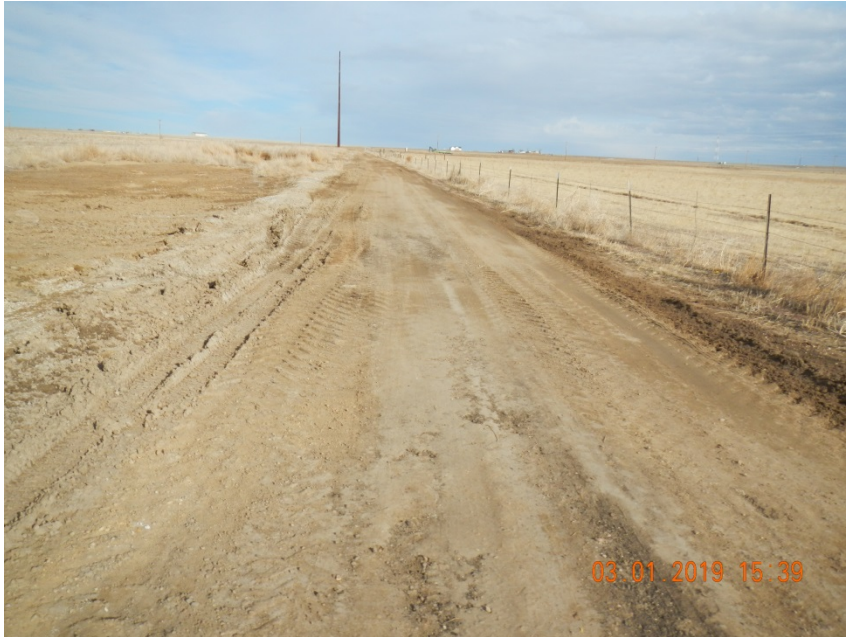
Photo 11. Photo taken from the location, facing East.
Photo depicts current access road condition.

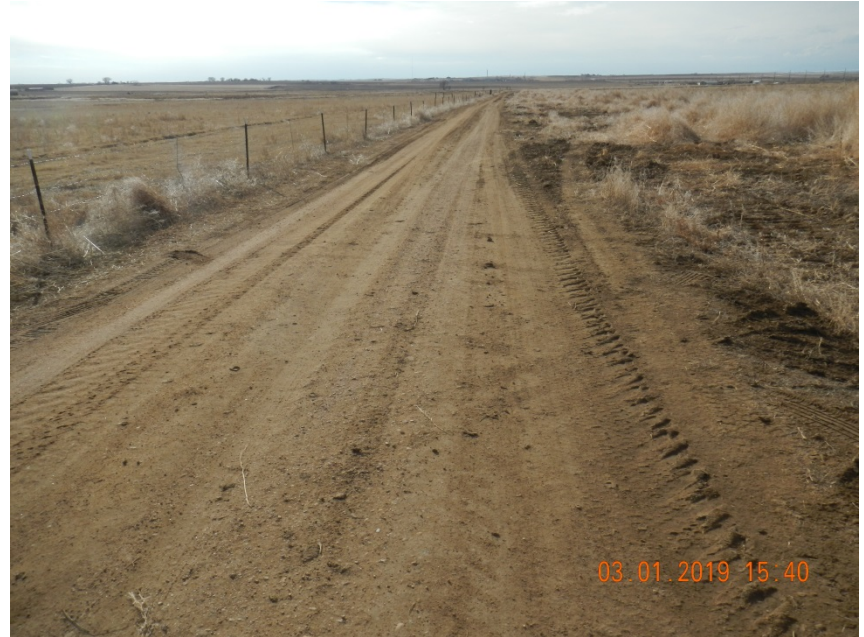
Photo 10. Photo taken from the access road, facing West.
Photo depicts current access road condition.
