Inspection Photos

Facility ID: 257675

Operator: PIONEER NATURAL RESOURCES

Inspection Date: 3/1/2019

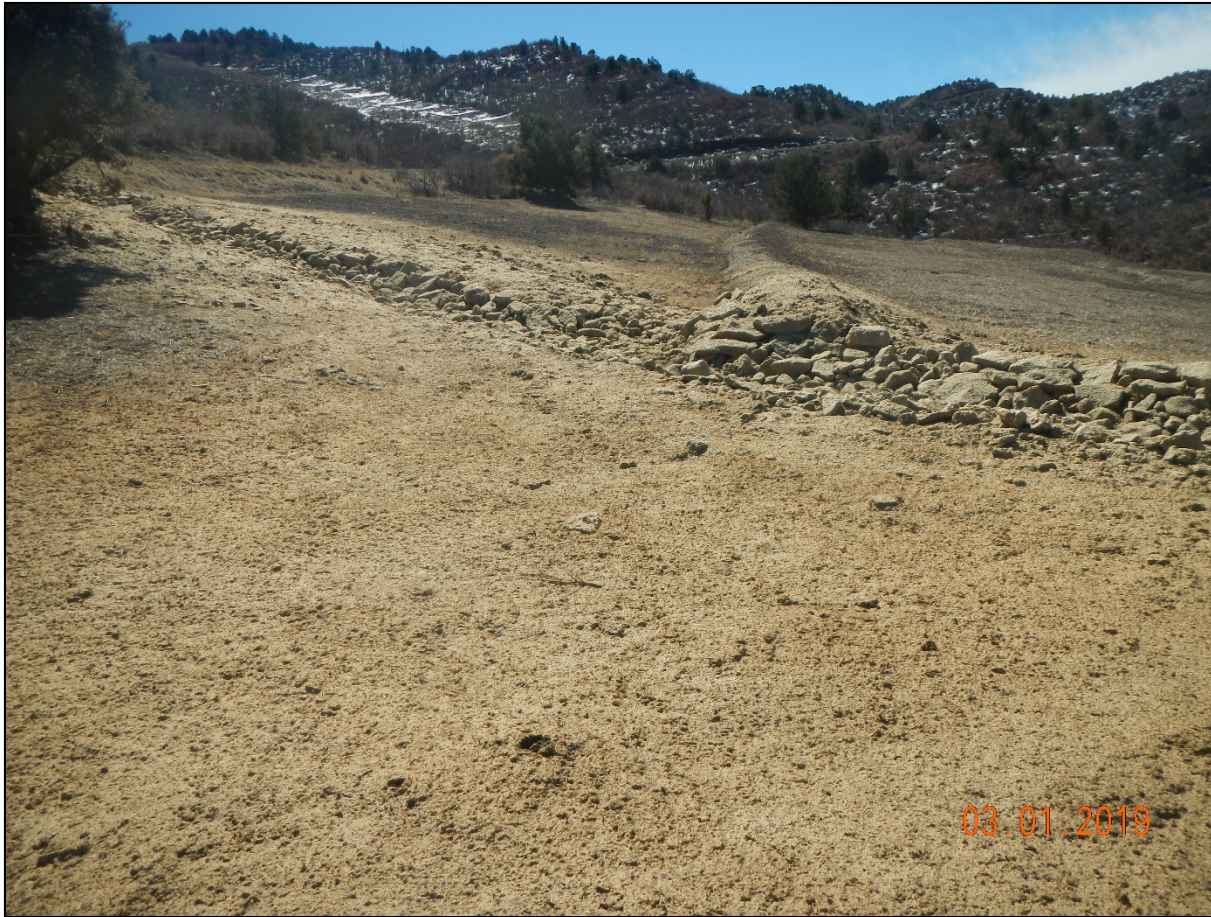
Photo 1. Facing south toward the recontoured and reclaimed location. Pit has been backfilled and closed.

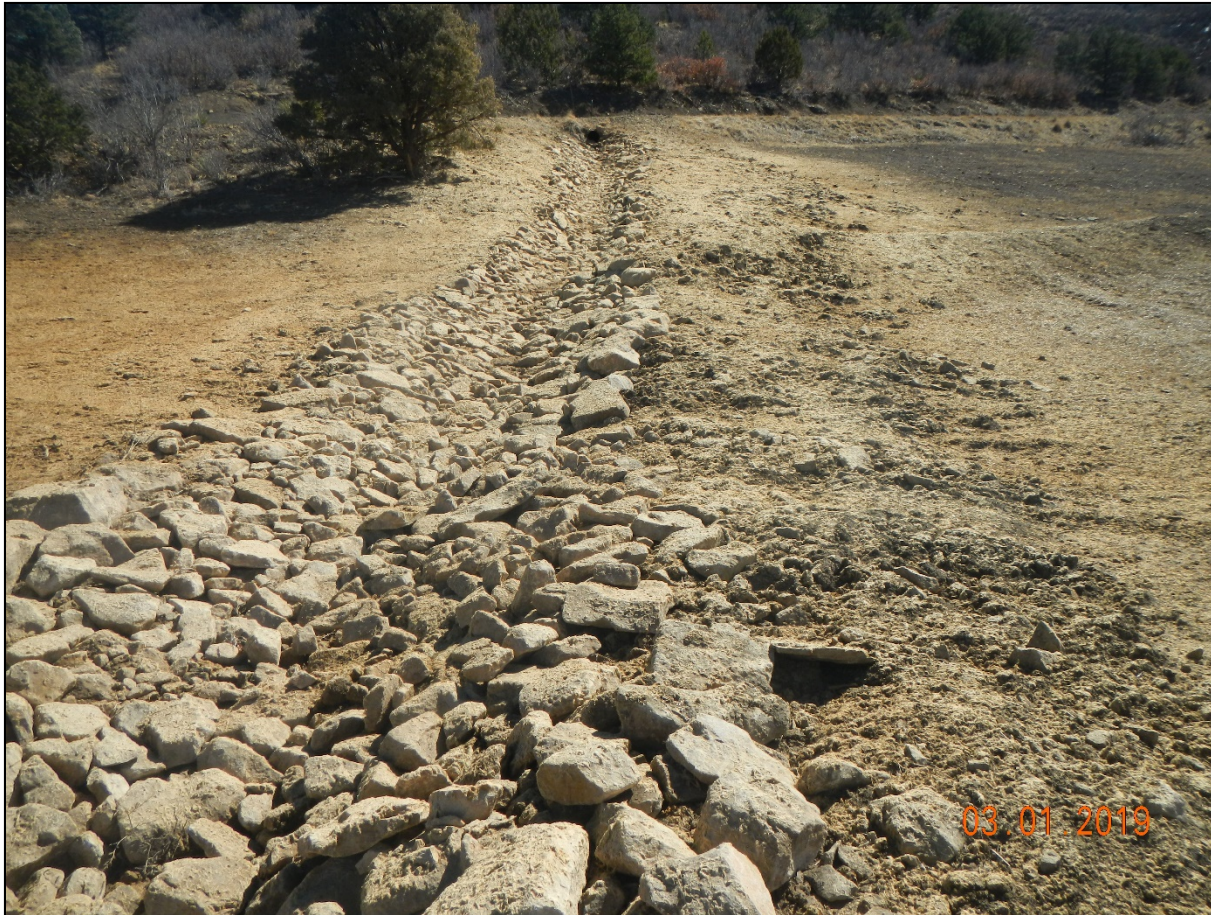
Photo 2. Rock rip/rap is placed in the drainage channel.

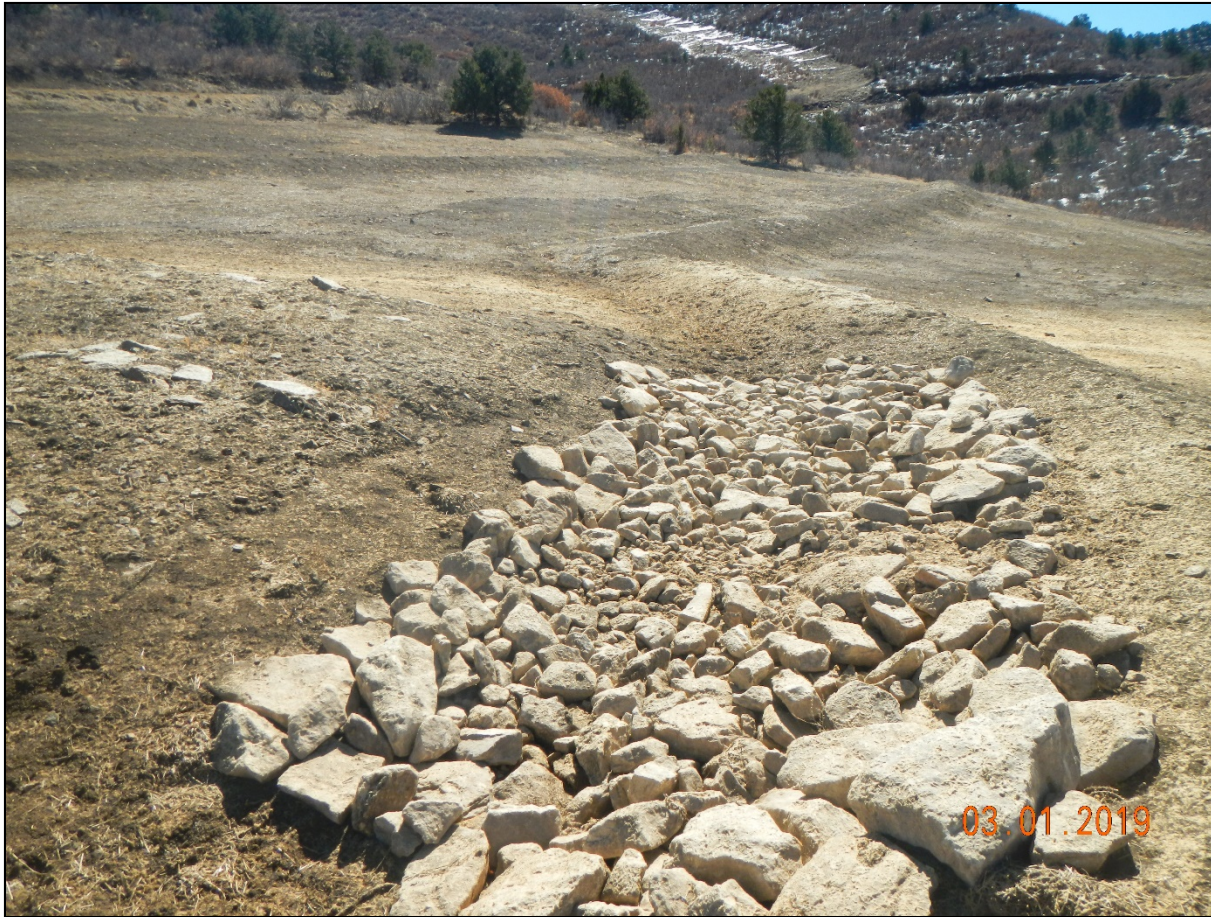
Photo 3. Facing south toward the recontoured and reclaimed location. Pit has been backfilled and closed.
