Inspection Photos
Operator: Ausco Petroleum Inc.
Location/API #: 043-06231
Date: 2/26/2019

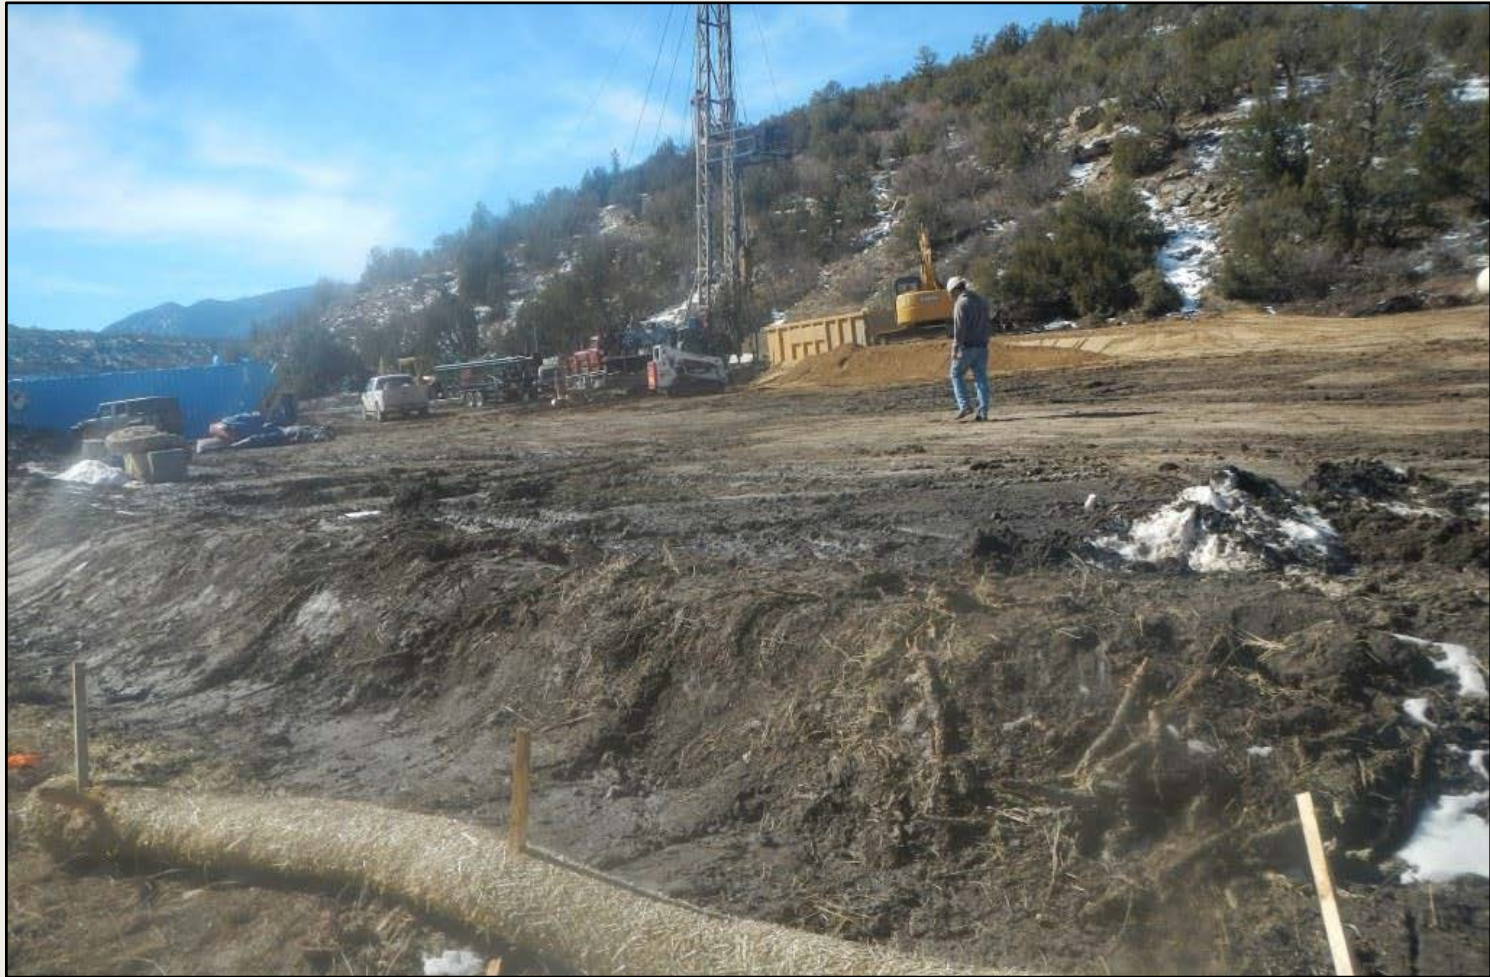
Photo 1. View of the project area from the northeastern corner facing center. Berms contain vegetation and are likely comprised of topsoil.

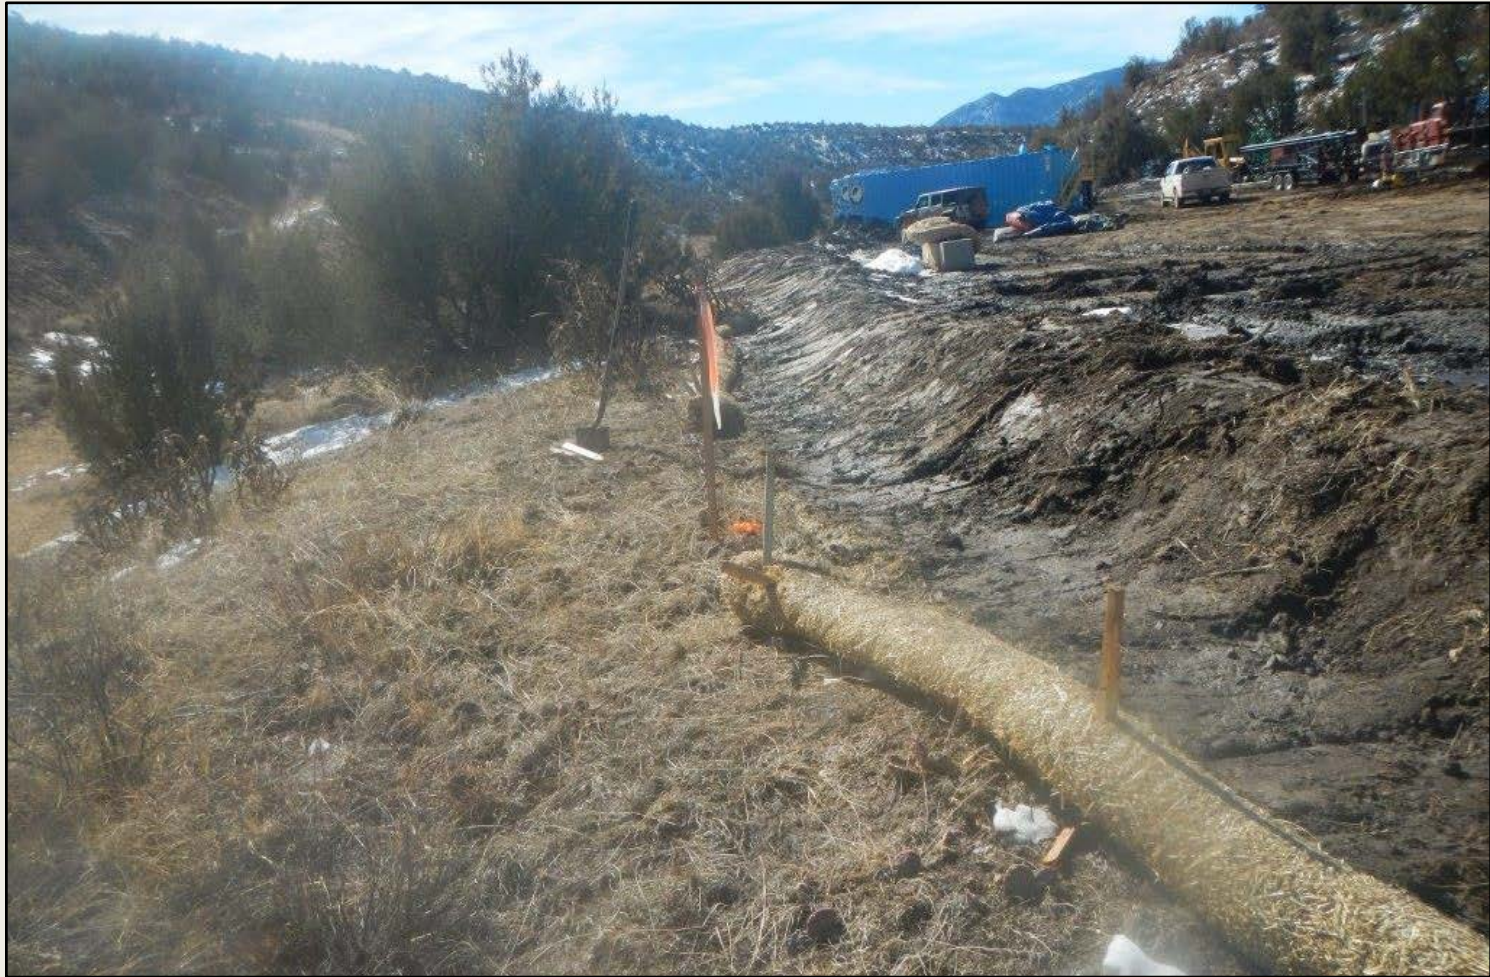
Photo 2. View of the eastern portion of the project area from the northeastern corner facing southward. Wattles are not properly installed due to lack of trenching, and gaps along the boundary remain.

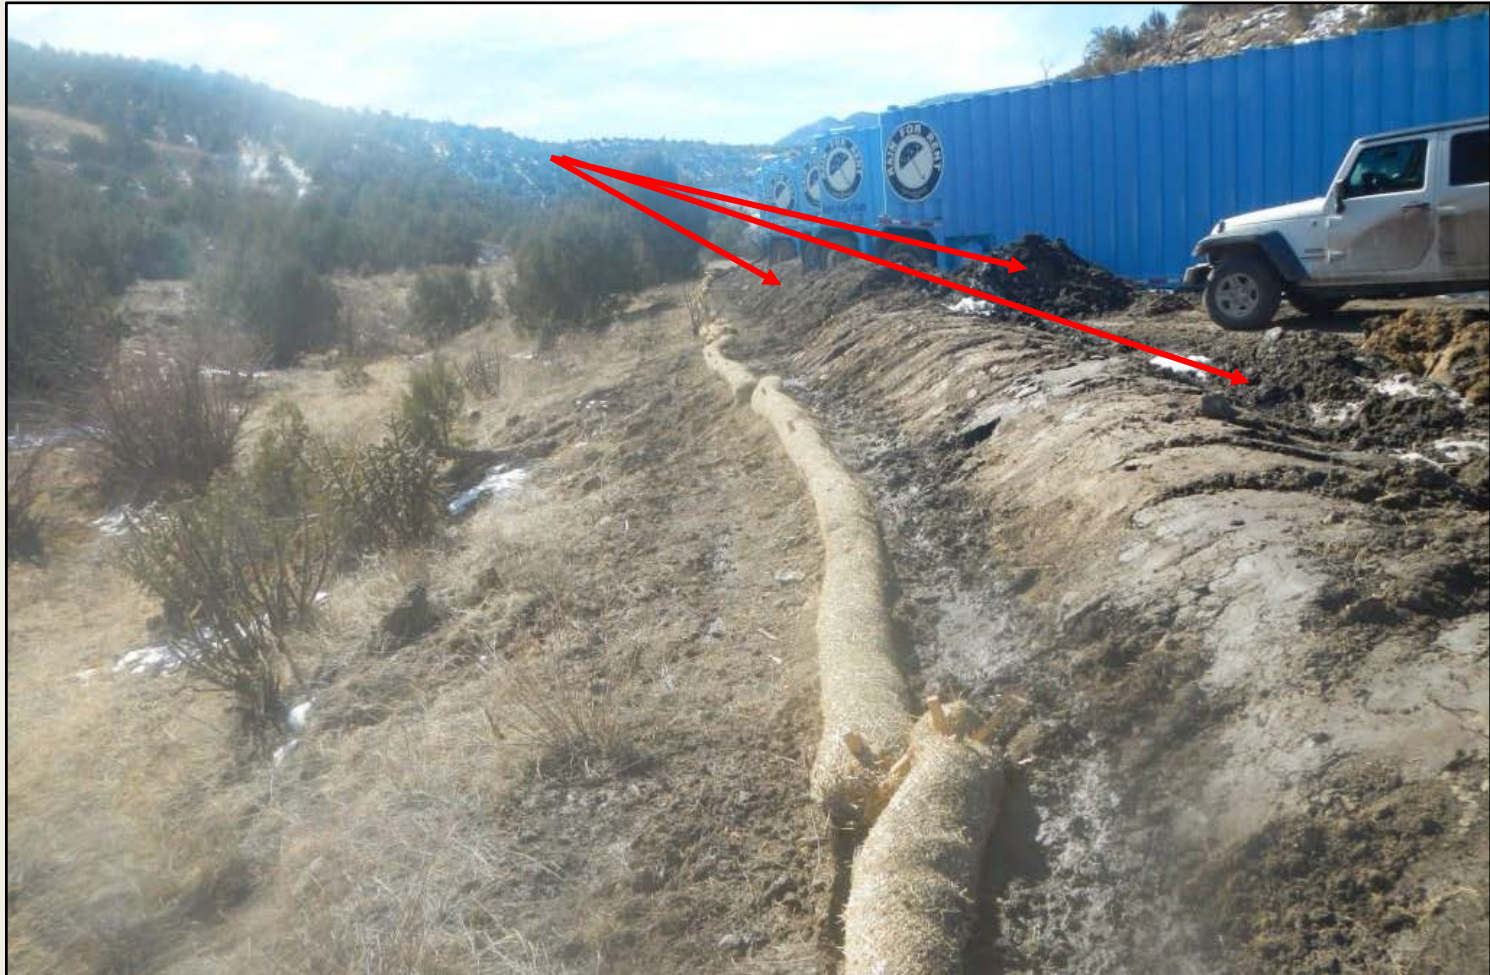
Photo 3. View of the southeastern edge of the project area from the eastern edge facing southward. Wattles are not properly placed as loose soil down slope from wattles needs stabilization, and wattles are not properly installed (see Photo 2). Arrows indicate improperly salvaged and protected topsoil.

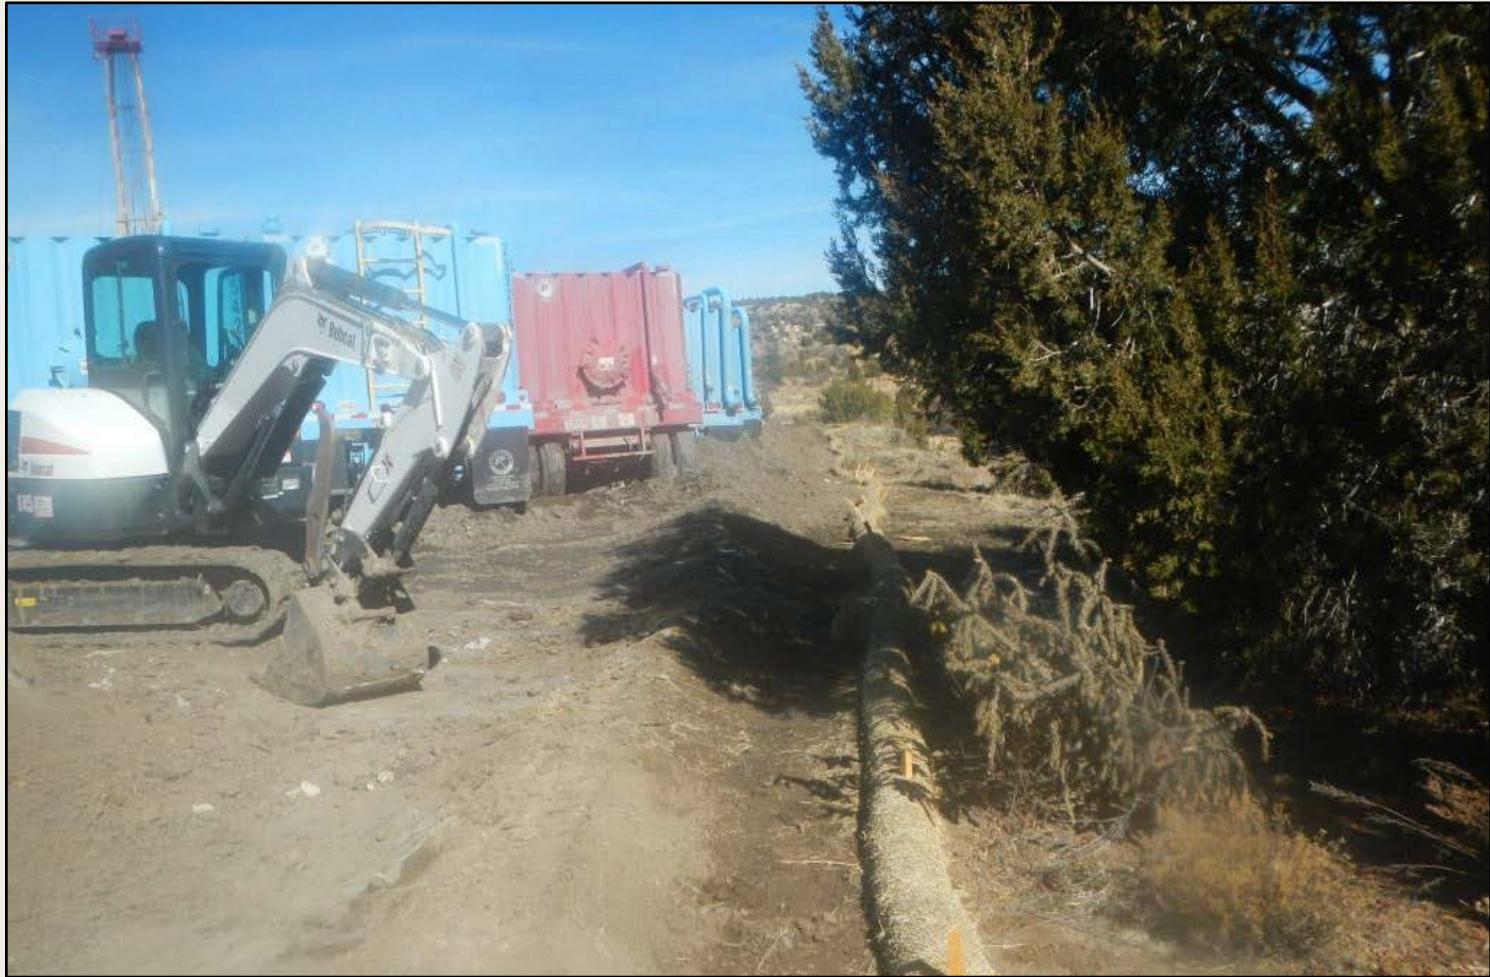
Photo 4. View of the eastern project area from the southeastern corner facing southward. Berms appear to be comprised of topsoil and are not properly installed. Controls in place do not appear to be sufficient to control stormwater from the location.

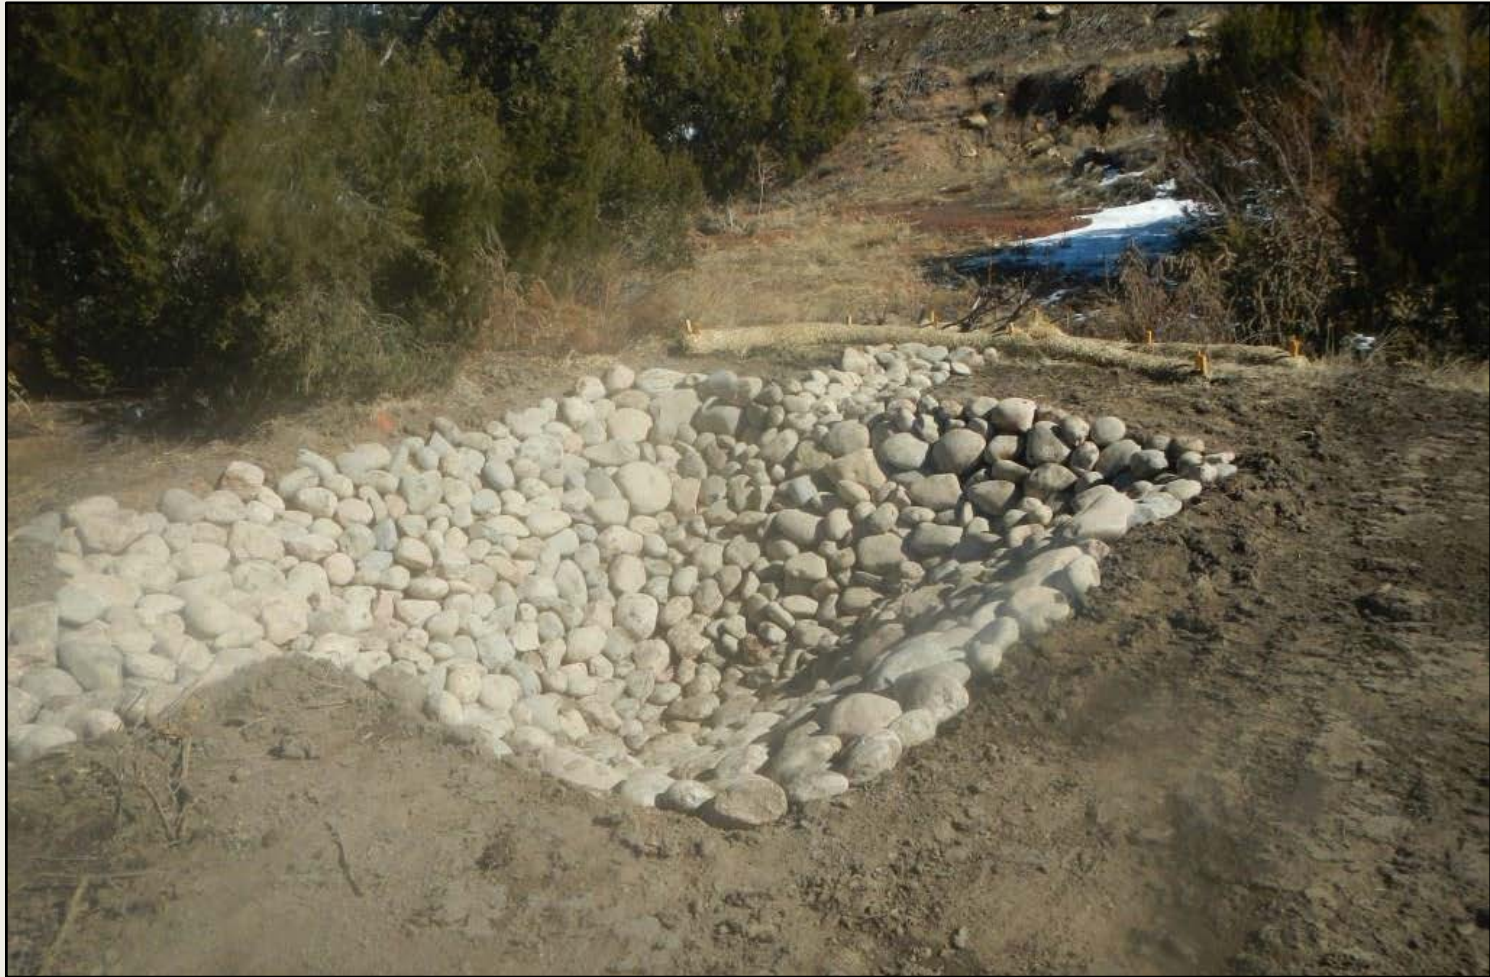
Photo 5. View of sediment trap run-on control, in the southeastern project area; recently redesigned. However, sediment trap has not been properly constructed due to the use of rounded cobble which is not considered a good engineering practice. It is expected that stormwater flows will undermine the cobble material. Angular rock and geotextile fabric should be used per good engineering practices.

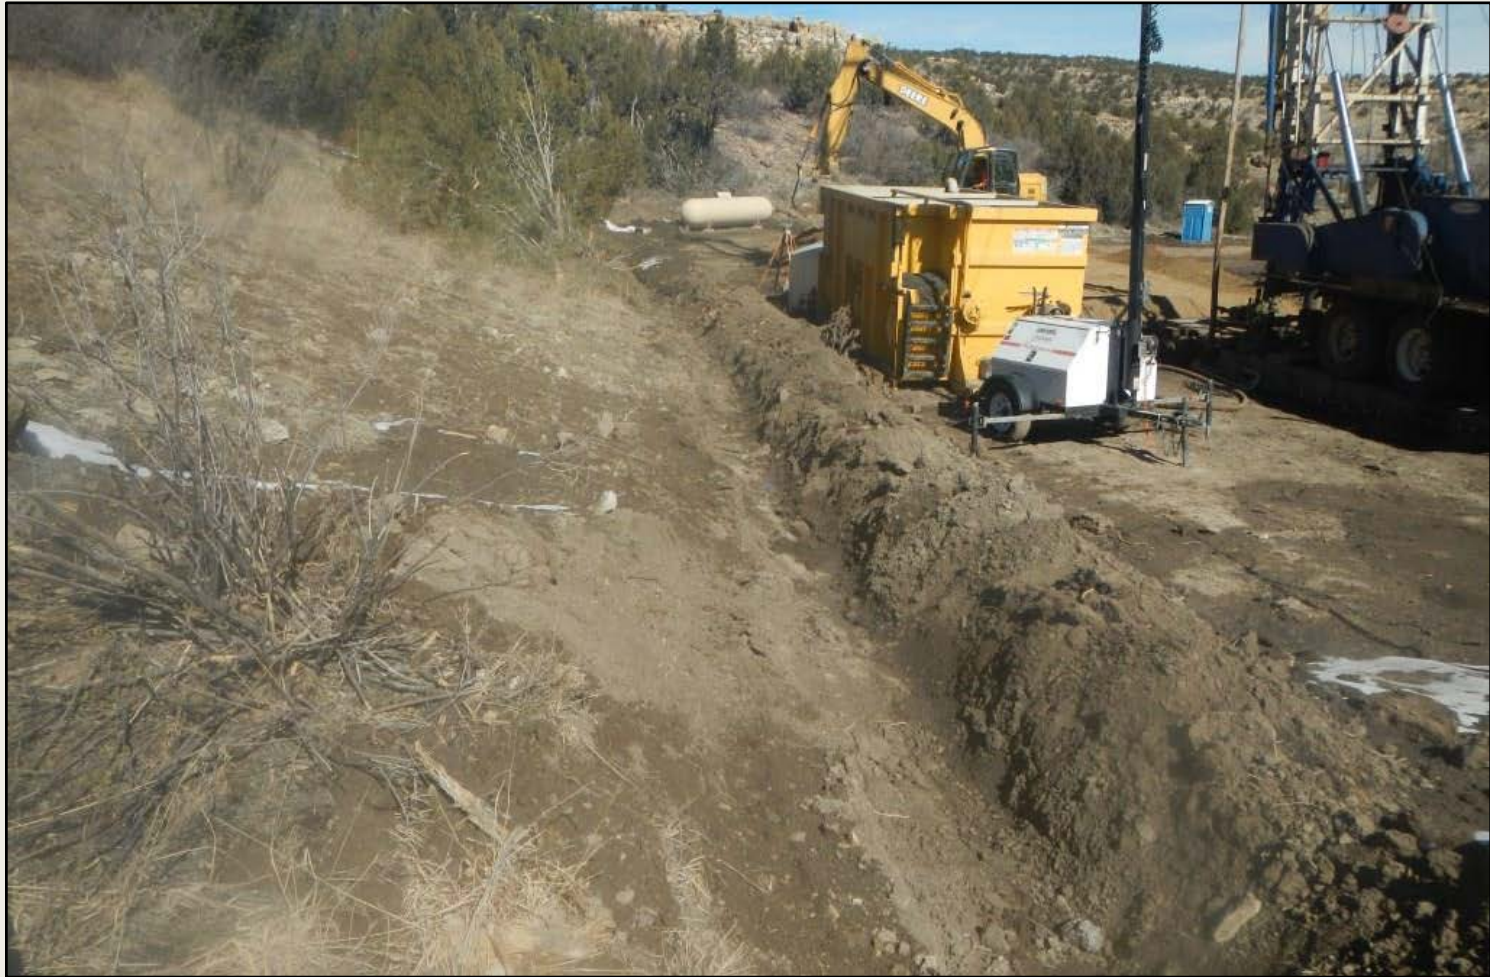
Photo 6. View of the western project area from the southwestern edge facing northward. Berms are not properly compacted and ditches are not stabilized. Loose soil within ditch bed will rapidly wash down gradient.

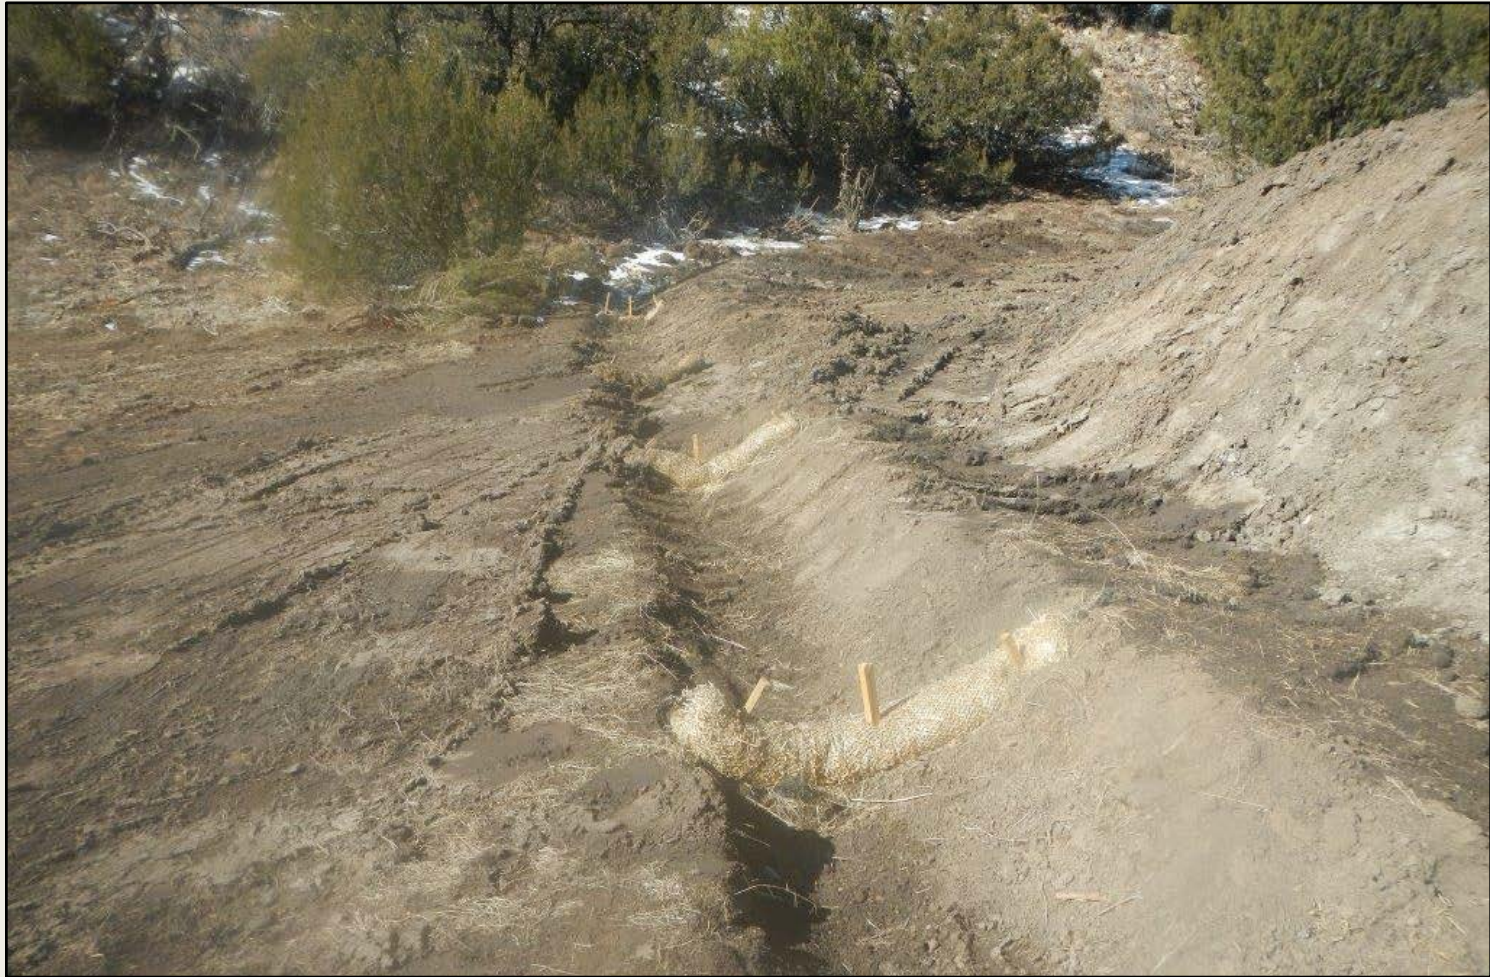
Photo 7. View of southern project area from the southeastern corner facing westward. Check dams not properly installed, or with the best engineering materials. Loose material remains in the ditch.

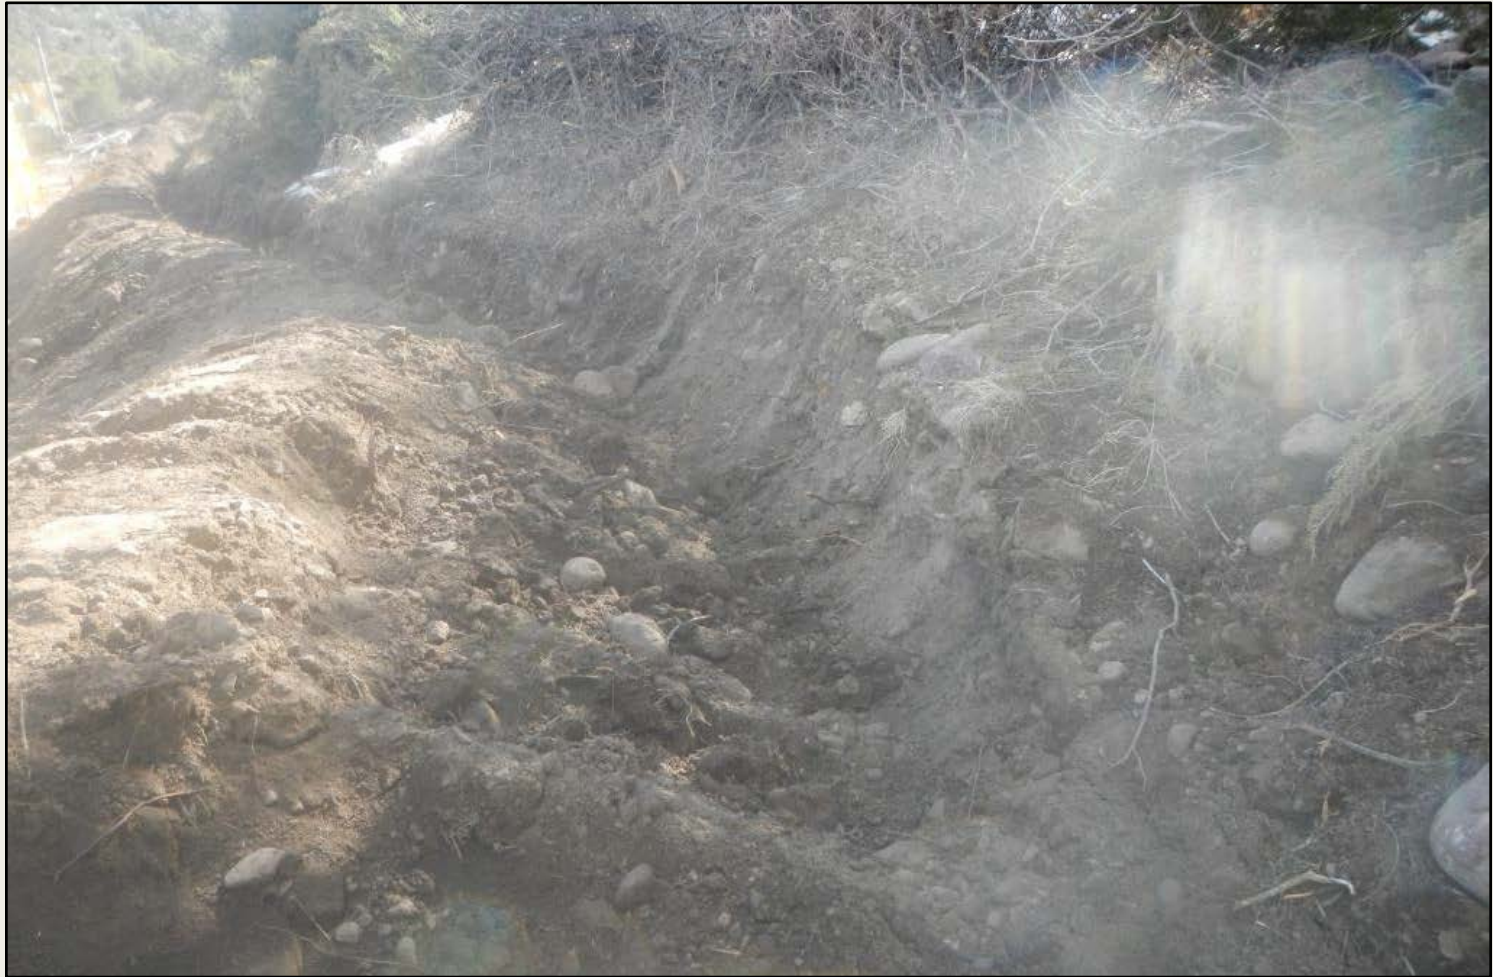
Photo 8. View of ditch within the western project area. Cut bank, berms and ditch bottom are not stabilized or properly installed.

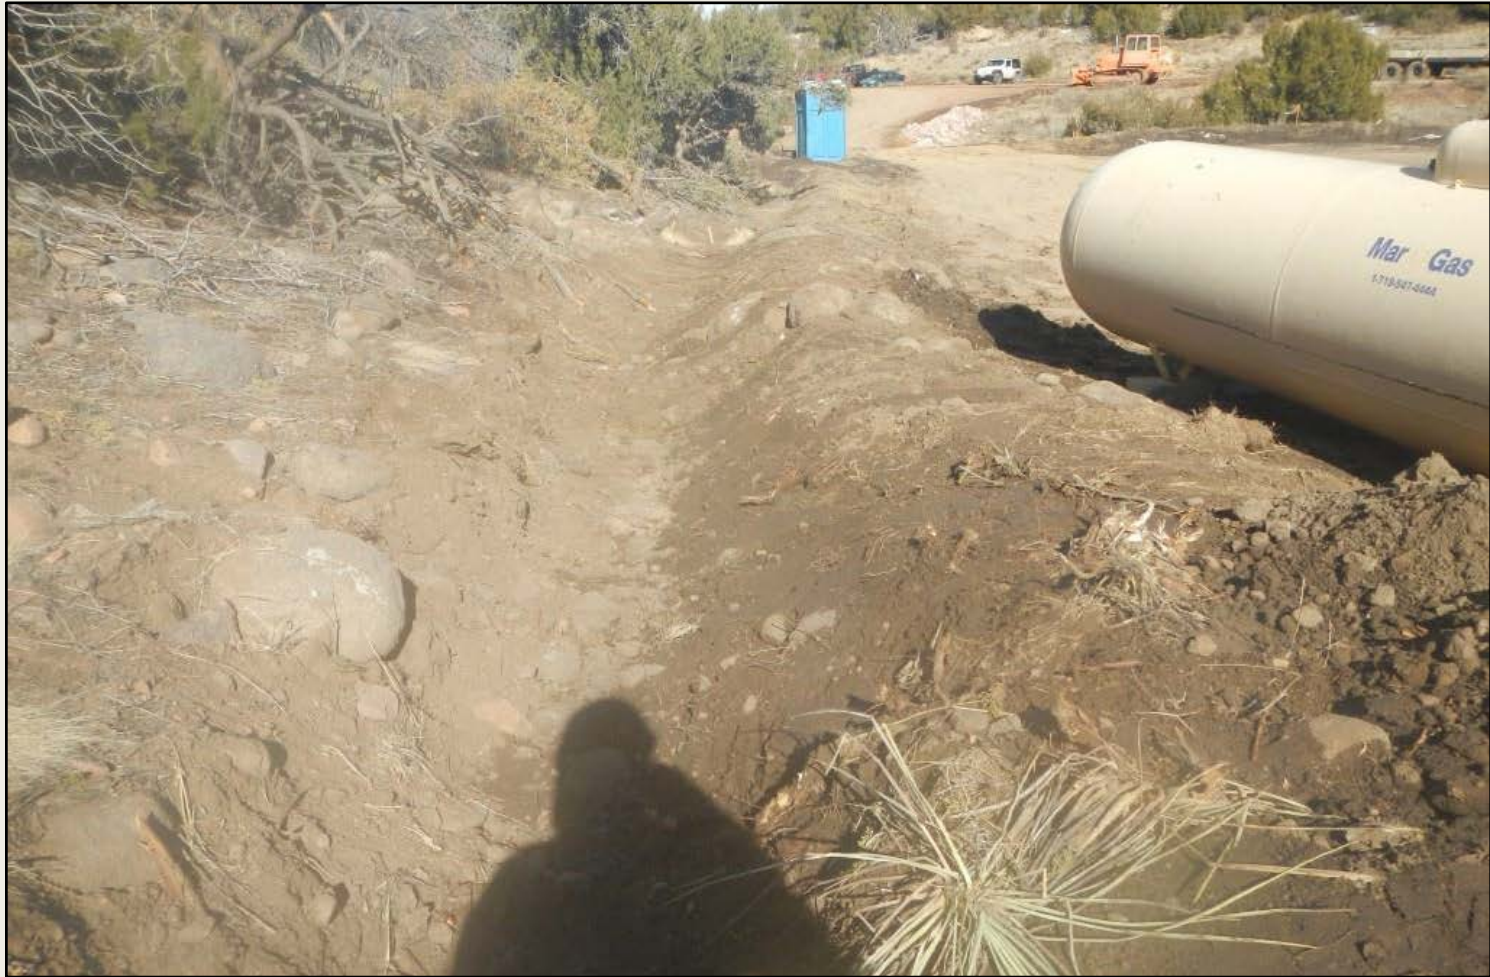
Photo 9. View of the northwestern project area from the northwestern corner facing eastward. As described above, diversion not properly stabilized or properly installed.

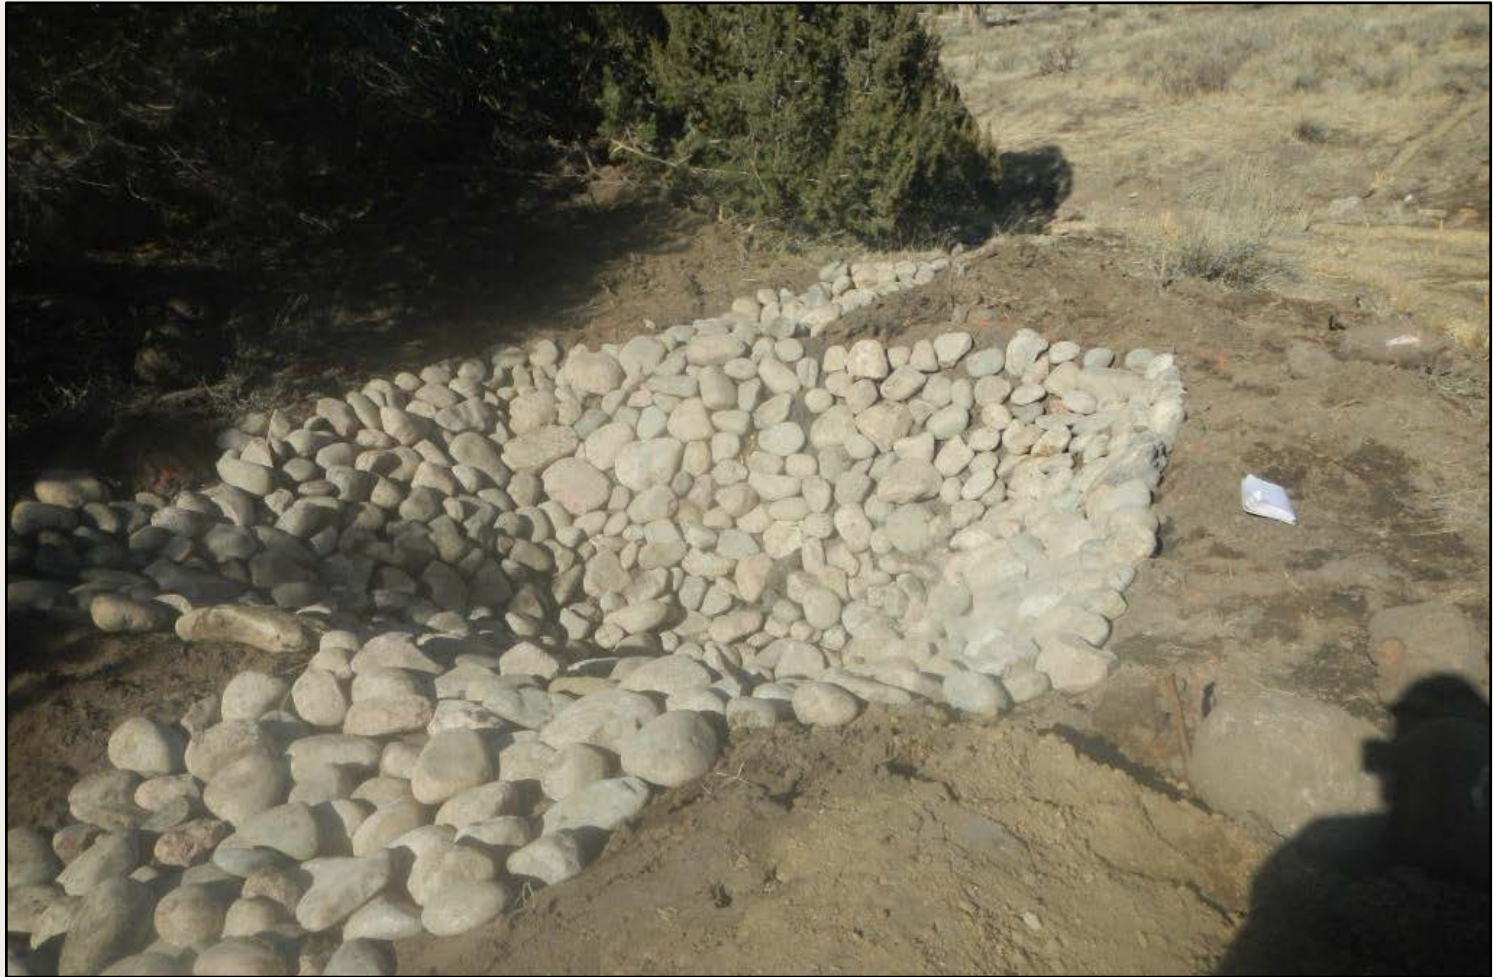
Photo 10. View of sediment trap within the northern project area. See comments on Photo 5.

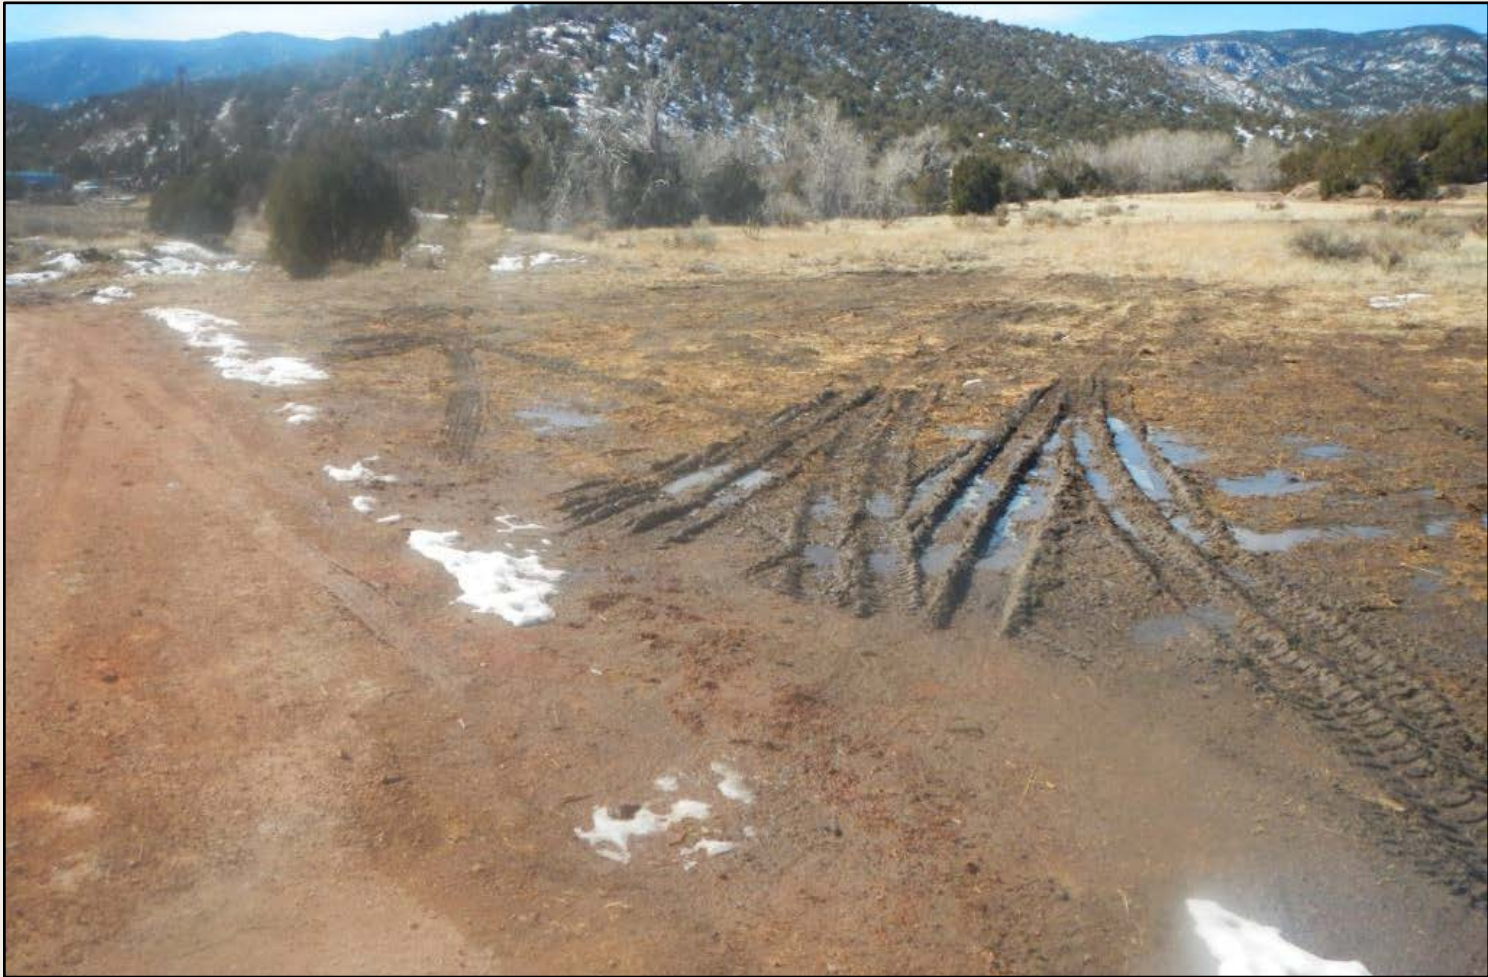
Photo 11. View of staging area north of the well pad that will need revegetation. All areas disturbed by oil and gas operations will require reclamation per reclamation rules.

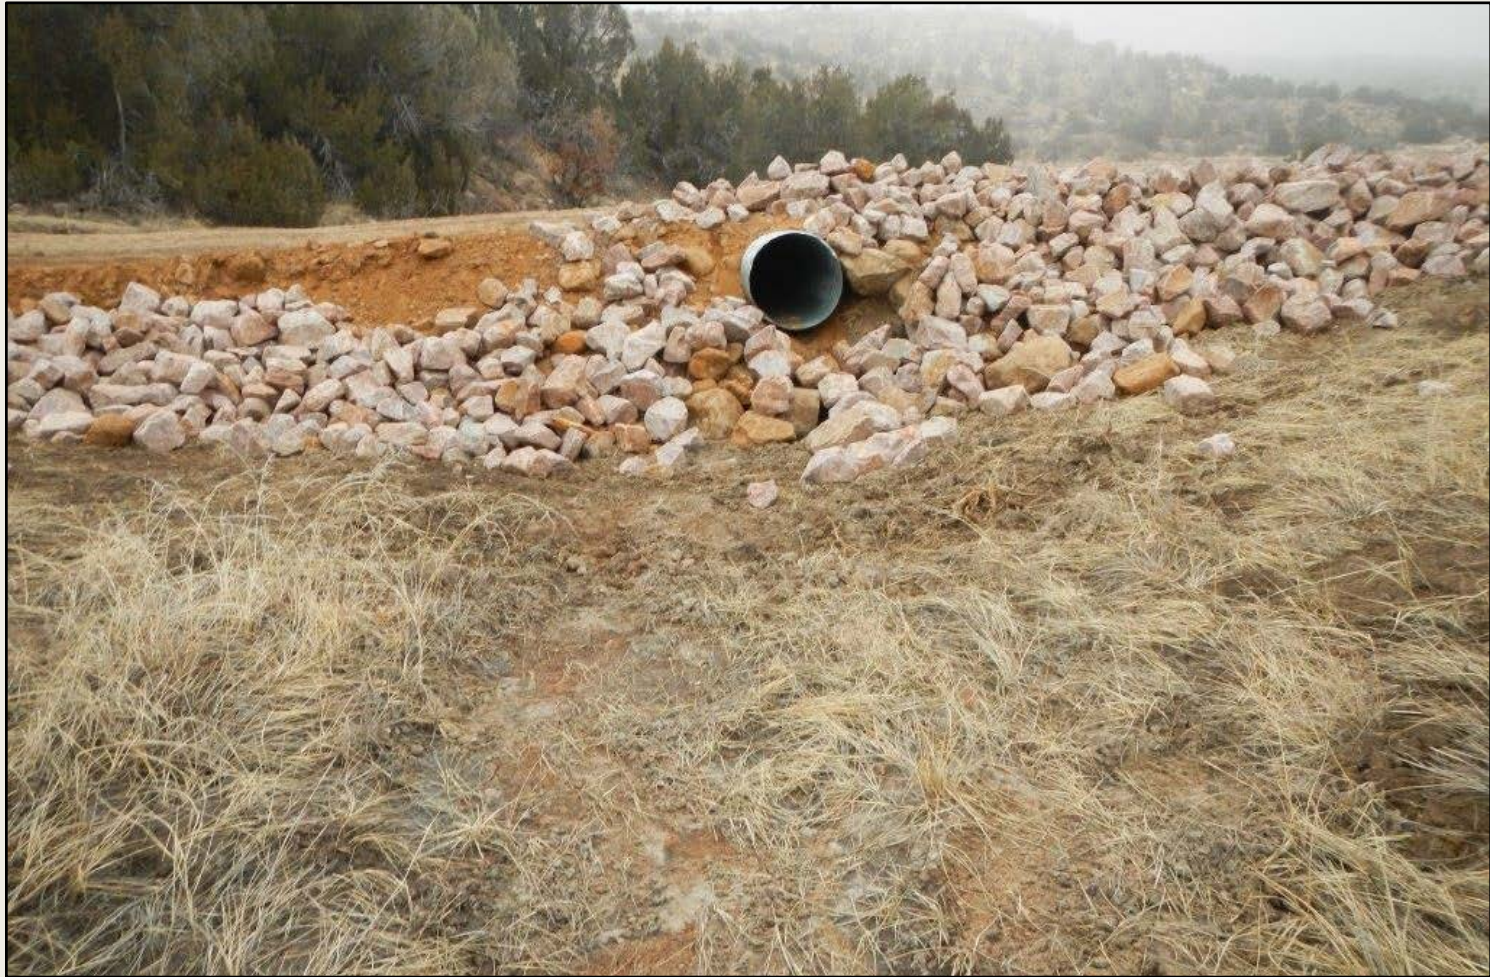
Photo 12. View of culvert inlet facing northward, downstream. Culvert is approximately 3 feet above ground elevation and not properly constructed for a stream crossing.

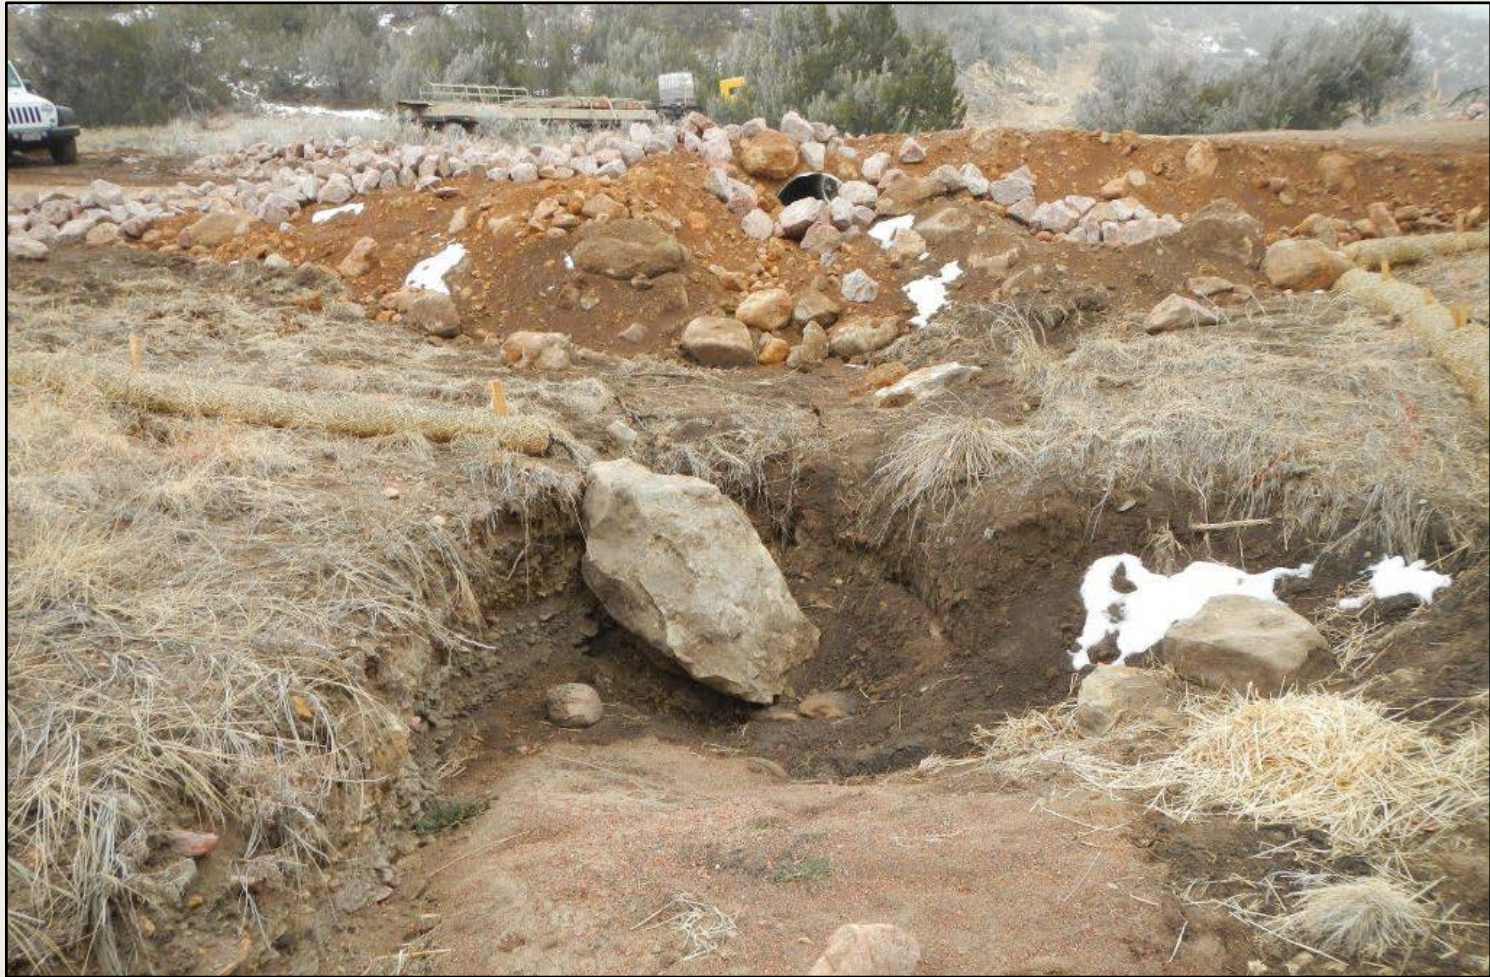
Photo 13. View of culvert outlet facing southward, upstream. Culvert outlet is partially blocked with rock and soil. Head-cut that is approximately 3 feet tall and 3.5 feet wide will need stabilization as concentrated stormwater flows from the culvert will likely accelerate erosion. Stream crossing has not been properly constructed see Photo 12.

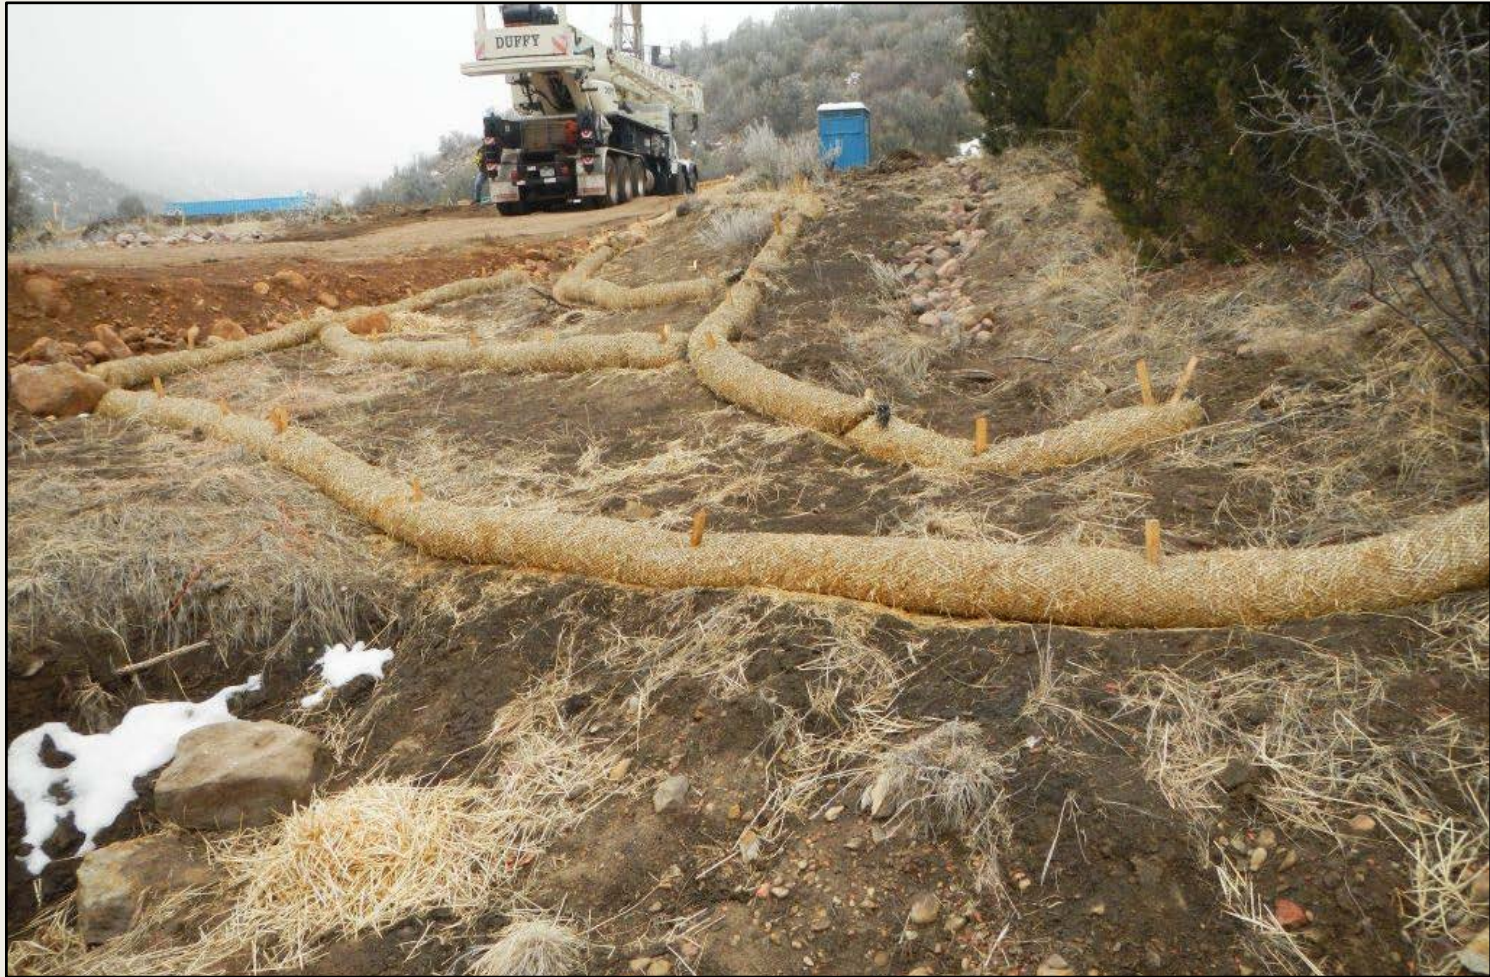
Photo 14. View of wattles and straw placed in the northern project area. Wattles and BMP are not properly installed.
