## Inspection Photos

Location Name: CSF T Pad and Castle Springs T Spill

Location ID: #335052 Spill ID #462303

Inspection Date: March 6, 2019

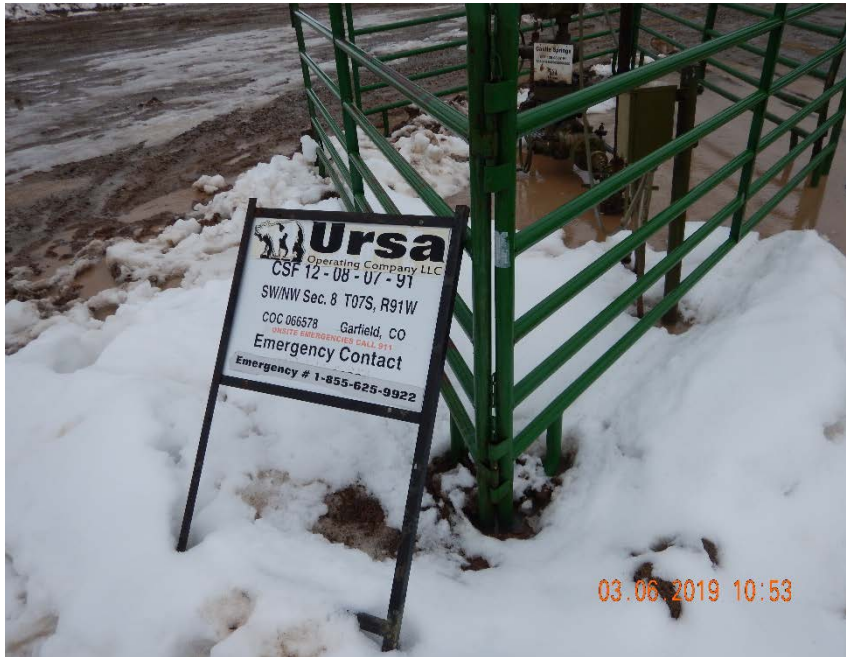
Photo #1 – Well sign for CSF 12-08-07-91, located in center of upper well pad.

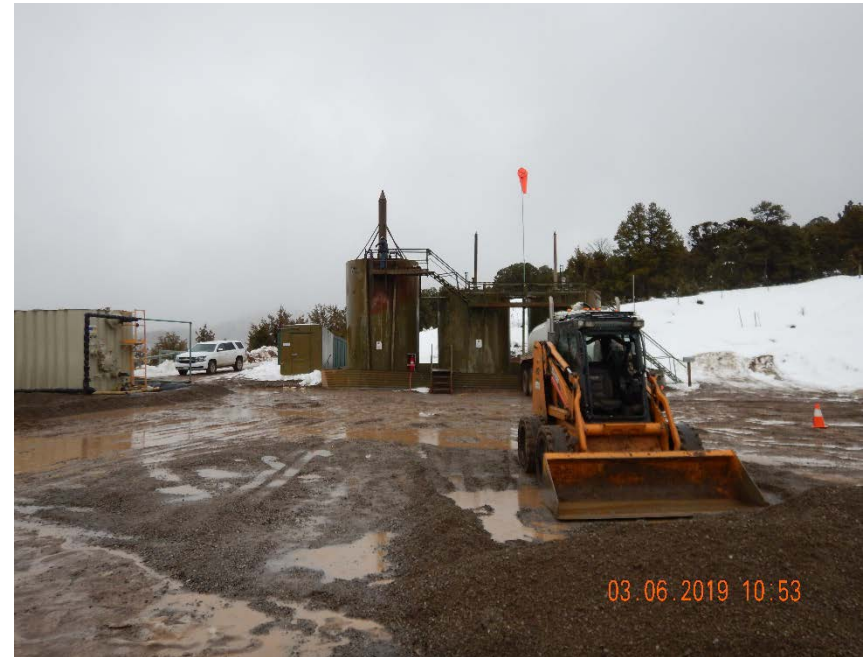
Photo #2 – View of existing tank battery from wellhead, looking east. Note presence of frac tank on left side of photo and puddles of stormwater throughout pad.

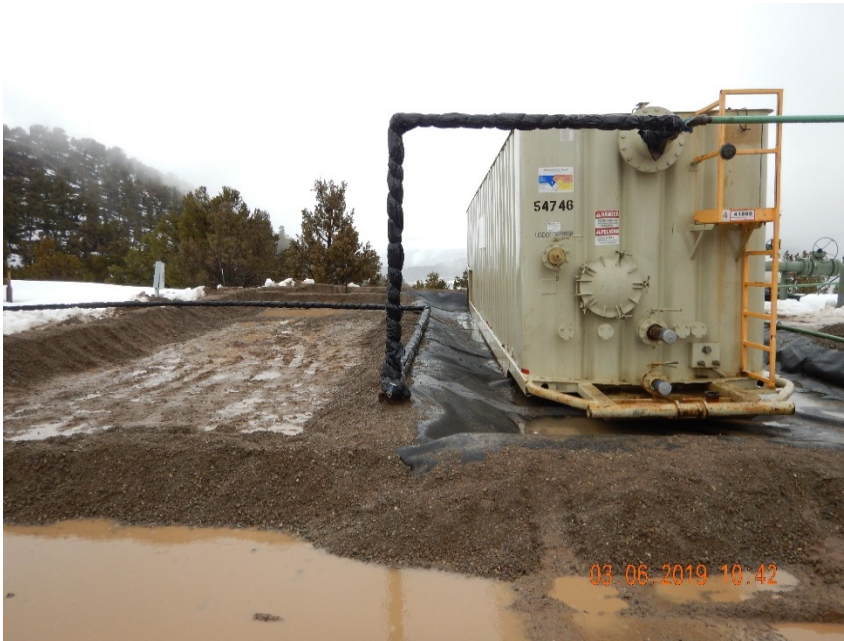
**Photo #3 – View of temporary tank battery from south. Note that liner has been installed beneath frac tank but earthen berm lacks compaction. Berm capacity may not be sufficient to contain contents of frac tank plus freeboard, per 605.a.(4).**

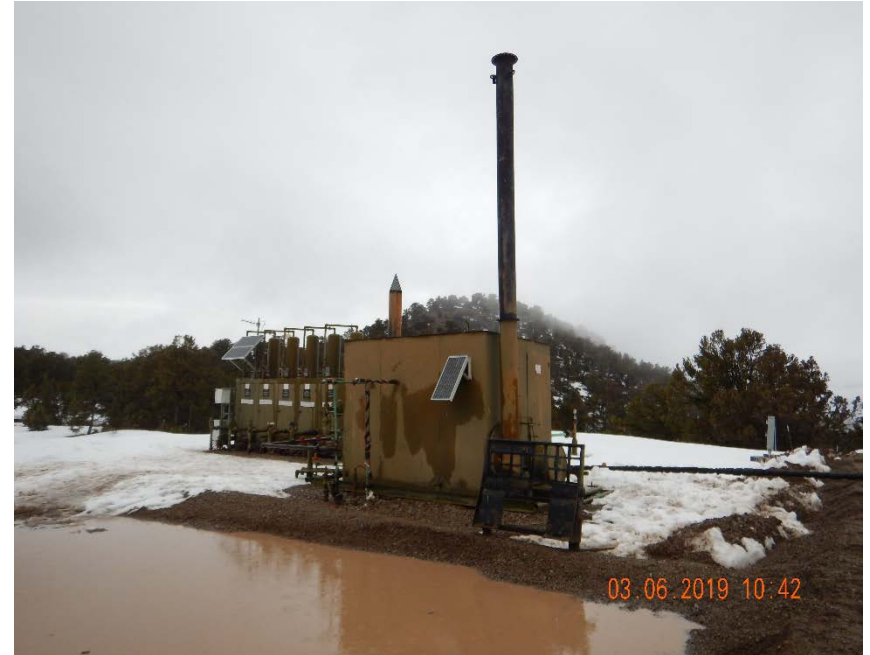
**Photo #4 – View of heated horizontal separator (foreground) and heated vertical separators (background), located west of frac tank. Note that heated horizontal separator in foreground lacks bird protection.**

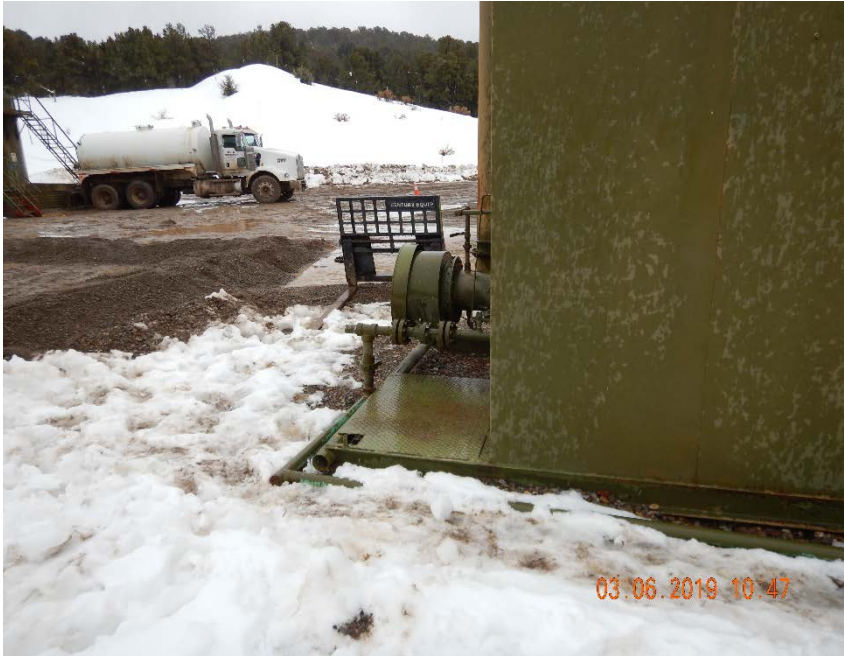
**Photo #5 – View of vertical heated separator array from north. Distance from this point on separator to frac tank was measured to be 60' on inspection date.**

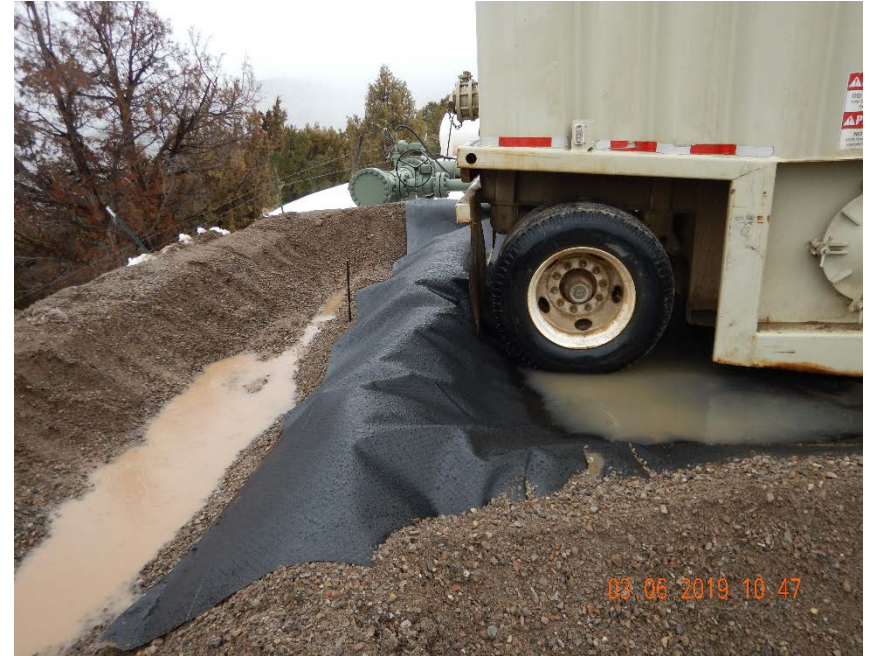
**Photo #6 – North side of frac tank secondary containment.**

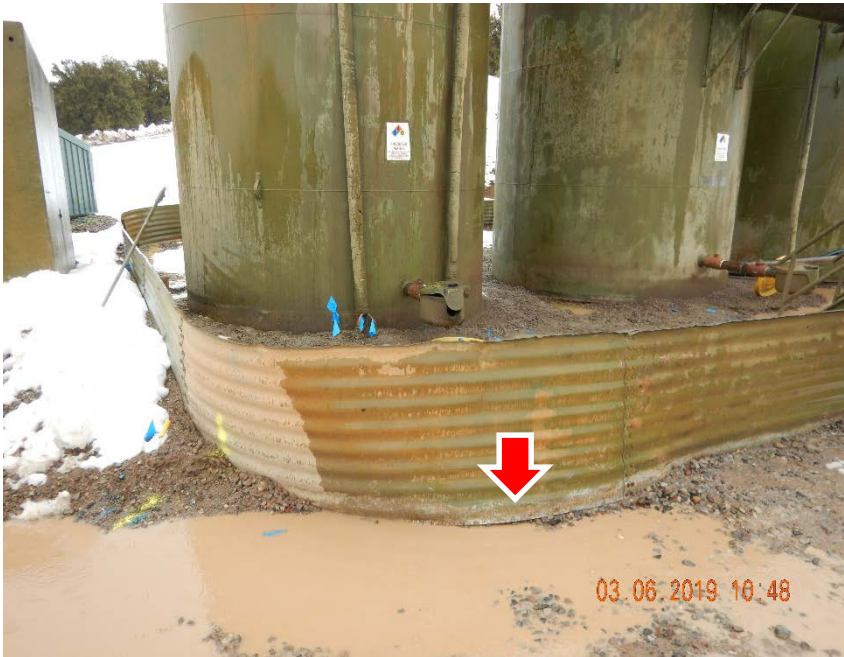
**Photo #7 – View of existing tank battery containment device at northwest corner. Note that base of metal ring is visible (red arrow).**

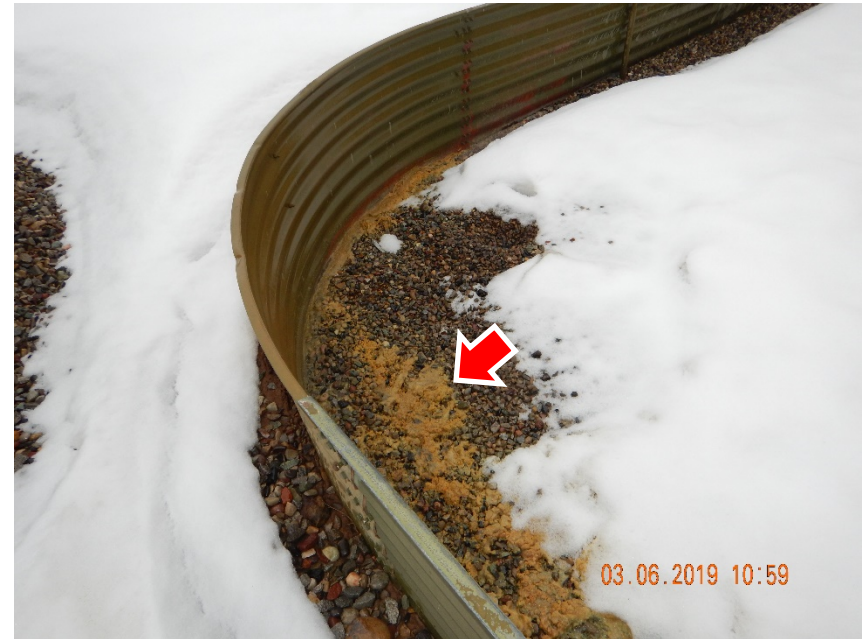
**Photo #8 – Fluid accumulation within existing tank battery containment (red arrow). Work to delineate and remediate impacts within existing tank battery is proceeding under Remediation Project #12674.**

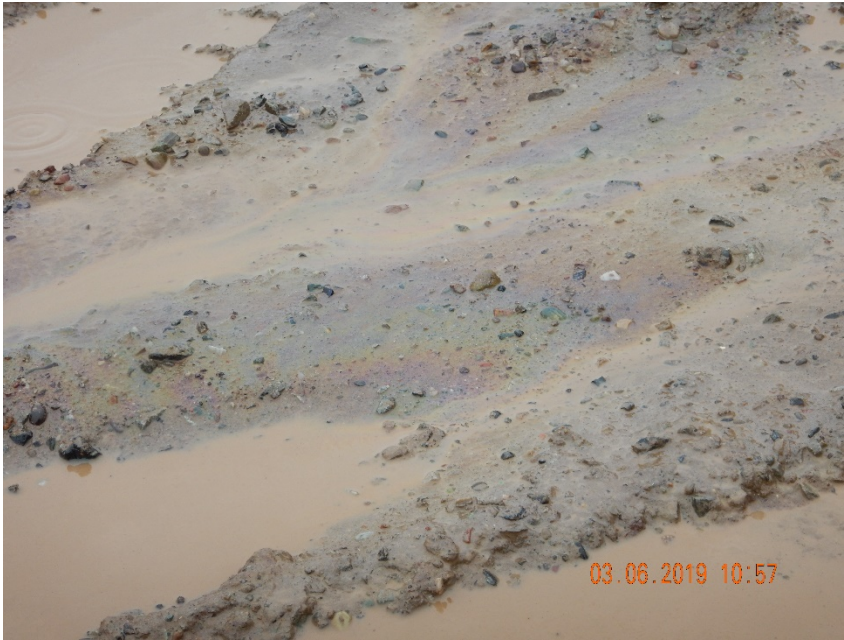
**Photo #9 – Hydrocarbon sheen observed on soils and in pooled stormwater at northeast corner of upper well pad on inspection date. Operator was contacted via phone on 3/6/2019 and instructed to remove free fluids within 24 hours.**

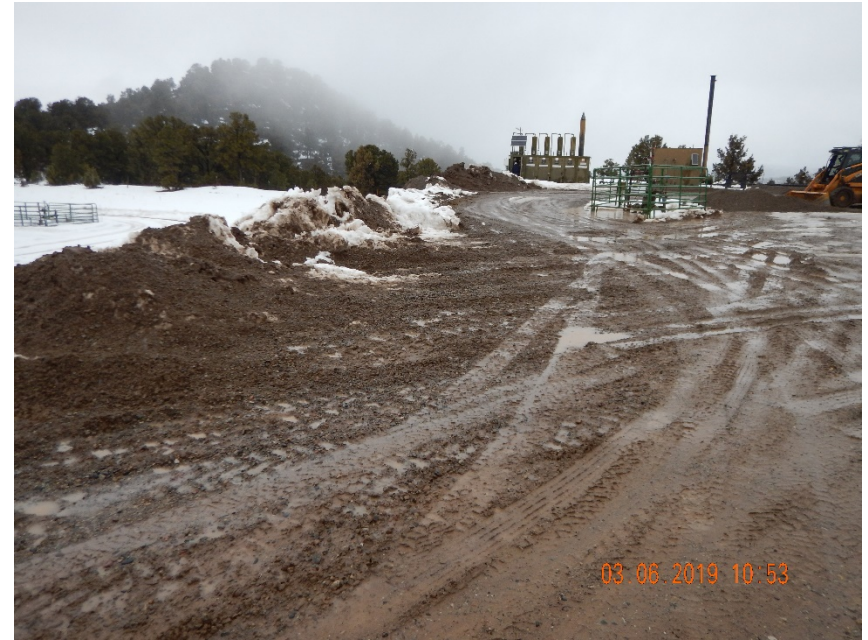
**Photo #10 - View along flow path of Spill ID #462303, looking north. No hydrocarbon odor, staining, or sheens were observed in this location on inspection date.**

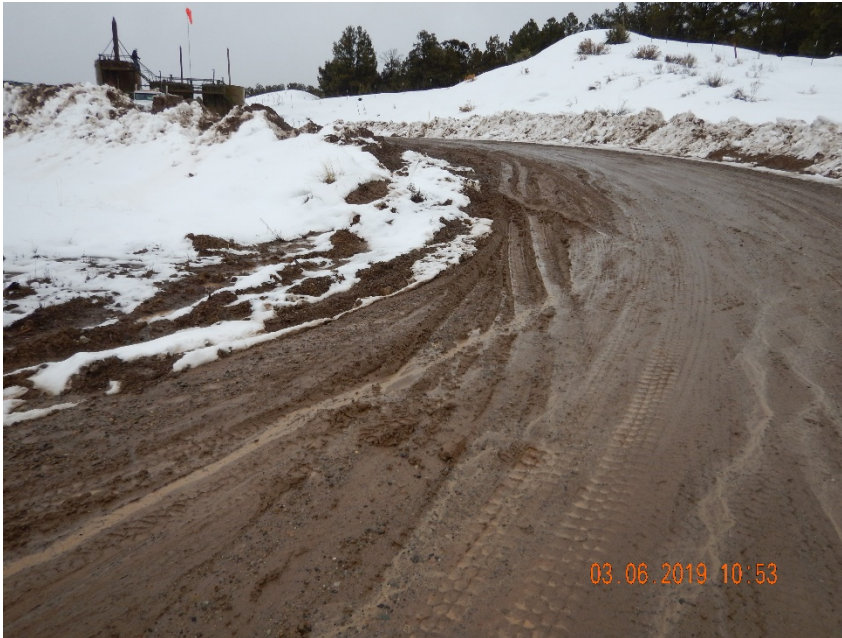
**Photo #11 - View along flow path of Spill ID #462303, looking east. No hydrocarbon odor, staining, or sheens were observed in this location on inspection date.**

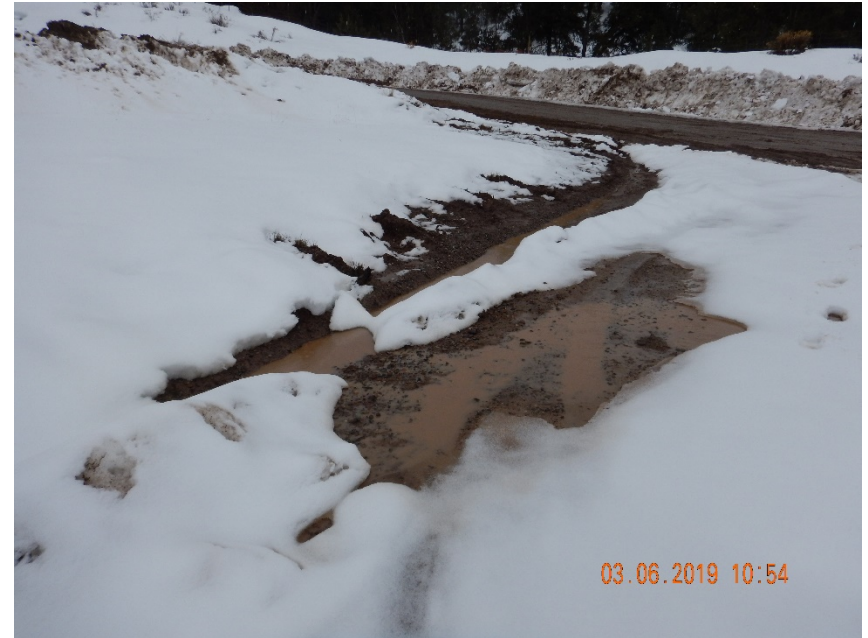
**Photo #12 - View of reported flow path terminus of Spill ID #462303, looking south. No hydrocarbon odor, staining, or sheens were observed in this location on inspection date.**
