Inspection Photos
Location Name: CD #3
API: 05-083-06726

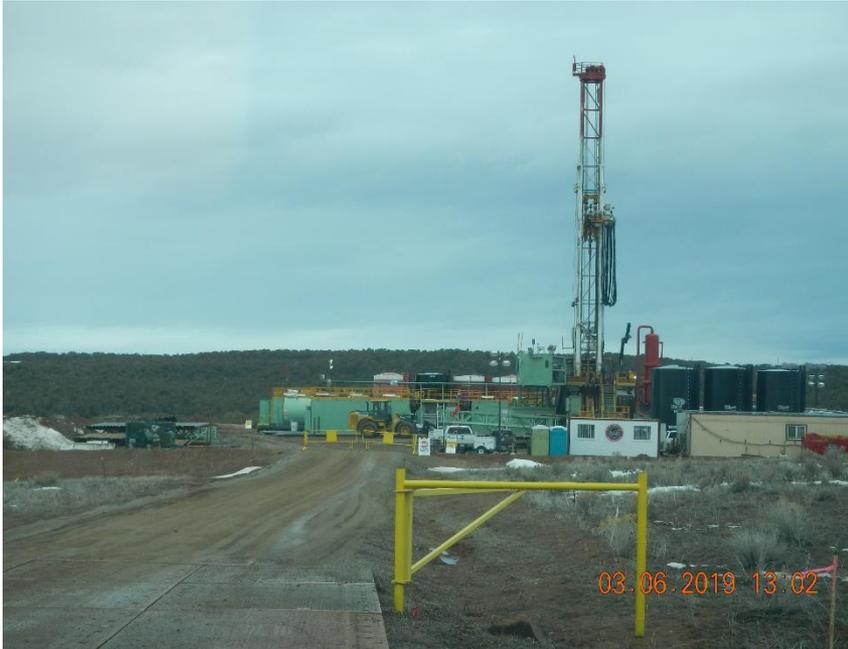
CD #3 location photo.

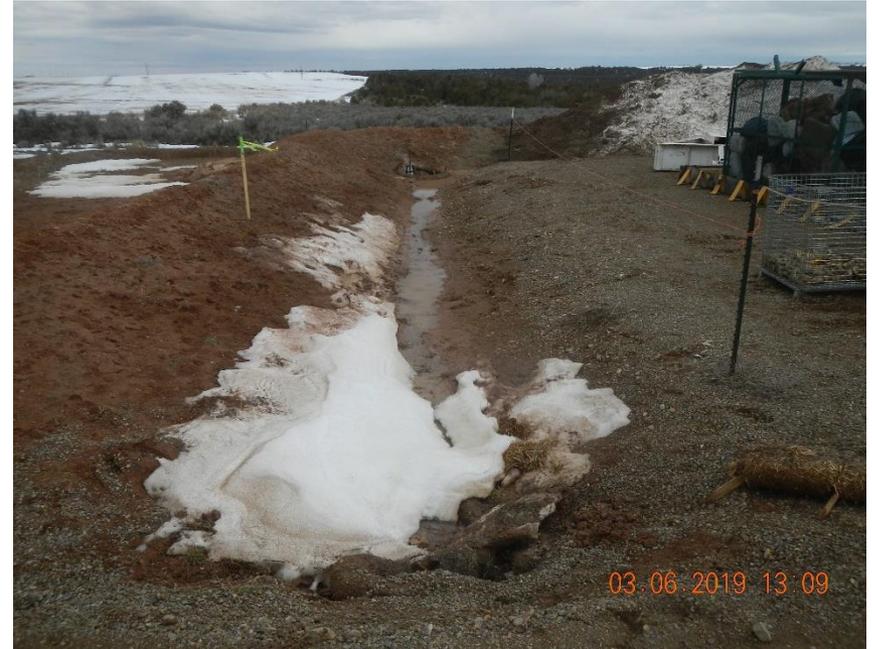
Location drain in SW corner of location.

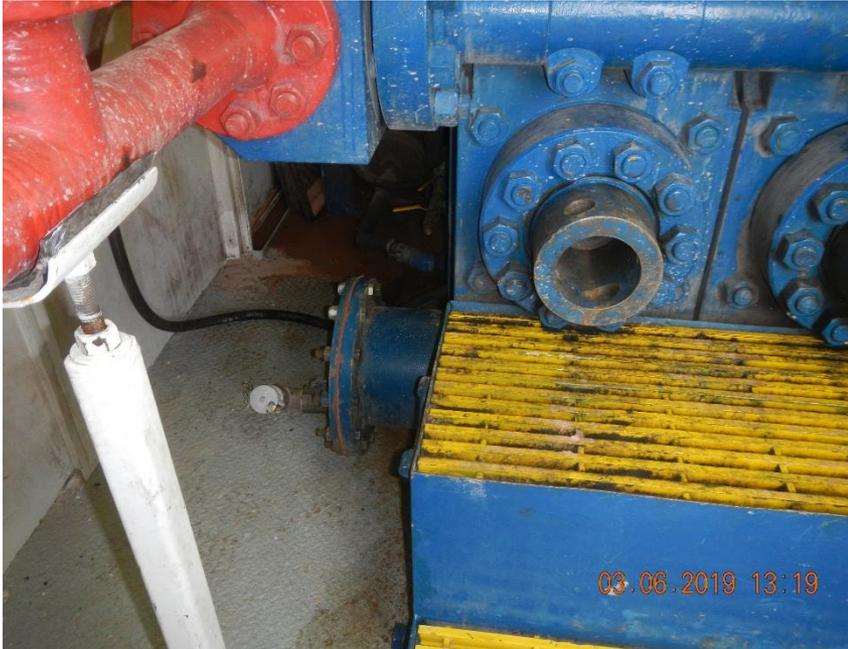
Mud pump gasket repair referenced in Initial Spill Report.

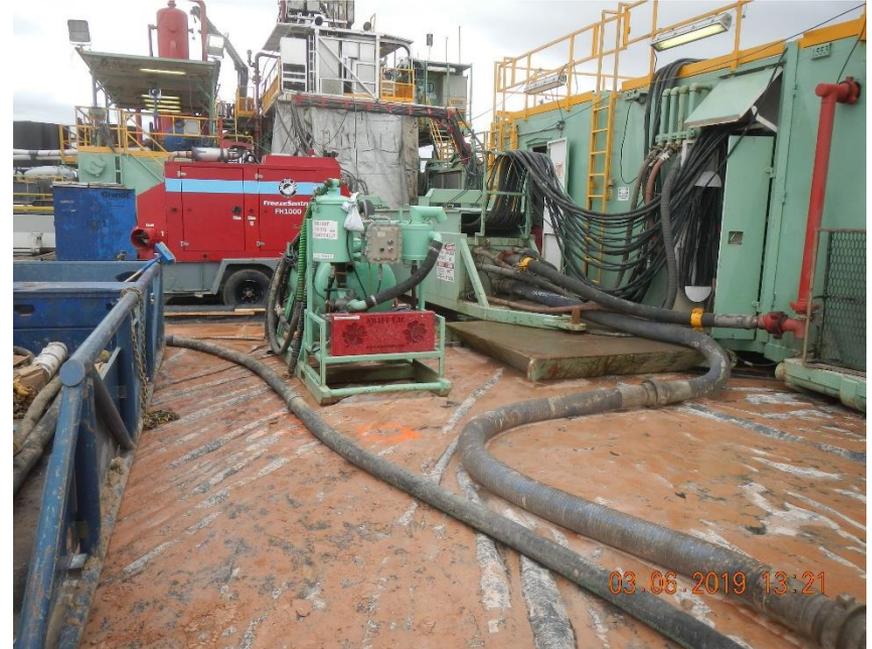
Mud pump room (left side of photo) where release occurred.

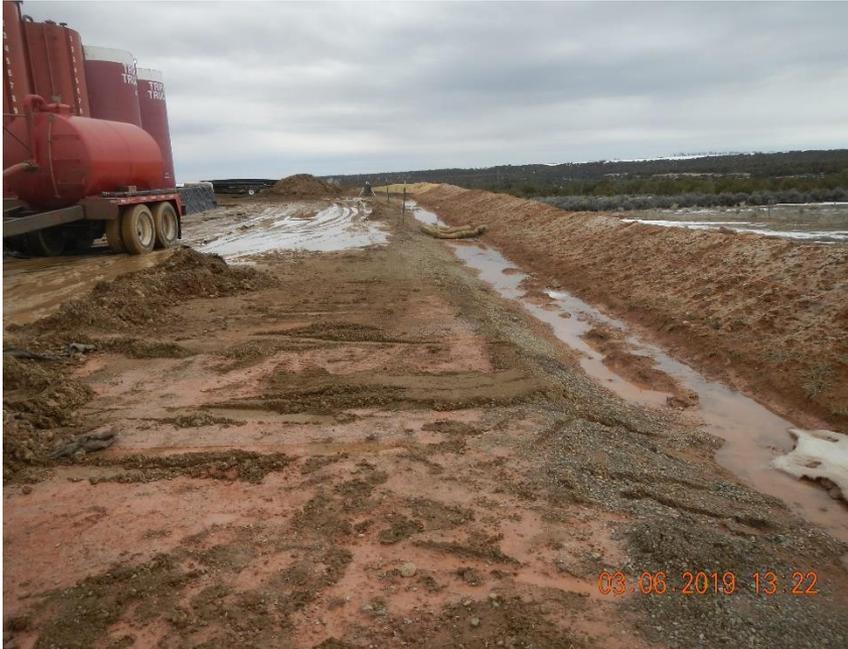
Terminus of drilling fluid release in perimeter ditch along N edge of location.

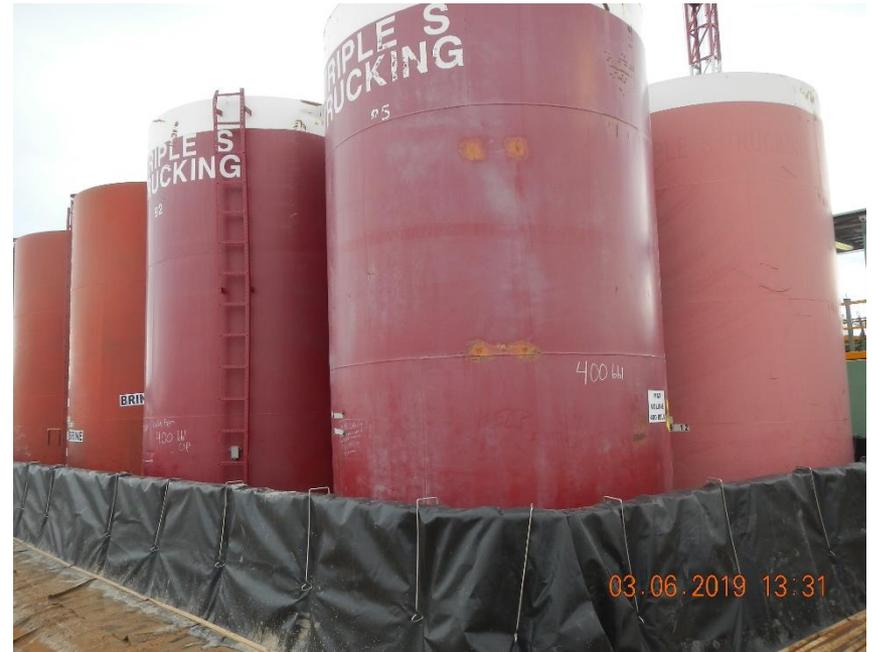
Lined secondary containment berm for fresh water/brine ASTs.

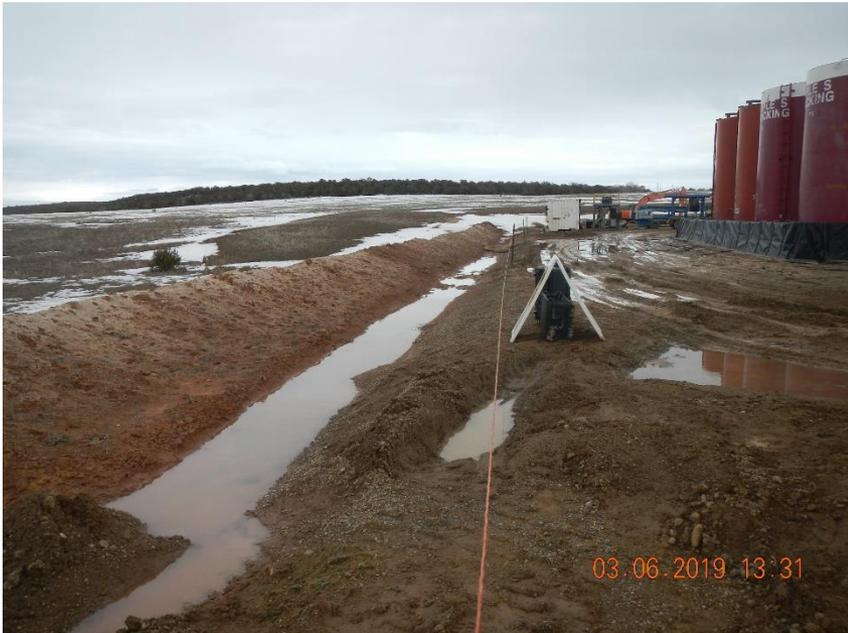
Northern edge of location, view to the east.

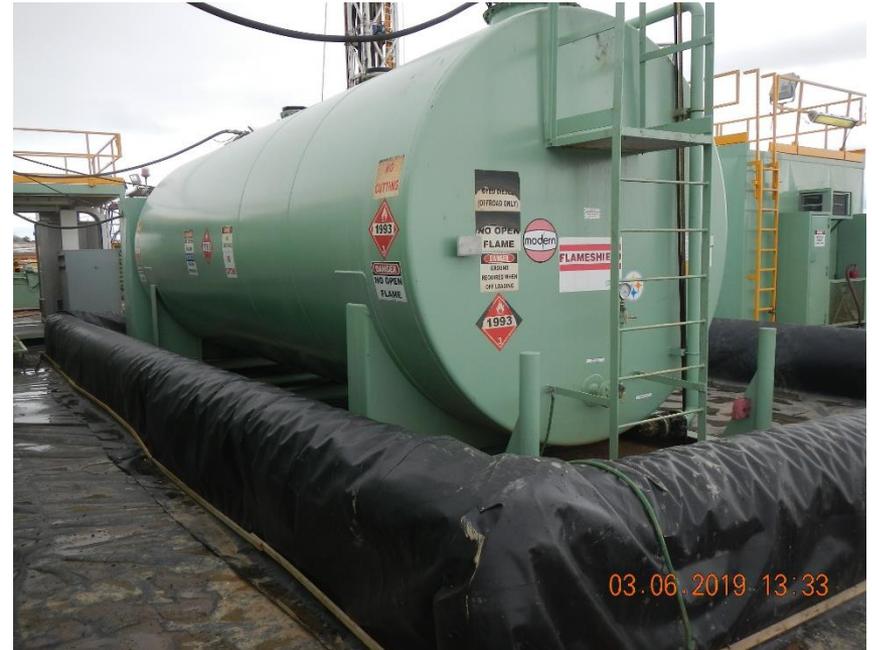
Diesel fuel container with secondary containment.

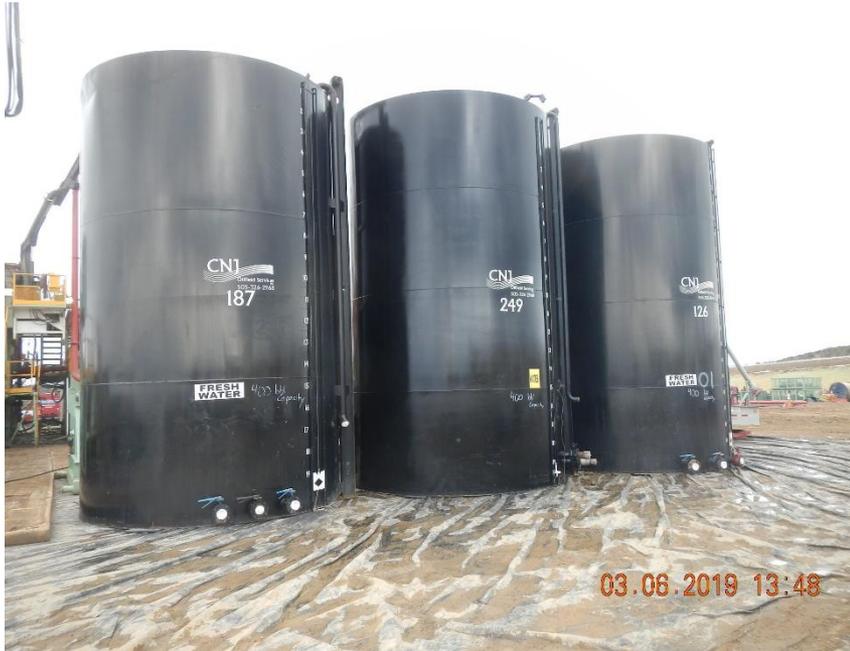
Three 400 bbl. ASTs labeled fresh water.

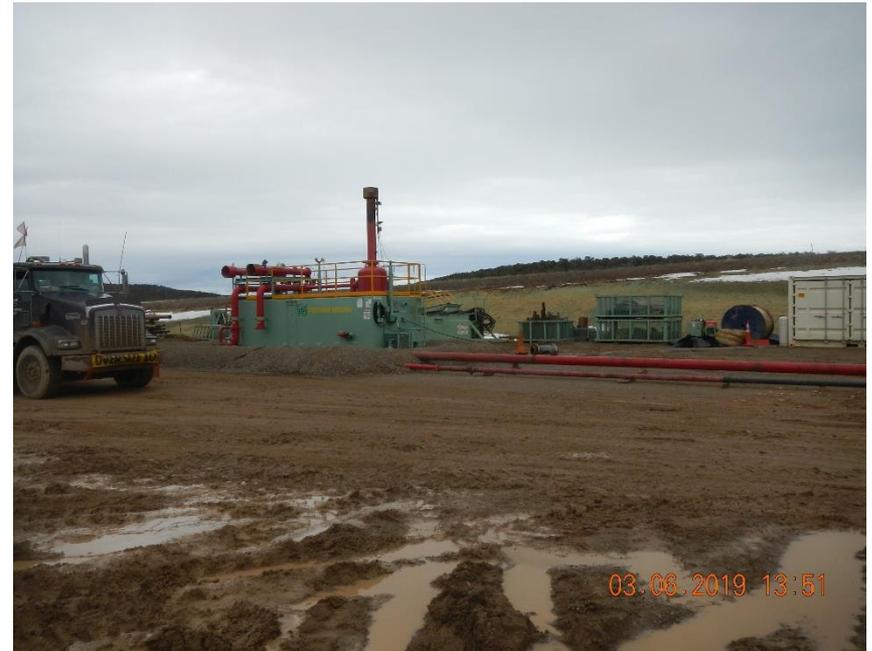
Flare stack in NE corner of location.

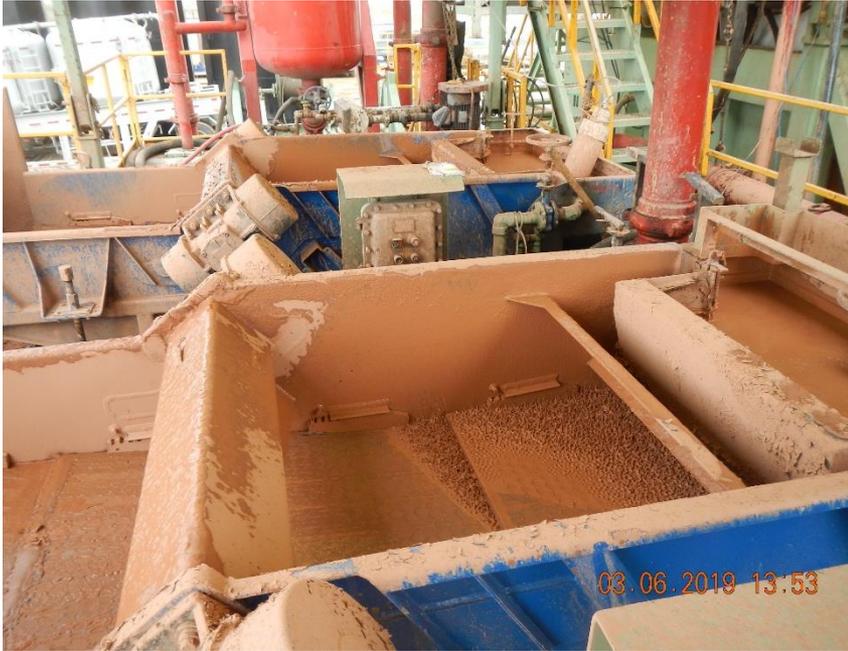
Shakers on mud pit.

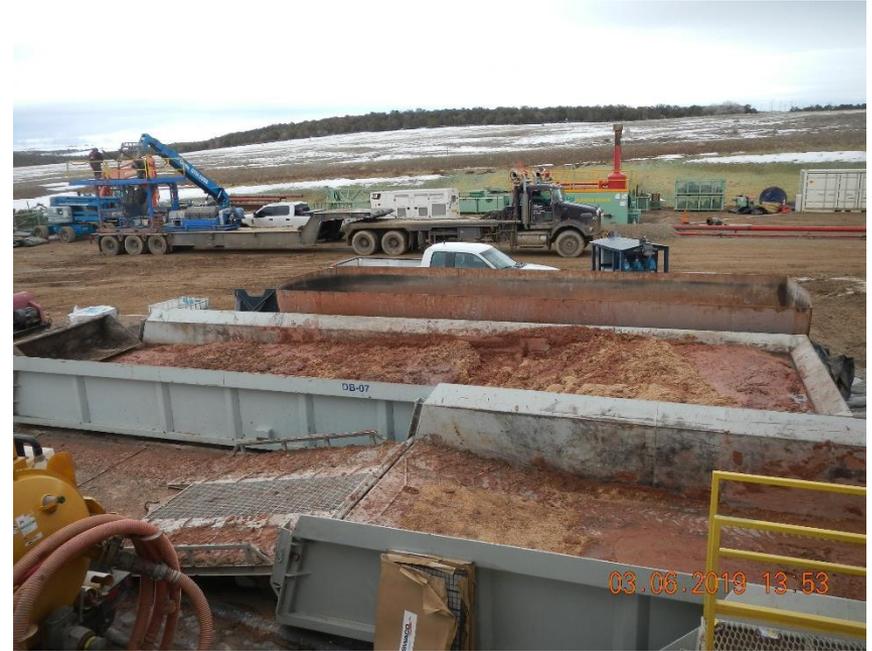
Drilling mud disposal containers.
