Inspection Photos
Operator: Ausco Petroleum Inc.
Location/API #: 043-06216
Date: 2/28/2019

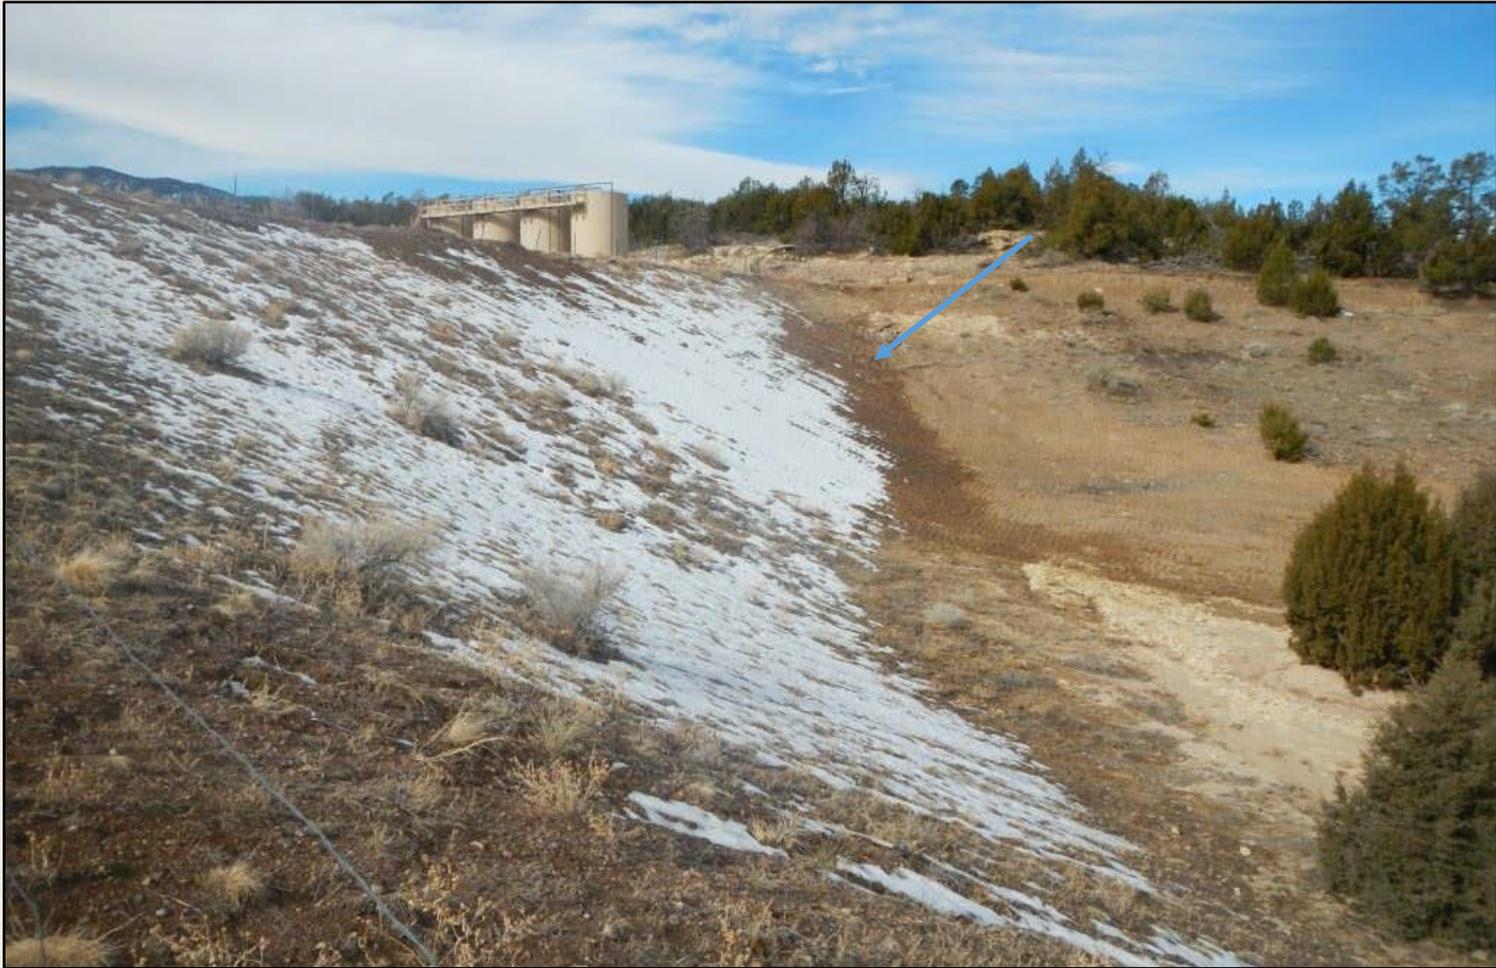
Photo 1. View of the northeastern project area from the access road facing northward. Erosion is occurring in area where arrow is pointing, and long term erosion control is needed in this area.

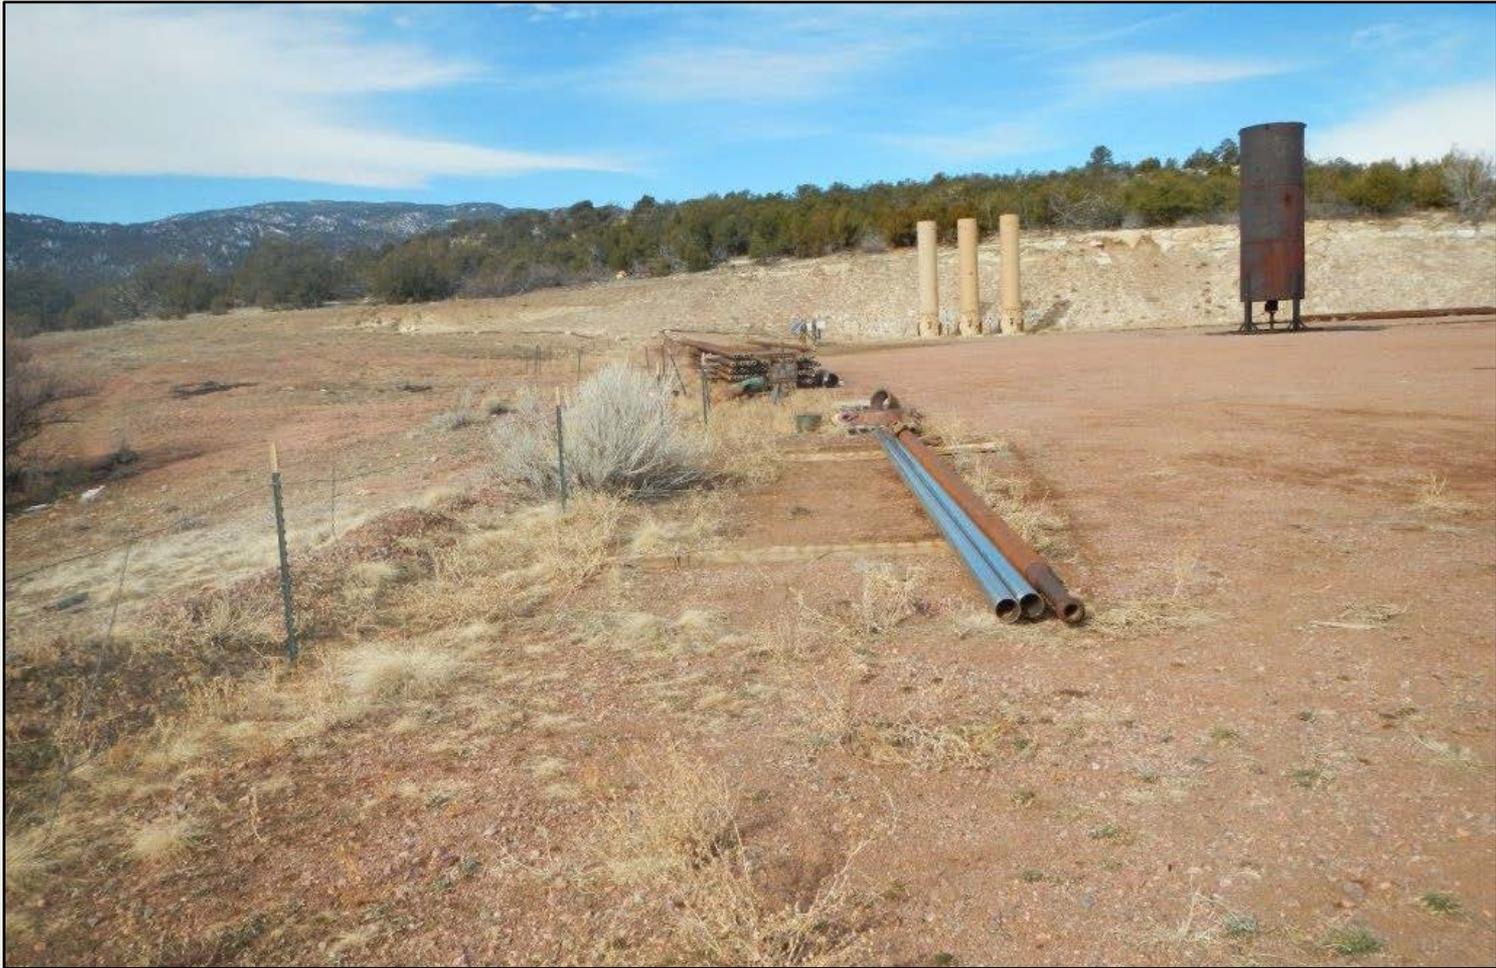
Photo 2. View of the southern project area from the southeastern corner facing westward. Unused equipment is stored along the outer edges of the well pad.

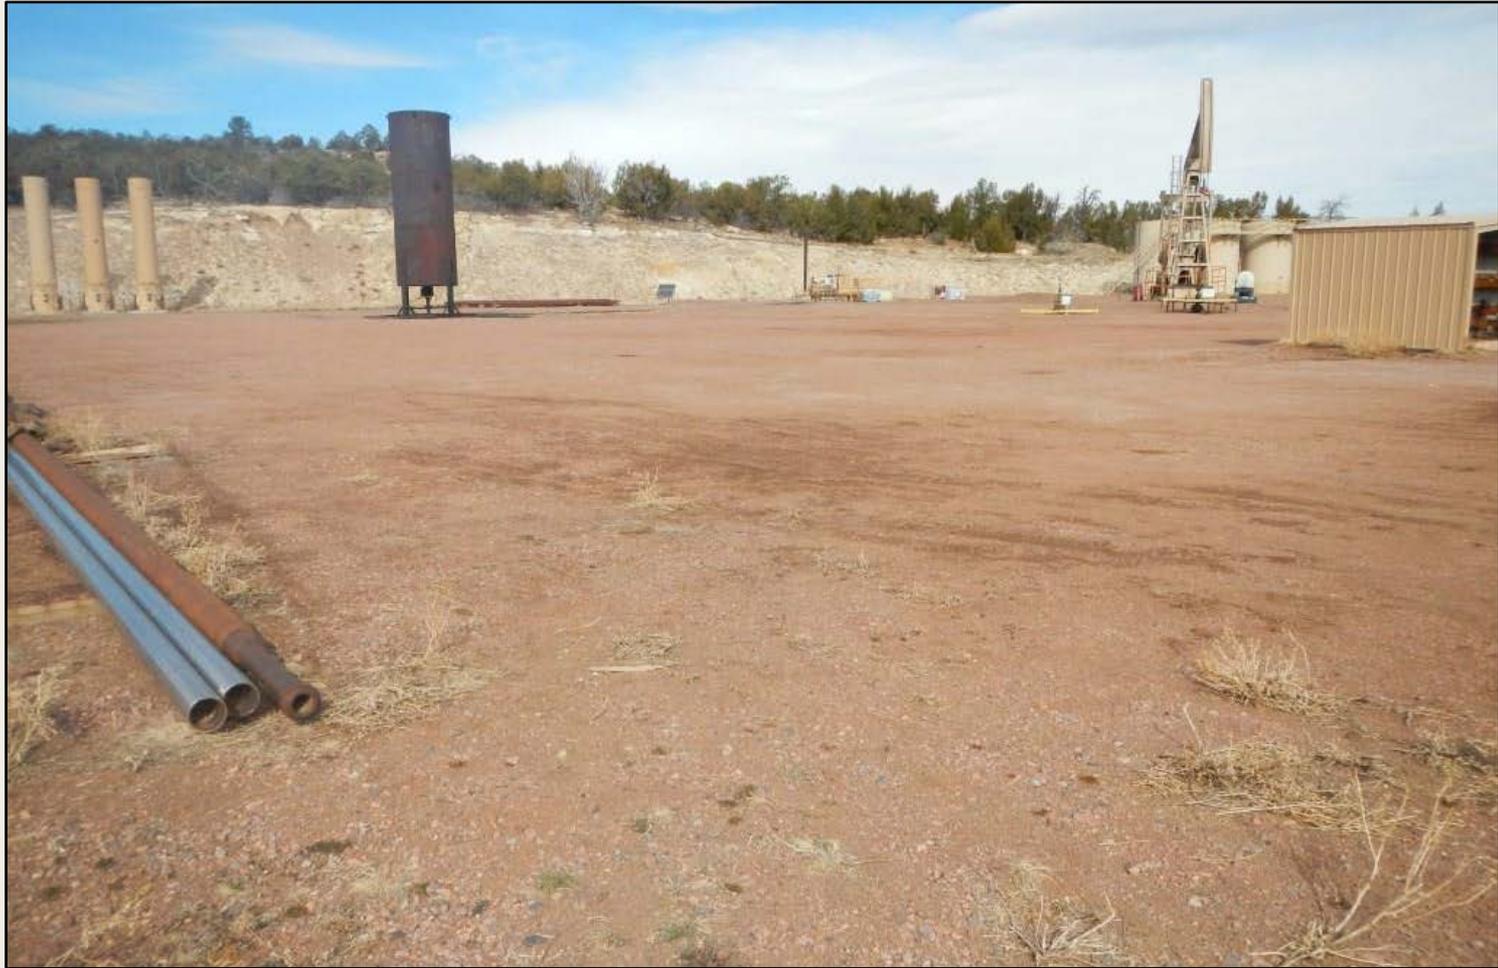
Photo 3. View of the project area from the southeastern corner facing center. Interim reclamation needs to be conducted as large portions of the well pad do not appear needed for existing production operations. Date of first production was November 22, 2012. Therefore interim reclamation should have been conducted by May 22, 2013.

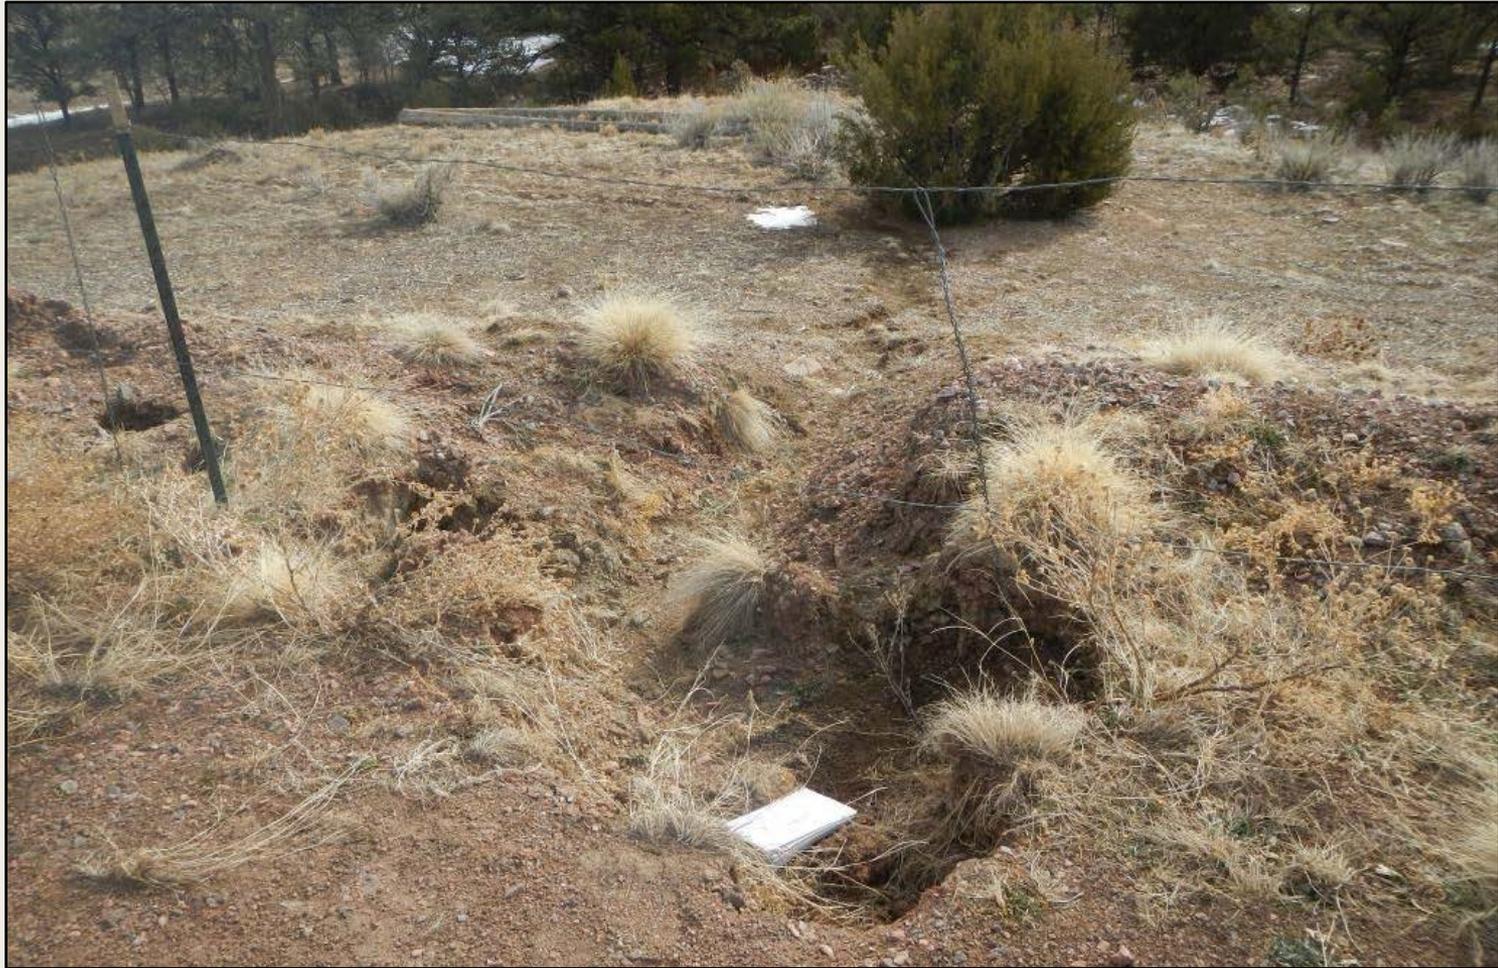
Photo 4. View of erosional channel approximately 3 feet wide and 2 feet deep, forming in the eastern project area where concentrated stormwater flows off of the well pad.

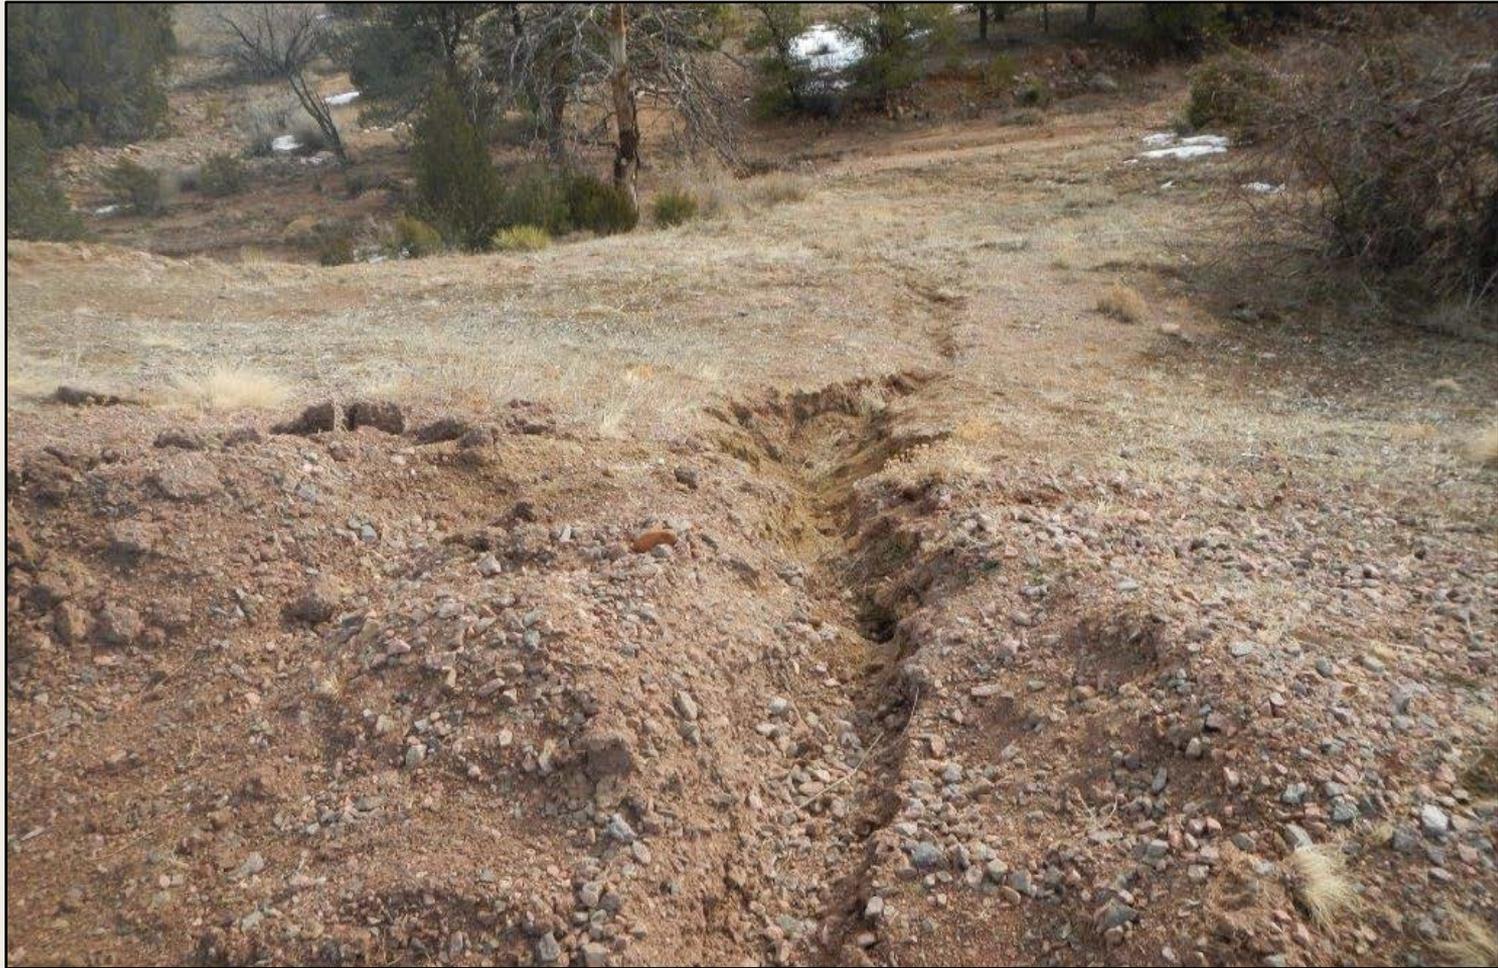
Photo 5. View of another erosional channel within the eastern project area, approximately 1.5 feet wide and 1 foot deep.

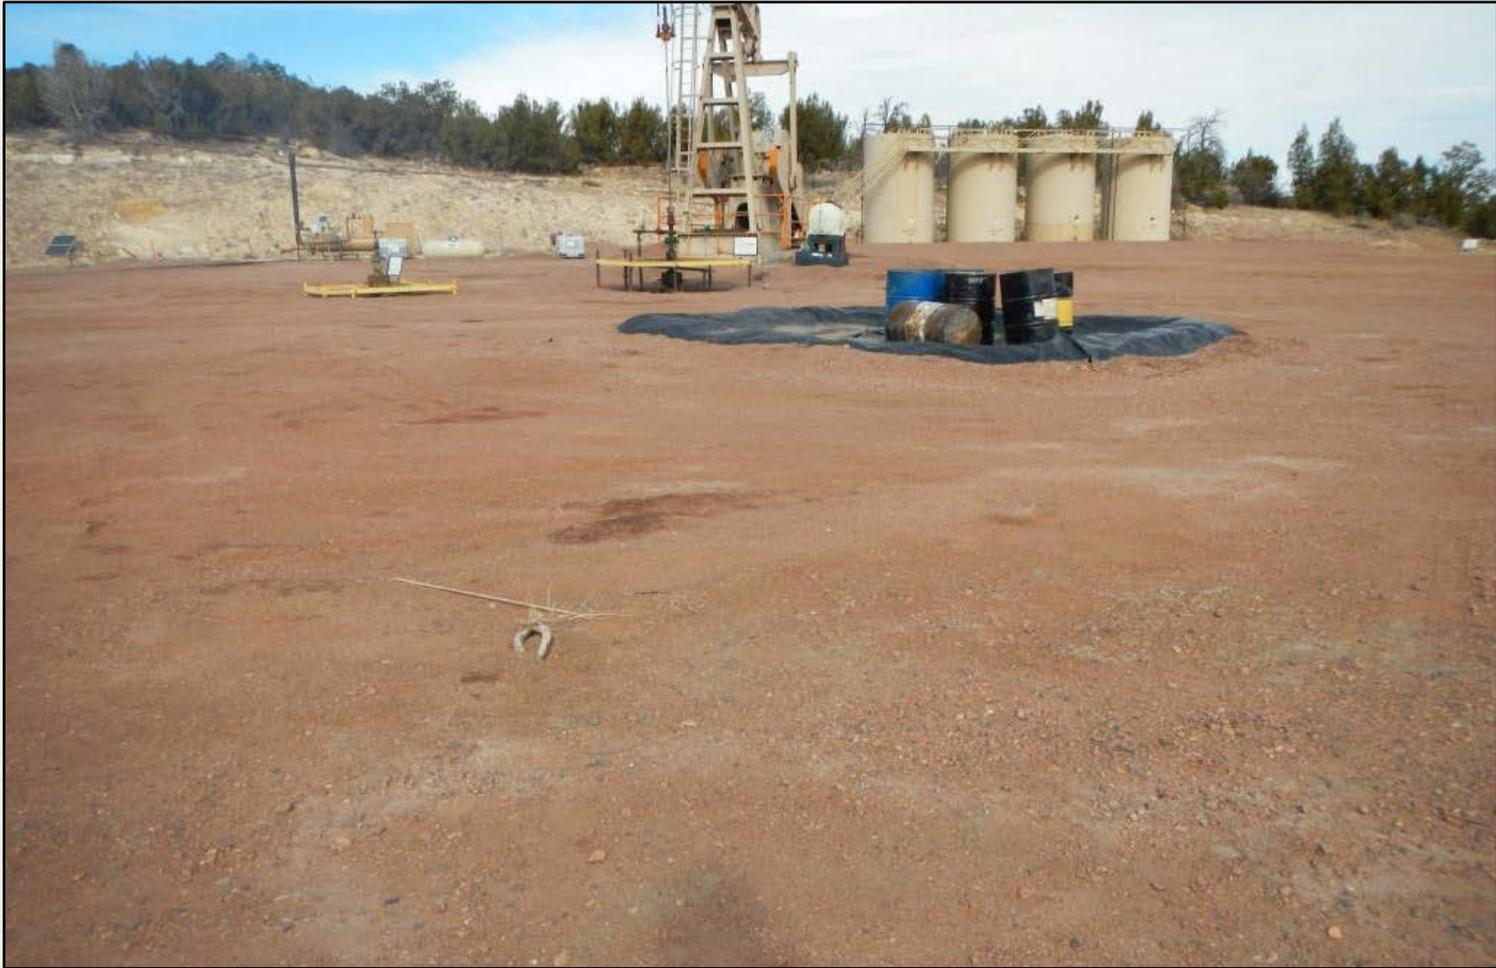
Photo 6. View of unmarked anchor marker in the southeastern project area. Barrels are in lined containment.
