Inspection Photos

Operator: FOUNDATION ENERGY
MANAGEMENT LLC - 10112

Location ID: 330865

Inspection Doc. Number: 682504574
Weld County, CO

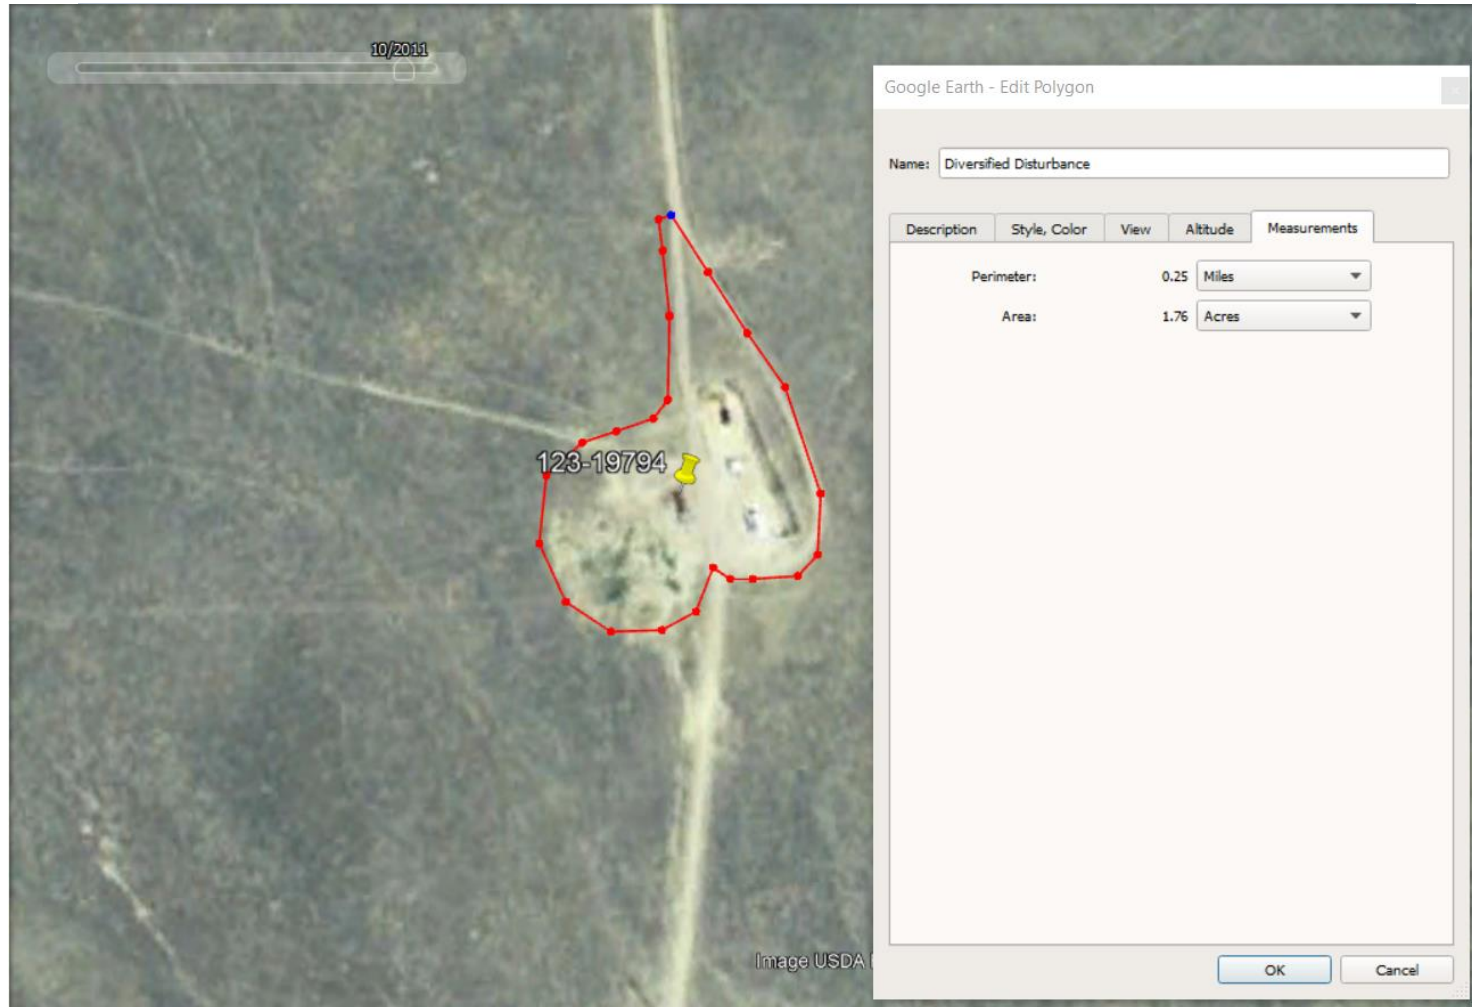
Photo 1: 2011 Aerial imagery. Location under the operation of Diversified Operating at time of image. Photo shows disturbance area to be ~1.76 acres

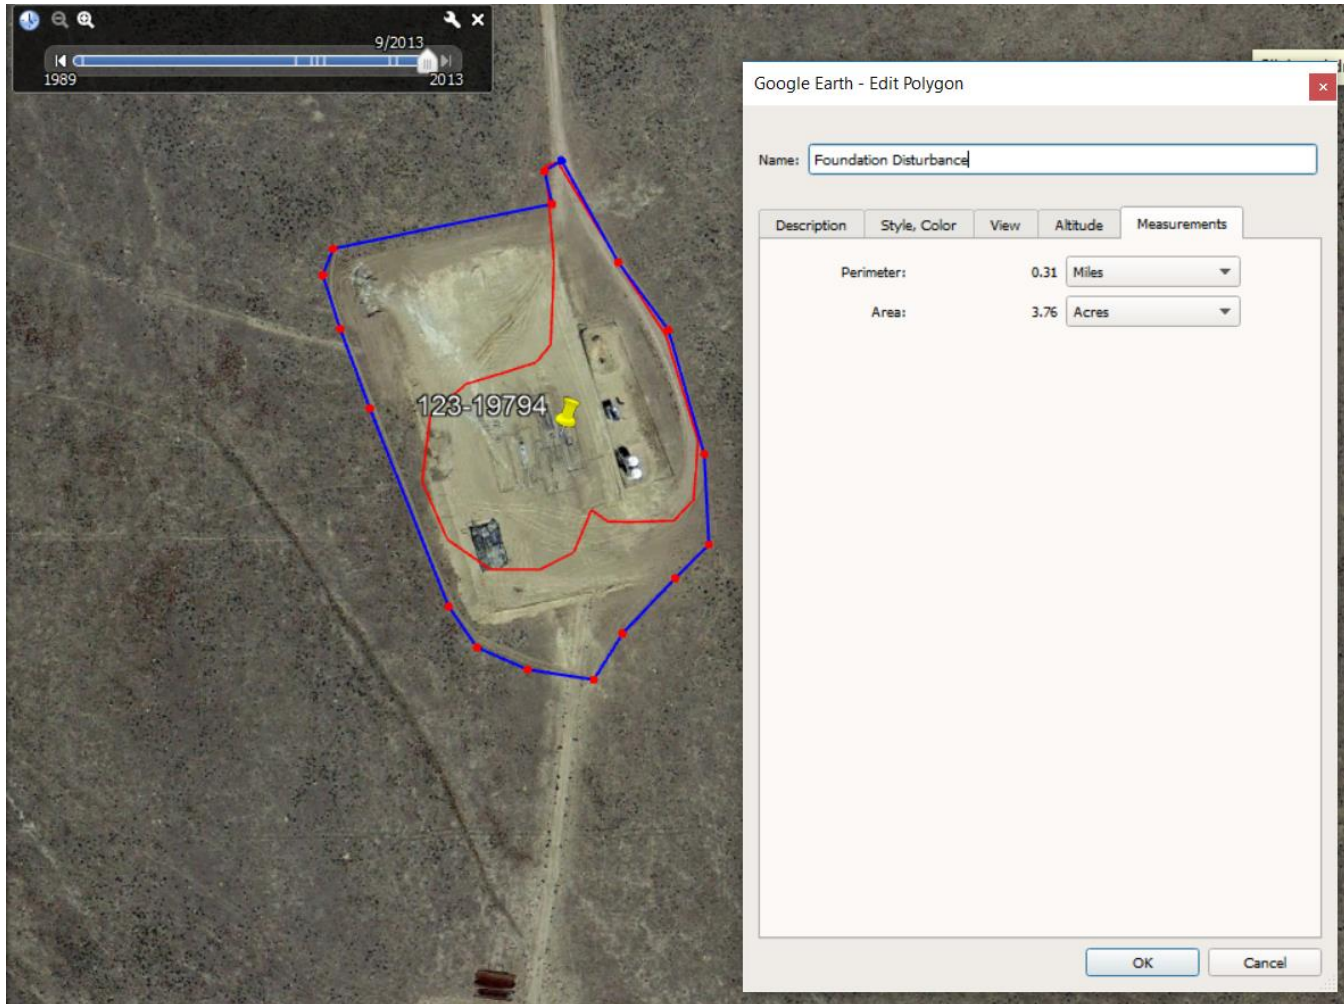
Photo 2: 2013 Aerial imagery. Location transferred ownership from Diversified to Foundation Energy in 2012. Photo shows Foundation expanded the disturbance of the location to its current size of ~3.76 acres. Location disturbance area, and areas not needed for production were not reclaimed in accordance with 1003.b.

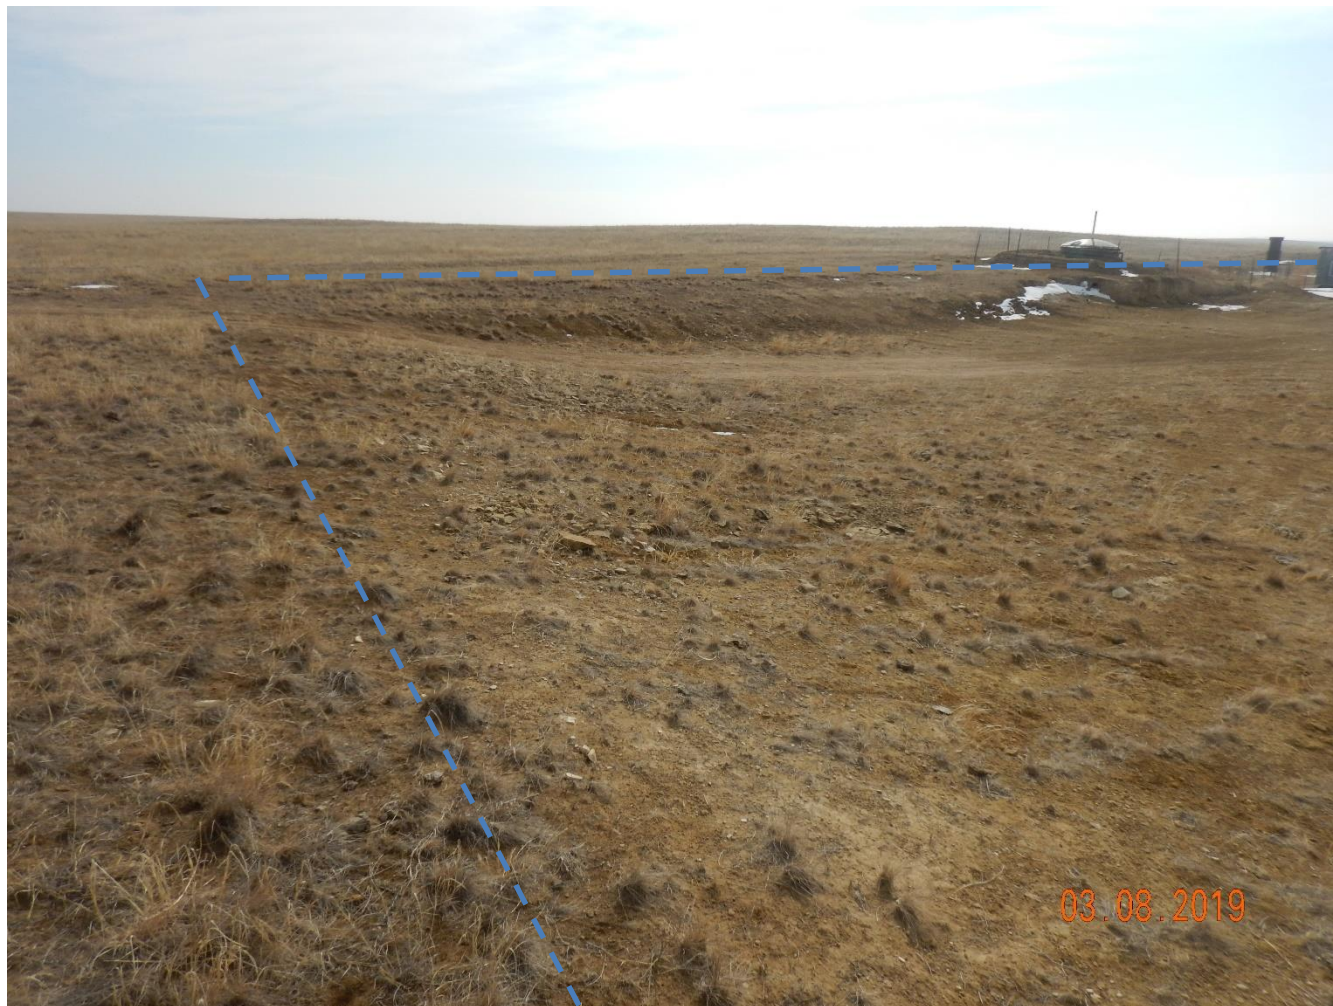
Photo 3: Photo taken from the north end of the location, facing east. Photos 3- 6 provide and overview of the location from east, southeast, southwest to west. Previous inspections required operator to comply with 1003 and conduct interim reclamation on areas not needed for production. Photos show interim reclamation has not been conducted in accordance with Rule 1003.b. Blue line shows approximate perimeter of the pad.

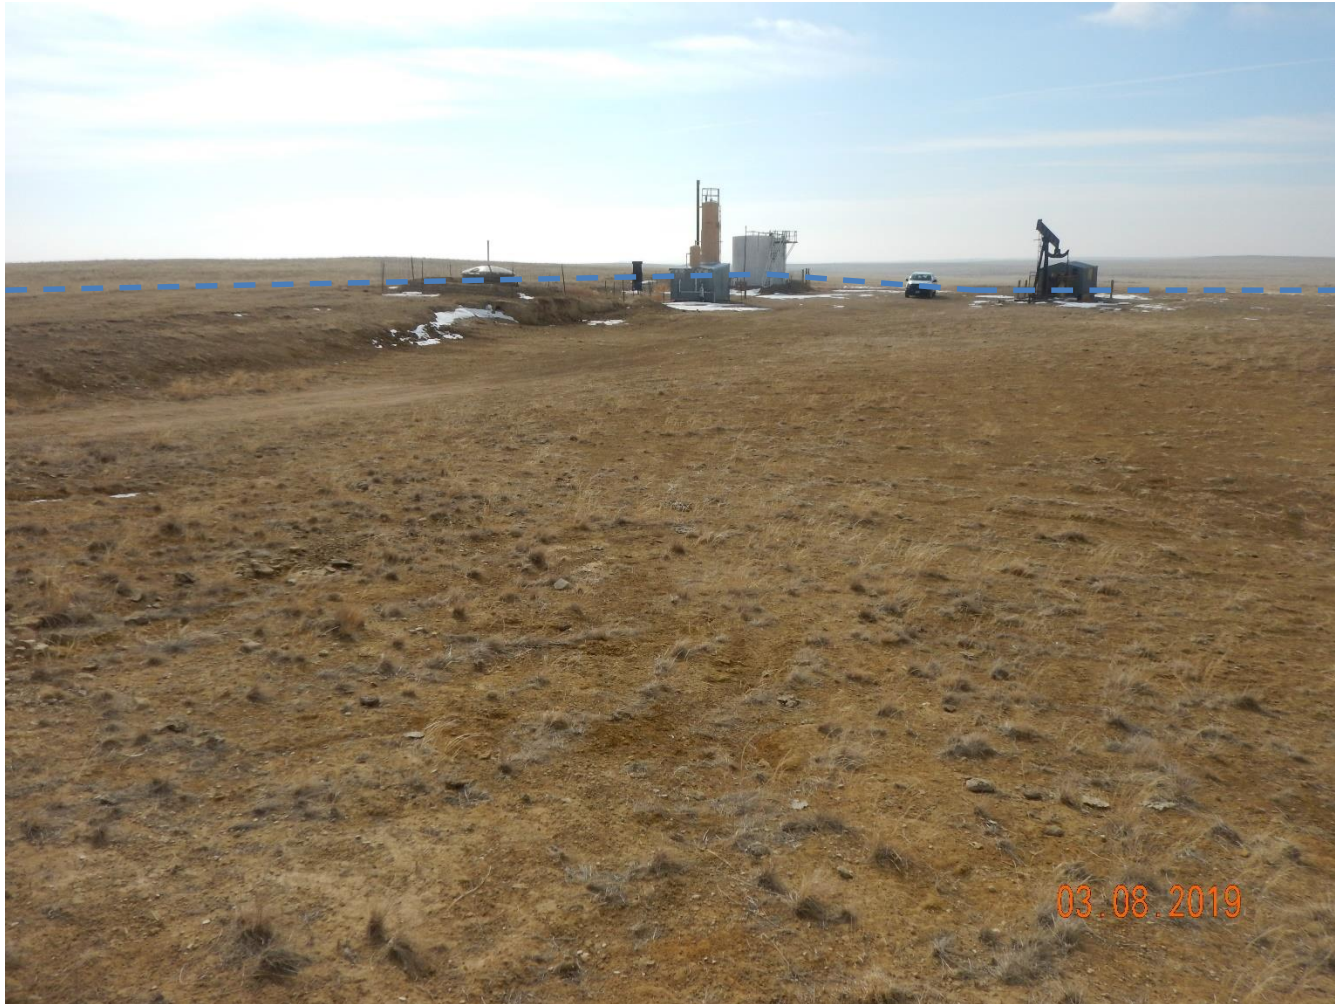
Photo 4: See comments under photo 3.

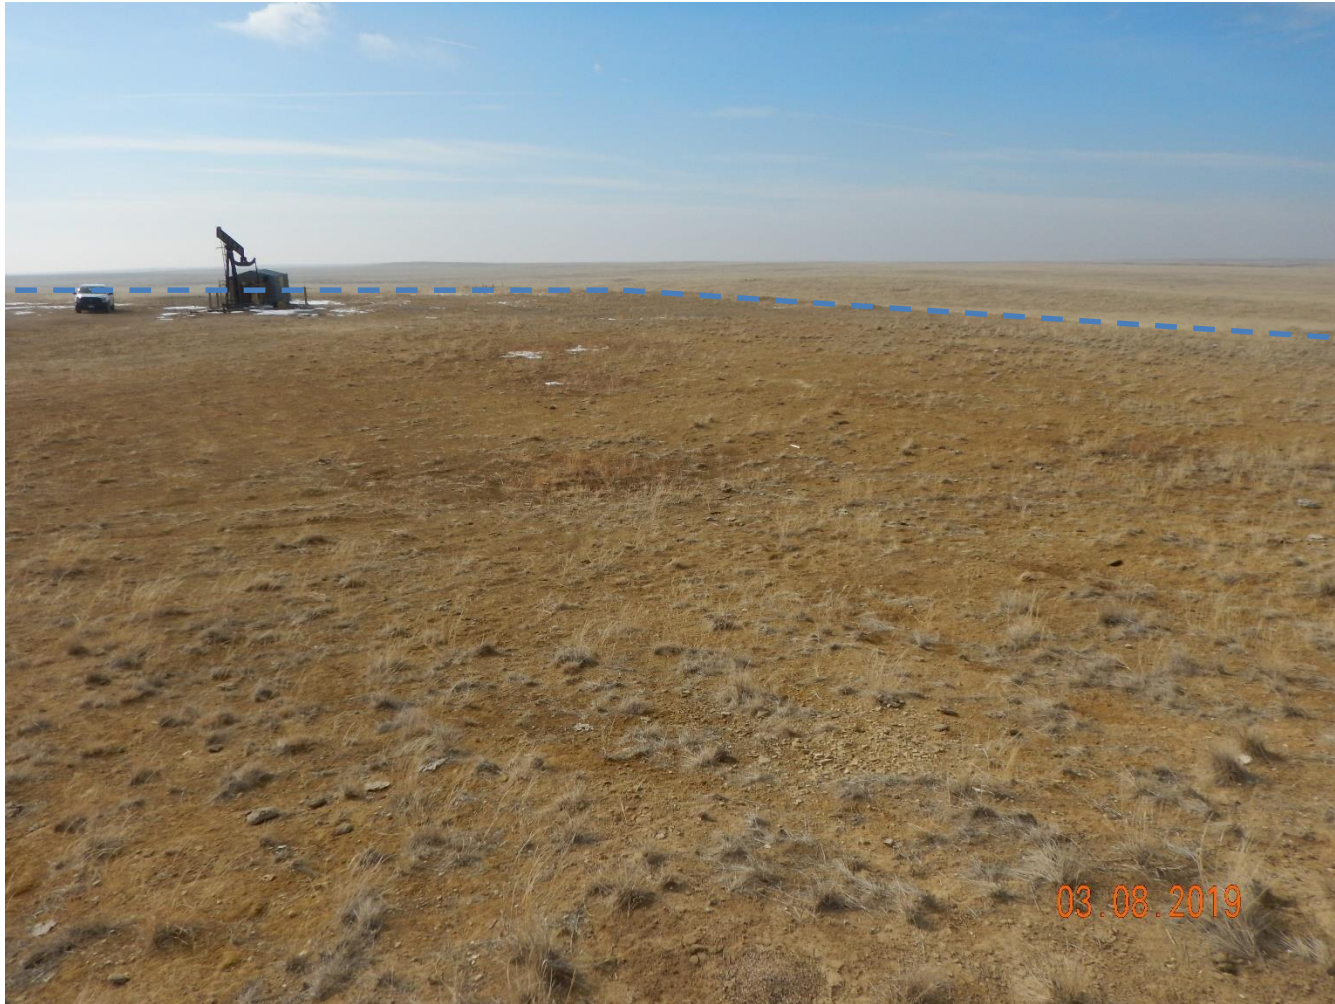
Photo 5: See comments under photo 3.

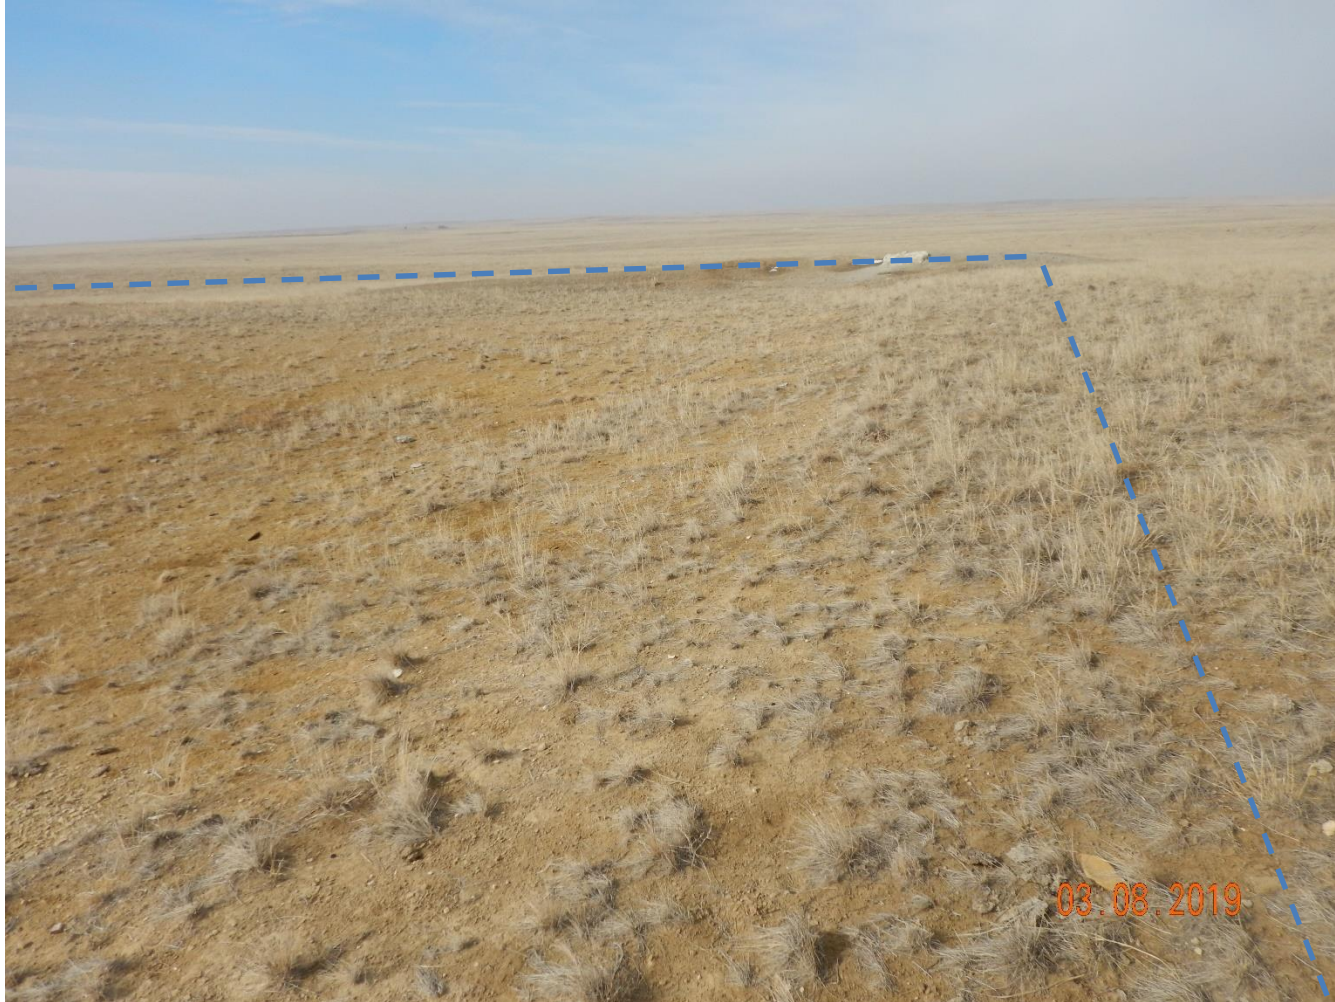
Photo 6: See comments under photo 3.

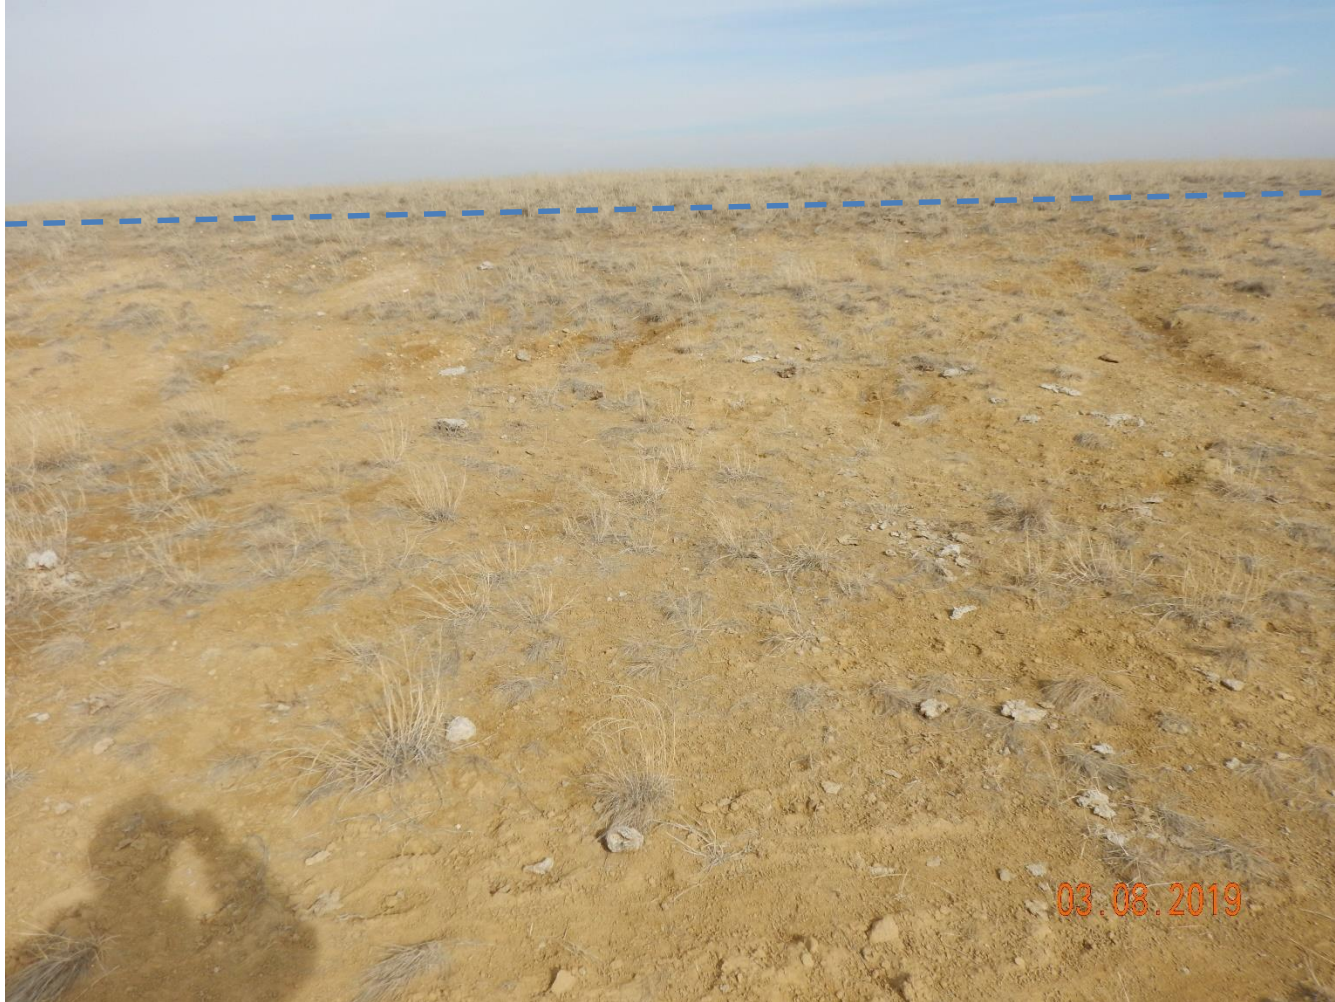
Photo 7: Photo taken from the north end of the location, facing north. Previous inspections documented slopes on location remain predominantly bare and exposed soil with stormwater erosion degradation evident. Slopes remains bare and erosion degradation remains evident.

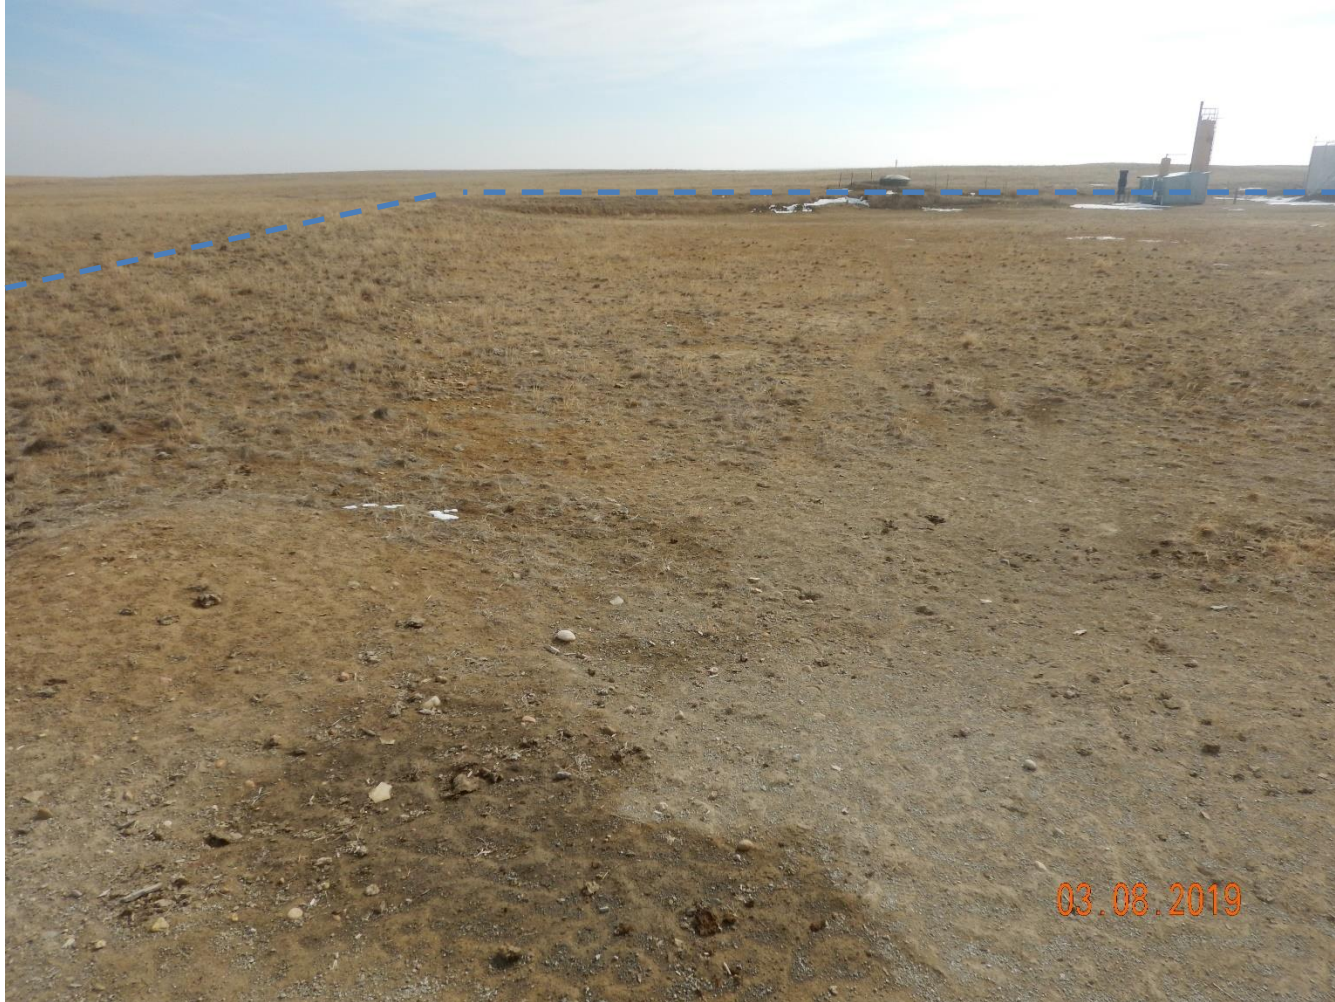
Photo 8: Photo taken from the northwest corner of the location, facing east. See comments under photo 3.

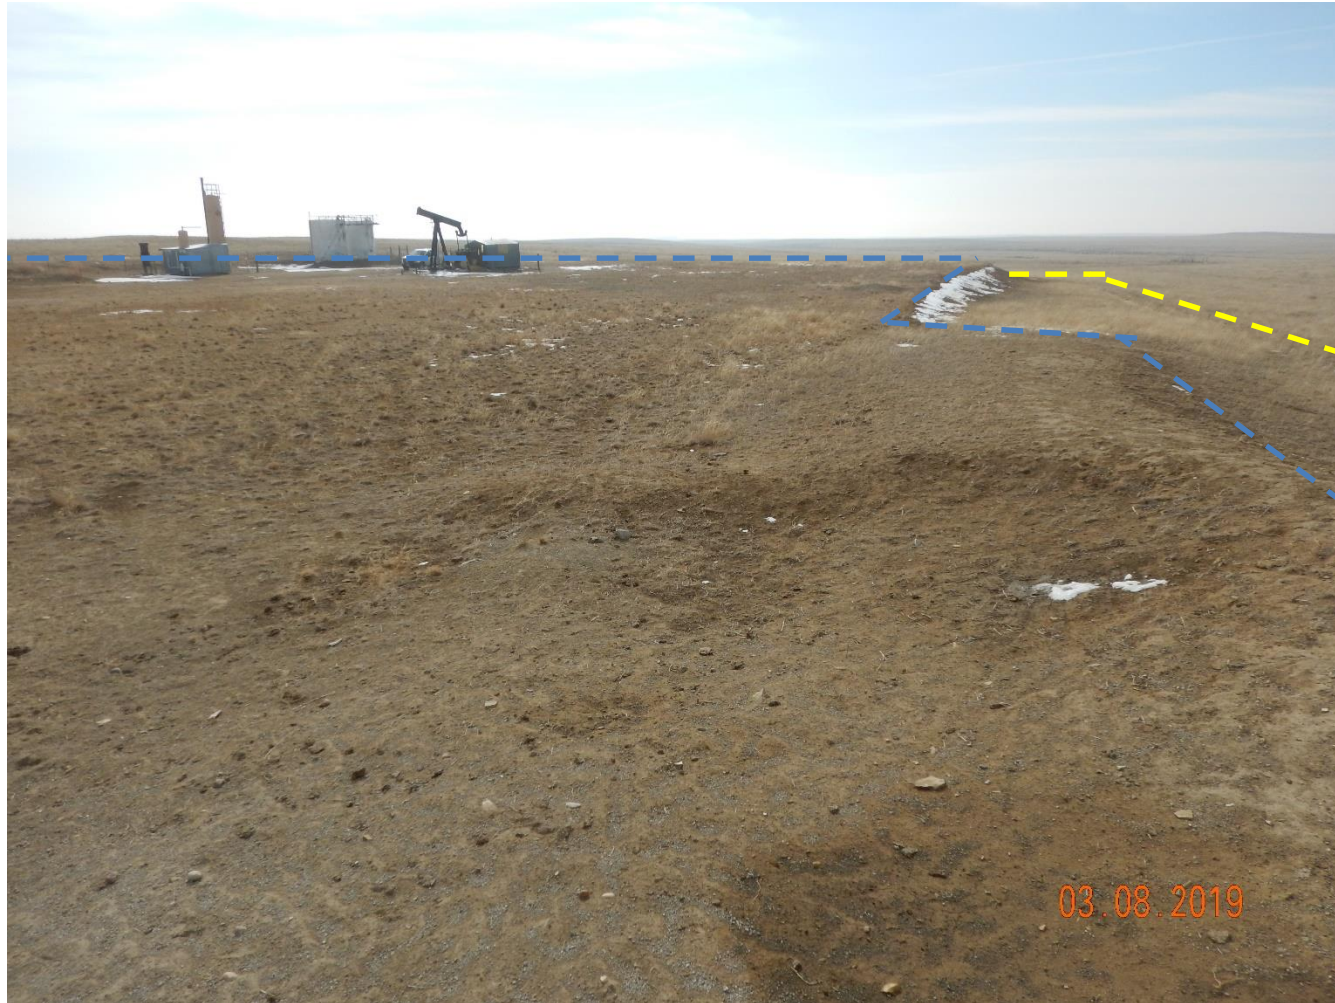
Photo 9: Photo taken from the northwest corner of the location, facing south. See comments under photo 3. Blue line shows perimeter of pad. Yellow lines shows perimeter of the disturbance area.

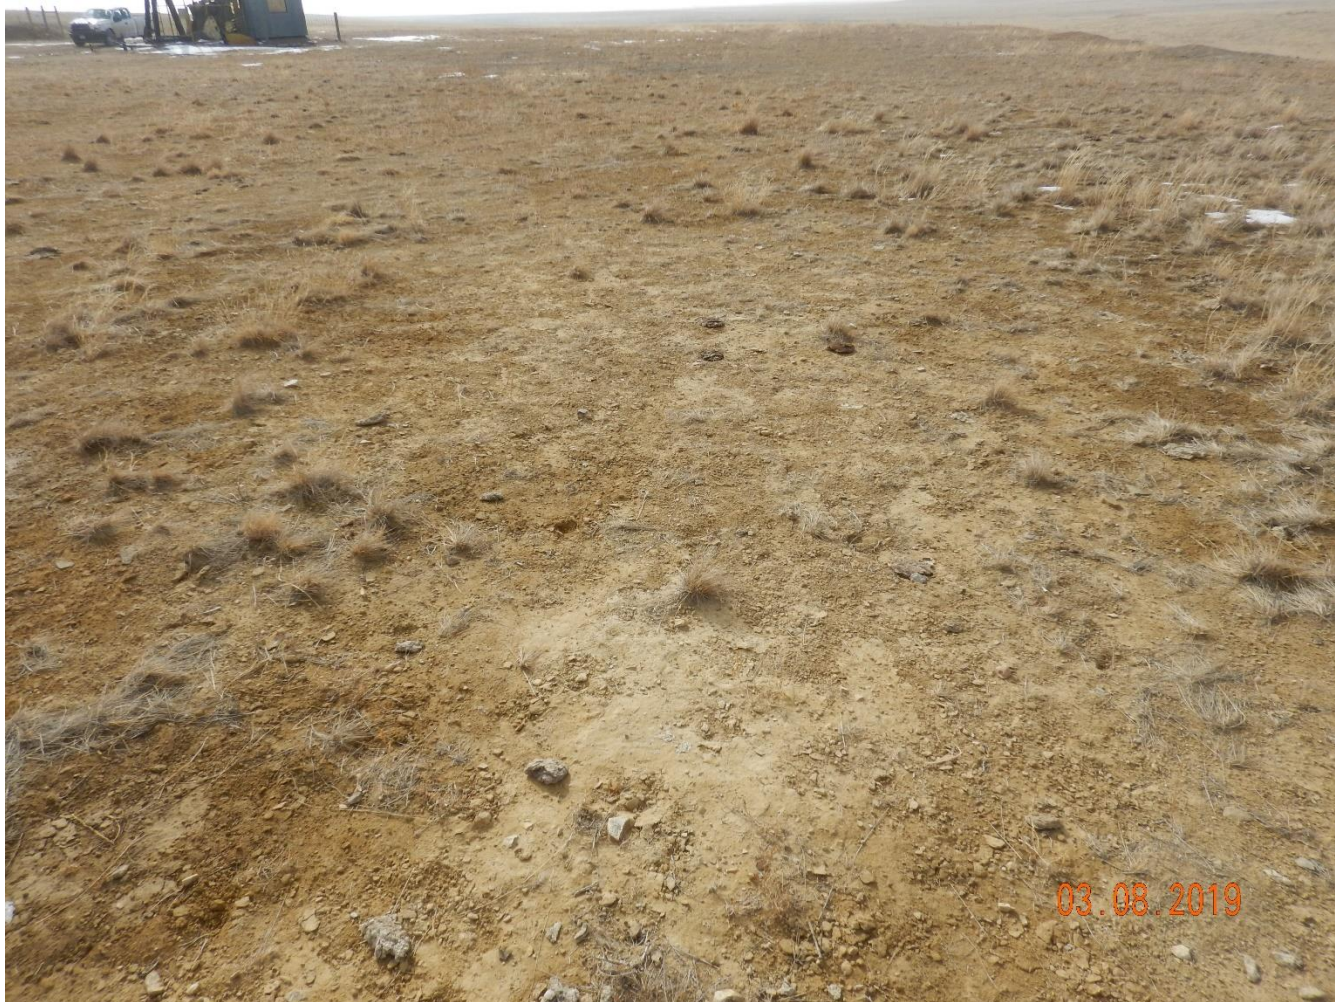
Photo 10: Photo taken from the northwest end of the pad, facing south. Photo shows the location remains predominantly bare and exposed soil.

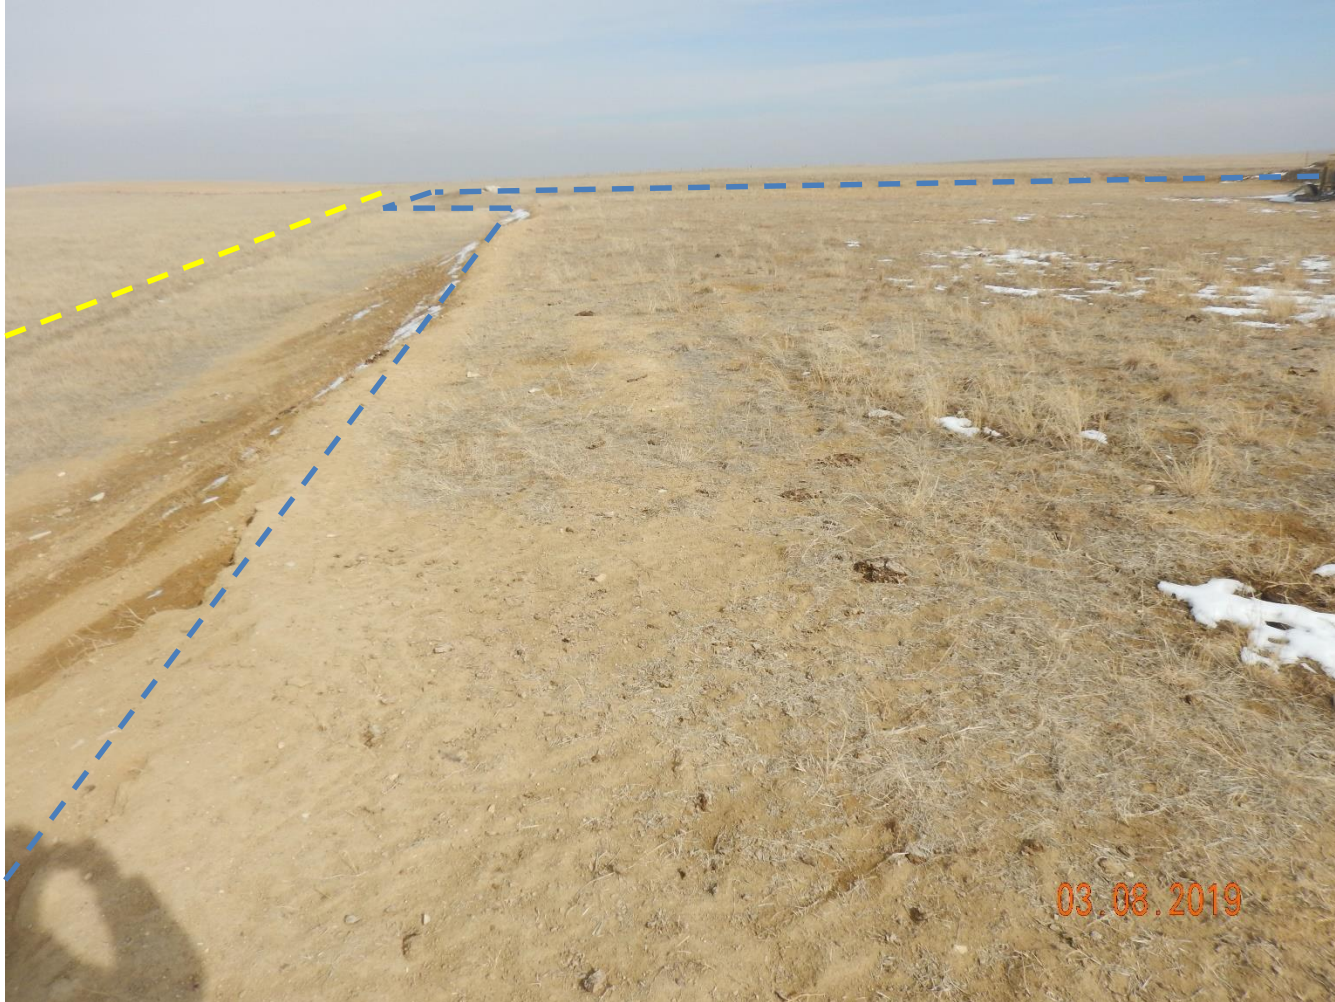
Photo 11: Photo taken from the southeast corner of the pad, facing north. See comments under photo 3.

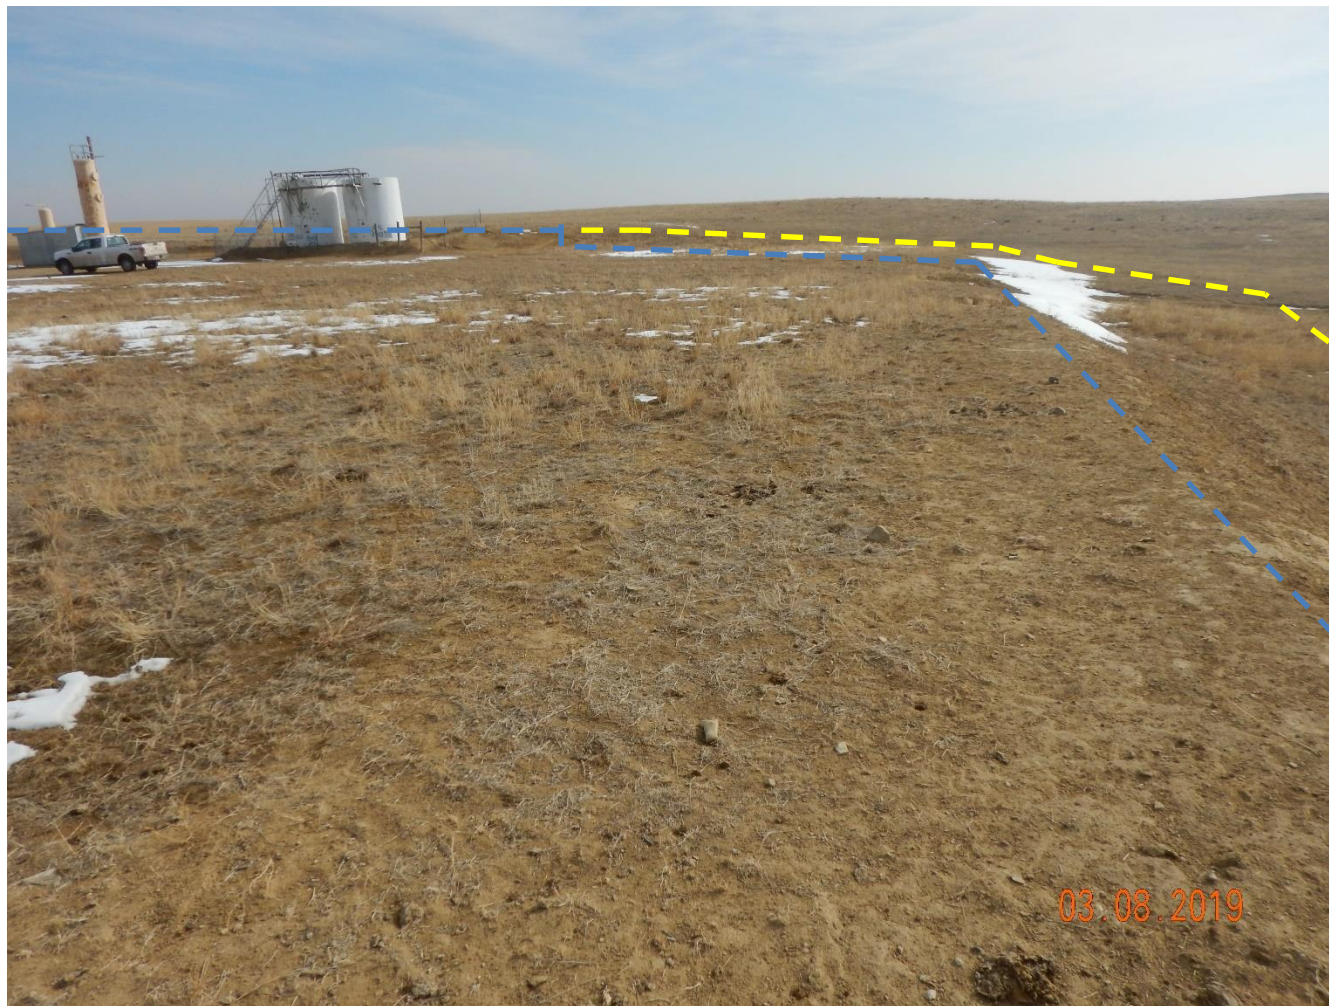
Photo 12: Photo taken from the slopes of the interim areas on the east end of the location. Photo shows slopes remains predominantly bare and exposed soil with little desirable perennial vegetative establishment. Photo also shows the erosion blankets/netting along slopes are in disrepair and no longer in proper functioning condition.

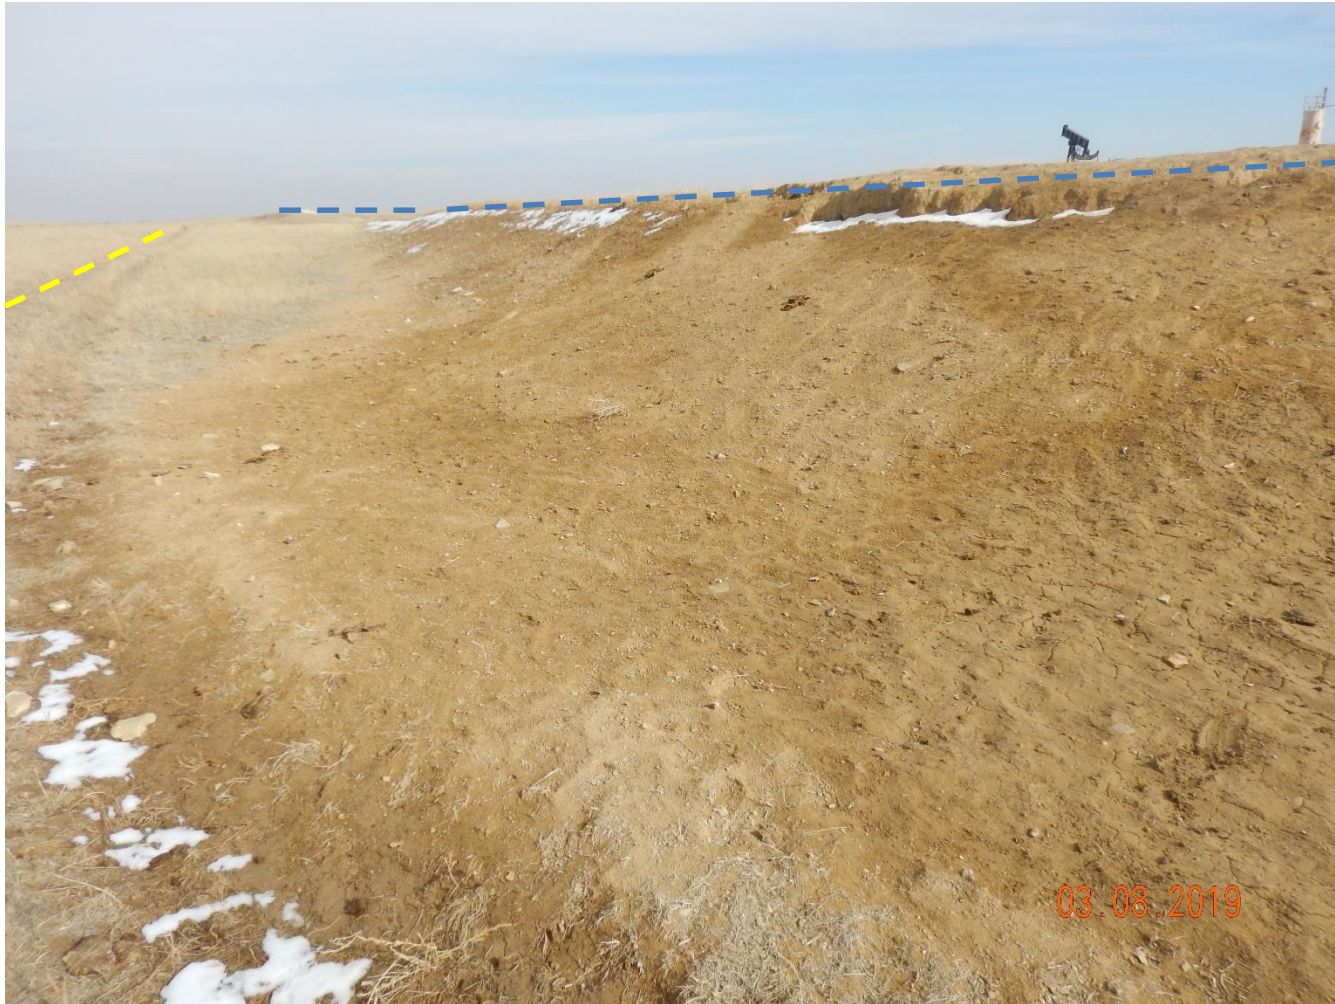
Photo 13: Photo taken from the southwest corner of the location, facing northeast. Previous inspections documented slopes on location remain predominantly bare and exposed soil with stormwater erosion degradation evident. Slopes remains bare and erosion degradation remains evident.

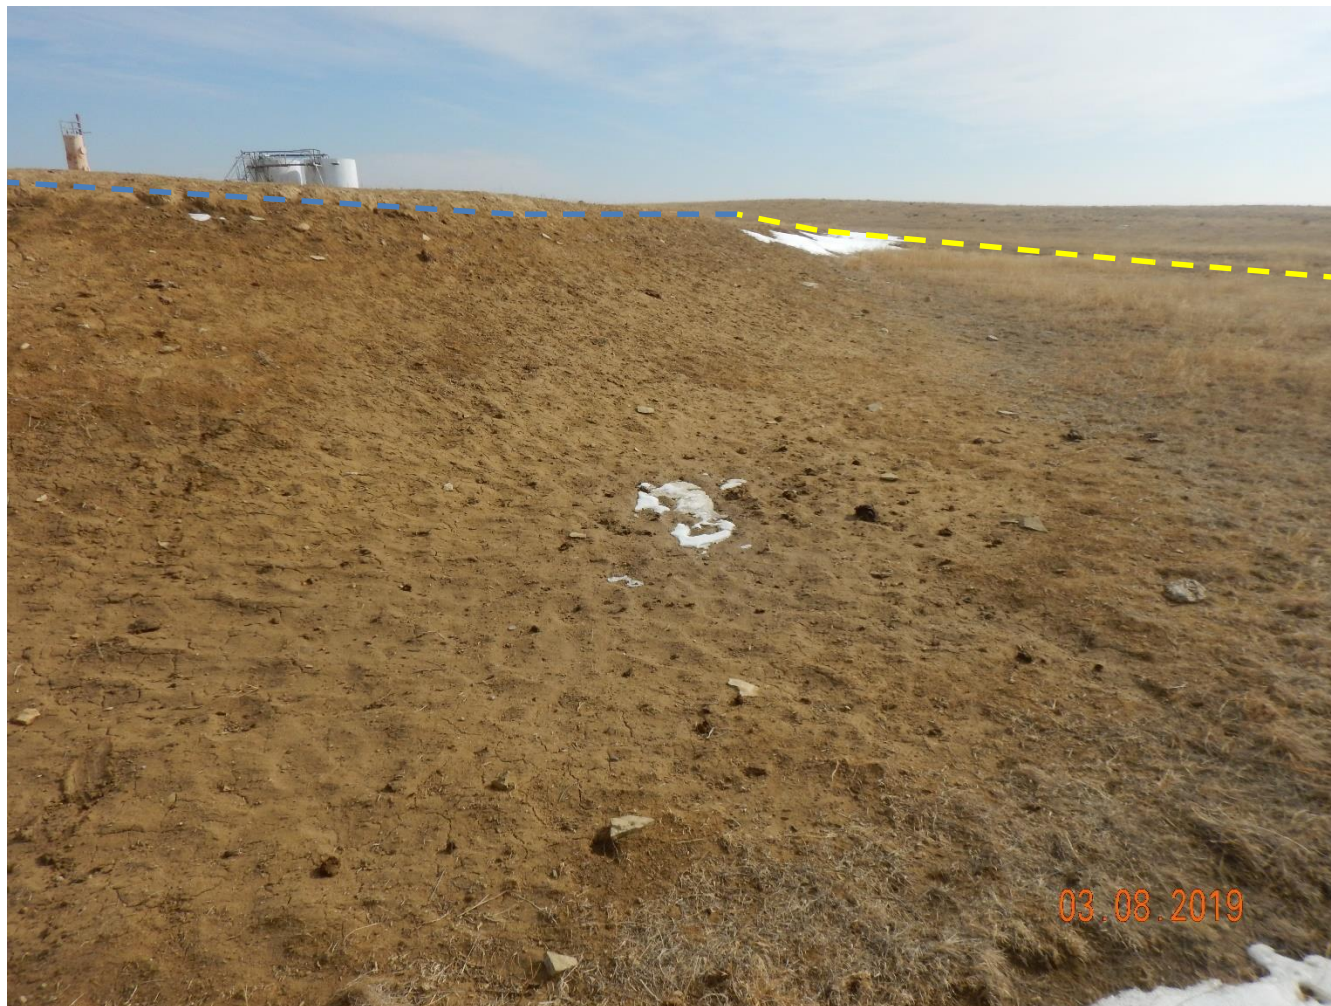
Photo 14: Photo taken from the southwest corner of the location, facing east. Previous inspections documented slopes on location remain predominantly bare and exposed soil with stormwater erosion degradation evident. Slopes remains bare and erosion degradation remains evident.

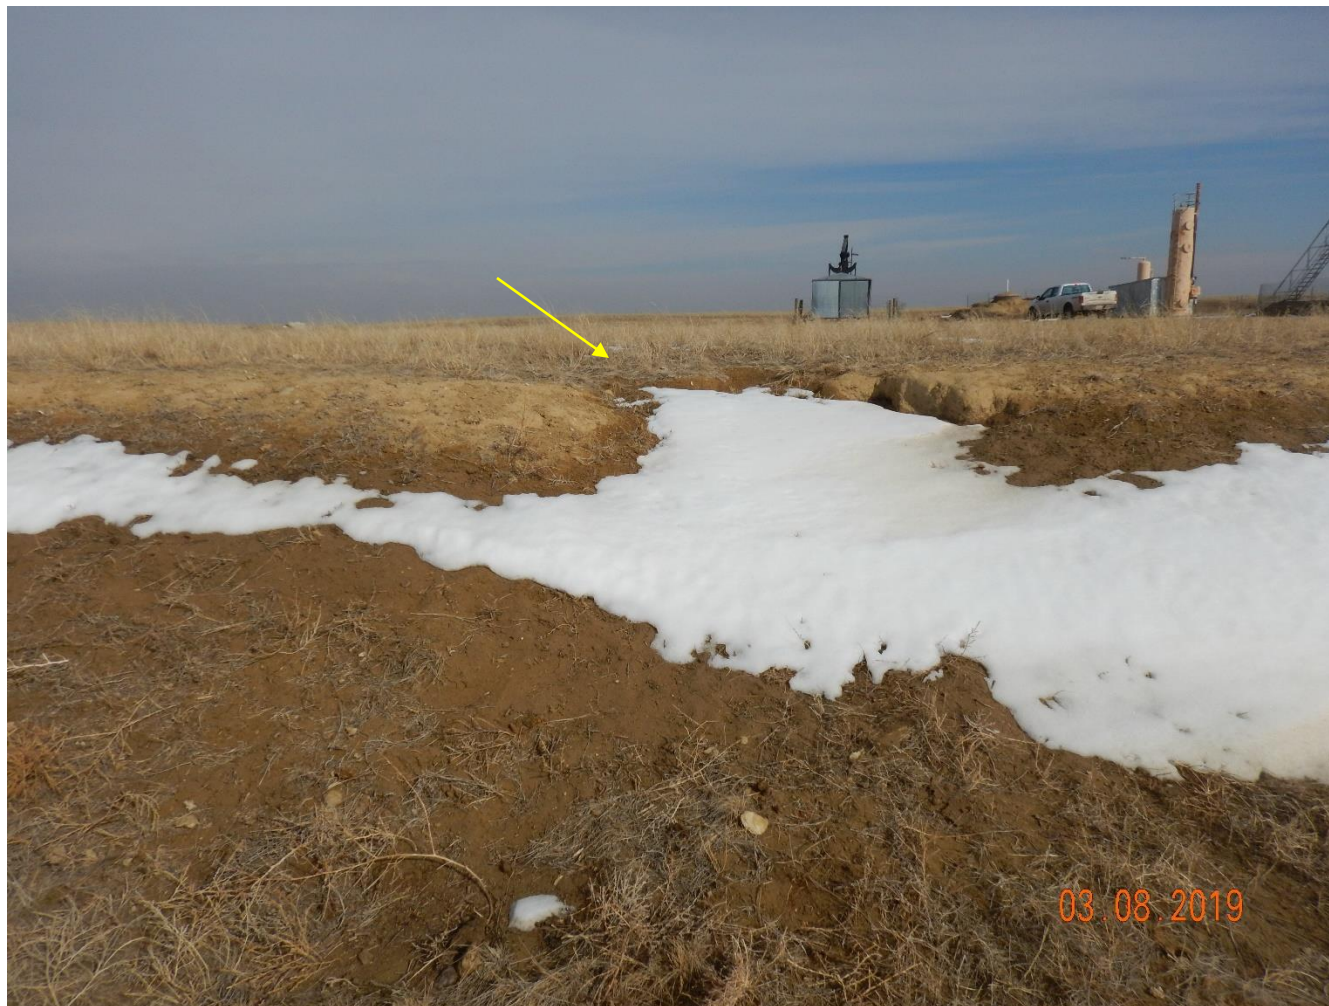
Photo 15: Photo taken from the south end of the location, facing north. Previous inspections documented erosion degradation on the location and required operator to implement BMPs in accordance with 1002.f. Photo shows erosion degradation remains, no BMPs have been installed or maintained.

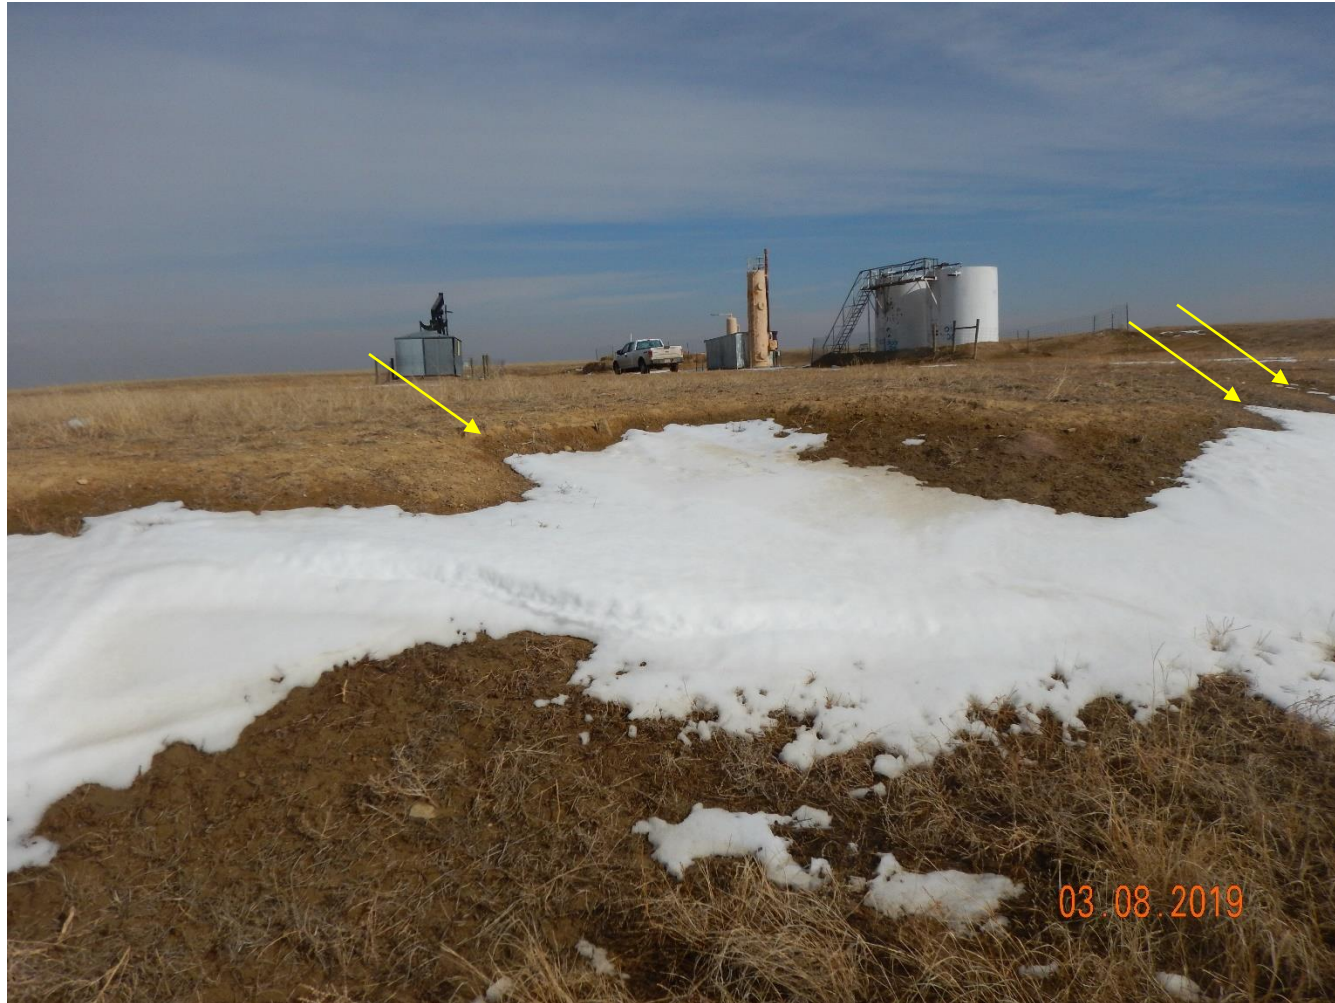
Photo 16: PhoPhoto taken from the south end of the location, facing northeast. Previous inspections documented erosion degradation on the location and required operator to implement BMPs in accordance with 1002.f. Photo shows erosion degradation remains, no BMPs have been installed or maintained.
