Inspection Photos

Operator: FOUNDATION ENERGY
MANAGEMENT LLC - 10112

Location ID: 330865

Inspection Doc. Number: 682504574
Weld County, CO

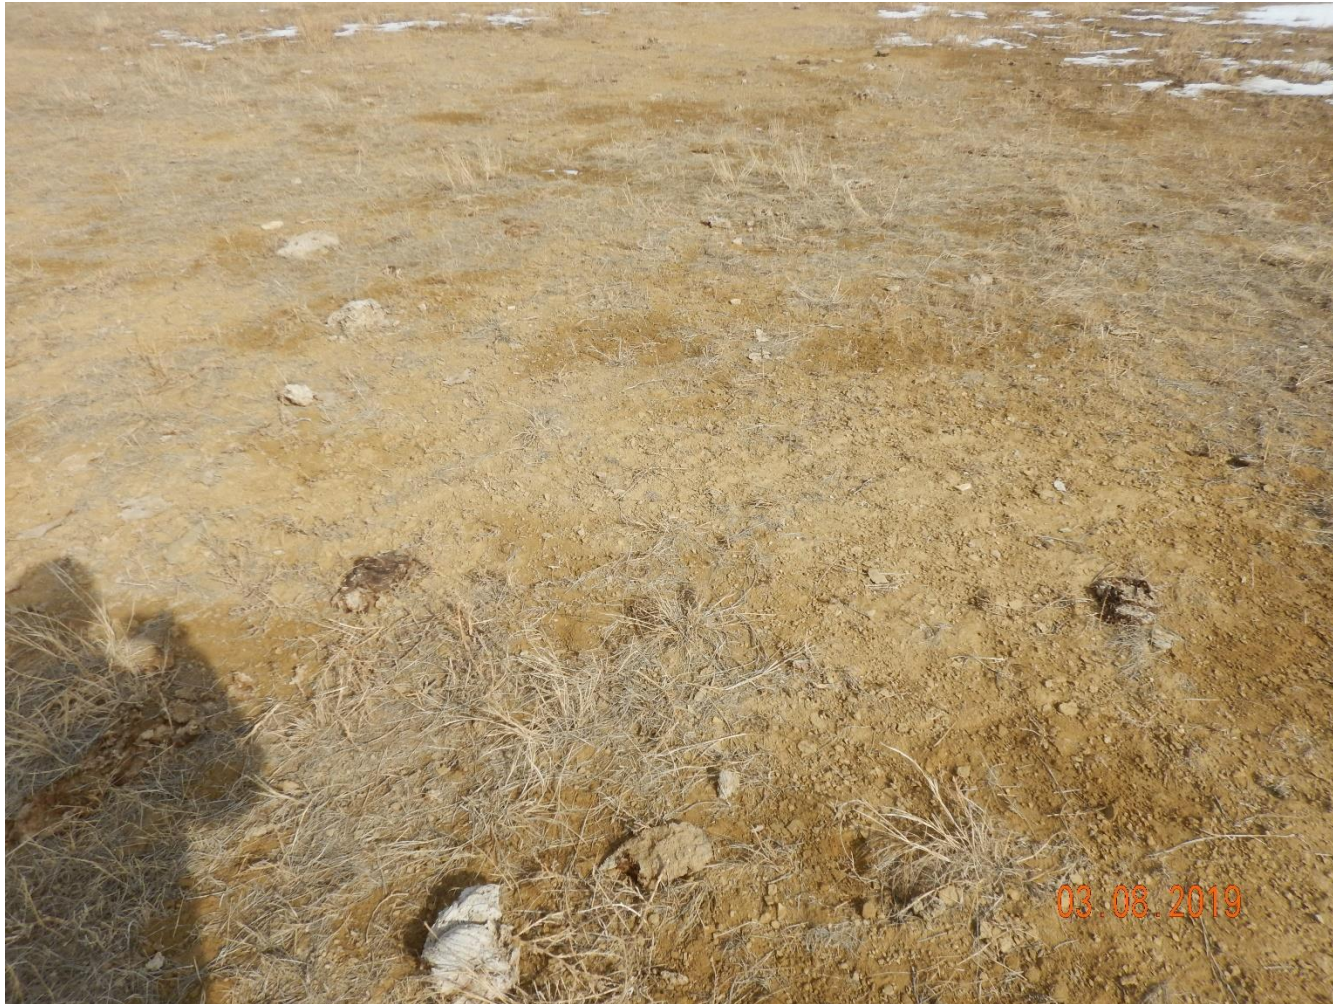
Photo 17: Photo taken from the northwest end of the pad, facing south. Photo shows the location remains predominantly bare and exposed soil.

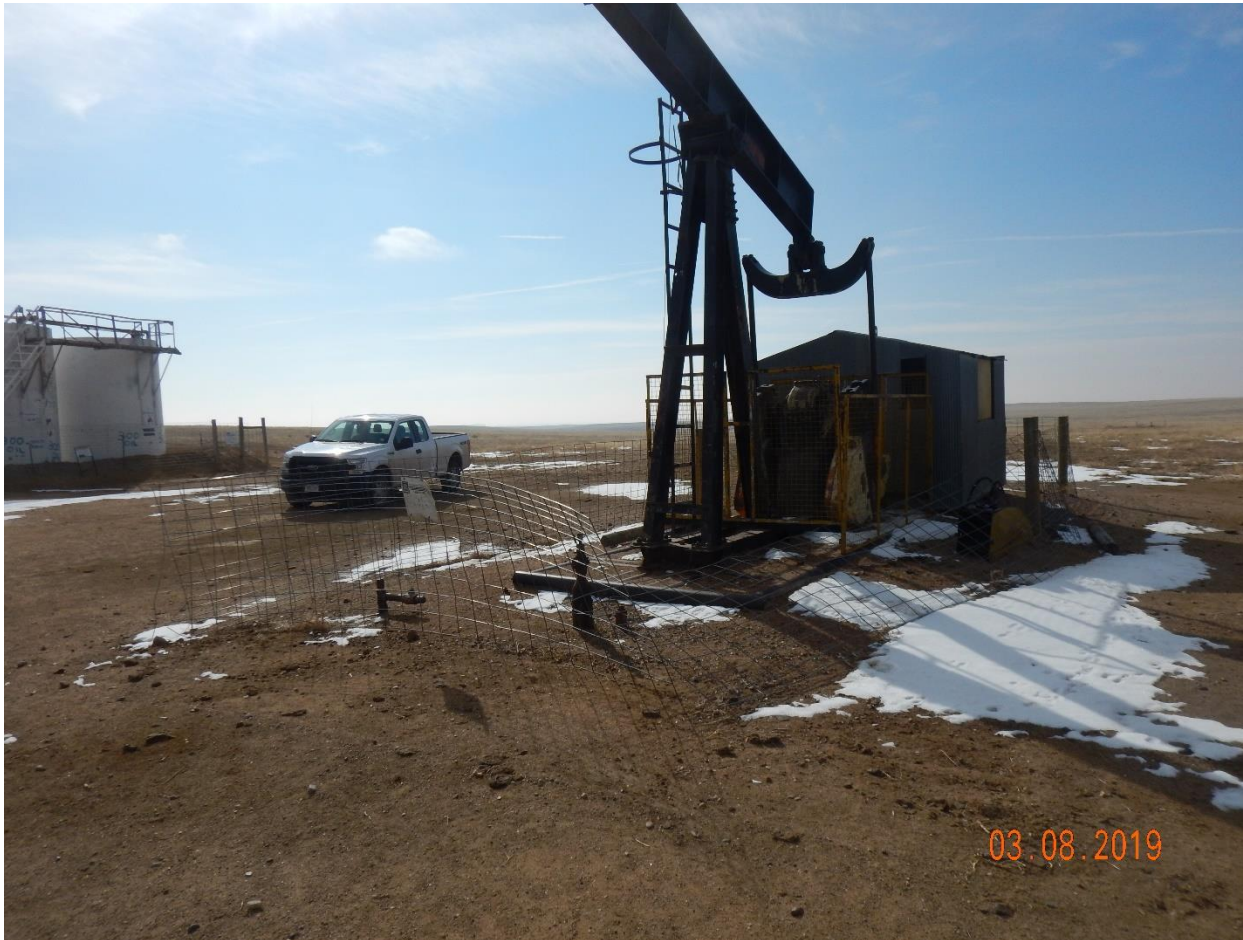
Photo 18: Photo taken from the well, facing south. Photo shows fence around pump unit is in disrepair.

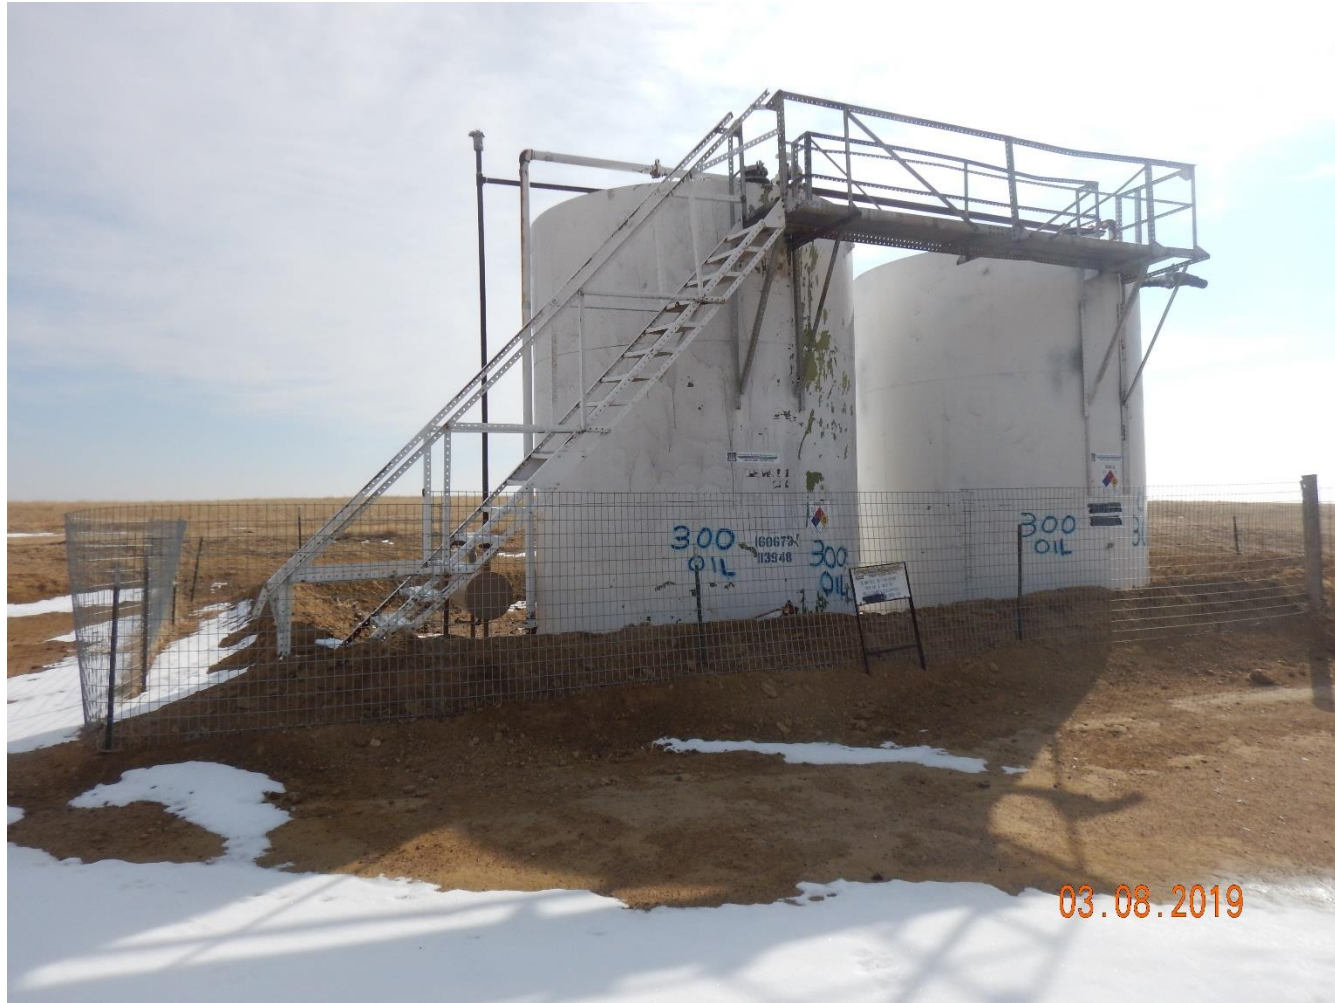
Photo 19: Photo taken from the east end of the location, facing southeast. Photo of tank battery.

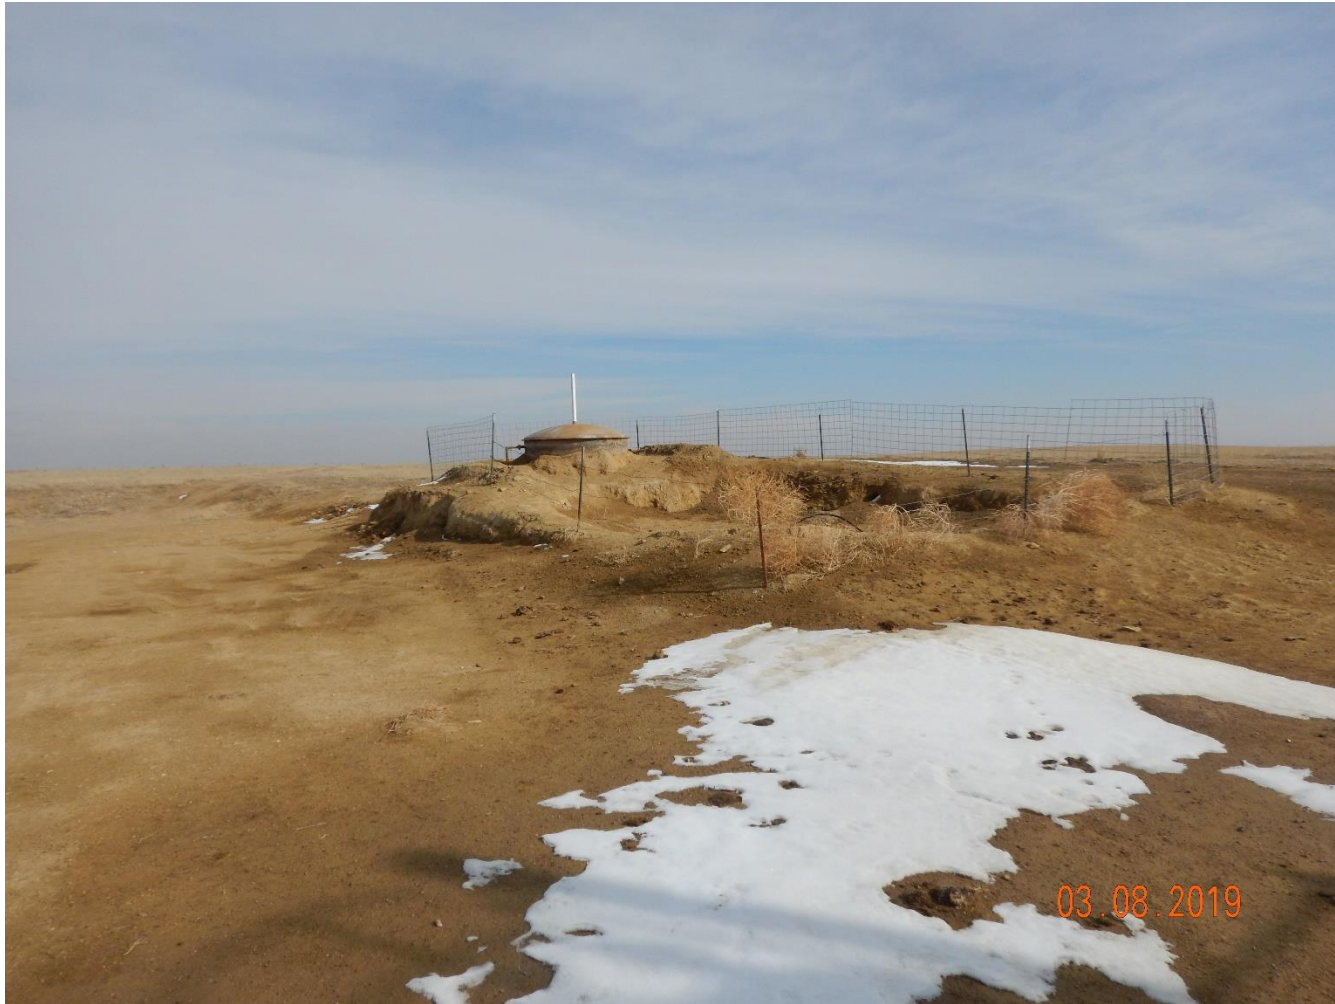
Photo 20: Photo taken from the east end of the location, facing northeast. Photo shows unpermitted pit.

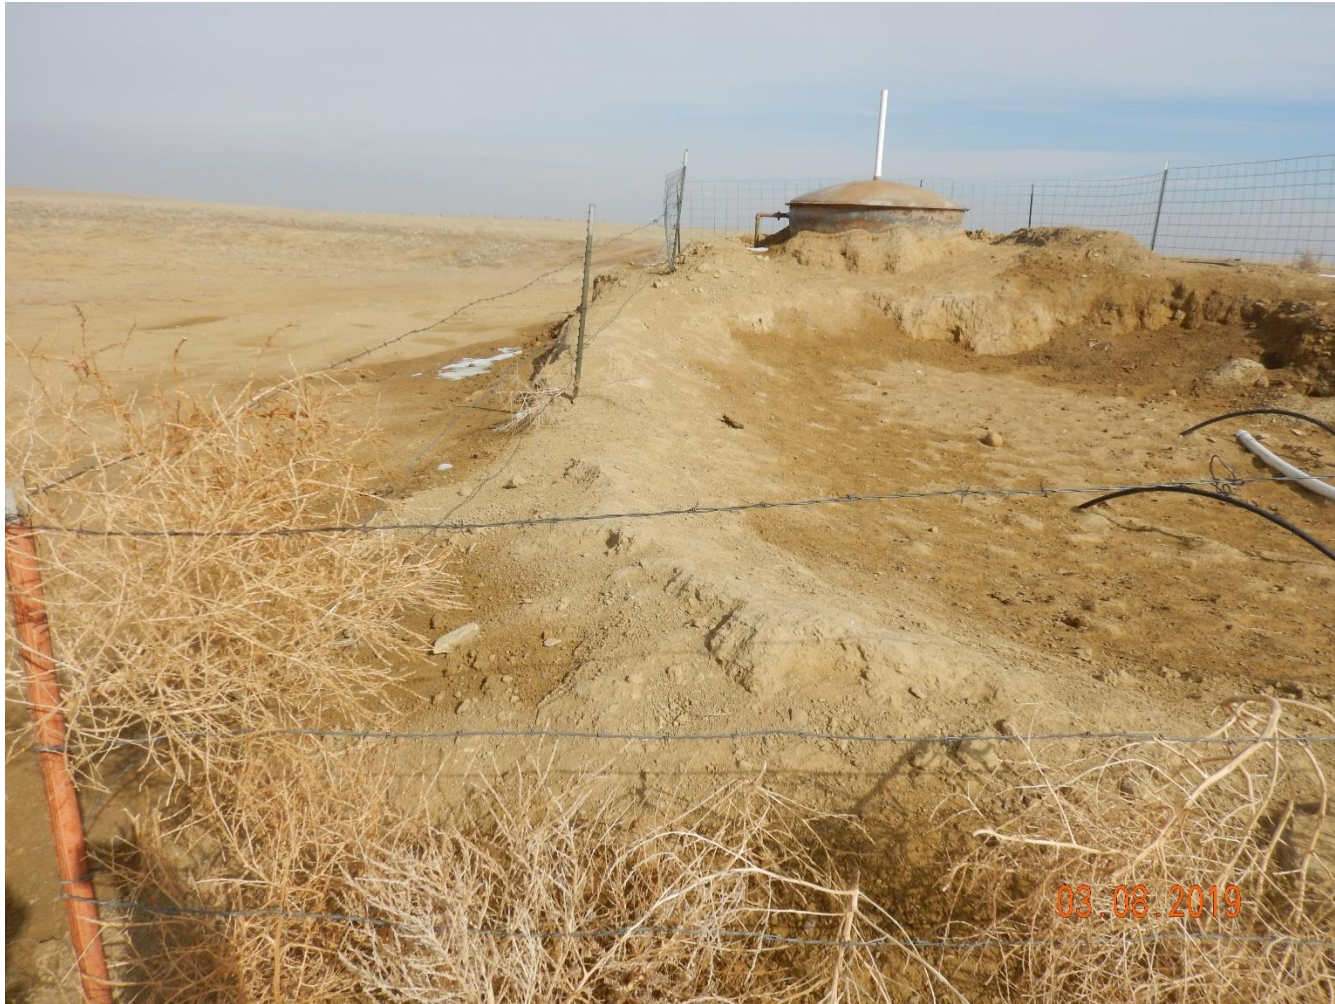
Photo 21: Photo taken from the southwest corner of the unpermitted pit.

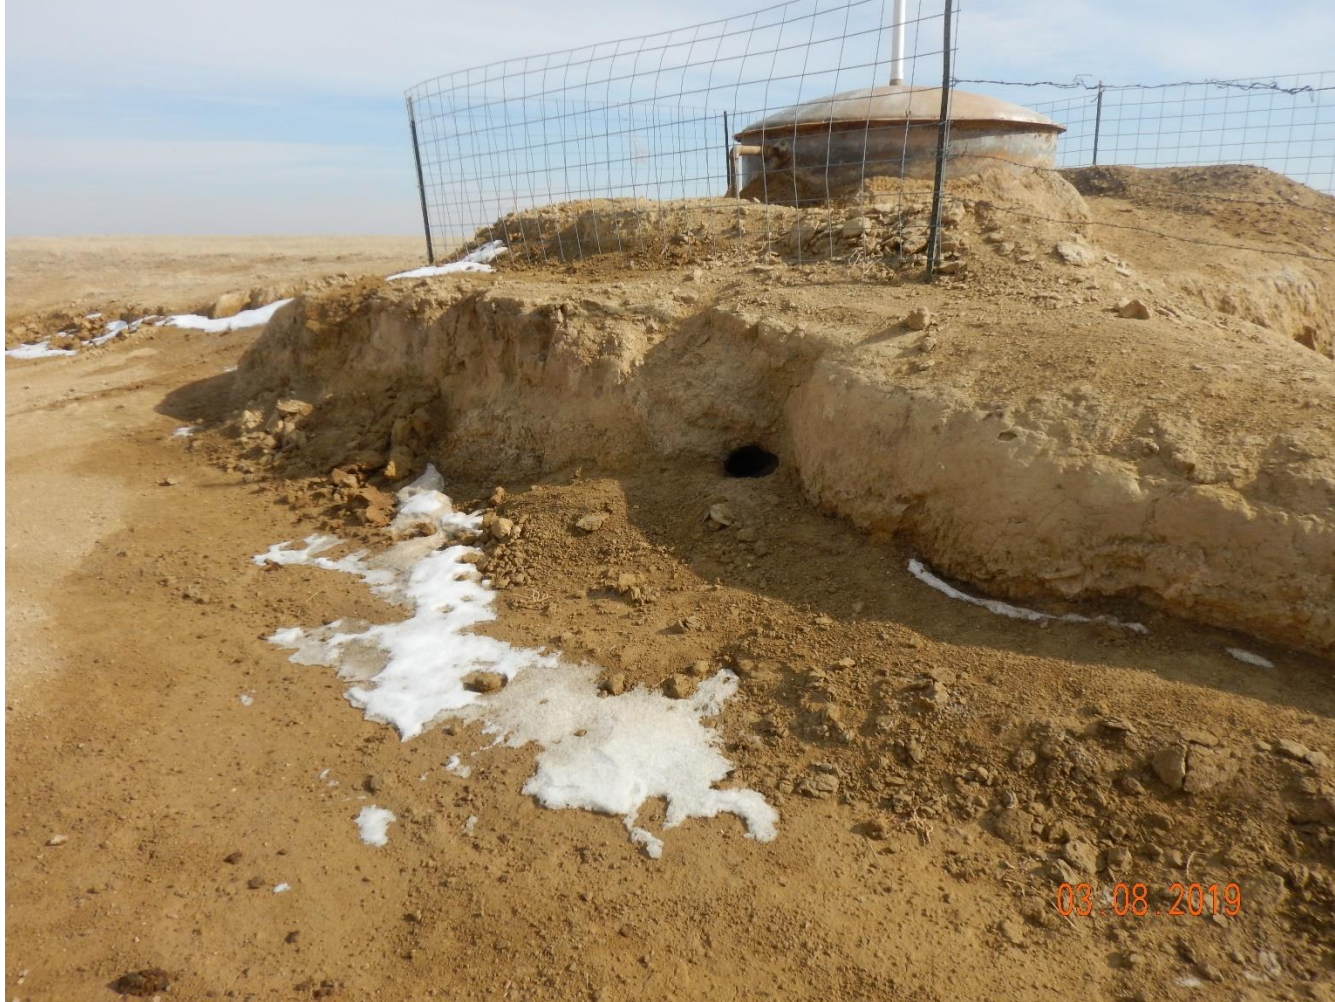
Photo 22: Photo taken from the west end of the unpermitted pit, facing northeast. Photo shows wildlife have burrowed into the walls of the pit compromising the integrity of the pit walls.

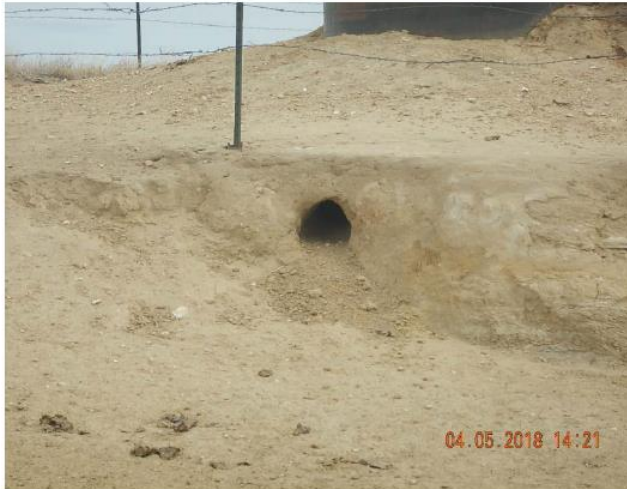
Photo 12: Burrow on NW side of pit

Photo 23: Photos from the 4/05/2018 inspection. Photos for comparison to photo 22. Photo show burrows at pit have not been repaired.

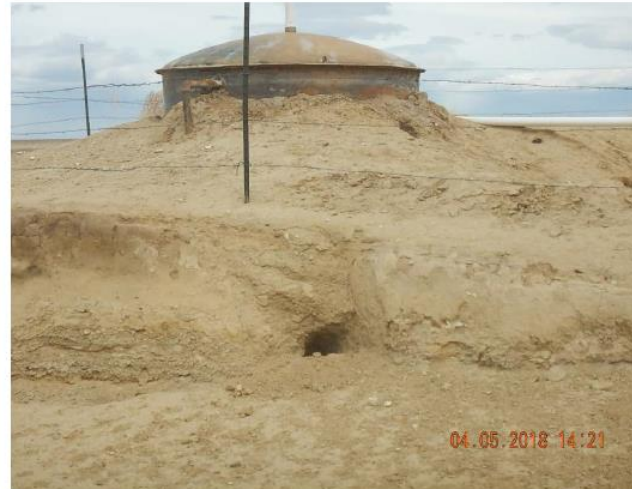
Photo 13: Burrow on W side of pit

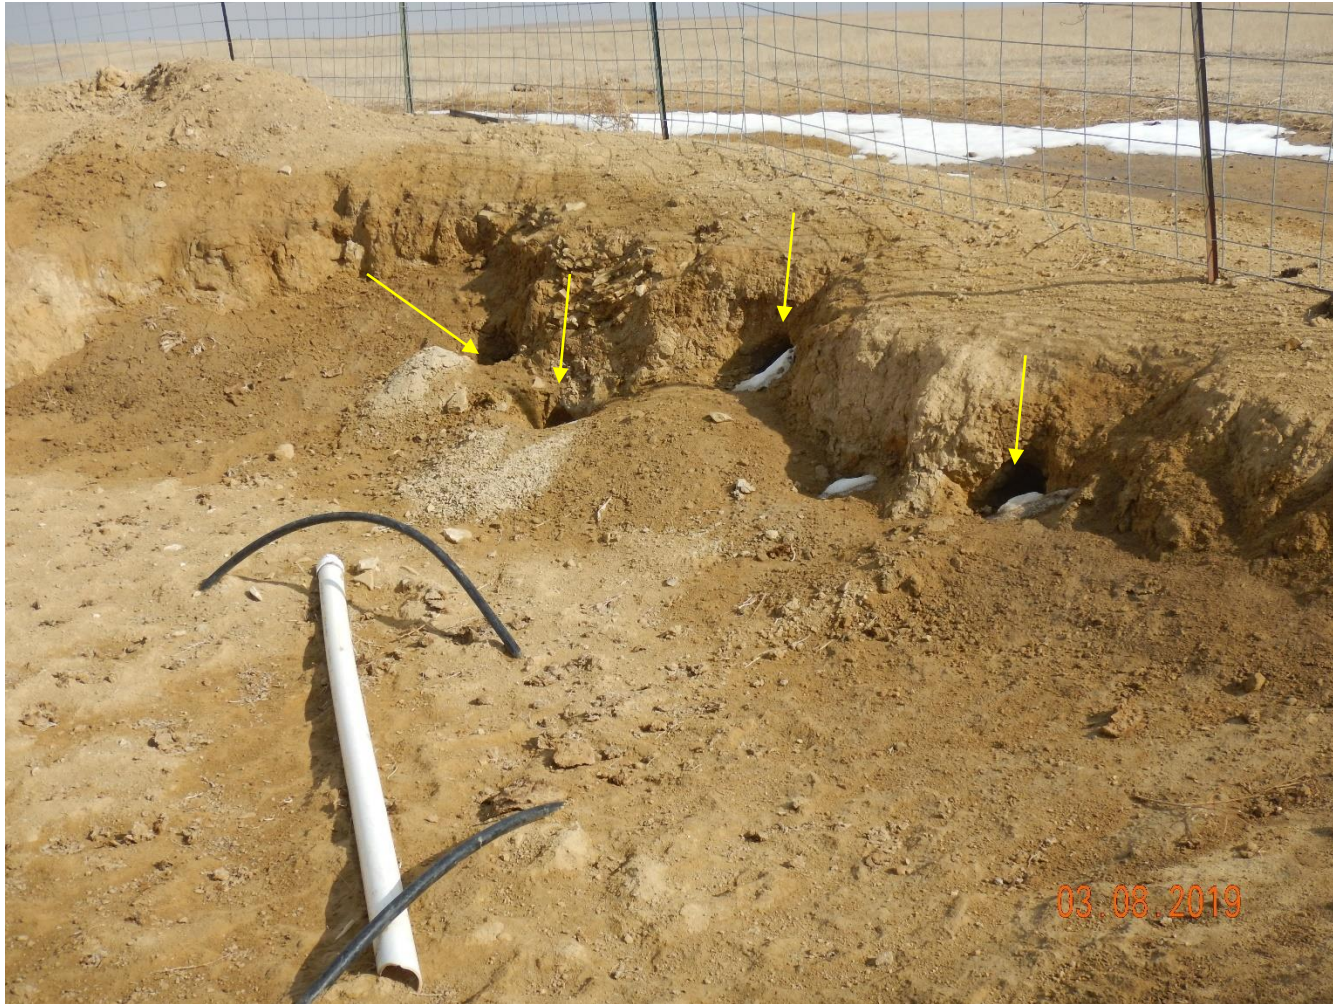
Photo 24: Photo taken from the pit, facing northeast. Photo shows wildlife have burrowed into the walls of the pit compromising the integrity of the pit walls.
