Inspection Photos

Operator: BISON OIL & GAS II LLC # 10661

Location ID: 454166

Inspection Doc. Number: 682504584

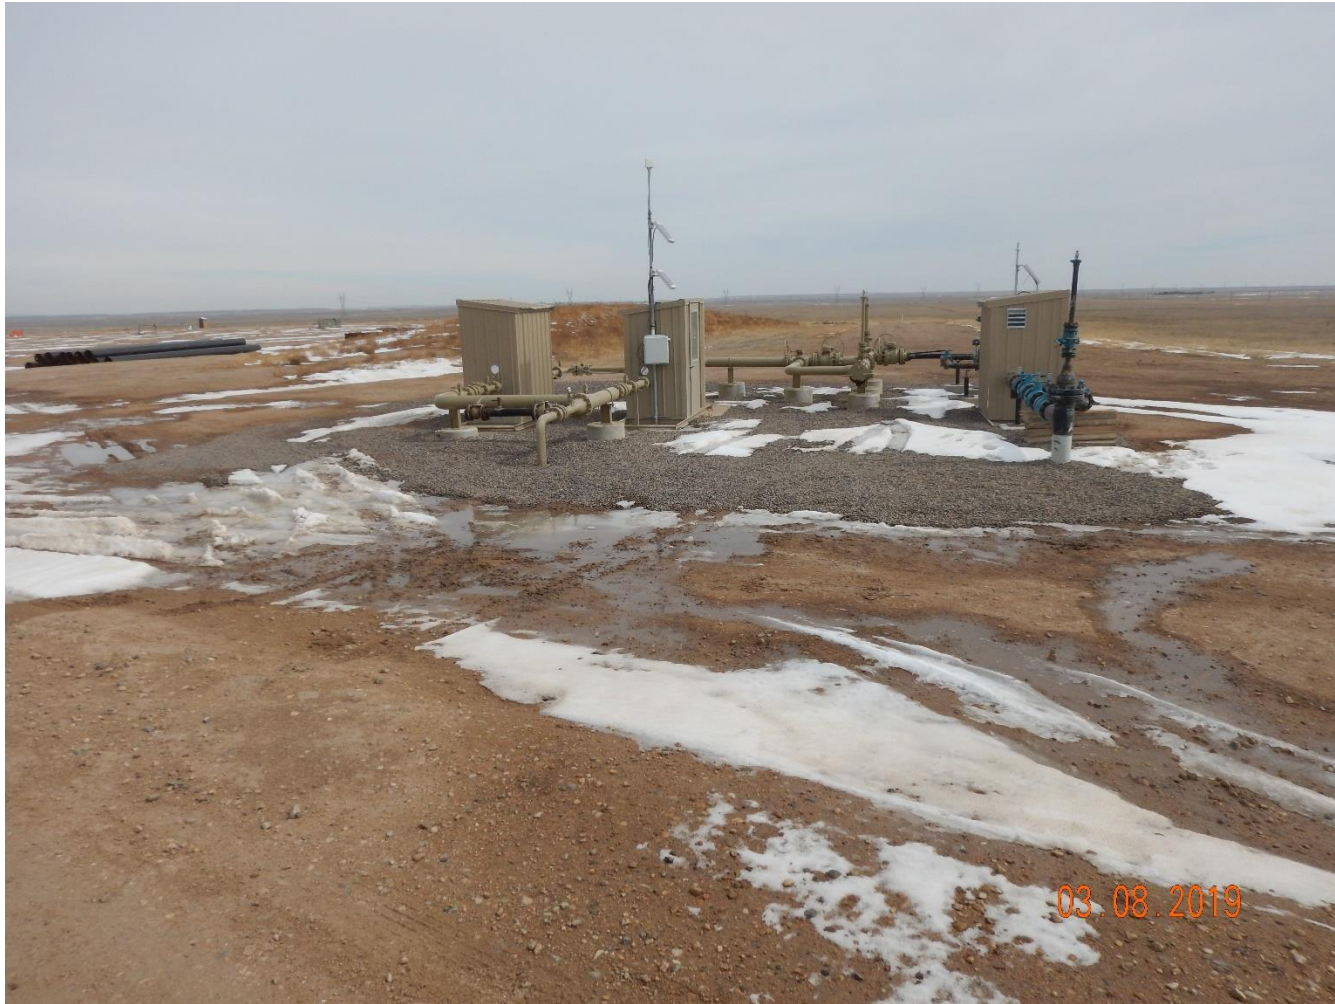
Photo 1: Photo taken from the southwest end of the location, facing east. Photos 1-4 provide an overview of the location from east, northeast, north to northwest.

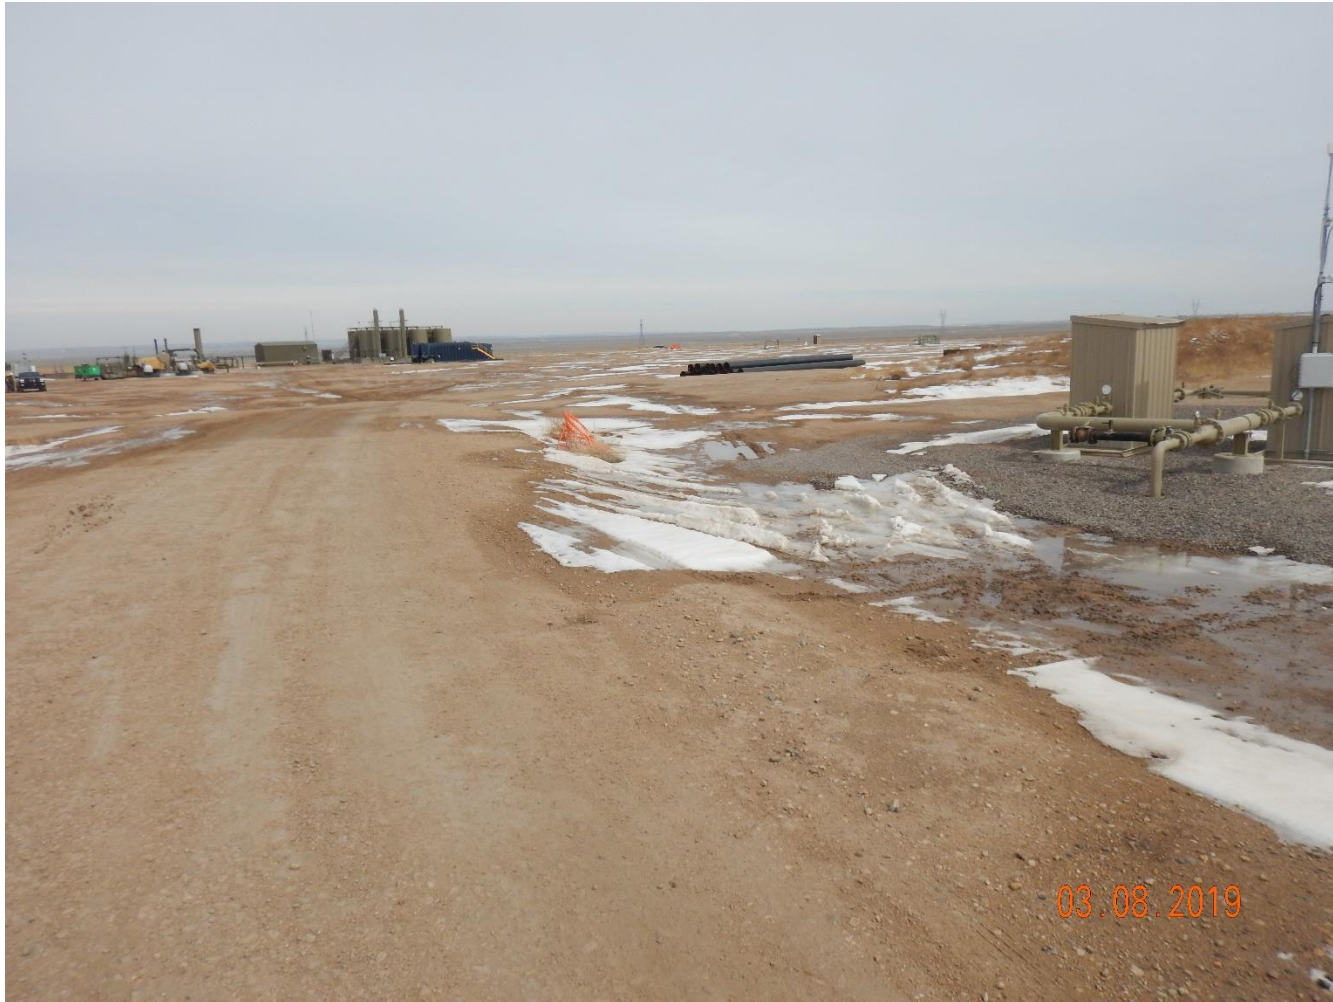
Photo 2: See comments under photo 1.

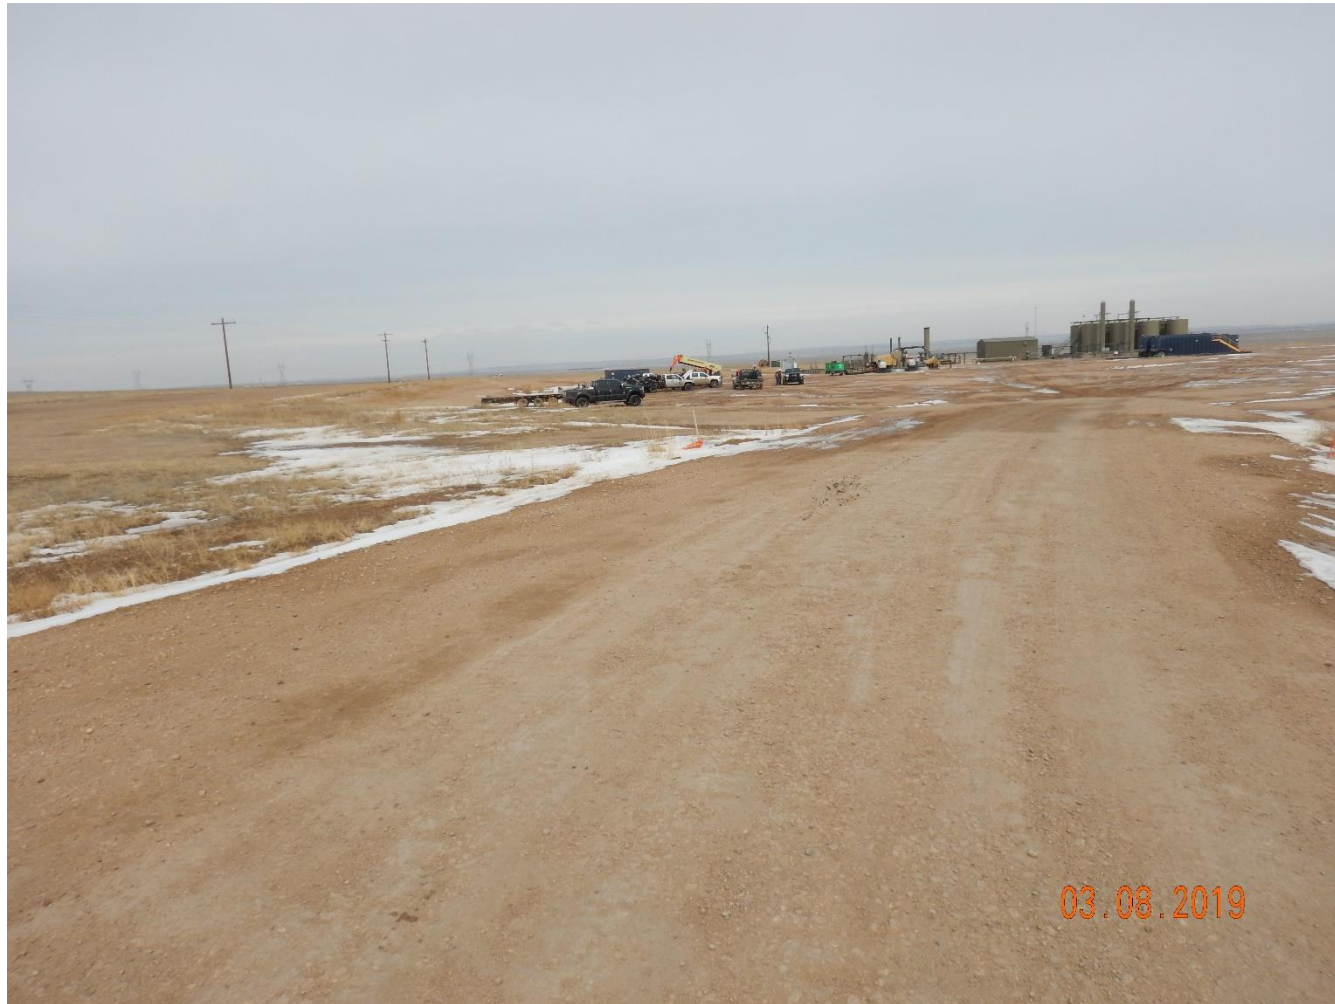
Photo 3: See comments under photo 1.

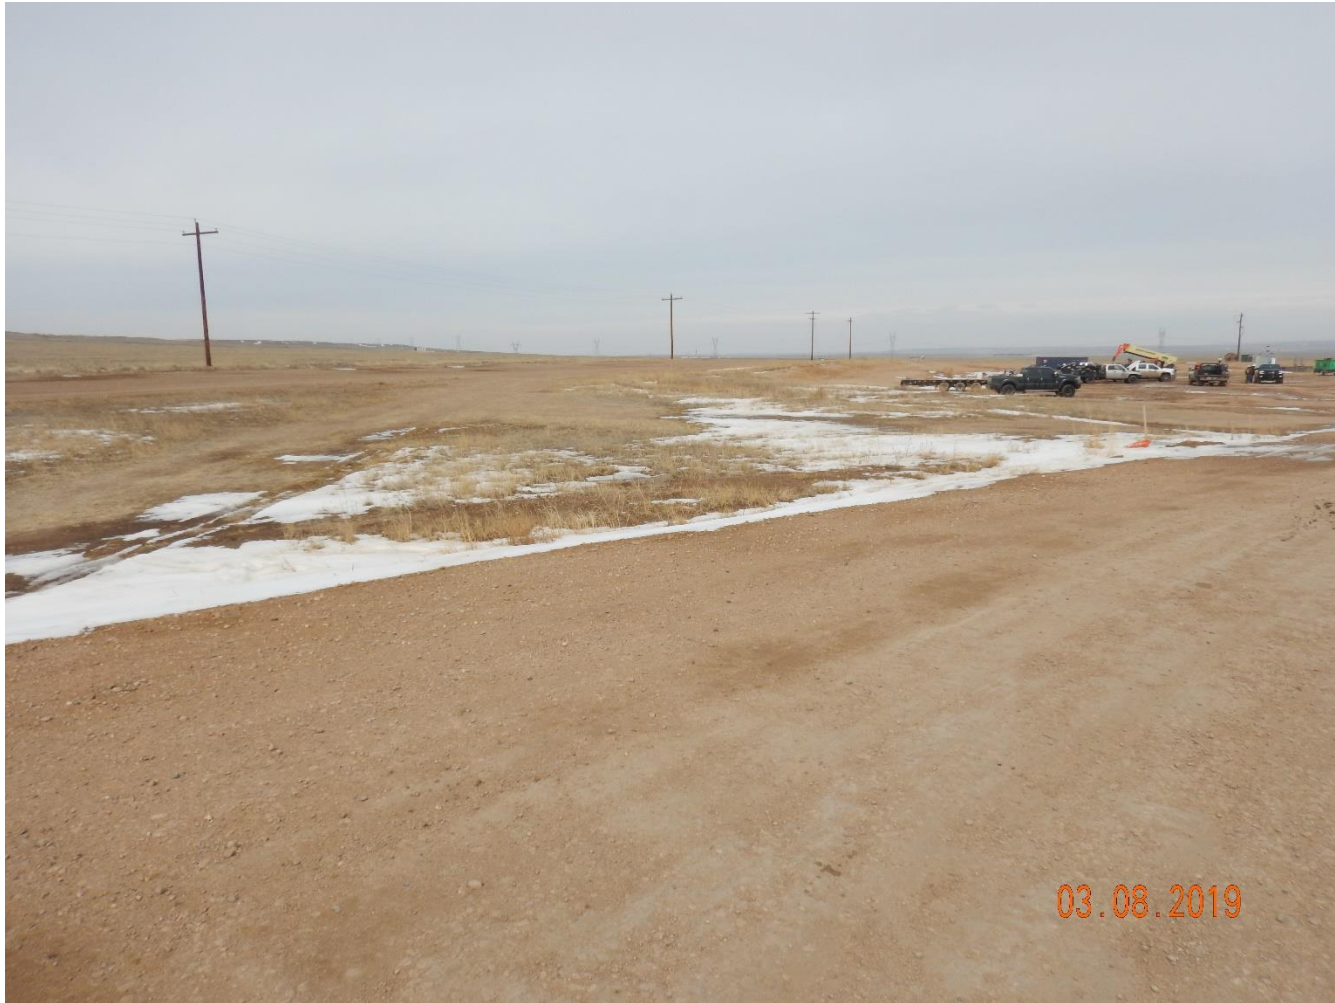
Photo 4: See comments under photo 1.

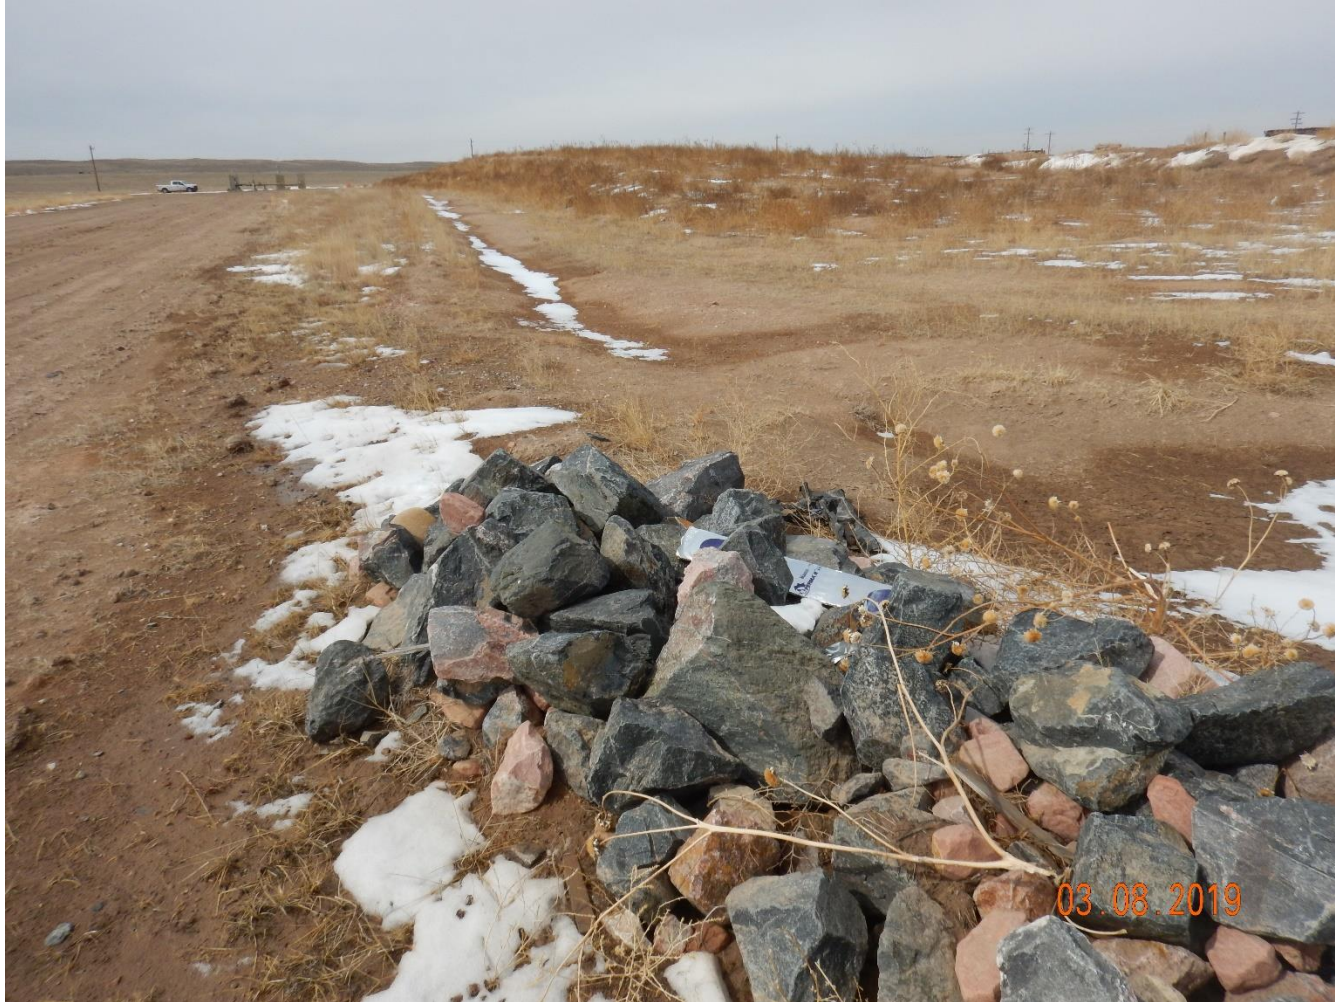
Photo 5: Photo taken from the southeast end of the location, facing west. Photo shows perimeter stormwater ditch on the south end of the location, and the topsoil stockpile. Ditch does not appear to be sufficient and has filled with sediment.

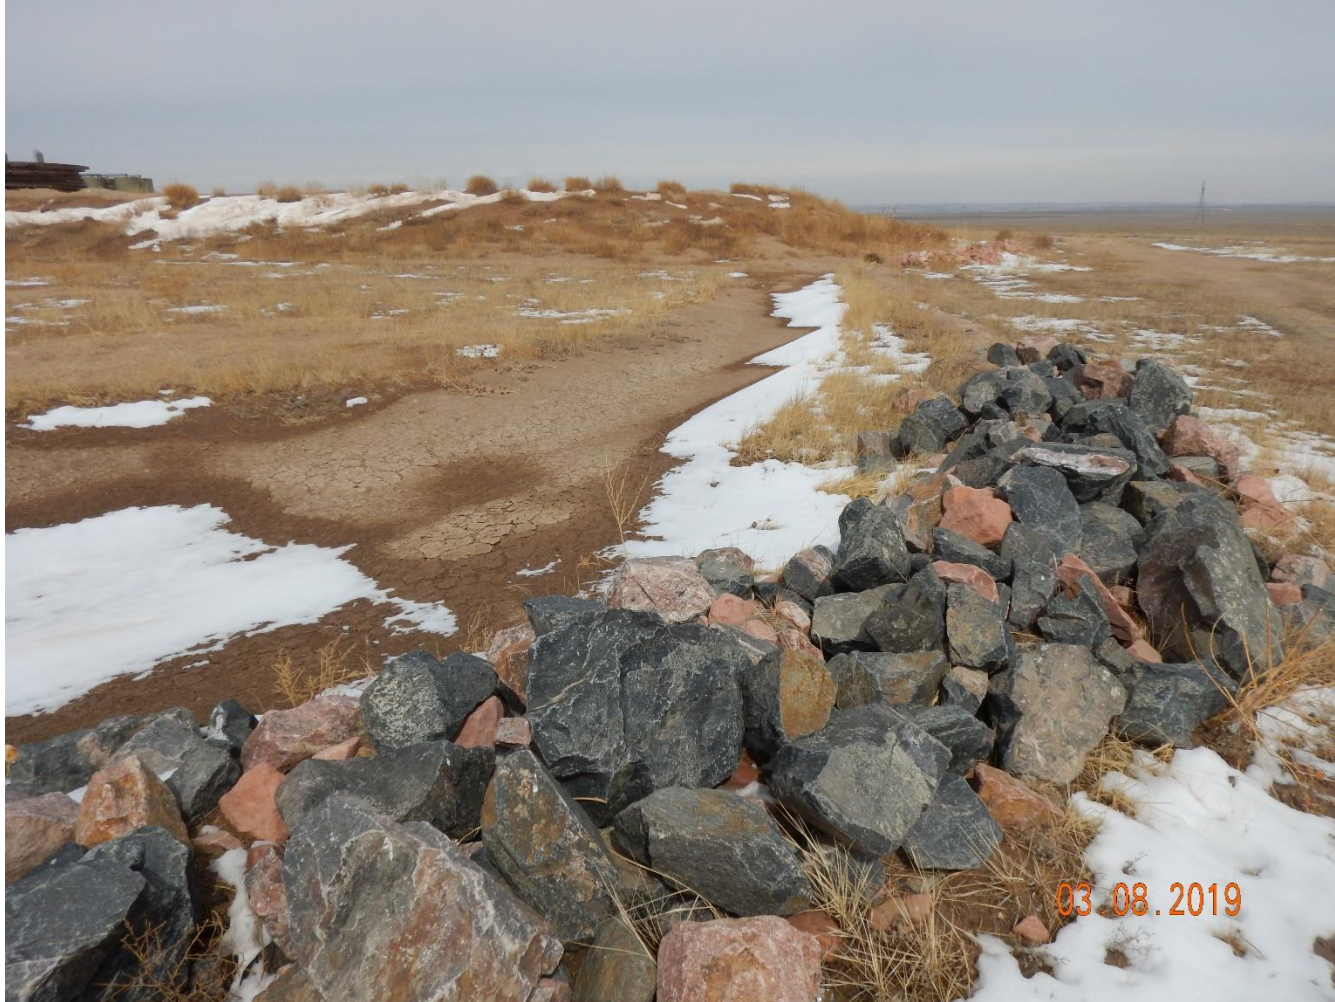
Photo 6: Photo taken from the southeast end of the location, facing north. Photo shows perimeter stormwater ditch on the east end of the location. Ditch does not appear to be sufficient and has filled with sediment.

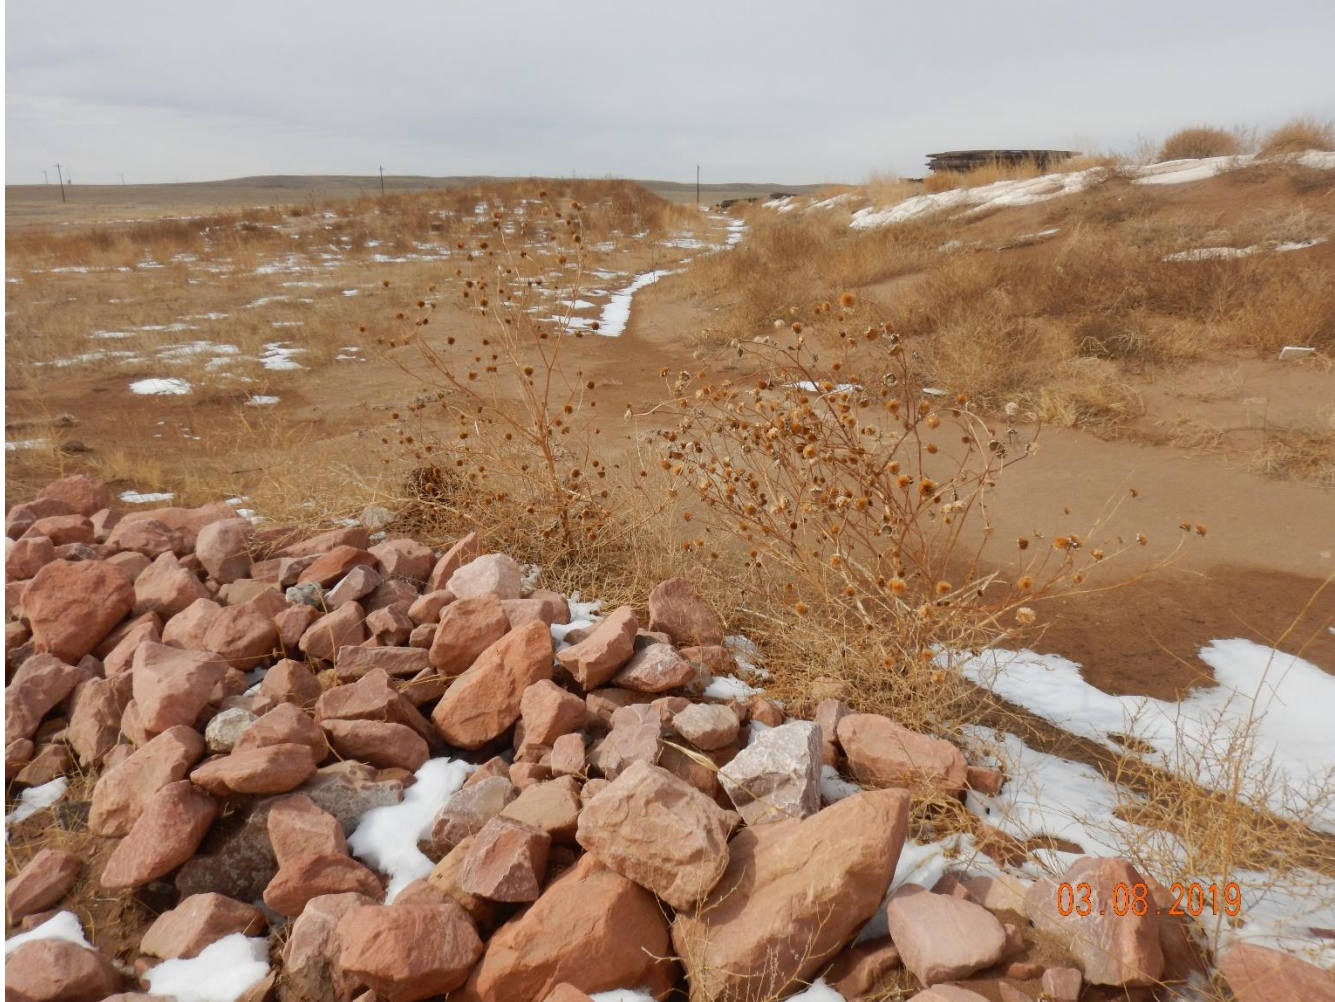
Photo 7: Photo taken from the southeast end of the location, facing west. Photo shows stormwater ditch between pad and the topsoil stockpile. Ditch does not appear to be sufficient and has filled with sediment.

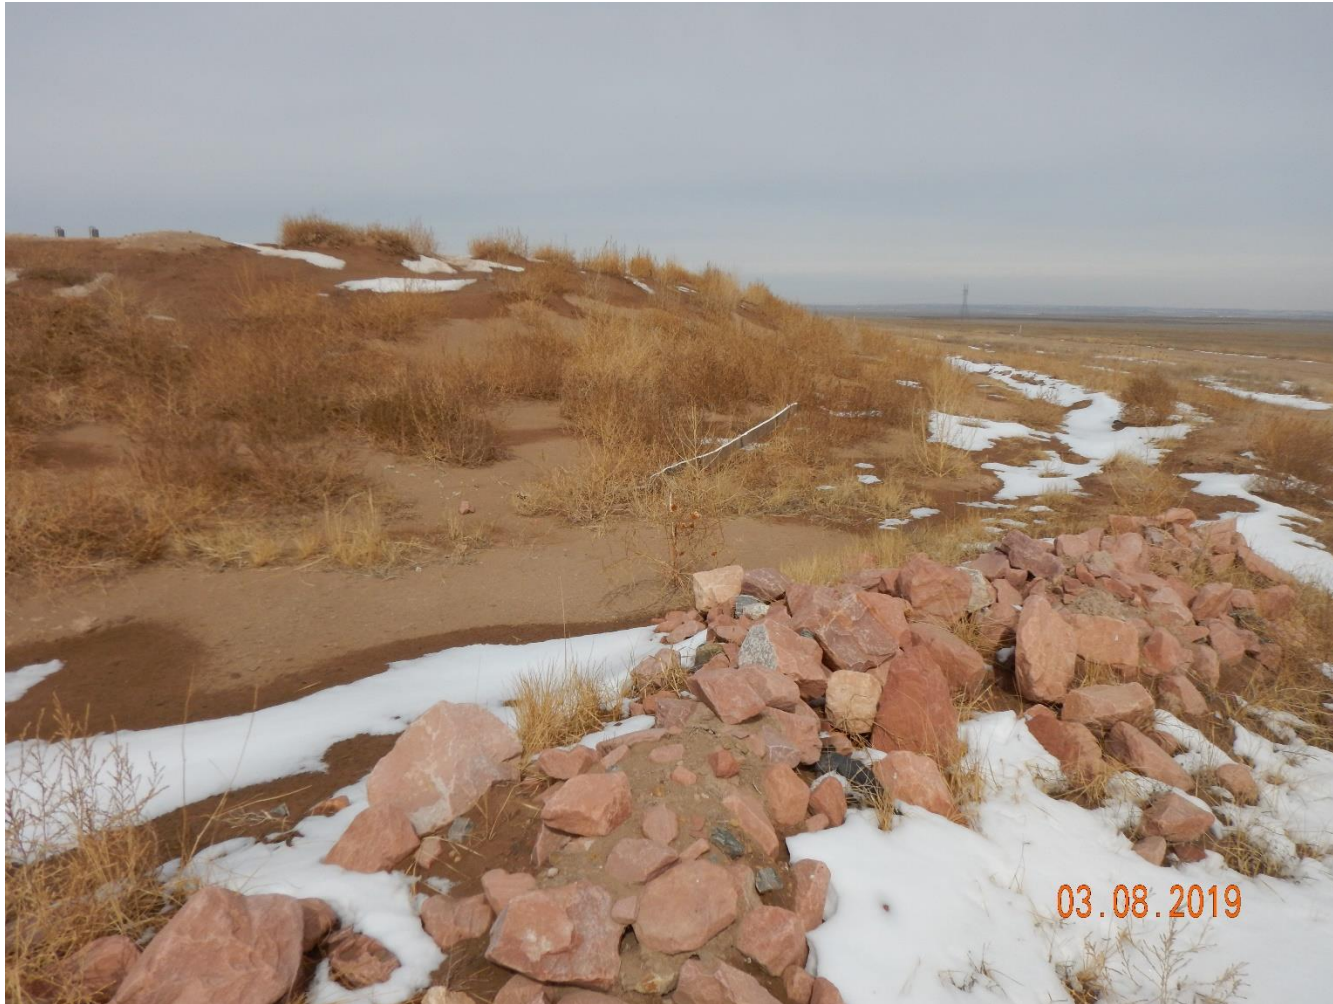
Photo 8: Photo taken from the southeast end of the location, facing north. Photo shows perimeter stormwater ditch on the east end of the location. Ditch does not appear to be sufficient and has filled with sediment. Photo also shows slopes of the pad are bare and exposed soil, or vegetated by undesirable weedy plant species.

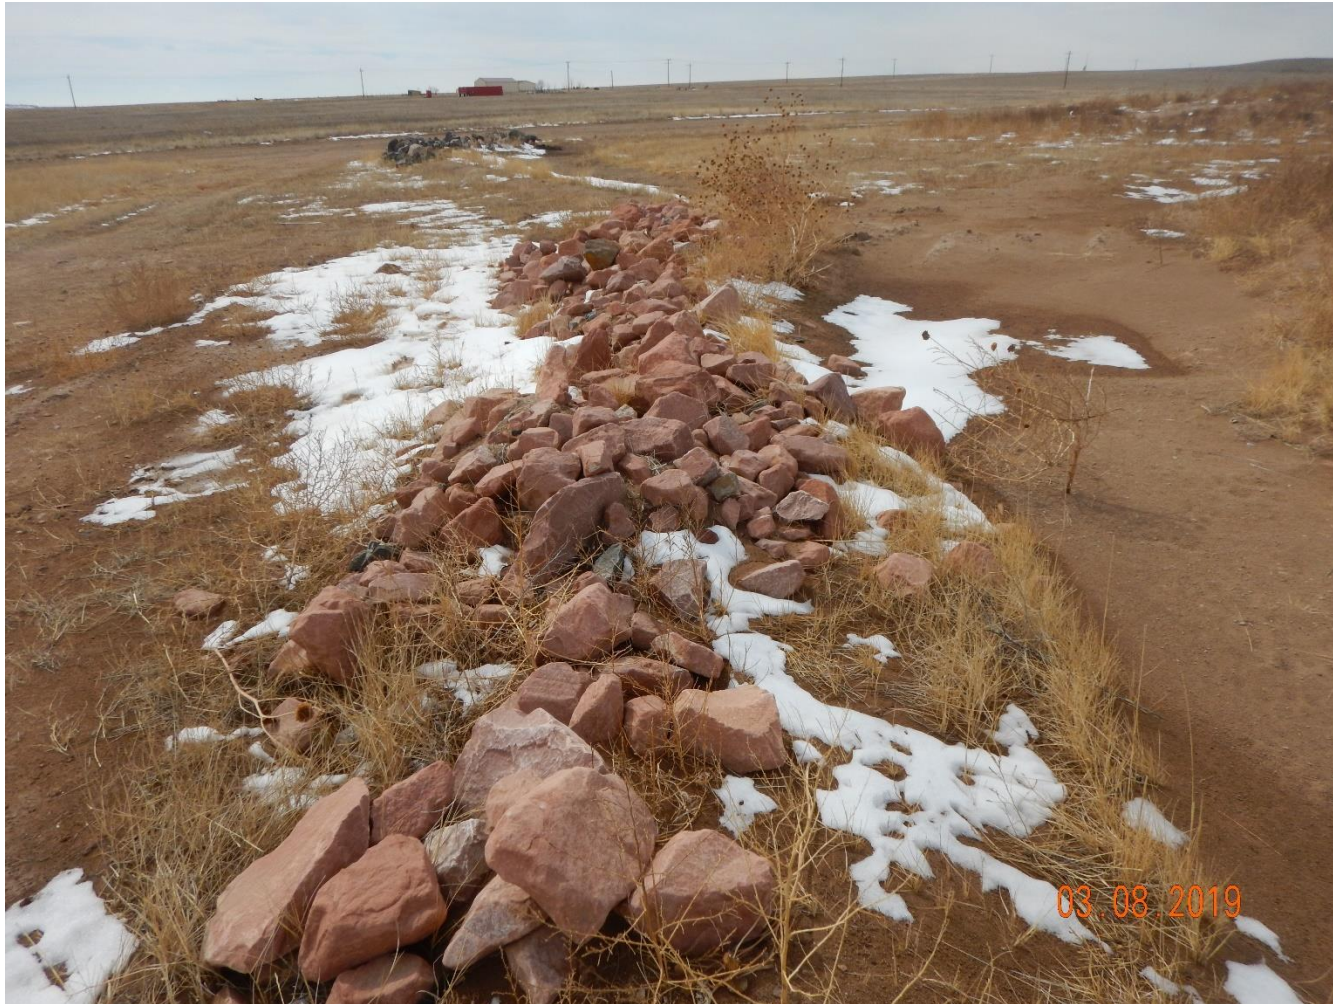
Photo 9: Photo taken from the southeast end of the location, facing south. Photo shows perimeter stormwater ditch on the east end of the location. Ditch does not appear to be sufficient and has filled with sediment.

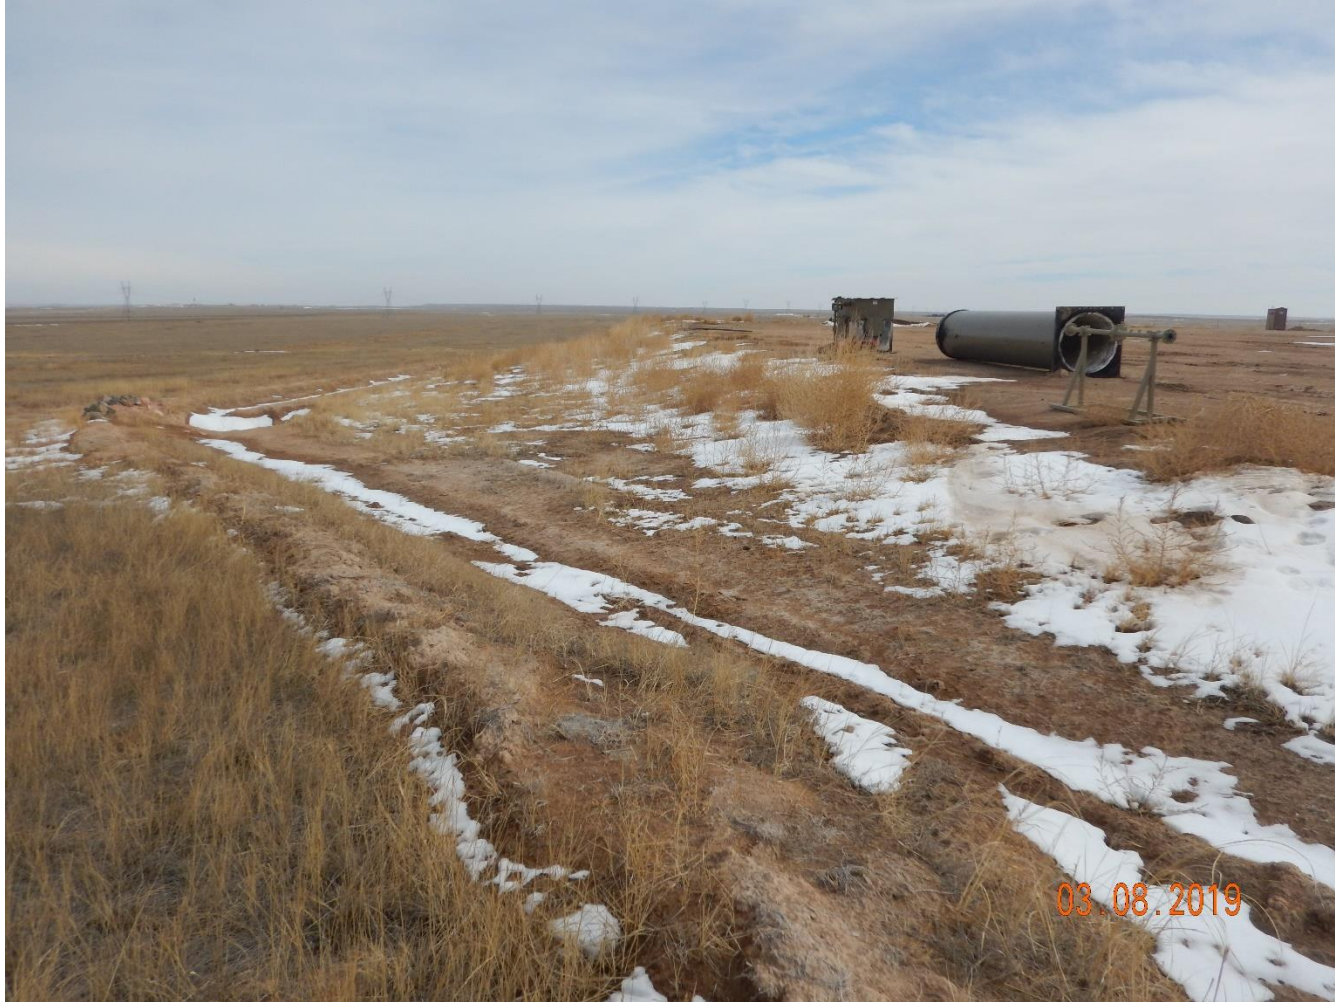
Photo 10: Photo taken from north end of the location, facing southeast. Photo shows slopes of the pad and the perimeter stormwater ditch. Slopes of the pad are bare and exposed soil, or vegetated by undesirable weedy plant species.

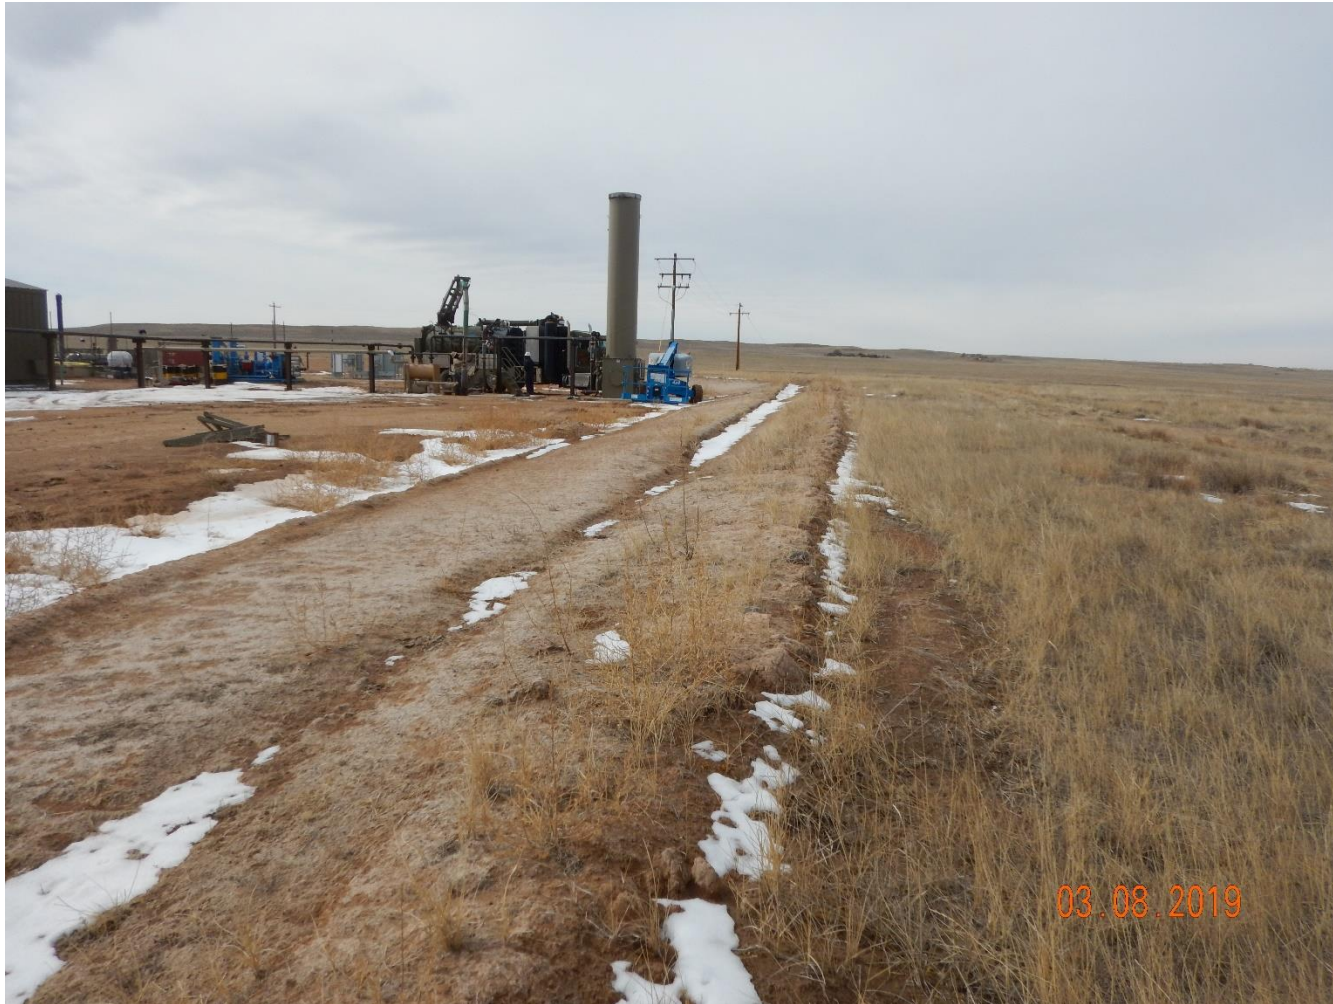
Photo 11: Photo taken from north end of the location, facing west. Photo shows perimeter stormwater ditch.

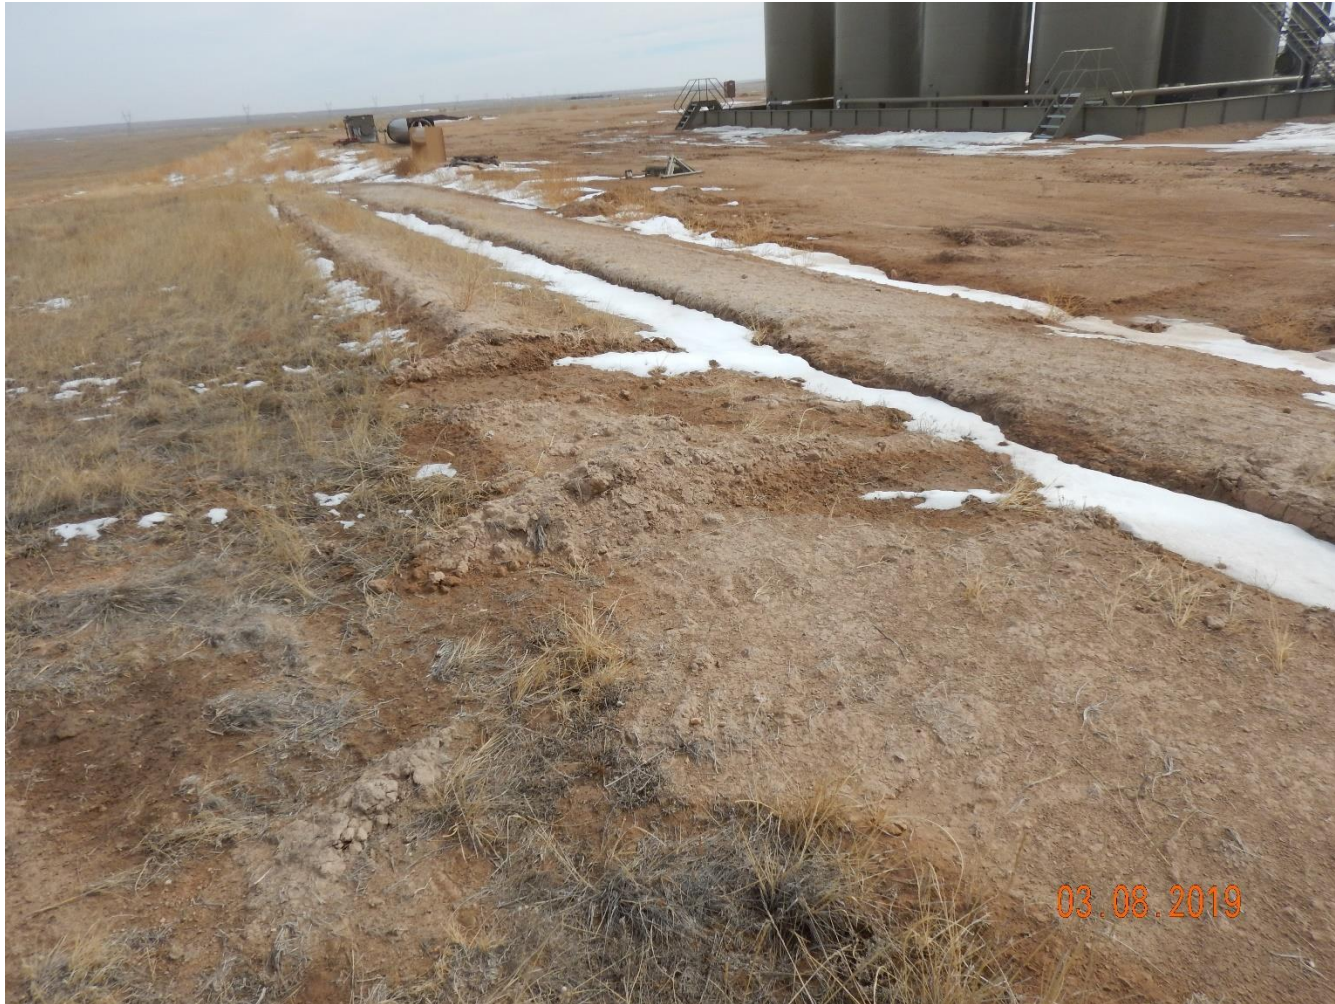
Photo 12: Photo taken from the north end of the location, facing east. Photo shows areas of the ditch where vehicles were operated over the BMP. This is not advised.

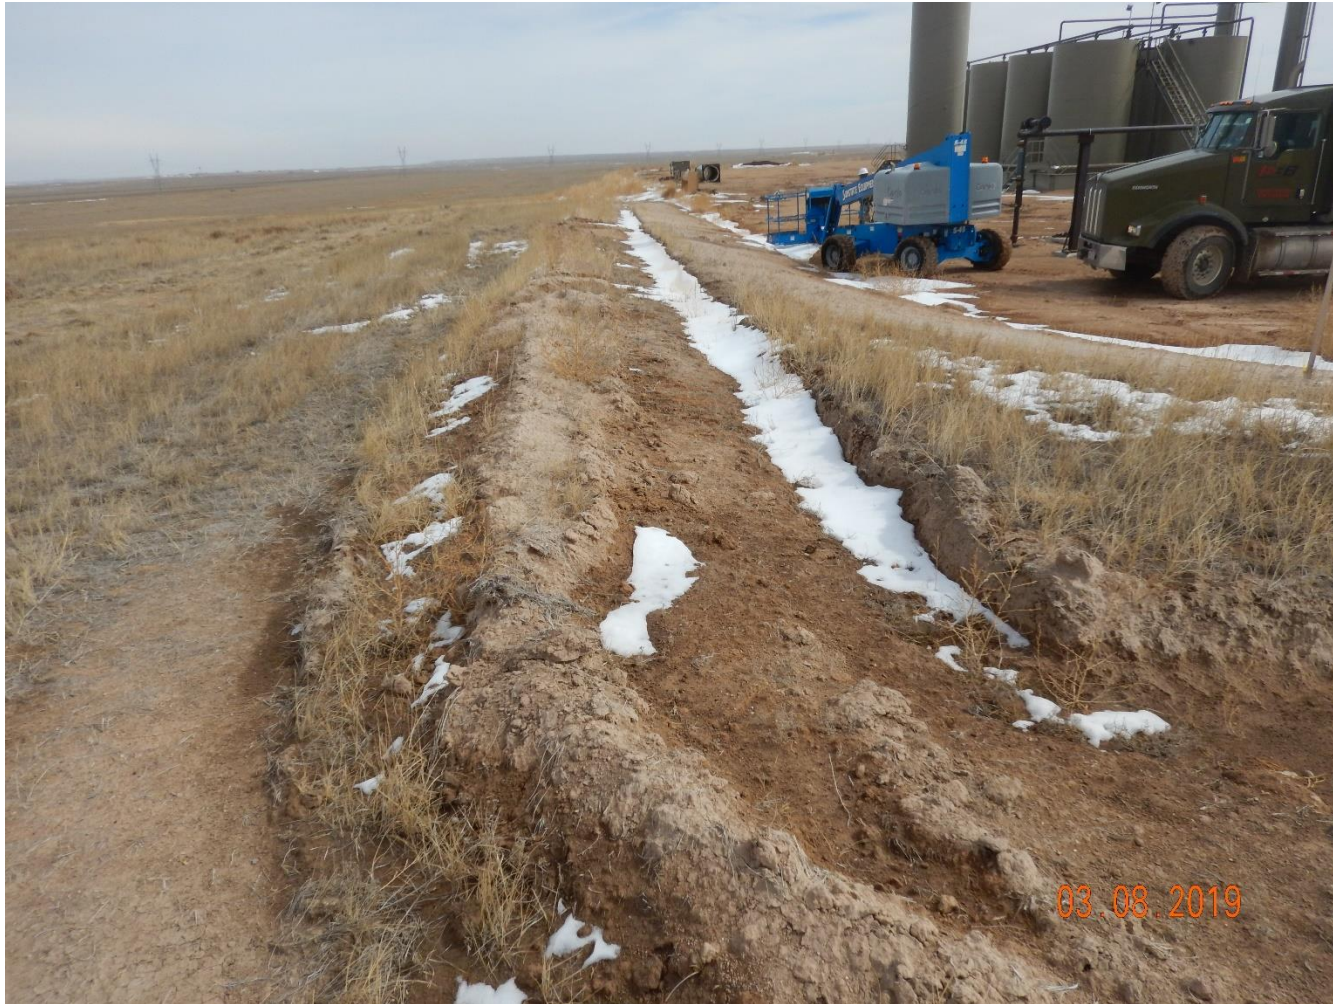
Photo 13: Photo taken from the north end of the location, facing east. Photo shows perimeter stormwater ditch.

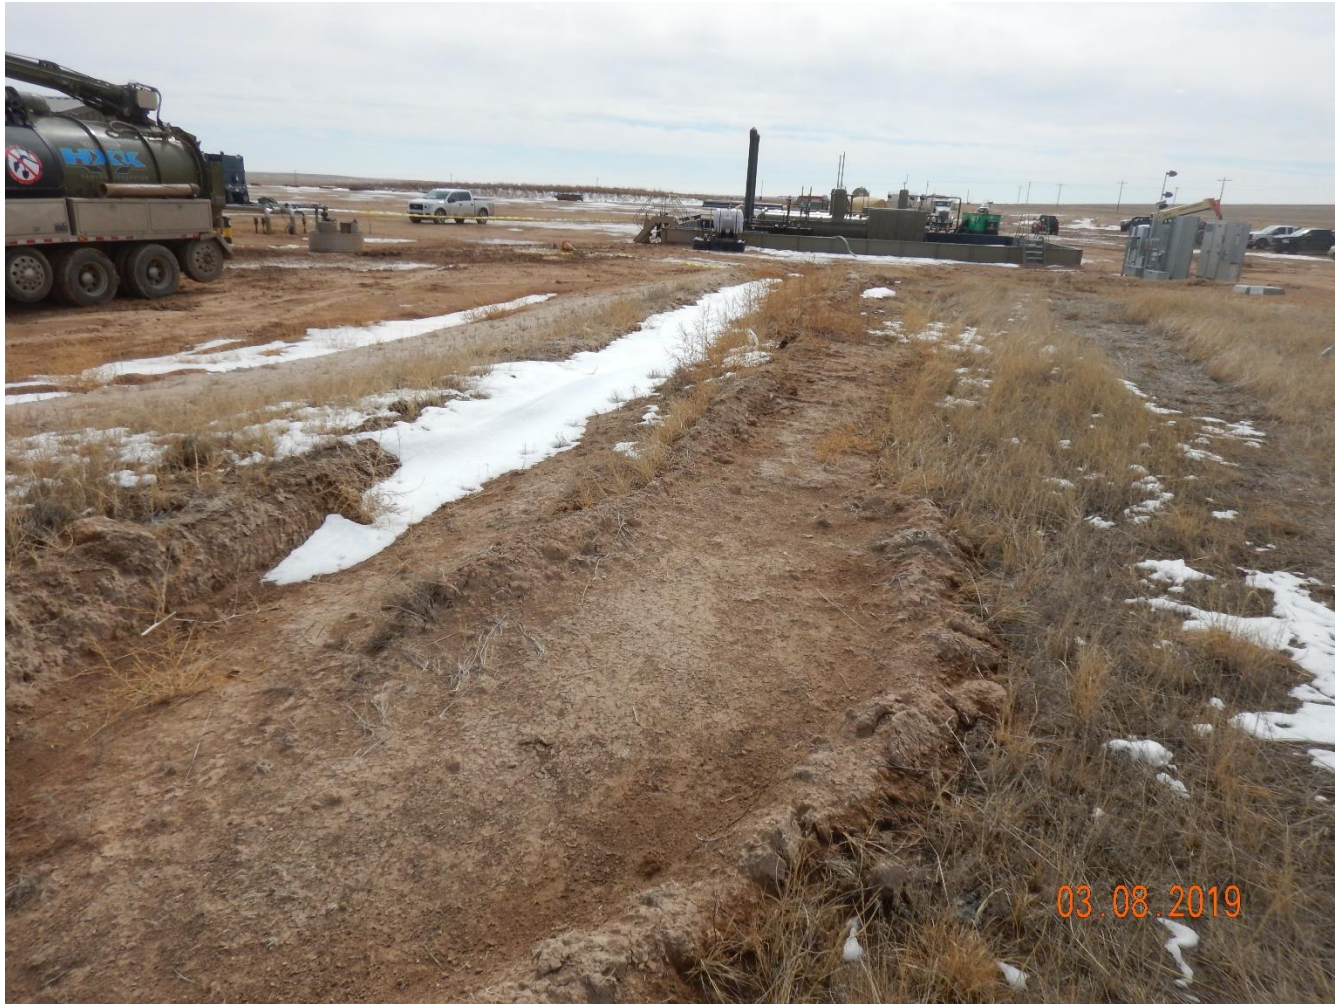
Photo 14: Photo taken from the north end of the location, facing south. Photo shows perimeter stormwater ditch.

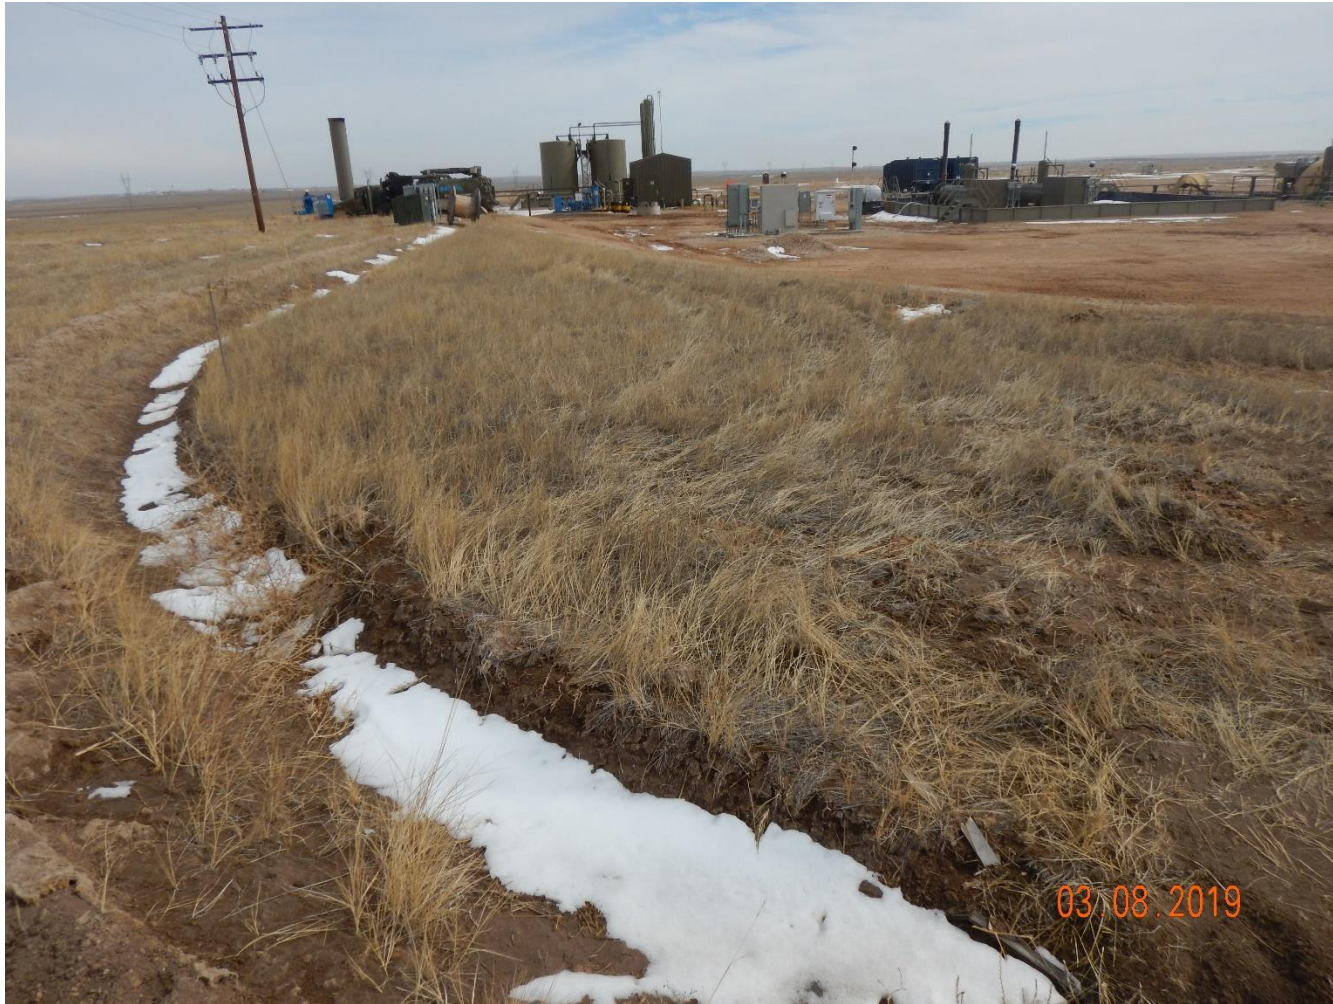
Photo 15: Photo taken from the north end of the location, facing east. Photos 15-17 provide an overview of the location from east, southeast, to south.

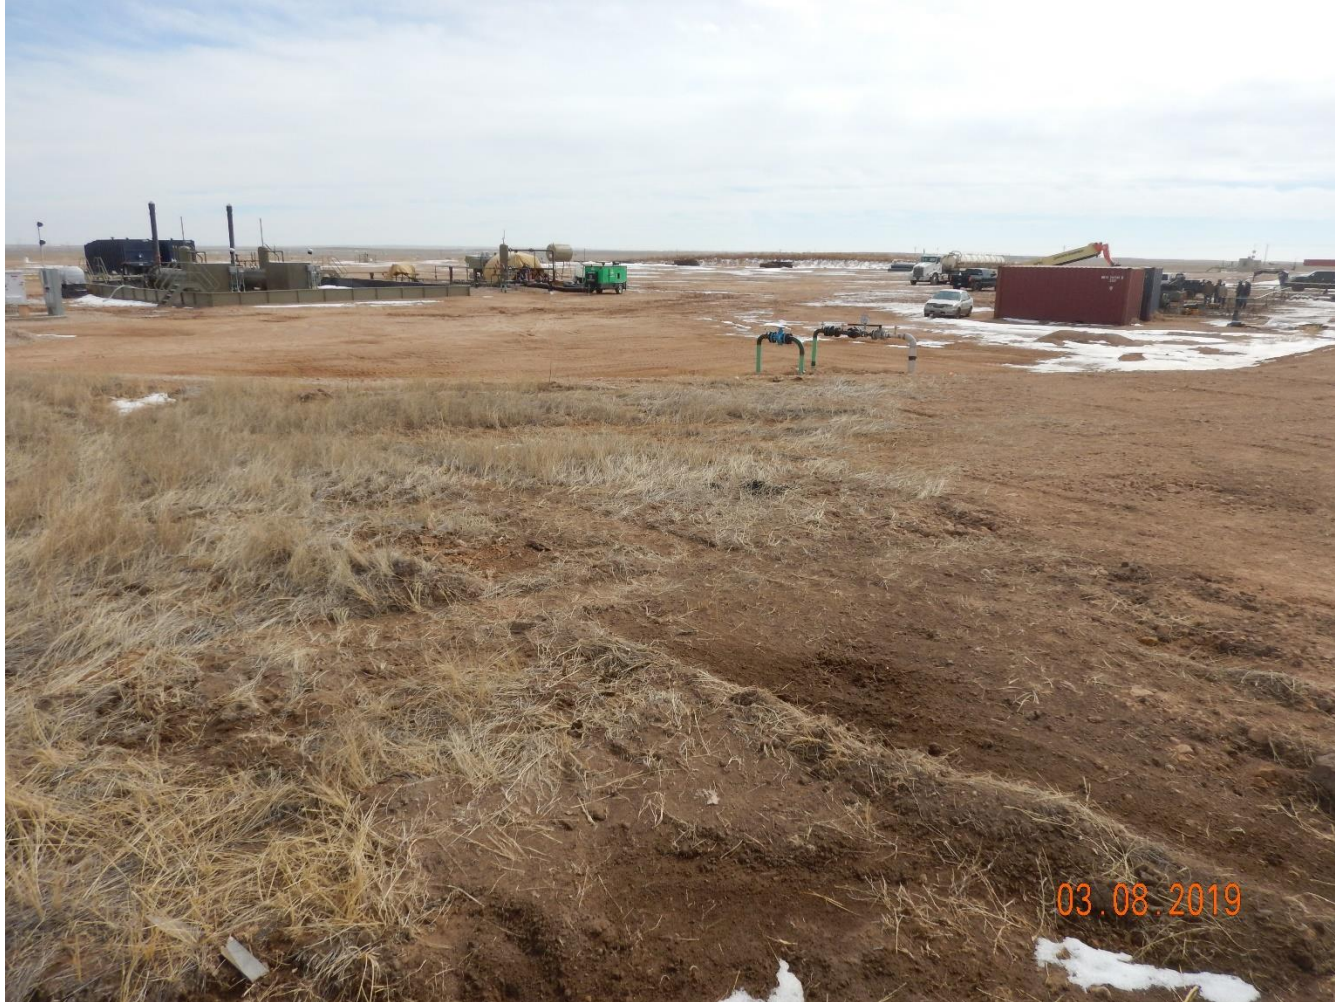
Photo 16: See comments under photo 15.
