Inspection Photos

Operator: BISON OIL & GAS II LLC # 10661

Location ID: 454166

Inspection Doc. Number: 682504584

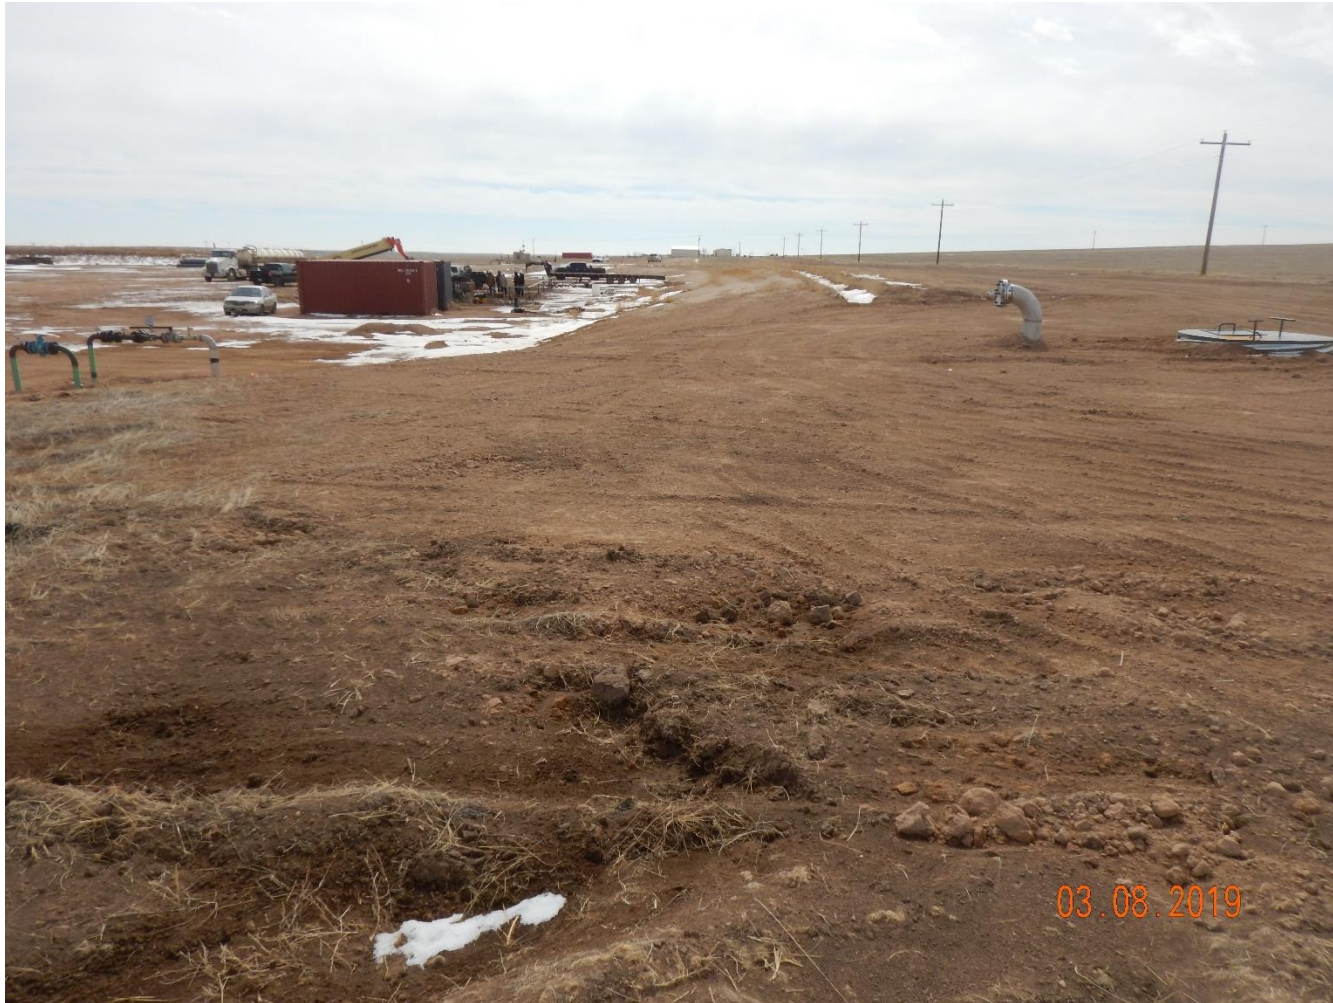
Photo 15: Photo taken from the north end of the location, facing east. Photos 15-17 provide an overview of the location from east, southeast, to south.

Photo 17: See comments under photo 15.

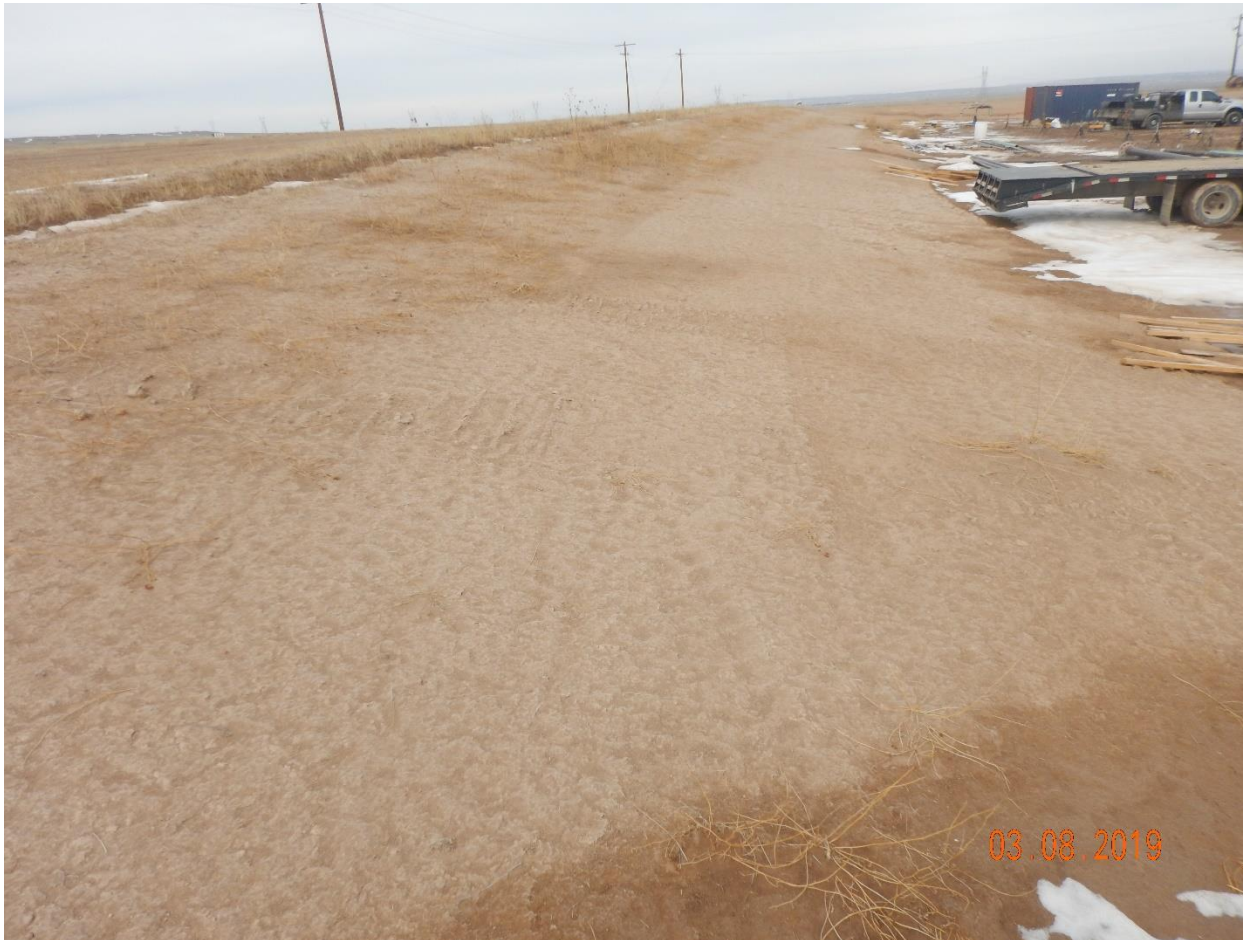
Photo 18: Photo taken from the west end of the location, facing north. Operator appears to have applied a tackier onto the slopes. Cut slopes sufficiently stabilized at time of inspection.

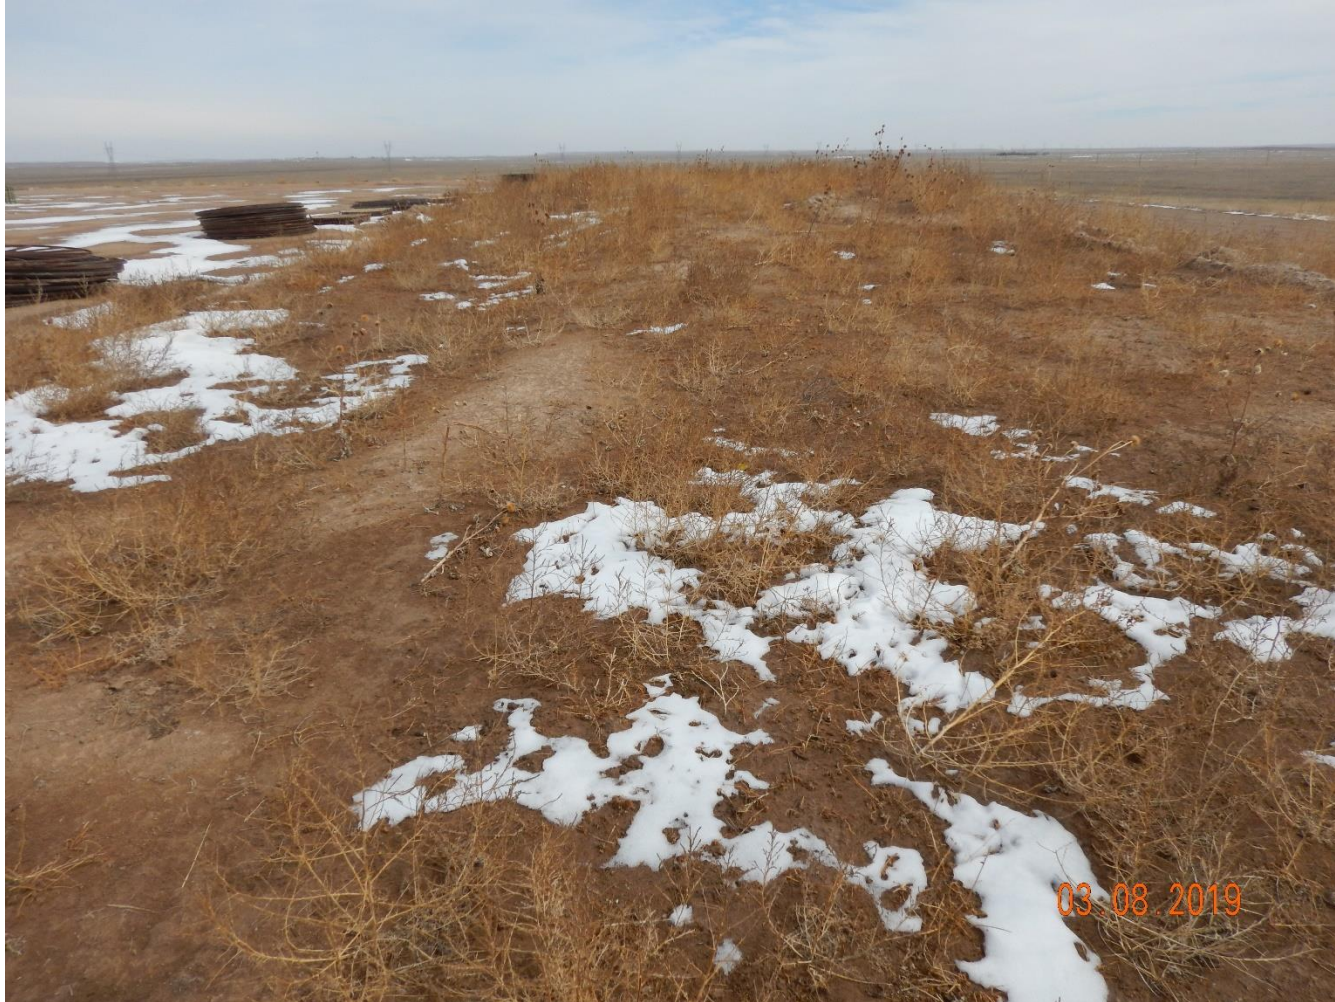
Photo 19: Photo taken from the topsoil stockpile on the south end of the location. Photo shows topsoil stockpile is bare and exposed soil, or vegetated by undersirable weedy plant species such as *Salsola* sp. This does not comply with 1002.c

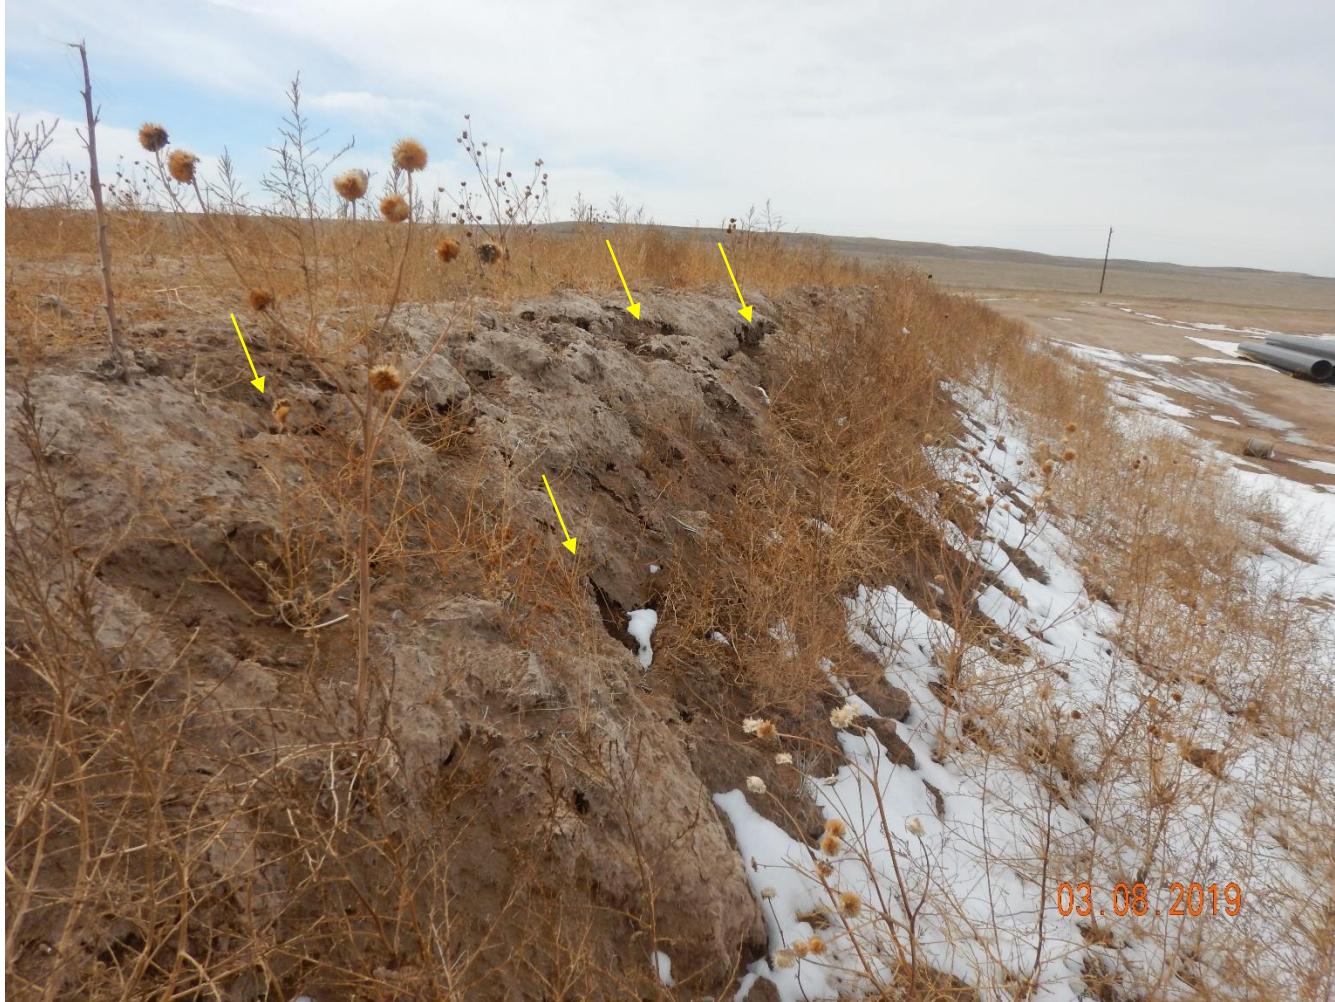
Photo 20: Photo taken from the north facing slope of the topsoil stockpile. Operator does not appear to have constructed the stockpile with an appropriate grade. Photo shows slopes do not appear to be sufficiently stabilized. Erosion degradation evident.

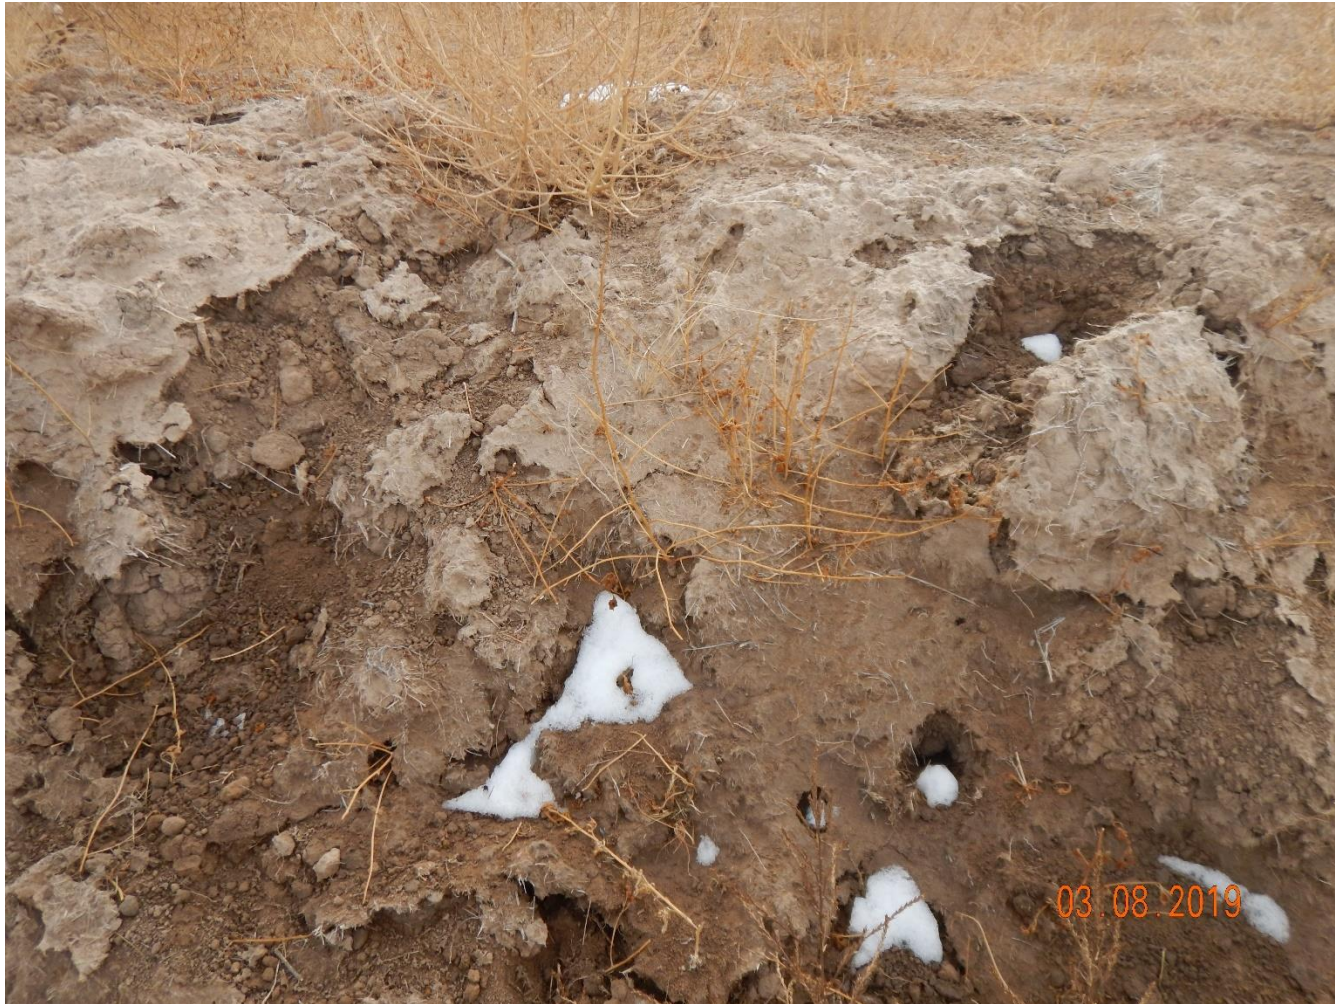
Photo 21: See comment under photo 20.

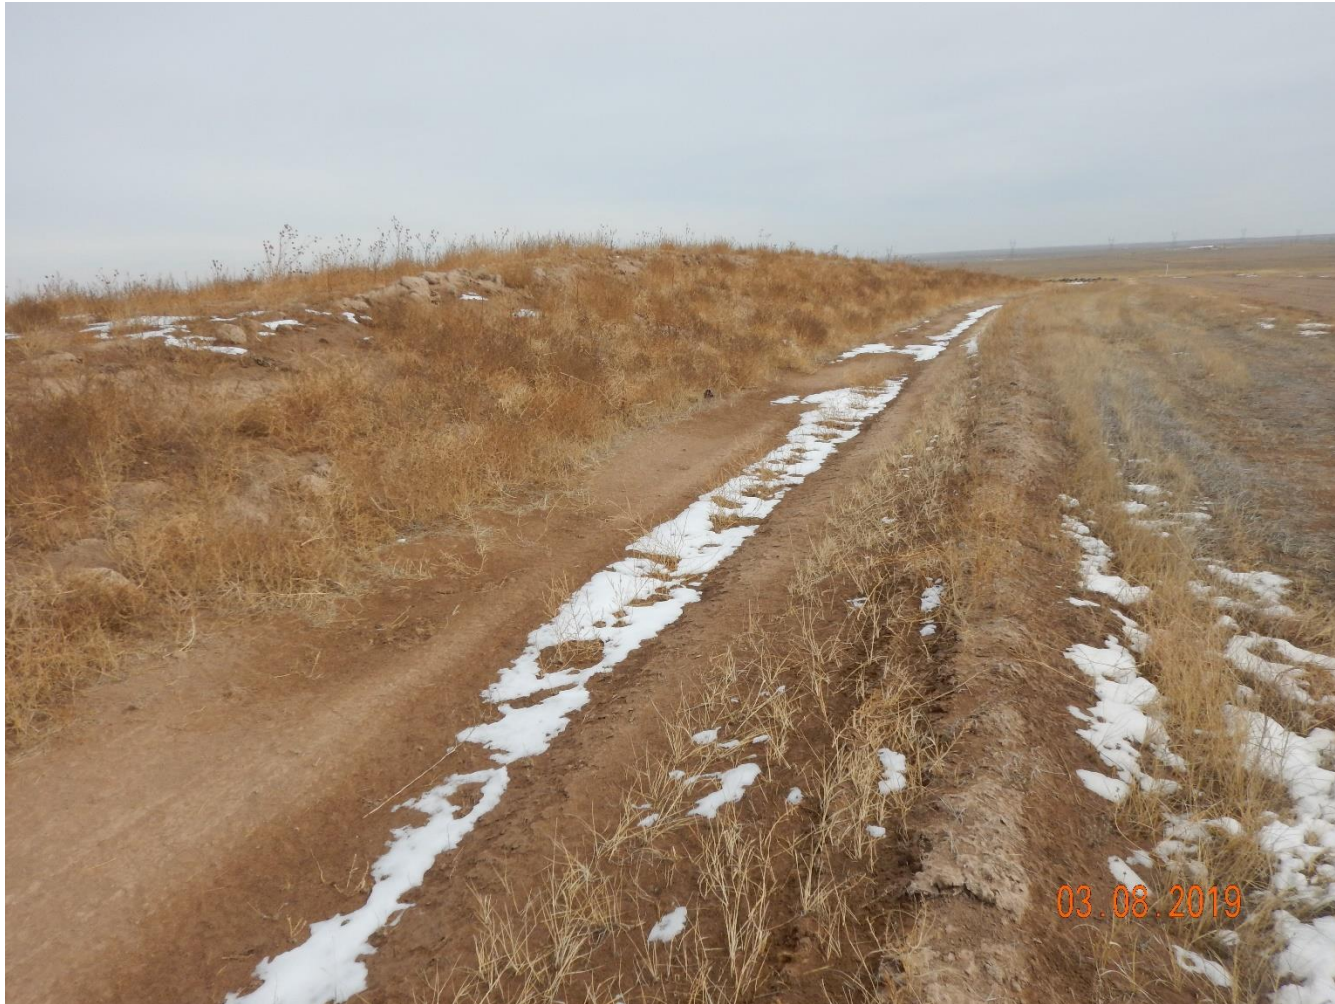
Photo 22: Photo taken from the south end of the topsoil stockpile. See comments under photo 19

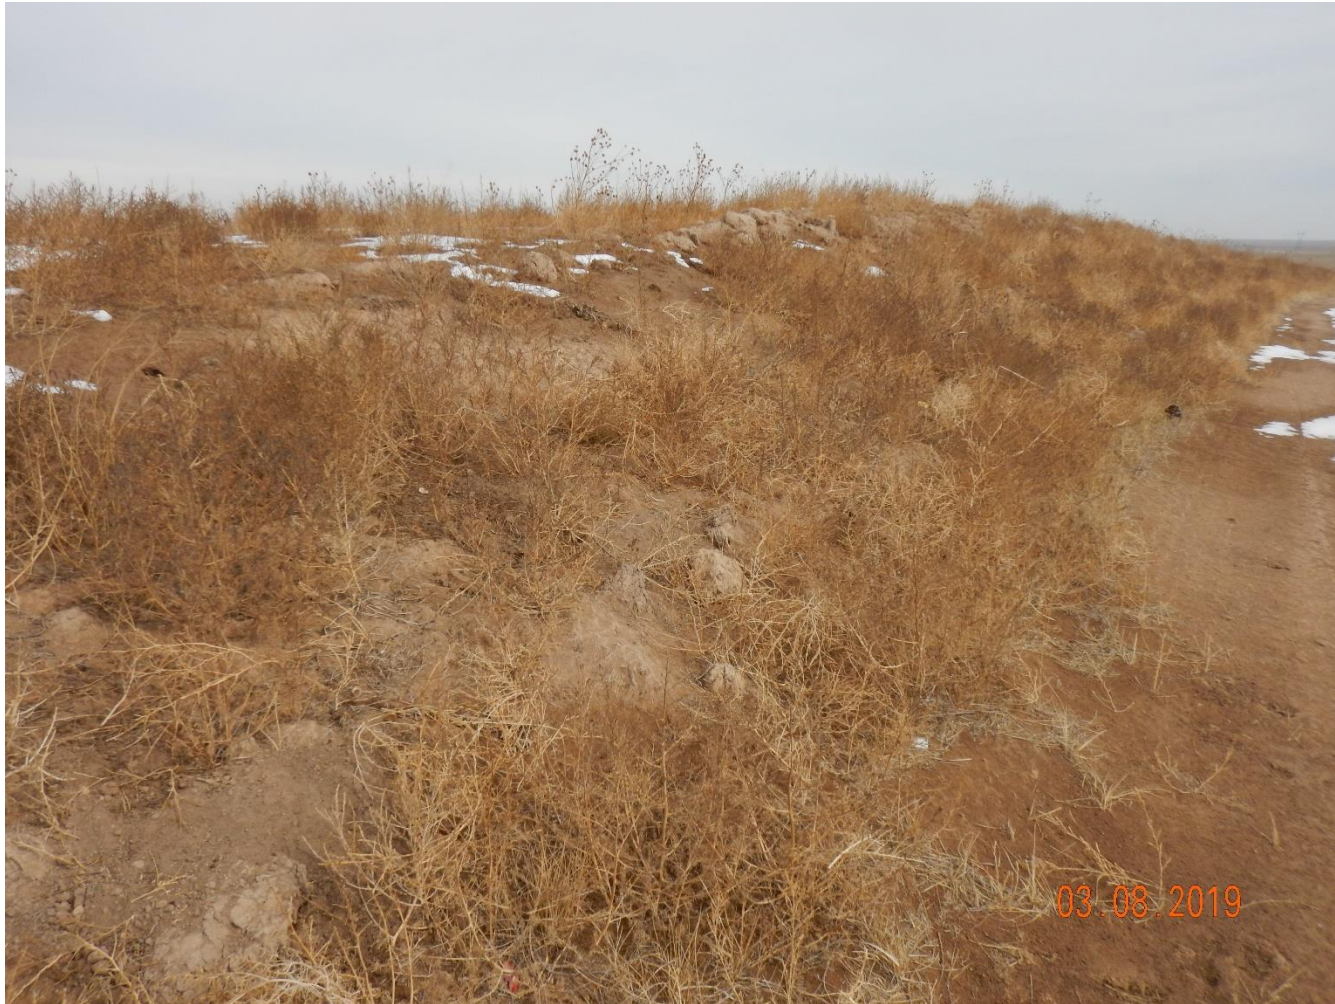
Photo 23: Photo taken from the south end of the topsoil stockpile. See comments under photo 19

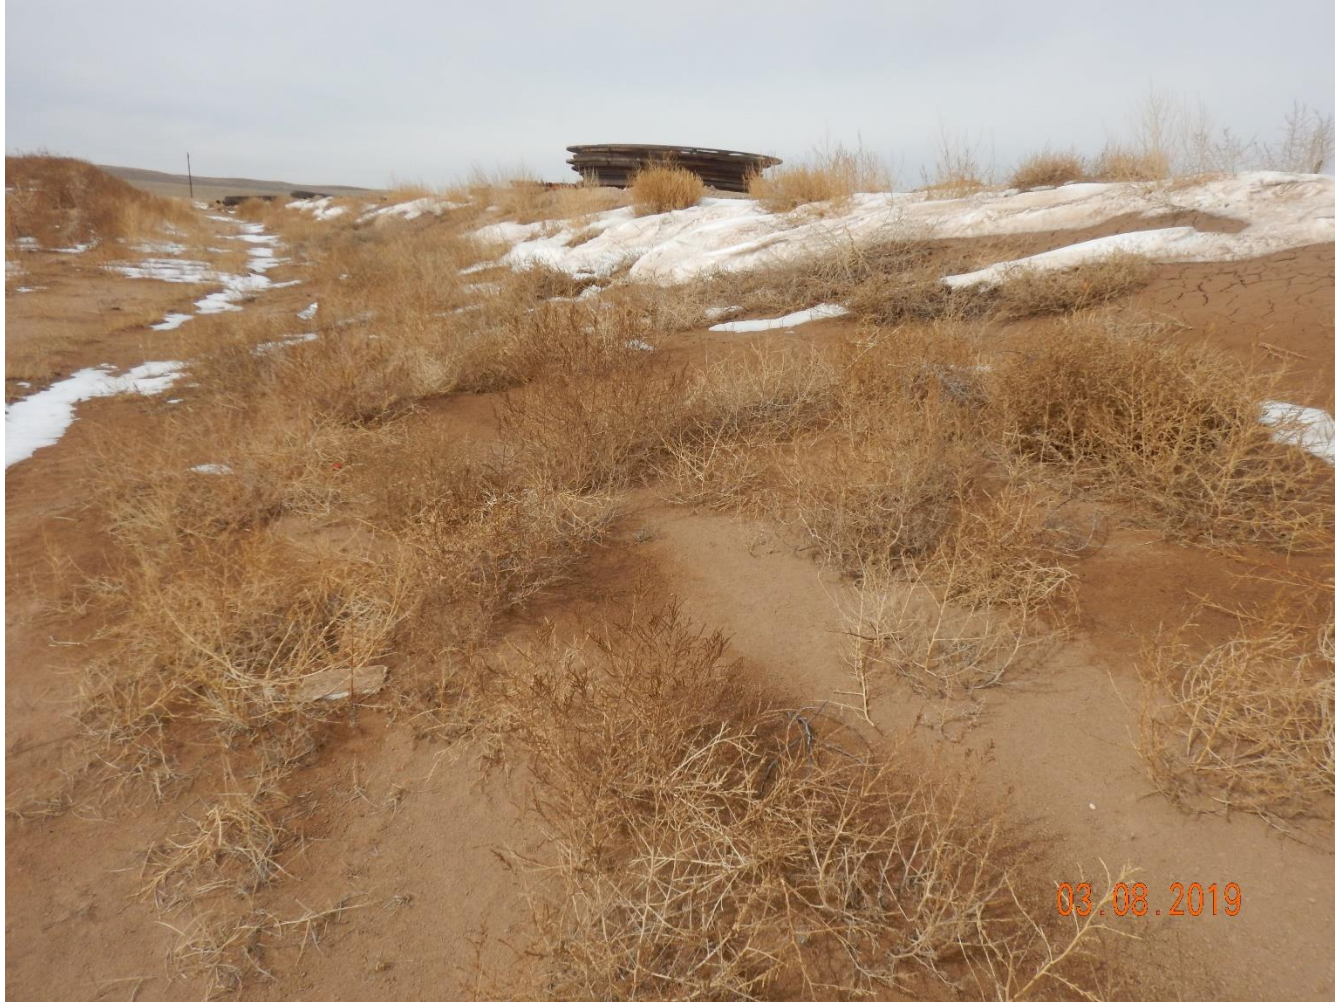
Photo 24: Photo taken from the slopes on the south end of the pad. Photo shows slopes are bare and exposed soil, or vegetated by undersirable weedy plant species such as *Salsola* sp. Slopes have not been sufficiently stabilized. Stormwater erosion and sediment deposition evident.

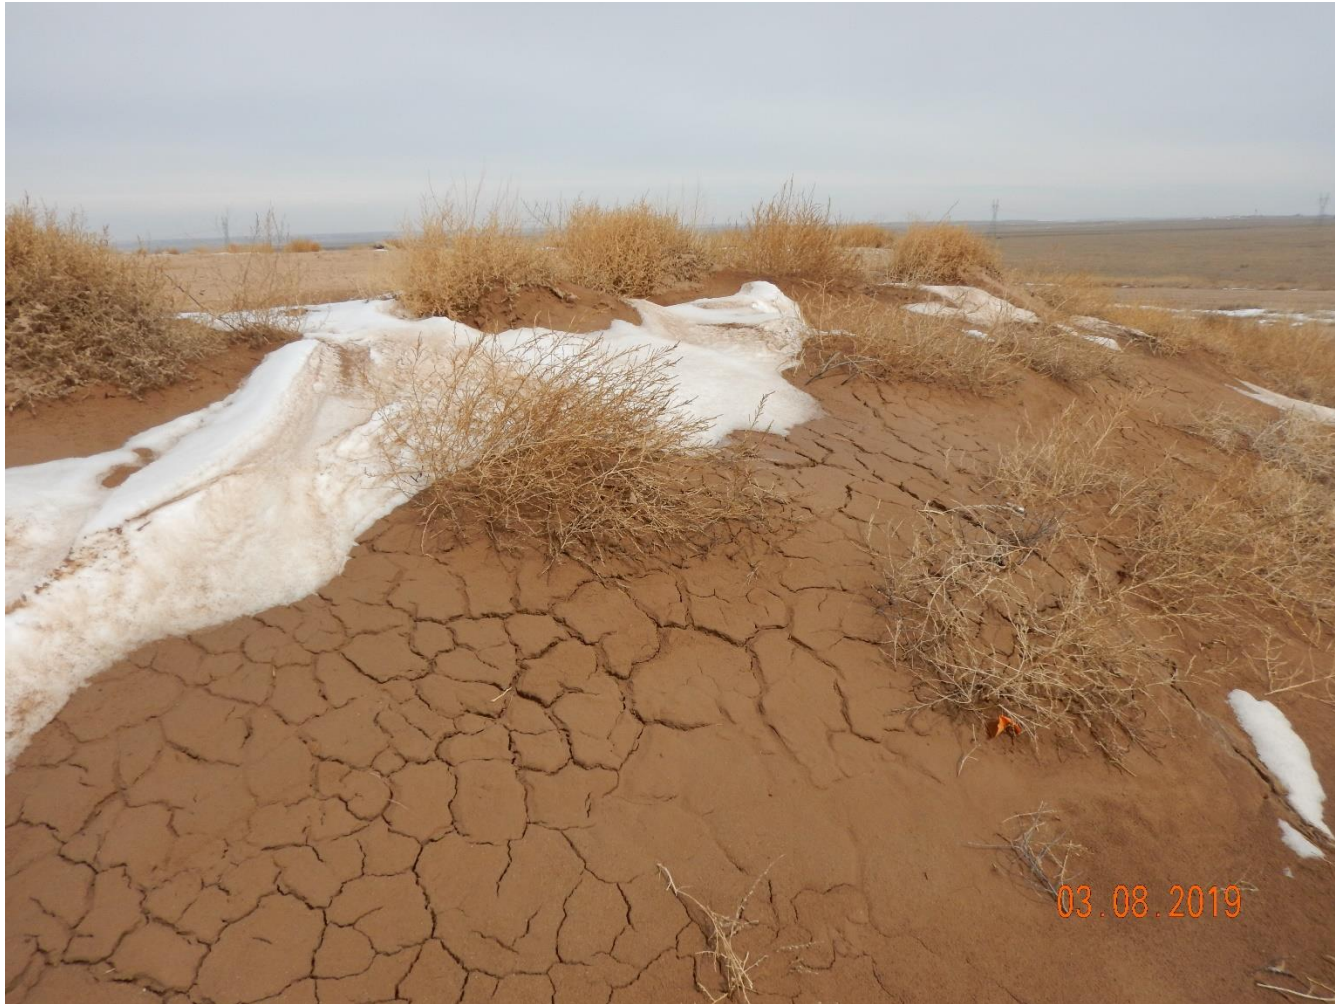
Photo 25: See comments under photo 24.

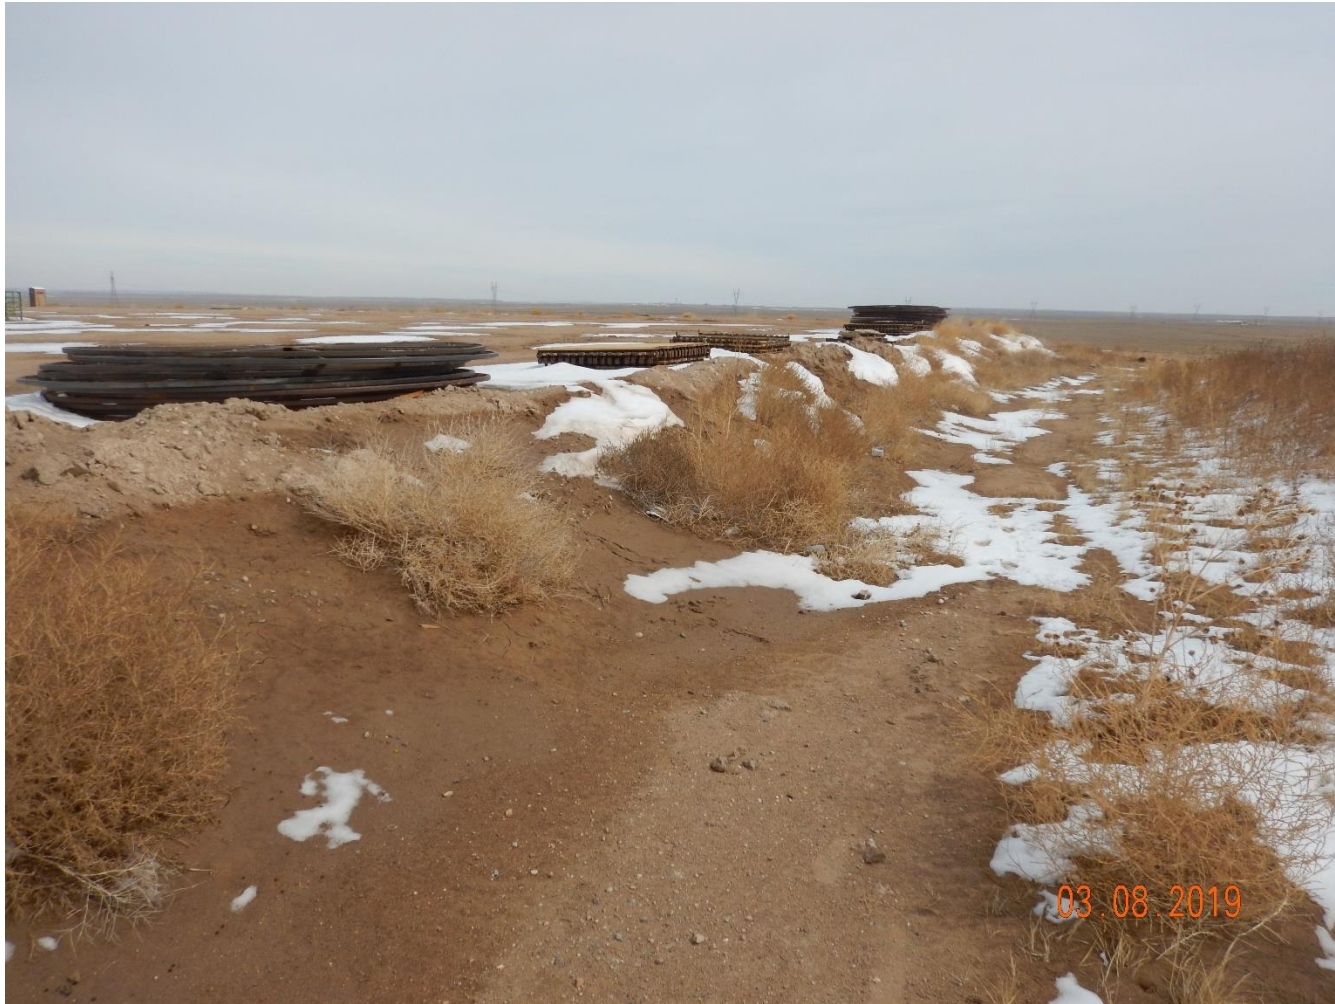
Photo 26: See comments under photo 24.

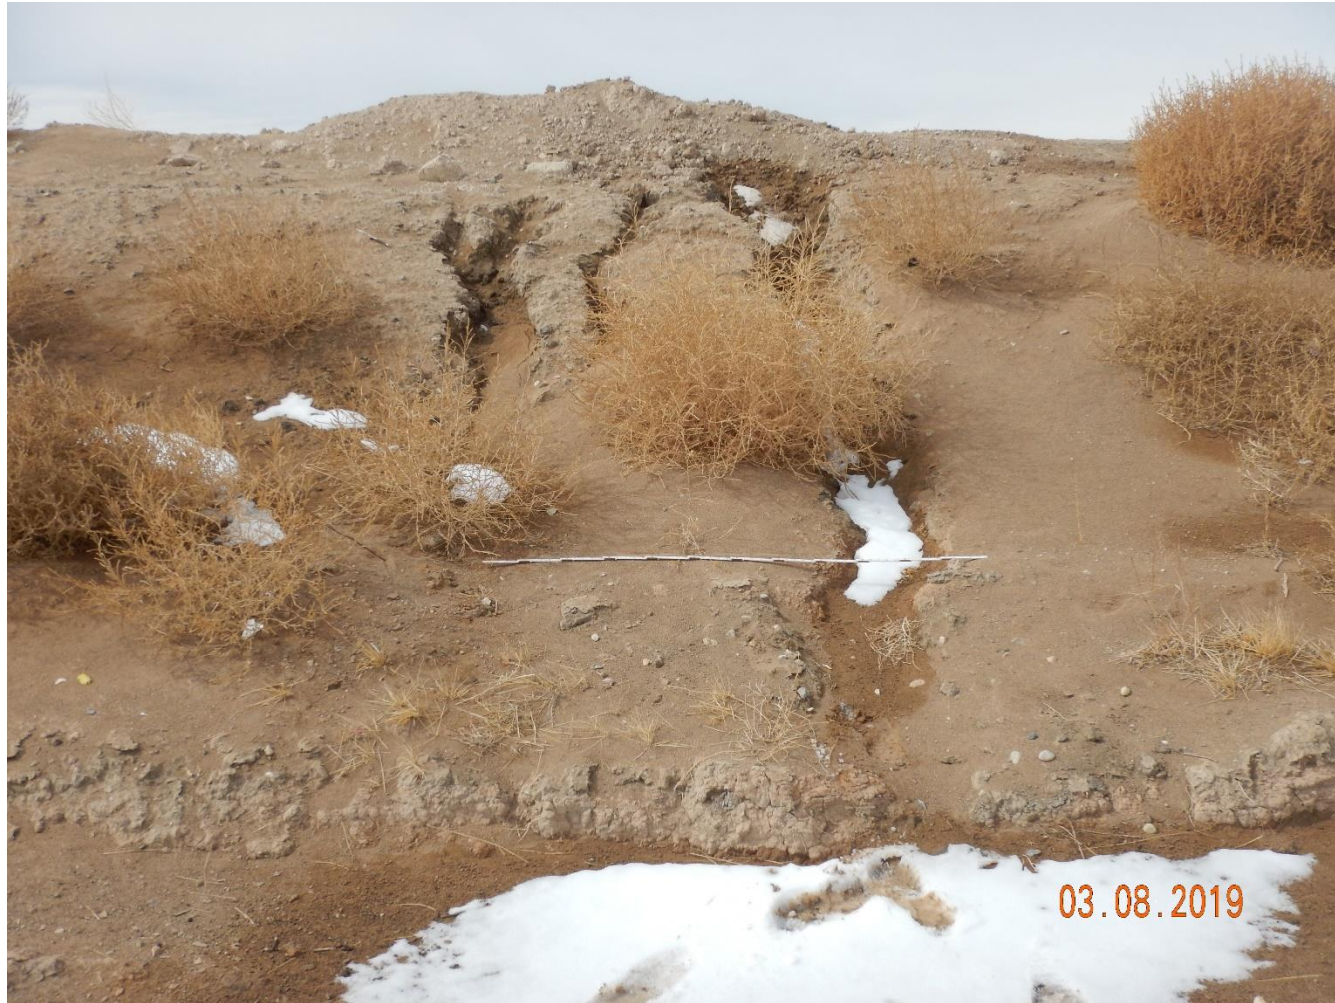
Photo 27: Photo taken from the east end of the pad, facing west. Photo shows slopes are bare and exposed soil, or vegetated by undersirable weedy plant species such as *Salsola* sp. Slopes have not been sufficiently stabilized. Stormwater erosion and sediment deposition evident. 6 foot measuring stick for reference.

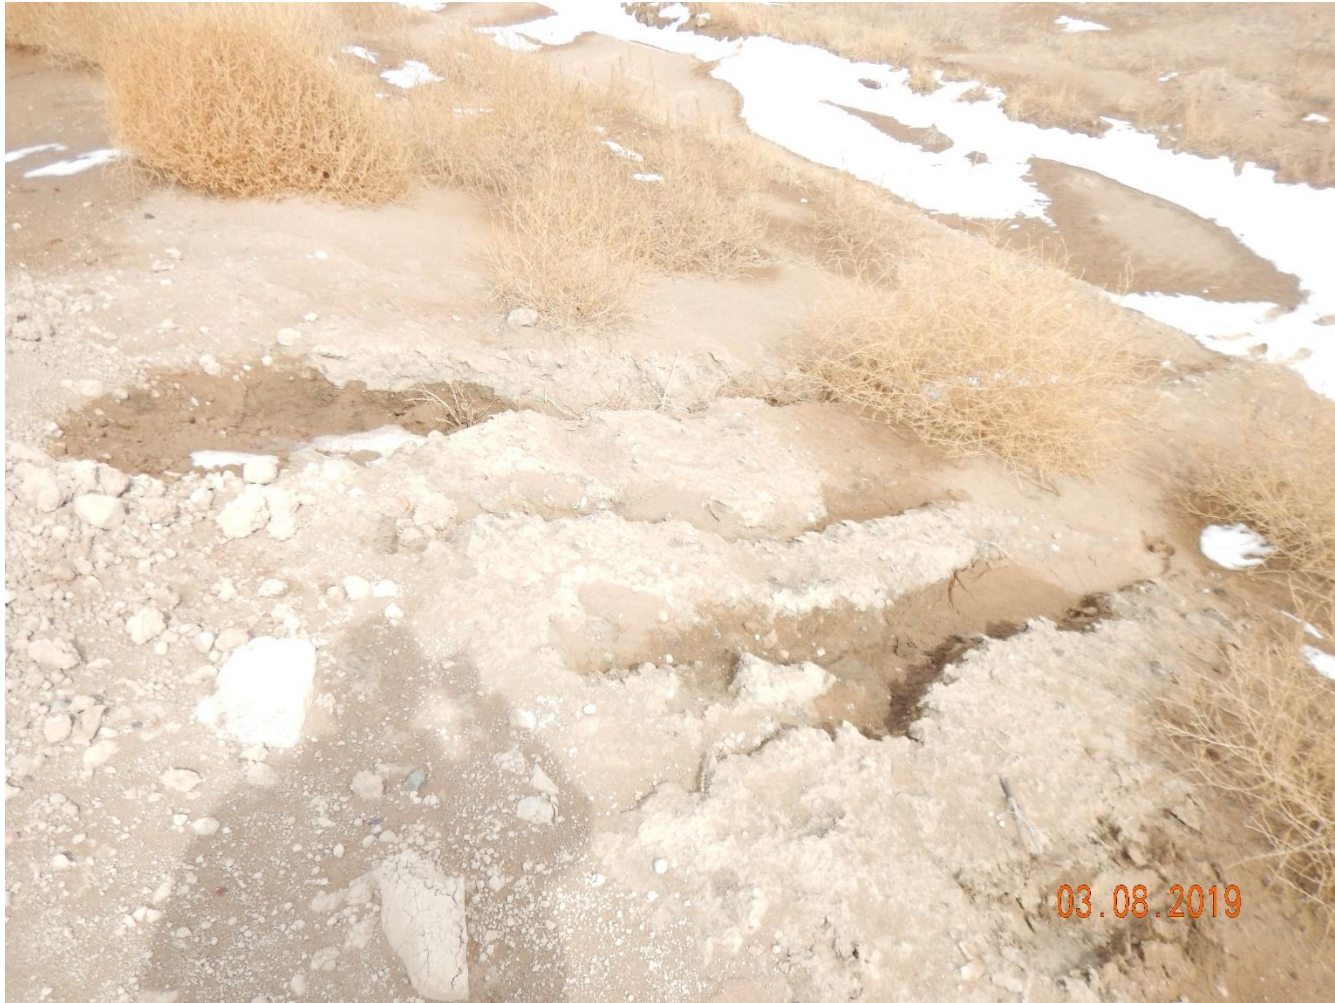
Photo 28: See comments under photo 27.

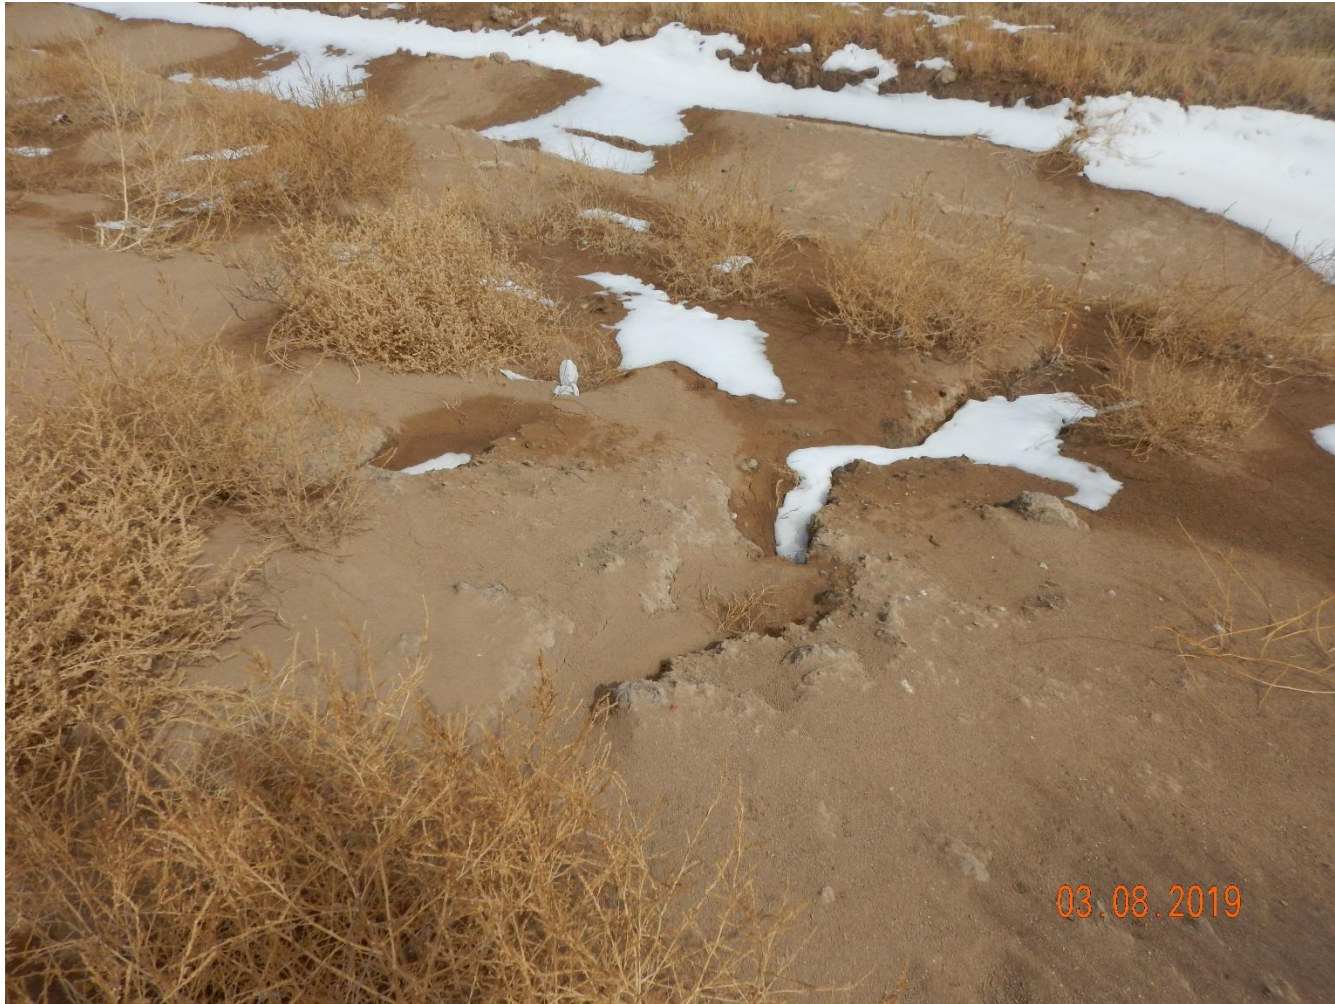
Photo 29: See comments under photo 27.

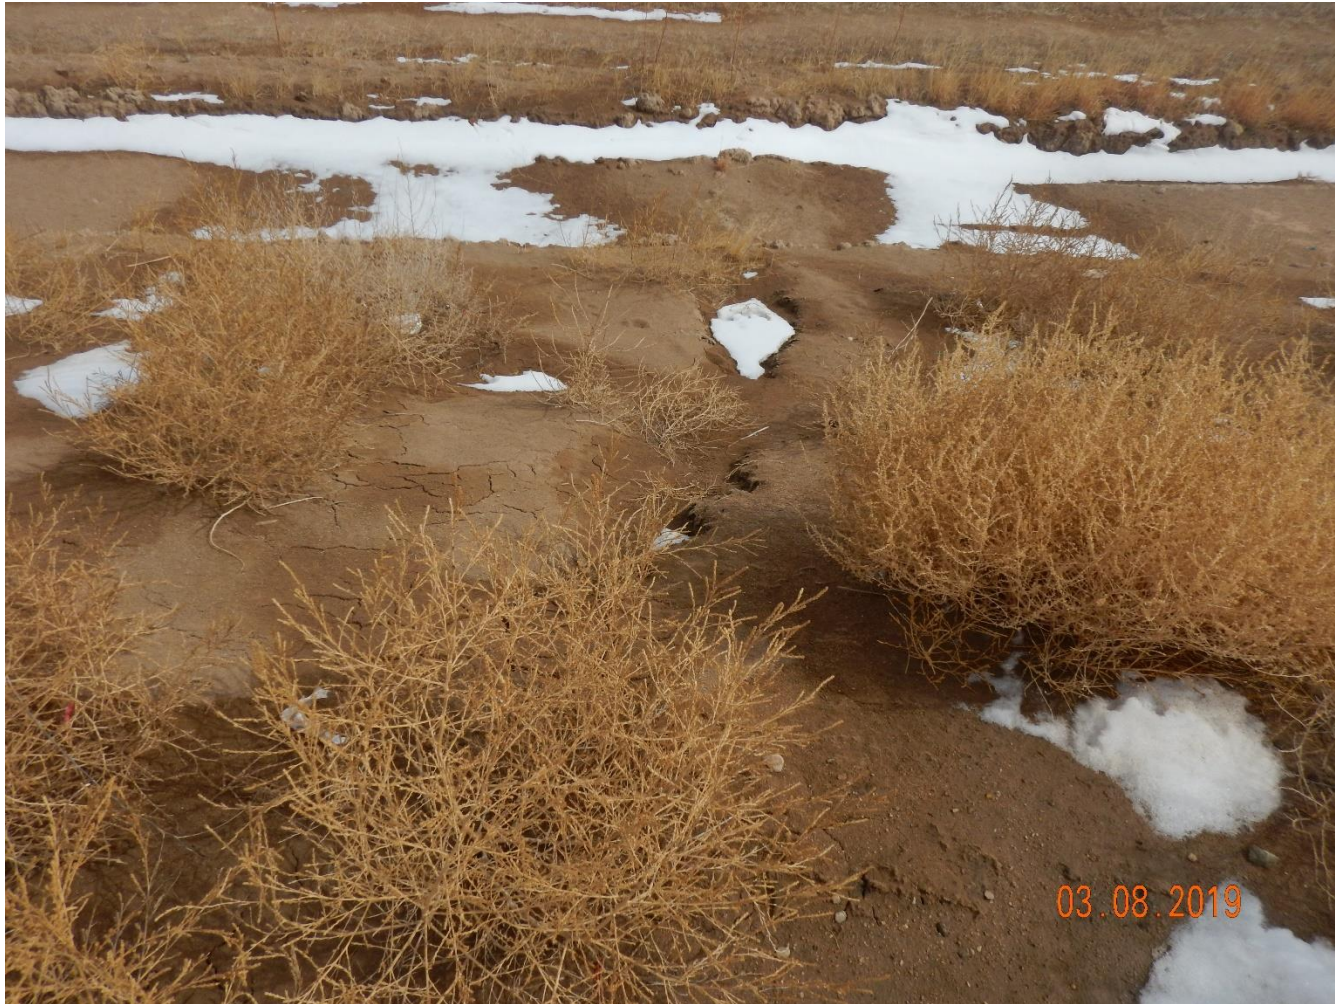
Photo 30: See comments under photo 27.

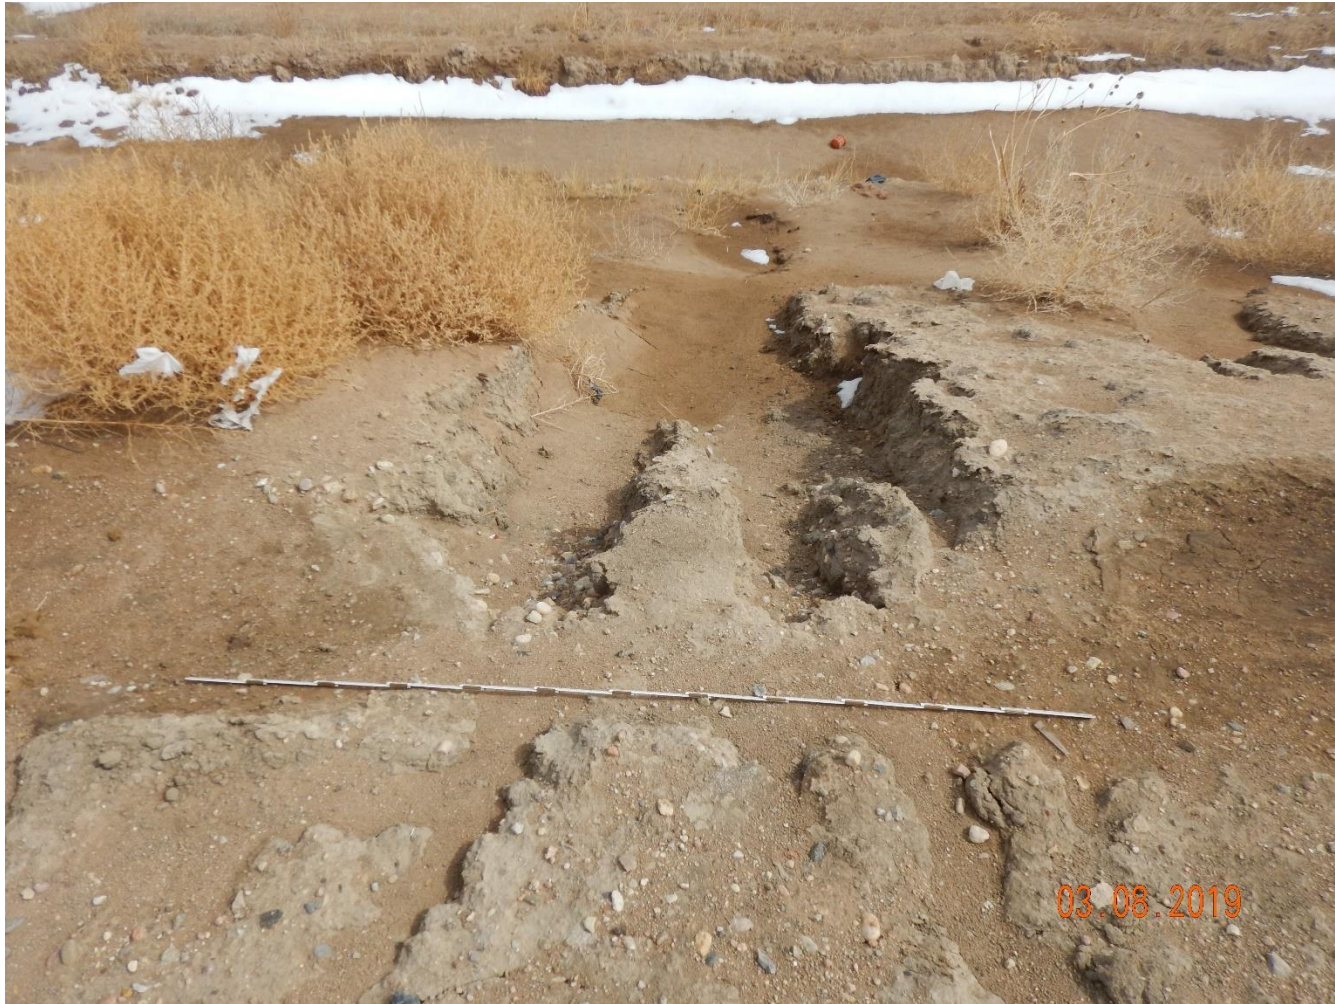
Photo 31: See comments under photo 27.

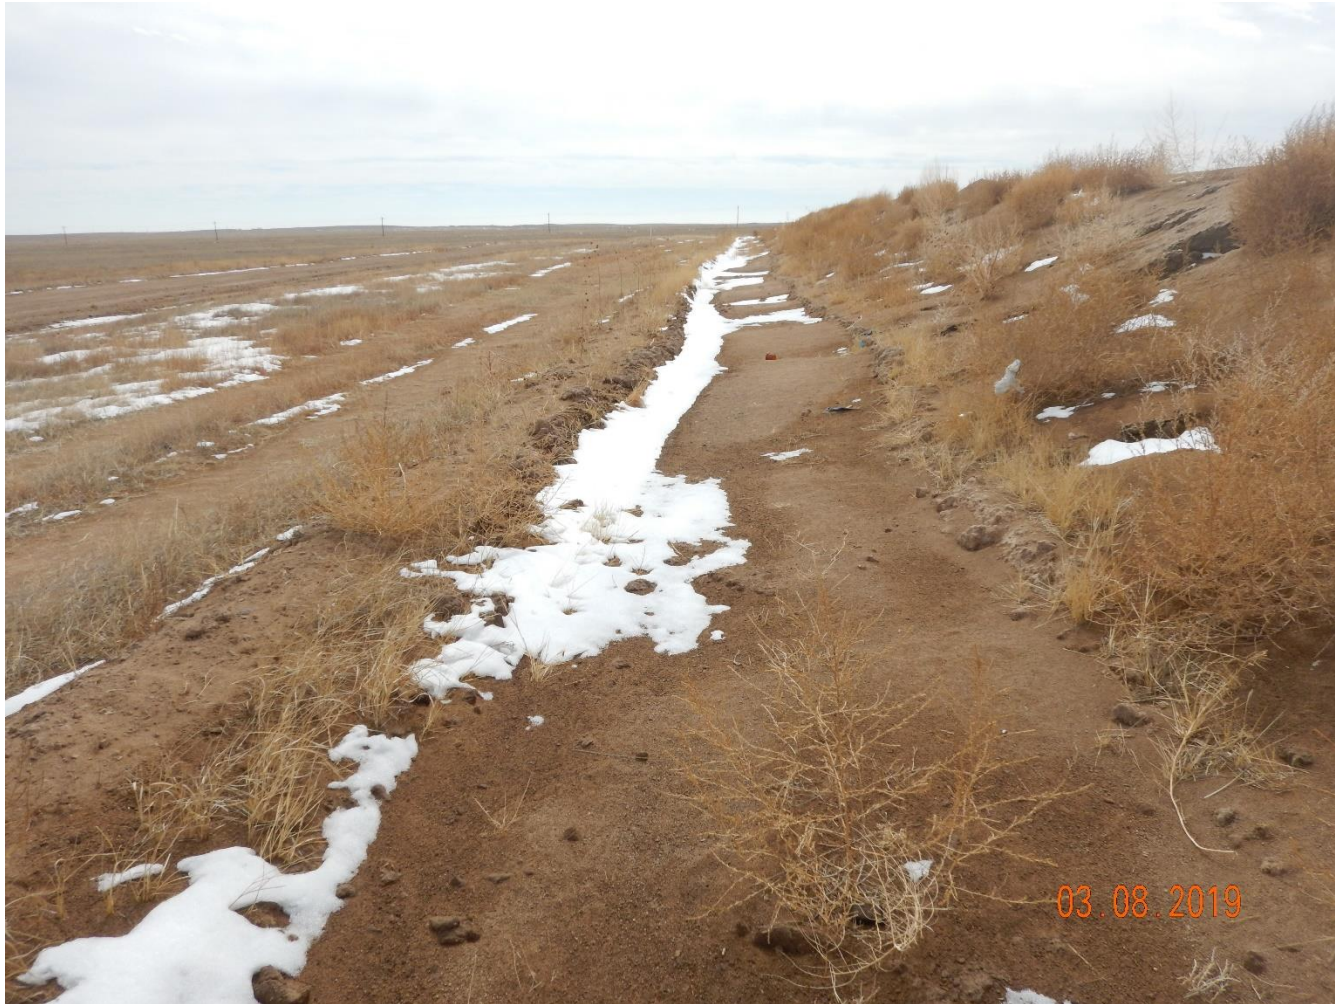
Photo 32: Photo taken from the east end of the location, facing south. Photo shows ditch has filled with sediment and is not longer in proper functioning condition.

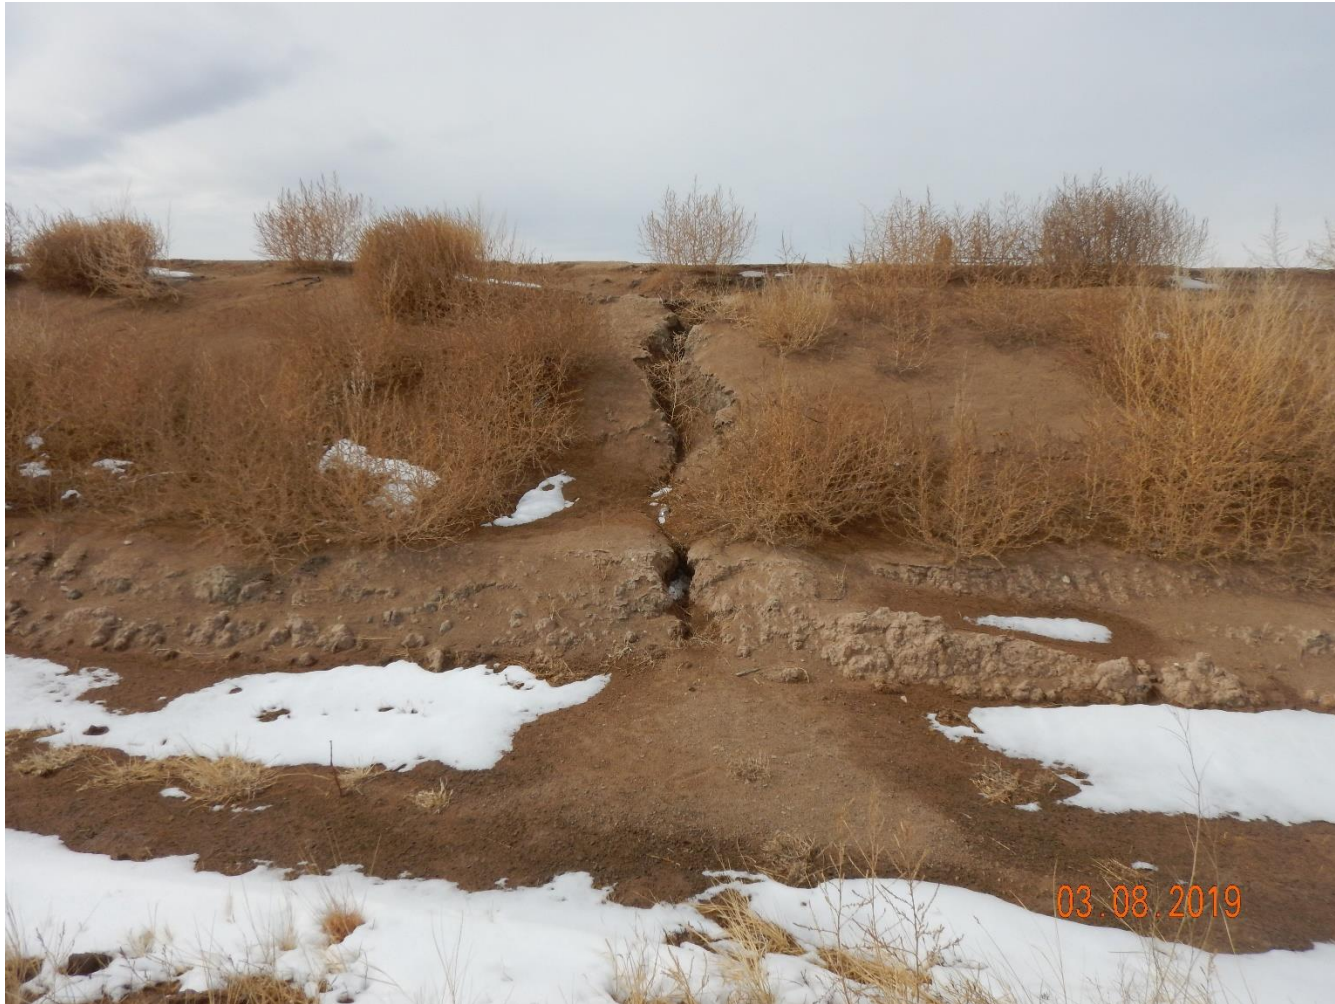
Photo 33: See comments under photo 27.
