Inspection Photos

Operator: BISON OIL & GAS II LLC # 10661

Location ID: 454166

Inspection Doc. Number: 682504584

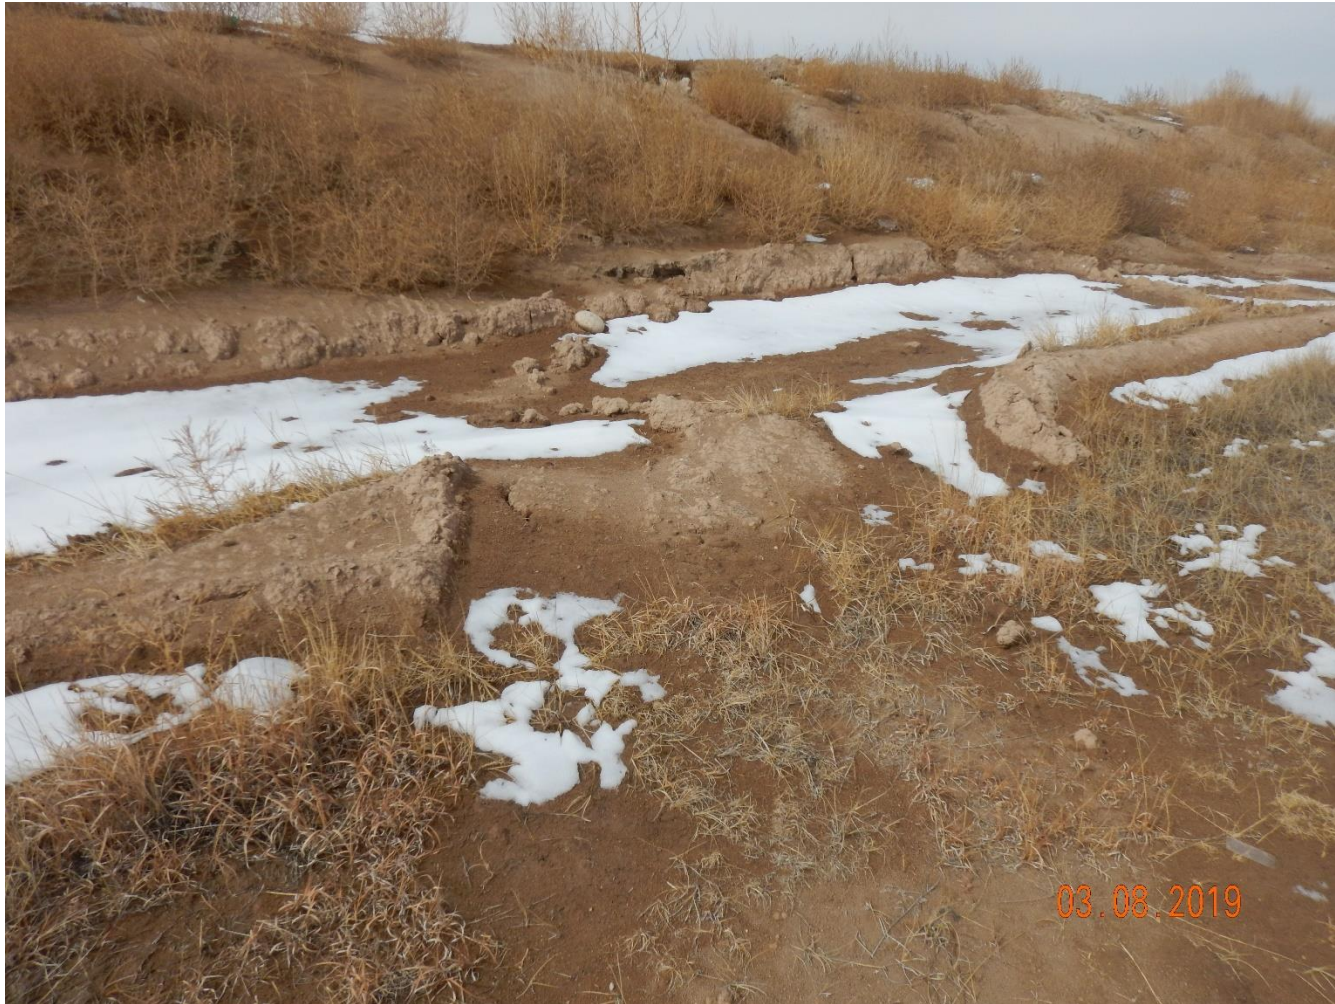
Photo 34: Photo taken from the ditch on the east end of the location. Photo shows a vehicle appears to have traveled over and damaged the ditch/berm. BMP no longer in proper functioning condition.

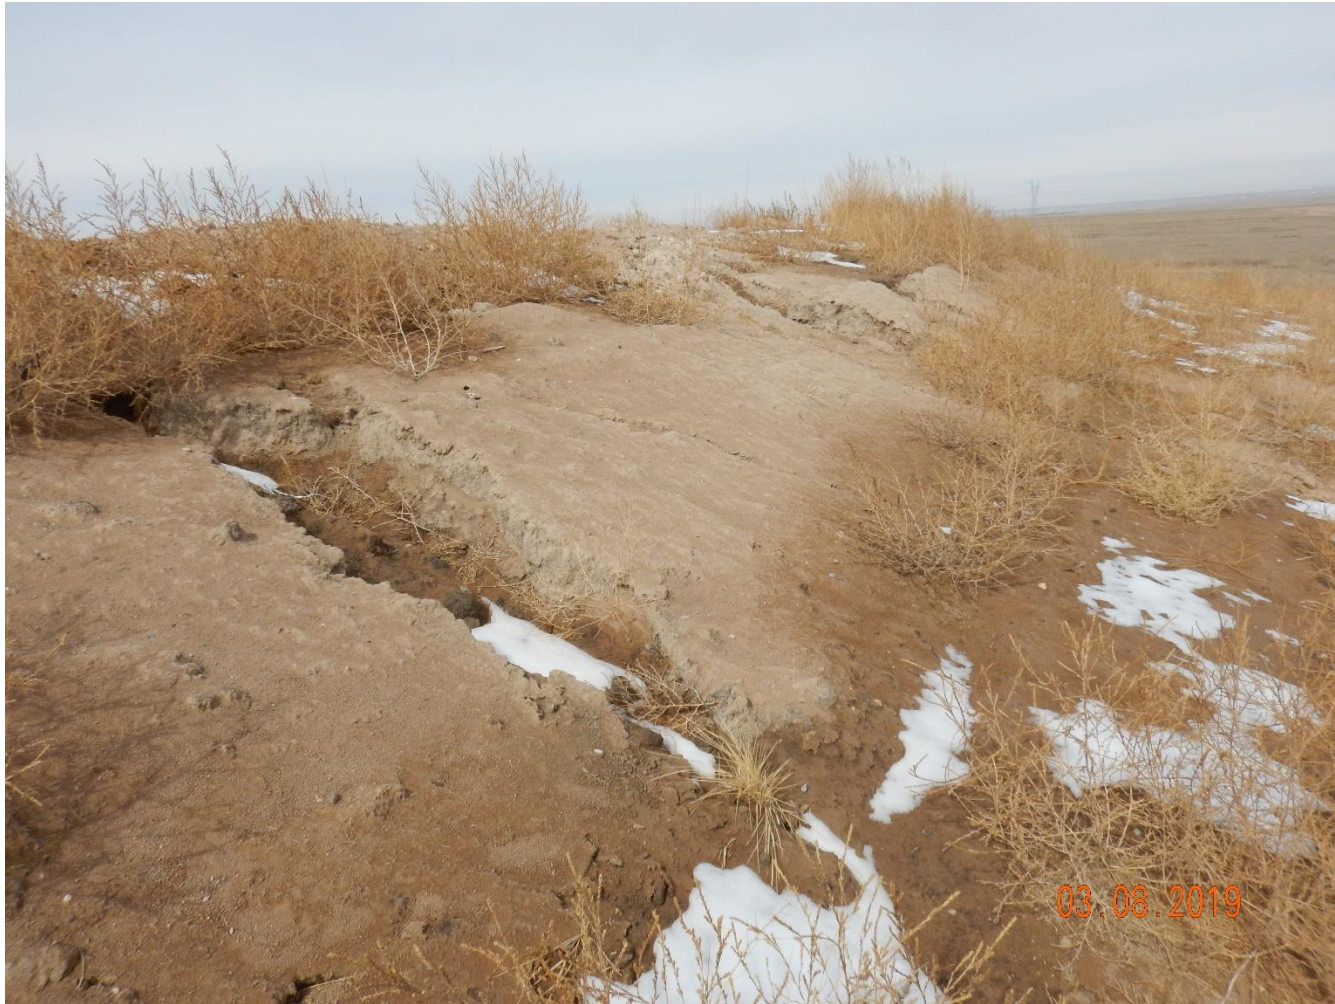
Photo 27: Photo taken from the east end of the pad, facing west. Photo shows slopes are bare and exposed soil, or vegetated by undersirable weedy plant species such as *Salsola* sp. Slopes have not been sufficiently stabilized. Stormwater erosion and sediment deposition evident. 6 foot measuring stick for reference.

Photo 35: See comments under photo 27.

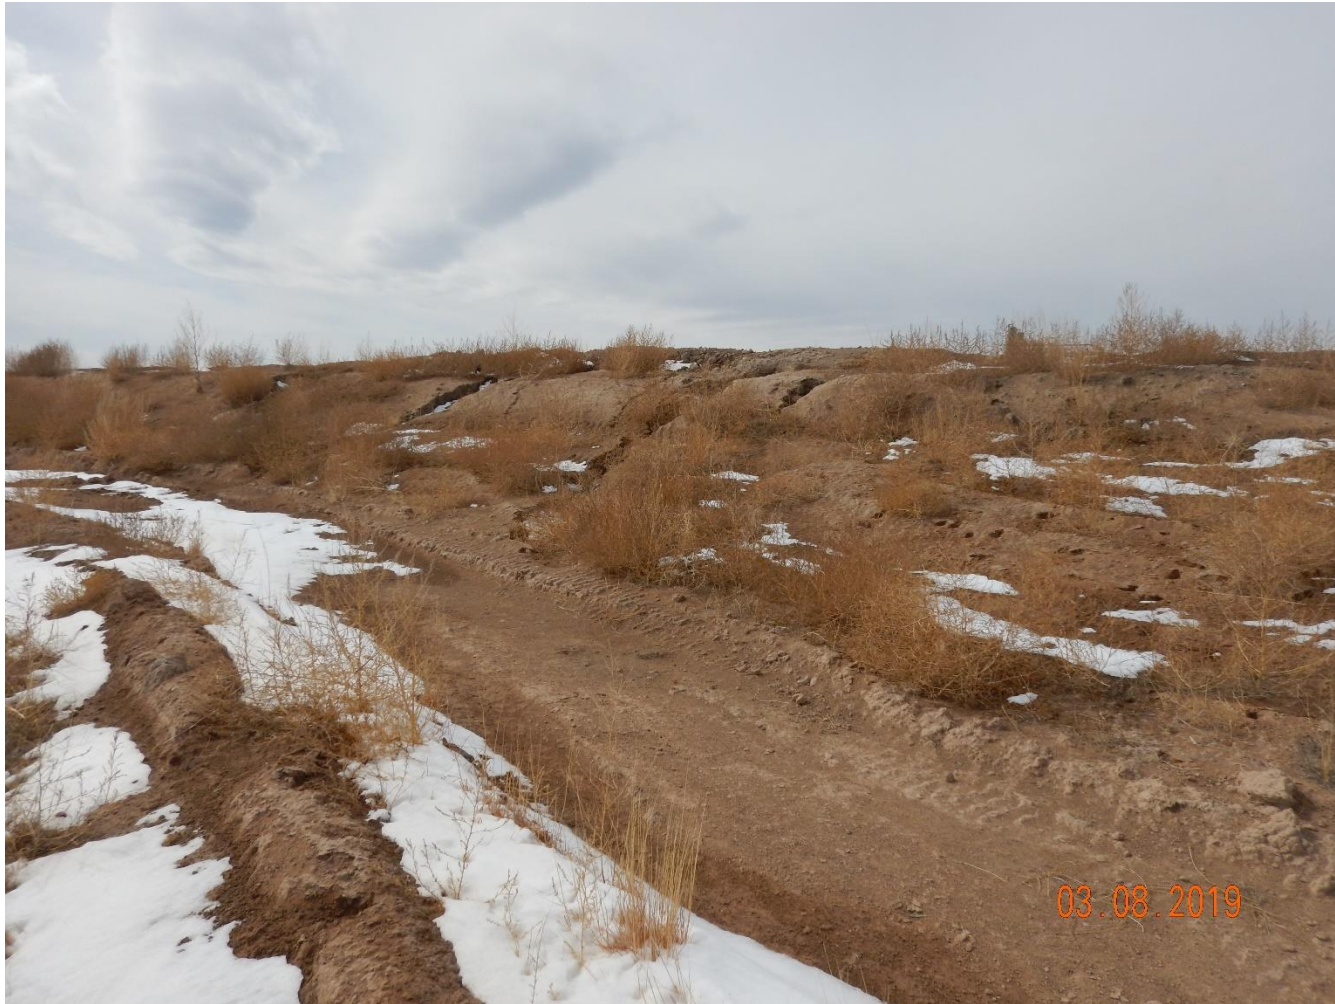
Photo 36: See comments under photo 27.

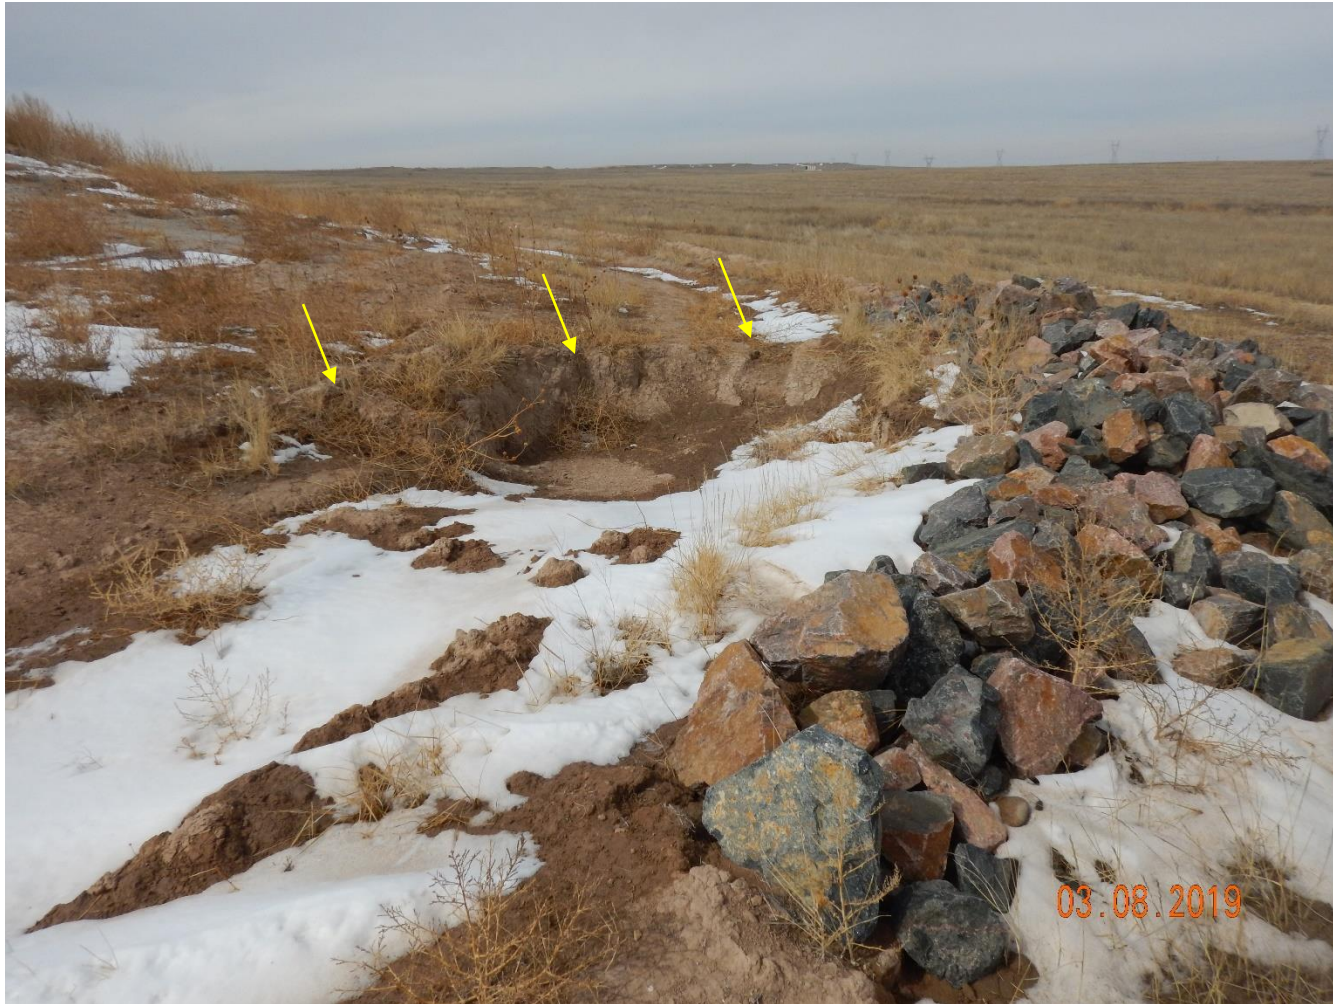
Photo 37: Photo taken from the sediment trap on the northeast corner of the location. BMP does not appear to have been constructed in accordance with good engineering practices; insufficient inlet and slope protection. Stormwater has incised the ditch at the inlets of the sediment traps. Slopes of the traps do not appear to have been constructed at an advisable grade in accordance with good engineering practices; stormwater erosion degradation evident along the slopes of the sediment traps.

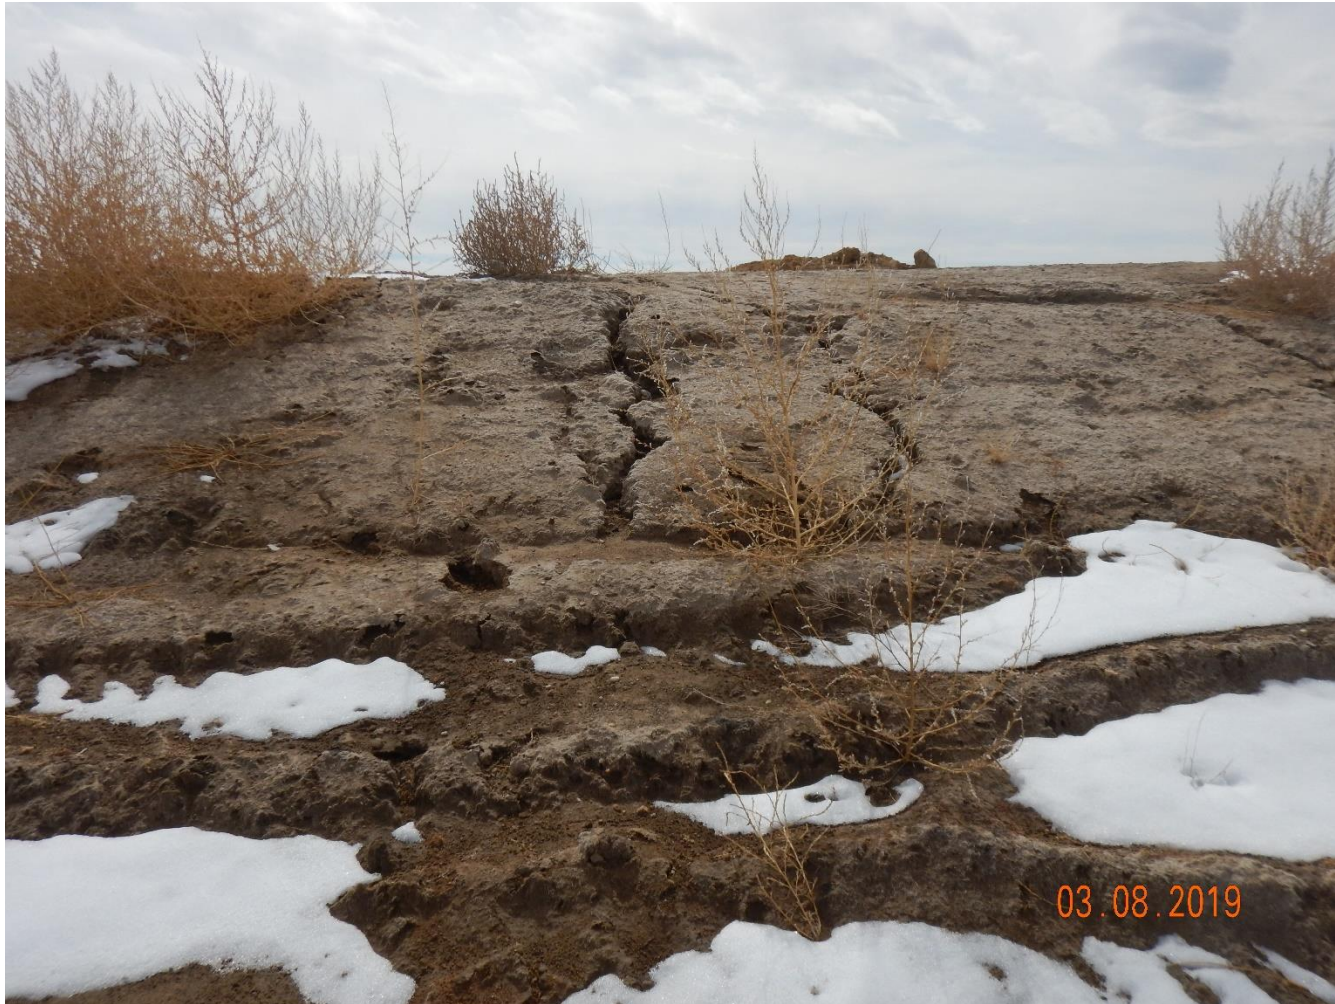
Photo 38: See comments under photo 27

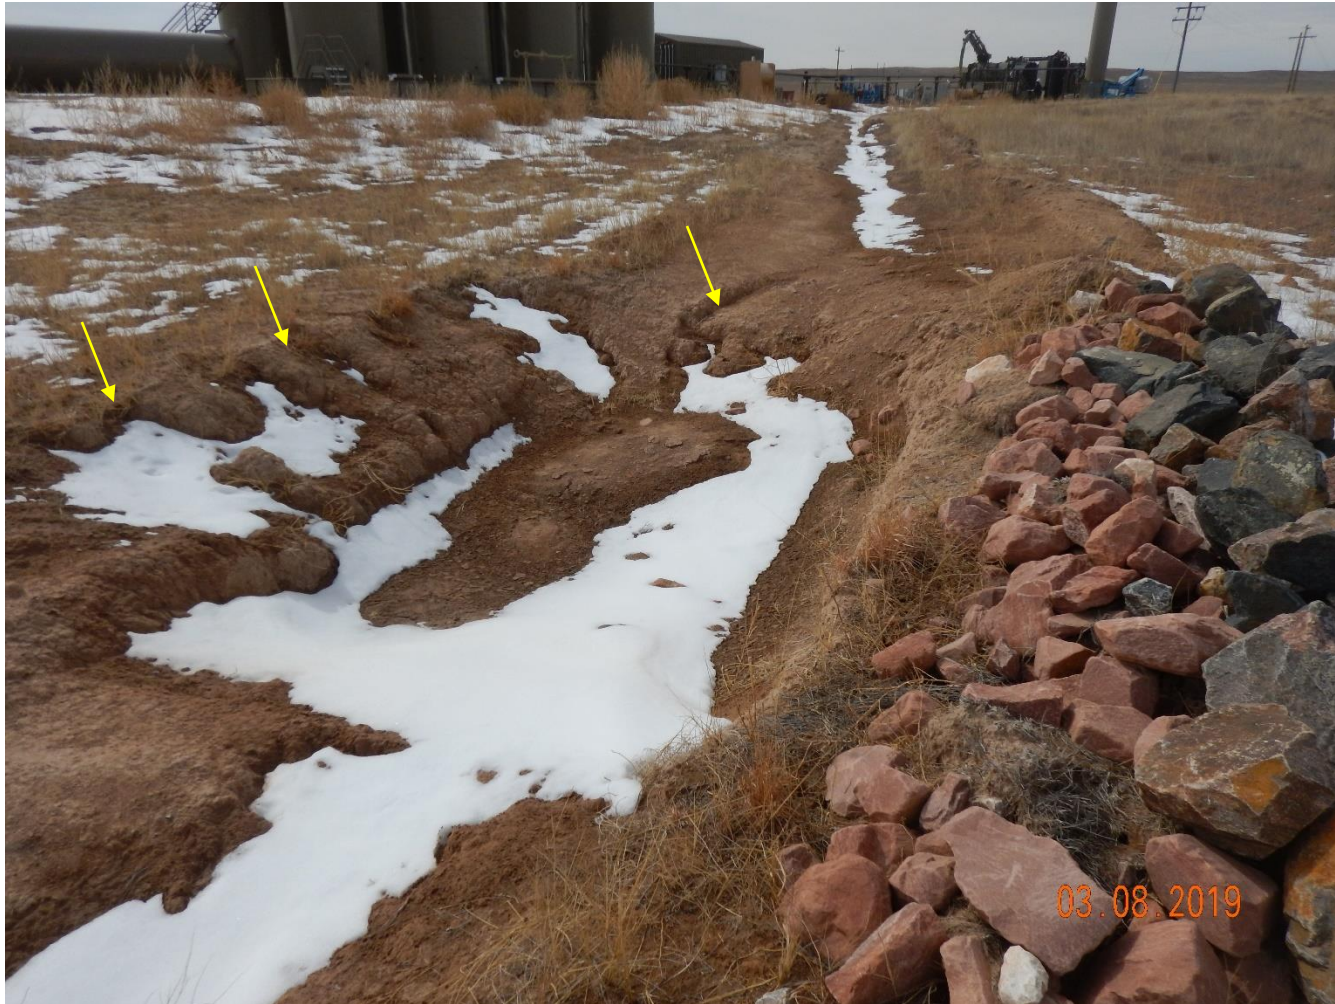
Photo 39: See comments under photo 37

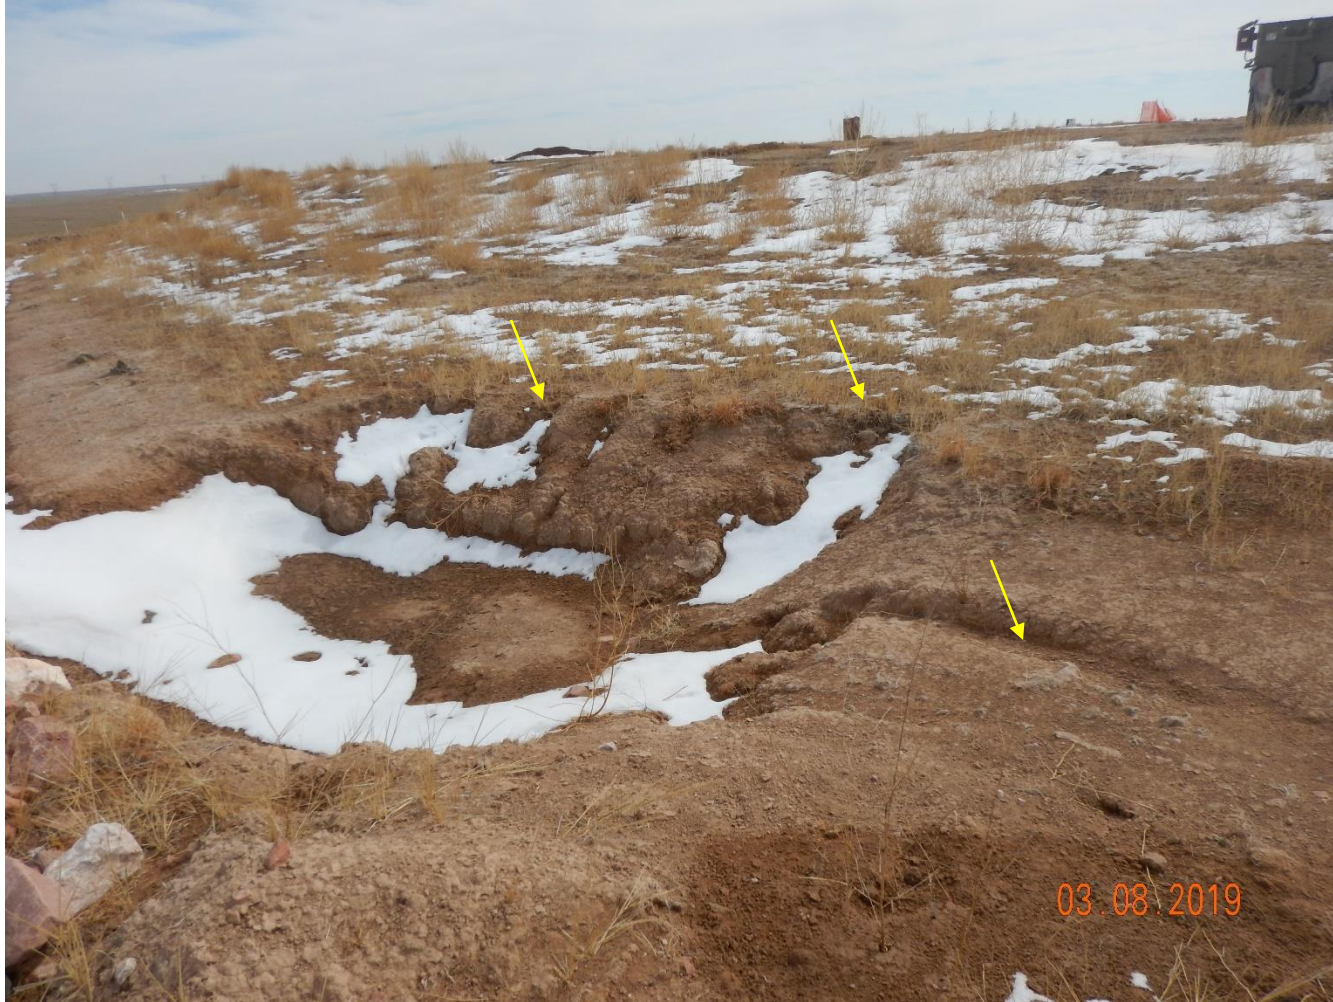
Photo 40: See comments under photo 27. In addition It does not appear that the perimeter stormwater and erosion controls installed on location are sufficient to mitigate stormwater runoff from the 11 acre disturbance; The two (2) sediment traps on the northeast and northern ends of the location also do not appear to be sufficient in size for the location.

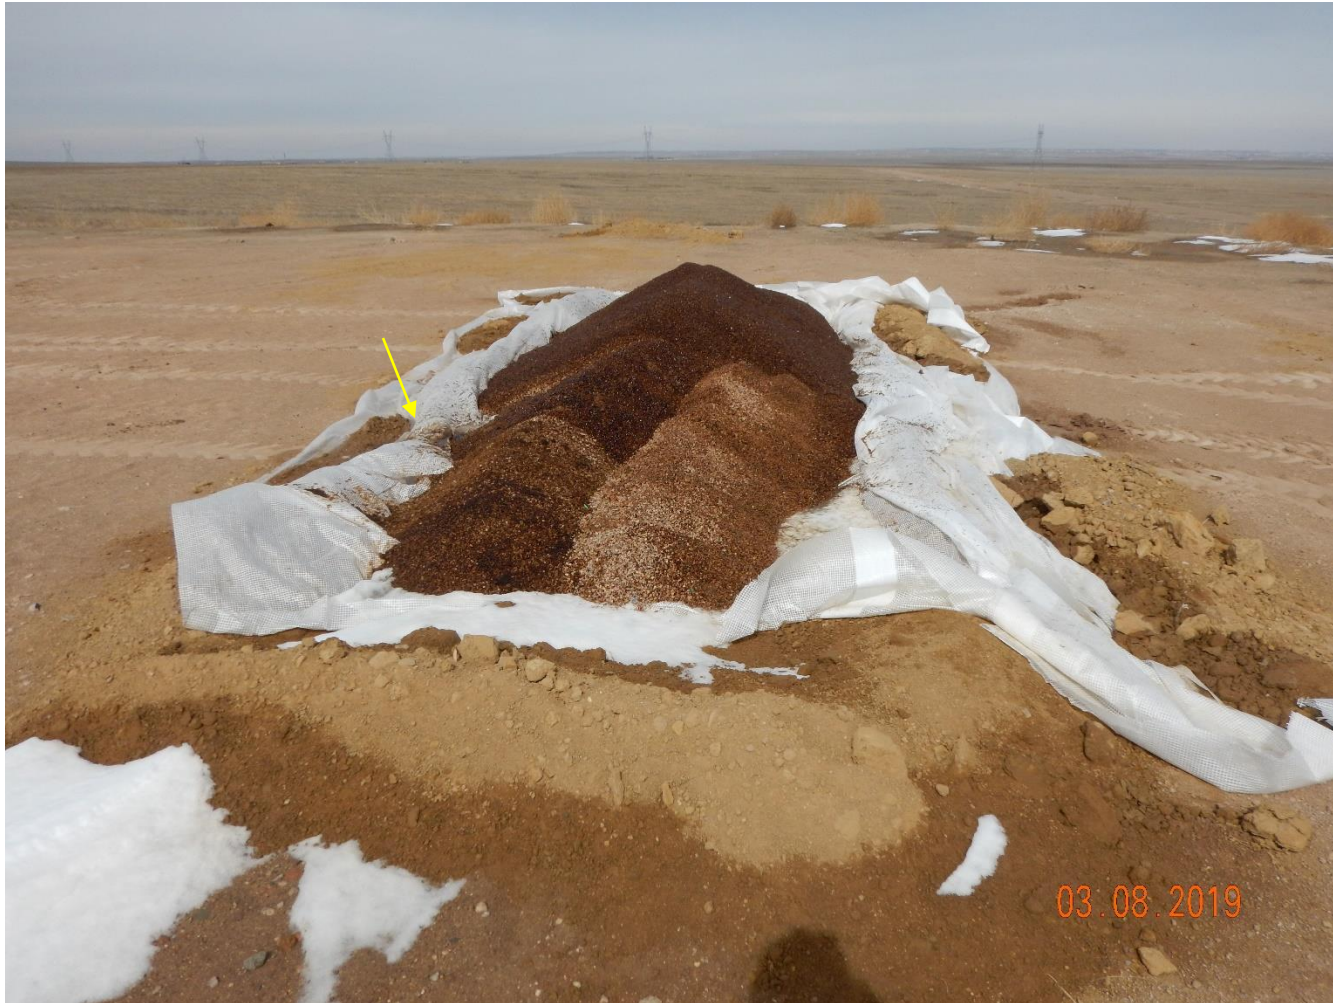
Photo 41: Photo taken from the northeast corner of the pad. Photo shows Operator is storing contaminated soils on the northeast corner of the pad. Containment BMPs are insufficient as pollutant discharge from the contaminated soils is evident.

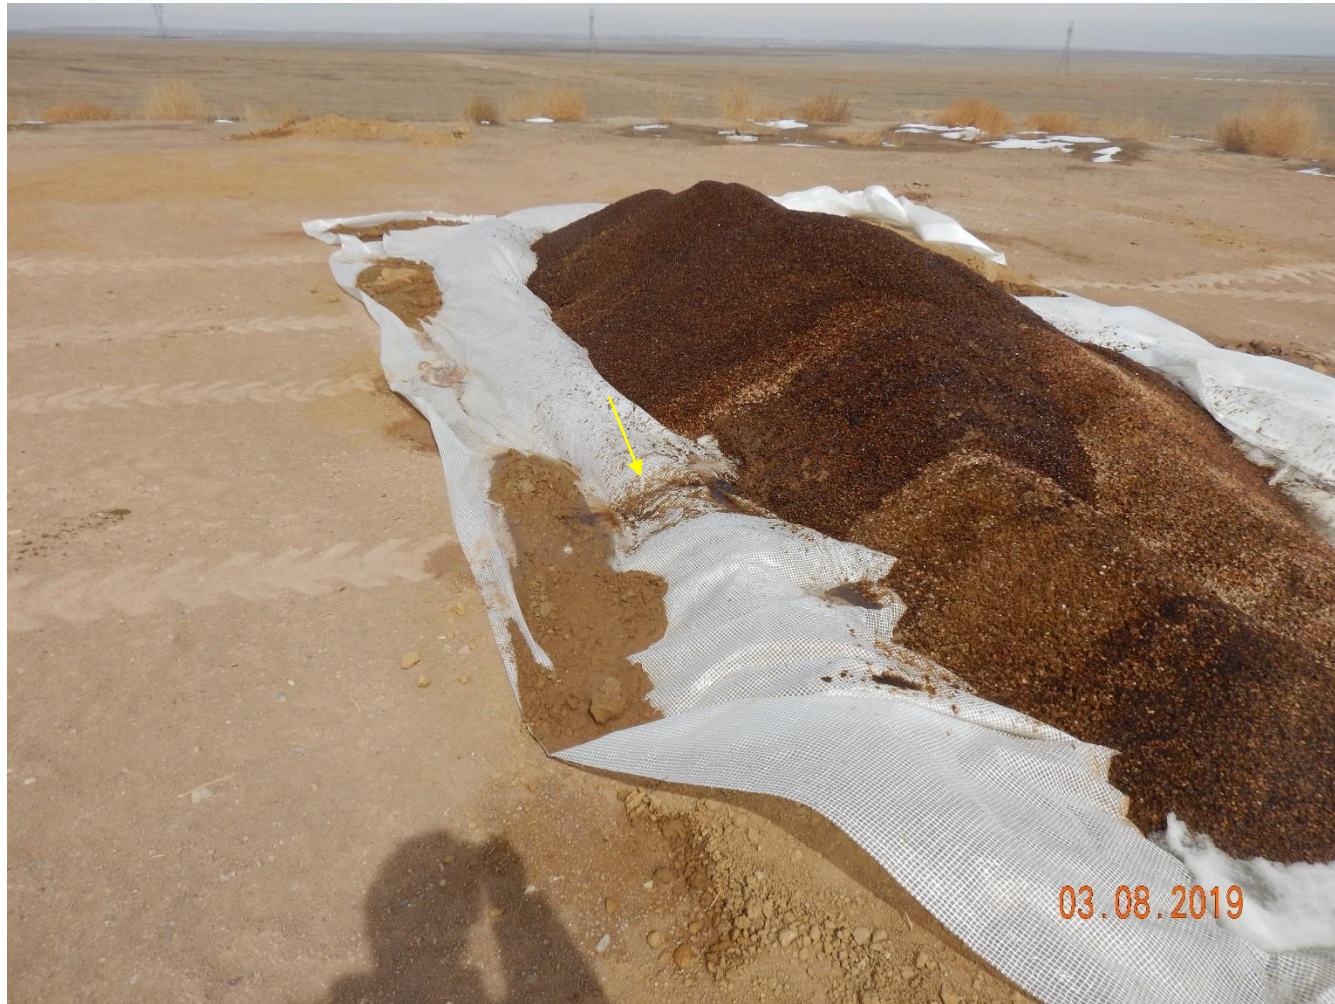
Photo 42: See comments under photo 41.

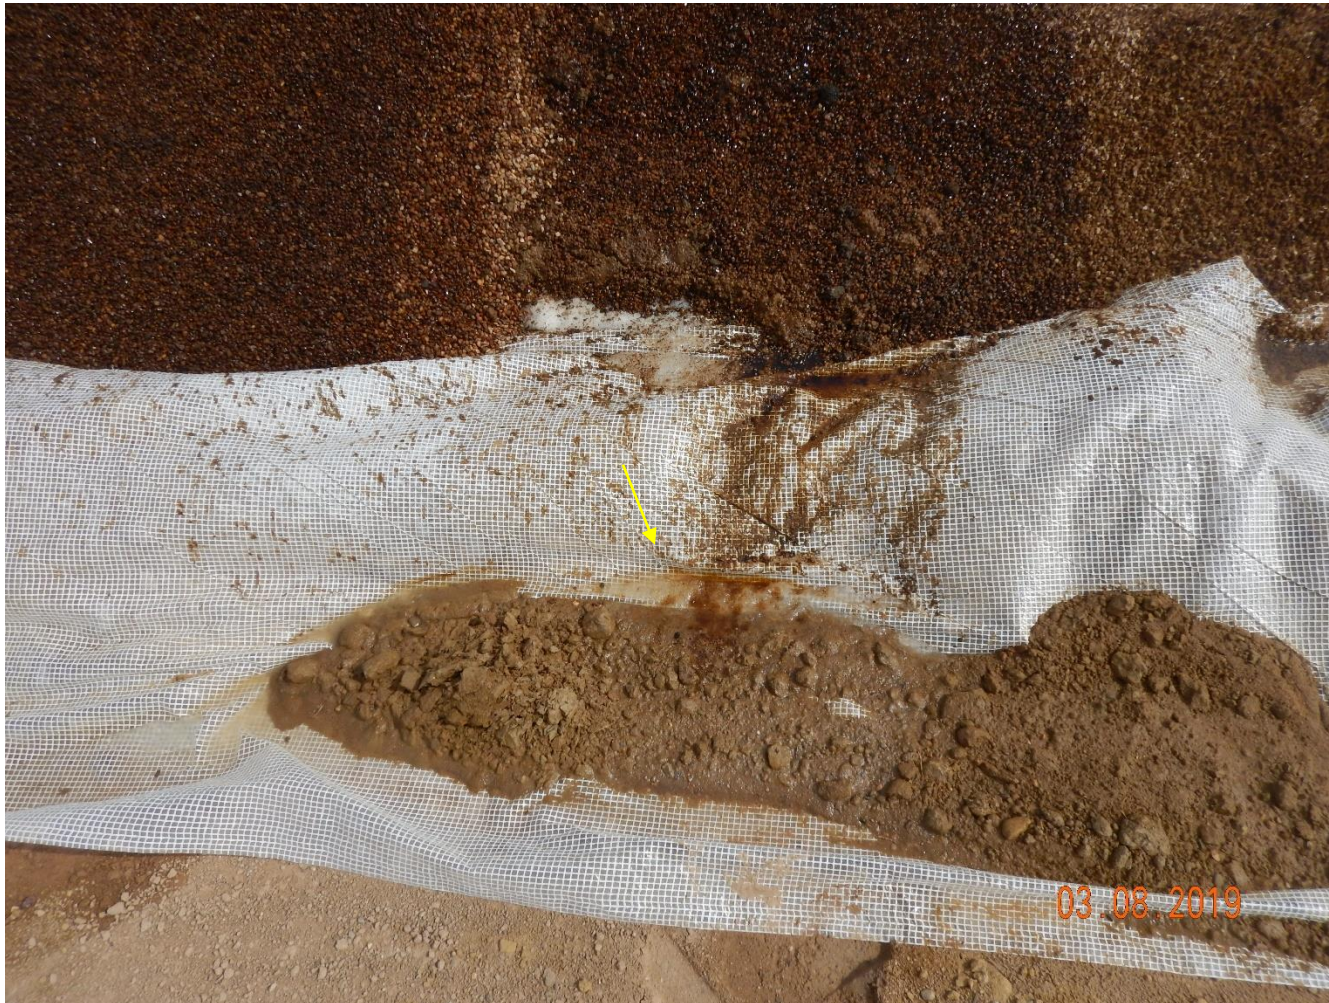
Photo 43: See comments under photo 41.

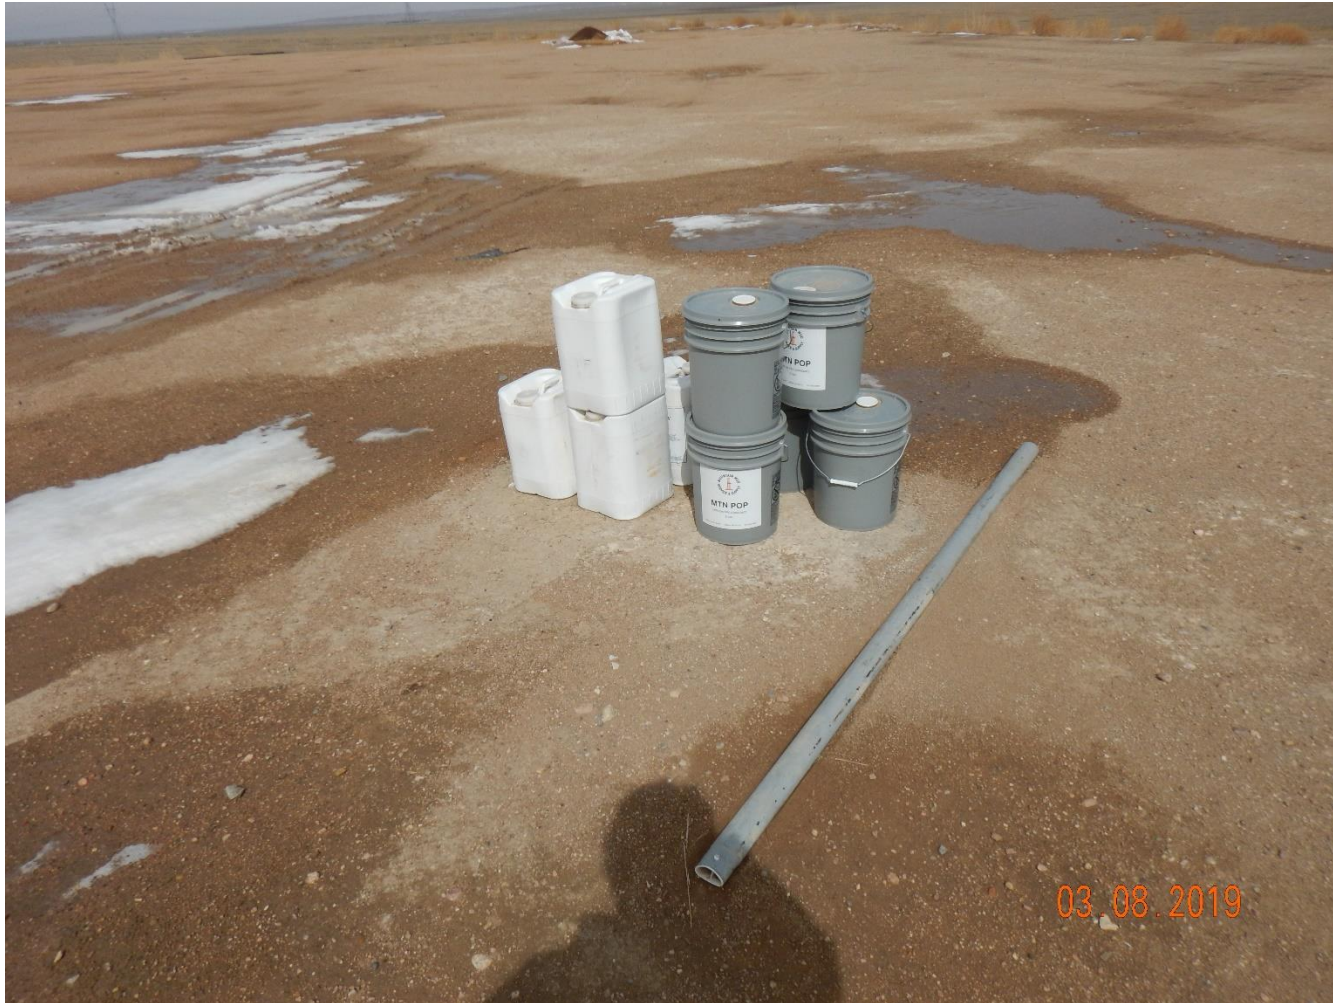
Photo 44: Photo taken from the east end of the pad. Photo shows multiple 5 gallon buckets and jugs are being stored directly upon the surface of the soil. This is not proper materials management.

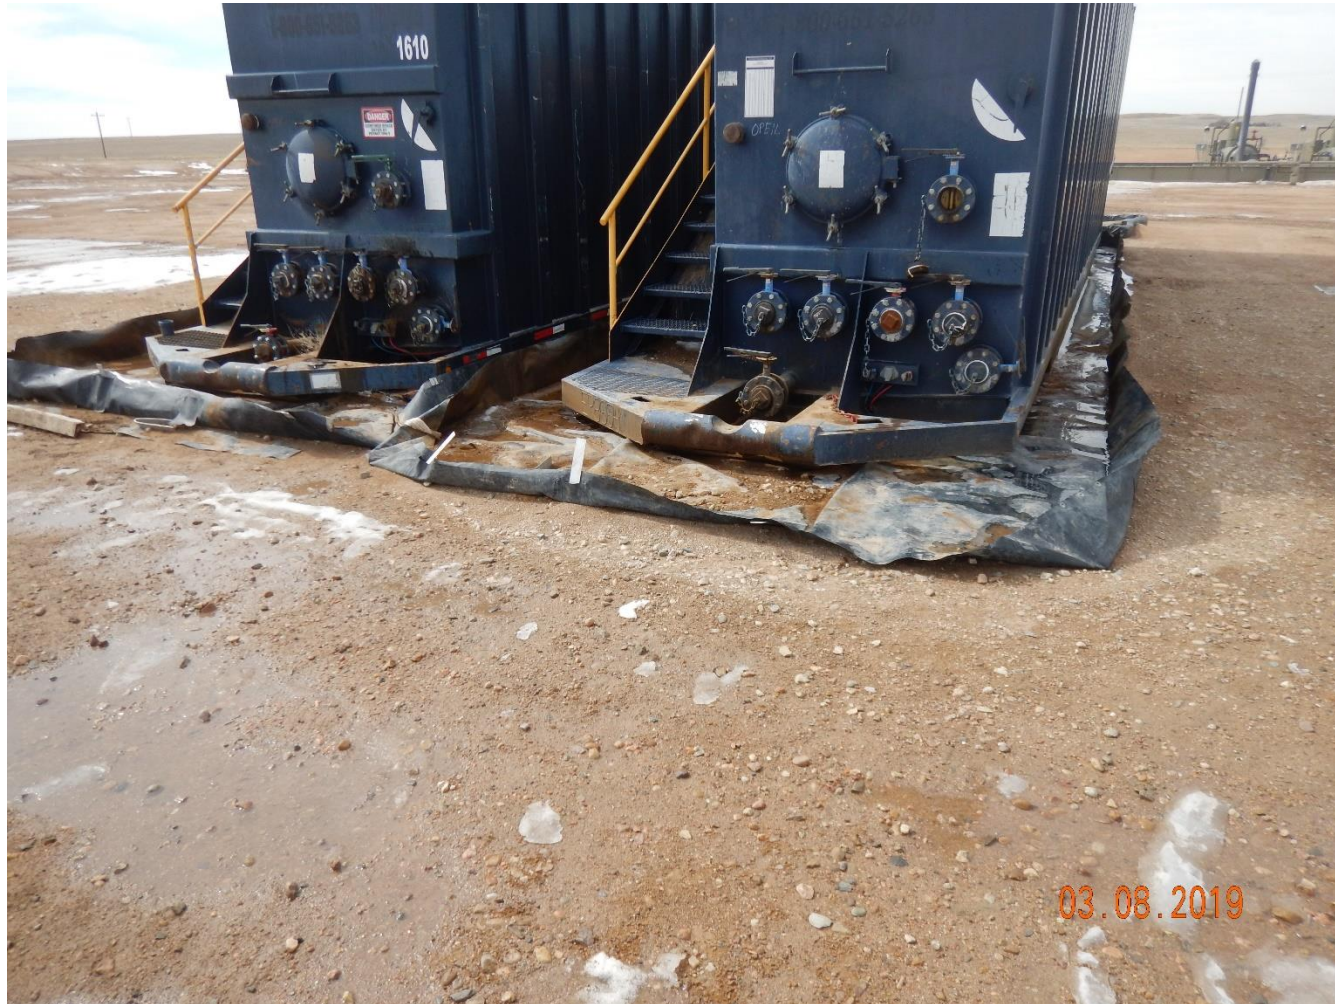
Photo 45: Photo taken from the southeast end of the location, facing north. See comments under photo 3..

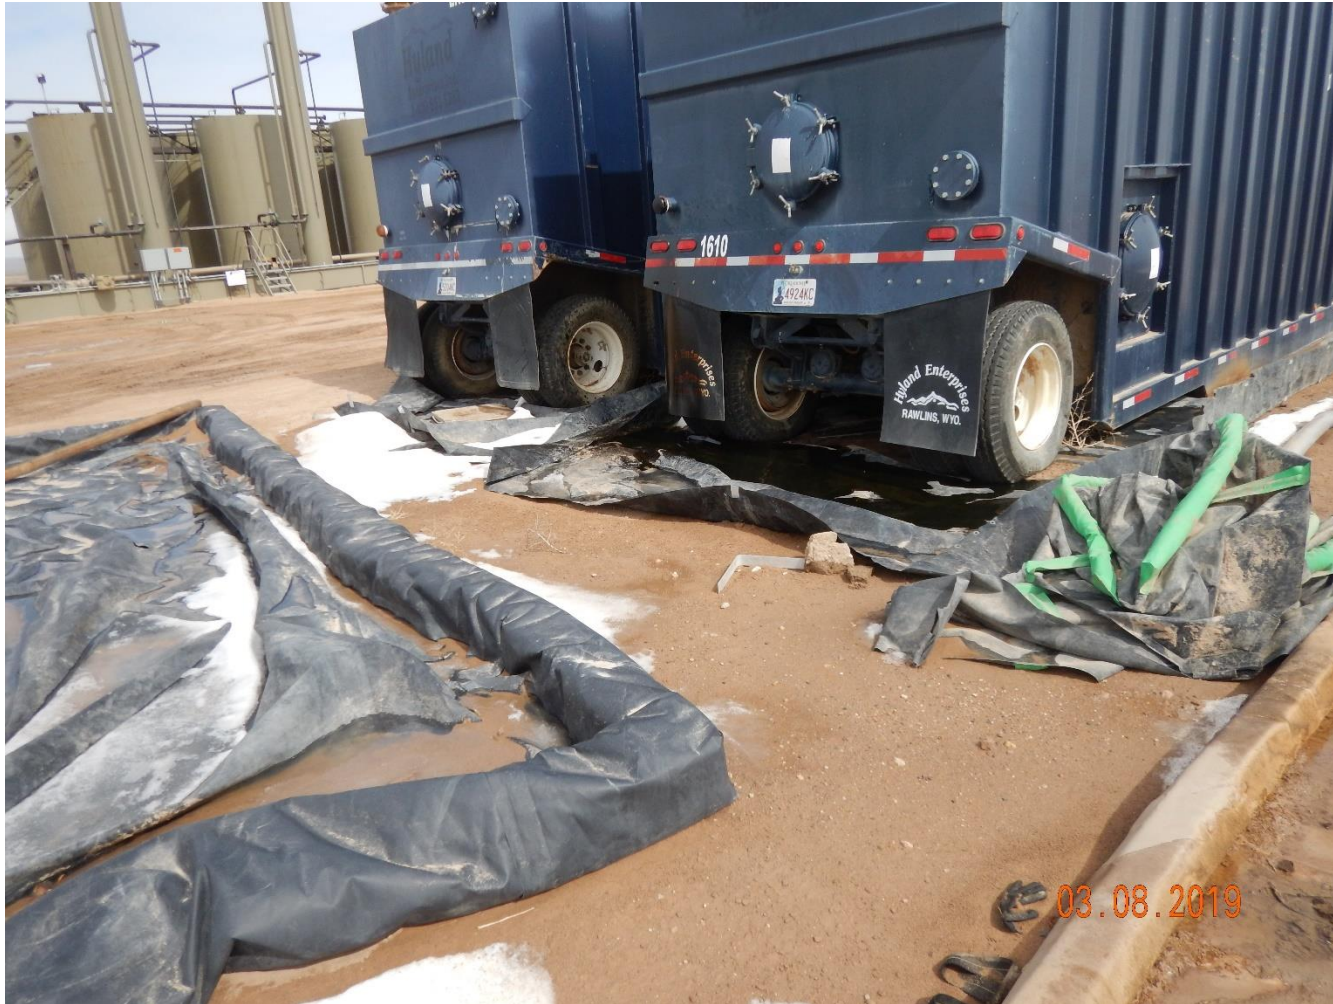
Photo 46: Photo taken from the southeast end of the location, facing north. See comments under photo 3..

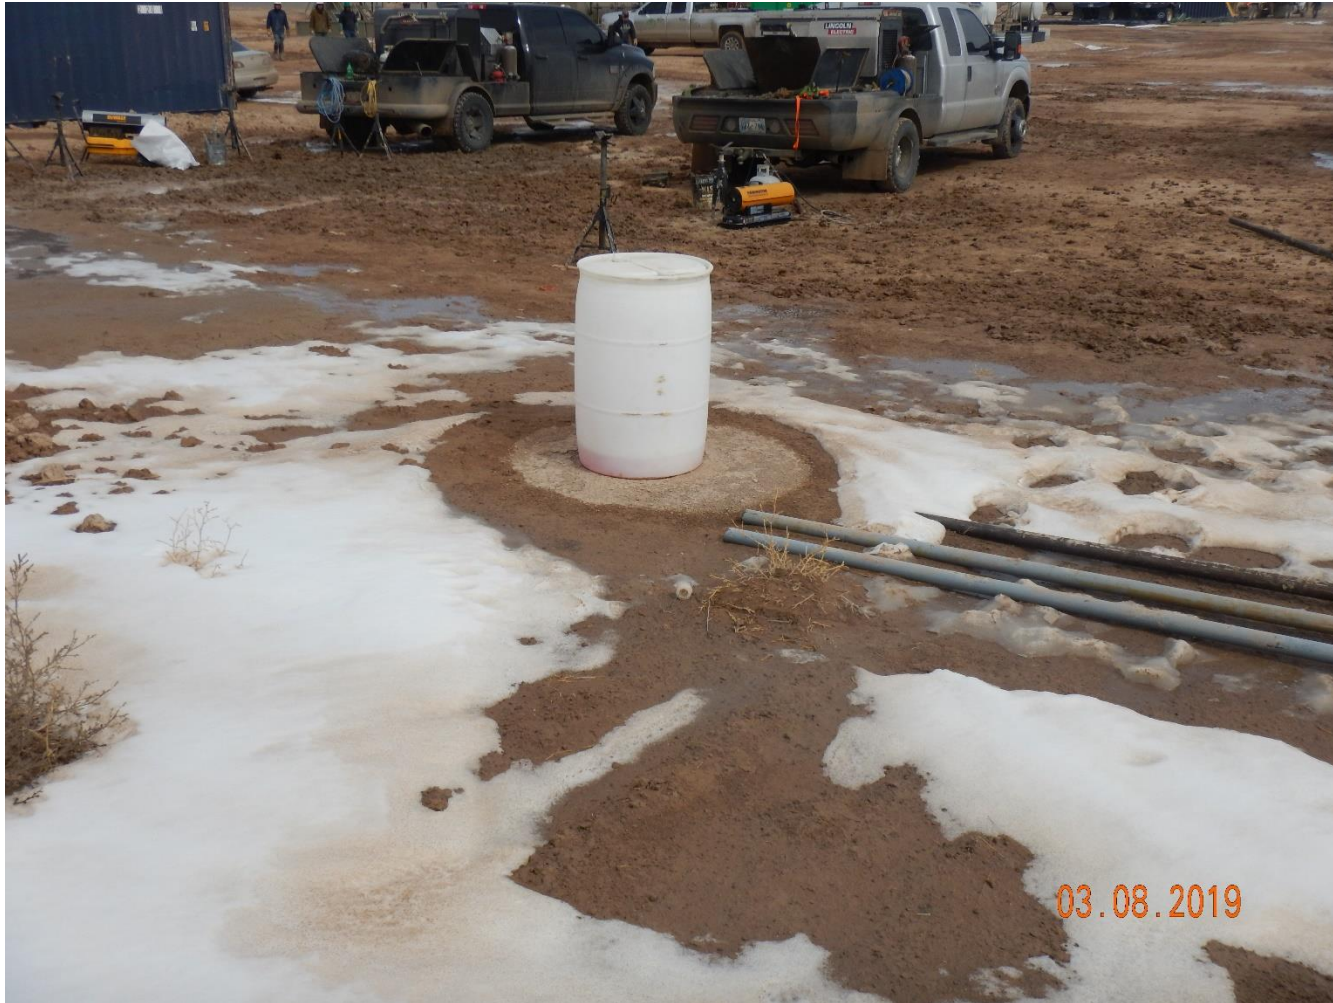
Photo 46: Photo taken from the west end of the pad. Photo shows a barrel being stored directly upon the surface of the soil. This is not proper materials management.

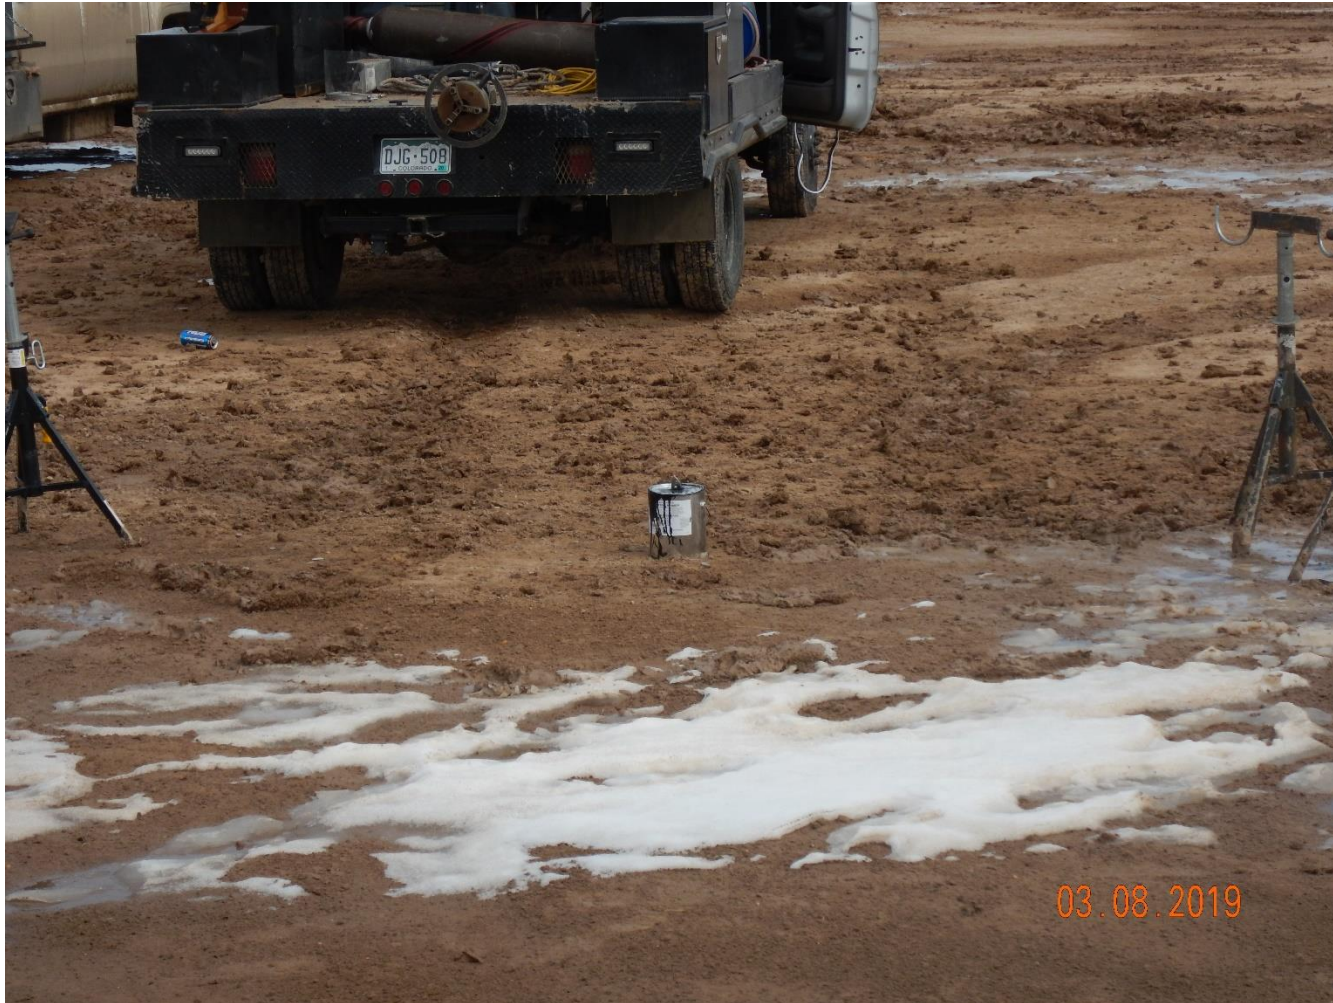
Photo 47: Photo taken from the west end of the pad. Photo shows what appears to be a paint can being stored directly upon the surface of the soil. This is not proper materials management.

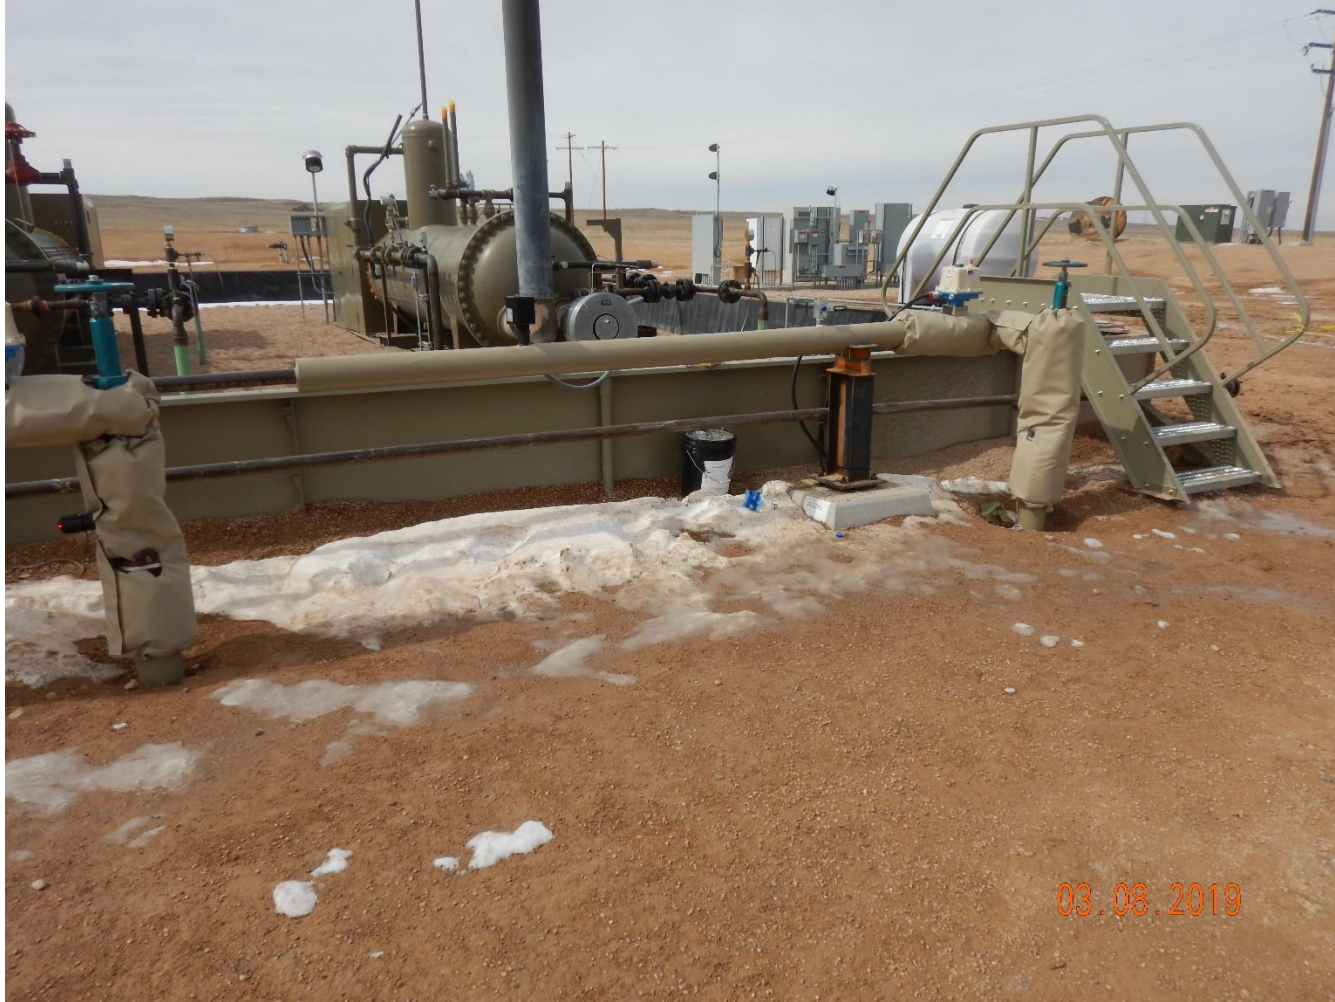
Photo 48: Photo taken from the east end of the pad. Photo shows a 5 gallon buckets being stored directly upon the surface of the soil. This is not proper materials management.

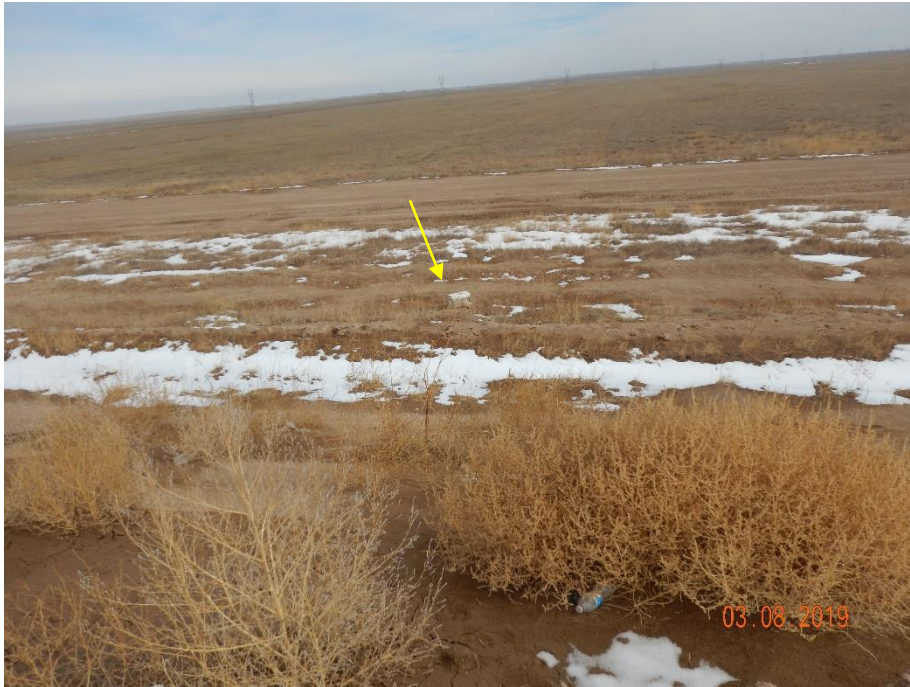
Photo 49: Photo taken from the east end of the pad. Photo shows trash debris (jug) appears to have been blown from the location.
