Inspection Photos

Operator: BISON OIL & GAS II LLC # 10661

Location ID: 454166

Inspection Doc. Number: 682504584

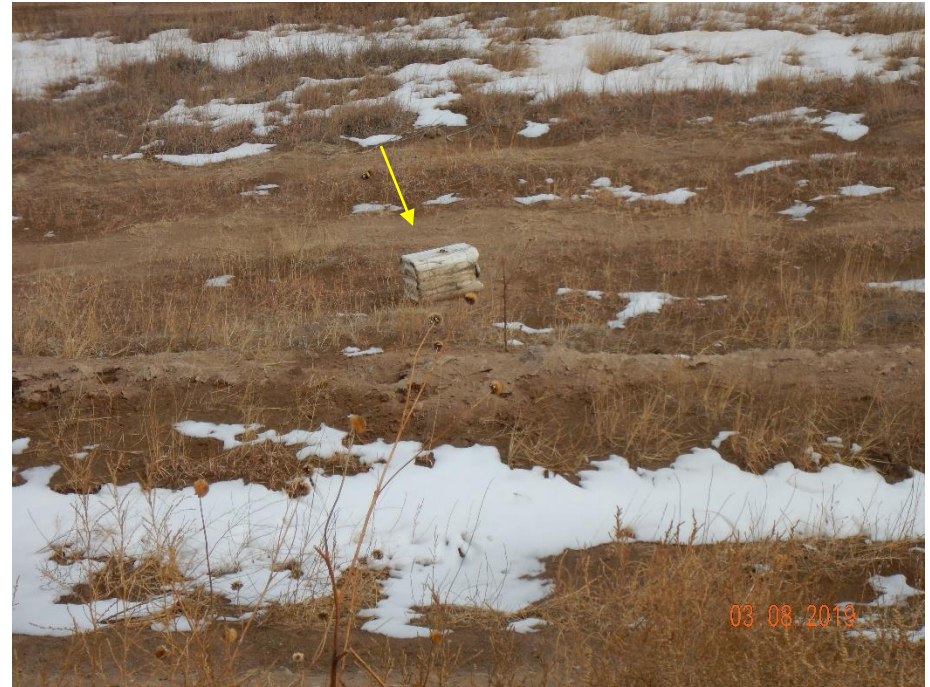
Photo 49: Photo taken from the east end of the pad. Photo shows trash debris (jug) appears to have been blown from the location.

Photo 50: Continued from photo 49.

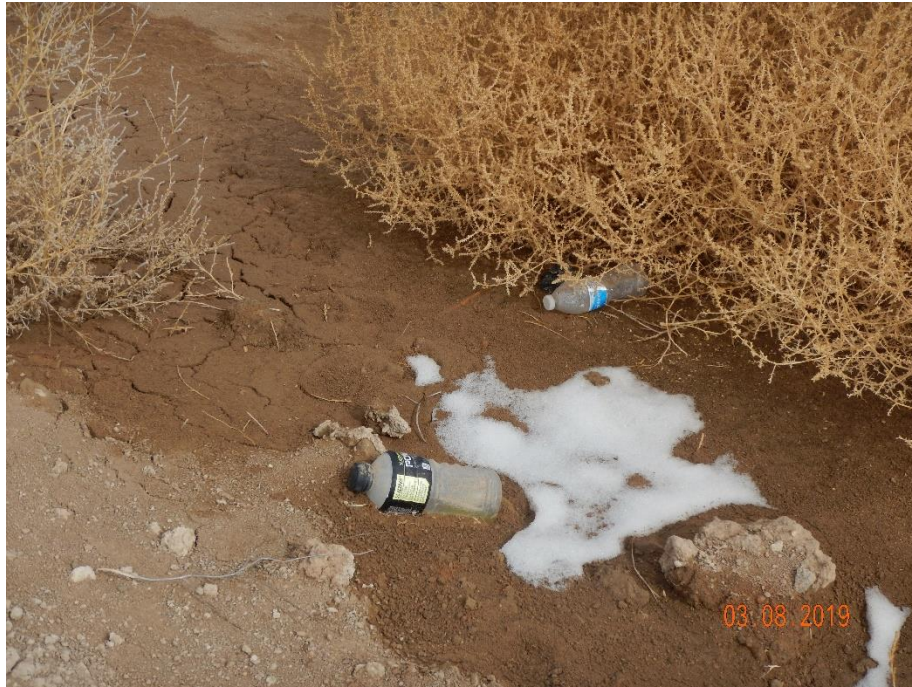
Photo 51: Photo taken from the perimeter of the pad. The following photos are examples of multiple areas throughout the perimeter of the location where trash debris was observed.

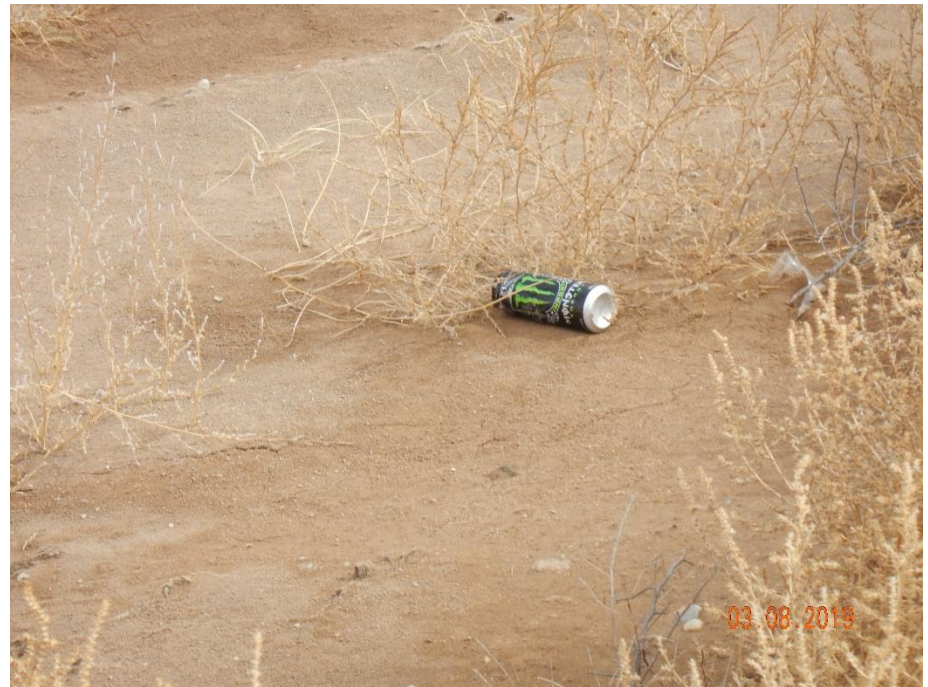
Photo 52: See comments under photo 51.

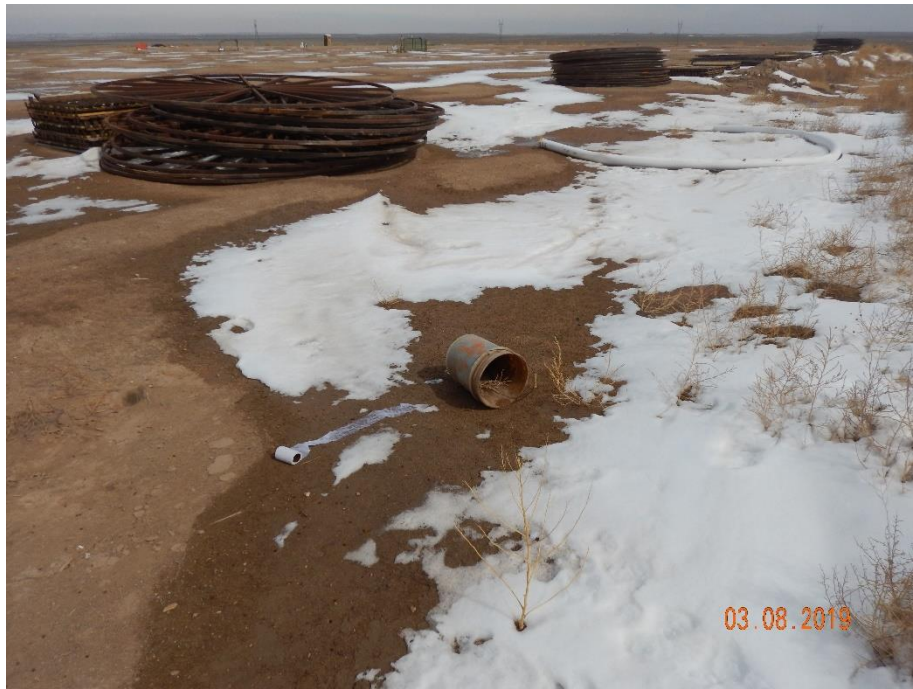
Photo 53: See comments under photo 51. .
