Inspection Photos  
Operator: Javernick Oil  
Location/API #: 043-40020  
Date: 2/28/2019

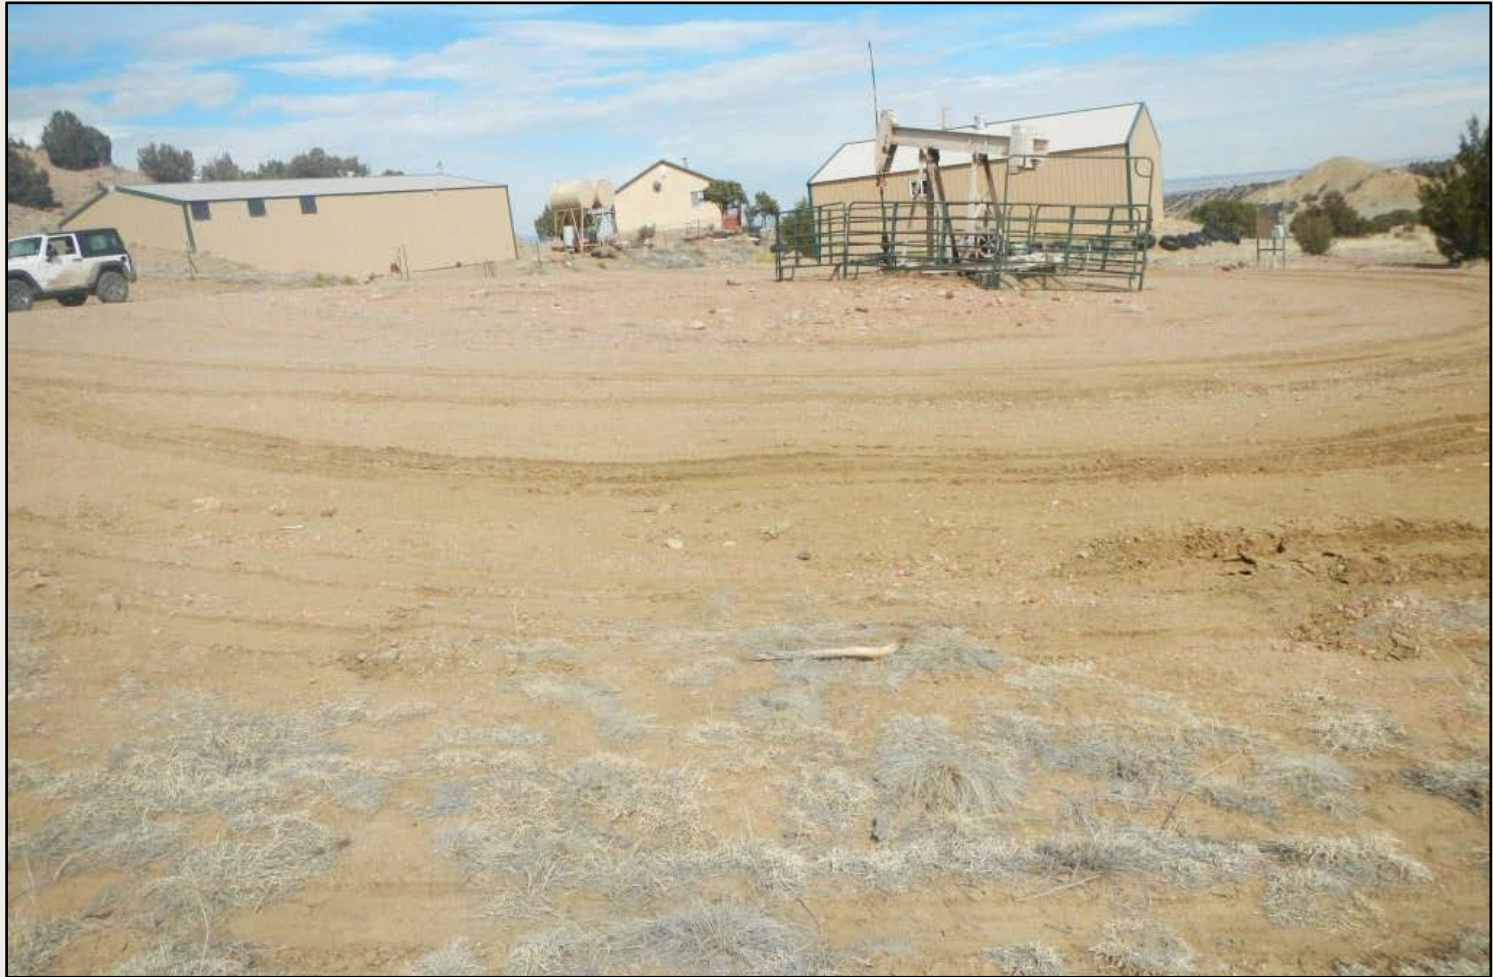
Photo 1. View of the project area from the southern corner facing center.

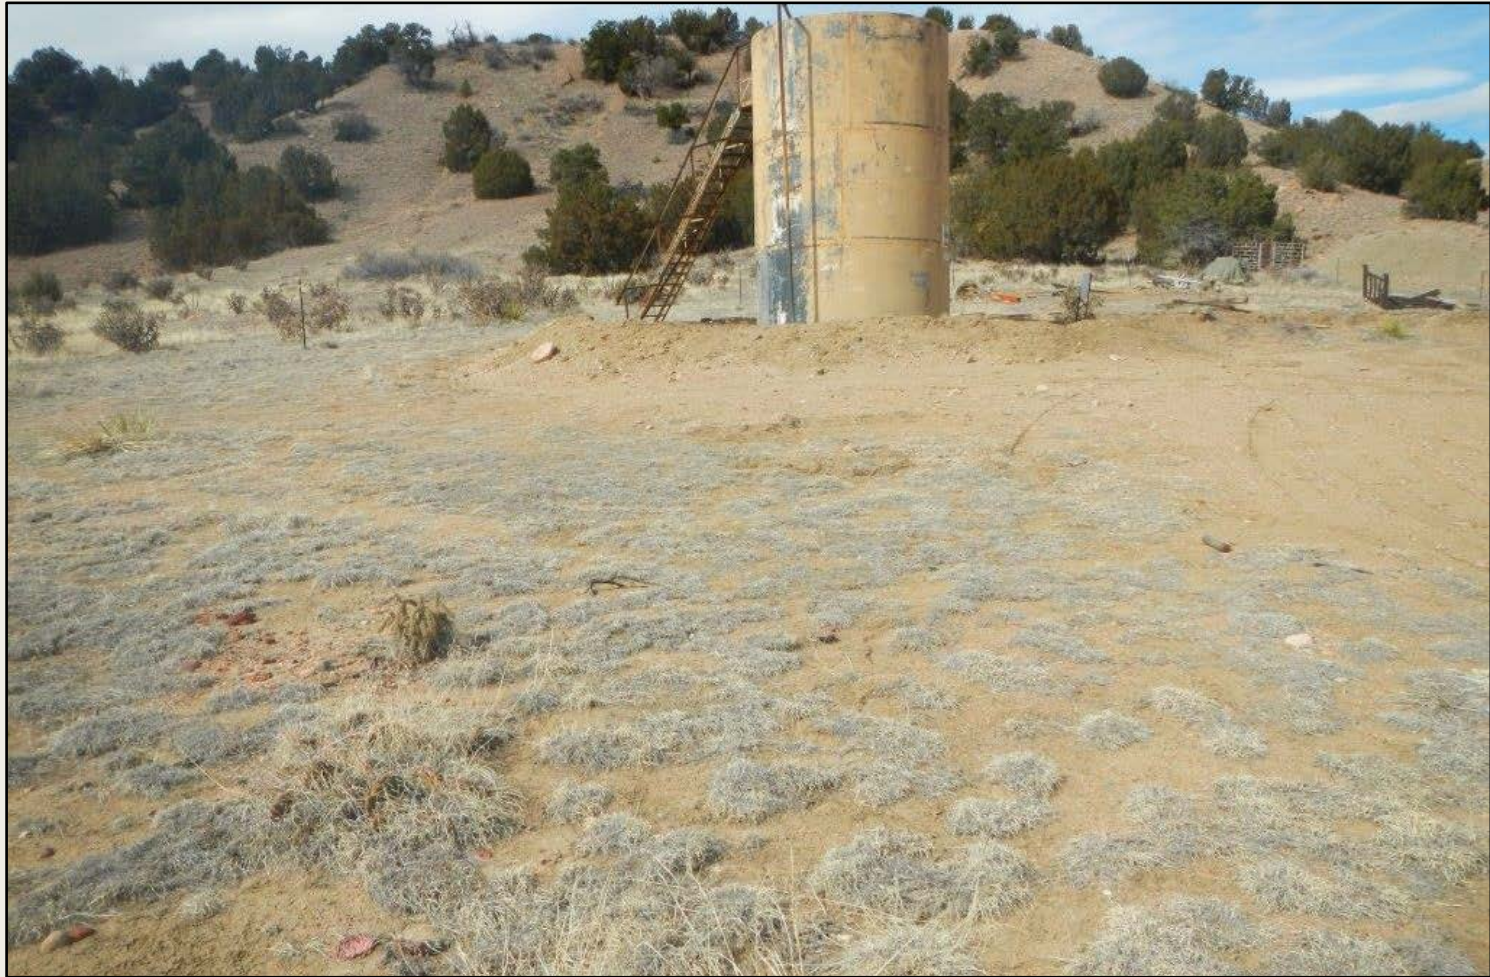
Photo 2. View of the western project area from the southern corner facing northwestward. Revegetation is progressing within portions of the interim reclamation areas.

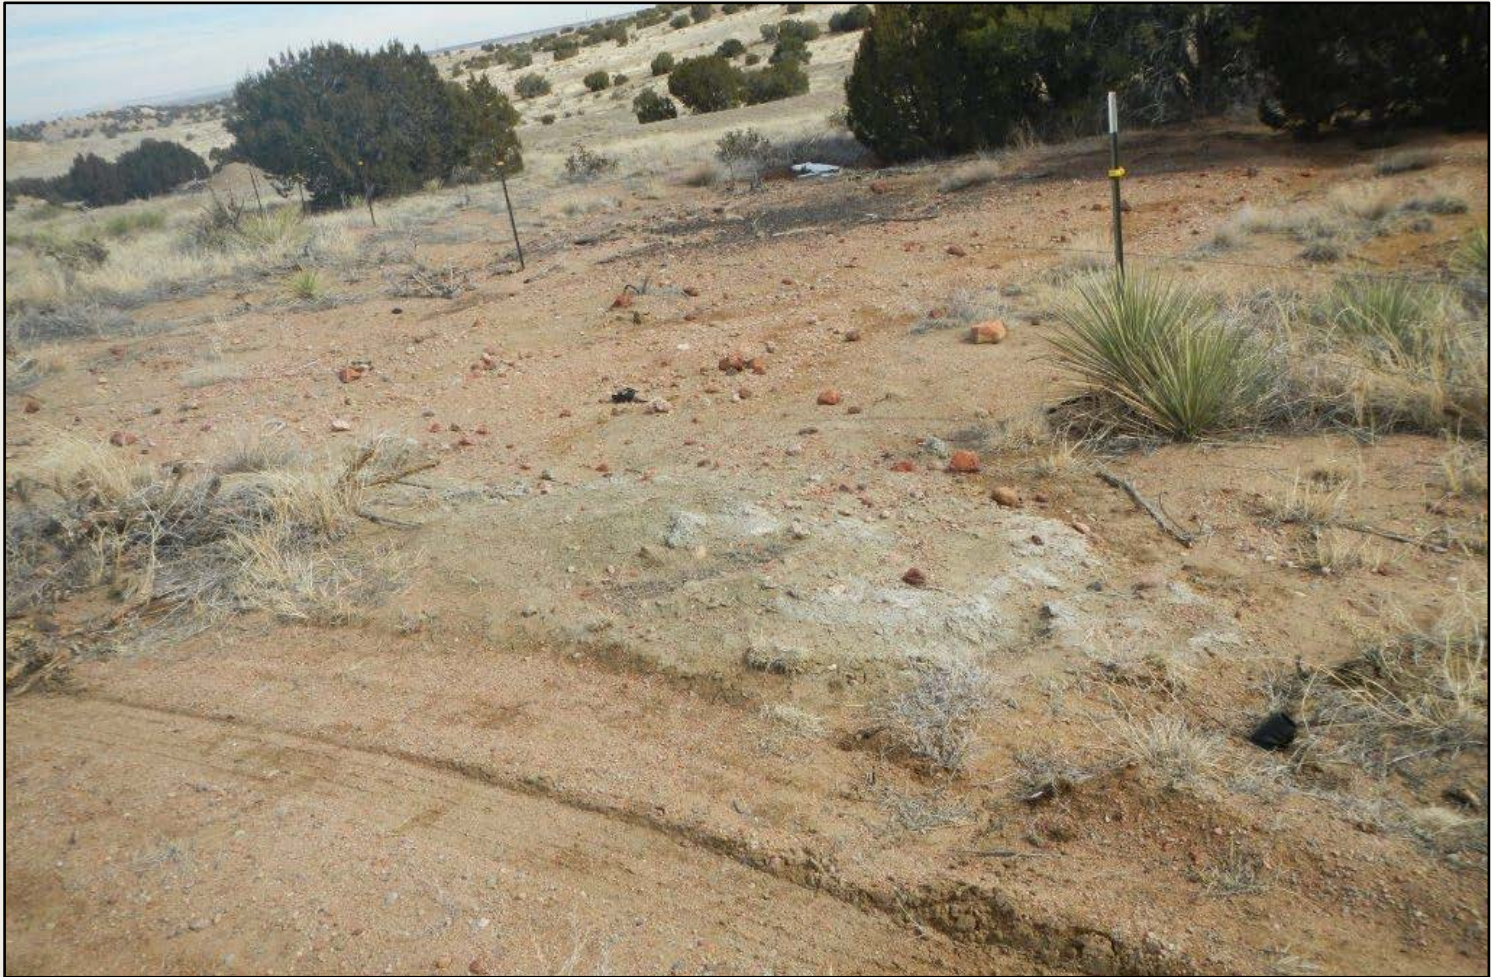
Photo 3. View of area in the southeastern project area where stormwater erosion is resulting in erosional scouring and downcutting.

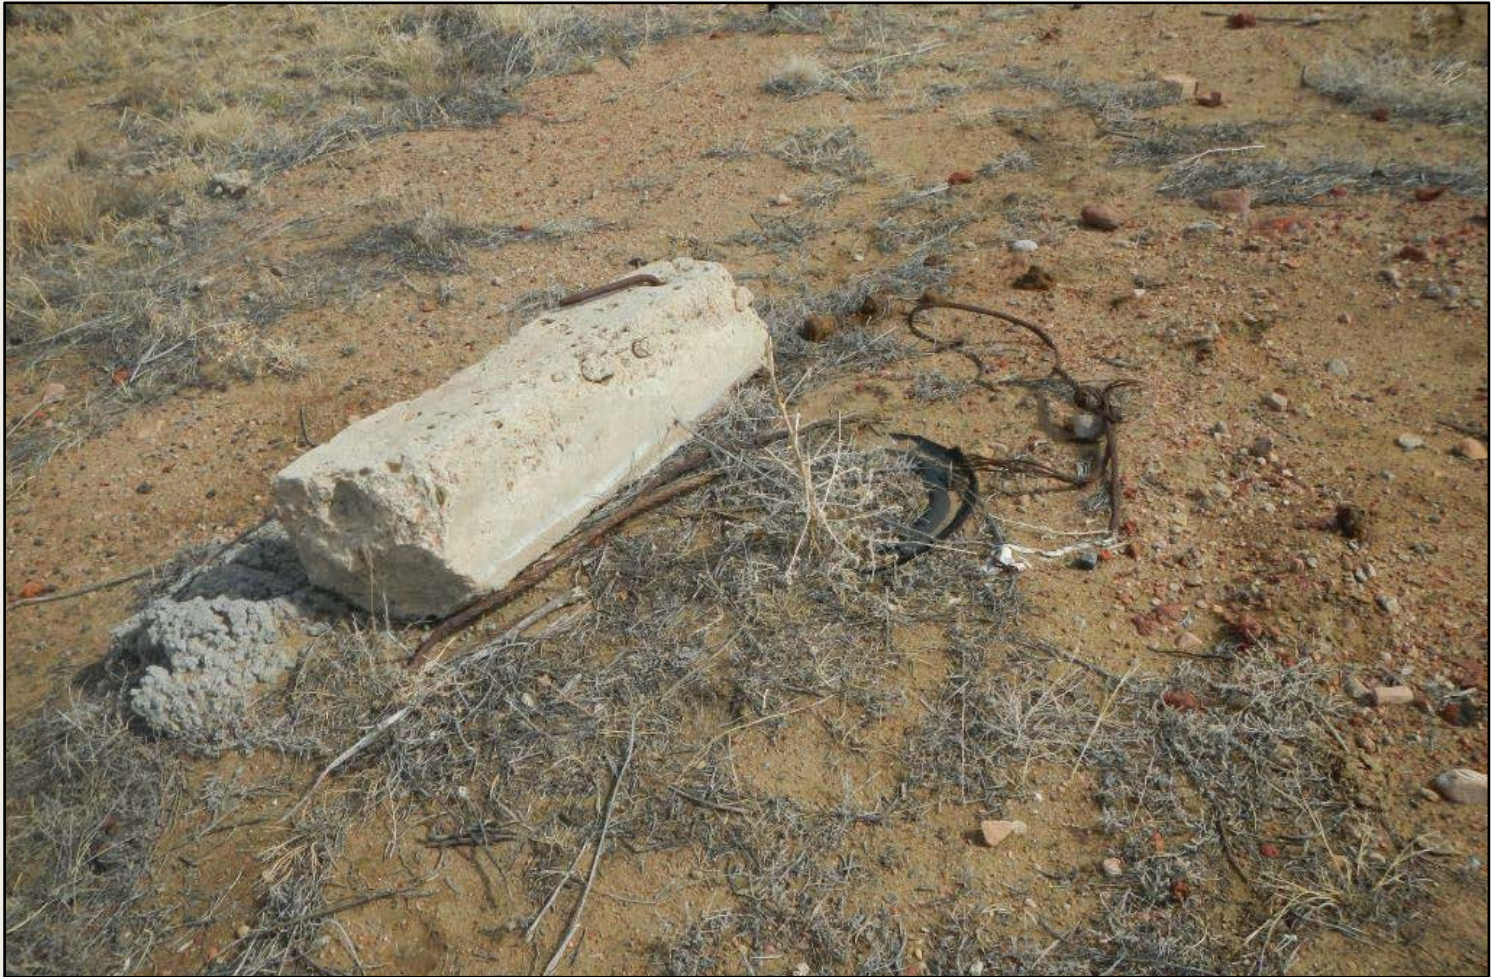
Photo 4. View of debris on the well pad.
