Construction and Stormwater Inspection

March 12, 2019

Location ID: 462850

Inspection Photos
Location Name: FLASCHENRIEM PAD
Location ID: 462850

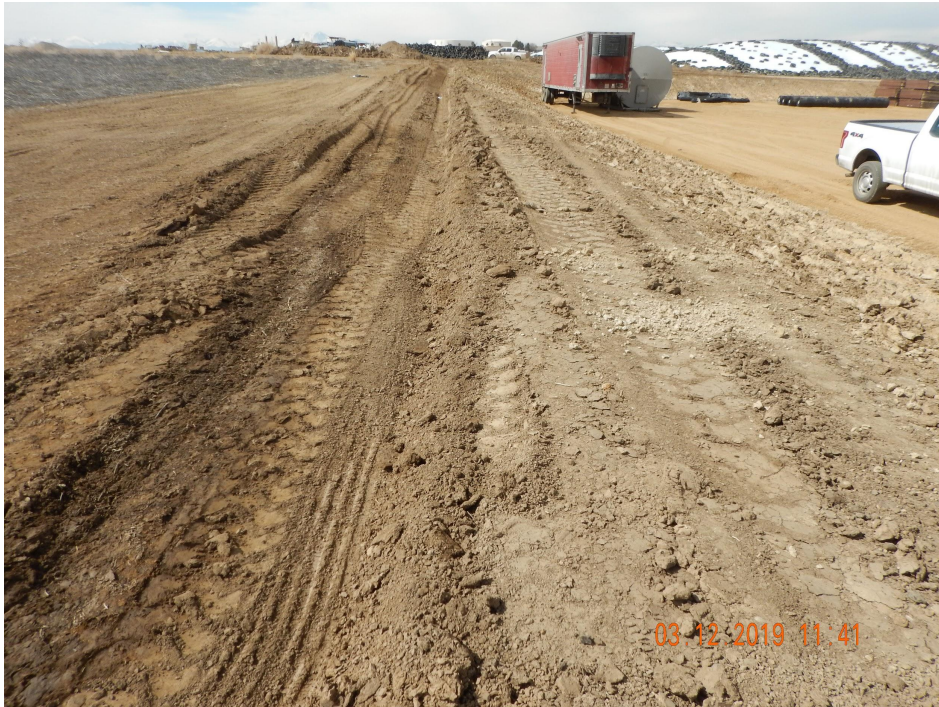
Photo 1. Photo taken from the entrance of the Location, facing West. Photo illustrates a ditch and berm BMP to control run-on onto Location. Ditch does not appear to be installed to a sufficient depth along portions of the perimeter and the berm BMP has been left unconsolidated. An unconsolidated berm BMP is not a proper functioning BMP. Most of the adjacent, uphill land has no vegetation which will likely contribute to increase run-on potential. Cut slopes were tracked in and further stabilization (hydromulch) is planned.

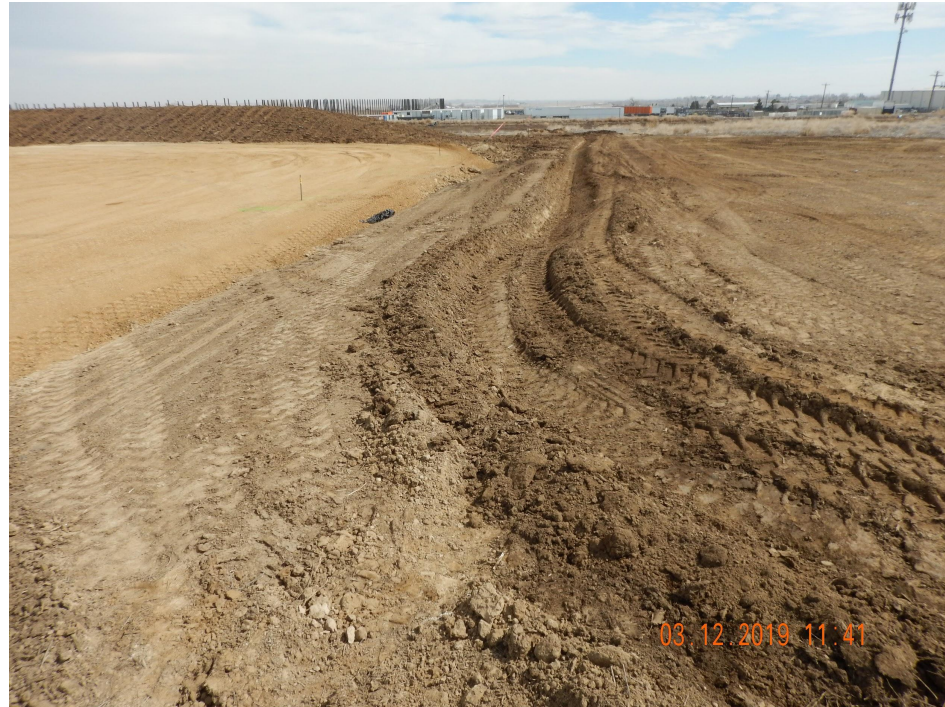
Photo 2. Photo taken from the entrance of the Location, facing East. See comments under Photo 1.

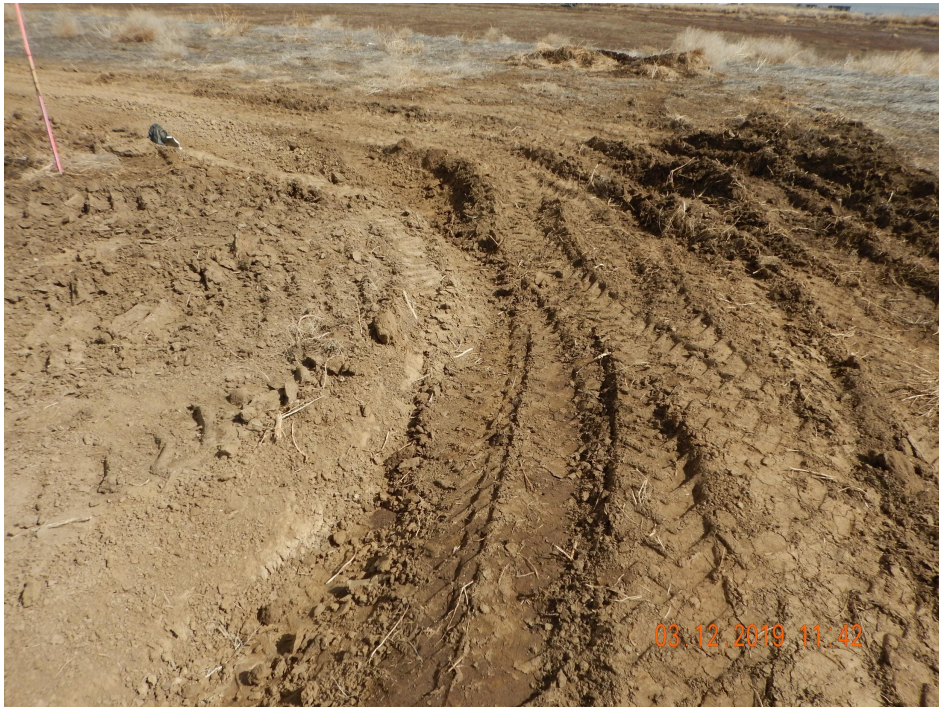
Photo 3. Photo taken from the southeastern perimeter of Location, facing East. Photo illustrates a ditch and berm BMP that has not been installed with good engineering practices.

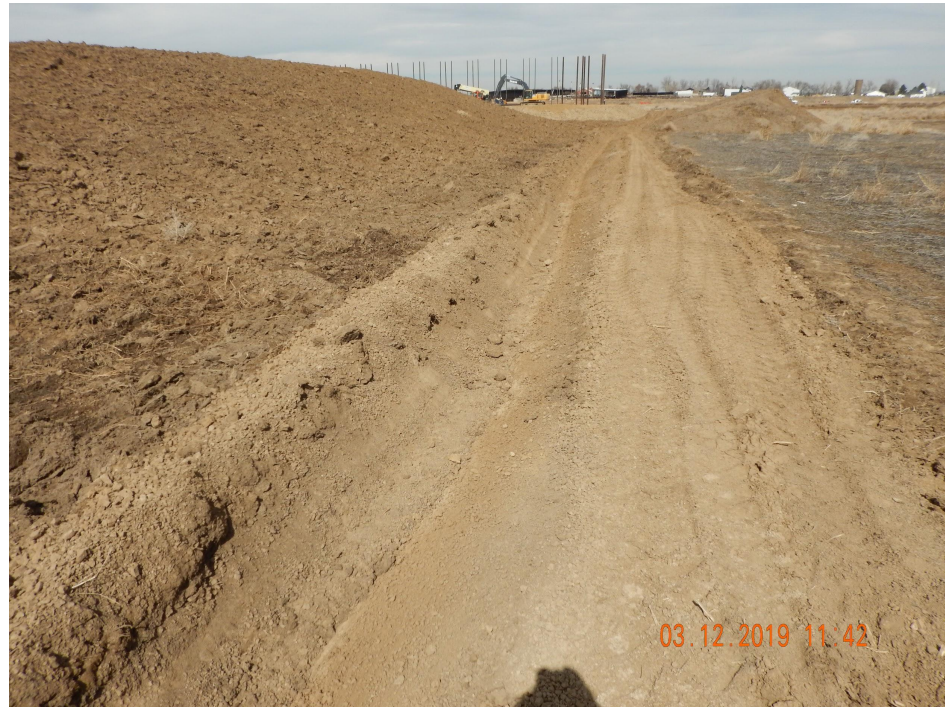
Photo 4. Photo taken from the southeastern perimeter of Location, facing North. Photo illustrates a sufficient ditch but Operator should consider re-installing the berm, as it doesn't appear to be constructed to a sufficient height.

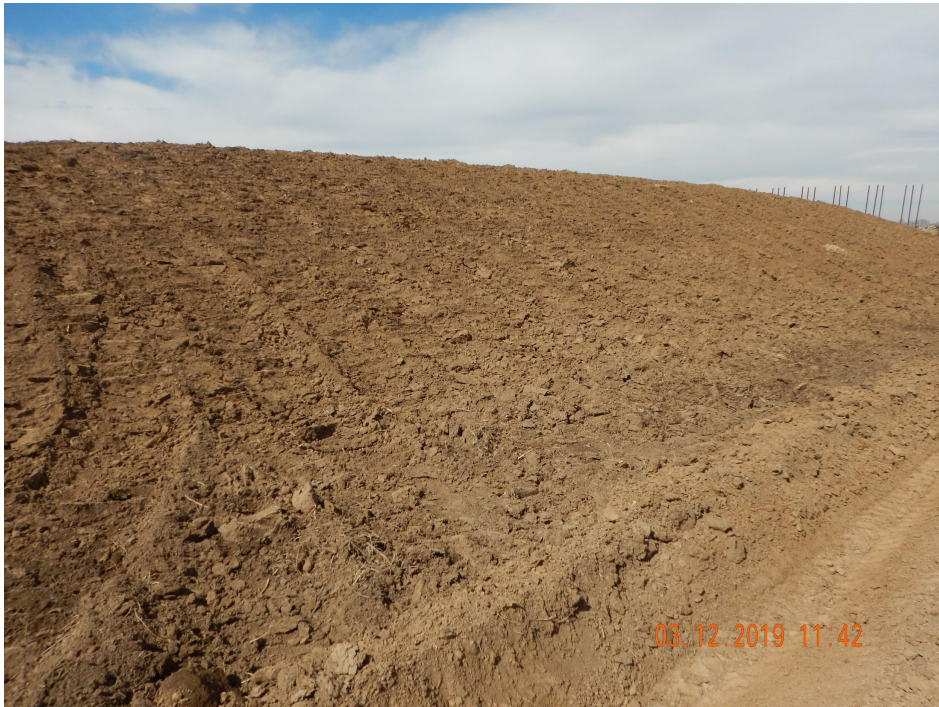
Photo 5. Photo taken from the southeastern perimeter of Location, facing North. Photo illustrates the topsoil stockpile that has been temporarily stabilized with equipment tracking.

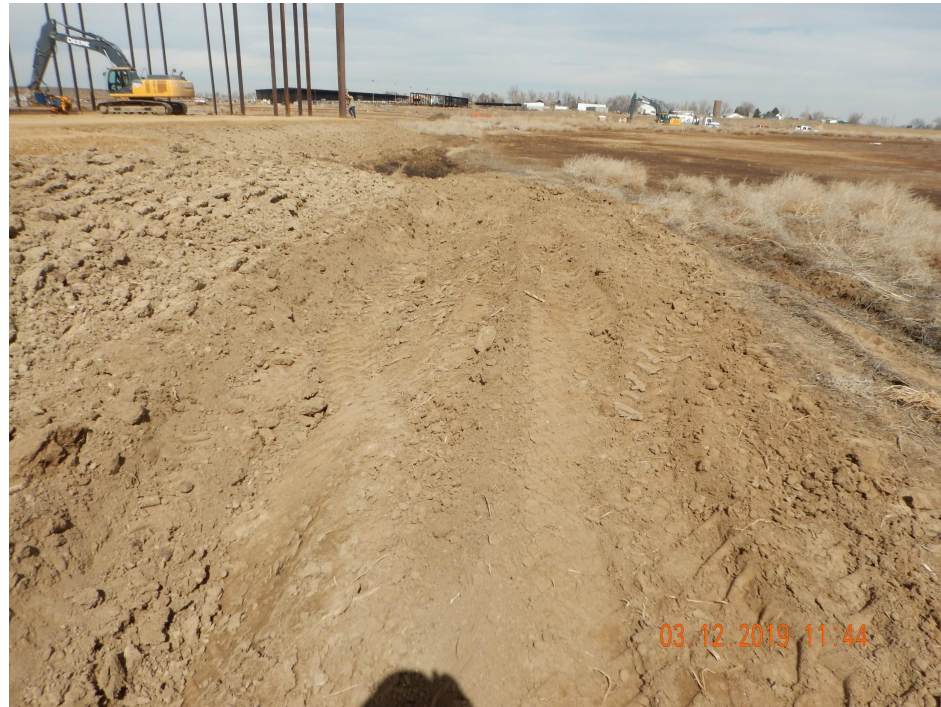
Photo 6. Photo taken from the eastern perimeter of Location, facing North. Photo illustrates a ditch and berm BMP that has not been installed with good engineering practices.

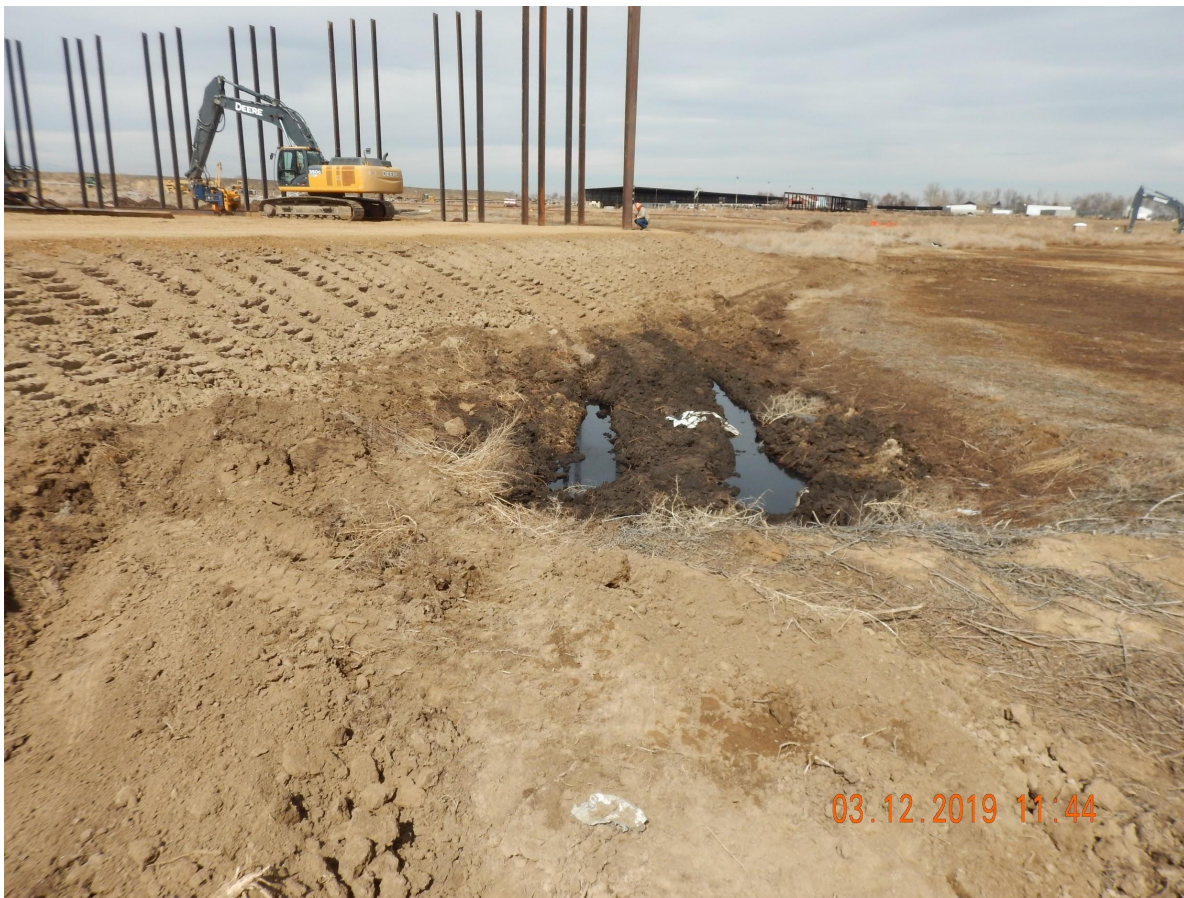
Photo 7. Photo taken from the northeastern perimeter of Location, facing North. Operator has failed to install a perimeter BMP around this portion of the Location during construction activities.

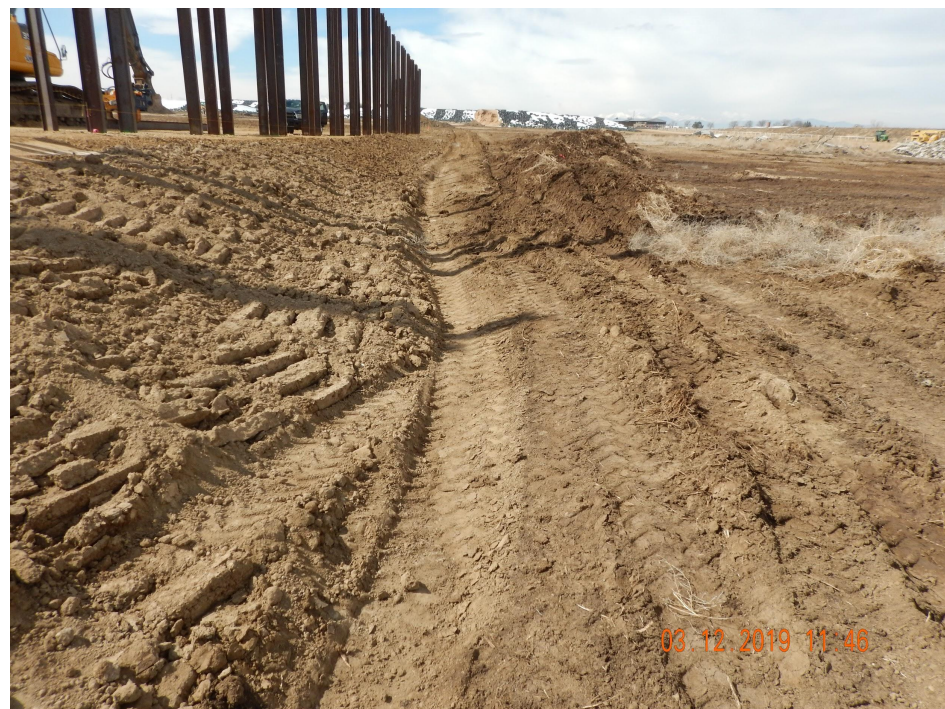
Photo 8. Photo taken from the northeastern perimeter of Location, facing West. See comments under Photo 4 regarding the berm BMP.

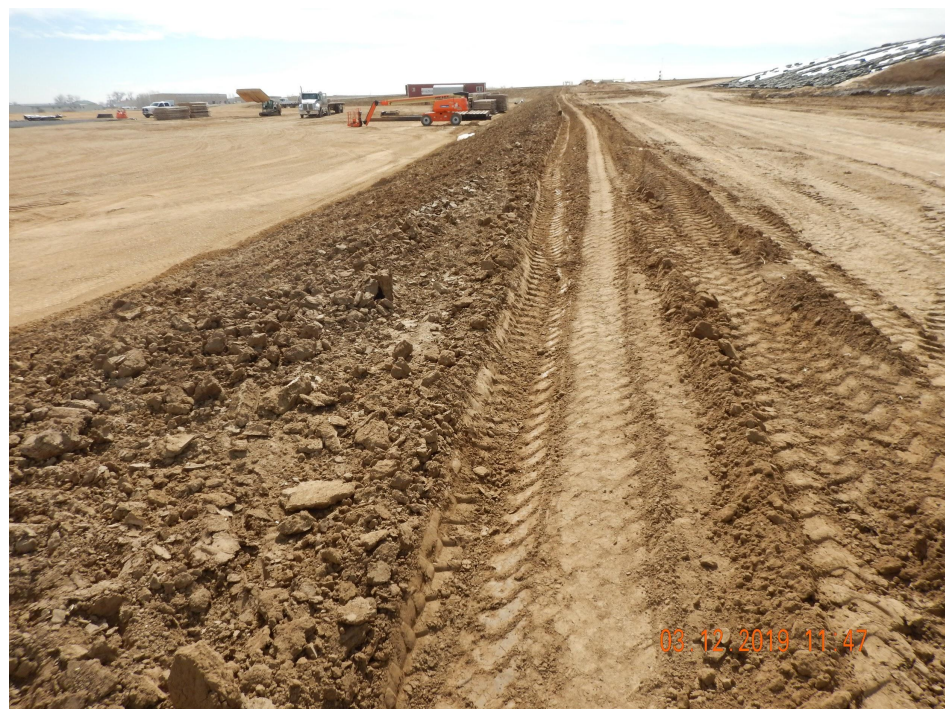
Photo 9. Photo taken from the northwestern perimeter of Location, facing South. See comments under Photo 1 and see comments under Photo 4 regarding the berm BMP.

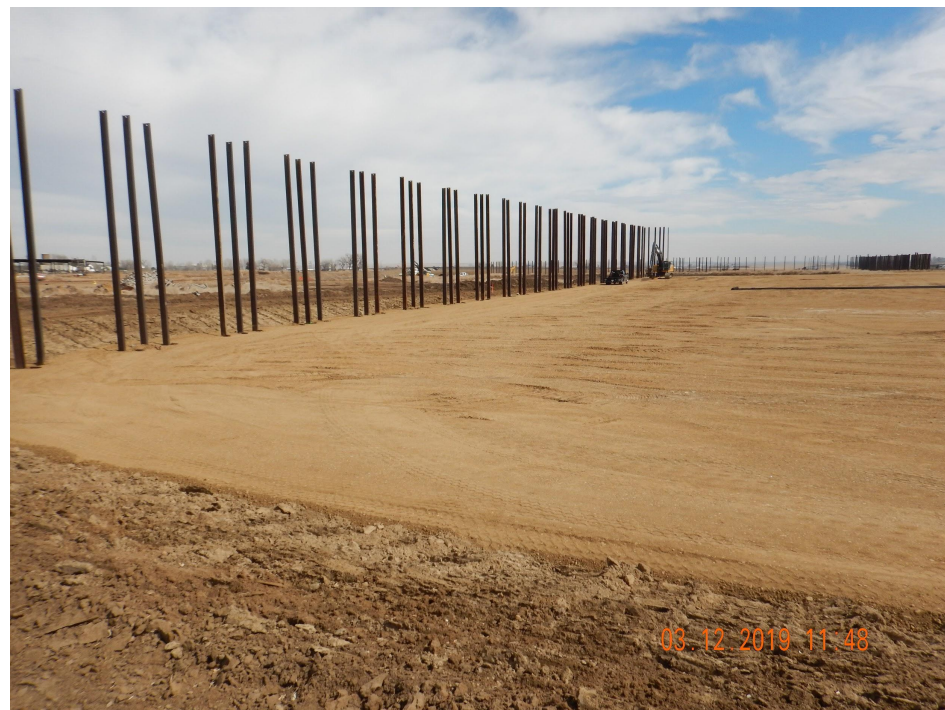
Photo 10. Photo taken from the northwestern perimeter of Location, facing Northeast. Photo illustrates sound wall installation and it appears the well pad has been stabilized with gravel.

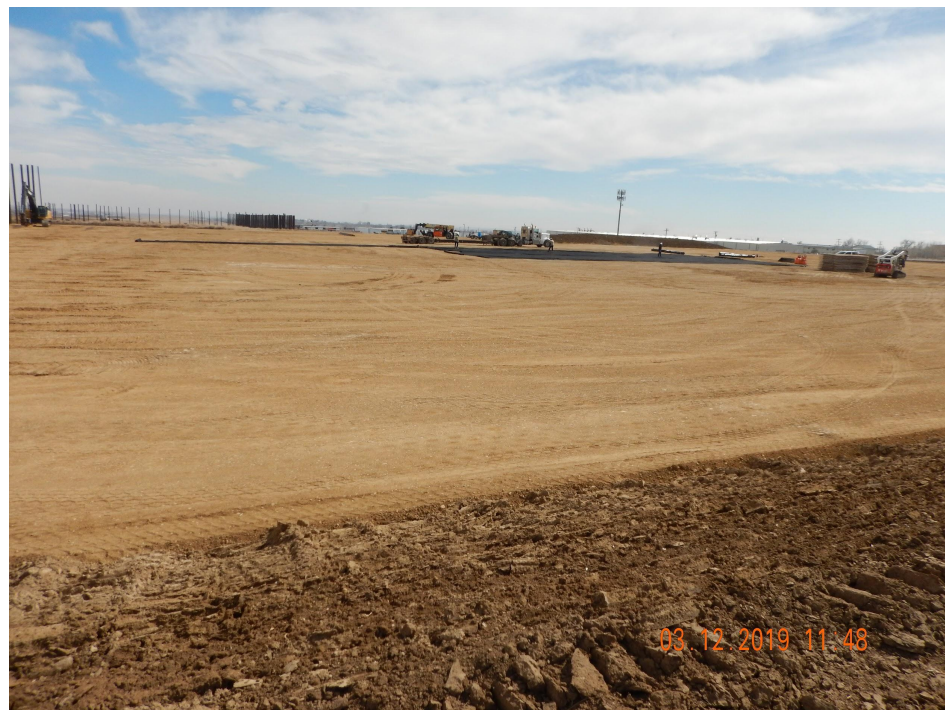
Photo 11. Photo taken from the northwestern perimeter of Location, facing East. See comments under Photo 10.

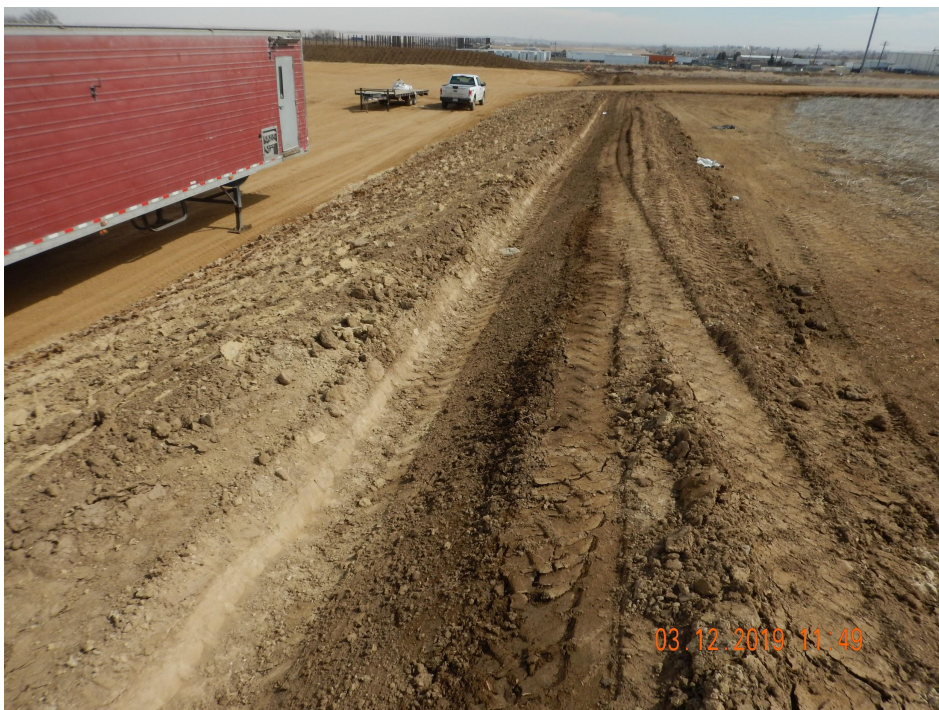
Photo 12. Photo taken from the southwestern perimeter of Location, facing East. See comments under Photo 1.

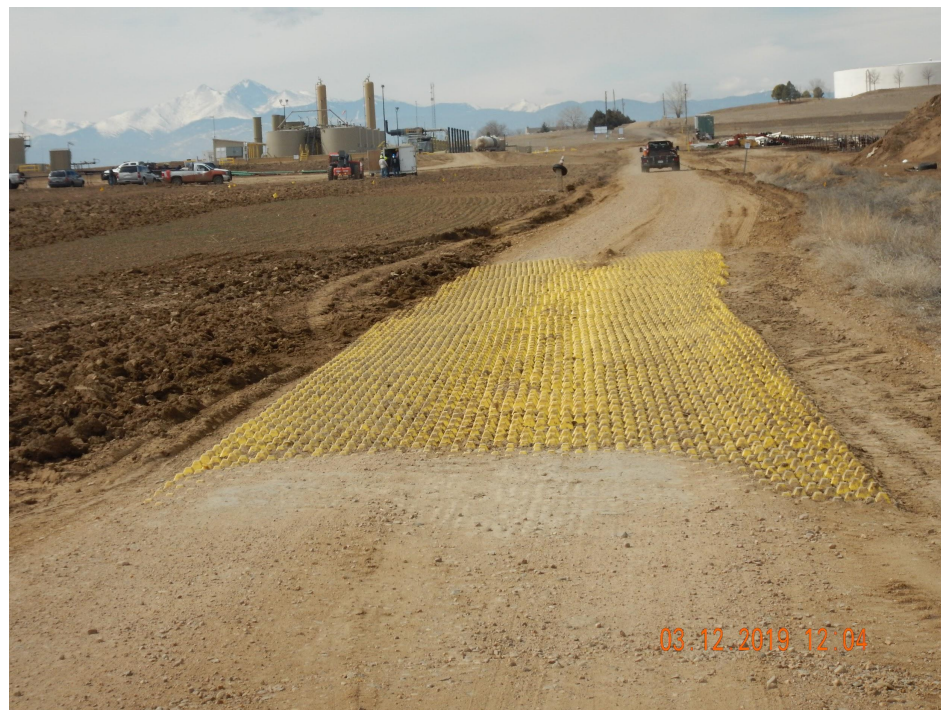
Photo 13. Photo taken along a portion of the access road, facing West. Photo illustrate a vehicle tracking device BMP that appears to be in proper functioning condition at the time of this inspection.
