Inspection Photos

Operator: NOBLE ENERGY INC # 100322

Location ID: 460414

Inspection Doc. Number: 682504592

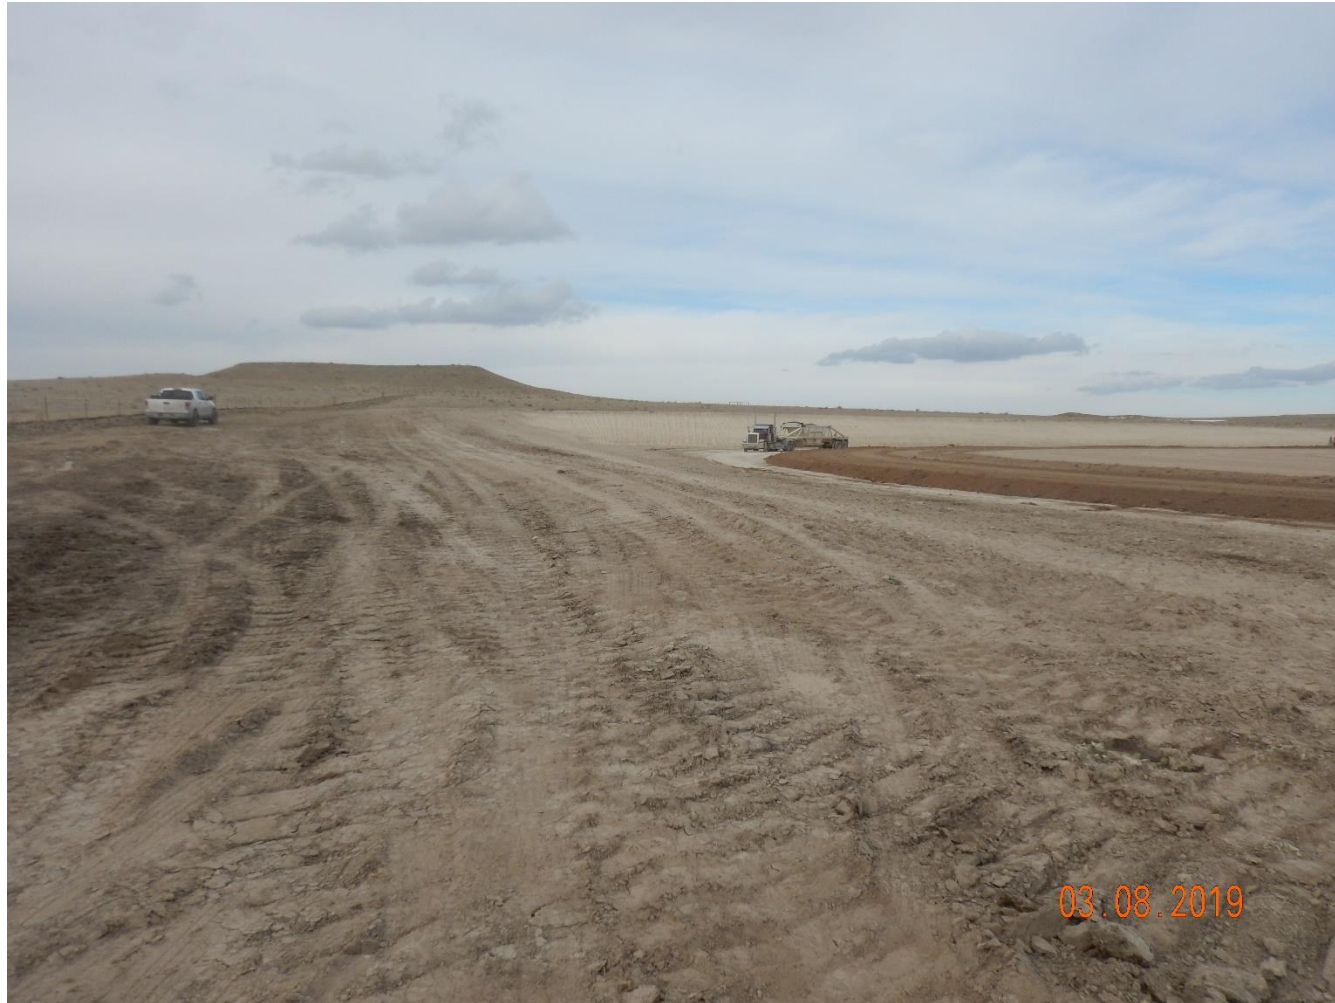
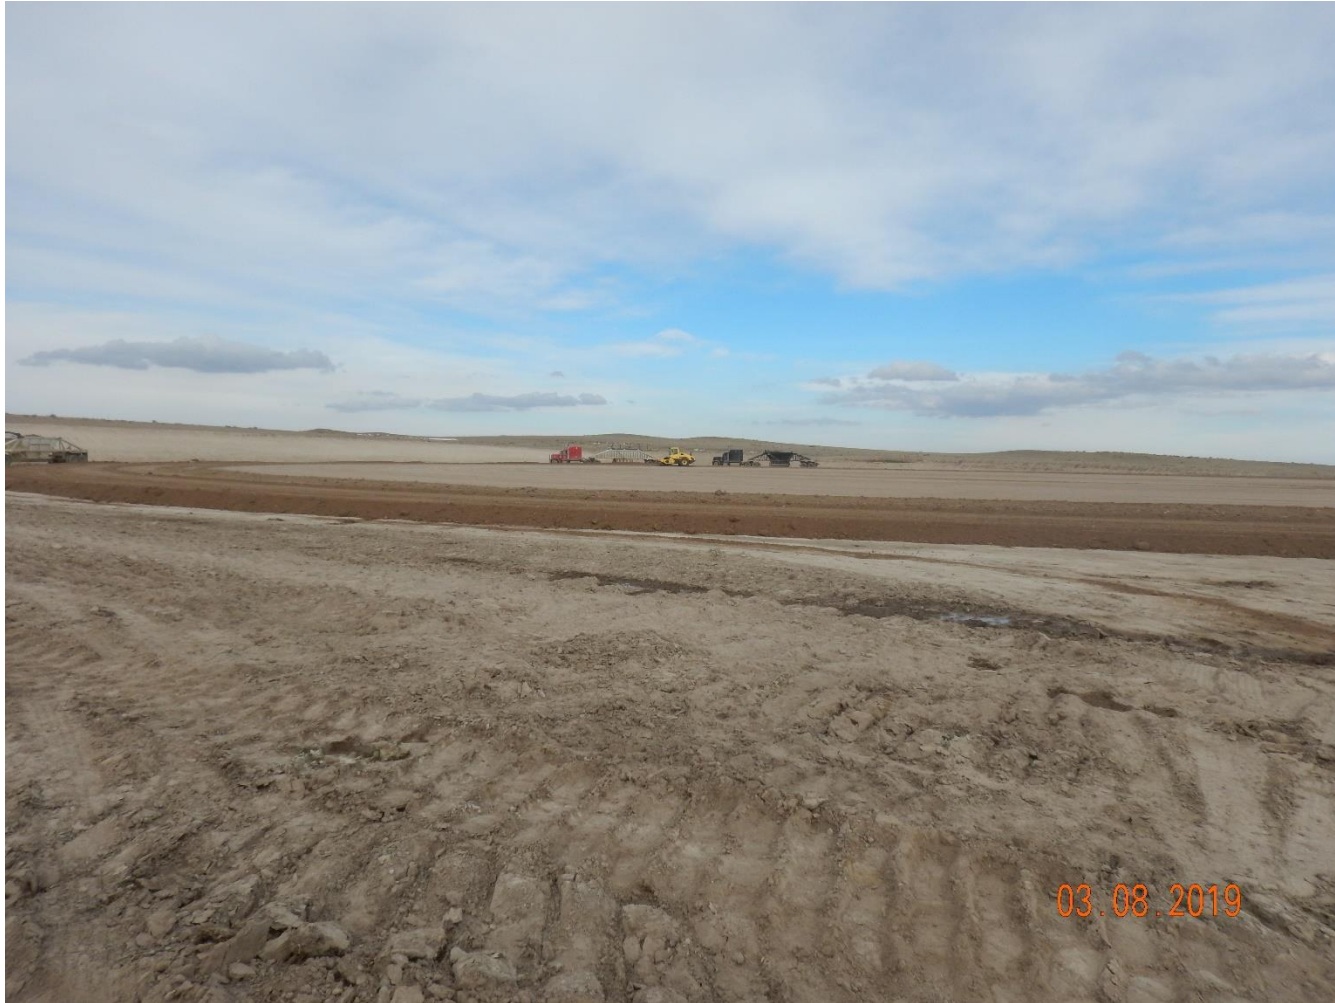
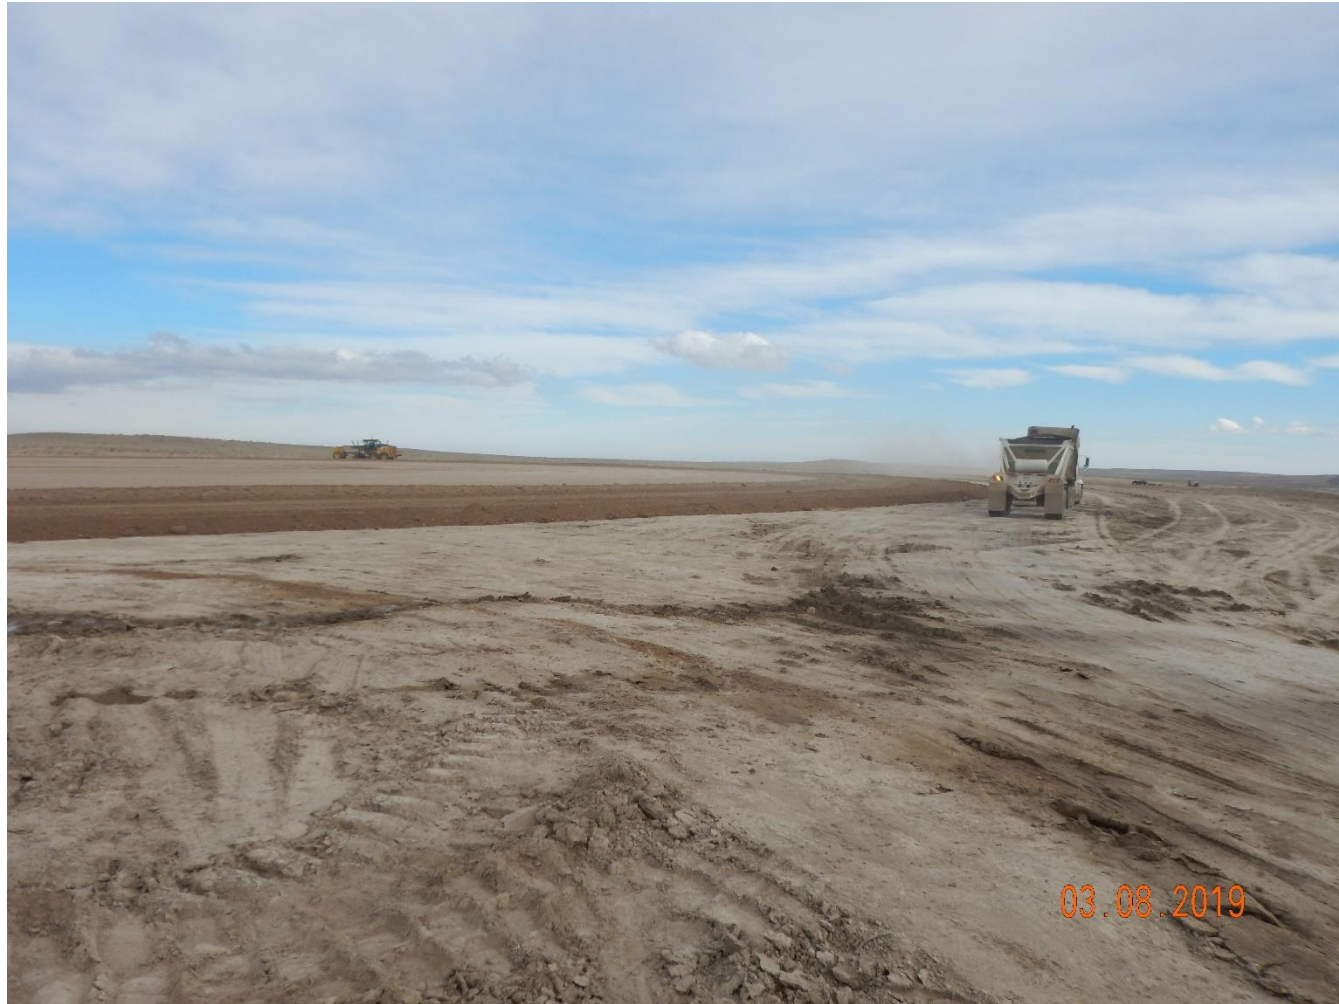
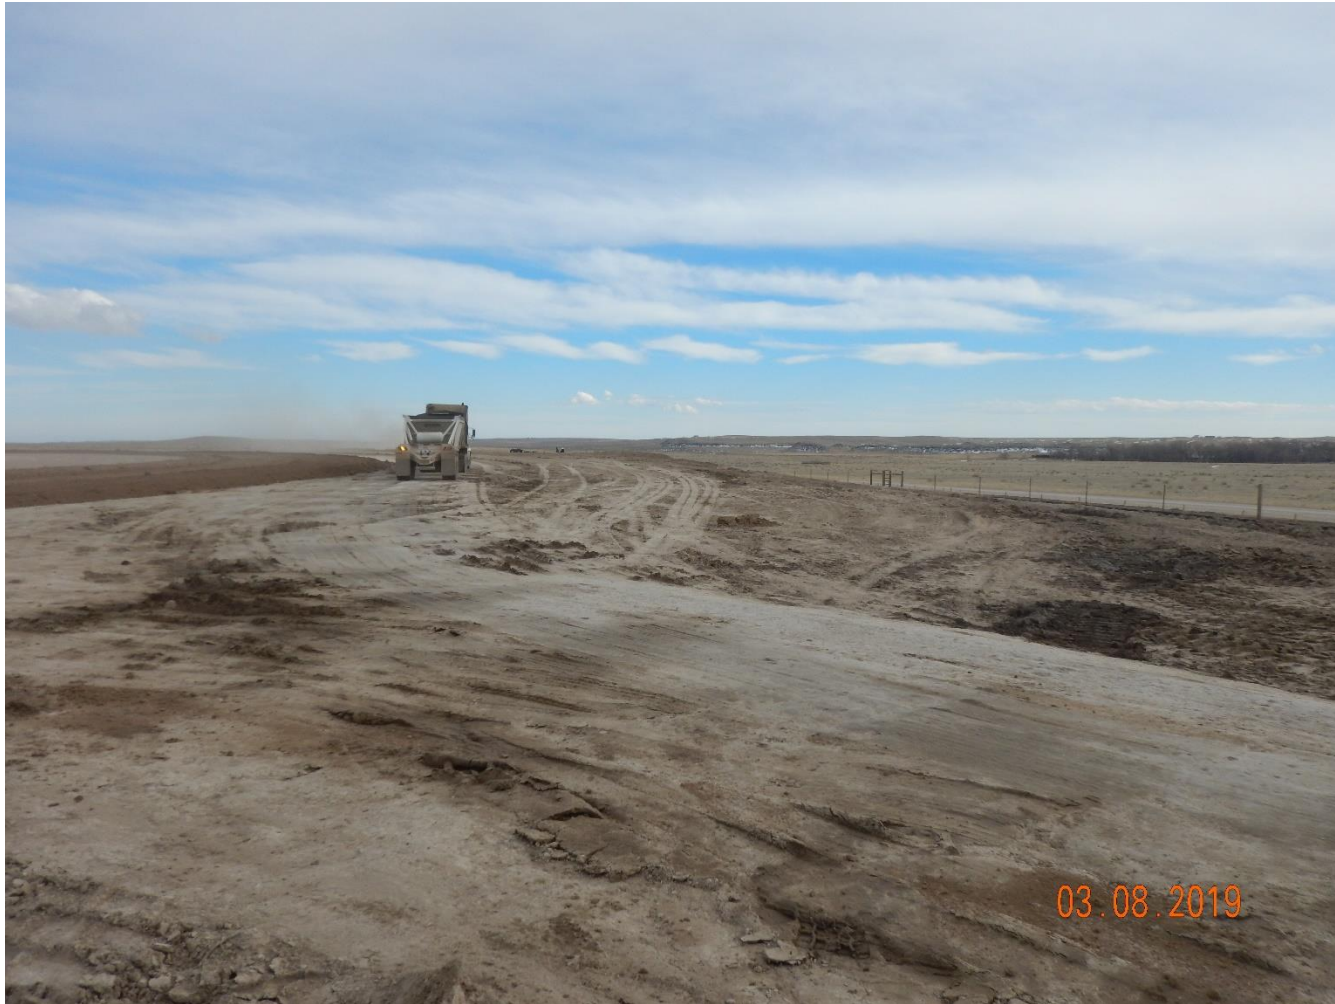
Photo 1: Photo taken from the southwest corner of the location facing north. Photos 1-4 provide an overview of the location from north, northeast, east to southeast. Construction in process.

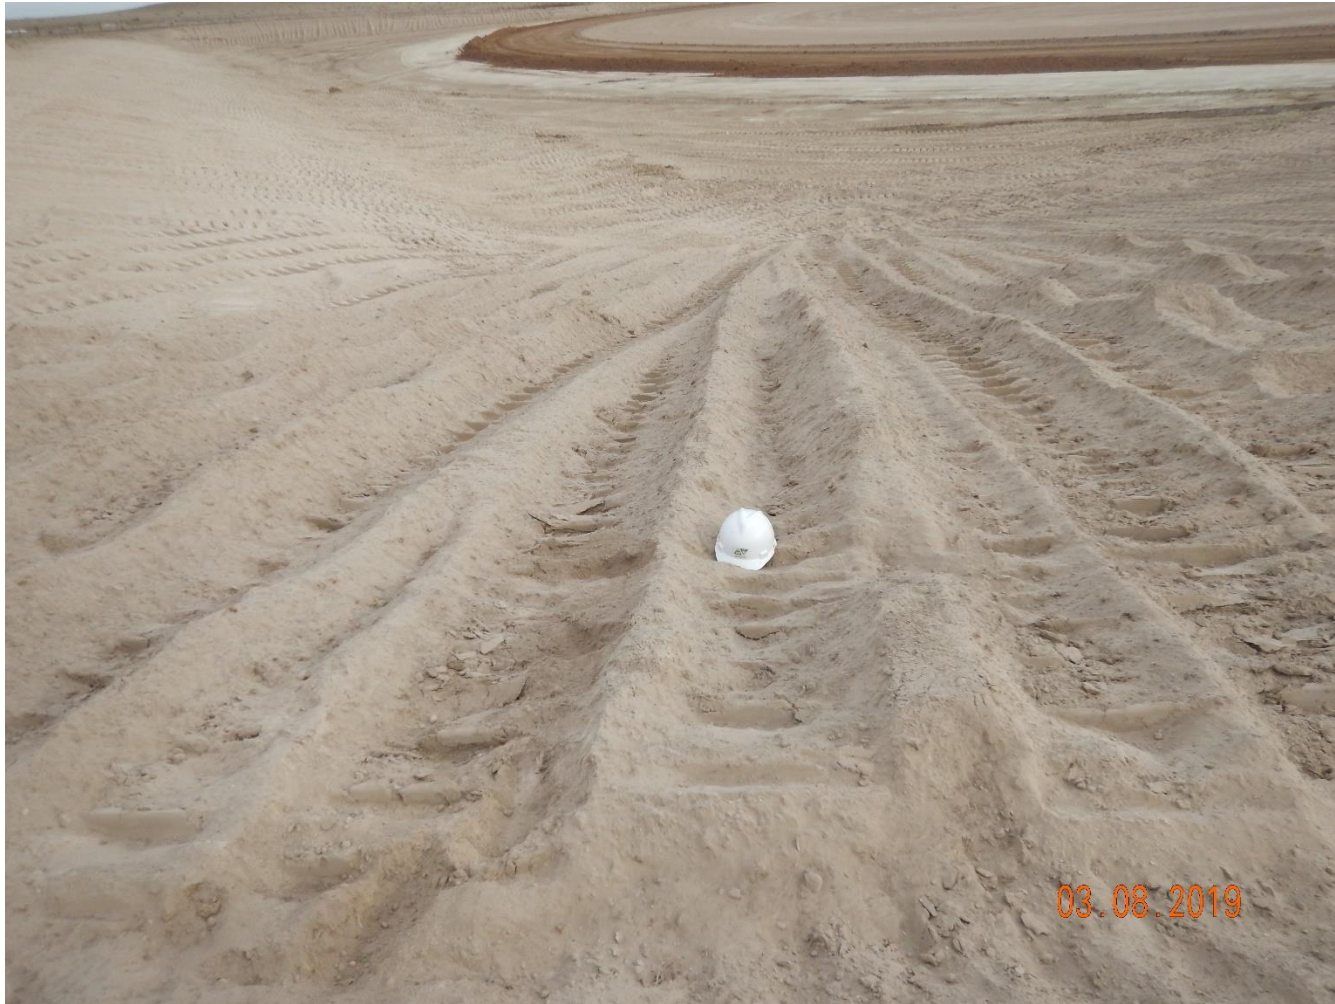
Photo 5: Photo taken from the northwest corner of the pad. Photo shows operator has implemented tracking along the cute slopes. Photo shows BMP has not been sufficiently installed. Soils remain loose material at risk to erosion degradation.

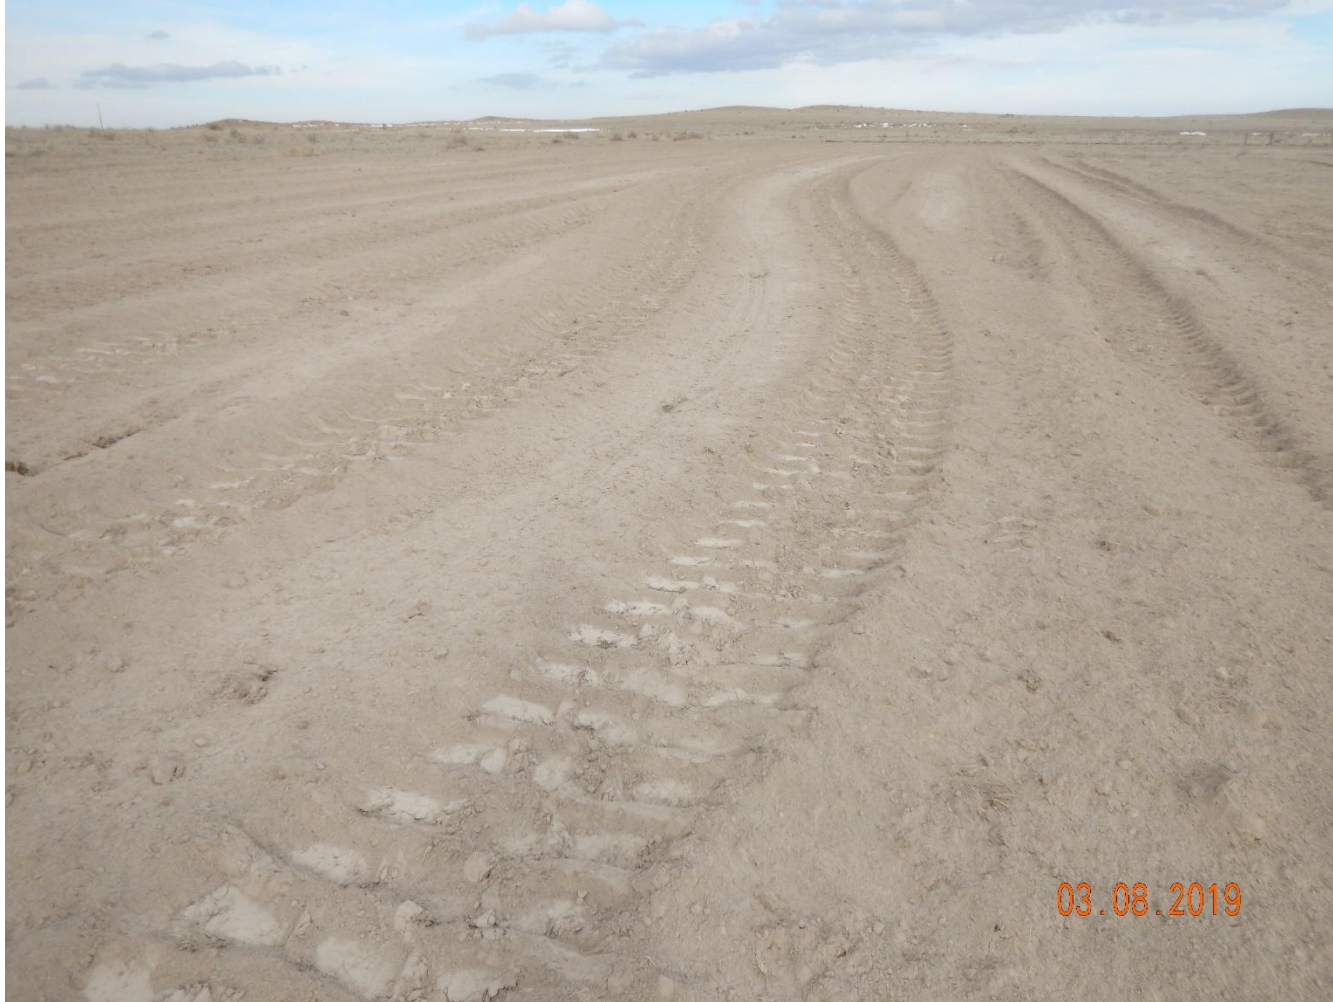
Photo 6: Photo taken from the north end of the location. Photo shows area where topsoil stockpile was stored. Operator appears to have removed topsoil stockpiles from the location.

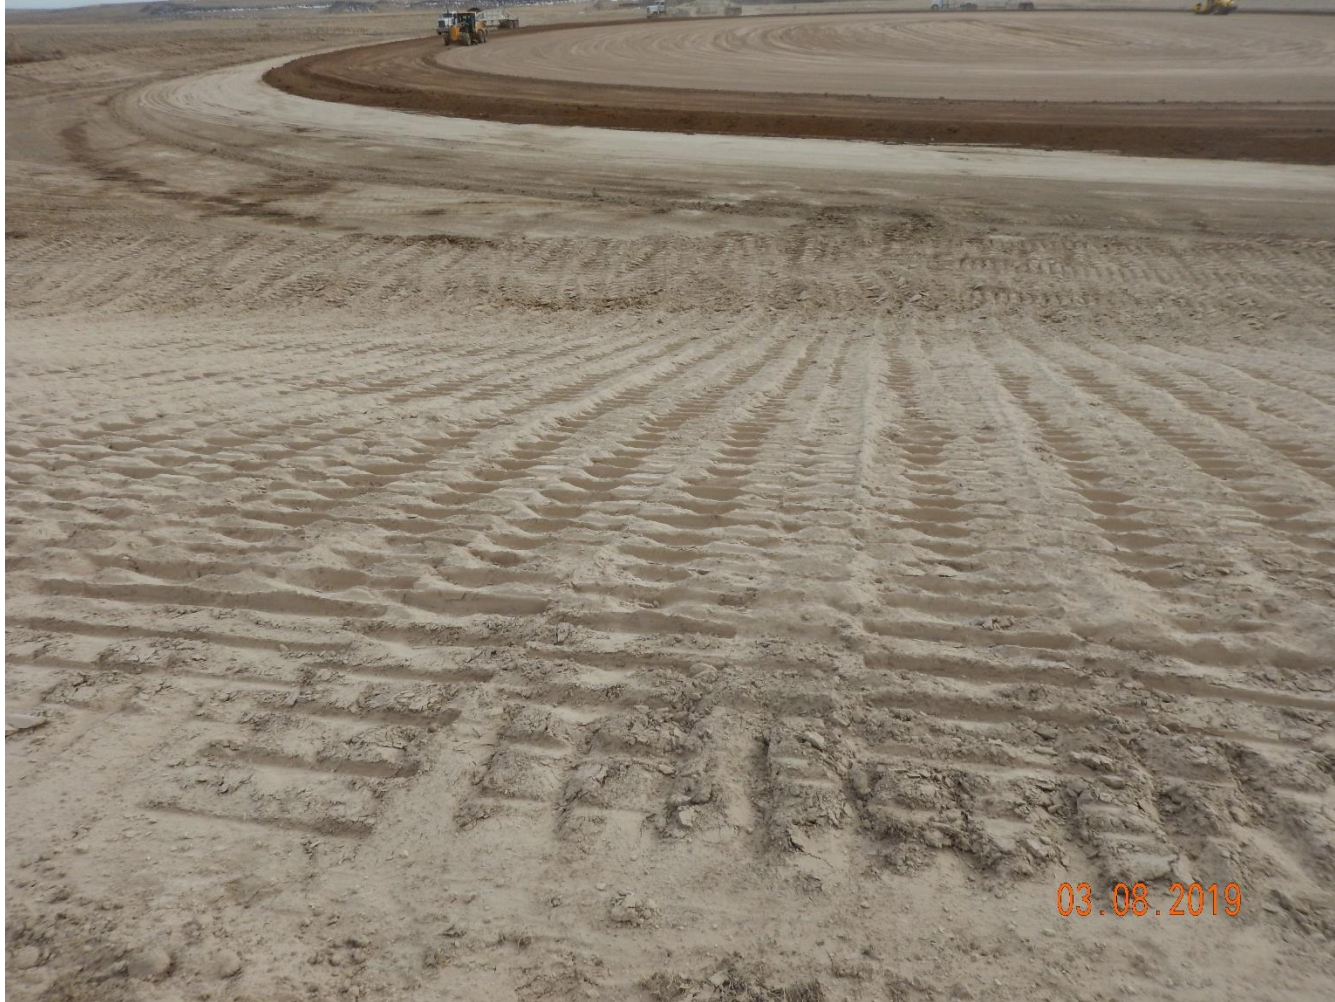
Photo 7: Photo taken from the cut slopes on the northeast corner of the pad. Photo shows areas where operator appears to have sufficiently tracked and stabilized the slopes.

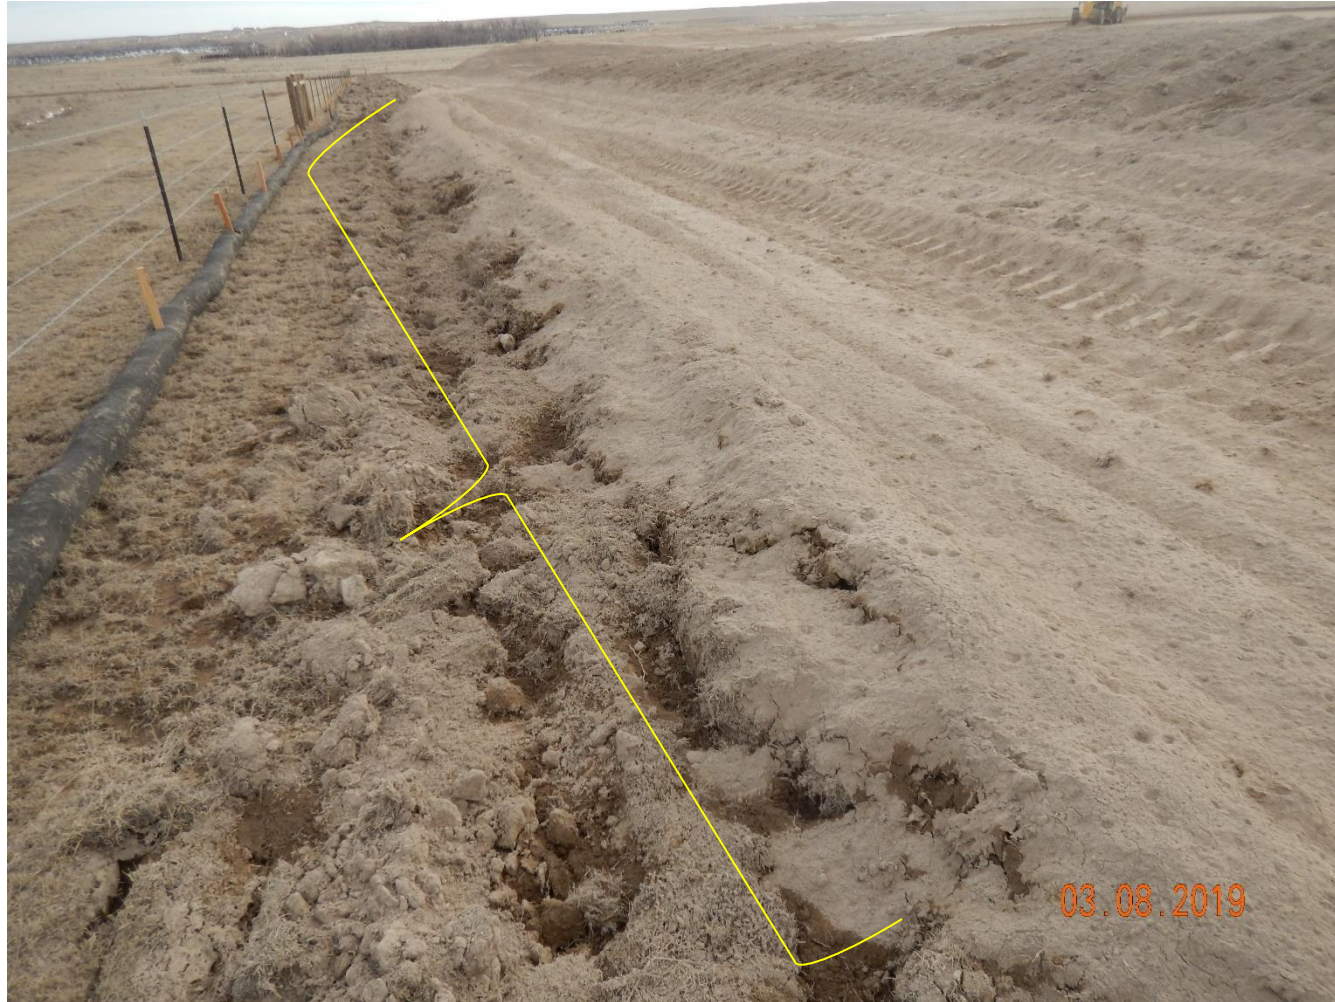
Photo 8: Photo taken from the east end of the location. Photo shows surface roughening (ripping) BMP has filled with sediment and is not longer in proper functioning condition.

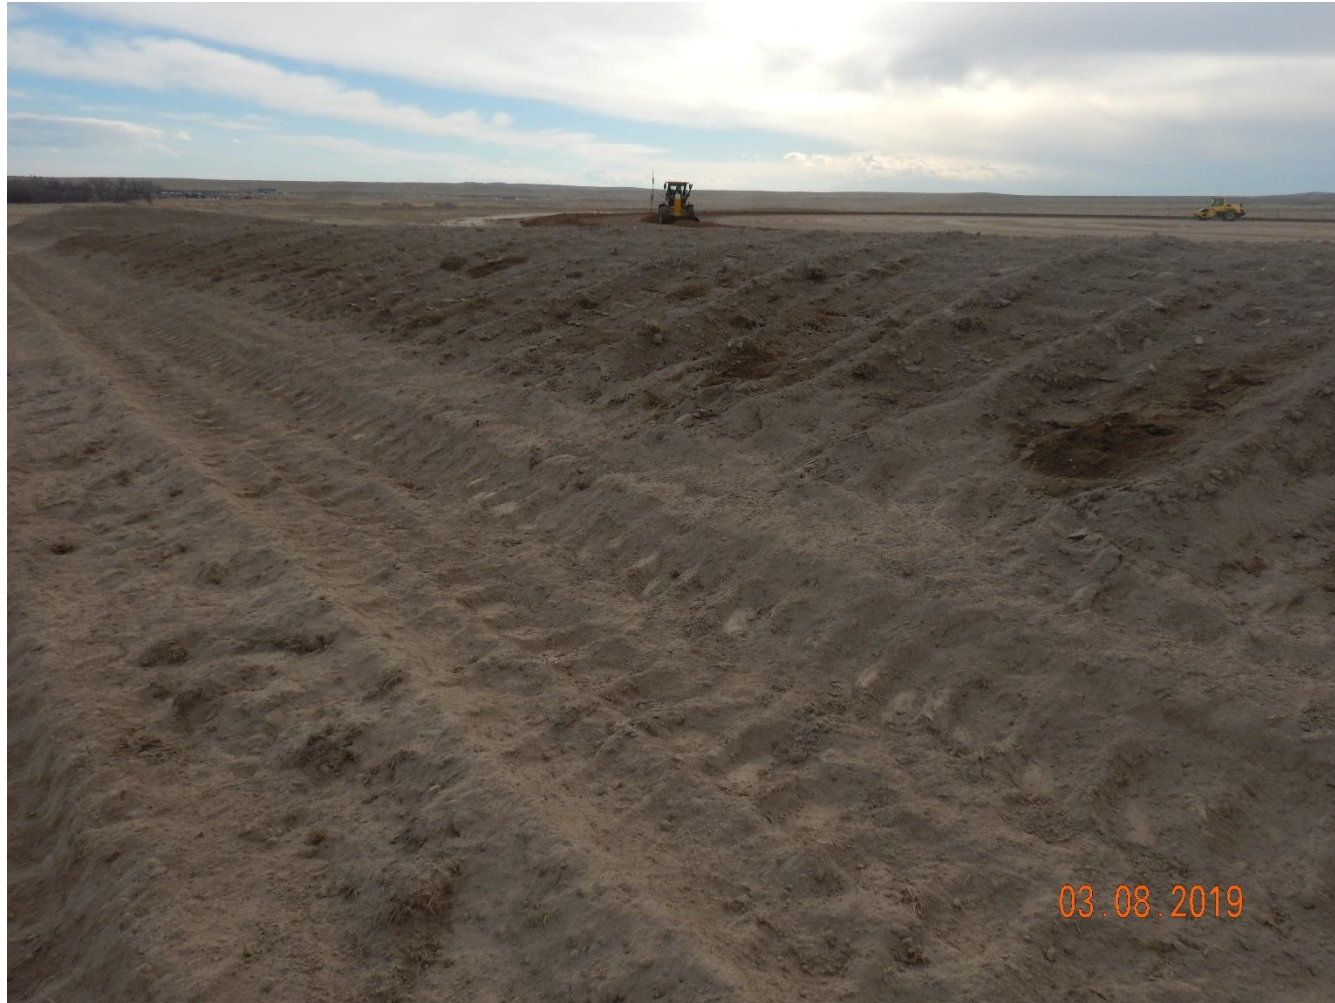
Photo 9: Photo taken from the east end of the location, facing southwest. Photo shows operator has implemented tracking along the slopes. Photo shows BMP has not been sufficiently installed. Soils remain loose material at risk to erosion degradation.

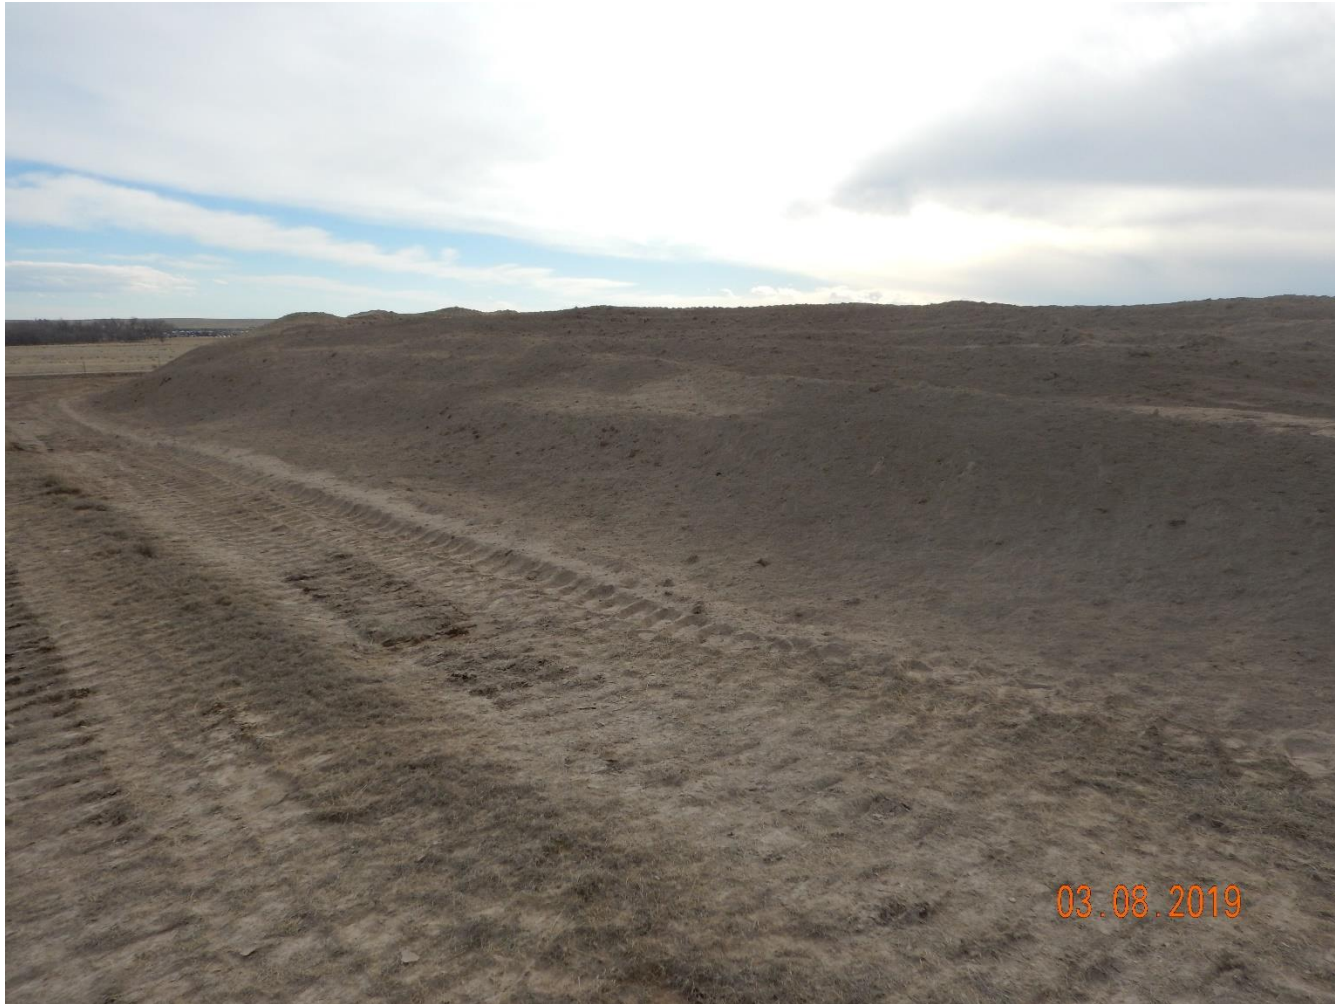
Photo 10: Photo taken from the east end of the location, facing southwest. Photo shows unstabilized soils on location at risk to erosion degradation.

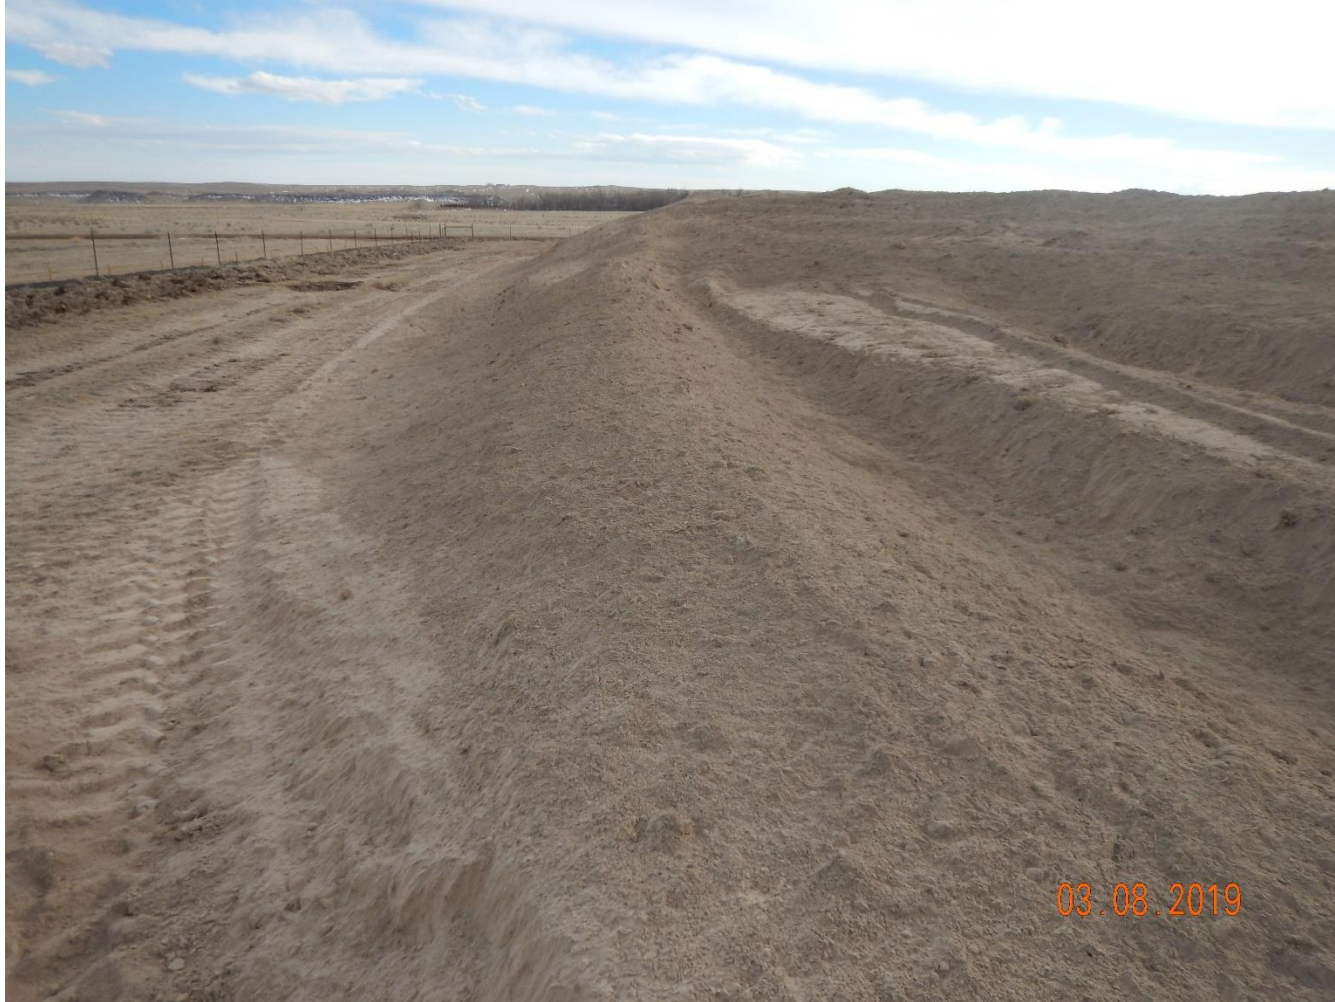
Photo 11: Photo taken from the east end of the location, facing south. Photo shows unstabilized soils on location at risk to erosion degradation.

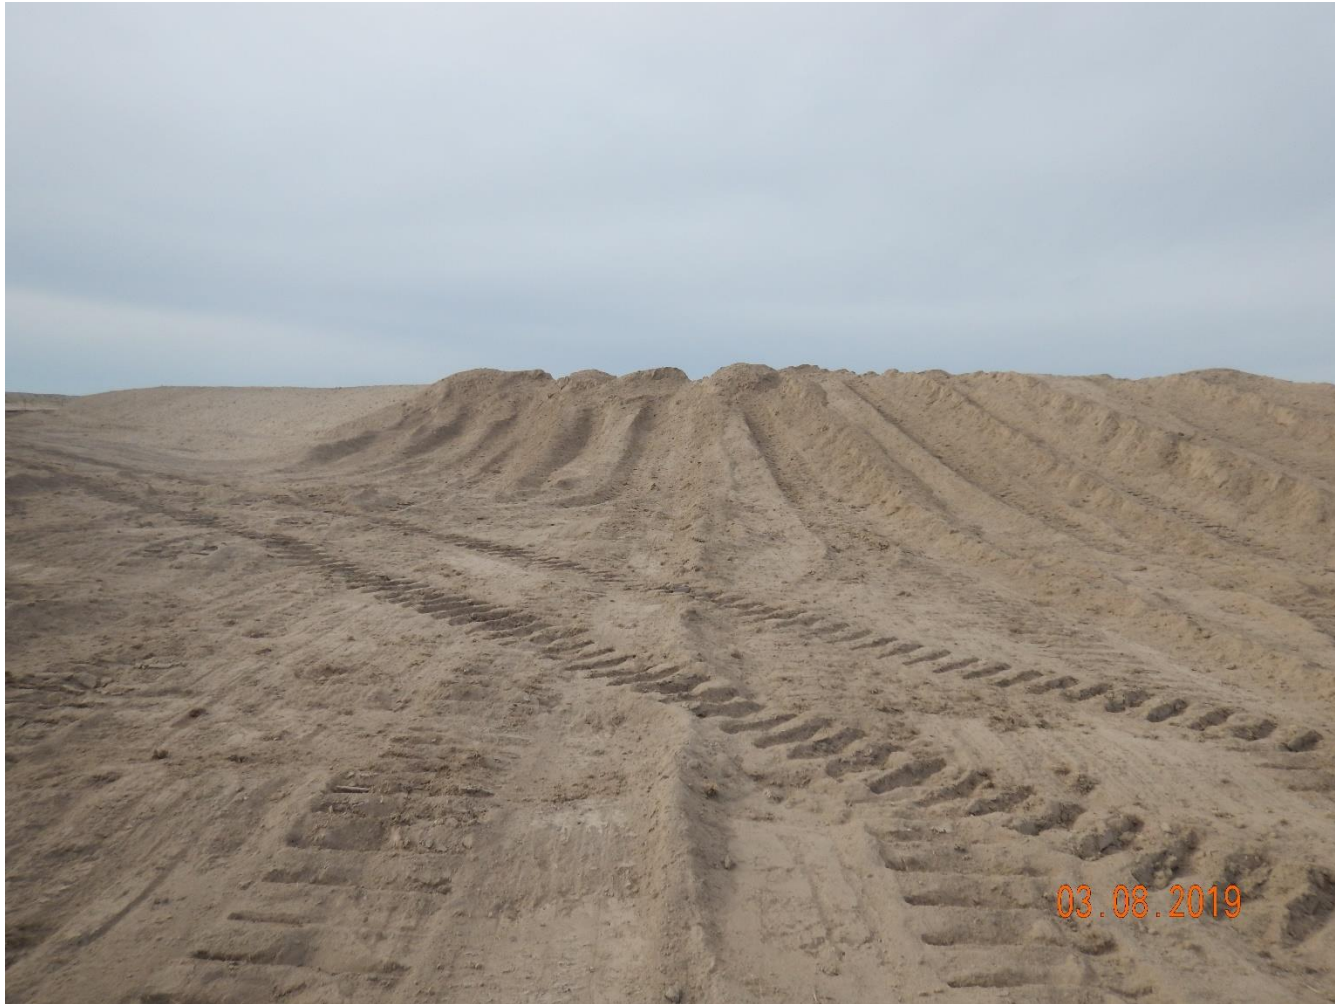
Photo 12: Photo taken from the south end of the location, facing north. Photo shows unstabilized soils on location at risk to erosion degradation

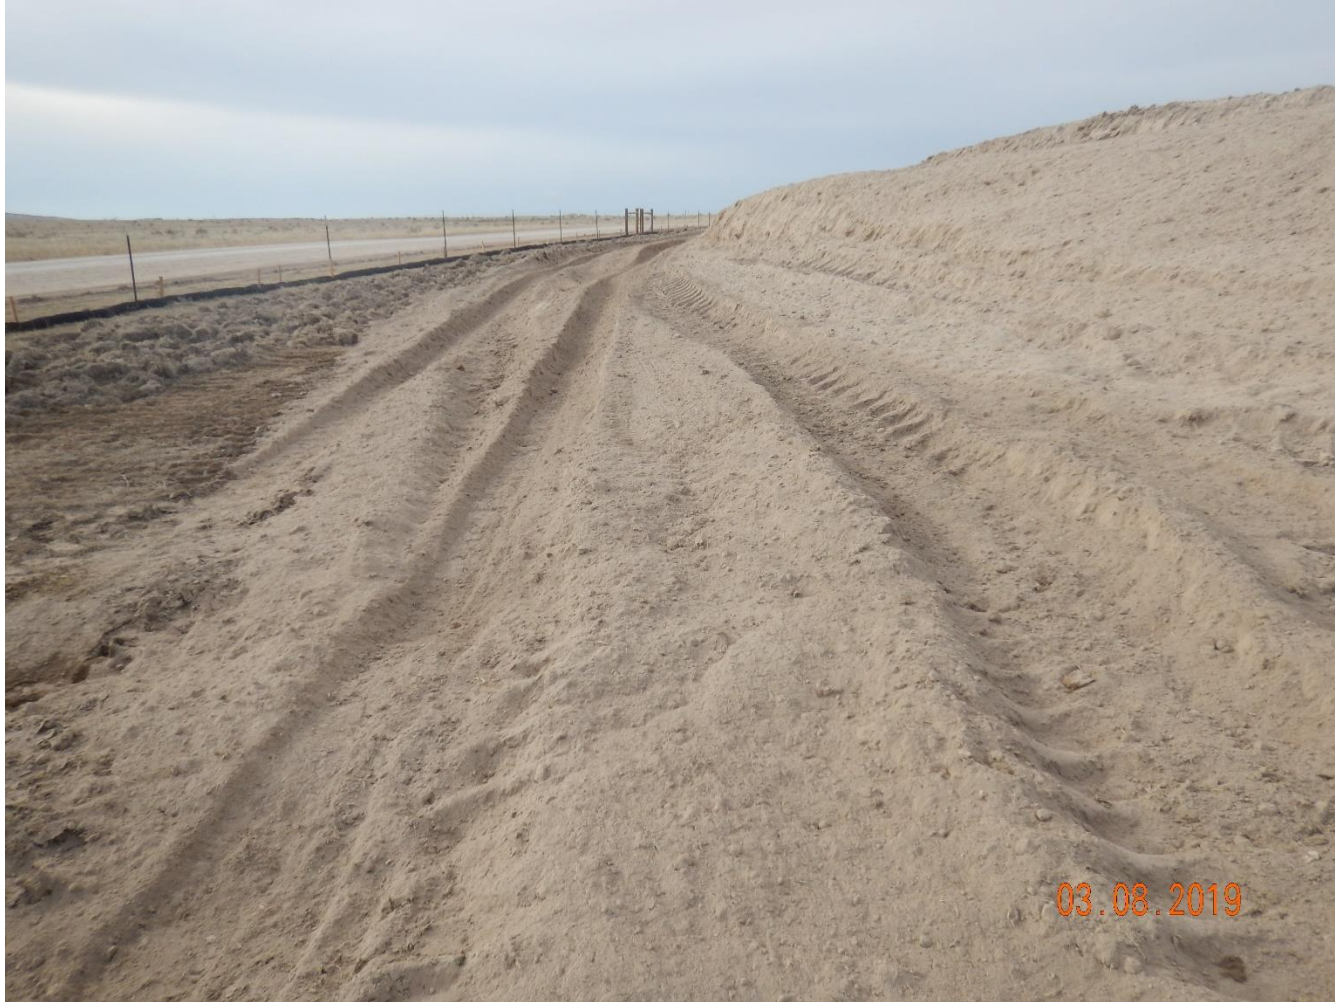
Photo 13: Photo taken from the south end of the location, facing west. Photo shows unstabilized soils on location at risk to erosion degradation.
