Inspection Photos

API: 05-073-06065

Operator: NIGHTHAWK PRODUCTION LLC

Inspection Date: 3/11/2019

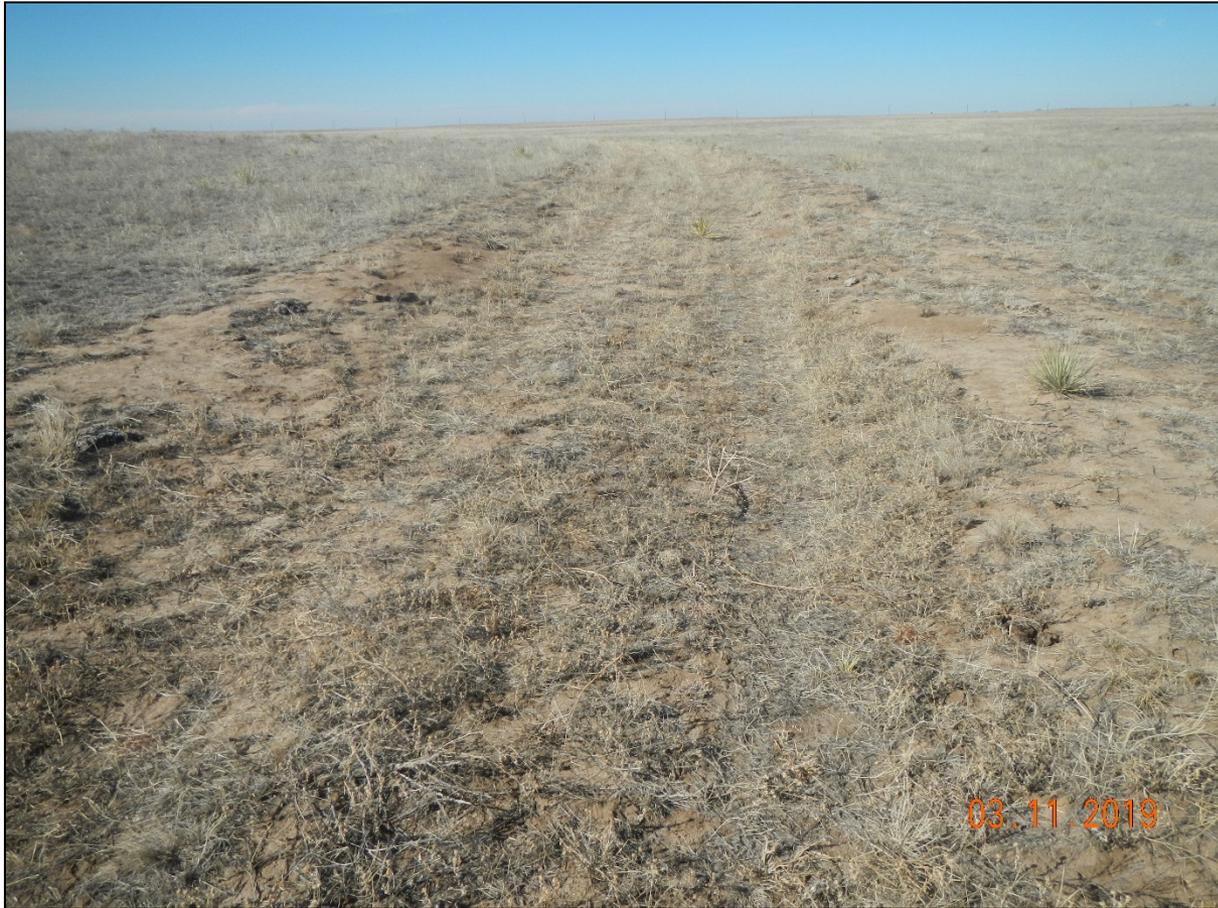
Photo 1. Facing north along the access road. Vegetation has established along areas of the road.

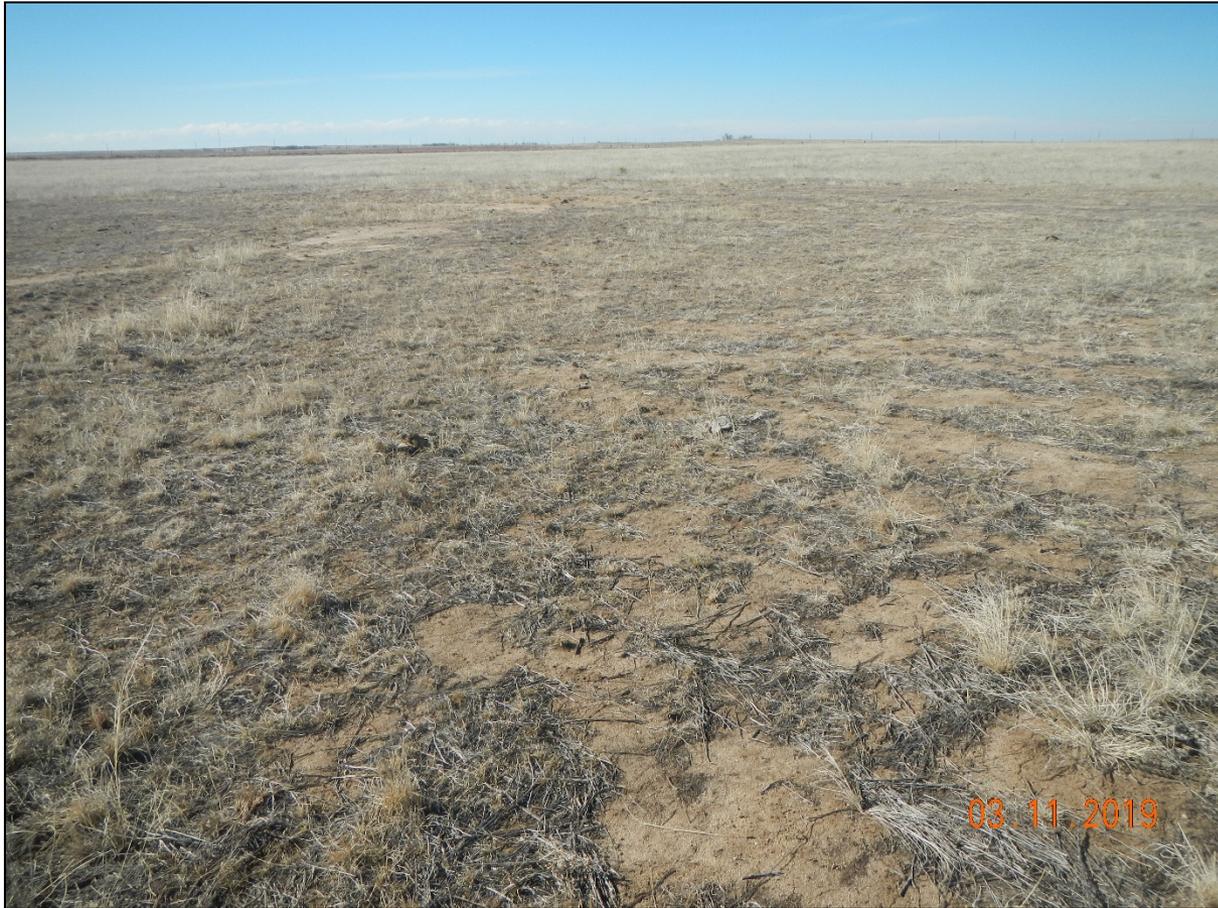
Photo 2. Facing northwest toward the location. Vegetation is establishing in areas of the location.

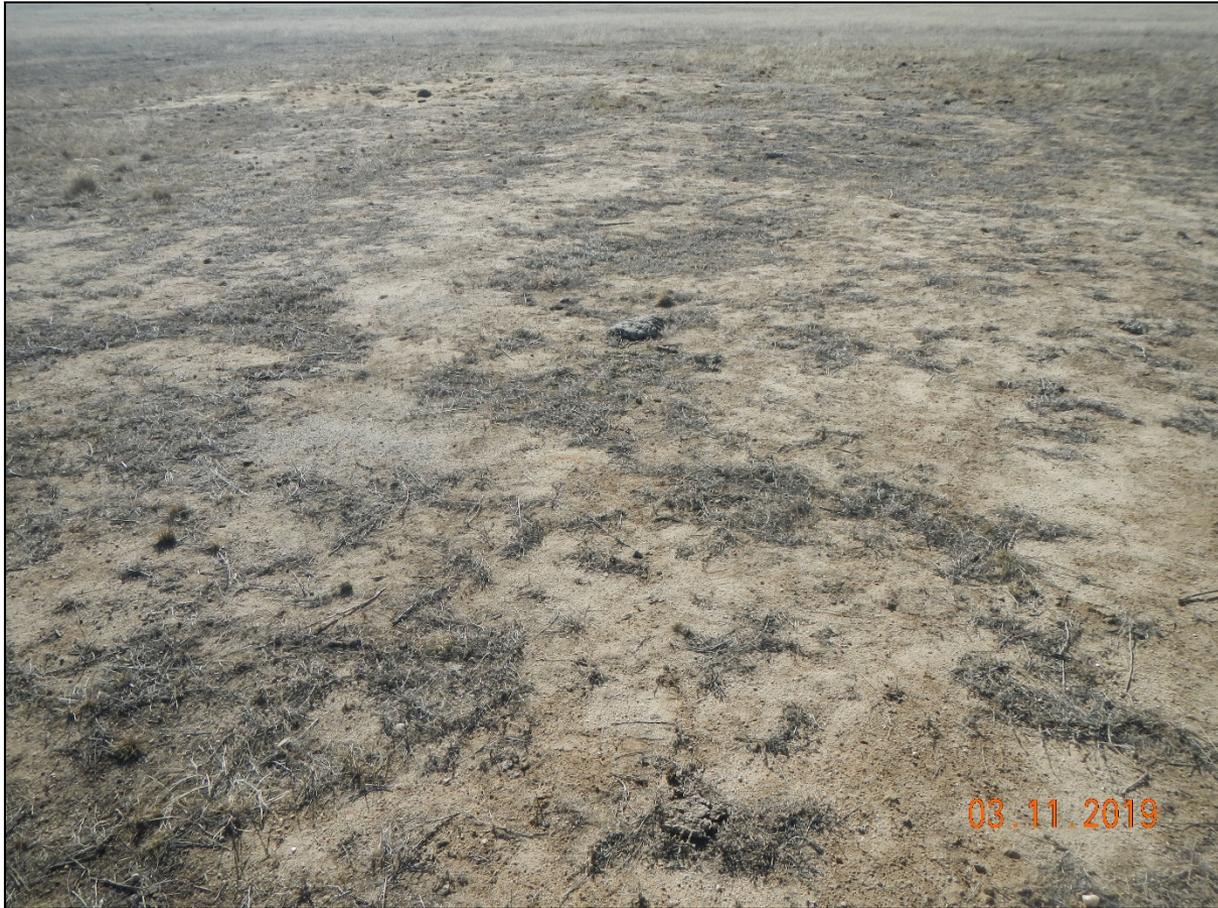
Photo 3. Facing west at the location. This area does not appear to have adequate vegetation cover.

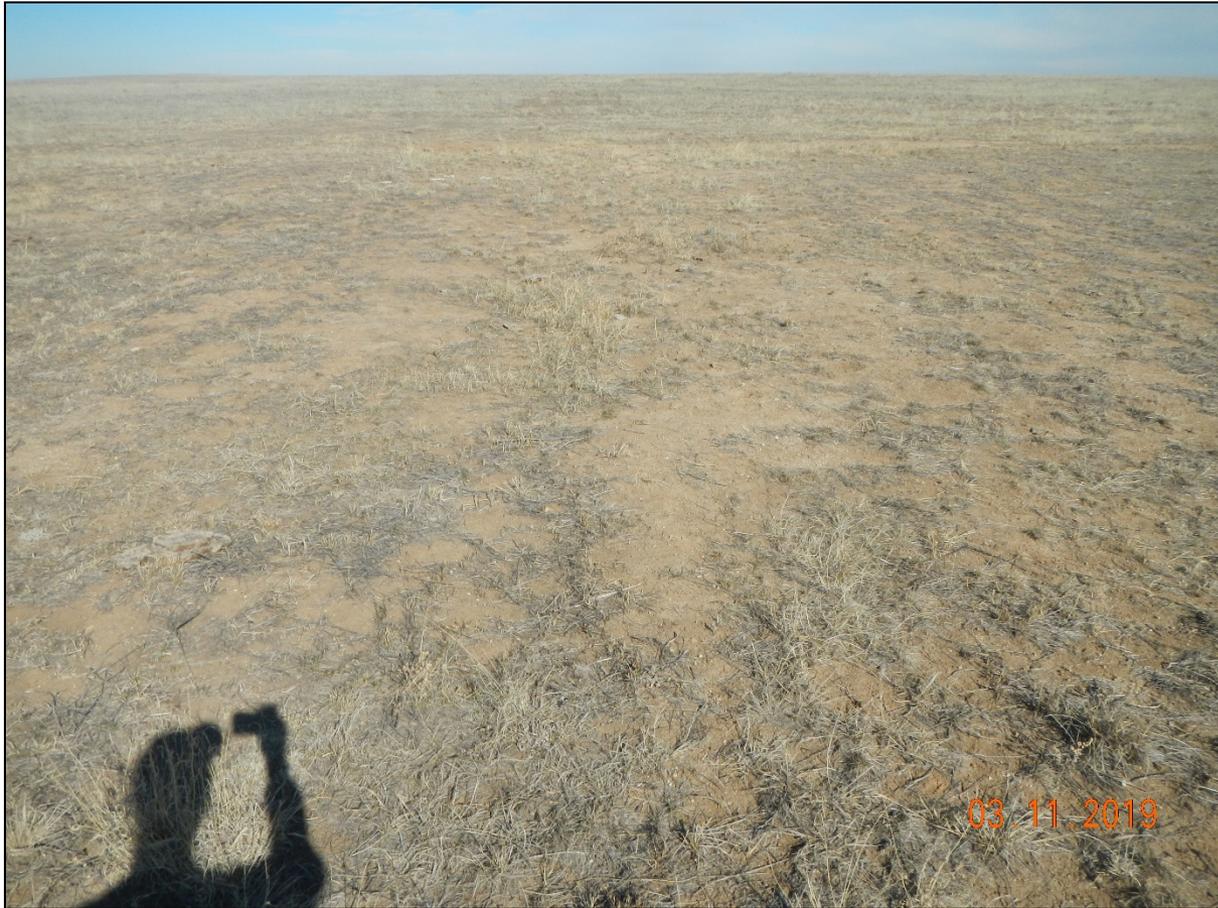
Photo 4. Facing east toward the location. Vegetation is establishing in areas of the location.

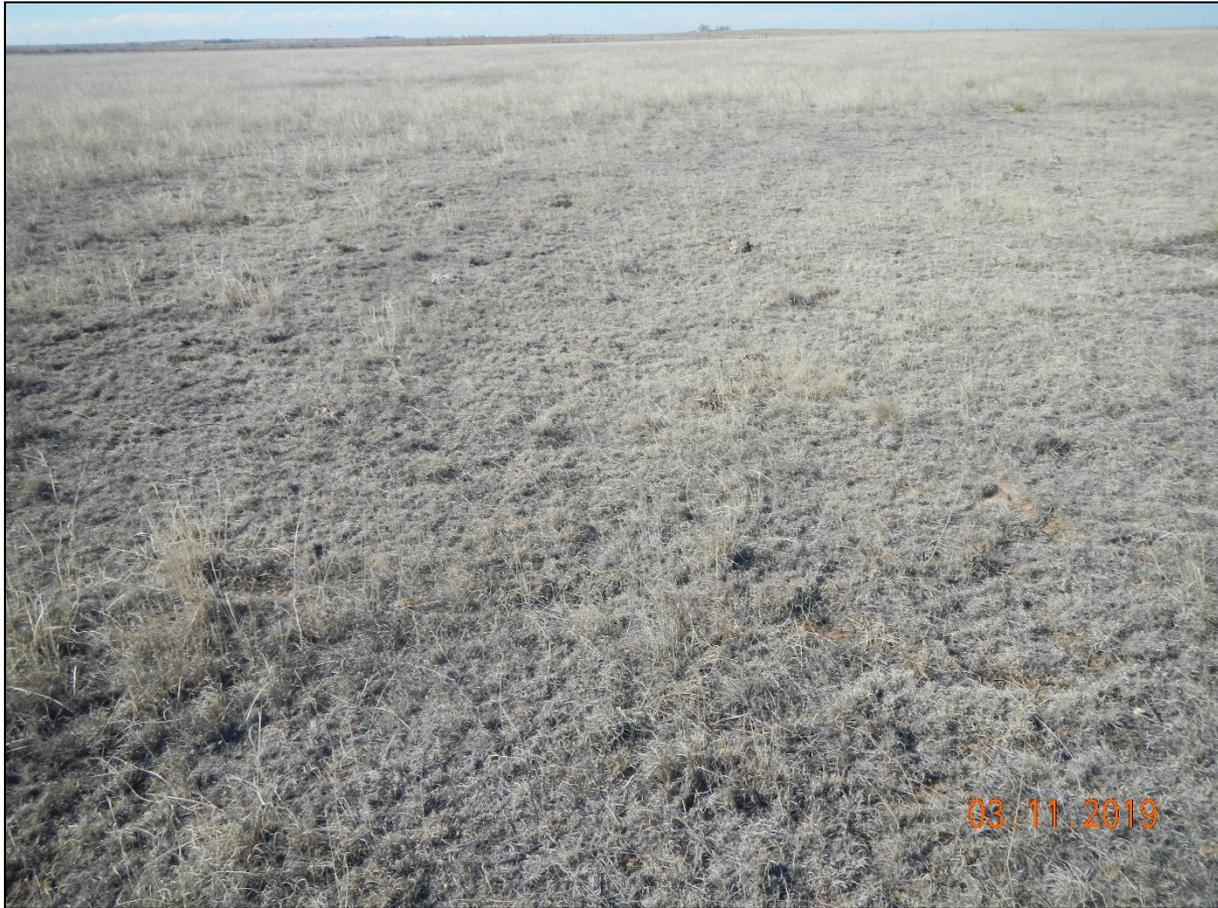
Photo 5. Facing north at the surrounding undisturbed pasture.

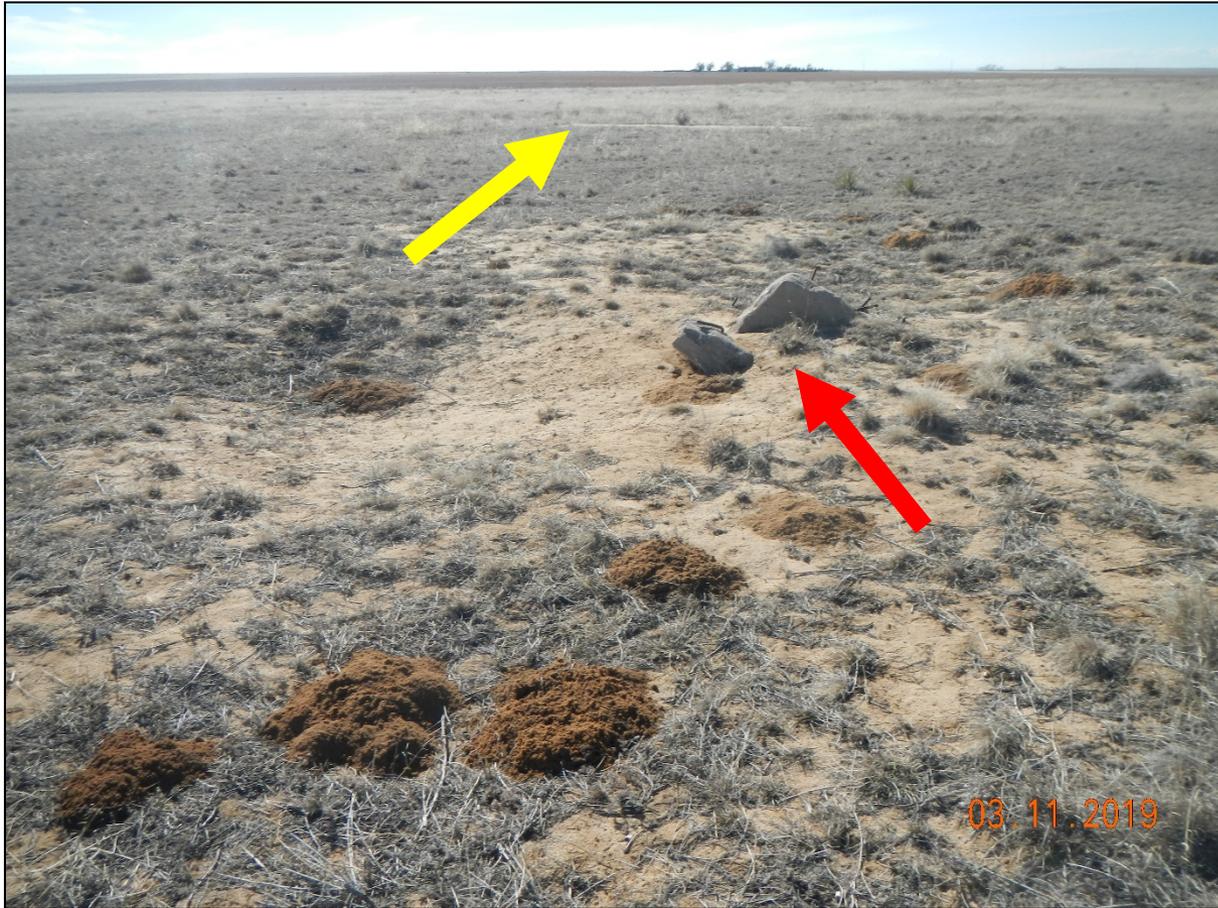
Photo 6. South of the location at:Lat/Long:38.79662,-103.65101. A chunk of cement remains (red arrow). This appears to be old battery site. A possible cement pad (yellow arrow) can be seen in aerial photo.

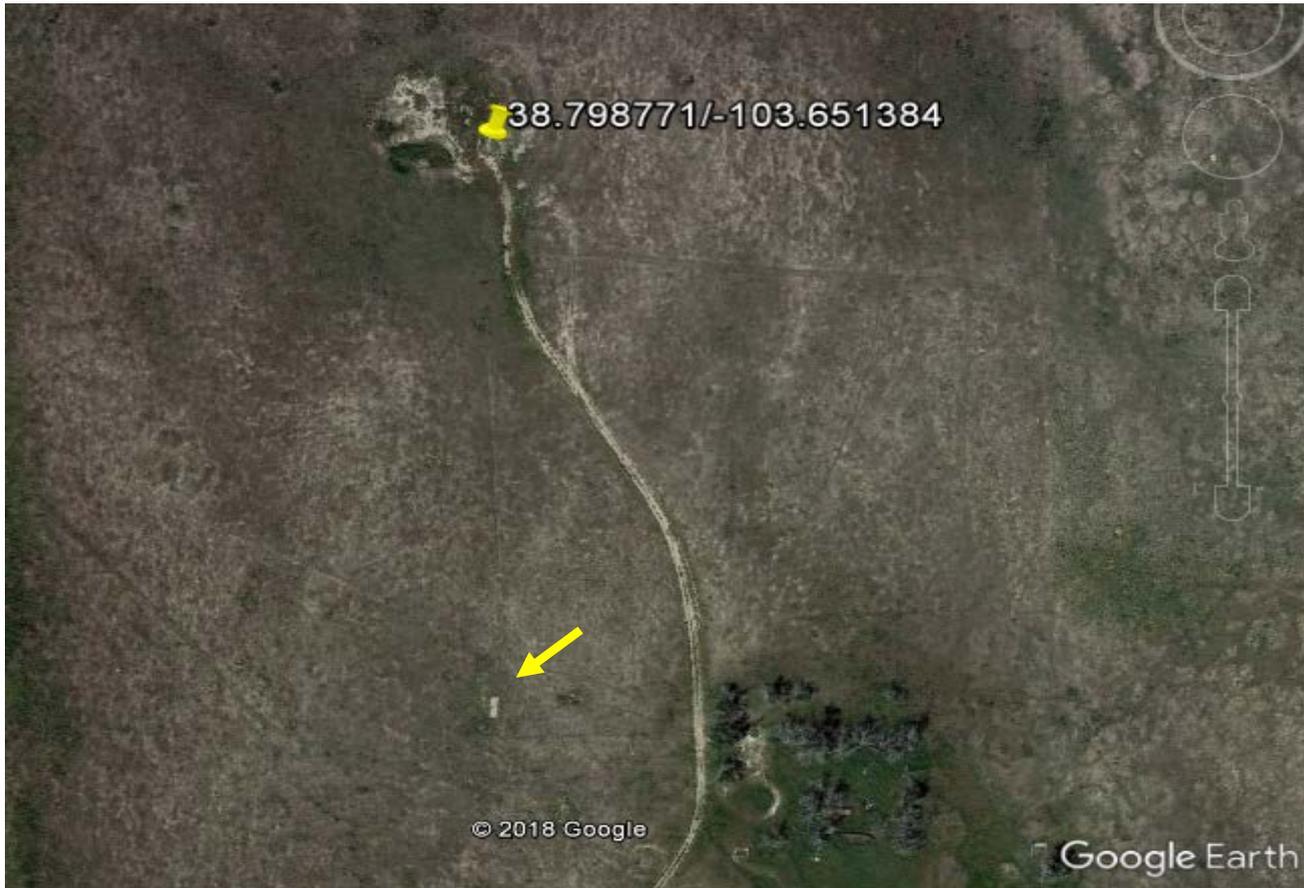
Photo 7. Yellow arrow points to possible cement pad at the battery site. Follow up inspection needs to be performed to evaluate.
