PIT STATUS EVALUATION FORM

Facility ID: 115088

Pit Name: MILLER 41-5 1

S.S. PAPADOPULOS & ASSOCIATES, INC.

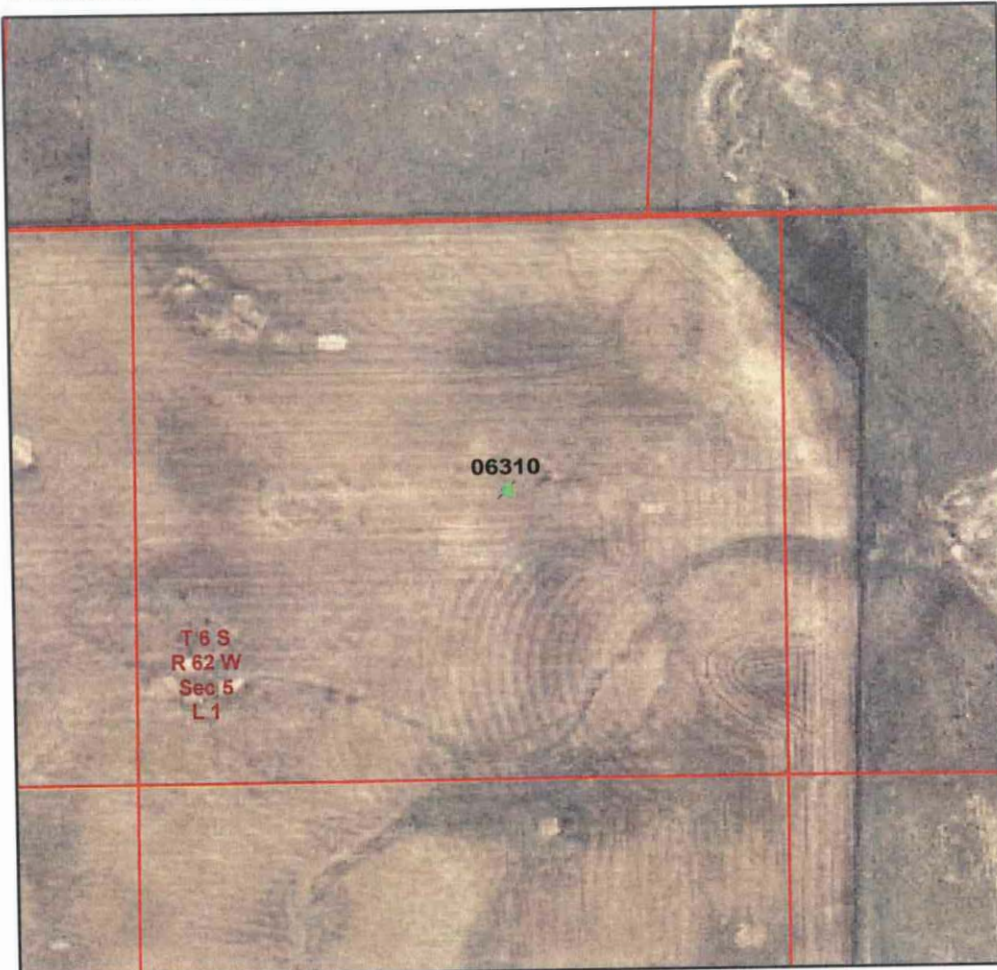
Notes: LIF (1982) 10'x14' pit, no produced water; recommend covered
skim pit. Aerials indicate site recontoured.
