**Inspection Photos**  
**Location Name: BOUNCER 41-27 AND TR**  
**API #: 05-071-07610**  
**Insp. Doc. # 695100349**

Location Name: BOUNCER 41-27 AND TR

API #: 05-071-07610

Insp. Doc. # 695100349

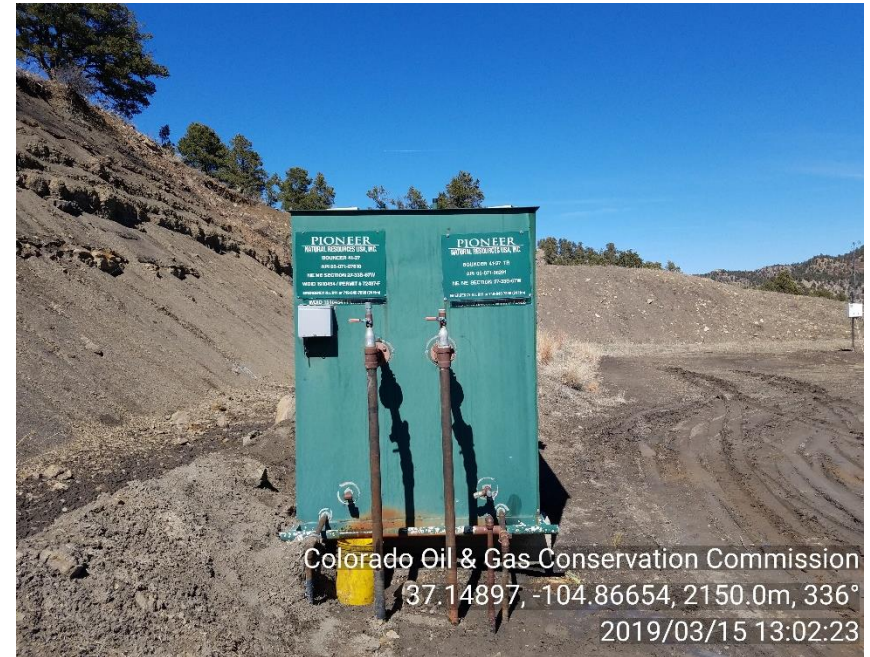
**PHOTO 2: WELL SIGN/METER HOUSE**

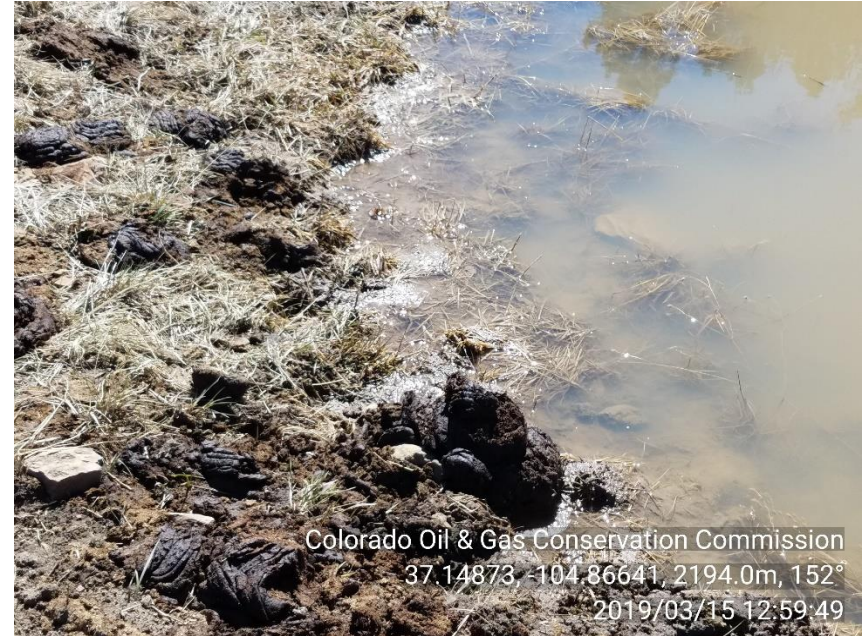
**PHOTO 3: PRODUCED WATER IN PIT IS ABOVE THE 2' FREEBOARD.**

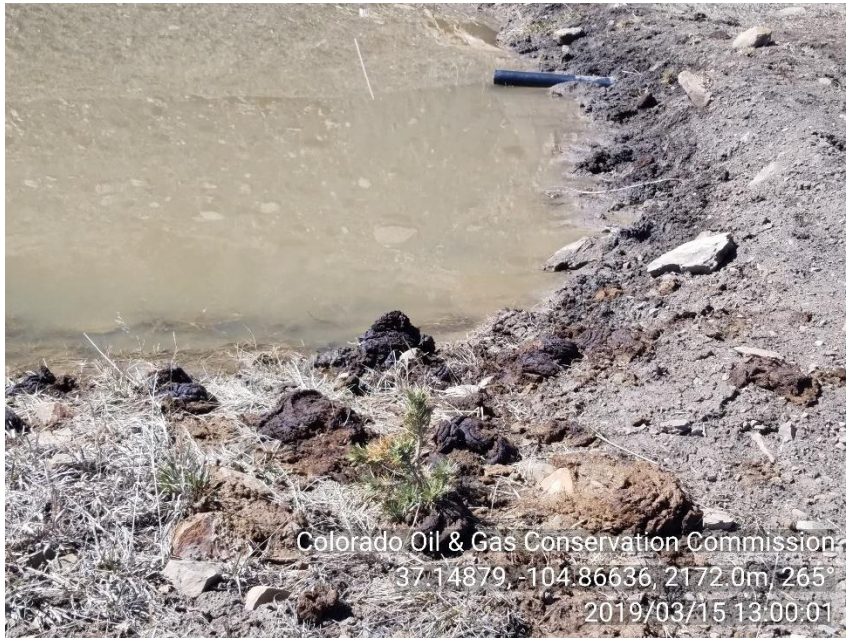
**PHOTO 5: PRODUCED WATER IN PIT IS ABOVE THE 2' FREEBOARD.**

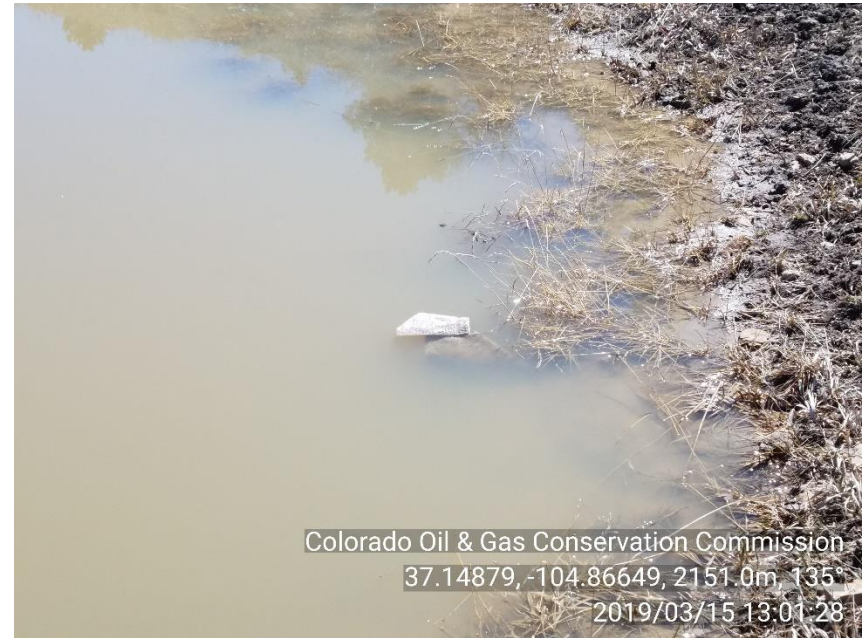
**PHOTO 6: PRODUCED WATER IN PIT IS ABOVE THE 2' FREEBOARD.**

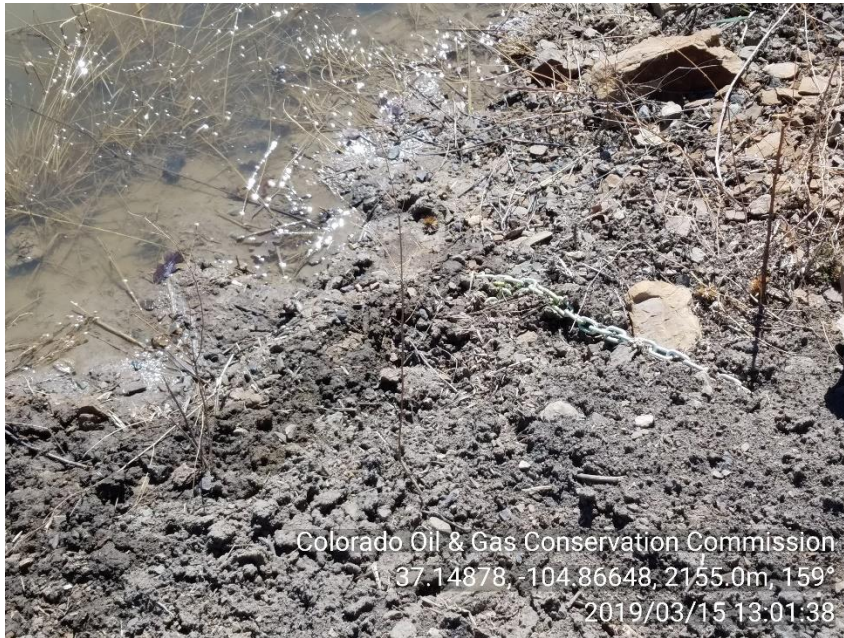
**PHOTO 7: FREEBOARD MARKER IS IMPROPERLY INSTALLED  
ON THE HIGHER ELIVATION SIDE OF PIT.**
