Inspection Photos
Location Name: TYRANNOSAURUS 43-22
API #: 05-071-07533
Insp. Doc. # 695100351

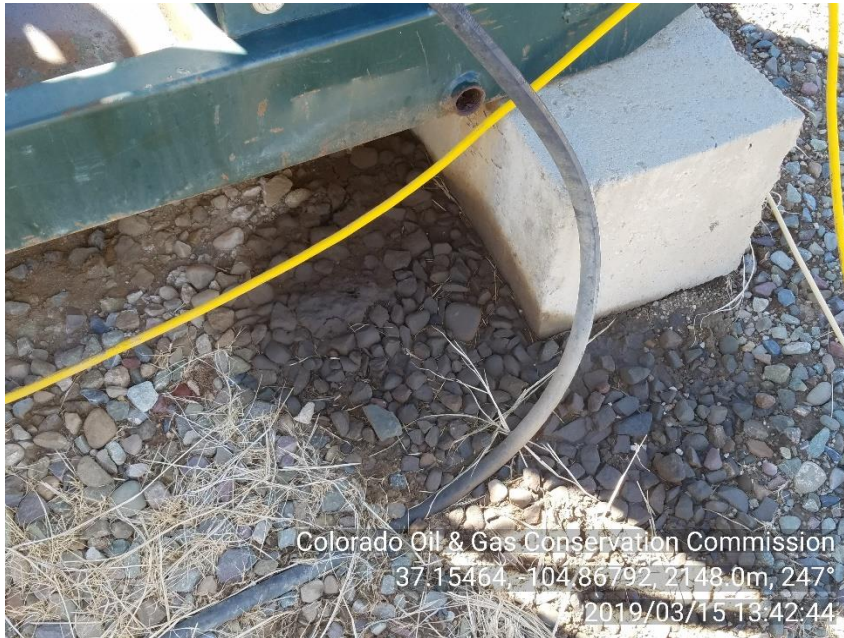
PHOTO 3: IMPACTED SOIL ON EAST SIDE OF ENGINE SKID

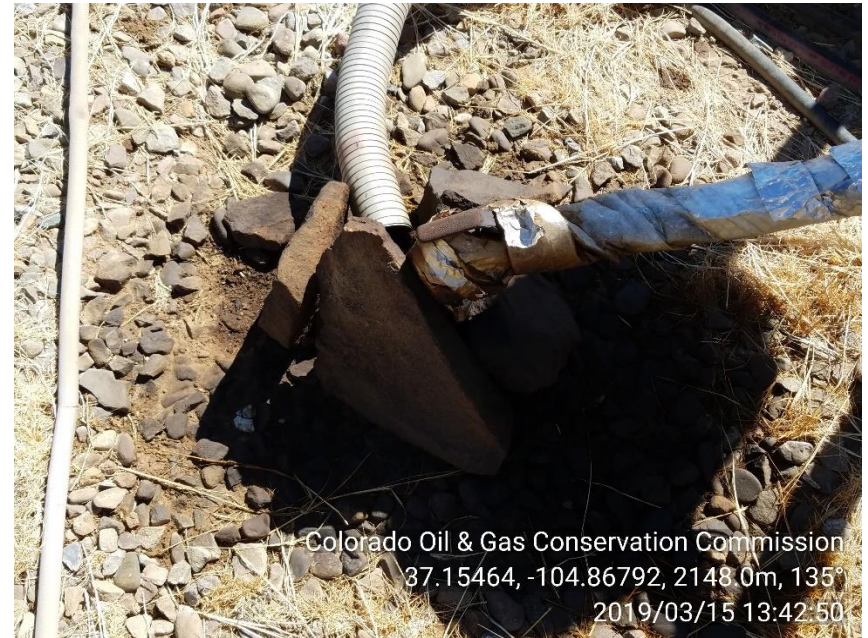
PHOTO 4: IMPACTED SOIL ON EAST SIDE OF SKID AT END OF EXHAUST PIPE OUTLET.
