Inspection Photos
Location Name: APPALOOSA 42-22
API #: 05-071-07547
Insp. Doc. # 695100353

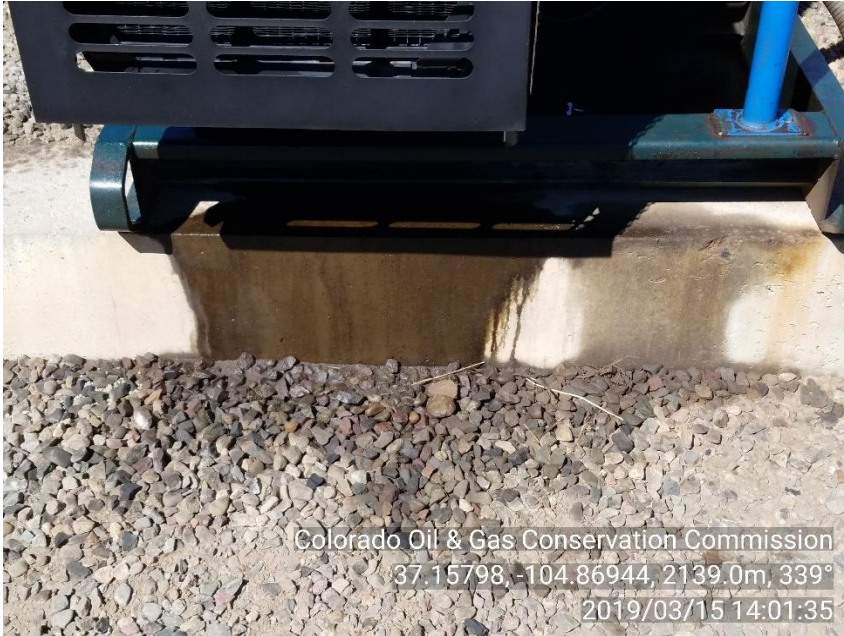
PHOTO 3: OIL FROM ENGINE IS RUNNING DOWN CONCRETE BLOCK AND IMPACTING SOIL.

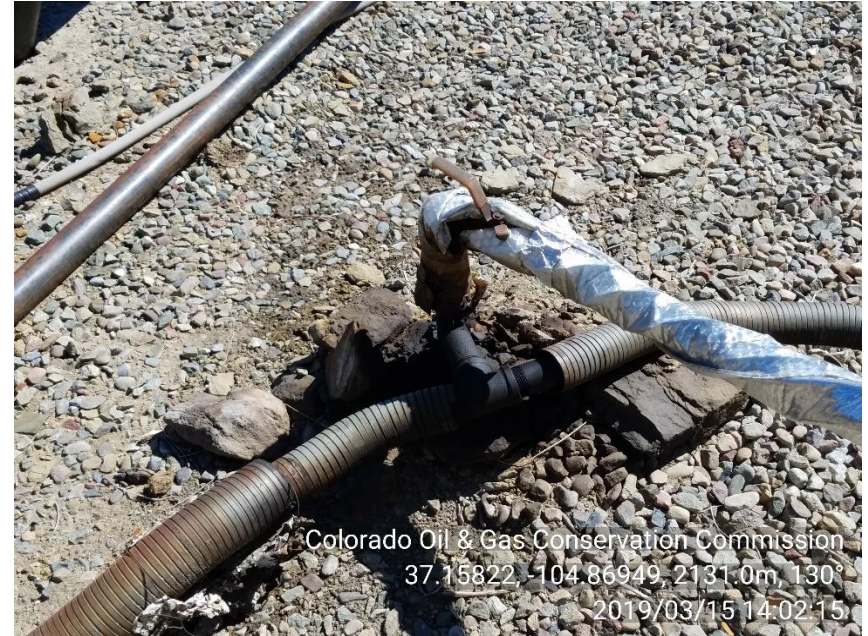
PHOTO 4: IMPACTED SOIL NEAR EXHAUST PIPE ON EAST SIDE OF ENGINE SKID.

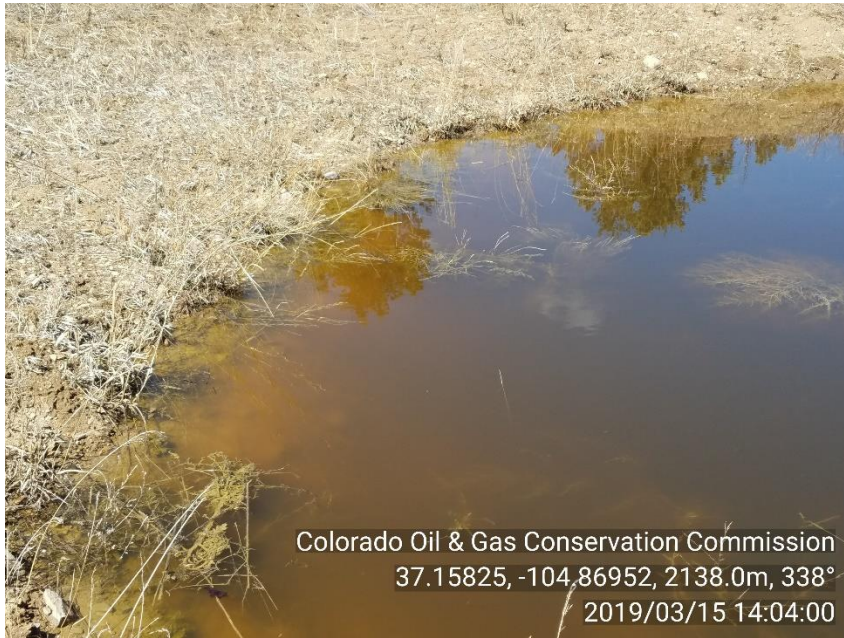
**PHOTO 5: PRODUCED WATER IS ABOVE 2' FREEBOARD. I
COULD NOT FIND A FREEBOARD MARKER**

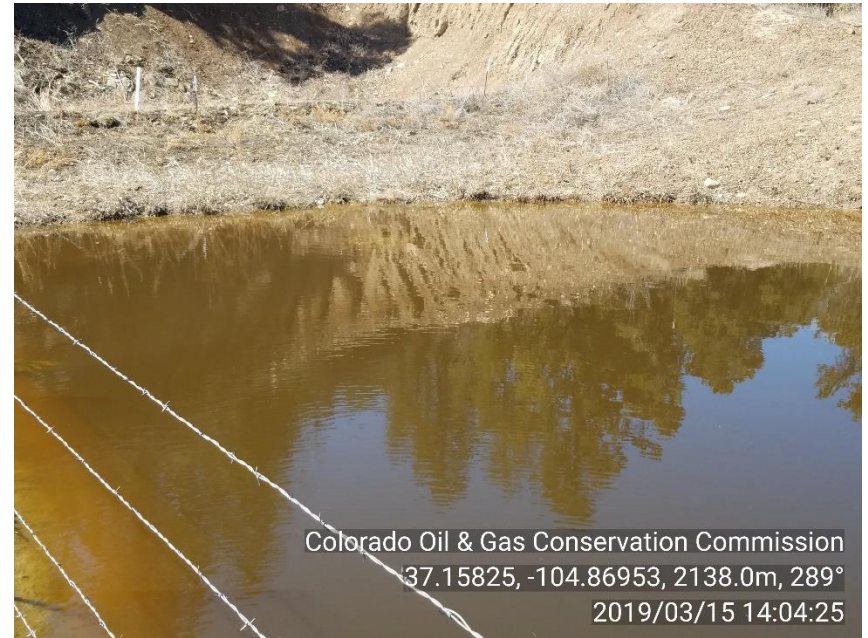
**PHOTO 6: ANOTHER VIEW OF PRODUCED WATER LEVEL
ABOVE 2' FREEBOARD.**
